Archaeological Excavation Report

# FORGE MILL CONGLETON

For Nexus Heritage

Doc Ref: LP2381C-AMR-v1.5

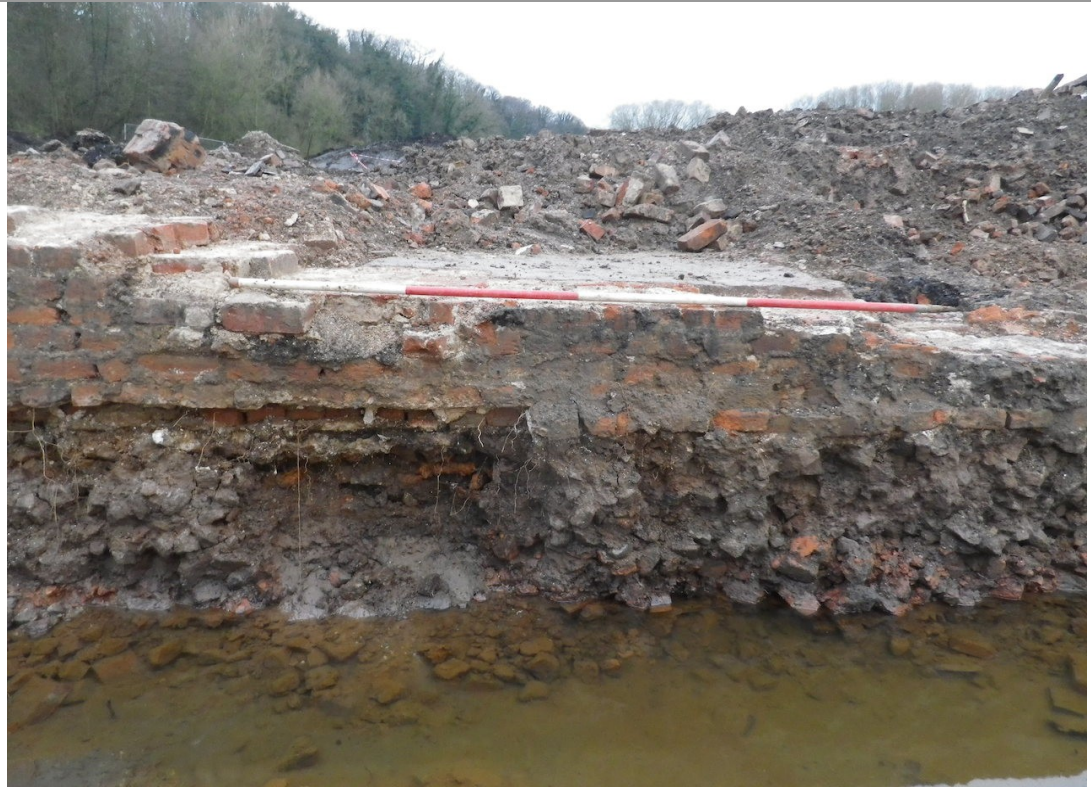
Plate 1 - Detail of south facing section of Trench 4, showing Phase 2 brick rubble deposit (50) beneath Carding Room wall foundation (11), with 1 x 2m scale.

5.2.5. Deposit (50) was initially thought to be the backfill of a void associated with machinery for the Carding Shed; however, the foundations of wall (11) could be seen to be laid over the top of deposit (50) ( Plate 1). This would suggest that deposit (50) was the backfill of a large void cut in to layer (3) but pre-dating the construction of the Carding Shed. Deposit (50) did not extend south beyond the Phase 4 flue wall (49) and it was removed to the north of wall (11) by the construction of substantial later cellared structures ( Plate 2). The

5.2.8. The northern wall (11) of the Carding Room was 0.48m wide and consisted of a foundation course of brick headers laid directly on to Phase 2 rubble deposit (50). Towards the western end of wall (11) there was a greater depth of foundation courses ( Plate 3); however, this lower brickwork was slightly off-set and it is possible that it represents part of an earlier structure associated with brick rubble (50). Above the header course wall (11) had six surviving brick stretcher courses bonded in an off-white lime mortar, giving the wall a surviving height of 0.45m. The average brick dimensions for wall (11) were 230 x 110 x 70 mm. The eastern end of wall (11) was bonded to (and of the same construction phase as) the outer wall (63) of the Stair-Chimney.

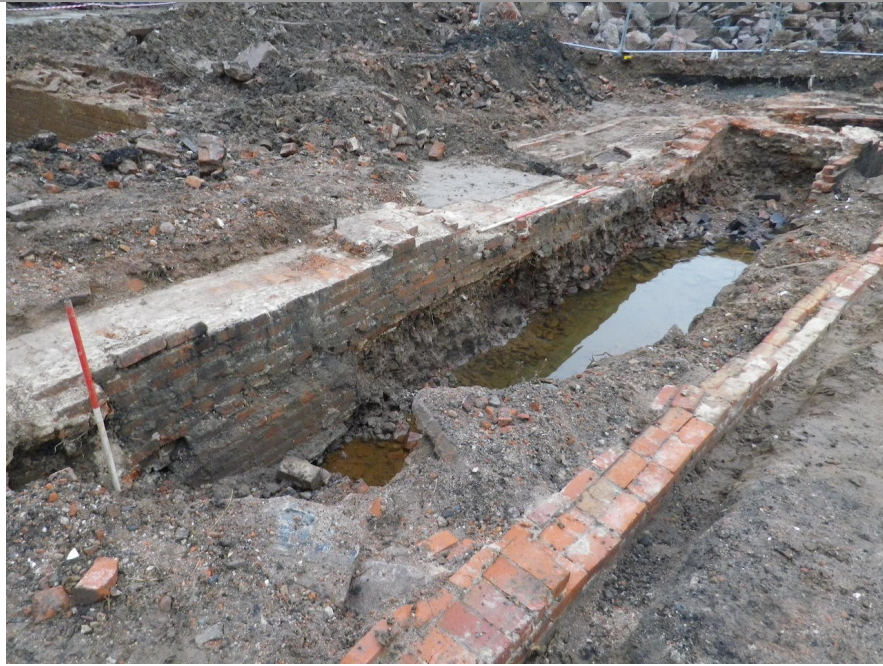
Plate 2 - South facing section of Trench 4, showing Phase 2 brick rubble deposit (50) beneath Carding Room wall foundation (11), with 1 x 2m scale.

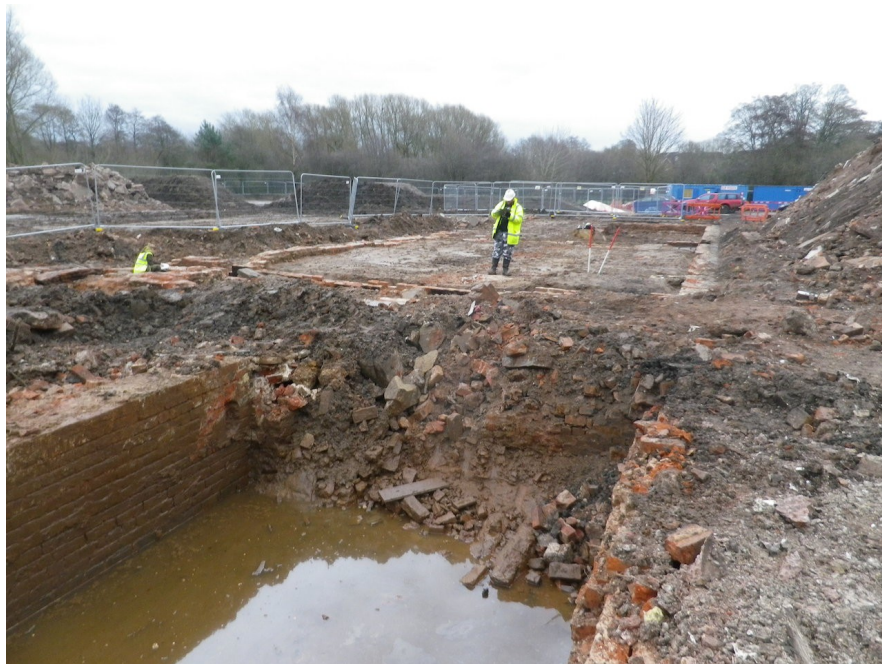
Plate 3 - Looking south towards Trench 4, showing the later brick cellar north of Carding Room wall foundation (11).

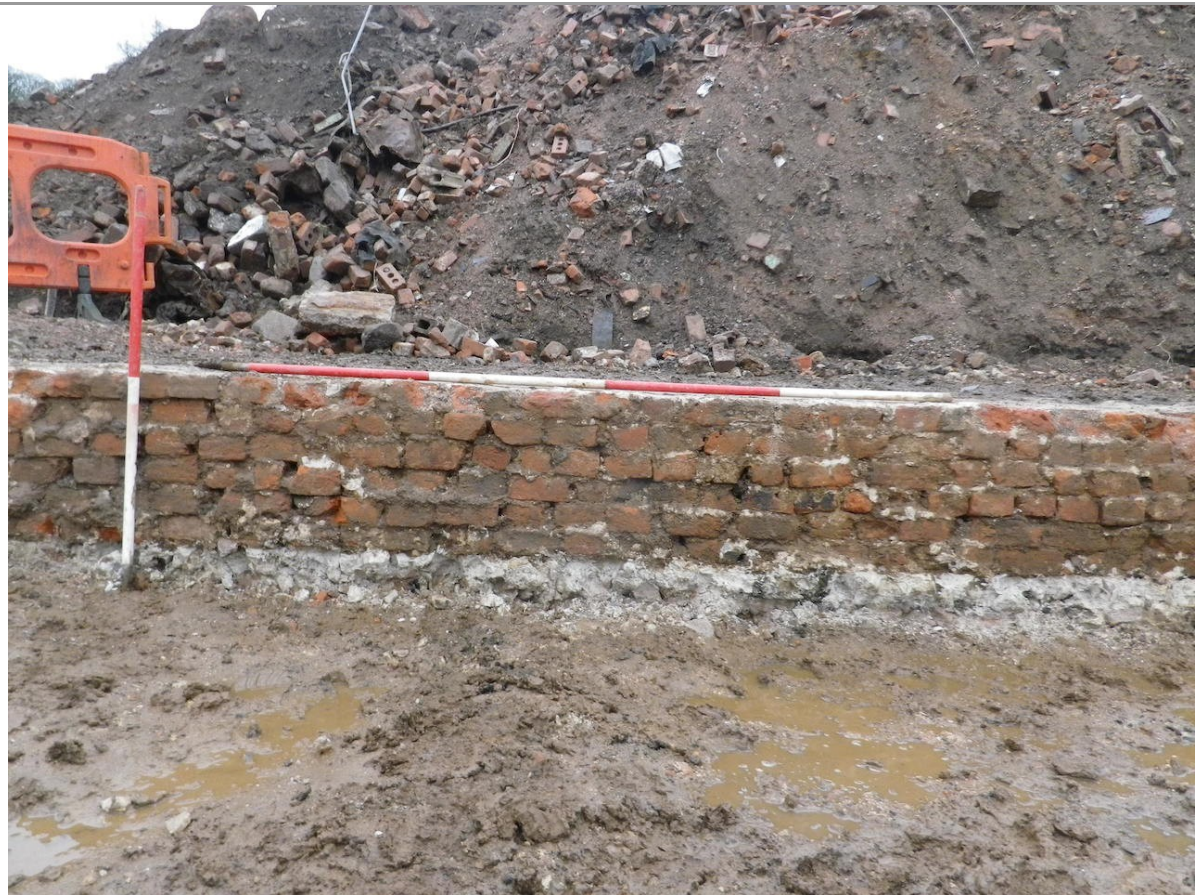
Plate 5 - Trench 4. Looking west, showing the mortar and brick wall elevation of Carding Room wall foundation (14), 1 x 1m and 1 x 2m scale.

5.2.9. The western wall (14) of the Carding Room was 0.6m wide and consisted of a foundation of hard pale grey brick and lime mortar aggregate up to 0.13m thick ( Plate 5). Above the aggregate foundation there were six surviving brick header courses bonded in an off-white lime mortar, giving the wall a surviving height of 0.45m. The wall (14) foundation was cut in to Phase 1 layer (3).

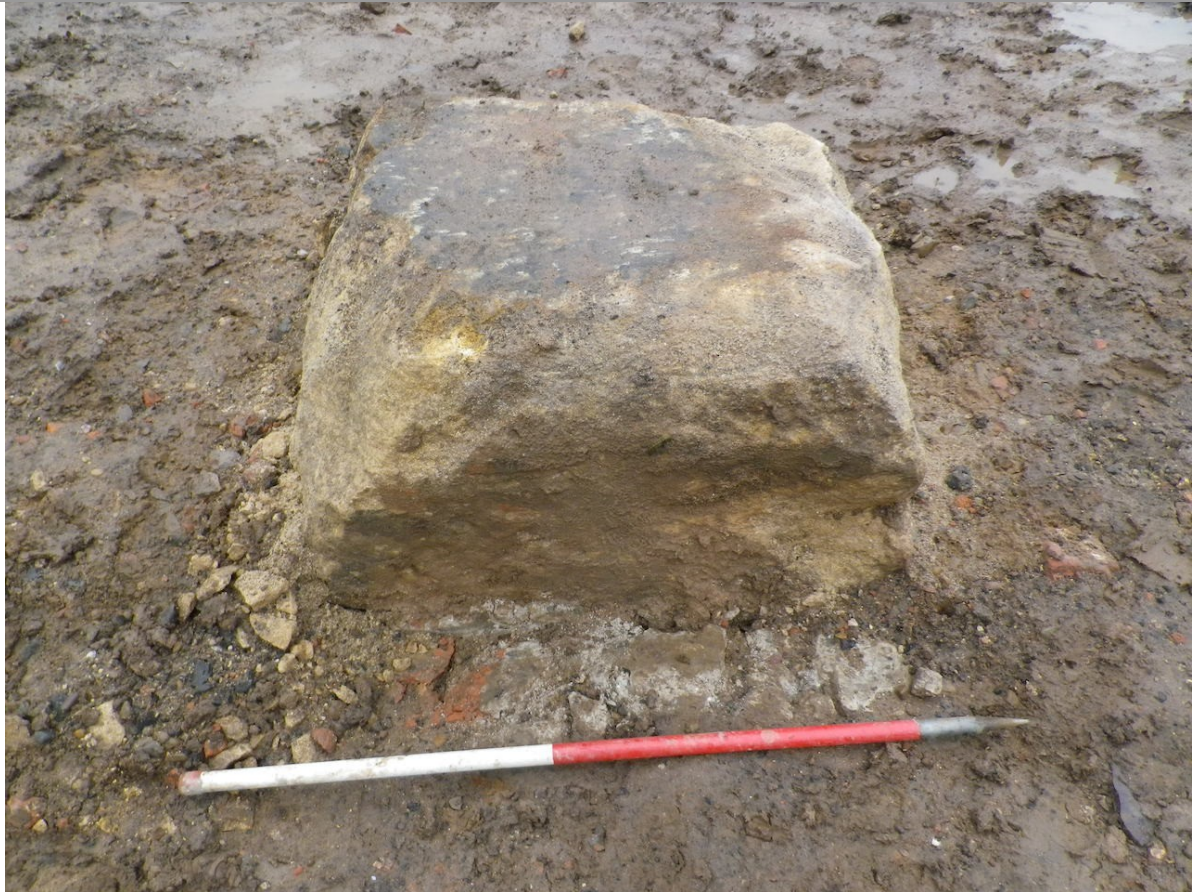
Plate 6 - Trench 4. Looking east, showing sandstone pier base (21) set on top of a pale grey mortar foundation, 1 x 1m scale.

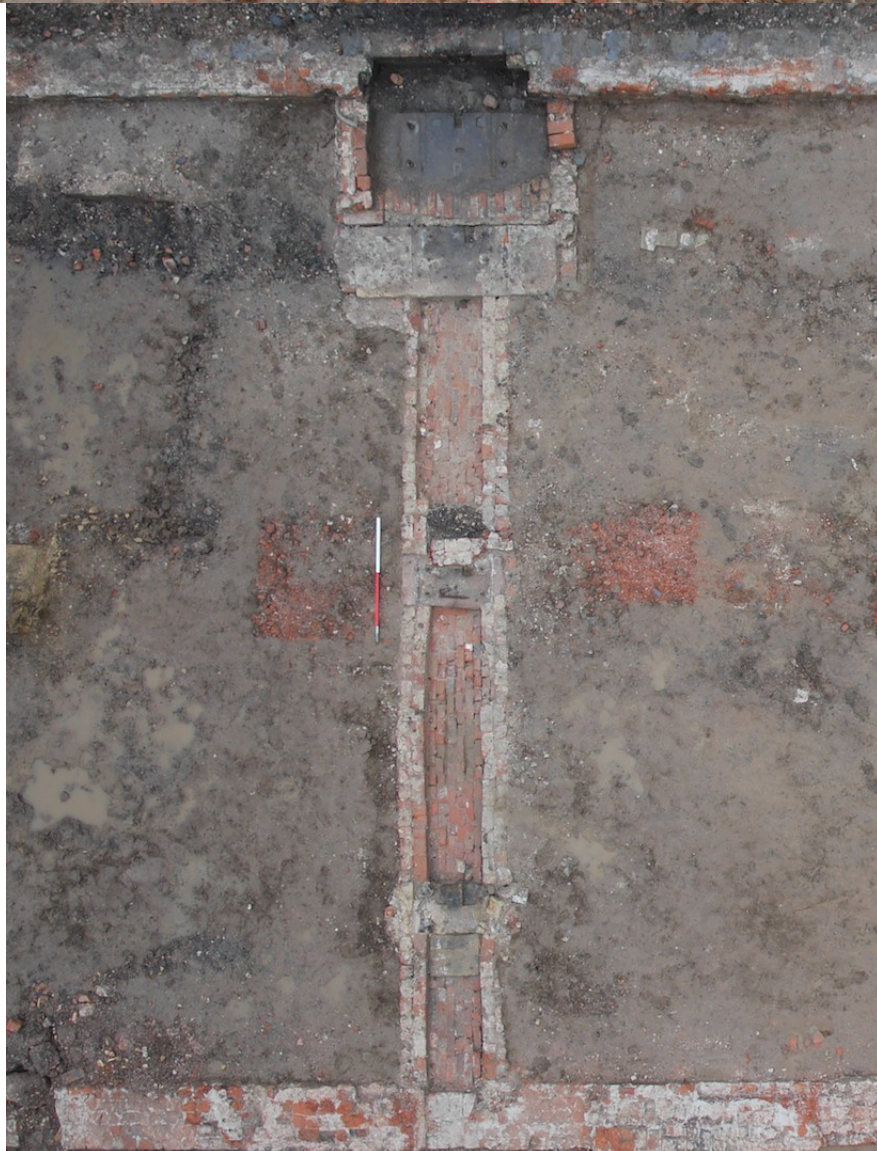
Plate 8 - Trench 4. Aerial view, showing brick and stone machine base (32) within the Carding Room, 1 x 1m scale.

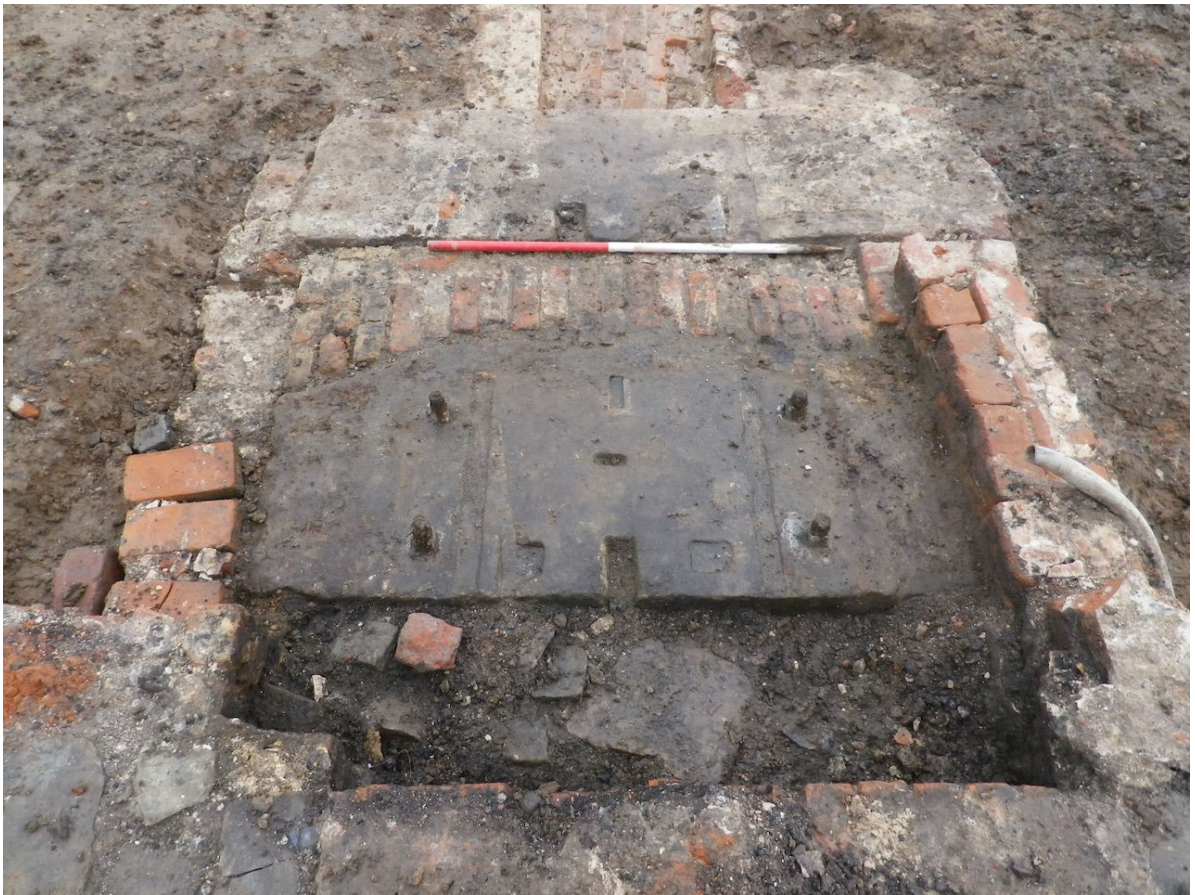
Plate 9 - Trench 4. Looking east, showing machine mounting blocks (45) and (43), 1 x 1m scale.

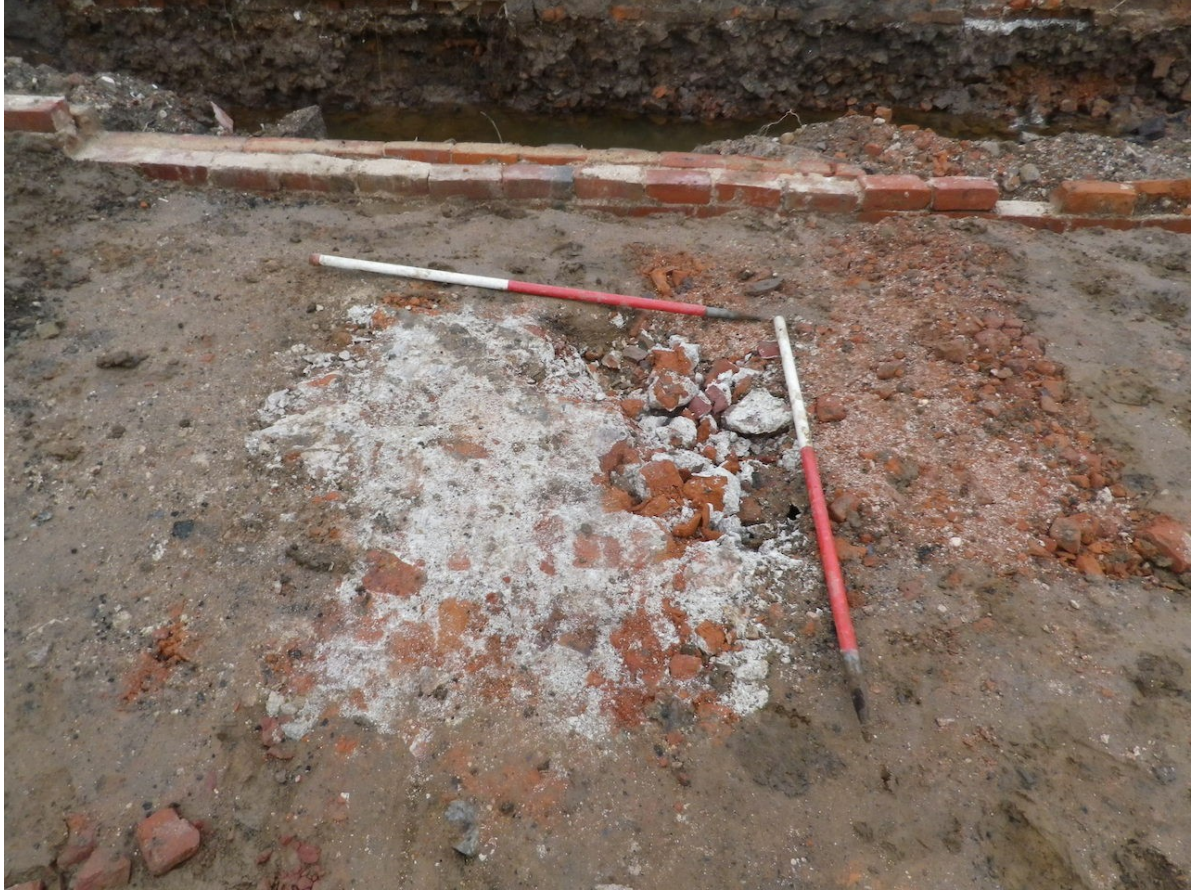
Plate 10 - Trench 4. Looking north, showing relocated pier base (64) cut in to original pier base (30), 2 x 1m scale.

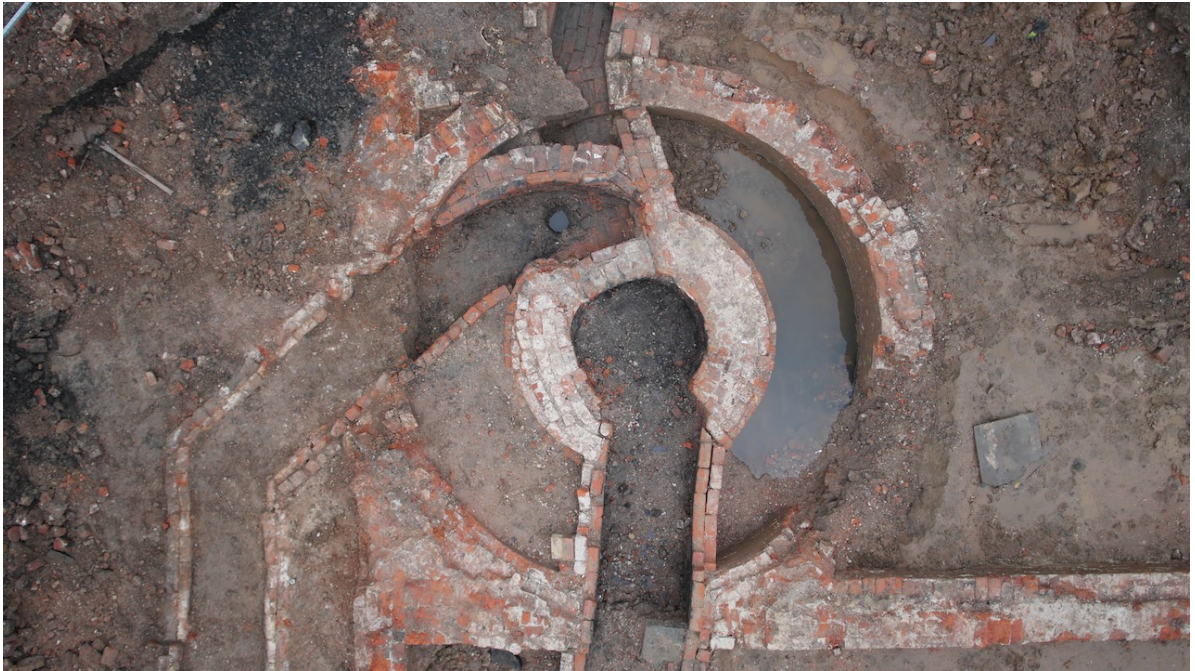
Plate 11 - Trench 1. Showing aerial view of Stair-Chimney (56)/(63) and (58) with the three successive flues.

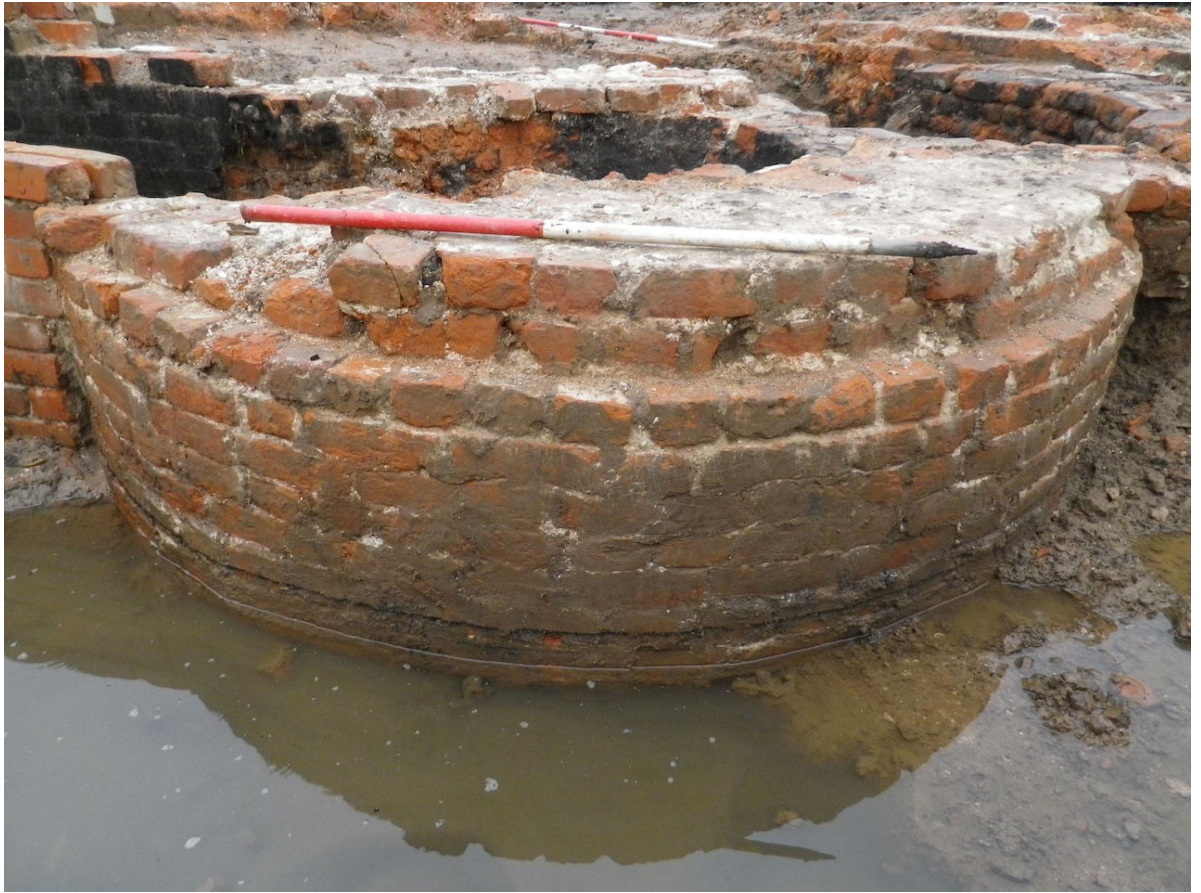
Plate 12 - Trench 1. Looking north-west showing the elevation of Chimney wall (58), 1 x 1m scale.

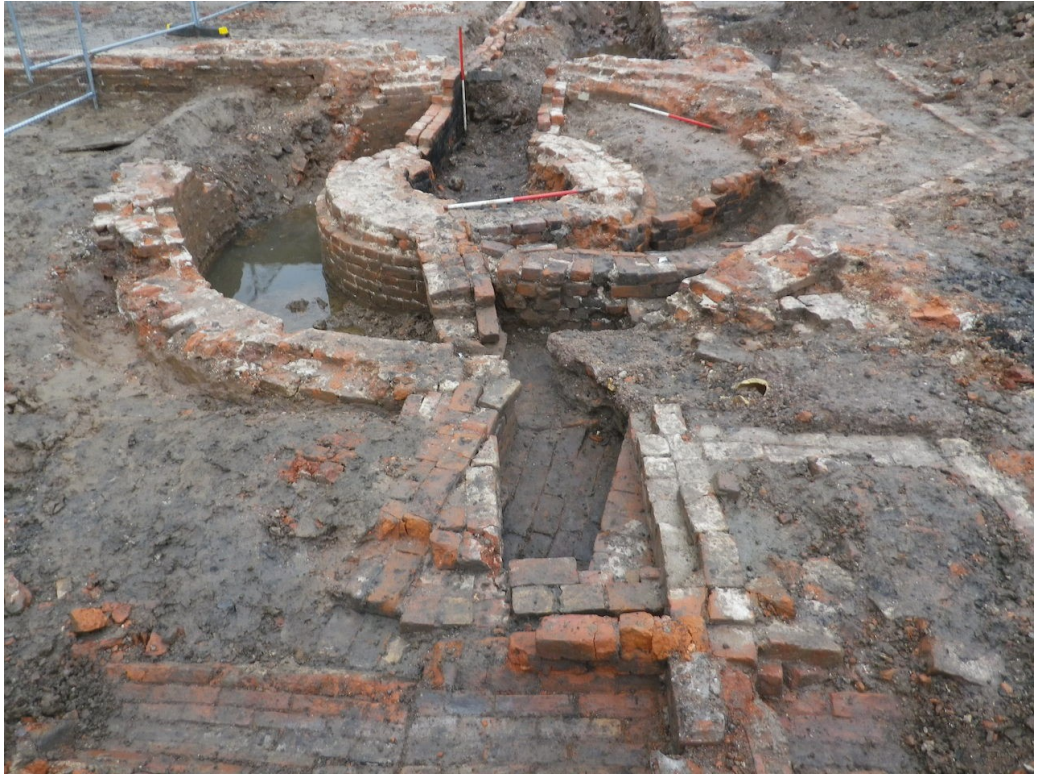
Plate 13 - Trench 1. Looking south-west showing Phase 3 flue wall (57), (66), (69) and flue floor (82), x 1m scale.

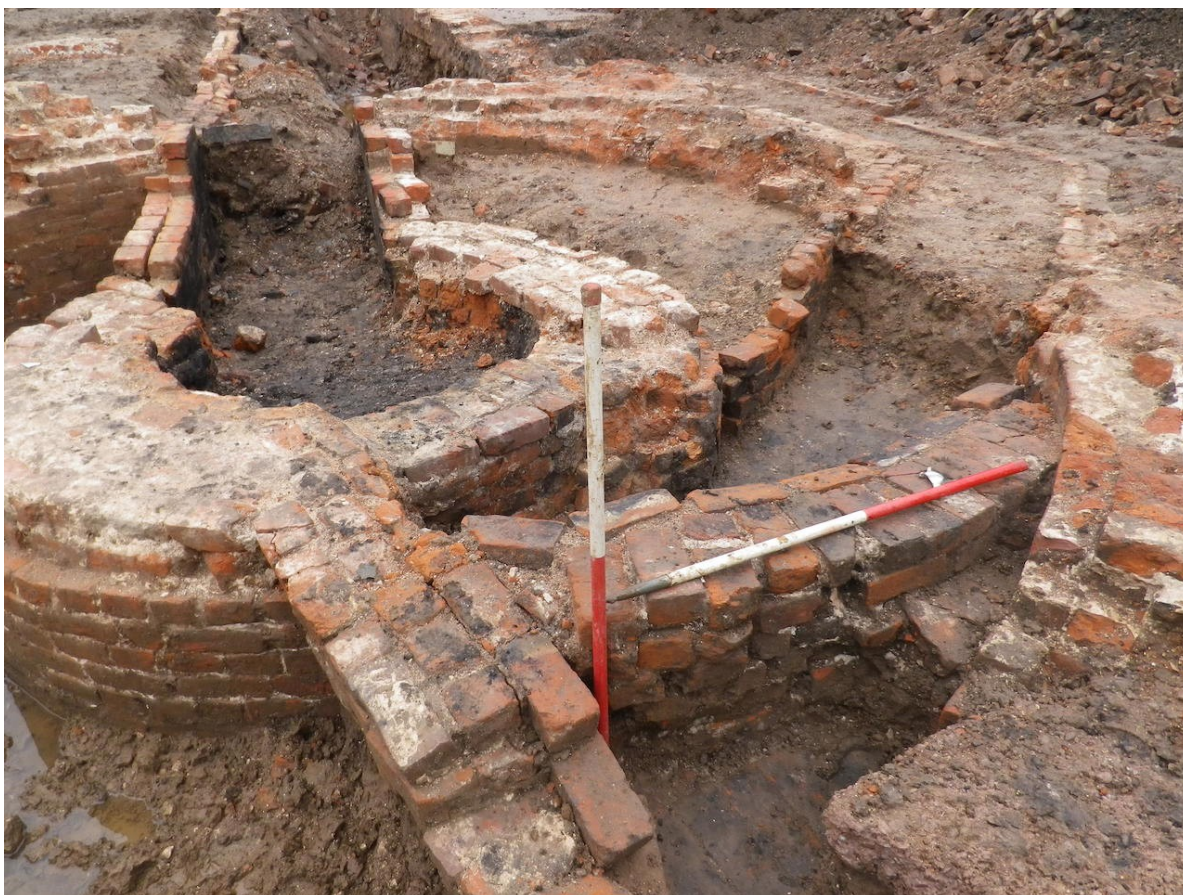
Plate 14 - Trench 1. Looking north-west showing the elevation of flue blocking wall (59), 2 x 1m scale.

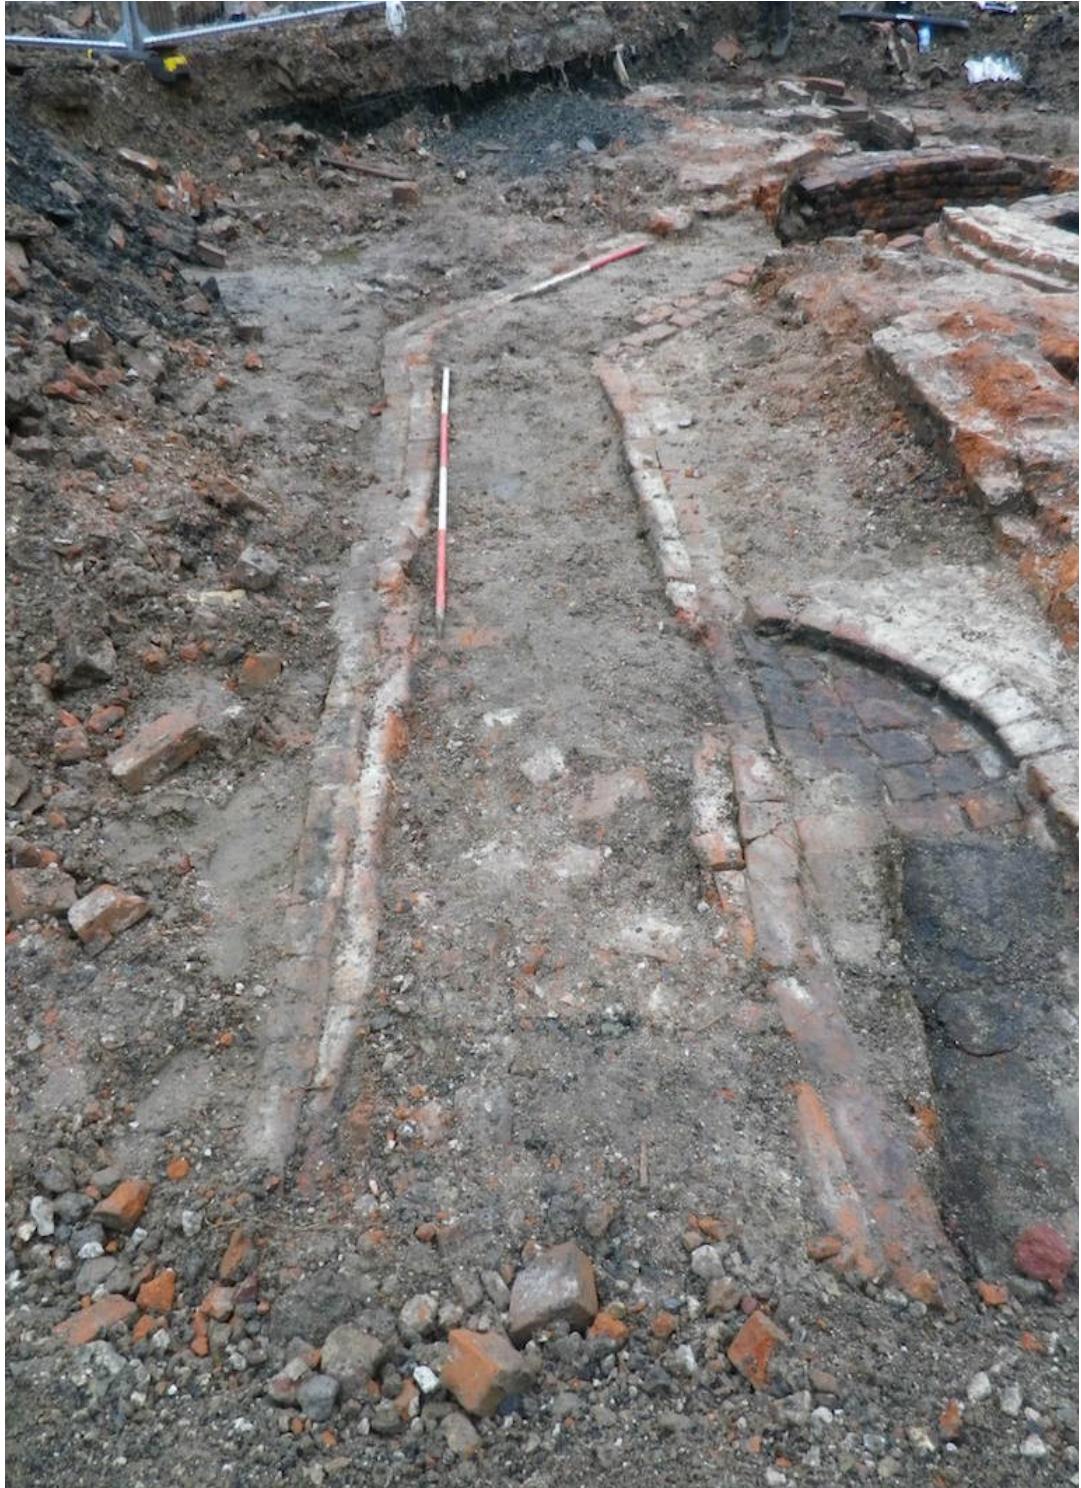
Plate 15 - Trench 1. Looking north-east showing the brick flue (75), 1 x 1m and 1 2m scale.

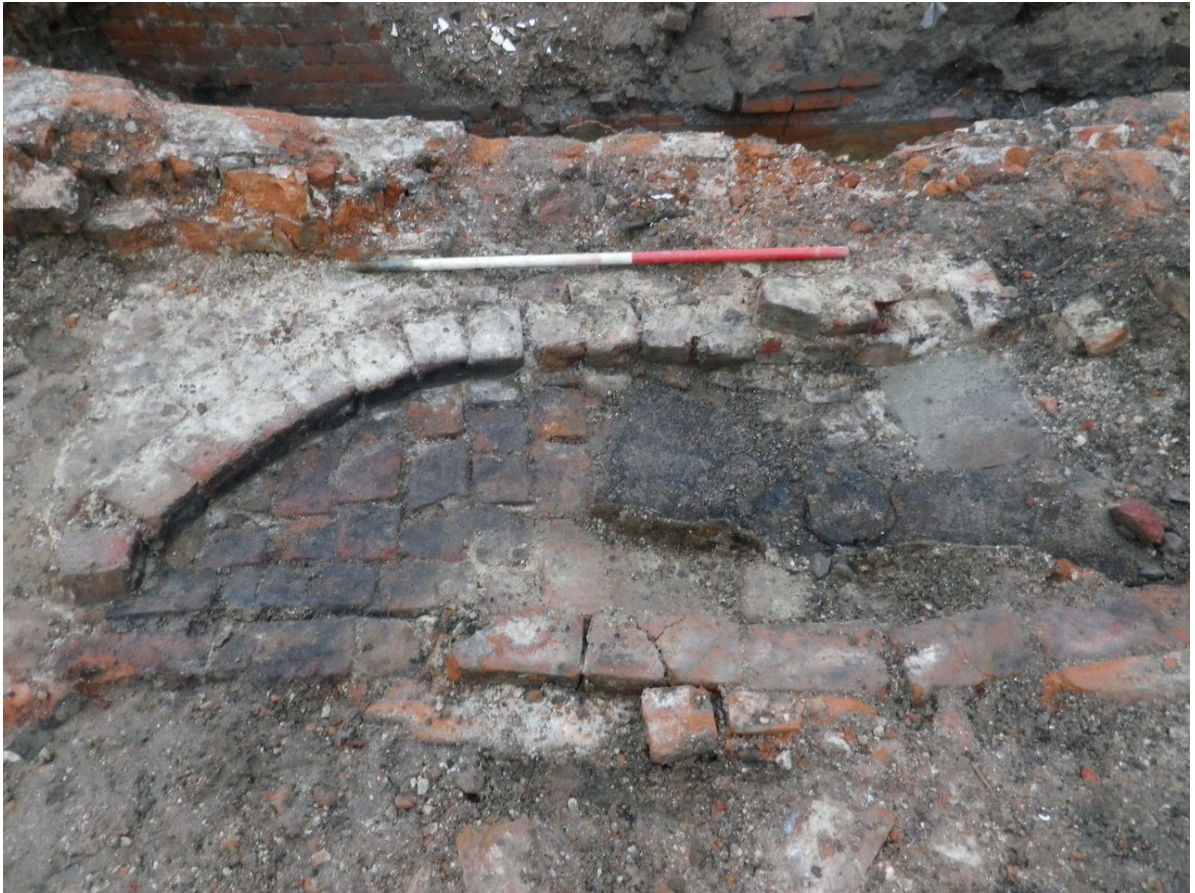
Plate 16 - Trench 1. Looking south-east showing side chamber (78)/(79), 1 x 1m scale.

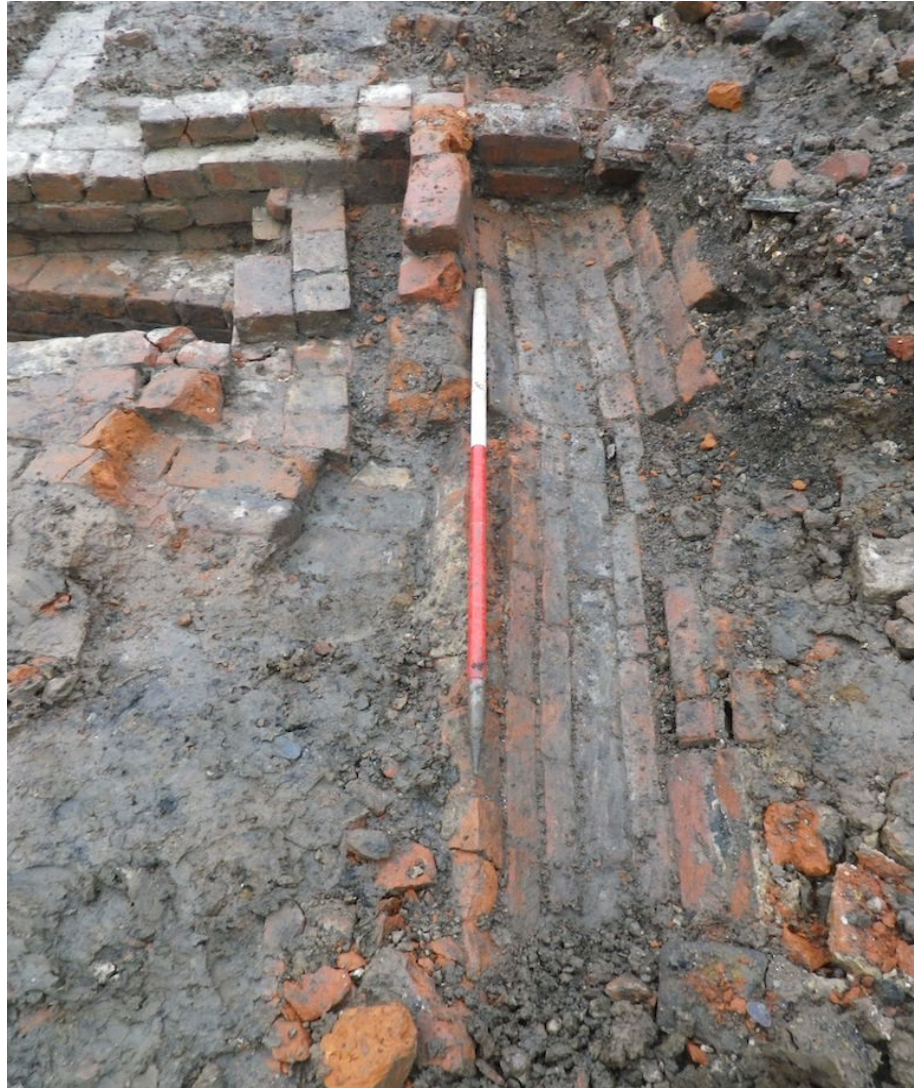
Plate 17 - Trench 1. Looking north-west showing the brick culvert (71), 1 x 1m scale.

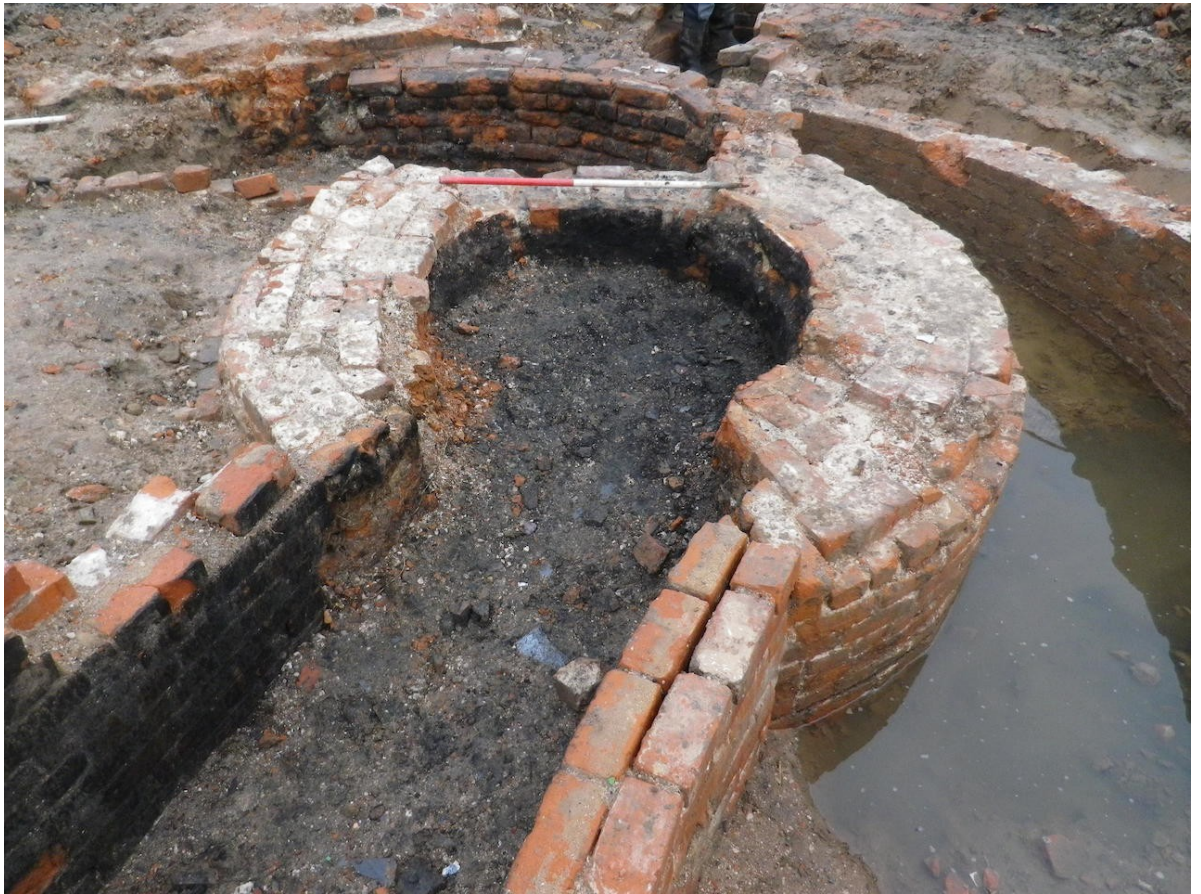
Plate 18 - Trench 1. Looking north-east showing Phase 5 flue walls (49)/(51) and blocking wall to Phase 3 flue, 1 x 1m scale.

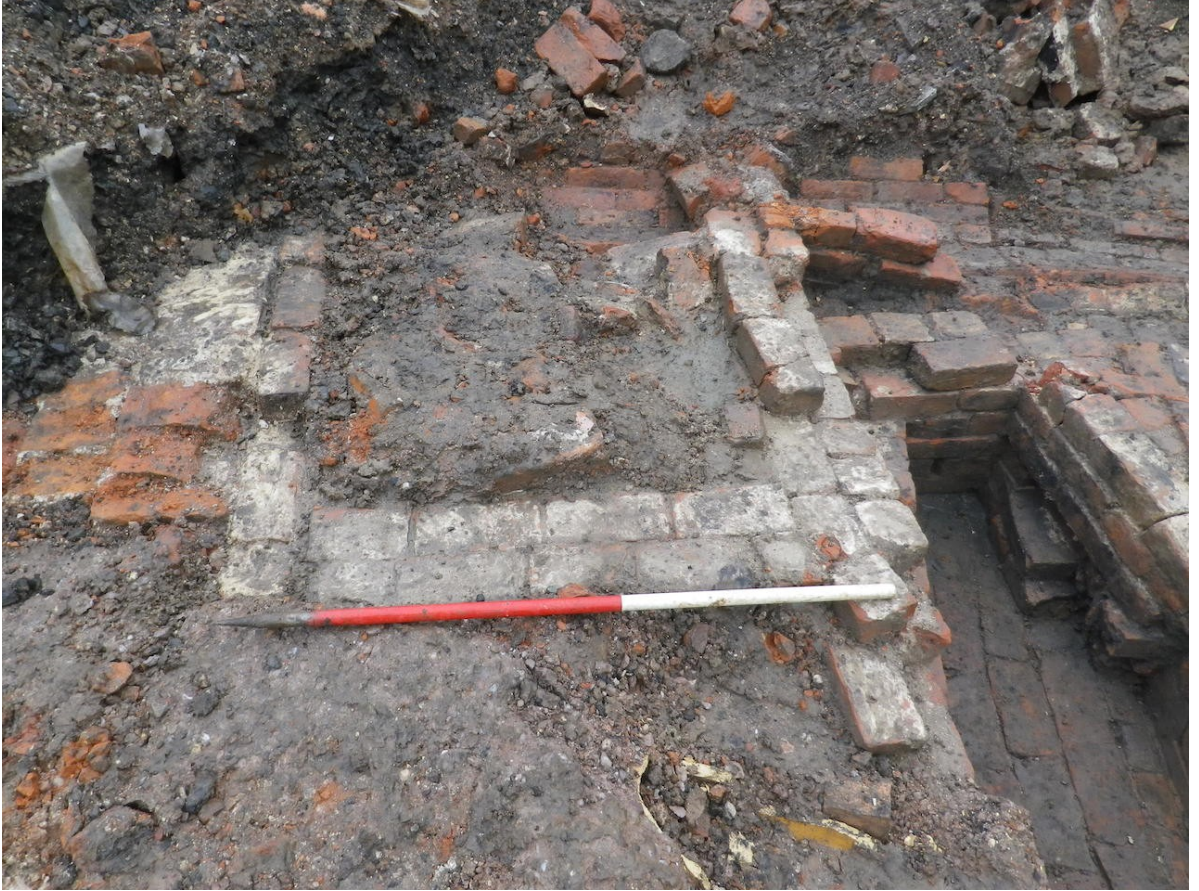
Plate 19 - Trench 1. Looking north-east showing structure (67)/(72)/(73), 1 x 1m scale.

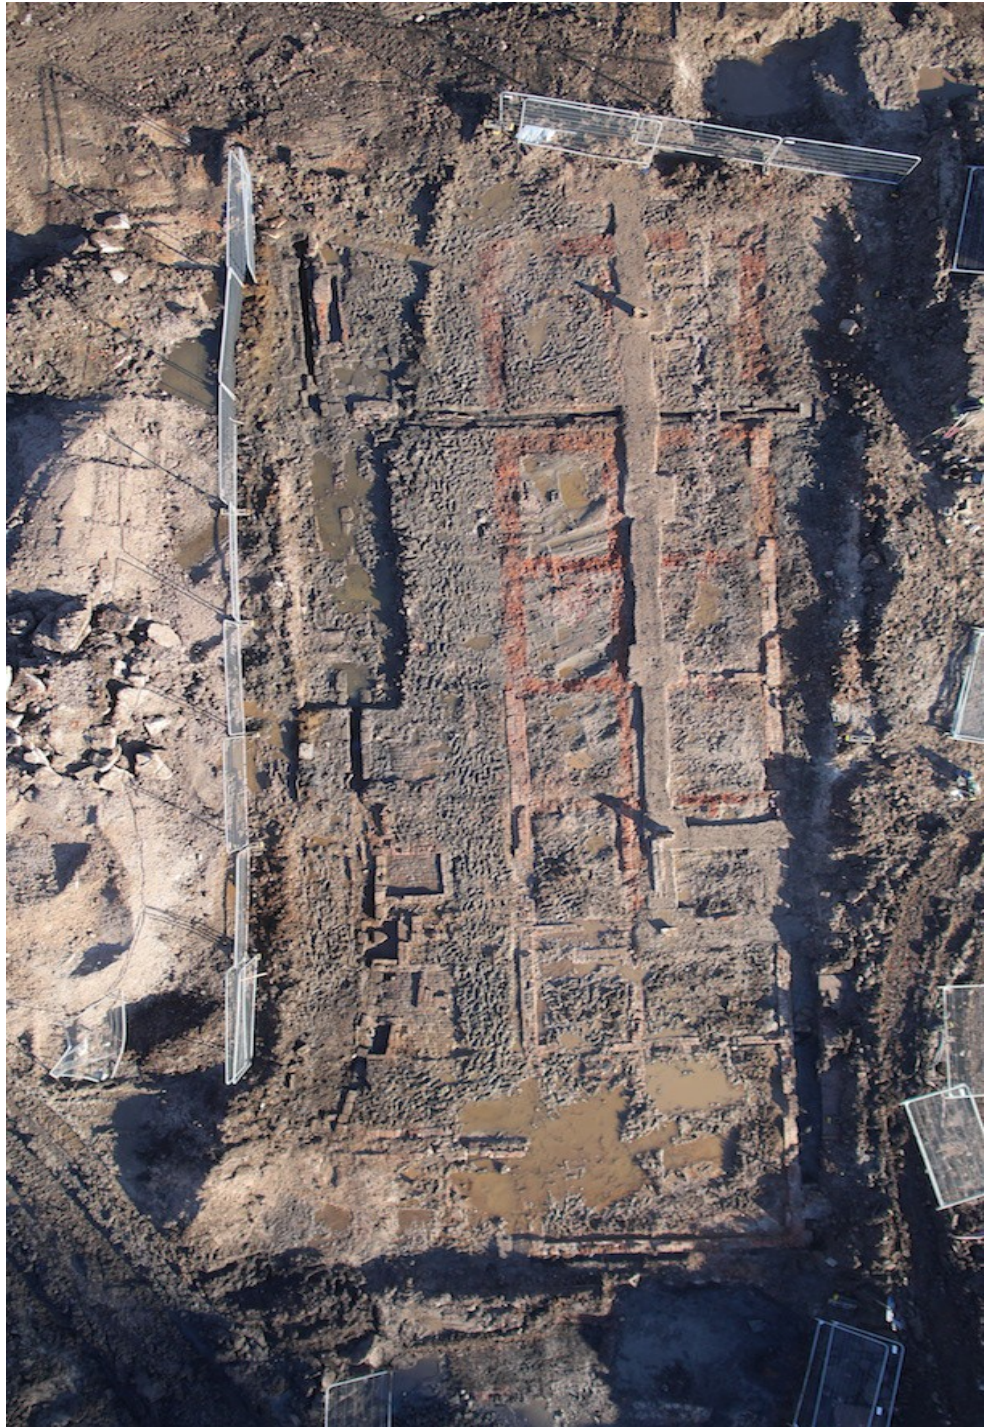
Plate 20 - Trench 2. Aerial view showing remains of the terraced cottages and associated outbuildings.

5.4.10. Phase 3 was dominated by the construction of a row of terraced cottages which were framed by brick outer walls (83), (84), (85) and (86) ( Plate 20) and (FIGURE 9). Preservation of the cottage foundations was variable along the length but in general the western end was slightly better preserved than the east. There were also a number of brick structures and associated floor surfaces to the north of the terraced cottages adjacent to stone culvert (103). These structures probably represent the outside toilets for the row of cottages.

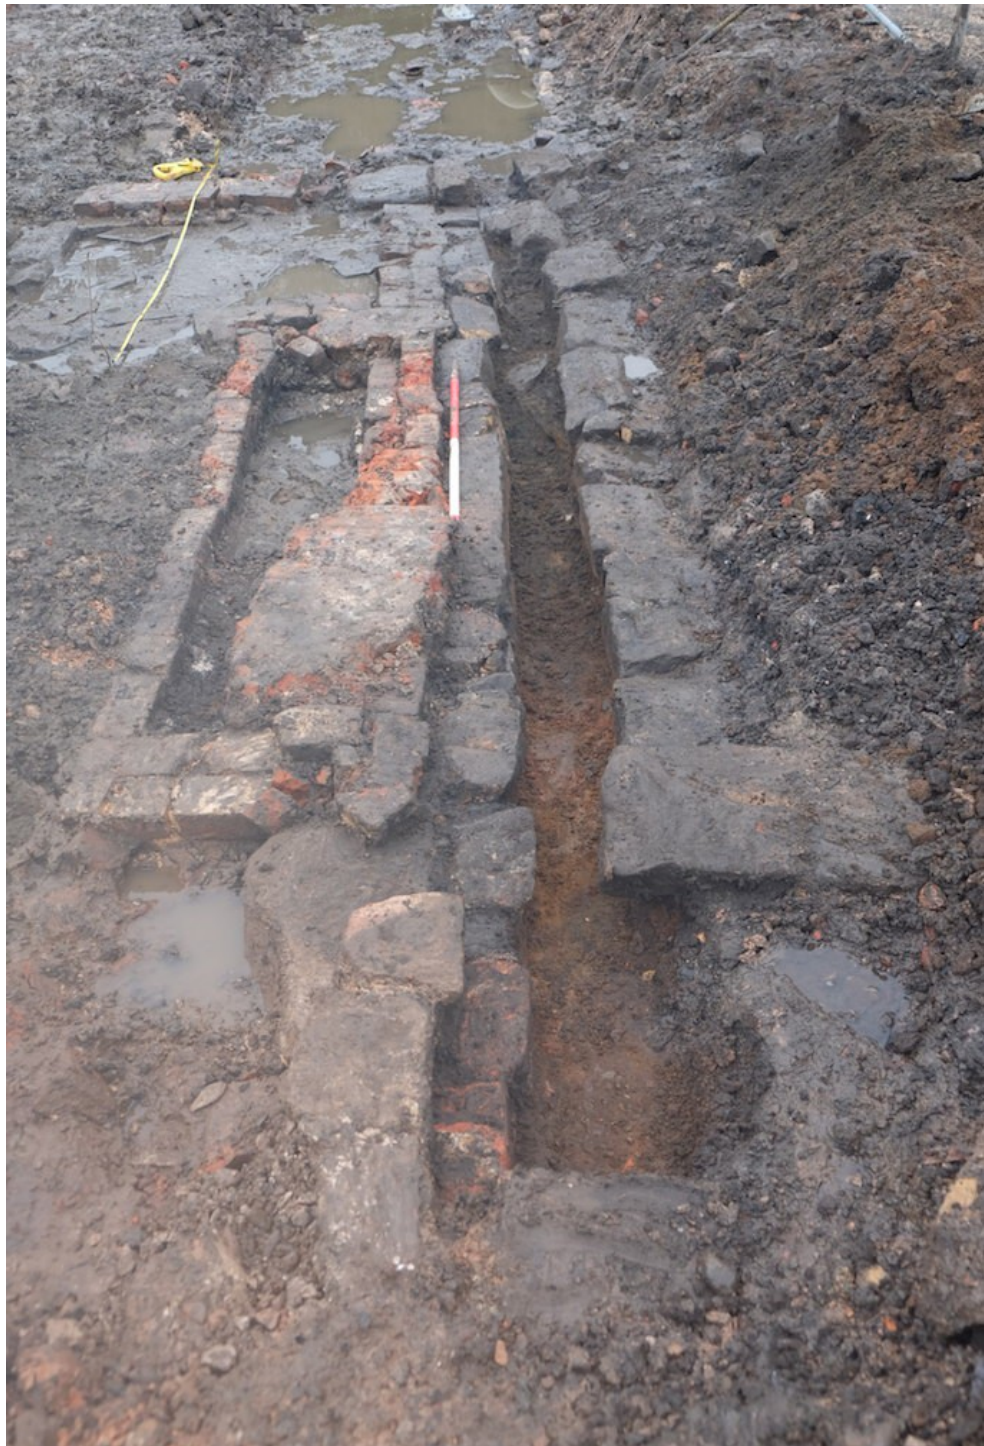
Plate 21 - Trench 2. Looking south-west showing the eastern end of stone culvert (103), 1 x 1m scale.

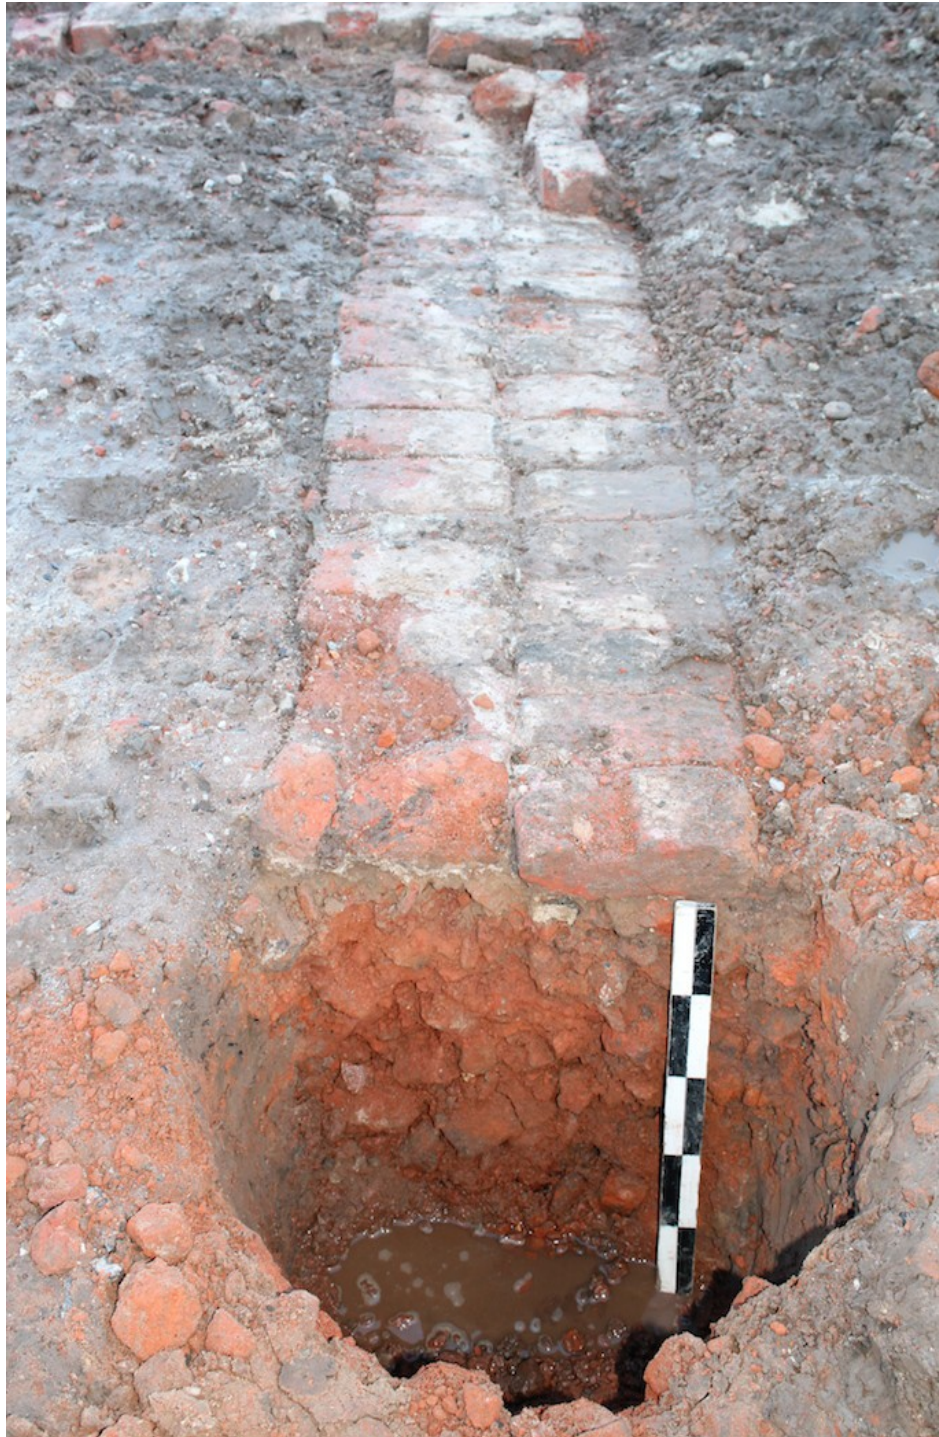
Plate 22 - Trench 2. Looking north-east showing the brick rubble foundation trench to wall (86), 1 x 0.5m scale.
