Archaeological Excavation Report

# FORGE MILL CONGLETON

For Nexus Heritage

Doc Ref: LP2381C-AMR-v1.5

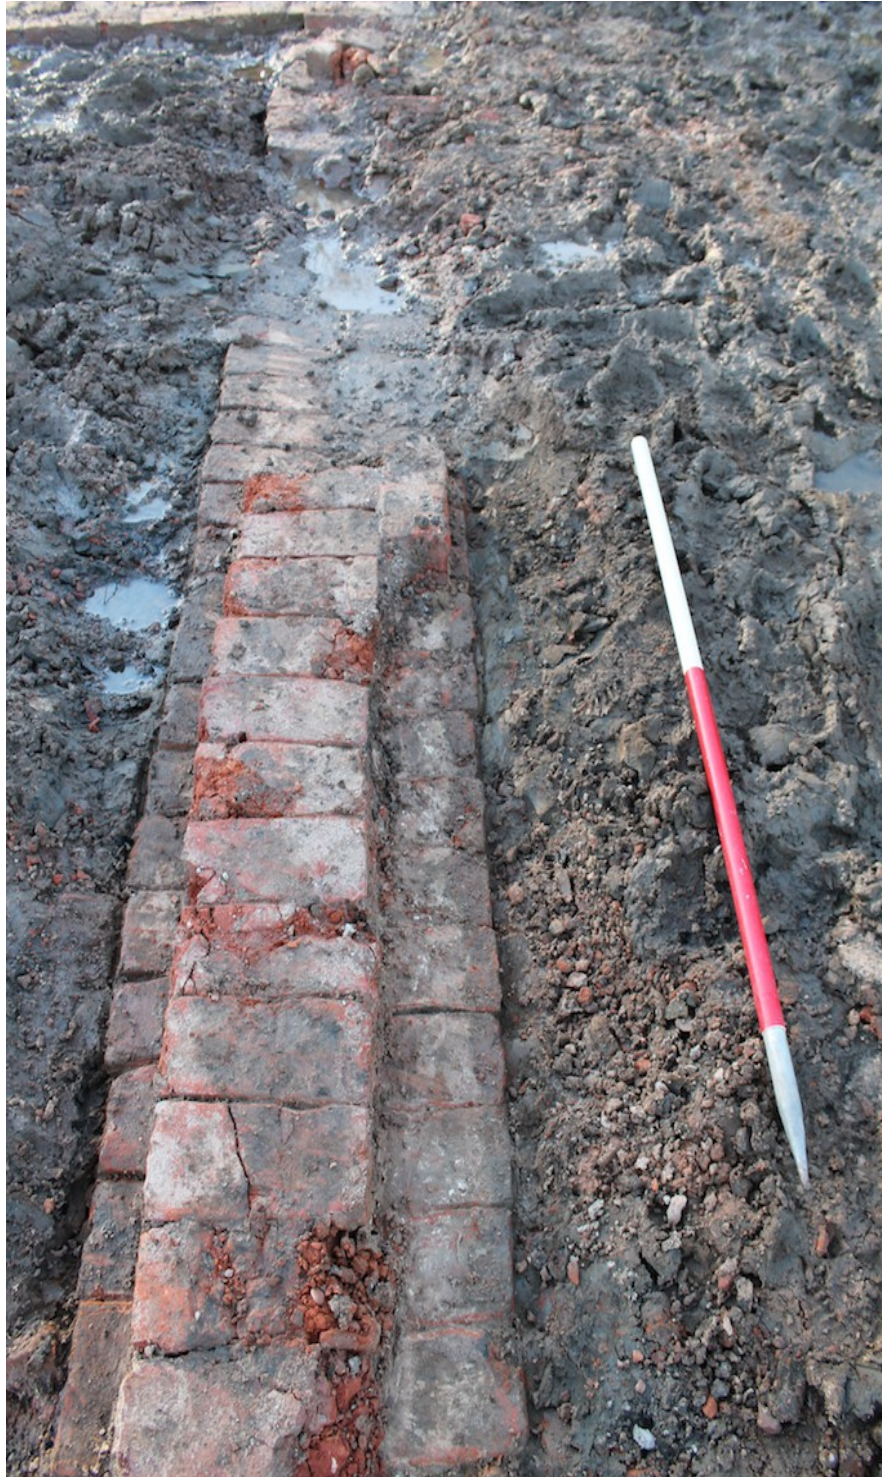
Plate 23 - Trench 2. Looking south-west showing a section of terraced cottage wall (83), 1 x 1m scale.

5.4.11. The terraced cottage block involved the erection of two continuous front and back walls (86) and (83) which were each 32.77m in length. These were connected at the east and west gables by walls (85) and (84) which were each 7.6m long. The method of construction in all four walls involved the excavation of a linear foundation trench which was entirely backfilled with loose brick rubble hardcore ( Plate 22). A single course of double-header bricks were then laid directly above the hardcore creating a foundation that was 0.47m wide. Above this basal course was a slightly more narrow off-set course of headers and stretchers ( Plate 23) 0.35m wide which were then alternated in higher courses of the walls.

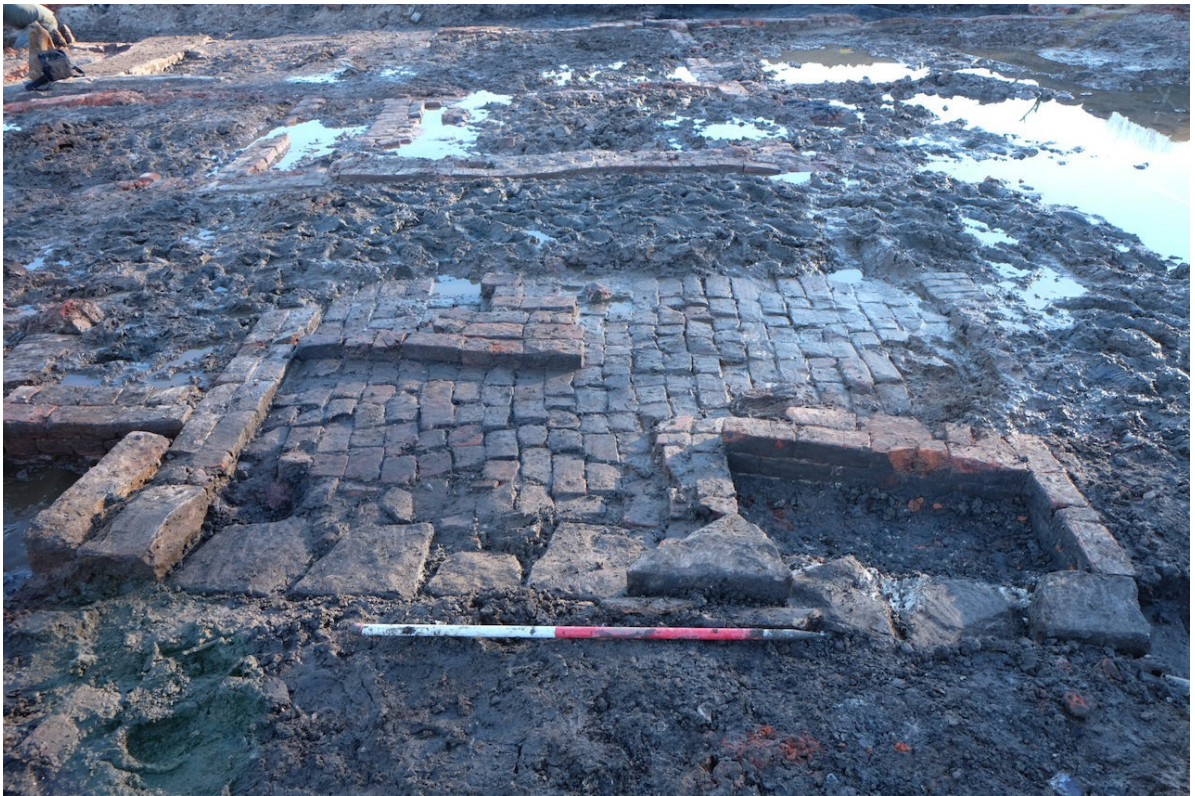
Plate 24 - Trench 2. Looking south-east showing outbuilding structures (106)/(125), 1 x 1m scale.

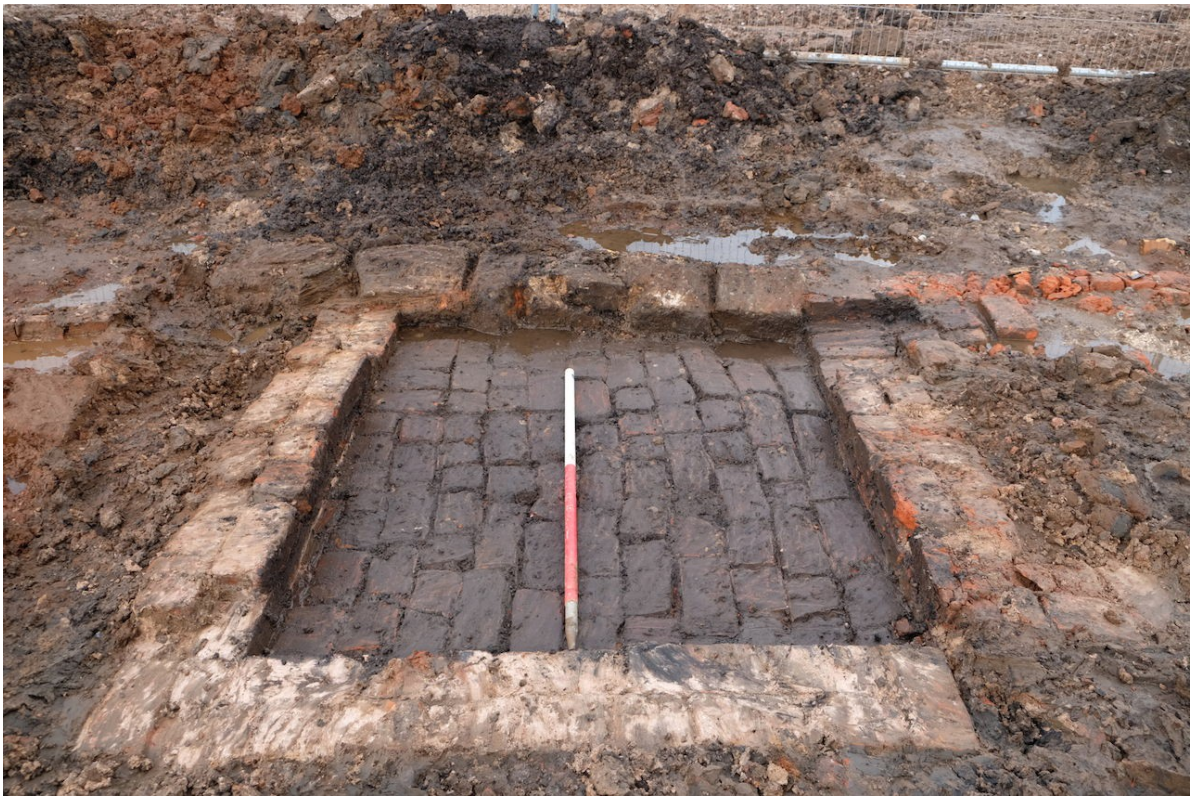
Plate 25 - Trench 2. Looking north-west showing outbuilding structure (104)/(112), 1 x 1m scale.

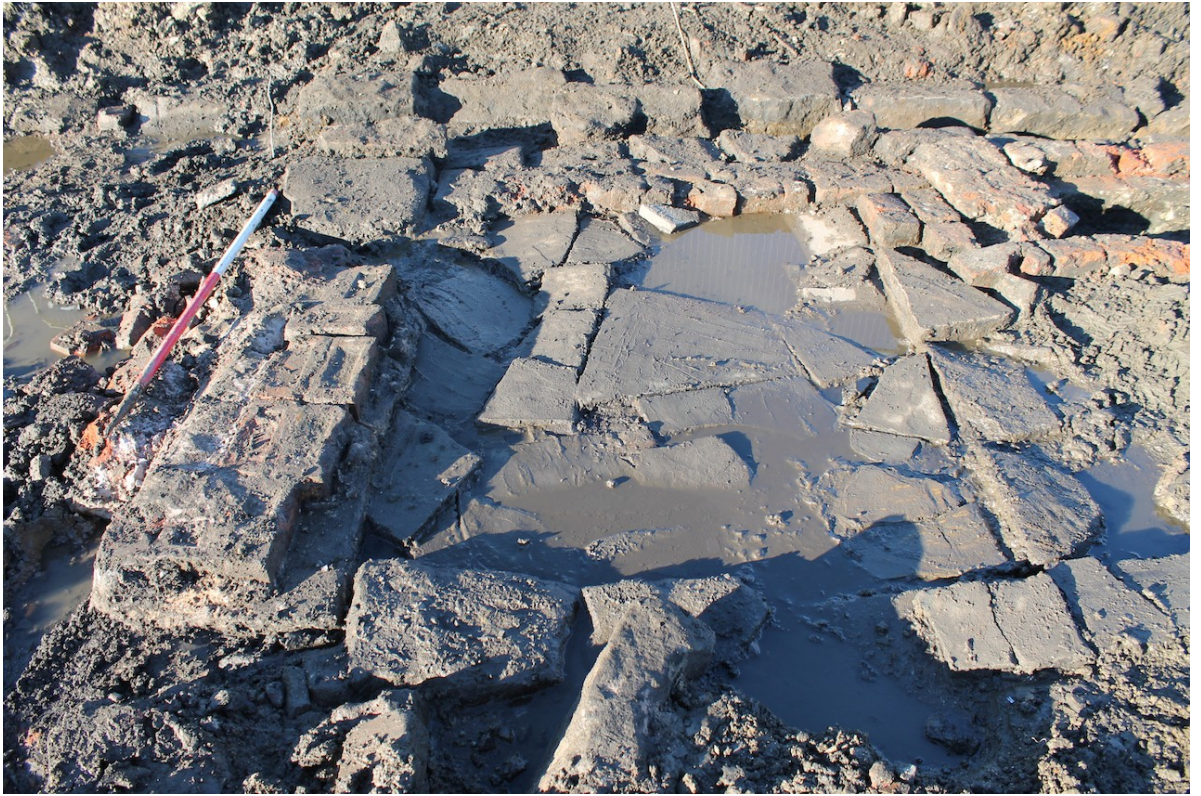
Plate 26 - Trench 2. Looking north-west showing outbuilding structure (117)/(118), 1 x 1m scale.

5.4.22. The rear yards to cottages 5 and 6 had been heavily disturbed by later activity and no evidence for outbuildings had survived. However, to the rear of cottage 7 there was a square brick and stone structure (117) measuring 2m east-west by 2m north-south which probably represented another outside latrine. The interior of structure (117) was covered by a floor of broken 'yorkstone' fragments (118) ( Plate 26).

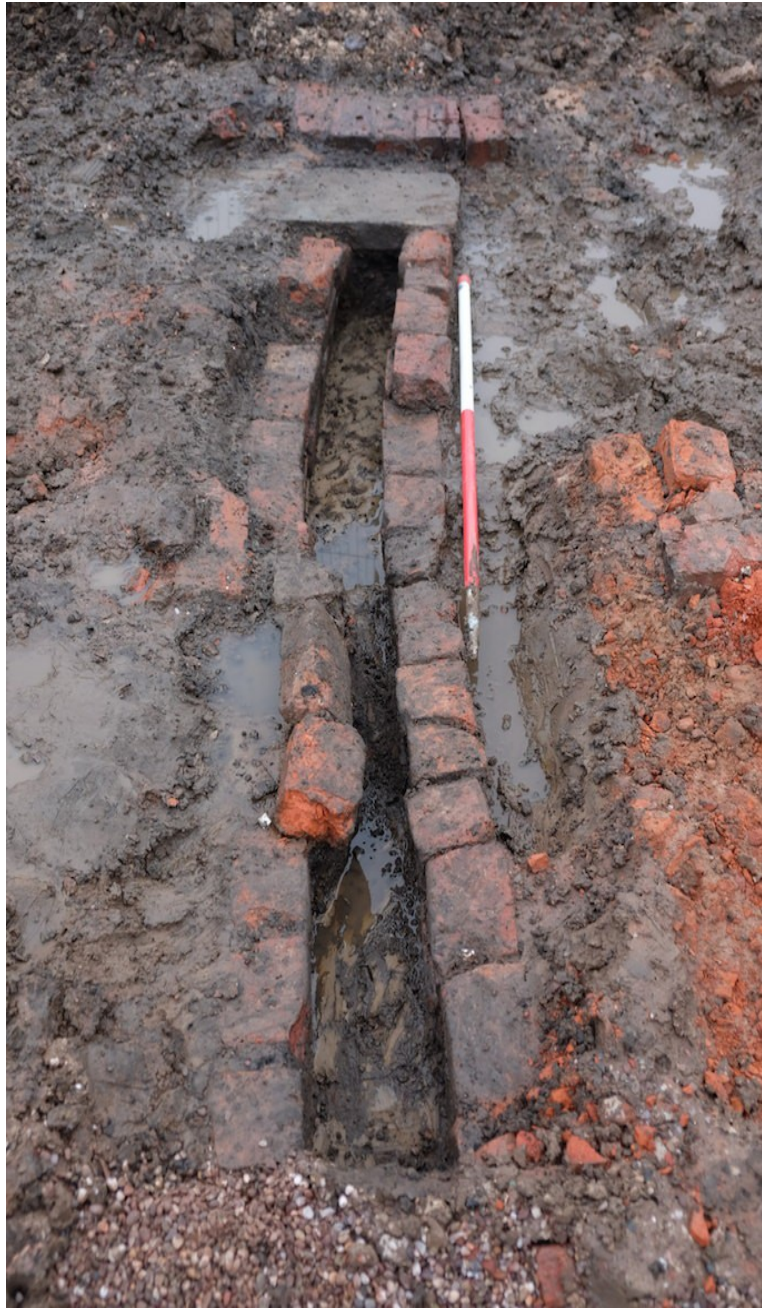
Plate 27 - Trench 2. Looking south-east showing brick culvert (102), 1 x 1m scale.

5.4.26. A brick culvert (102) was inserted beneath the western side of cottage 7, cutting through wall foundations (83) and (86), and running parallel with partition wall (87)/(100). Culvert (102) consisted of two parallel brick walls up to three courses high which had originally been capped with 'yorkstone' slabs ( Plate 27). The culvert was 12.3m long, 0.44m wide and 0.16m deep; and it ran from the roadside south of terrace wall (86) northwards to stone culvert (103). Culvert (102) appears to have served as a surface water drain for

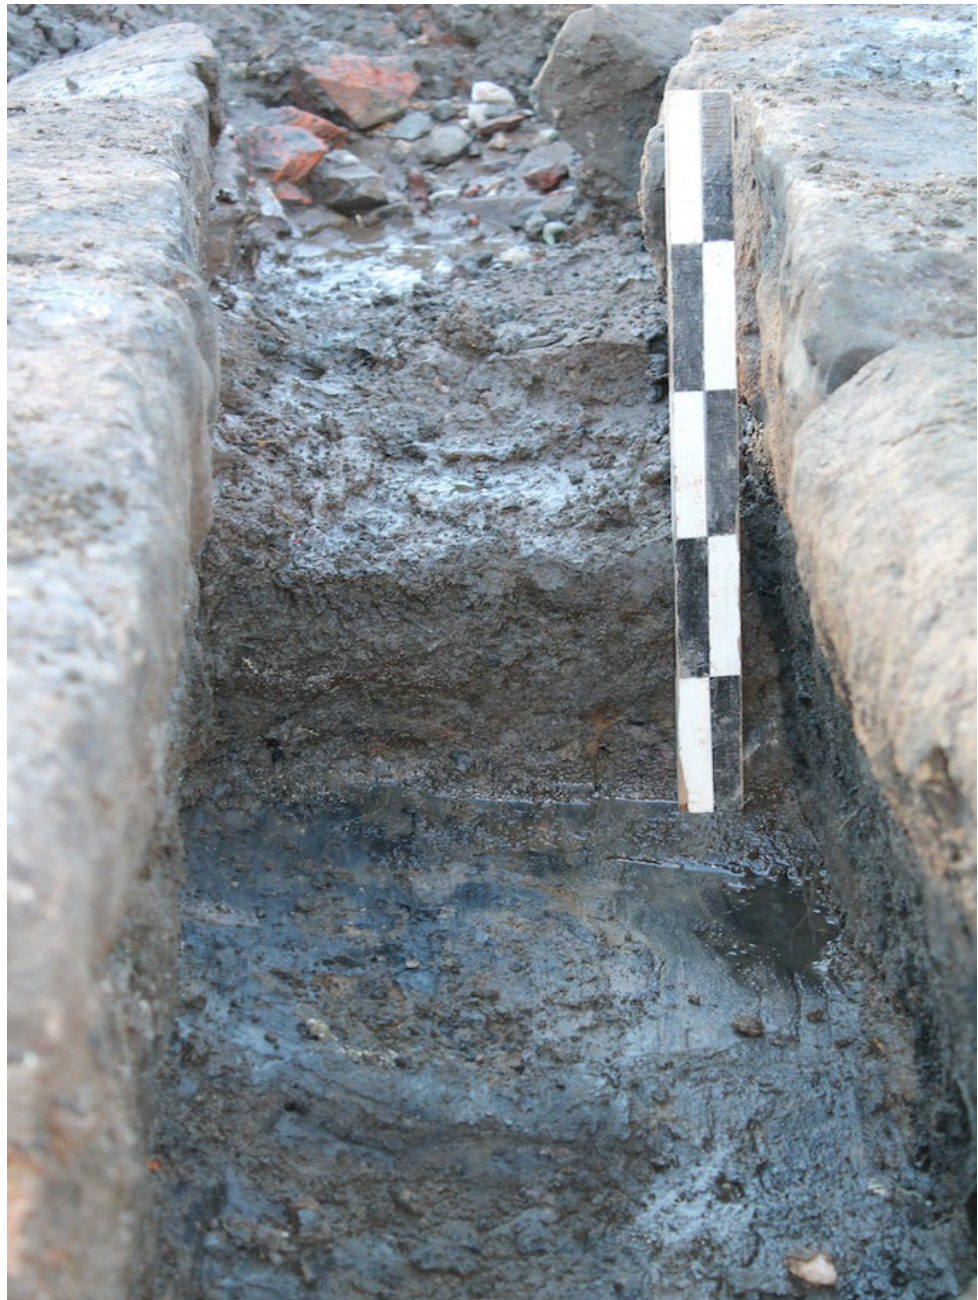
Plate 28 - Trench 2. Looking north-west showing silting (108) of stone culvert (103), 1 x 0.5m scale.

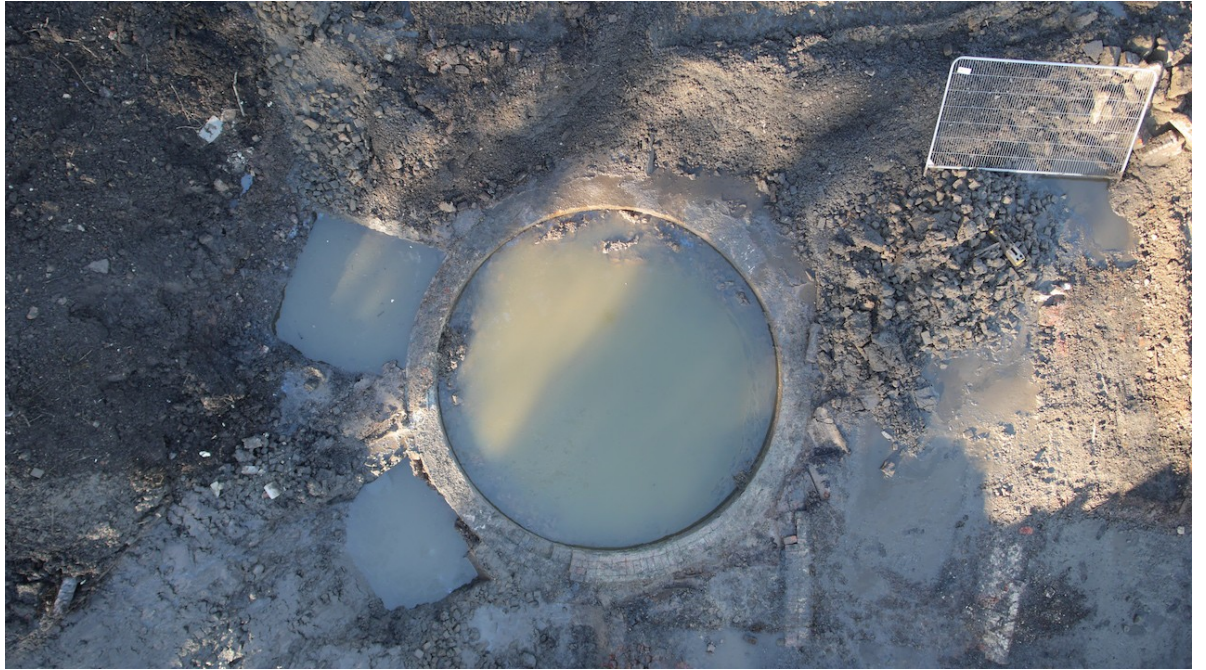
Plate 29 - Trench 3. Aerial view of gas tank (132).

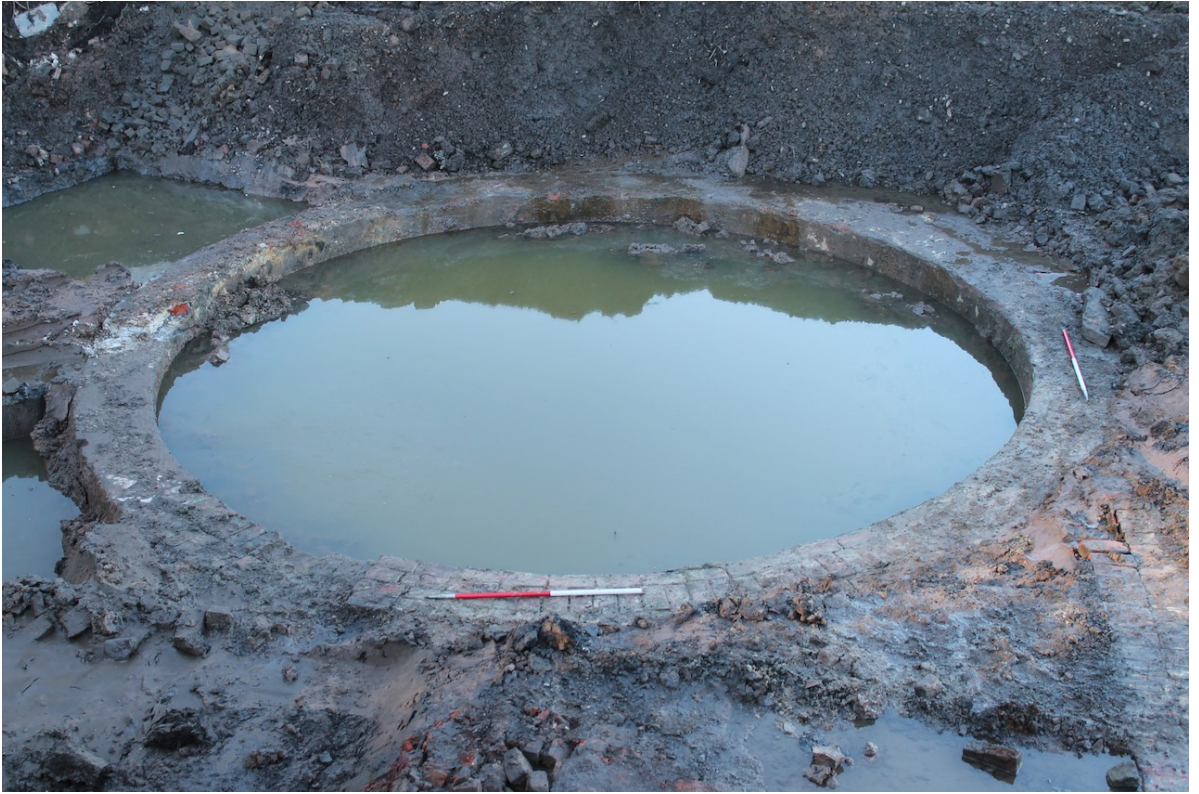
Plate 30 - Trench 3. Looking north-east showing brick gas tank wall (132), 2 x 1m scale.
