Archaeological Evaluation Report

ATHLONE HOUSE HIGHGATE

Client:	CgMs Consulting
Local Authority:	London Borough of Camden
NGR:	527682, 187461
Planning App:	Pre-Application
Author:	Barbora Brederova
Doc Ref:	LP2597L-AER-v1.2
Site Code:	AHN17
Date:	November 17

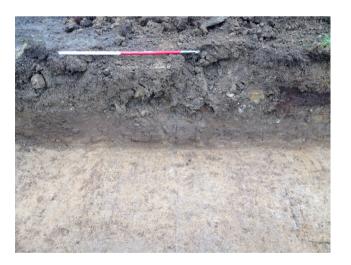
Plate 2 - South facing section of Trench 3

5.8.Trench 3 (20m x 1.8m) was located to the east of trench 2 and was on a north-east south-west alignment. No archaeological remains have been identified in this trench. It consisted of stony make-up deposits directly overlying natural clay. The centre of the trench was truncated by modern drain cut of east west orientation. The cut is 5.8m wide and more than 1.2m deep with a clay drain pipe at the depth of 1.2m. Natural clay (4) was recorded between 112.08m OD and 111.99m OD (FIGURE 6).

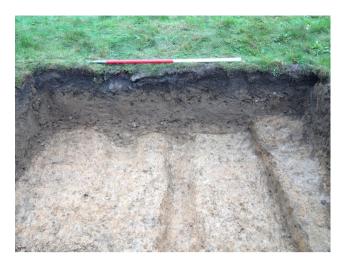
Plate 3 - Two parallel furrows [2] in Test Pit 4

5.13. Test Pit 4 (2m x 2m) was situated to the east of Test Pit 3. Beneath the 0.15m thick topsoil (5) is 0.2m deep levelling deposit (1). It is associated with two underlying parallel gullies [2] that extend in east west direction, towards the bottom of the slope. Due to their orientation and the fact that they don't contain organic materials, it can be assumed that these do not represent plant bedding or similar. The fill of the gullies (3) closely resembles natural, which suggests that they were manually backfilled. Fragments of glass and clay tobacco pipe recovered from levelling deposit (1) date the gullies to the Post Medieval period. They are dug directly into natural clay (4) that reaches the hight of 109.30m OD in this trench (FIGURE 4).

- **6.1.** All finds, having been assessed on site as mid 19^{th} century or later, were discarded on site.
- **6.2.**Levelling deposit (1) associated with two gullies [2] located within Test Pit 4 revealed fragments of Post Medieval tobacco pipe and glass.
- **6.3.**Test Pit 1 produced a Prehistoric pottery sherd with no associated archaeological deposits.

- **7.2.**Similarly, it is not possible to draw a precise interpretation of the two parallel furrows recorded in Test Pit 4 to the west of the standing building. Most likely, they do not represent garden features, and they are not depicted on any of the London's historical maps. It therefore might be assumed that the furrows were in use for only a short period of time and/or were not visible on the surface of the grassland.

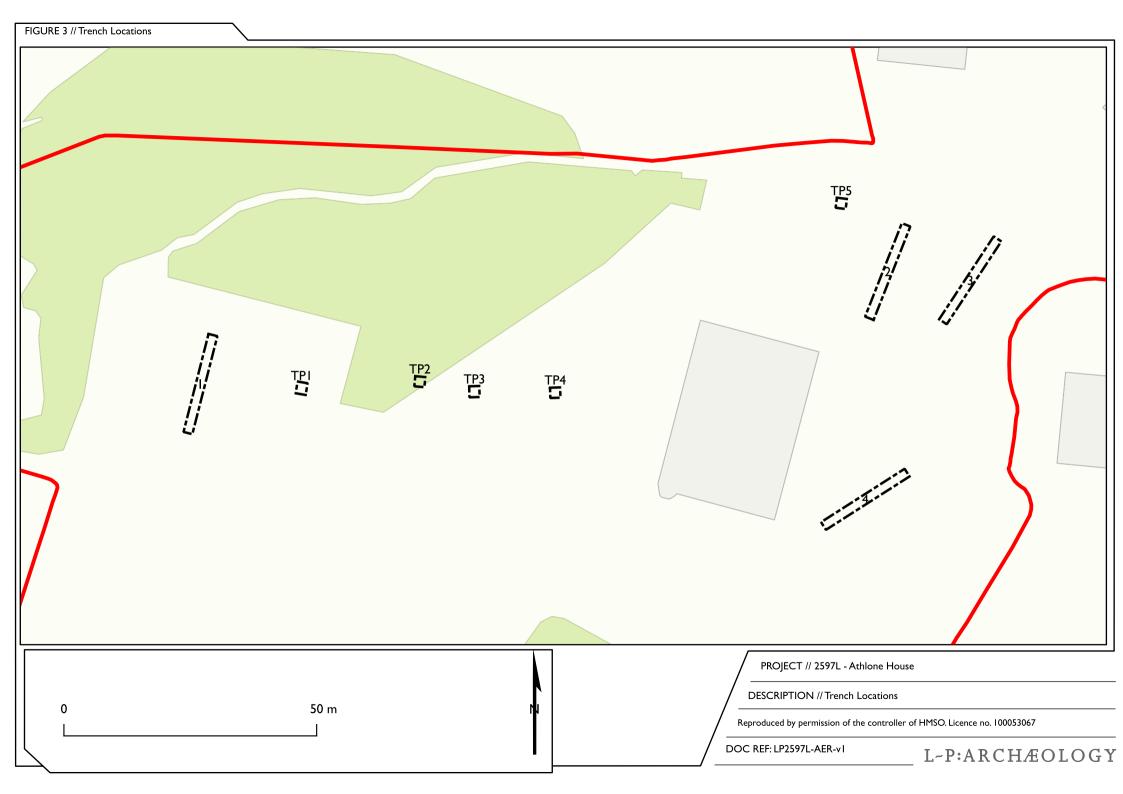
- **4.1.**For a full description of the archaeological methodology please refer to the WSI (CGMS CONSULTING 2017).
- **4.2.**A series of trial trenches and test pits were excavated in order to target specific areas of proposed development (FIGURE 3):

```
Trench 1 = 20 \text{m x } 1.8 \text{m} (targeting the proposed new garden house)
```

Trench 2 = 20 m x 1.8 m (targeting proposed ground source heat pump arrangement)

Trench 3 = 20 m x 1.8 m (targeting proposed ground source heat pump arrangement)

Trench 4 = 20 m x 1.8 m (targeting proposed fountain)

Test pits 1-6: 2m x 2m (targeting proposed new service runs)

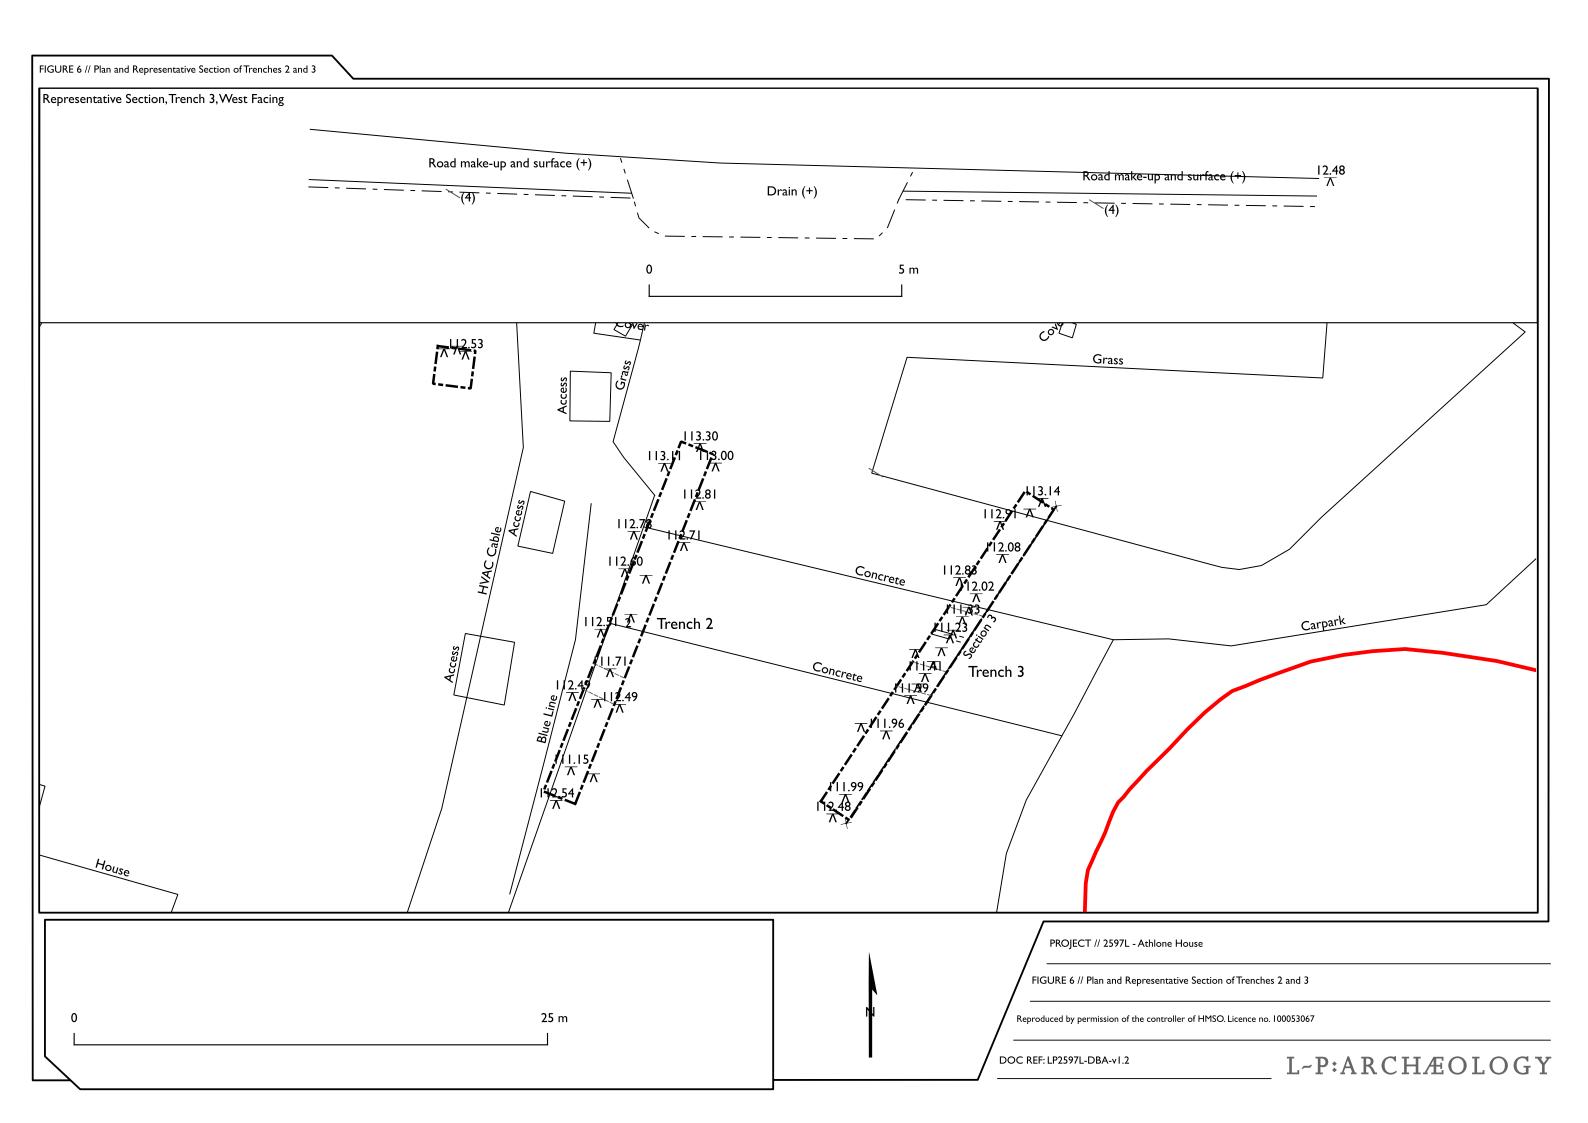
5.7.Trench 2 (20m x 1.8m) was located on the east side of the site on a north-east south-west alignment. No significant archaeological features were identified. A thick layer of redeposited natural, a likely levelling deposit, was present in the south section of the trench. Construction rubble within the deposit appeared to be of a 20th century production. The central section of the trench was truncated by a large modern drain cut extending from east to west and also appears in Trench 3. Within Trench 2 natural clay (4) was recorded between 111.71m and 111.15m OD (FIGURE 6).
