Archaeological Watching Brief Report

HUNTINGTON, WATER TREATMENT WORKS, CHESTER

For C2V+ on behalf of Untited Utilities

Doc Ref: 2609C-WBR-v.1.5

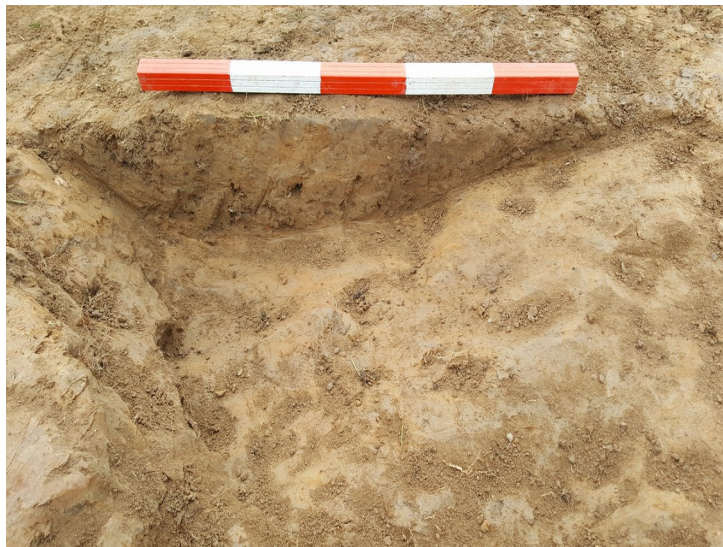
Plate 2 - West facing section through Curvilinear [04]. 0.5m scale.

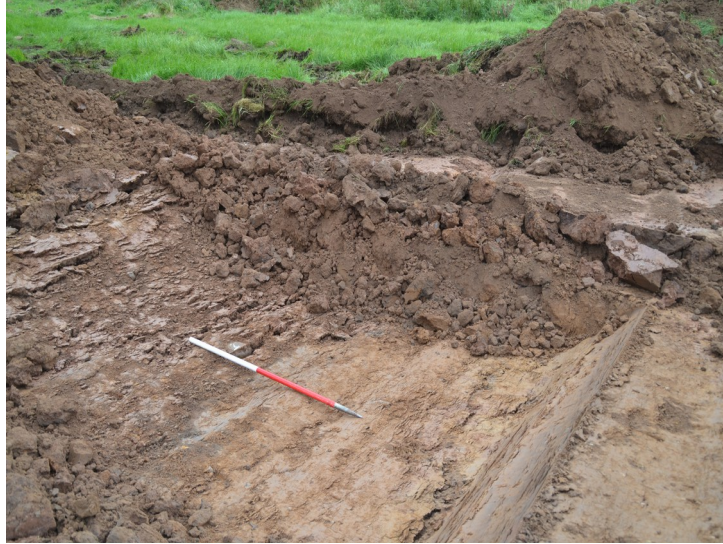
- 5.4.4. To the north extending into Area 2 was a large sub-circular feature [08]. Below the topsoil (01) and cut into natural subsoil (07) the feature extended beyond both the east and west edges the site. It appeared sub-circular in plan, with a

stepped, steep curved edge, the bottom of the feature was not located but it had a minimum depth of 1m. The feature [08] had a single fill of hard reddy pink clay (09), this was a deliberate backfill of the feature, with inclusion of modern debris (PLATE 4). Feature [08] corresponds with a series of ponds across the area identified on the historic mapping (FIGURE 4, FIGURE 5).

Plate 4 - Large pond feature [08] at the northern end of Area two. Facing northeast. 1m scale.

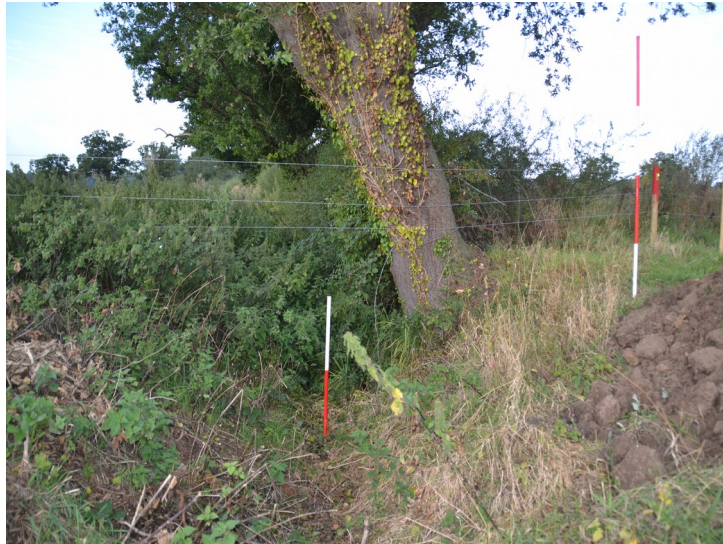
5.5.1. Area 3 was an L shaped field which had been extremely disturbed, a linear ditch created the boundary on the south (PLATE 5) and east (PLATE 6) sides of the field.

Plate 5 - Ditch which ran along the boundary between Area two and Area three, facing west.

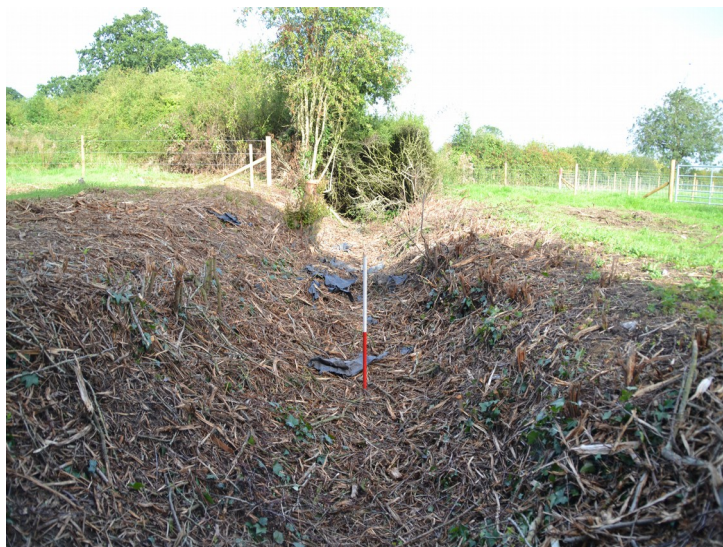
Plate 6 - The boundary ditch between Area three and four, facing north.

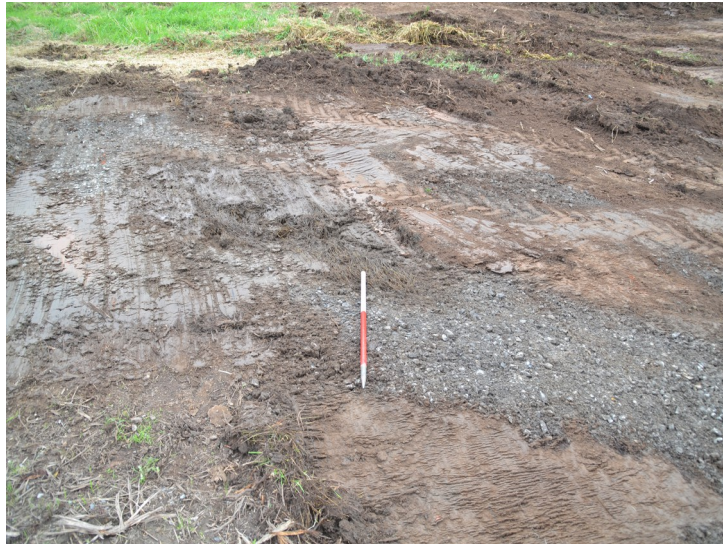
5.5.5. Approximately 70% of Area 3 had been disturbed and a layer of red brown clay had been spread across the centre of the area. This may have been due to the wet nature of this field which was noticeable even with the small amount of rain that had fallen while monitoring the works (PLATE 7).

Plate 7 - Evidence of gravels, red clay and dumping in Area three. 1m scale.

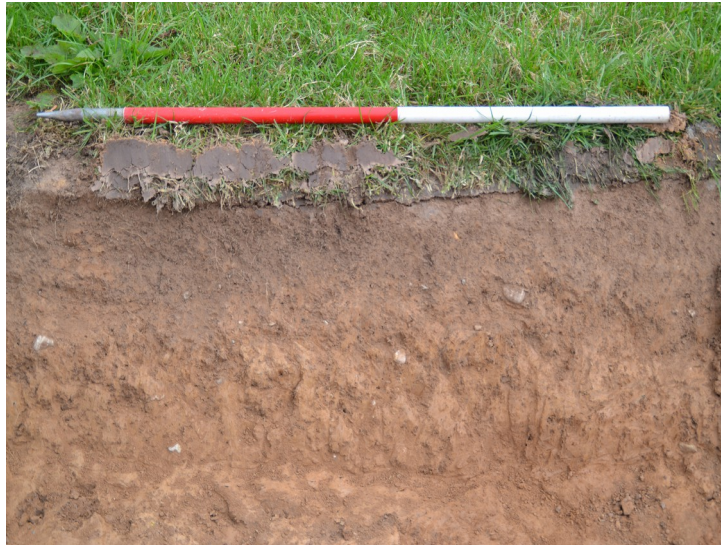
area (FIGURE 10) and the lower northern area. At the south the topsoil (01) was 0.05m thick and over lay a hard friable mid brown silty clay (13), which had inclusions of charcoal and CBM flecks. Clay (13) was up to 0.17m thick, but lack of a clear horizon meant that it was difficult to see where this deposit ended. Deposit (13) overlay a hard friable orange silty clay (14) which was the natural subsoil, containing patches of manganese (PLATE 8). Several north-south aligned field drains were present within this area cut into deposit (14).

Plate 8 - Southern upper area of Area four showing south facing section with (01), (13) and (14). 1m scale.

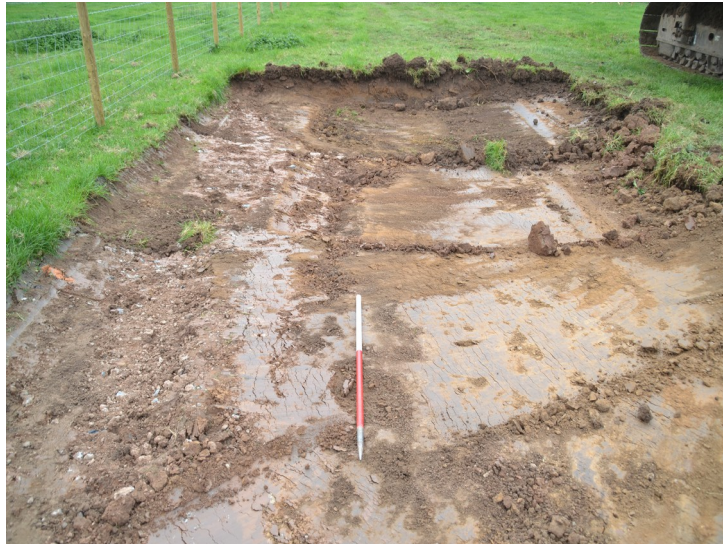
5.6.3. A large 20m long cut was identified at the eastern edge of Area 4 (Figure 12), cut into silty clay (14) and filled with a redeposited reddy brown clay (the same as feature [08] in Area 2)(Plate 9). This feature correlated to a pond seen on the historic mapping (FIGURE 4, FIGURE 5).

Plate 9- Edge of pond feature, facing south. 1m scale.

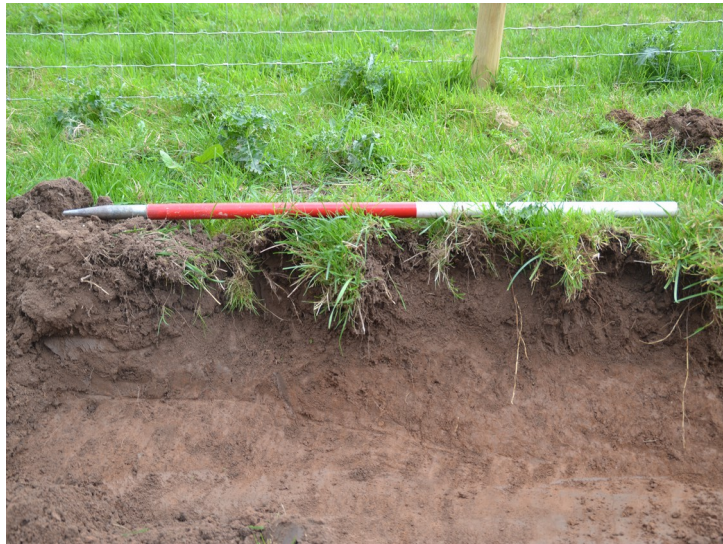
Plate 10 - Northern lower end of Area four, west facing section showing (01), (15) and (16). 1m scale.

5.6.4. At the northern end of Area 4 below the topsoil (01) was a soft brown silty clay (15), thought to be a possible plough soil or hill-wash from the upper area to the south; it was up to 0.18m thick. Beneath deposit (15) was a soft red brown silty clay (16), with CBM flecks and areas of manganese, at least 0.3m thick (PLATE 10).
