Archaeological Watching Brief Report

PRIDE HILL
SHREWSBURY

Client:	Balfour Beatty
Local Authority:	Shropshire Council
NGR:	349198, 312586
Planning App:	General Permitted development
Author(s):	C Matthews MRes
Doc Ref:	LP2768C-WBR-v.1.3
Date:	July 18
Site Code:	LP2768C

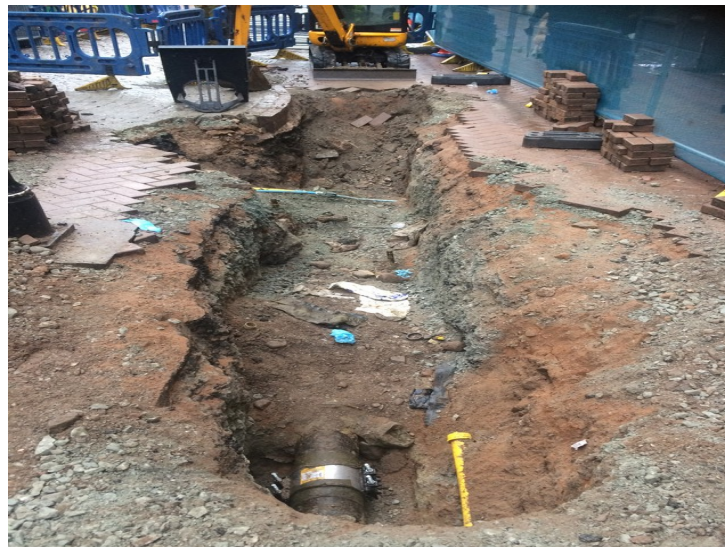
Plate 1 - Working shot of Trench 1 excavation showing gravel fills of services.

- 5.3.4. Running through the centre of the trench were two mains service pipes, one a capped off gas main with a later plastic service connection (also cut off), the other was the active gas main with a plastic service connection heading towards the southern shop fronts. A cut [05] for the active gas main was visible c.0.6m wide in the northern end of the trench and a smaller cut likely associated with the service connection was visible in the south eastern edge of the trench.

- 5.3.5. In the middle of the trench was a cut disused lead pipe and a second lead pipe connecting to a plastic water pipe (possibly active). Near to this and situated alongside the active gas main was an old disused iron hydrant and corroded iron pipe.

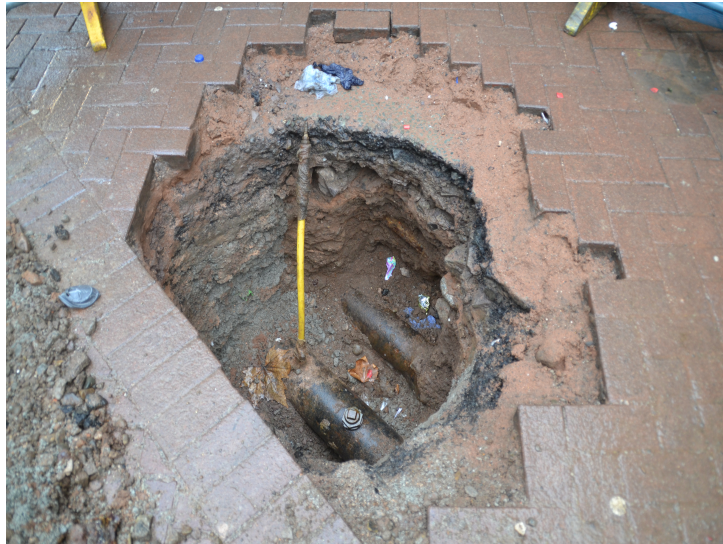
- 5.4.1. Trench two located outside 19 Pride Hill and consisted of a small oval trench targeting a tap on the gas main.
- 5.4.2. The surface consisted of the modern brick high street (01) 0.05m thick, with a bedding of sand (02) 0.05m thick. Below this was remnants of the former tarmac road (13) 0.05m thick with inclusions of large round pebbles inset, suggesting a pavement. This overlaid a dark brown soil (08) with large cobble and rubble inclusions, 0.35m thick. This sat above a dark orange-brown mixed sandy silty soil (04) at a minimum of 0.6m thick, this is likely to be the back fill of the service cut and at the base of the trench three service pipes were identified close together with one possible cut (FIGURE 5).

Plate 2 - Trench 2 excavation showing gas mains and adjacent disused mains.

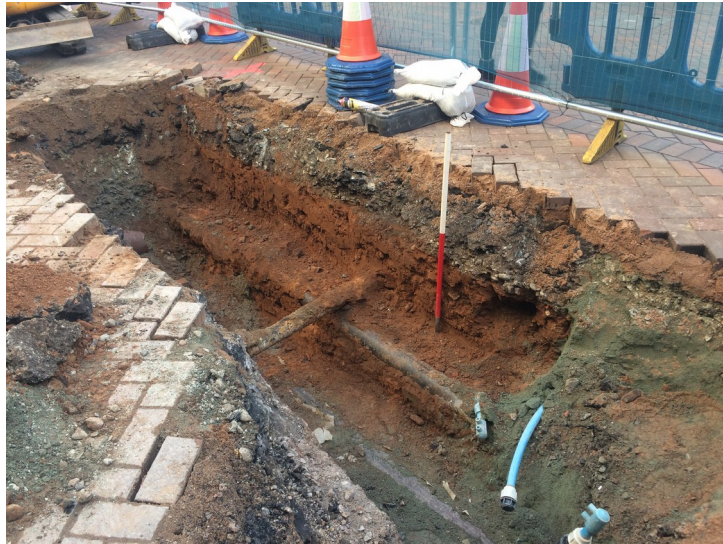
- 5.5.2. The surface consisted of the modern brick high street (01) 0.05m thick, with a bedding of sand (02) 0.05m thick. Below which was the former tarmac road (07) 0.05 m thick with visible yellow road markings and a grey stone hardcore (03)0.15m thick. Beneath this was a mixed deposit of red and orange sand with degraded sandstone (possible redeposited natural) (09) seen at a thickness of 0.5m; which contained a spread of mostly 19th and early 20th century pottery, as well as, rough hand cut brick (possibly 18th century).

- 5.5.3. Within the trench were several service cuts including the active gas main, a disused steal water pipe, an unknown corroded iron pipe, a modern plastic gas service connected to the main, a junction intersection for the gas main running towards Butchers Row and a cut with a capped water main consisting of both plastic and lead pipes.

Plate 3 - Oblique elevation shot of Trench 3 showing north west facing elevation.

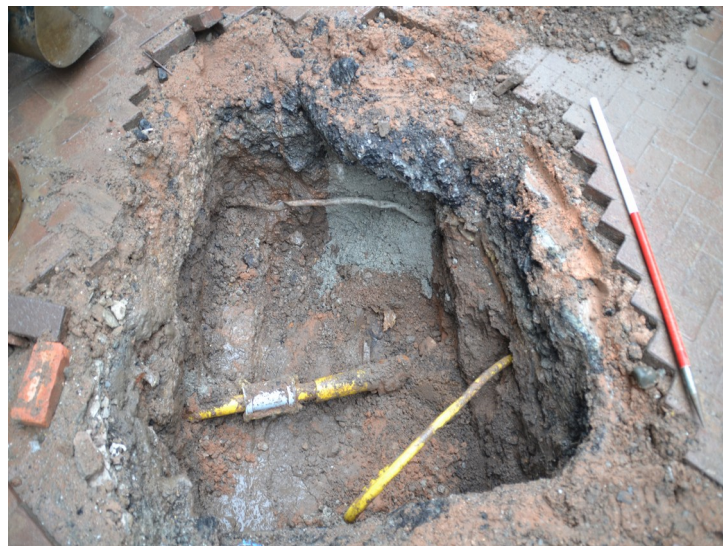
Plate 4 - Overview of Trench 5 with plastic services.

5.7.2. Within the base of the trench was the active ductile gas main and plastic service

connection, a disused steel gas main and a small corroded iron pipe. Truncated by these was an old cut for a lead water pipe.

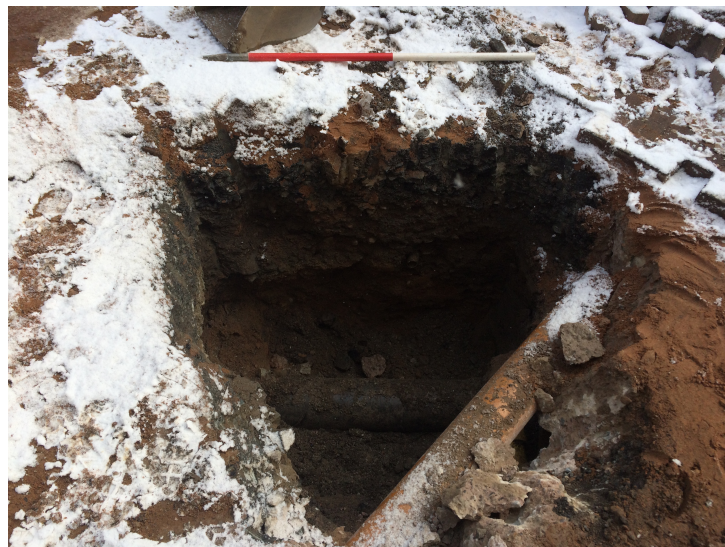
Plate 5 - Excavation of Trench 6 showing plastic drain pipe and gas service at the base.

5.8.2. Similar to Trench 5, within the base of the trench was the active ductile gas main with a plastic service connection, a disused steel gas main and a small corroded iron pipe.

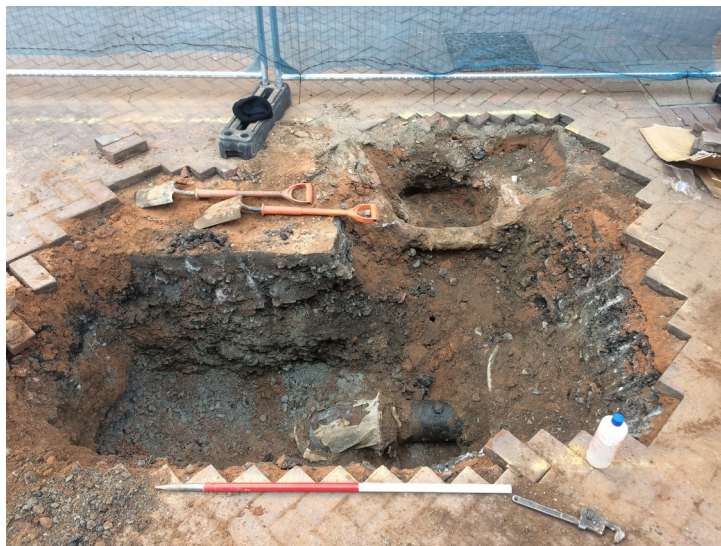
Plate 6 - Trench 7 excavation showing dropping gas main

5.9.3. At the base of the trench was the ductile gas main with a dropping bend.

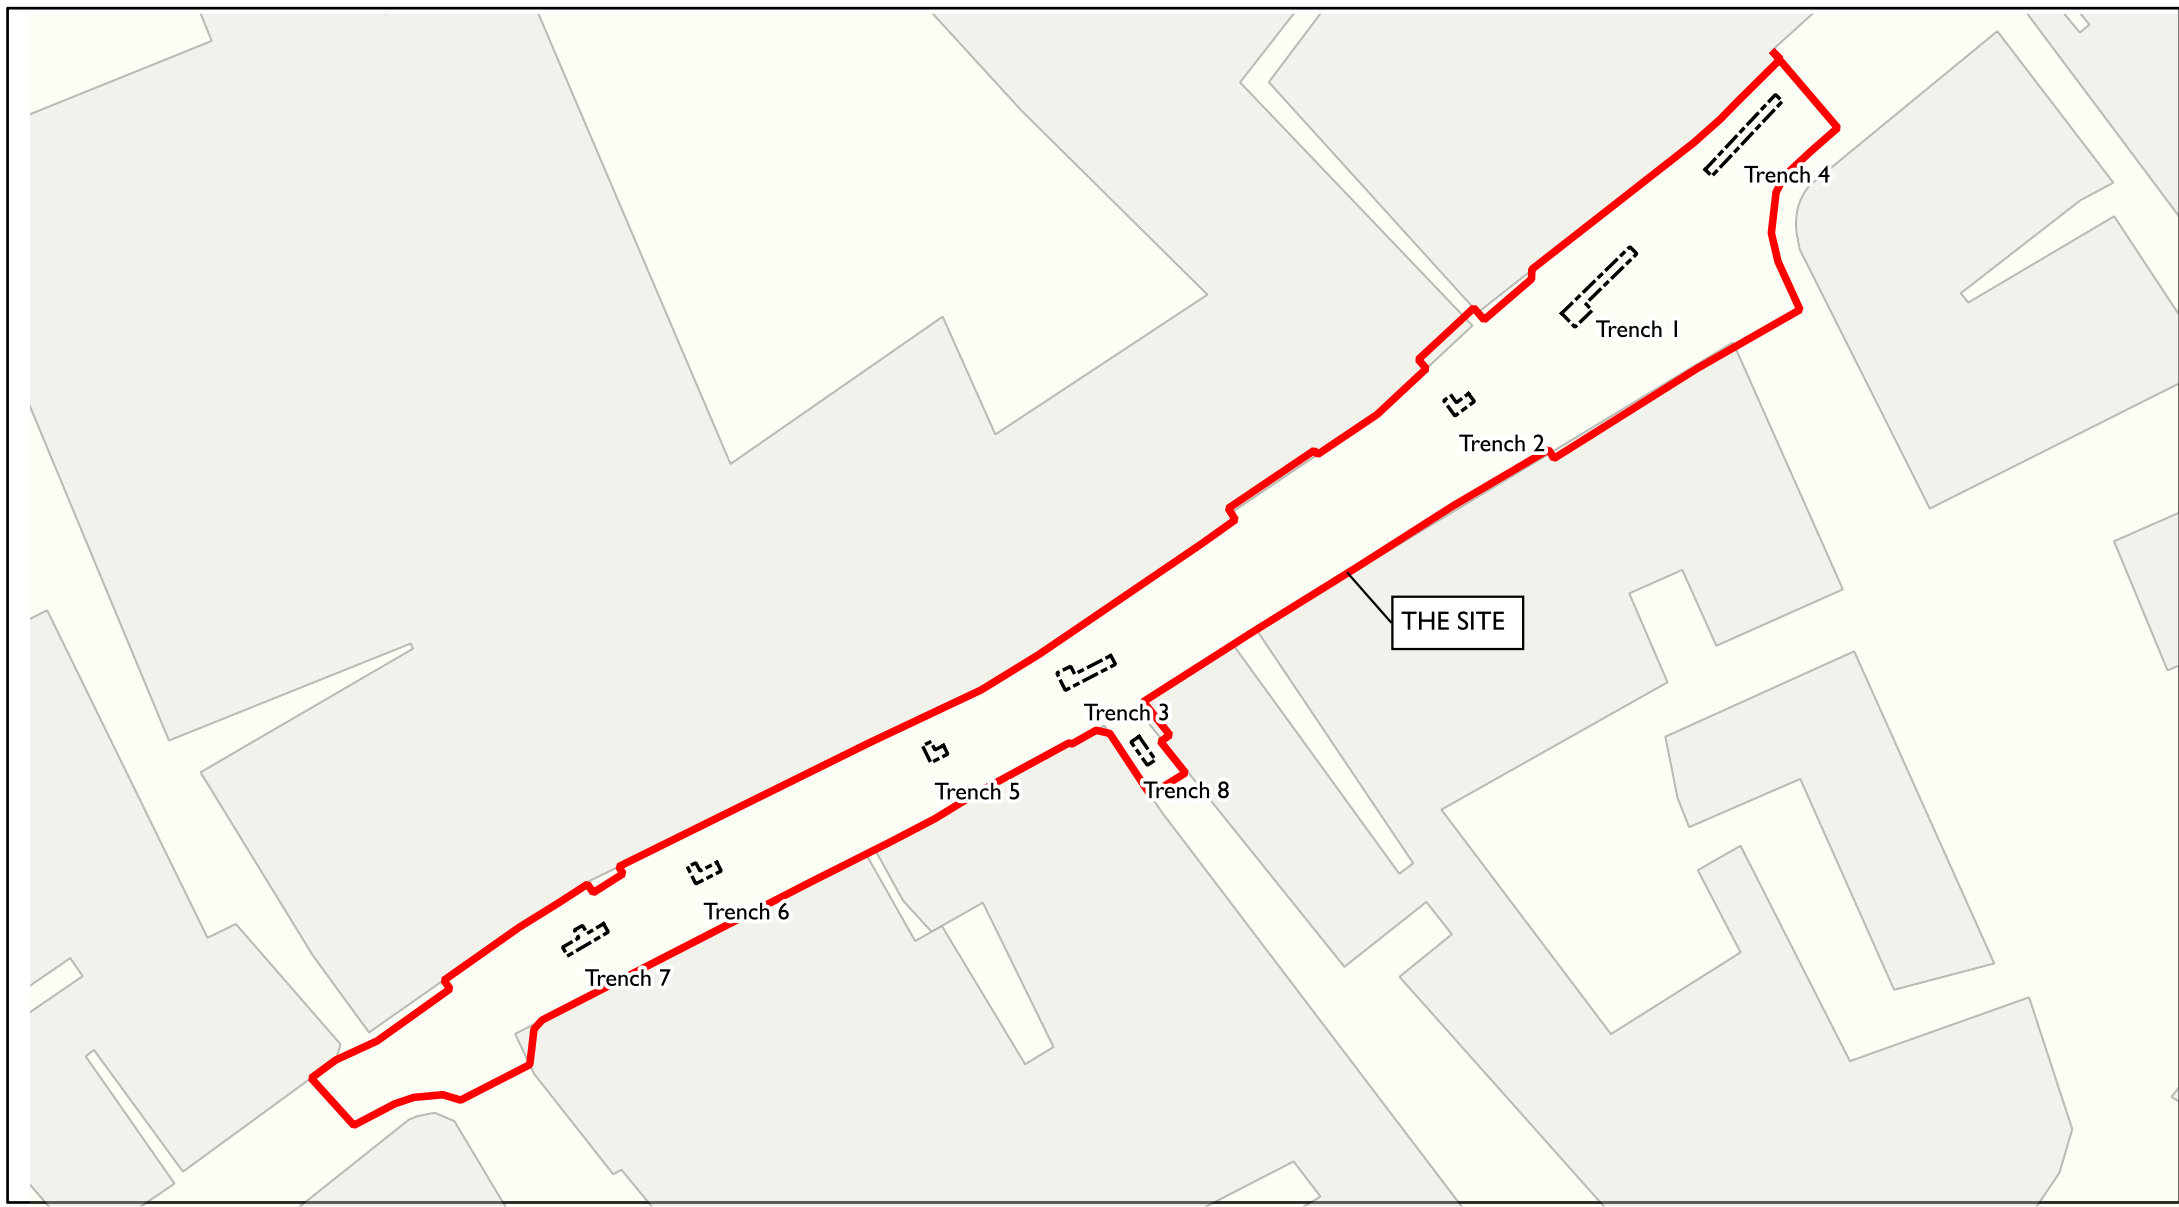
FIGURE 3 // Trench Locations

5.2. The Archaeological Watching Brief monitored work across eight excavations along Pride Hill, with one on Butchers Row and St Mary Street; these have been numbered in chronological order of excavation and the results are given in this format (FIGURE 3).
