Archaeological Watching Brief Report at

# **SUTTON GRANGE SHREWSBURY**

Client: Orion Heritage

Doc Ref: LP3030C-WB-v1.3

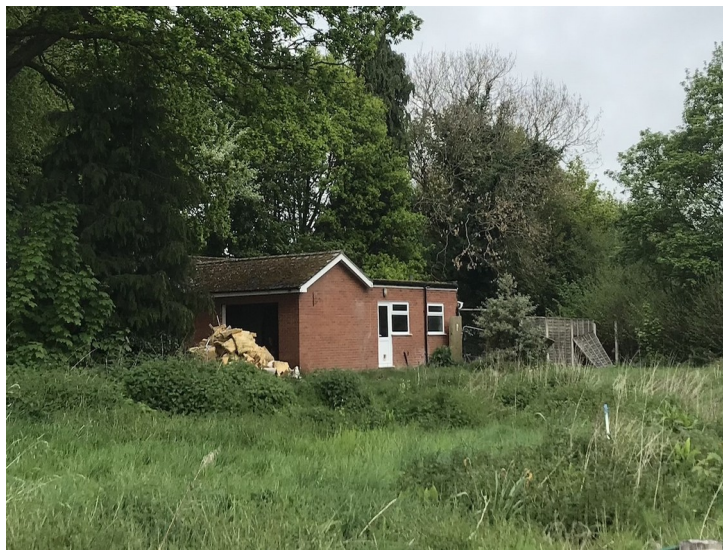
7.2.1. Building A in the northwest corner of the site was monitored during demolition, however, this was a late 20<sup>th</sup> century bungalow (PLATE 1) and no earlier evidence was identified below the footing.

Plate 1 - Building A

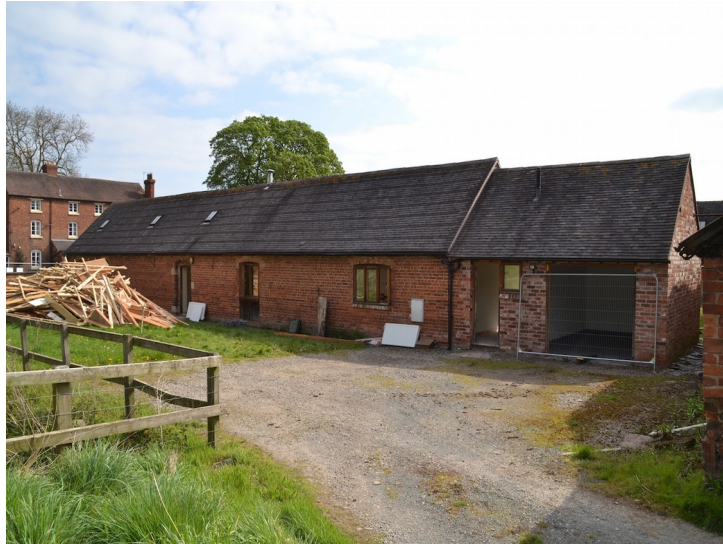
7.3.2. The south elevation was the gable end of a later garage extension which faced building E. On the west facing elevation there was a large garage door, with single door and window within the extension (PLATE 2). This joined onto the original building which had evidence of multiple windows and an original

Plate 2- Building B, west elevation. Facing northeast.

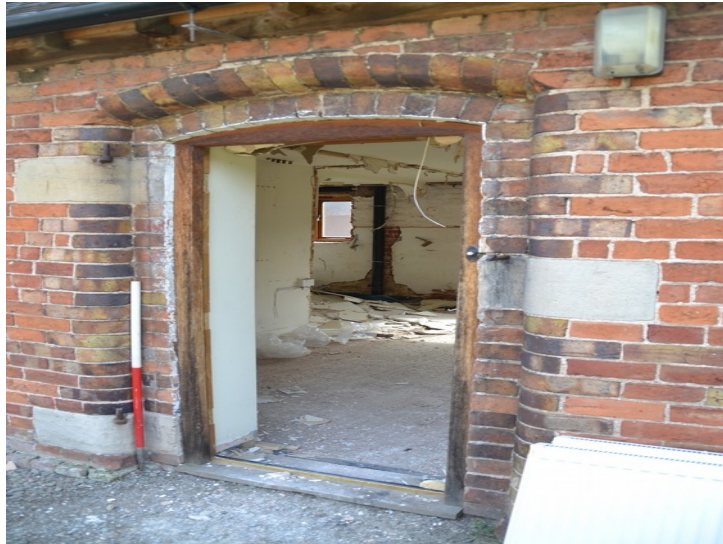
doorway. The doorway had an archway above it and curved brick detail down either side of the entrance. Three large sandstone blocks were located on these sides with original iron door fixtures still attached (PLATE 3). Evidence of a secondary door which had been converted into a window was identified in this elevation, however, this doorway did not have the same curved brick detail or keystones.

Plate 3- Building B, Door in west elevation. 1m scale

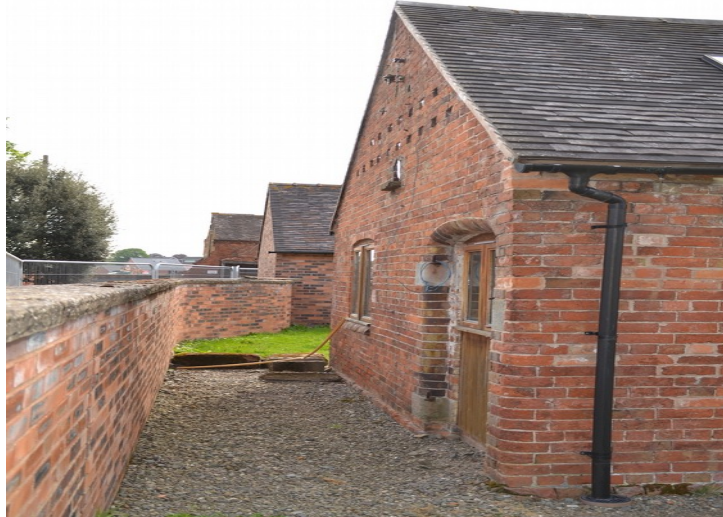
which had been partially blocked up and converted into a window (PLATE 4). A second window was located within this wall. In the apex of this elevation were dove holes, the remains of its former use as barn, they were blocked up with glass tiles creating an interesting structural feature.

Plate 4- Building B, north elevation. Facing east.

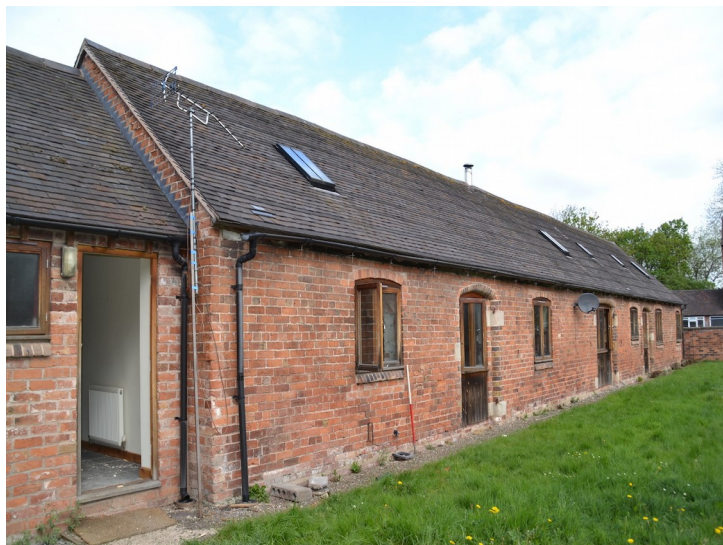
Plate 5- Building B, east elevation. Facing northwest, 1m scale.

7.3.4. The east facing elevation contained three more feature doors, which had been semi blocked up and converted into windows; with five further standard windows (PLATE 5). This facade faced into a grassed central area and building D.

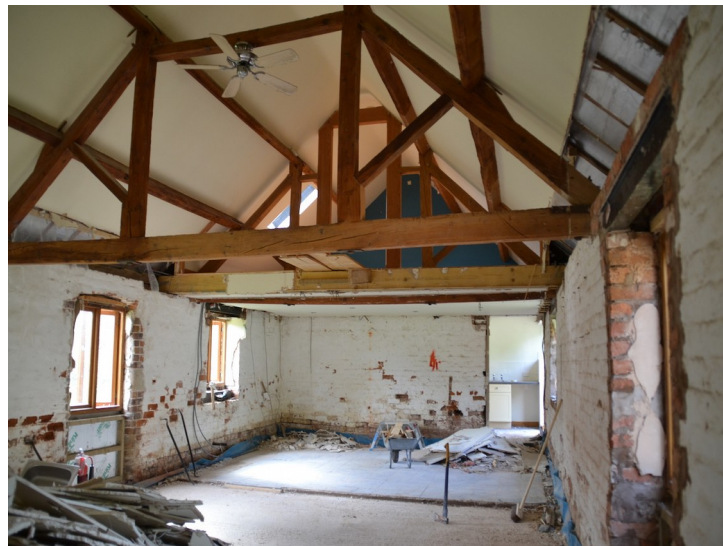
7.3.5. Internally the building was divided into multiple areas, the south end was accessed via the extension, into a large space with wooden exposed beams; a mezzanine level was on the south wall (PLATE 6) and a large chimney breast on the north brick wall. Though a door to the left of the chimney the space was divided into smaller rooms by partition walls (which had primarily been removed during the soft strip of the building), to the west was a wooden staircase leading to an upper level with bedrooms and a bathroom (PLATE 7). On the upper floor wooden beams were visible throughout, the beams appeared to vary in age, with some noticeable newer than others (PLATE 8, PLATE 10). The main bedroom at the northern end, revealed the dove hole feature wall (PLATE 9), with further evidence of original iron fitting noted on both the upper and ground floor levels (PLATE 11).

Plate 6- Building B, internal southern area, looking south to mezzanine area and doorway to extension.

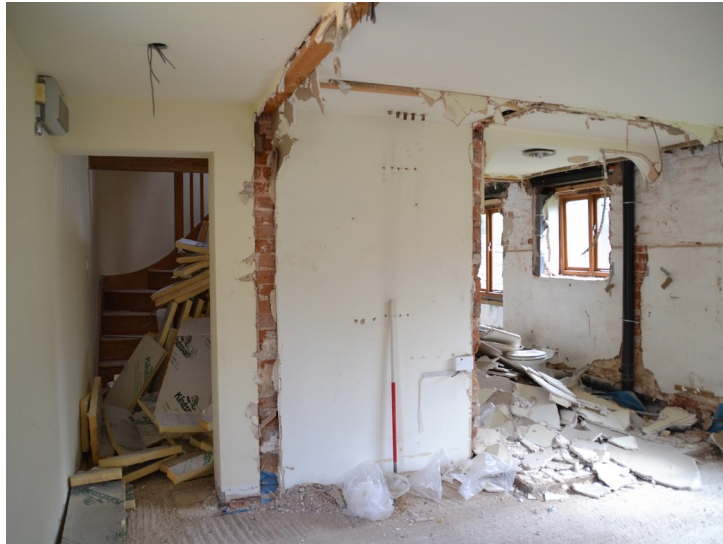
Plate 7- Building B, looking north at staircase. 1m scale

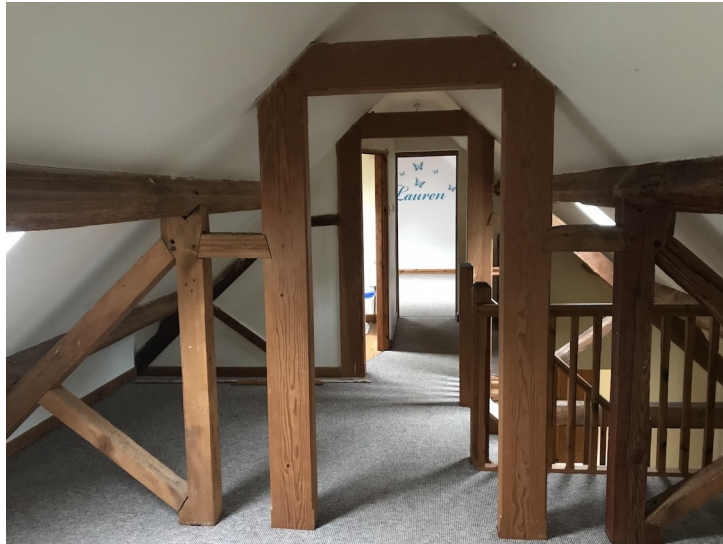
Plate 8- Building B, upper level looking south.

7.3.6. Originally a barn, this building had undergone extensive modification to convert the space into a liveable building. Many of the brick walls had been painted or plaster boarded over -revealed through the soft strip- with new windows and doors replacing or inserted in a sympathetic way. Most of the wooden beams had been left exposed, though many appeared to be modern replacements (PLATE 8).

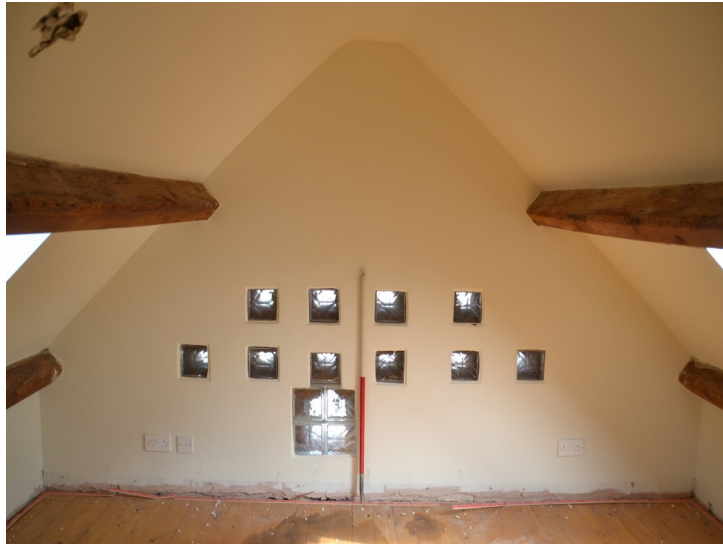
Plate 9- Building B, interior of north elevation, detail of dove holes. Facing north, 1m scale

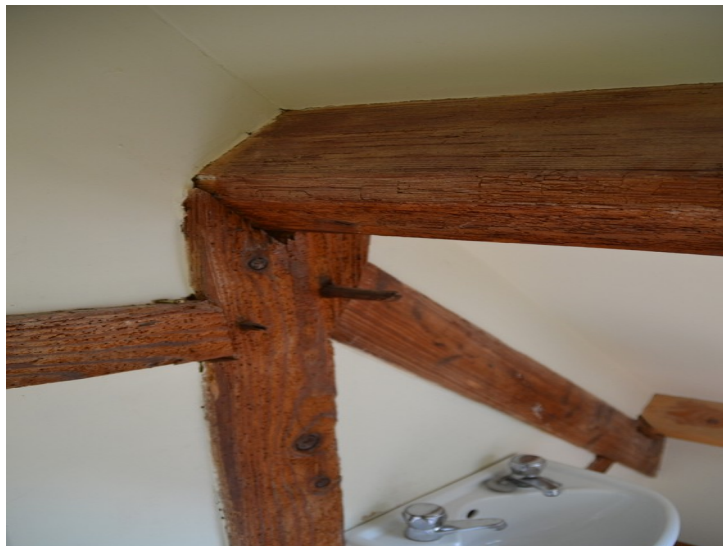
Plate 10- Building B, timber joins in the roof of the upper floor.

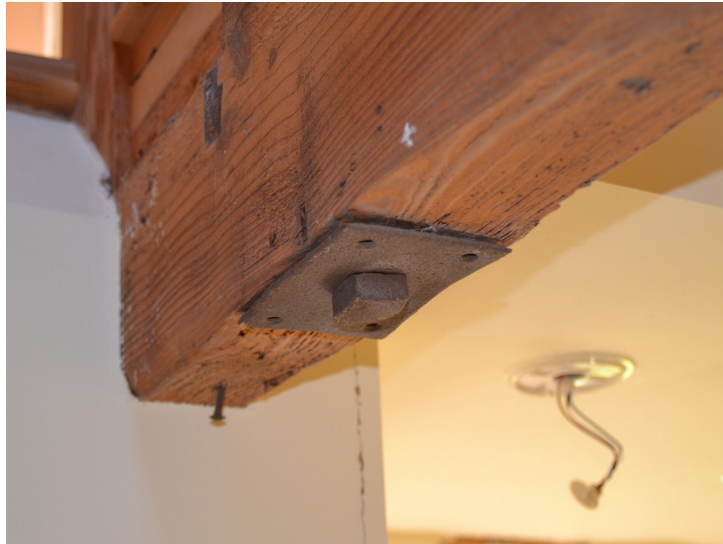
Plate 11- Building B, original iron fixtures, seen on the staircase.

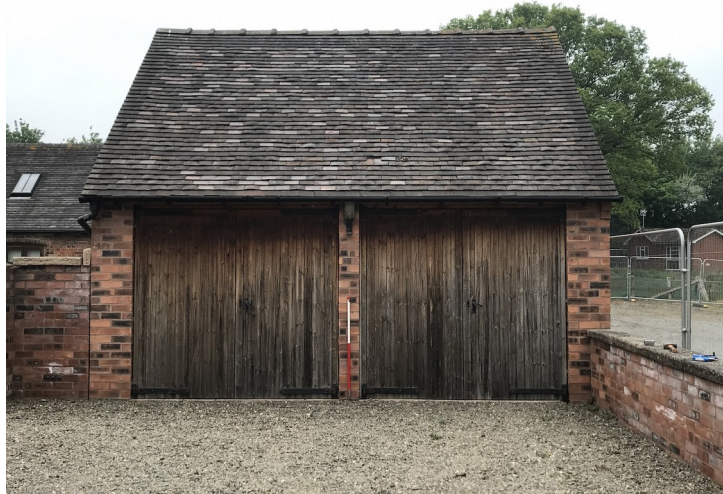
- 7.4.1. Building C was a modern late 20<sup>th</sup> – early 21<sup>st</sup> century brick building located to the north of the site between buildings B and D. It was functioning as a double doored single storey garage, with slate tiled roof.
- 7.4.2. The east facing frontage had two wooden double doors, constructed in a modern red-orange brick and adjoining a modern boundary wall which ran east to west to the north of the site (PLATE 12).
- 7.4.3. In the south facing gable elevation was a single wooden door and window; the west and north facing elevations were of solid brick (PLATE 13).
- 7.4.4. The internal space was a single open room 5.72m by 6m in plan and with a height of 2.4m to the base of the roof.

Plate 12- Building C, east facing elevation. Facing west, 1m scale

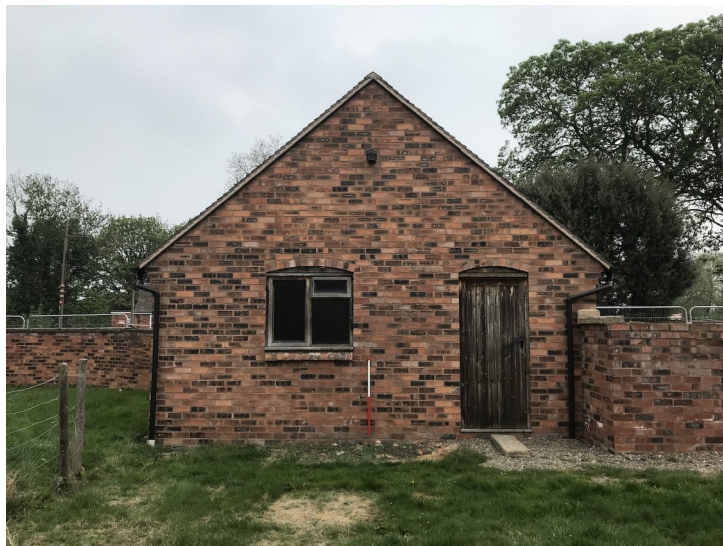
Plate 13- Building C, south facing elevation. Facing north, 1m scale.

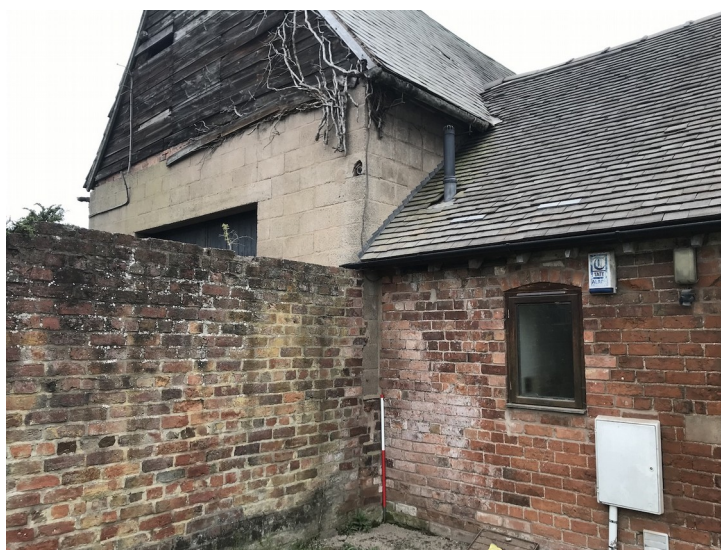
Plate 14- Building D, southern gable end joining building E. Facing southwest, 1m scale.

7.6.4. The eastern end of the structure appeared to be built into the southern end of building D (PLATE 14), the north elevation had wooden cladding (PLATE 24),

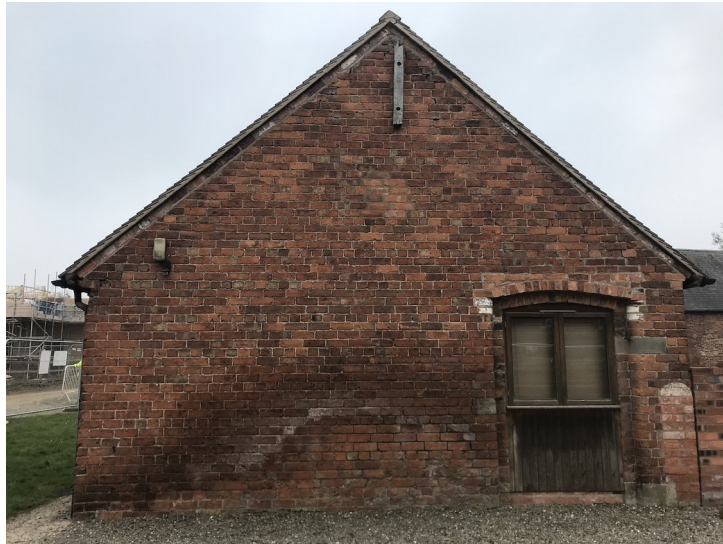
7.5.3. The north facing elevation showed evidence of a previous single large doorway, which had since been semi blocked up with wooden cladding and converted into a window. It had a brick archway, rounded side and sandstone key-stones mimicking the east and west elevations (PLATE 17).

Plate 17- Building D, north elevation. Facing south.

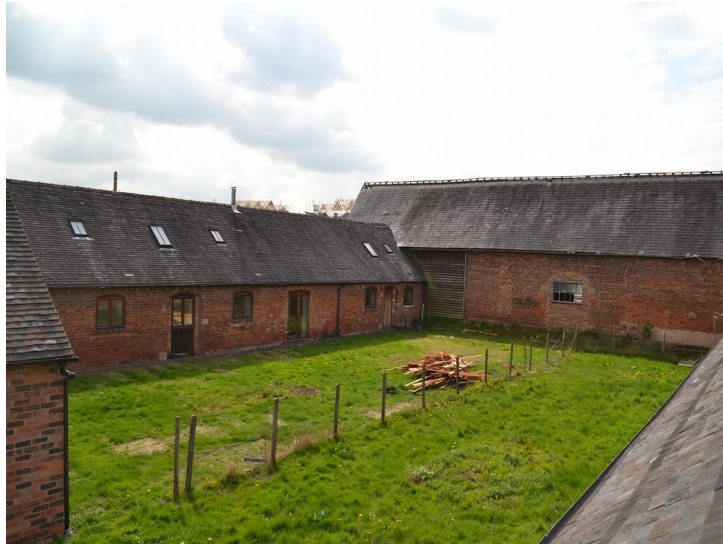
7.5.4. The west facing elevation faced building B, with original doors and windows of the same structural details of archways and rounded brick (PLATE 18). The exception was seen in one set of french double doors, which was a later addition. Velux windows had also been inserted in to this side of the slate roof.

Plate 18- Building D, west elevation with building E. Facing southeast.

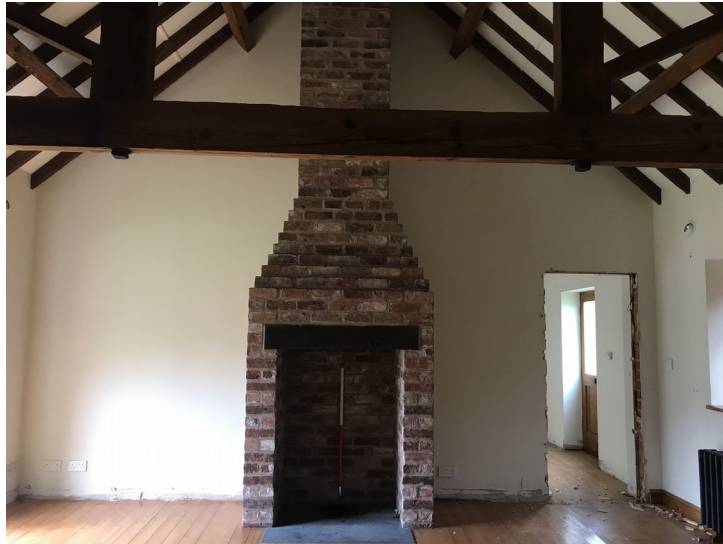
7.5.5. Internally the central area was an open plan room with later chimney breast inserted in the northern brick dividing wall (PLATE 19), to the south and north of this area the building had both a ground and upper floors. These were accessed by wooden staircases to landing areas and bedrooms. The wooden A frame roof beams were visible throughout the upper floors (PLATE 20).

Plate 19- Building D, central open area with inserted chimney. Facing north, 1m scale.

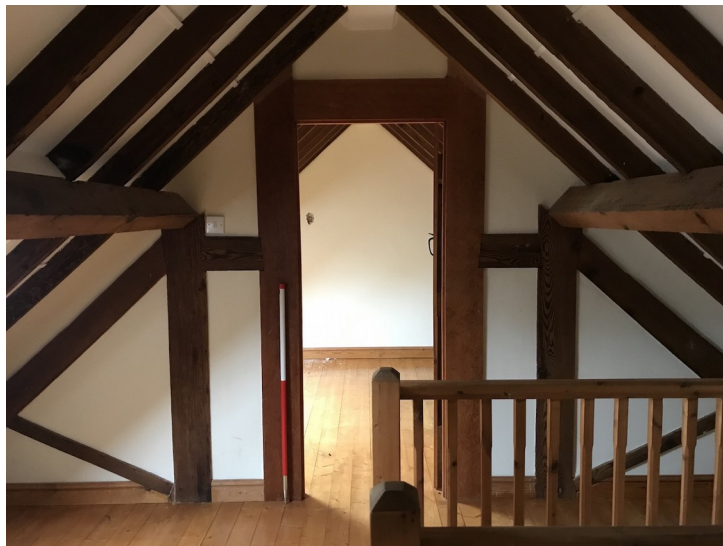
Plate 20- Building D, Upper floor timber beams. Facing north, 1m scale.

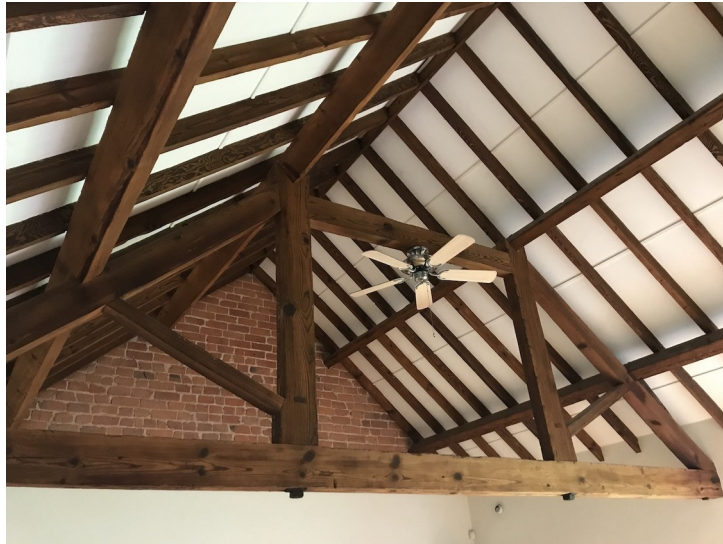
7.5.6. This building was similar to building B, originally a barn converted into a modern living space. Many of the brick walls had been painted or plaster boarded over, with evidence of 20<sup>th</sup> century concrete block modifications to the east elevation and a newly inserted chimney. Most of the wooden beams had been left exposed, though many appeared to be modern replacements.

Plate 21- Building D, timber roof beam in the central open area. Facing southwest.

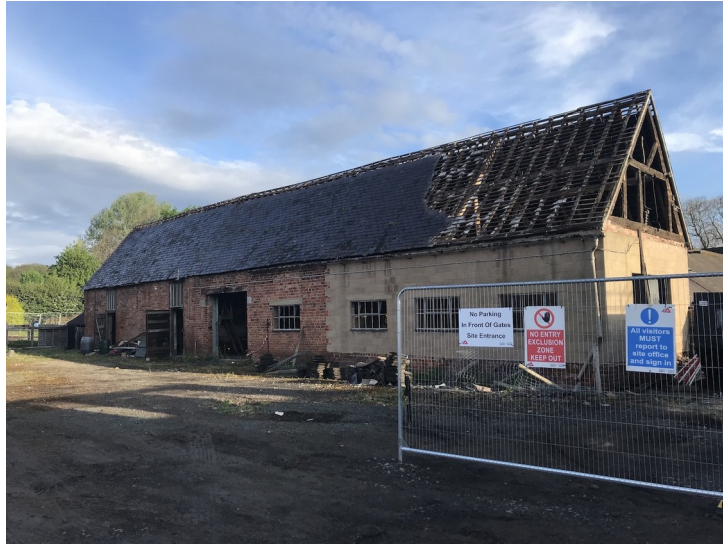
Plate 22- Building E, south and east facing elevations. Facing northwest.

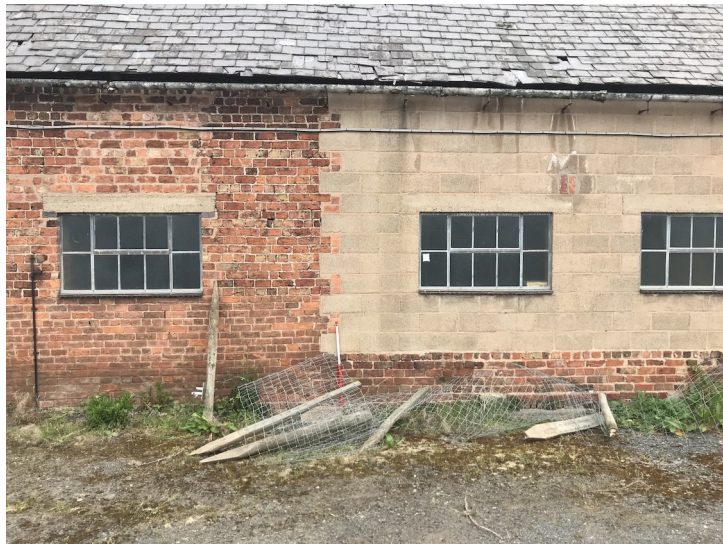
Plate 23- Building E, brick and concrete detail. Facing north, 1m scale.

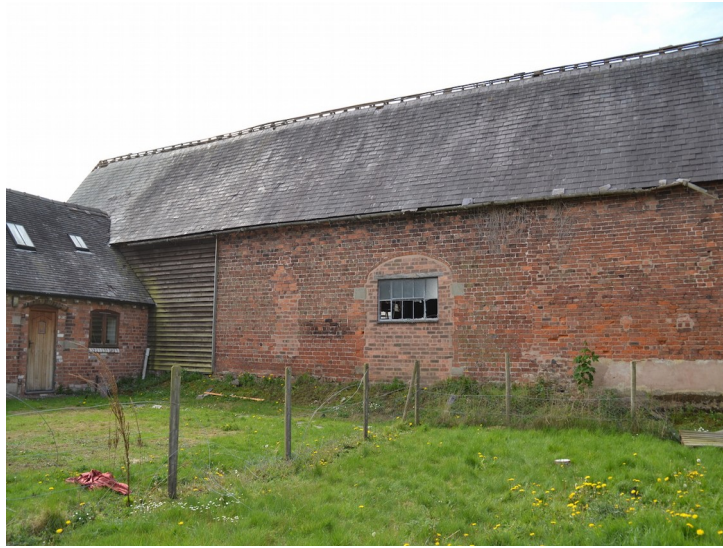
Plate 24- Building E, north facing Elevation. Facing southeast.

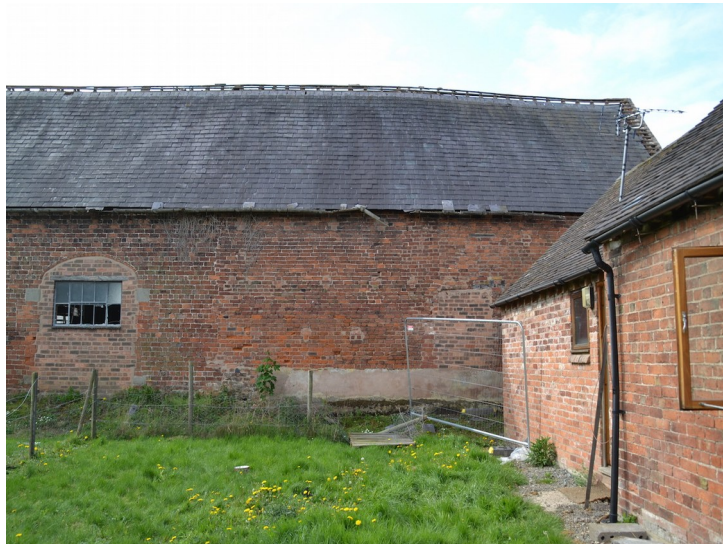
(PLATE 46, PLATE 49). The north facing elevations showed several areas of varying brickwork which appeared to correlate with the internal divisions (PLATE 25). A bricked up doorway way was present, with curved arch and four key stone sandstone blocks, similar to those seen in the doorways of buildings B and D.

Plate 25- Building E, north facing Elevation. Facing south.

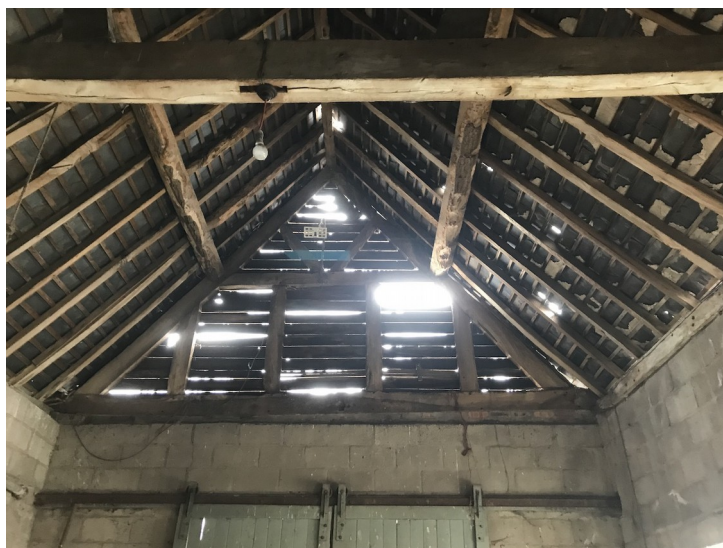
with the south and east elevations constructed of concrete blocks (PLATE 26).

Plate 26- Building E, room 1 the internal facade of the east elevation. Facing east.

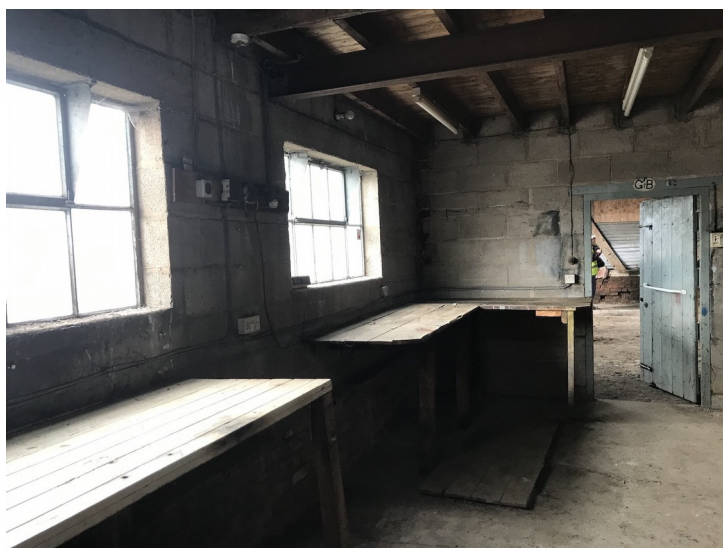
Plate 27- Building E, room 1 facing west.

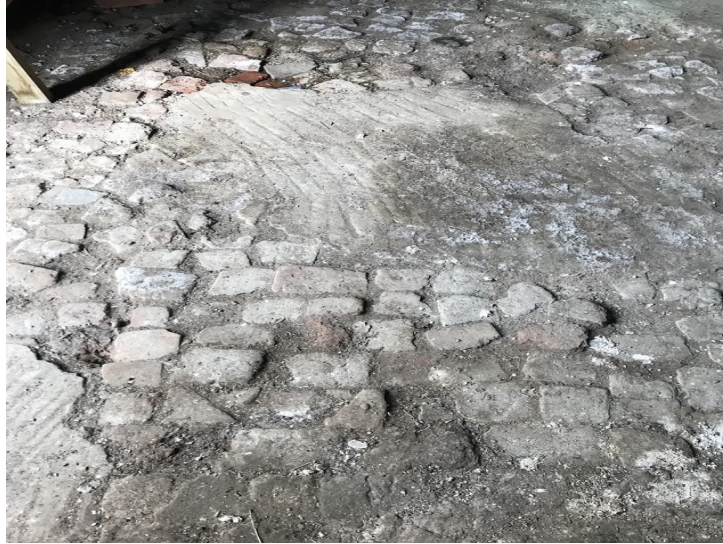
Plate 28- Building E, room 1 concrete and brick floor.

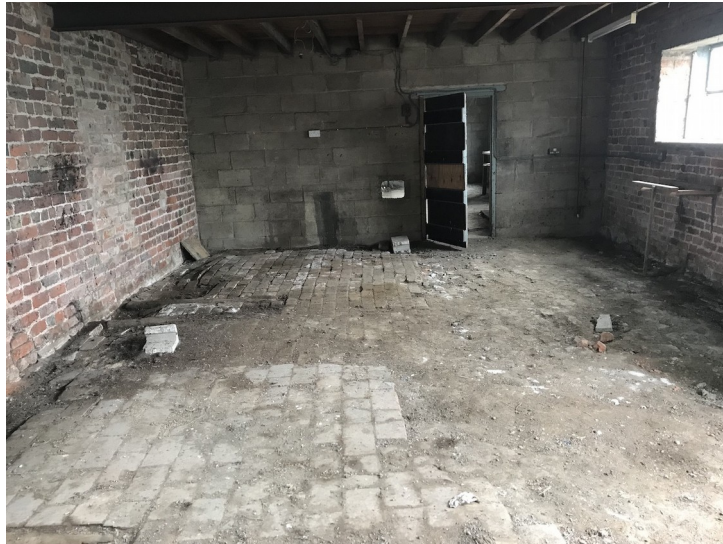
the building. It was 9.1m in length and 5.7m in width, an open space with a brick and concrete floor (PLATE 29).

Plate 29- Building E, room 2 facing east.

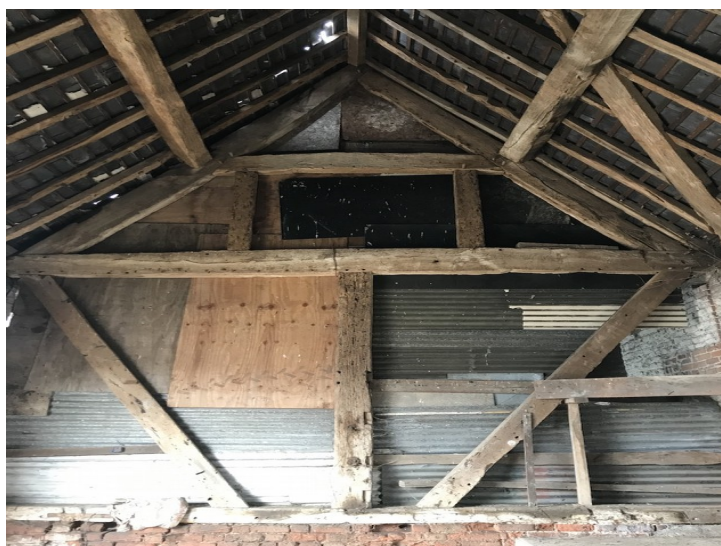
7.6.6. Room three was accessed through a single door in the south elevation, the room was 4.6m long by 5.7m wide. Separating rooms two and three was a large wooden A-framed truss with added wooden upright beams; corrugated iron sheets and wooden boards were used to create a wall (PLATE 30), wooden animal troughs were present in this room (PLATE 32). The division between room three and four was constructed of red brick with a concrete support lintel replacing the wooden beam (PLATE 31). This wall had areas of repair and a

Plate 30- Building E, room 3 exposed wooden beam division, facing east.

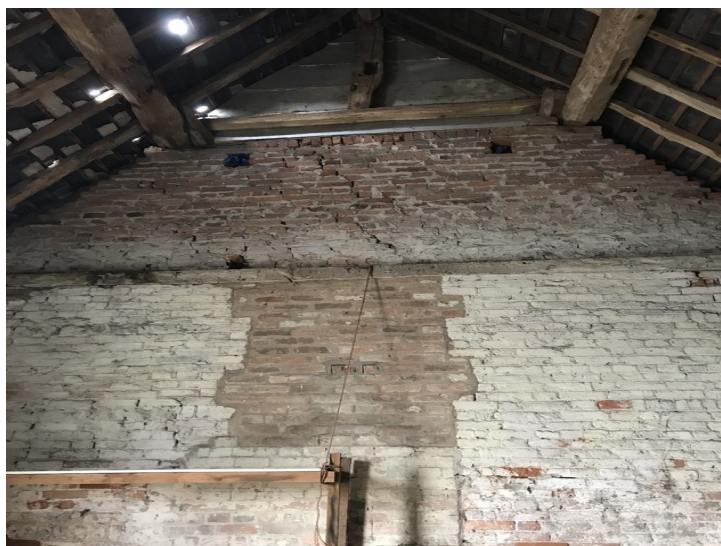
Plate 31- Building E, room 3 brick wall division with blocked up door. Facing west.

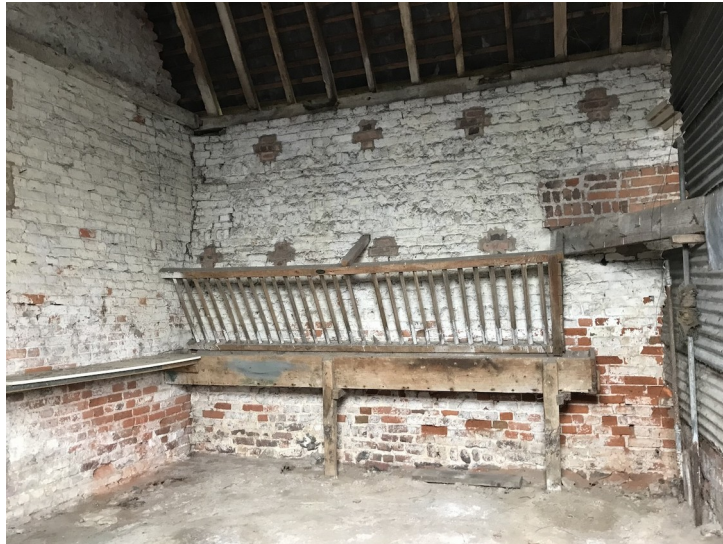
Plate 32- Building E, room 3 wooden animal troughs. Facing northwest.

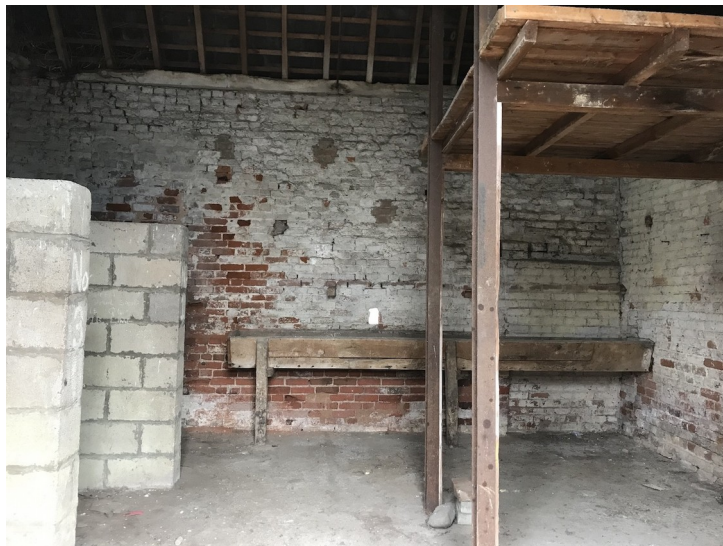
bricked up doorway. Room four was accessed by an external wooden door, 6.2m long and 5.7m wide. Modern breeze block divisions had been built to create animal stalls and wooden troughs were seen against the northern wall. A large elevated animal feeder was attached to the east dividing wall (PLATE 33) and evidence of the bricked -up door was seen from this room.

Plate 33- Building E, room 4 with breeze block stalls and animal feeder. Facing north.

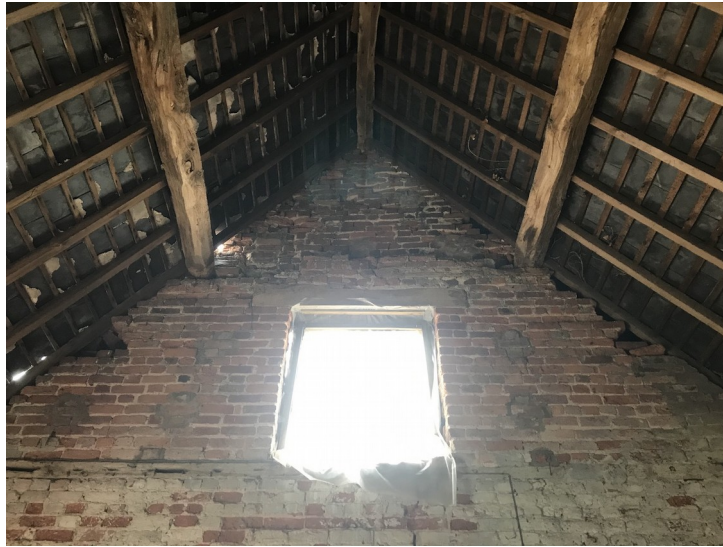
Plate 34- Building E, room 4 internal facade of west external wall. Facing west.

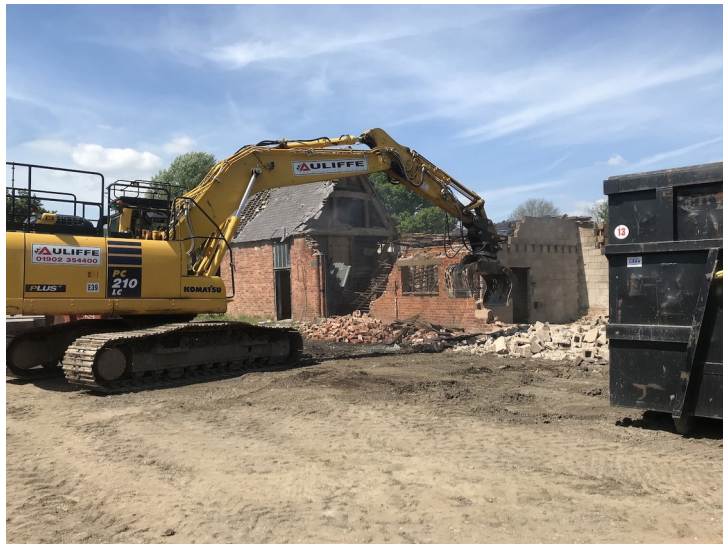
7.6.7. The eastern concrete side of the building is likely a repair or rebuild of the original building, using old brick and new blocks. The phases of brickwork seen internally and on the northern exterior wall suggests the structure had undergone several phases of repairs, rebuilds and modifications (PLATE 35). It is unclear whether these occurred over an extended period of time or as a single event.

Plate 35- Building E, multiple phases and materials of construction seen during demolition. Facing northwest.

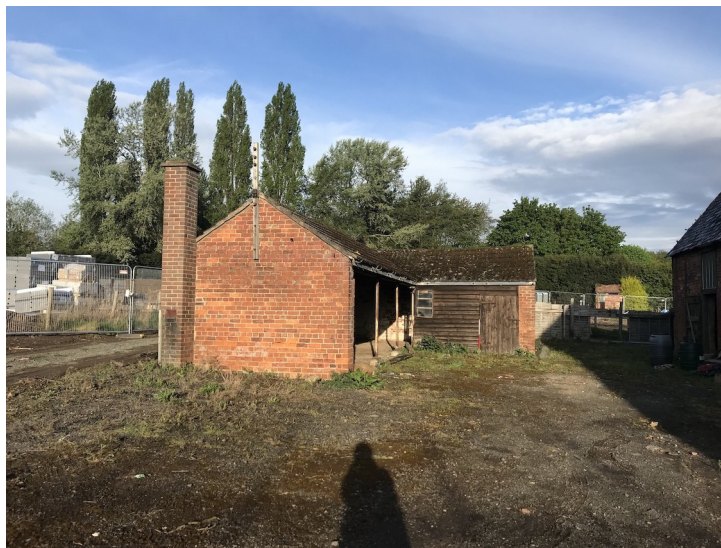
7.7.1. Building F was a single storey L-Shaped building (PLATE 36) constructed of timber frame and red brick, with a ceramic tile roof. The western end of the structure had a roughly built red brick and concrete block lean to (PLATE 40).

Plate 36- Building F, looking west. 1m scale.

7.7.4. The east facing facade of the dog-leg of the building was constructed of a timber frame and cladding (PLATE 36), the roof through-out was a wooden A-frame truss (PLATE 39).

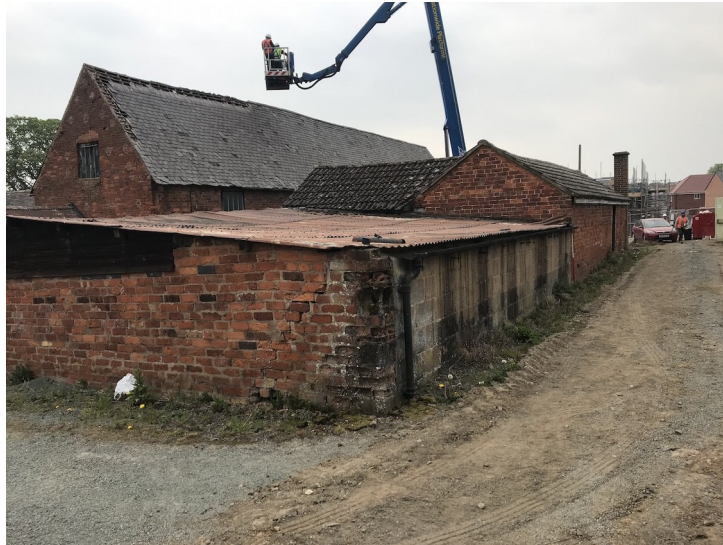
Plate 37- Building F, west and south elevations. Facing northeast.

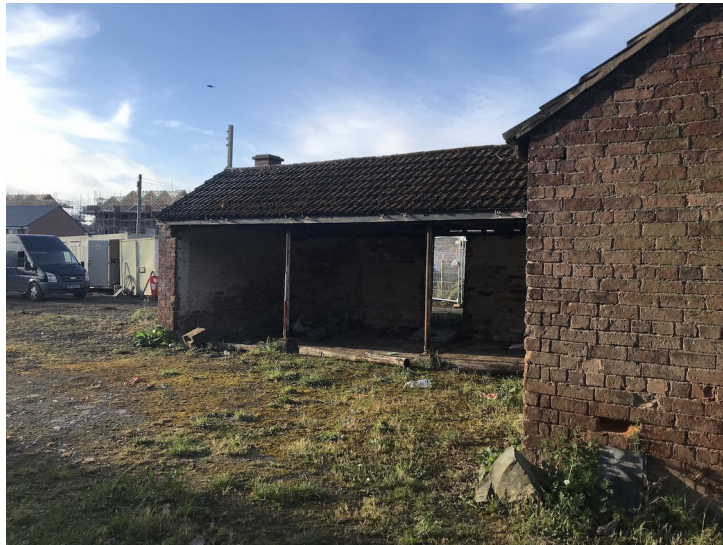
7.7.2. The north facing side of the building was open fronted, with red brick walls to the east, south and west, bonded with a white lime mortar. The open fronted side was supported by iron girders which had been put in place for safety (PLATE 38). A single timber door was located in the centre of the southern facade (PLATE 37) and a chimney flue had been inserted into the southeast corner of the building, though no associated grate was evidenced on the inside.

Plate 38- Building F, north open facade. Facing south, 1m scale.

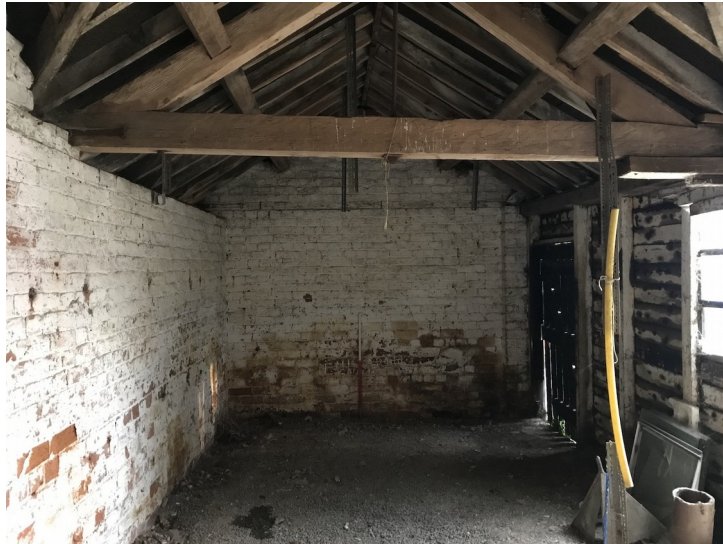
Plate 39- Building F, Dog leg of the building facing north.

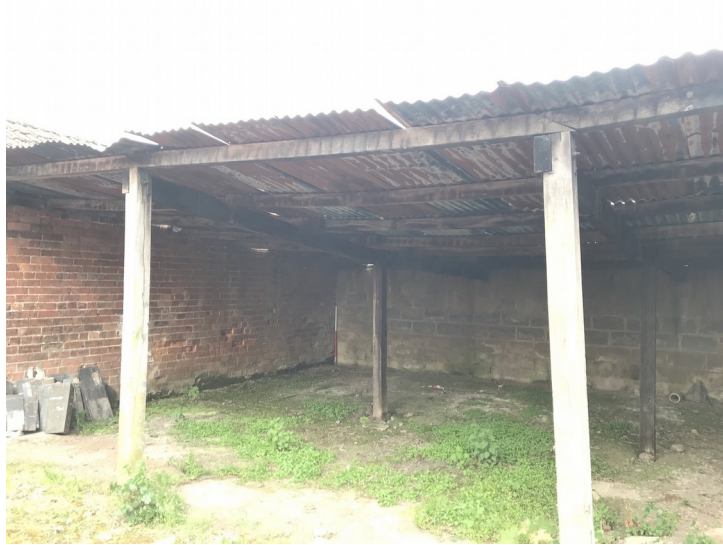
7.7.6. The lean-to was built onto the west facing facade of the building. The southing facing wall was constructed of large concrete blocks, with the western wall of rough red brick with a white lime mortar bonding and partial timber cladding. The structure had a timber frame with timber uprights supporting the weight of the roof, which was corrugated iron sheeting. The covered space of the lean-to was 8.6m x 7m.

7.7.7. This building appeared to be used as a barn and storage area, with the lean-to thought to be a later addition or possibly replacing an earlier structure.

Plate 40- Building F, corrugated iron and concrete lean-to to the west of the structure. Facing south, 1m scale.

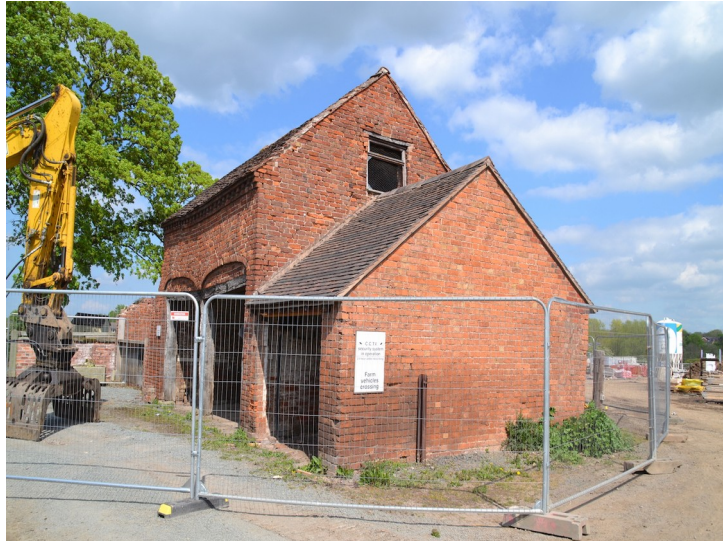
Plate 41- Building G, facing northeast.

7.8.4. The south facing gable end had a small window in the apex, with a single storey red brick extension built against this end (PLATE 41).

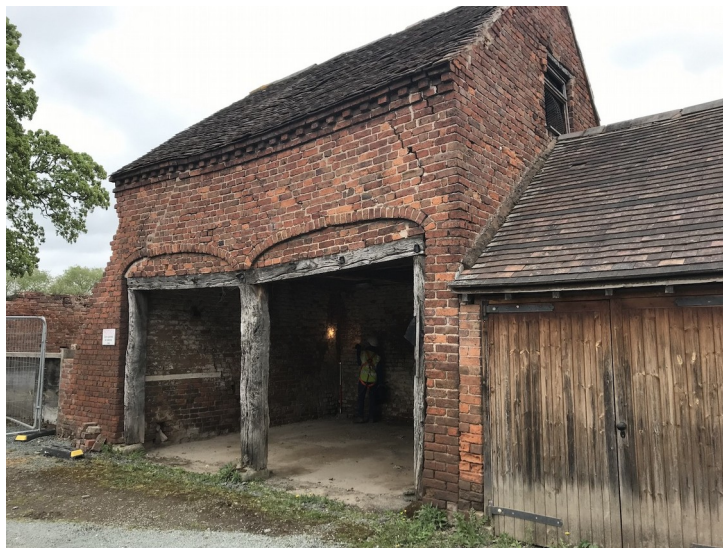
- 7.8.2. The front west facing facade was dominated by a large opening, with timber beam supports and two brick arches. The timber supports are most likely a later addition to aid in shoring the structure, which showed evidence of movement and would probably have originally been a brick support column (PLATE 42).

Plate 42- Building G, west facing open frontage. Facing northeast.

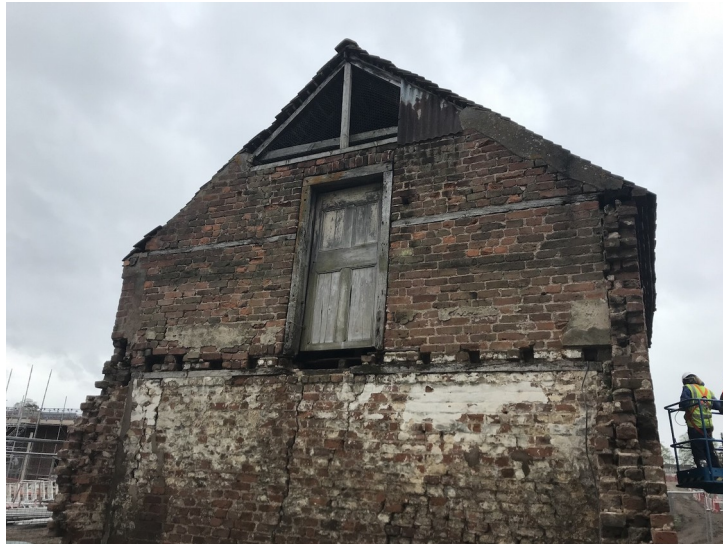
- 7.8.3. The north facing facade was only partially accessible due to safety constraints. A wooden interior style door was seen on the first floor of the structure, suggesting that the building and collapsed adjoining area, would have had a first floor level which was easily accessible from both sides (PLATE 43).

Plate 43- Building G, north facing elevation.

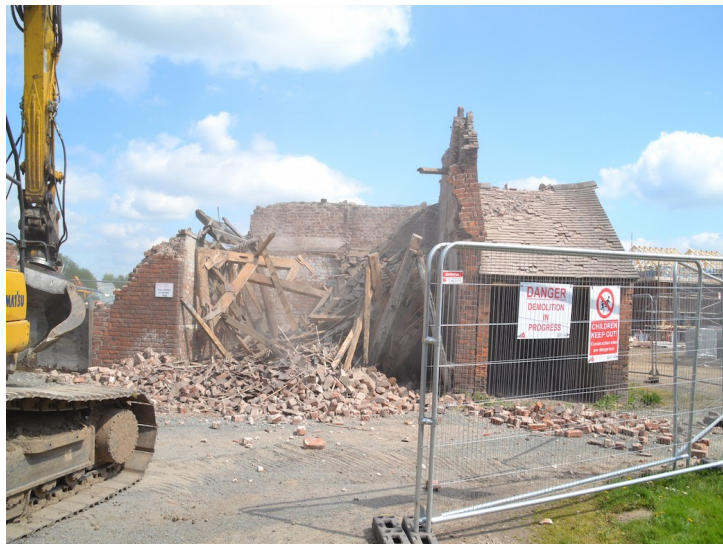
7.8.7. No new historic fabric was identified during the demolition of this building (PLATE 44).

Plate 44- Building G, eastern back wall seen during demolition. Facing east.

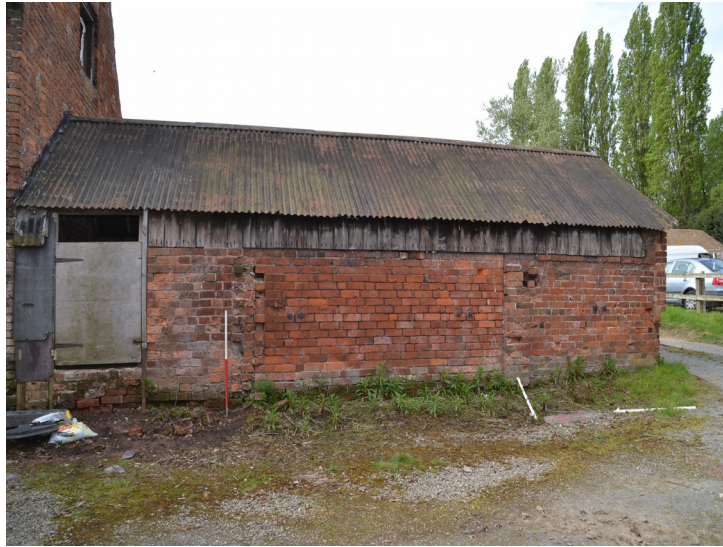
Plate 45- Building H, north facing elevation. Facing south, 1m scale.

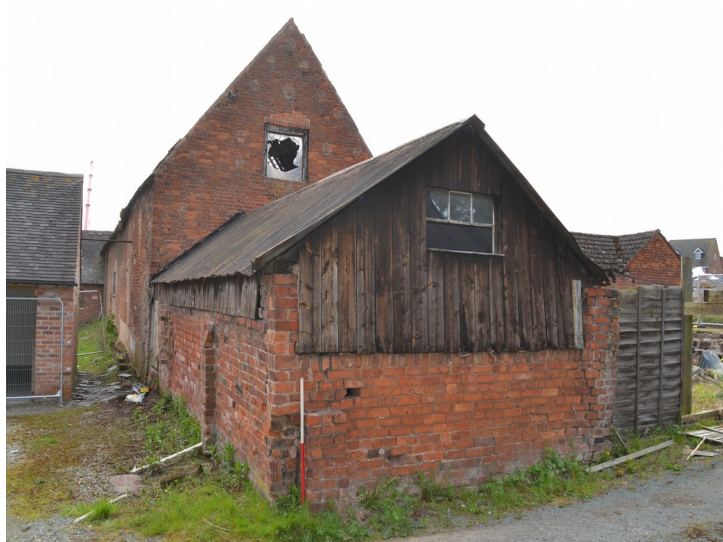
- 7.9.3. The west facing facade was constructed of red brick and wooden cladding, a broken wooden framed window was located in the apex of this elevation. A small brick buttress extended one brick length west from the northwest corner of the building, thought to be for support rather than evidence of a previous wall (PLATE 46).

Plate 46- Building H west facing elevation with building E behind. Facing southeast, 1m scale.

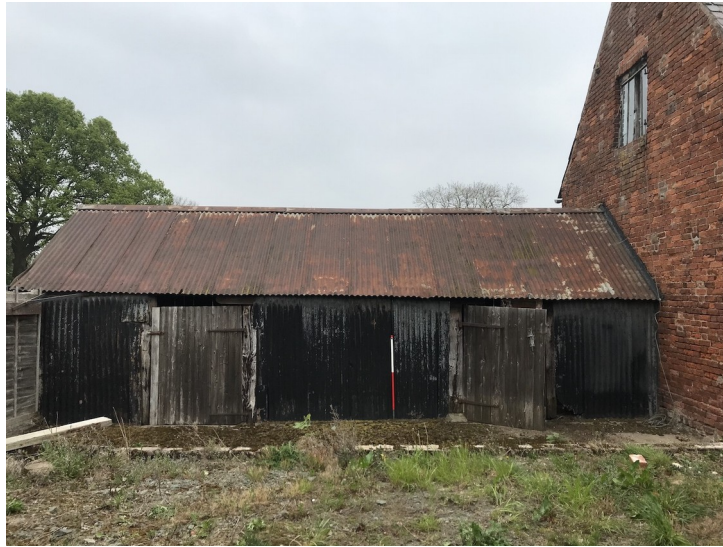
- 7.9.4. The south facing facade was constructed out of a timber frame and corrugated iron sheets, with two large wooden doorways (PLATE 47).

Plate 47- Building H, south elevation. Facing north, 1m scale.

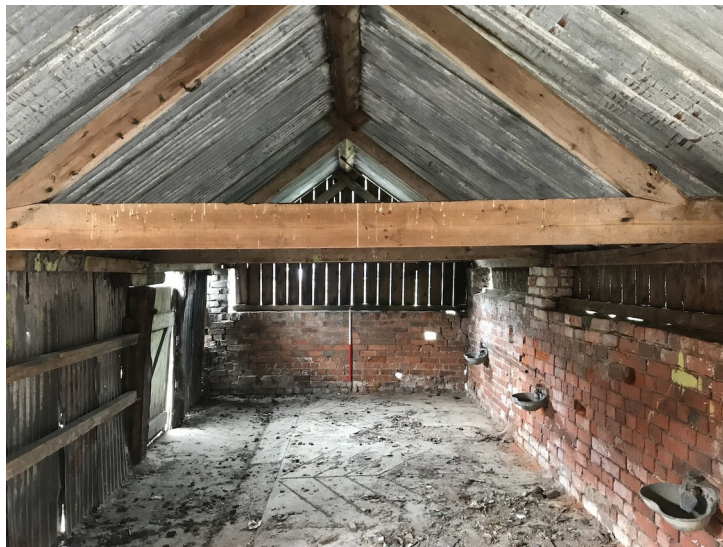
7.9.5. This structure had previously been used as a farm building/barn and was a single open room with concrete floor and wooden A-frame roof truss. Three metal sinks were fixed to the interior of the northern wall (PLATE 48).

Plate 48- Building H, internal view. Facing west, 1m scale.

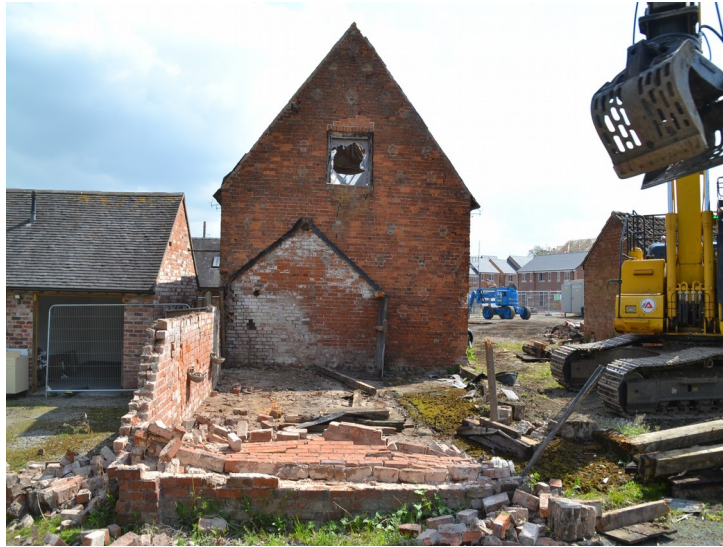
7.9.6. No new historic fabric was identified during the demolition of this building (PLATE 49).

Plate 49- Demolition of building H. Facing east.
