Archaeological Watching Brief Report at

# **SUTTON GRANGE SHREWSBURY**

Client: Orion Heritage

Doc Ref: LP3030C-WB-v1.3

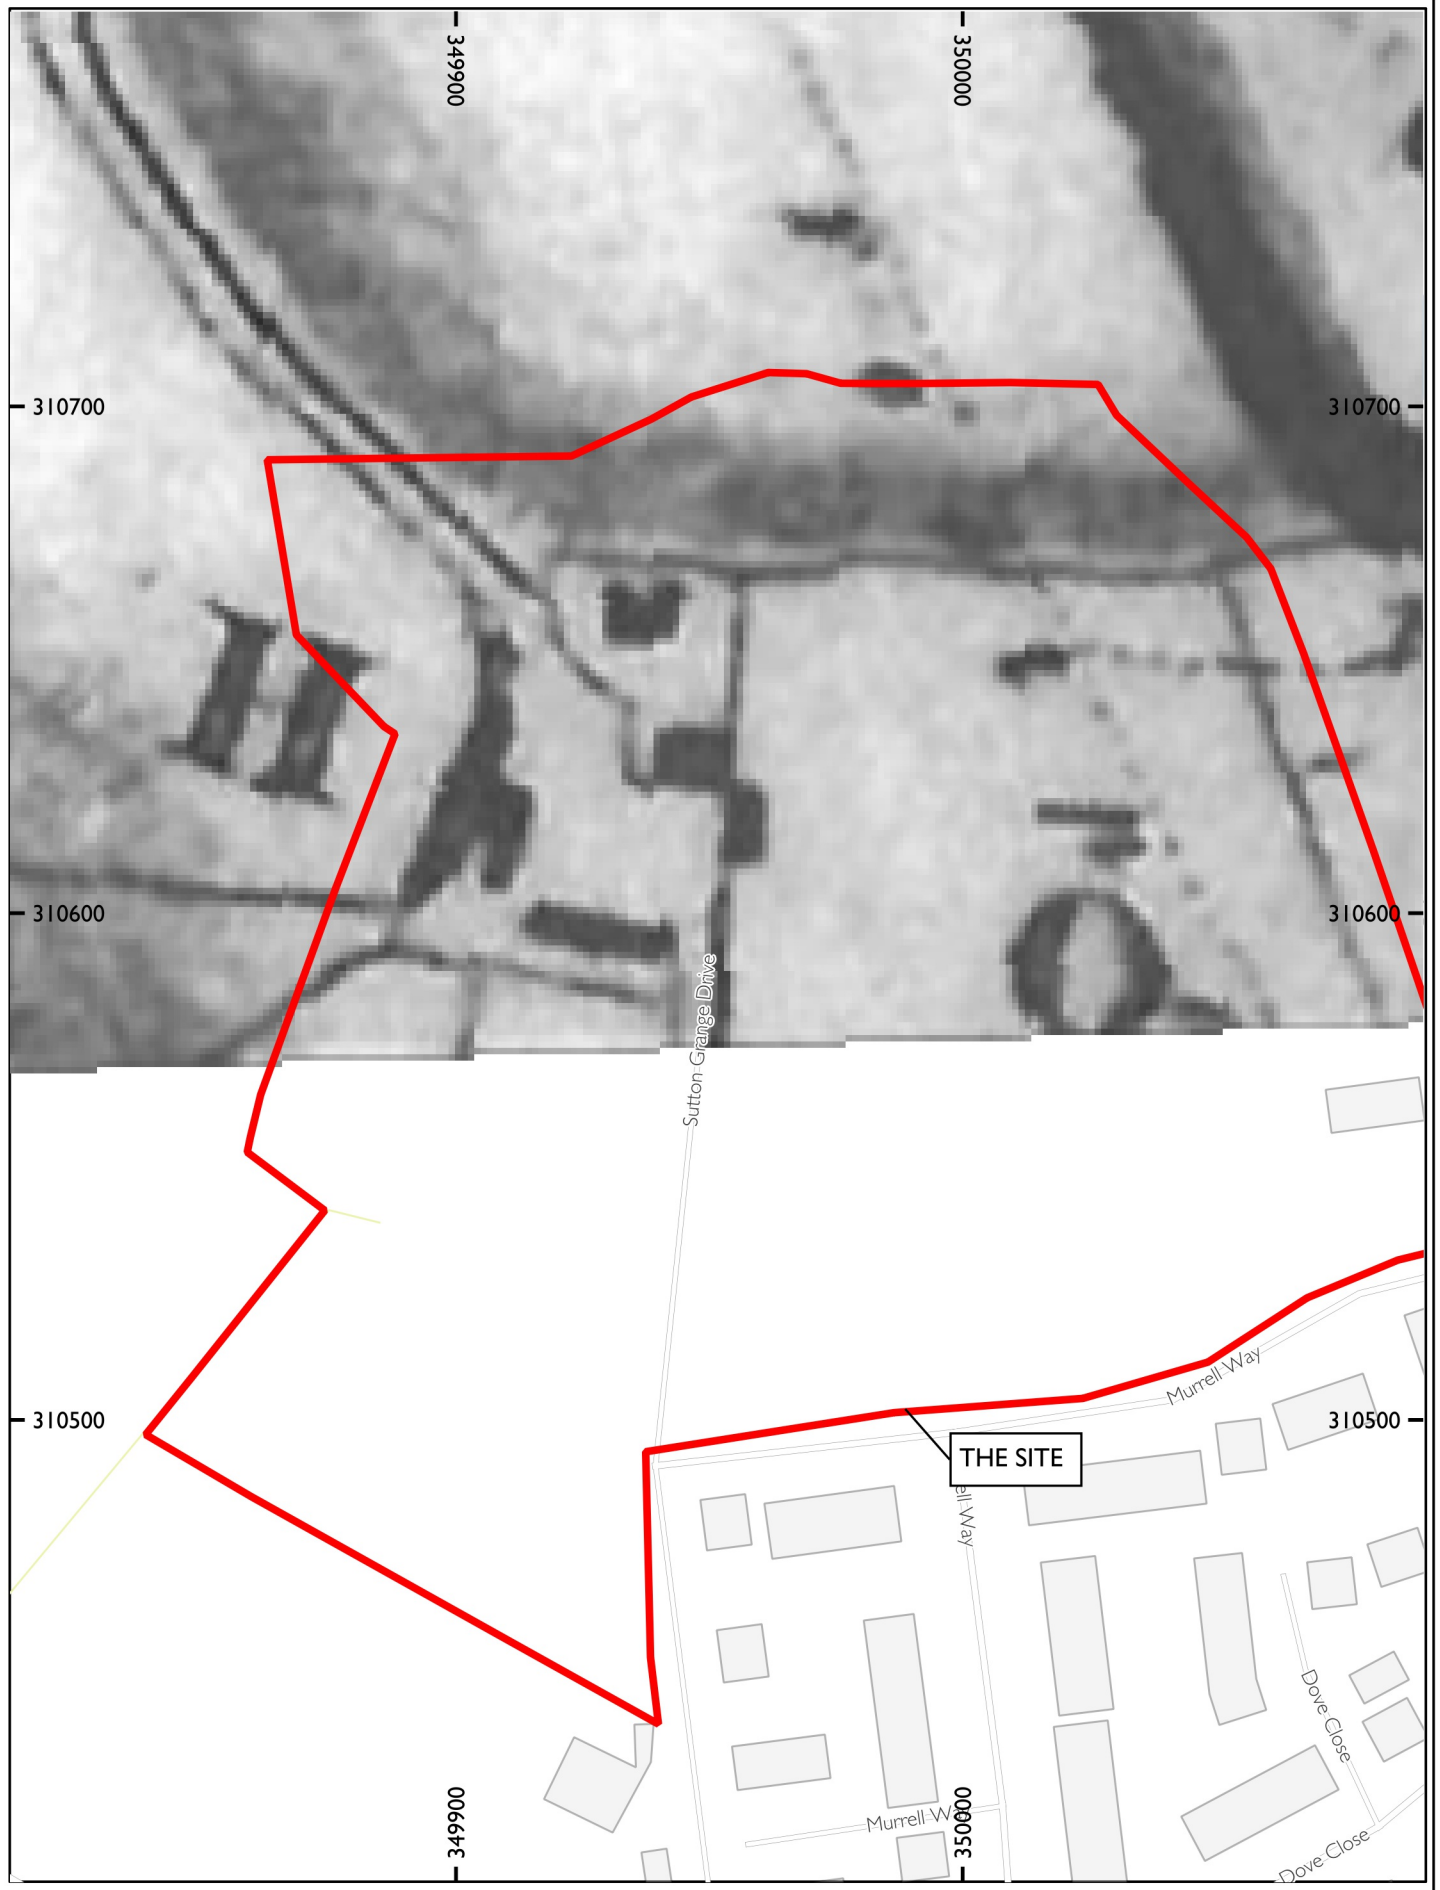
FIGURE 3 // 1832 Hitchcock map

- 6.10. The earliest detailed map of the site is the 1832 Hitchcock map (FIGURE 3), which shows Sutton Grange as a small collection of buildings including Sutton Grange House to the north and buildings to the south (the barn) and east (the cart shed) which still stand today. Sutton Grange House appears to be a single rectangular building with two small extensions on its northern side; to the south of the house is a square building. It is in the same plot of land as the house, but on its southern boundary. Attached or immediately next to the square building is the rectangular cart shed which is located in a second field on its western boundary. This occupies the location of structure G on FIGURE 2. This cart shed was built of red hand-made

- 8.2.5. Building E is potentially one of the oldest of the surviving structures, identified on the 1832 Hitchcock map of the site (FIGURE 3). Still used as a farm building with animal troughs and stalls. There was evidence of multiple phases of repairs, with the eastern part of the structure completely rebuilt in brick and

8.2.7. Building G in the northeast corner is likely the same structure as seen in the earlier 1832 Hitchcock map. Seen in semi-collapsed state with a modern small extension on the southern end. The upper floor no-longer survived and the wooden support beams likely replaced an earlier brick column.
