Archaeological Watching Brief Report

**KING'S DOCK,
LIVERPOOL, MERSEYSIDE**

For Willmott Dixon Construction Ltd

Doc Ref: LP2803C-WBR-v1.2

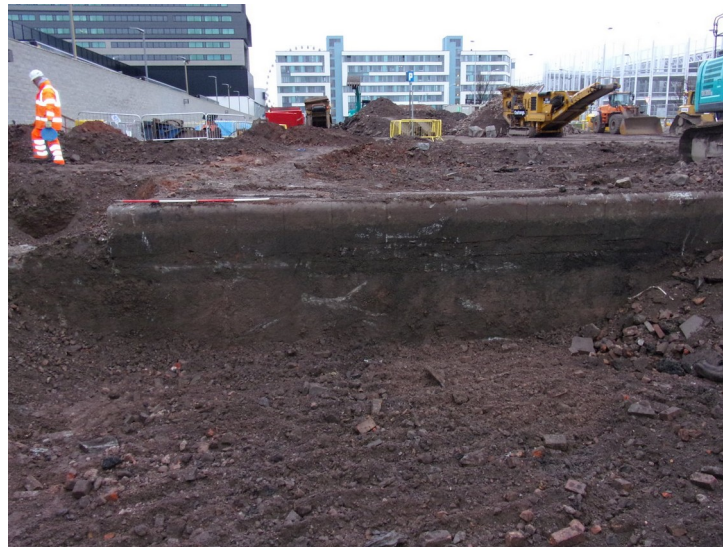
Plate 1- The southern face of the early 20th century Queen's Branch Dock wall [500] with granite coping blocks. Looking north, 2m scale.

southern face of this wall was seen to have a course of granite coping blocks set on top of a concrete wall (PLATE 1) with concrete buttress supports [501] to the rear on the northern side of the structure.

5.3.3. To the south of wall [500] the modern overburden and build up (503) exceeded the depth of the trench (PLATE 1).

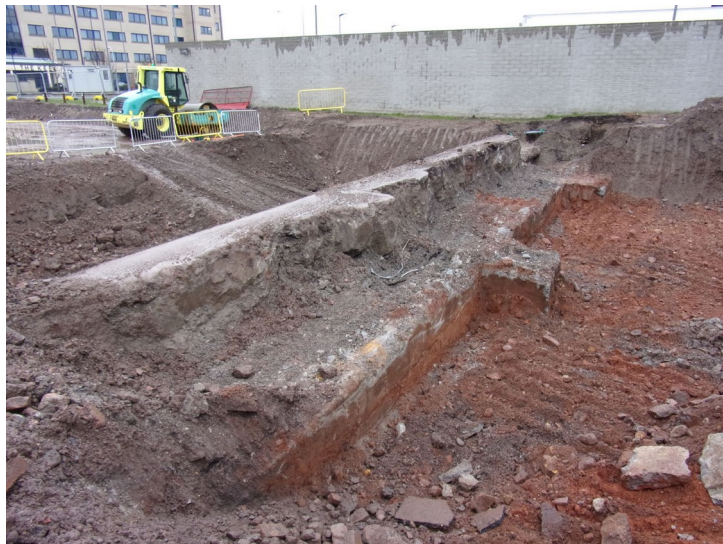
Plate 2- Concrete buttress supports [501] and red sandstone backfill deposit (502). Looking southwest.

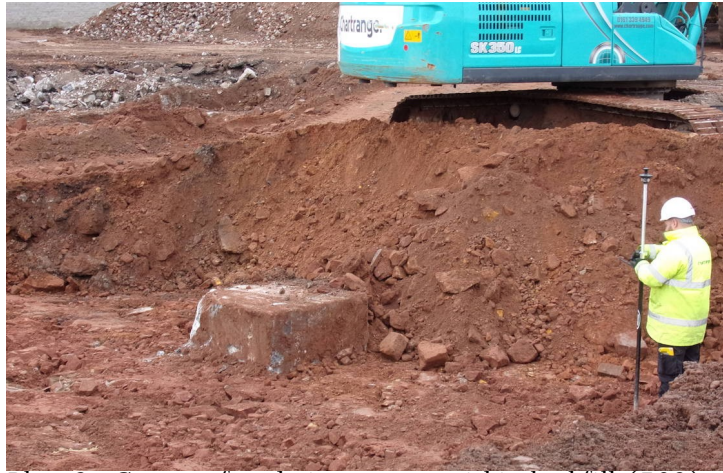
Plate 3- Concrete foundation support within backfill (502).

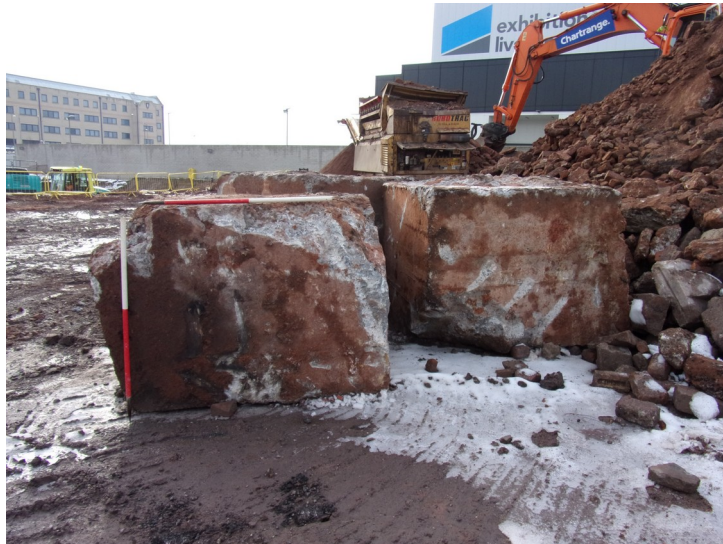
Plate 4- Concrete foundation supports after removal from (502).

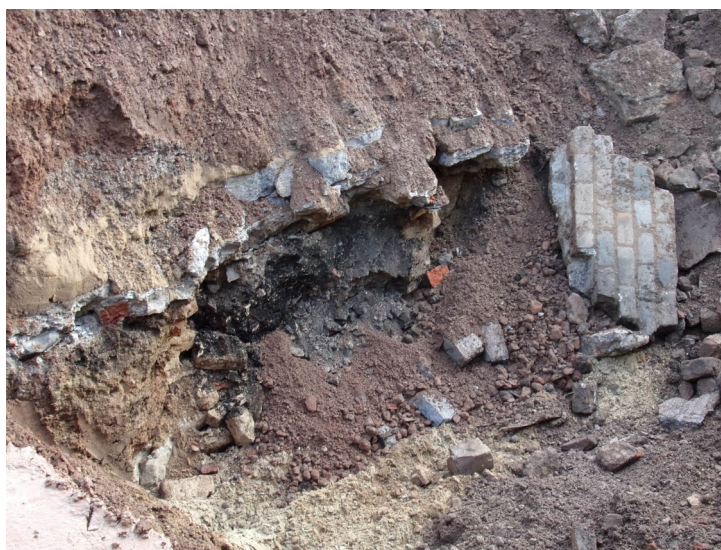
5.3.5. To the north of the southern face to the 19th century Queen's Basin/Half Tide Dock wall [504], a layer of stone sets (505) (PLATE 5) were overlying a concrete surface (506). Below this was a back fill deposit composed of a black burnt sandy material (507), which had the appearance of industrial waste. Within fill (507) a brick structure were identified forming a small tunnel [508], which ran east to west (PLATE 6). This feature could be seen in both the east and west facing sections of the trench.

Plate 5- Cobble sets (505) and industrial fill (507).

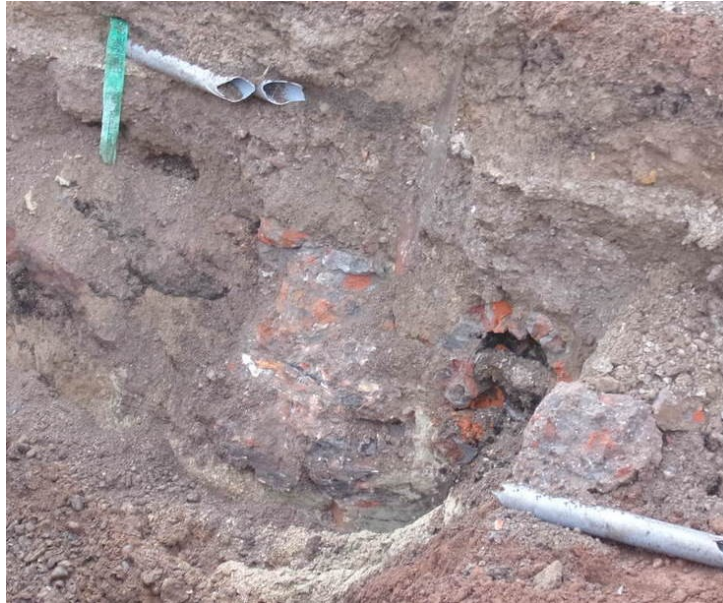
5.3.6. To the south of tunnel [508], a brick footing with mid bluish grey mortar [509] was identified (PLATE 6). This was interpreted as the footing of a dockside building which is marked as 'North Shed' on the 1893 OS 25 inch map (Lancashire sheet CVI.14) (FIGURE 5). Brick footing [509] was thought to be contemporary with the southern face to the 19th century Queen's Basin/Half Tide Dock wall [504] and brick tunnel [508], as similar materials were used in their construction. The tunnel [508] would have been situated within the dockside building and may have been a service/access tunnel for the underside of heavy machinery or a culvert/drain. This footing [509] was removed with a concrete breaker and the area subsequently back filled.

Plate 6- East facing section of brick footing [509] and associated brick tunnel [508]. Probably the remains of a dockside building which is marked as 'North Shed' on the 1893 OS map. Looking southwest.

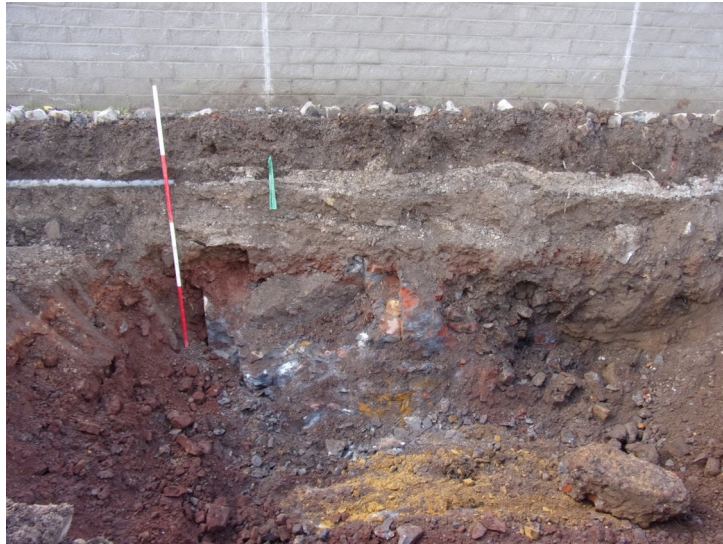
- 5.3.7. The southern face to the 19th century Queen's Basin/Half Tide Dock wall [504] was exposed using a large toothed bucket and the upper 1m was removed with a concrete breaker to the new construction formation level. Elements of the fabric to wall [504] were visible including a mix of brick fragments, red sandstone and some yellow sandstone fragments, bonded with a mid bluish grey mortar (PLATE 7).

Plate 7- Section through the top of the 19th century Queen's Basin/Half Tide Dock wall [504]. Looking west, 2m scale.

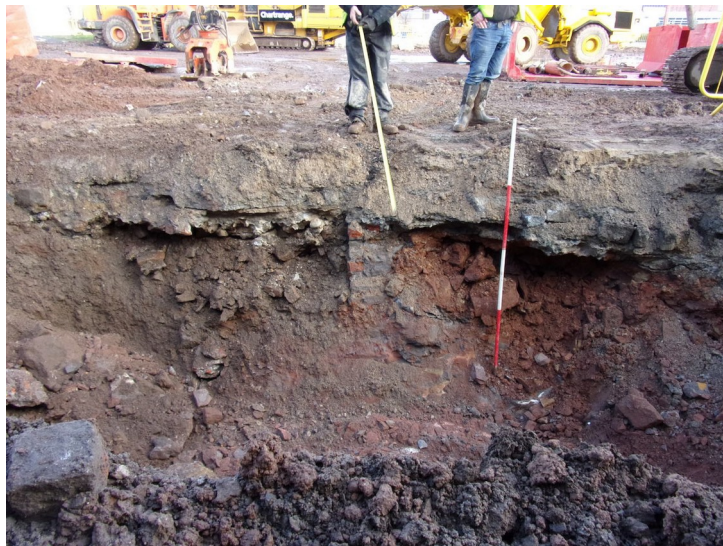
- 5.3.8. In the resulting west facing section through the 19th century Queen's Basin/Half Tide Dock wall [504], a further brick structure [510] was seen to be built into dock wall [504] (PLATE 8). Structure [510] formed a brick housing for a series of cast iron pipes, thought to be components of a hydraulic system which was used to power cranes and other dock machinery.

Plate 8- Brick structure [510] embedded into Dock wall [504]. Looking east, 2m scale.

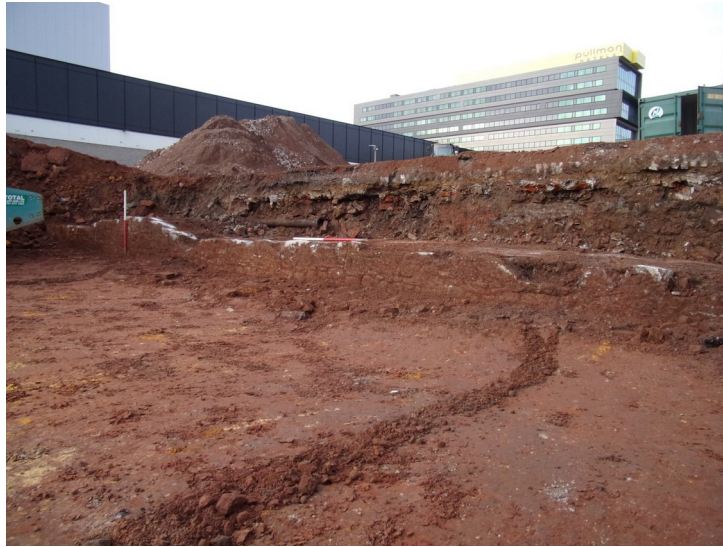
- 5.3.9. The upper part of the 19th century Queen's Basin/Half Tide Dock wall [504] was exposed from west to east across the site, revealing the surviving top of the wall and the upper 1m of the southern face elevation. The surface of the wall appeared truncated, with the height varying suggestive of previous interventions for modern services etc (PLATE 9).

Plate 9- The top of the 19th century Queen's Basin/Half Tide Dock wall [504]. Looking northwest, 1m scale.

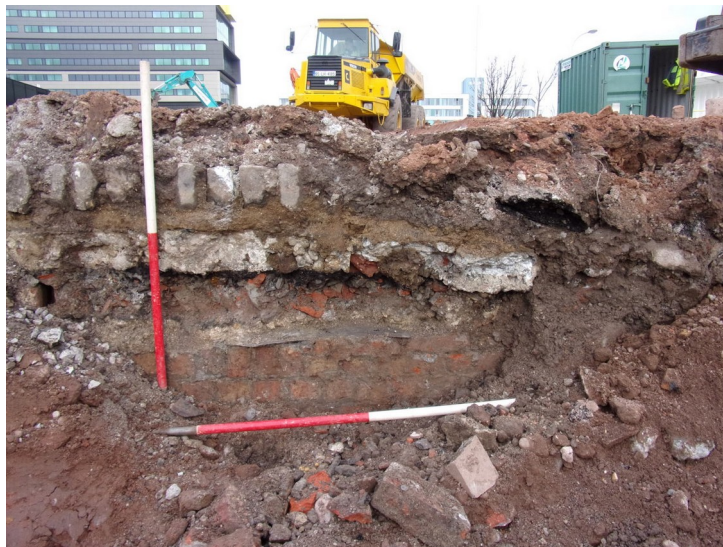
Plate 10 - Brick structure [513], possible hydraulics housing

5.3.10. A small segment of a brick structure [513] was identified in section above the 19th century Queen's Basin/Half Tide Dock wall [504] (PLATE 10). This appeared to be the same as brick housing [510], recorded in the west facing section through the dock wall [504], at the far western side of the site. Further excavation revealed additional segments of the brick structure [513] with cast iron pipes still *in situ*.

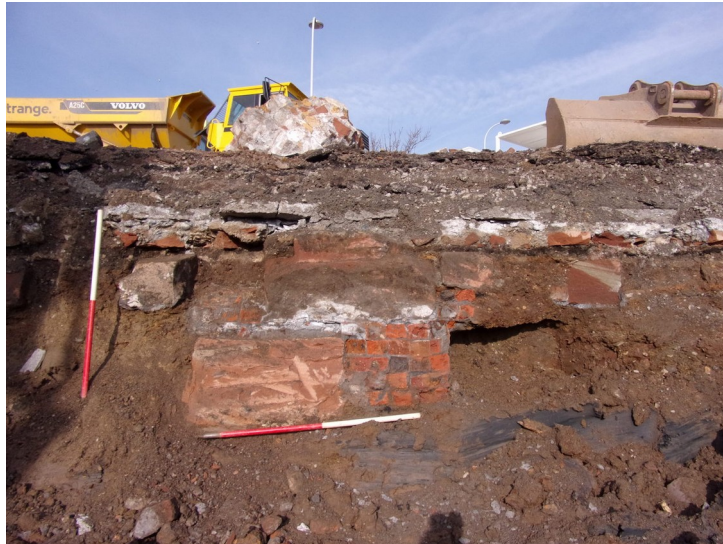
Plate 11- Sandstone and Brick footing [515] north of dock wall [504]. Looking north, 1m scale.

5.3.11. Towards the northern end of the western area, a sandstone and brick mortared footing was revealed [515] (PLATE 11). The large sandstone blocks forming this structure are thought to indicate a load bearing function; and [515] was interpreted as the possible foundation of the northern side to the dockside building which is marked as 'North Shed' on the 1893 OS 25 map (FIGURE 5).

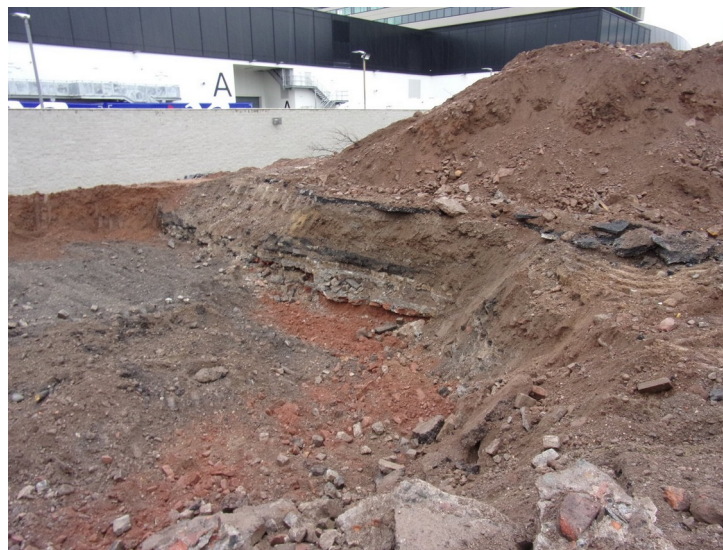
5.4.1. At the northern end of the site there was a continuation of the sequence seen to the south with concrete layers overlying red sandstone backfill deposit (502) (PLATE 12), to the north of the 19th century Queen's Basin/Half Tide Dock wall [504] (FIGURE 5).

Plate 12- Red sandstone backfill deposit (502) at the northwest corner of the site. Looking northwest.

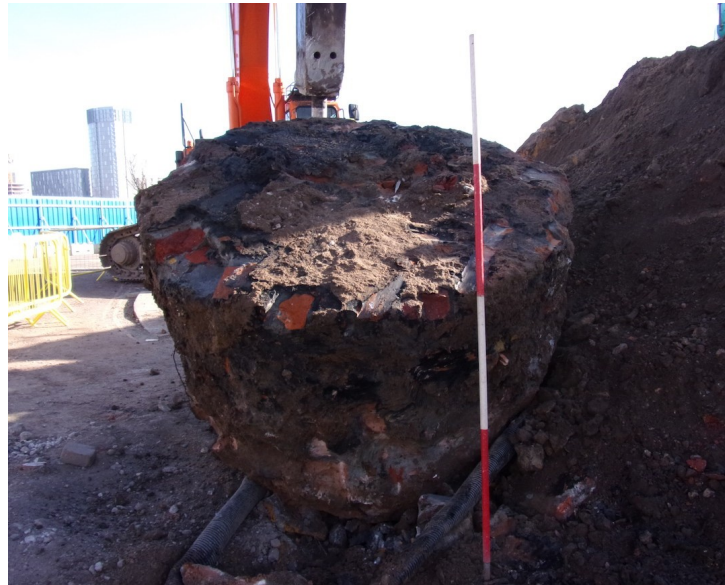
Plate 13- A possible northern Crane base after removal. Facing South.

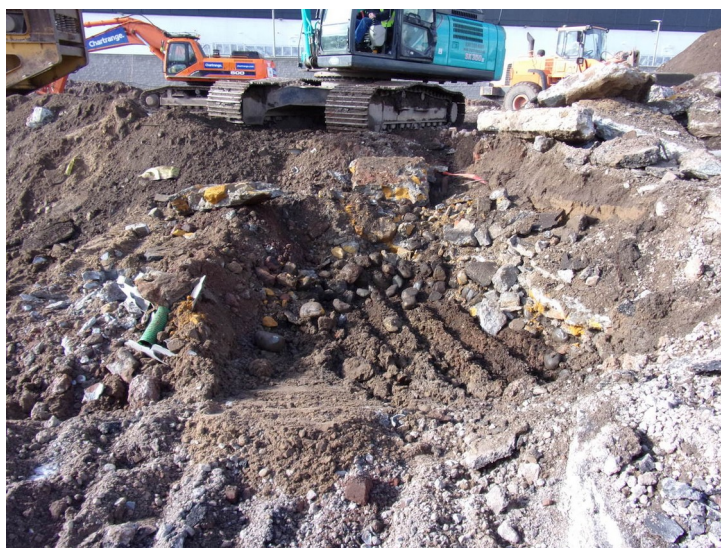
- 5.5.1. The centre of the eastern area revealed the same mixed and patchy deposits (512) as in the northern area, with concrete and cobble layers similar to those seen to the west (PLATE 14).

Plate 14- Mixed deposit (512) in the eastern area. Looking west.

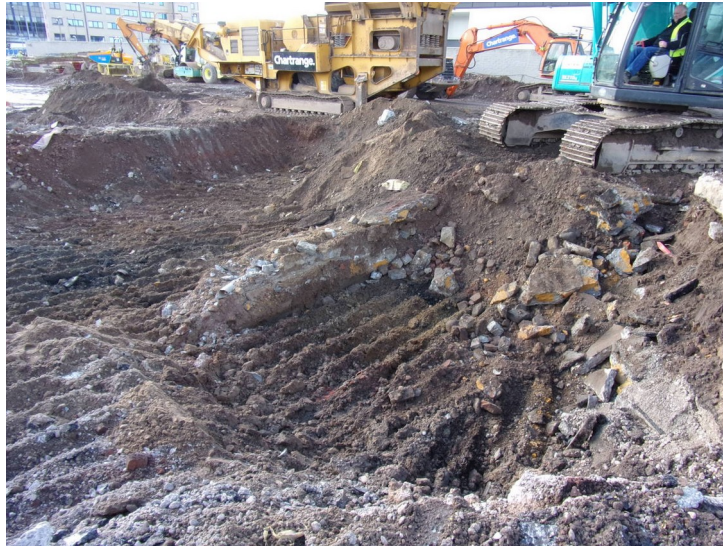
- 5.5.2. To the north of deposit (512) was another segment of concrete footing [511] thought to be associated with the southern side of a warehouse contemporary with the early 20th century King's Dock wall (shown on the 1908 OS 25 inch map) (PLATE 15) (FIGURE 6). To the north of footing [511] was a brick structure [514] bonded with bluish grey mortar. Structure [514] was interpreted as a second crane base, identical in construction to the one found in the northwest area. The location of this second possible crane base may correspond with a dockside feature shown on the 1882 6 inch Ordnance Survey (OS) map (FIGURE 4).

Plate 15- Concrete footing [511] in the eastern area of the site. Looking southwest.

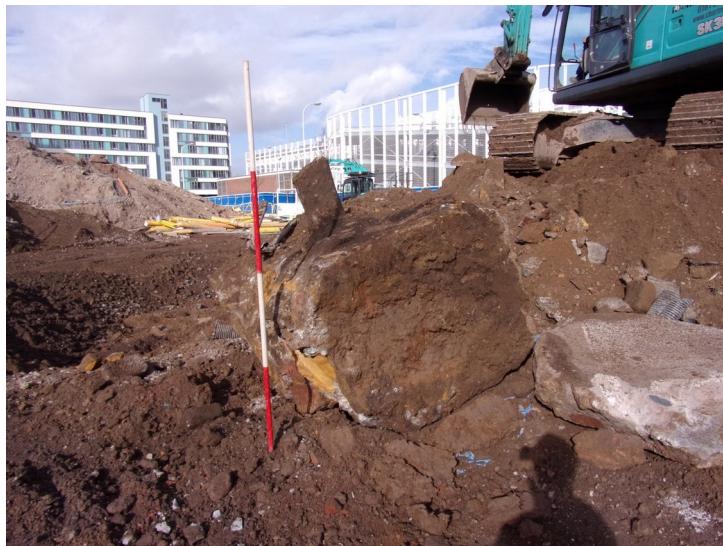
- 5.5.3. A third possible crane base was located to the west of [514] (PLATE 16) but this appeared to be built to support a larger machine, with larger components still

attached. The evidence suggests that during the 19th century there had been a row of three cranes positioned close to the northern side of the King's Dock wall; however, these are not shown on the 1893 OS 25 inch map (Lancashire sheet CVI.14) (FIGURE 5).

Plate 16- The third possible crane base. Facing northeast, 2m scale.

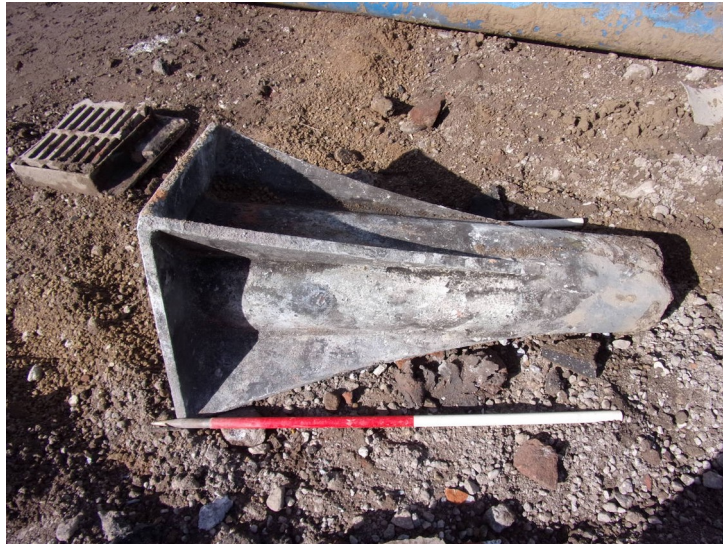
Plate 17- Cast iron fixture set within possible crane base [514], 2m scale.

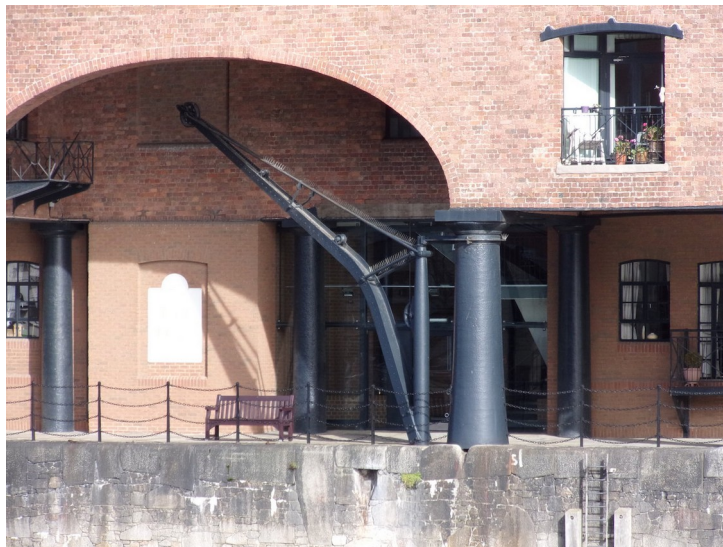
5.4.2. Further segments of the concrete footings to a warehouse shown at the southern side of King's Dock on the 1908 OS 25 inch map (Lancashire sheet CVI.14) were identified [516] (FIGURE 6). Immediately north of these footings was a large circular pad made of bricks and sandstone fragments bonded with a bluish grey mortar (PLATE 13). It contained a central cast iron fixture probably designed to support a small crane, which was likely to have been operated by hand (PLATE 17); similar cranes are still *in situ* along the side of the neighbouring Wapping Dock (PLATE 18).

Plate 18- Example of an in situ cast iron crane set on the edge of the neighbouring Wapping Dock wall

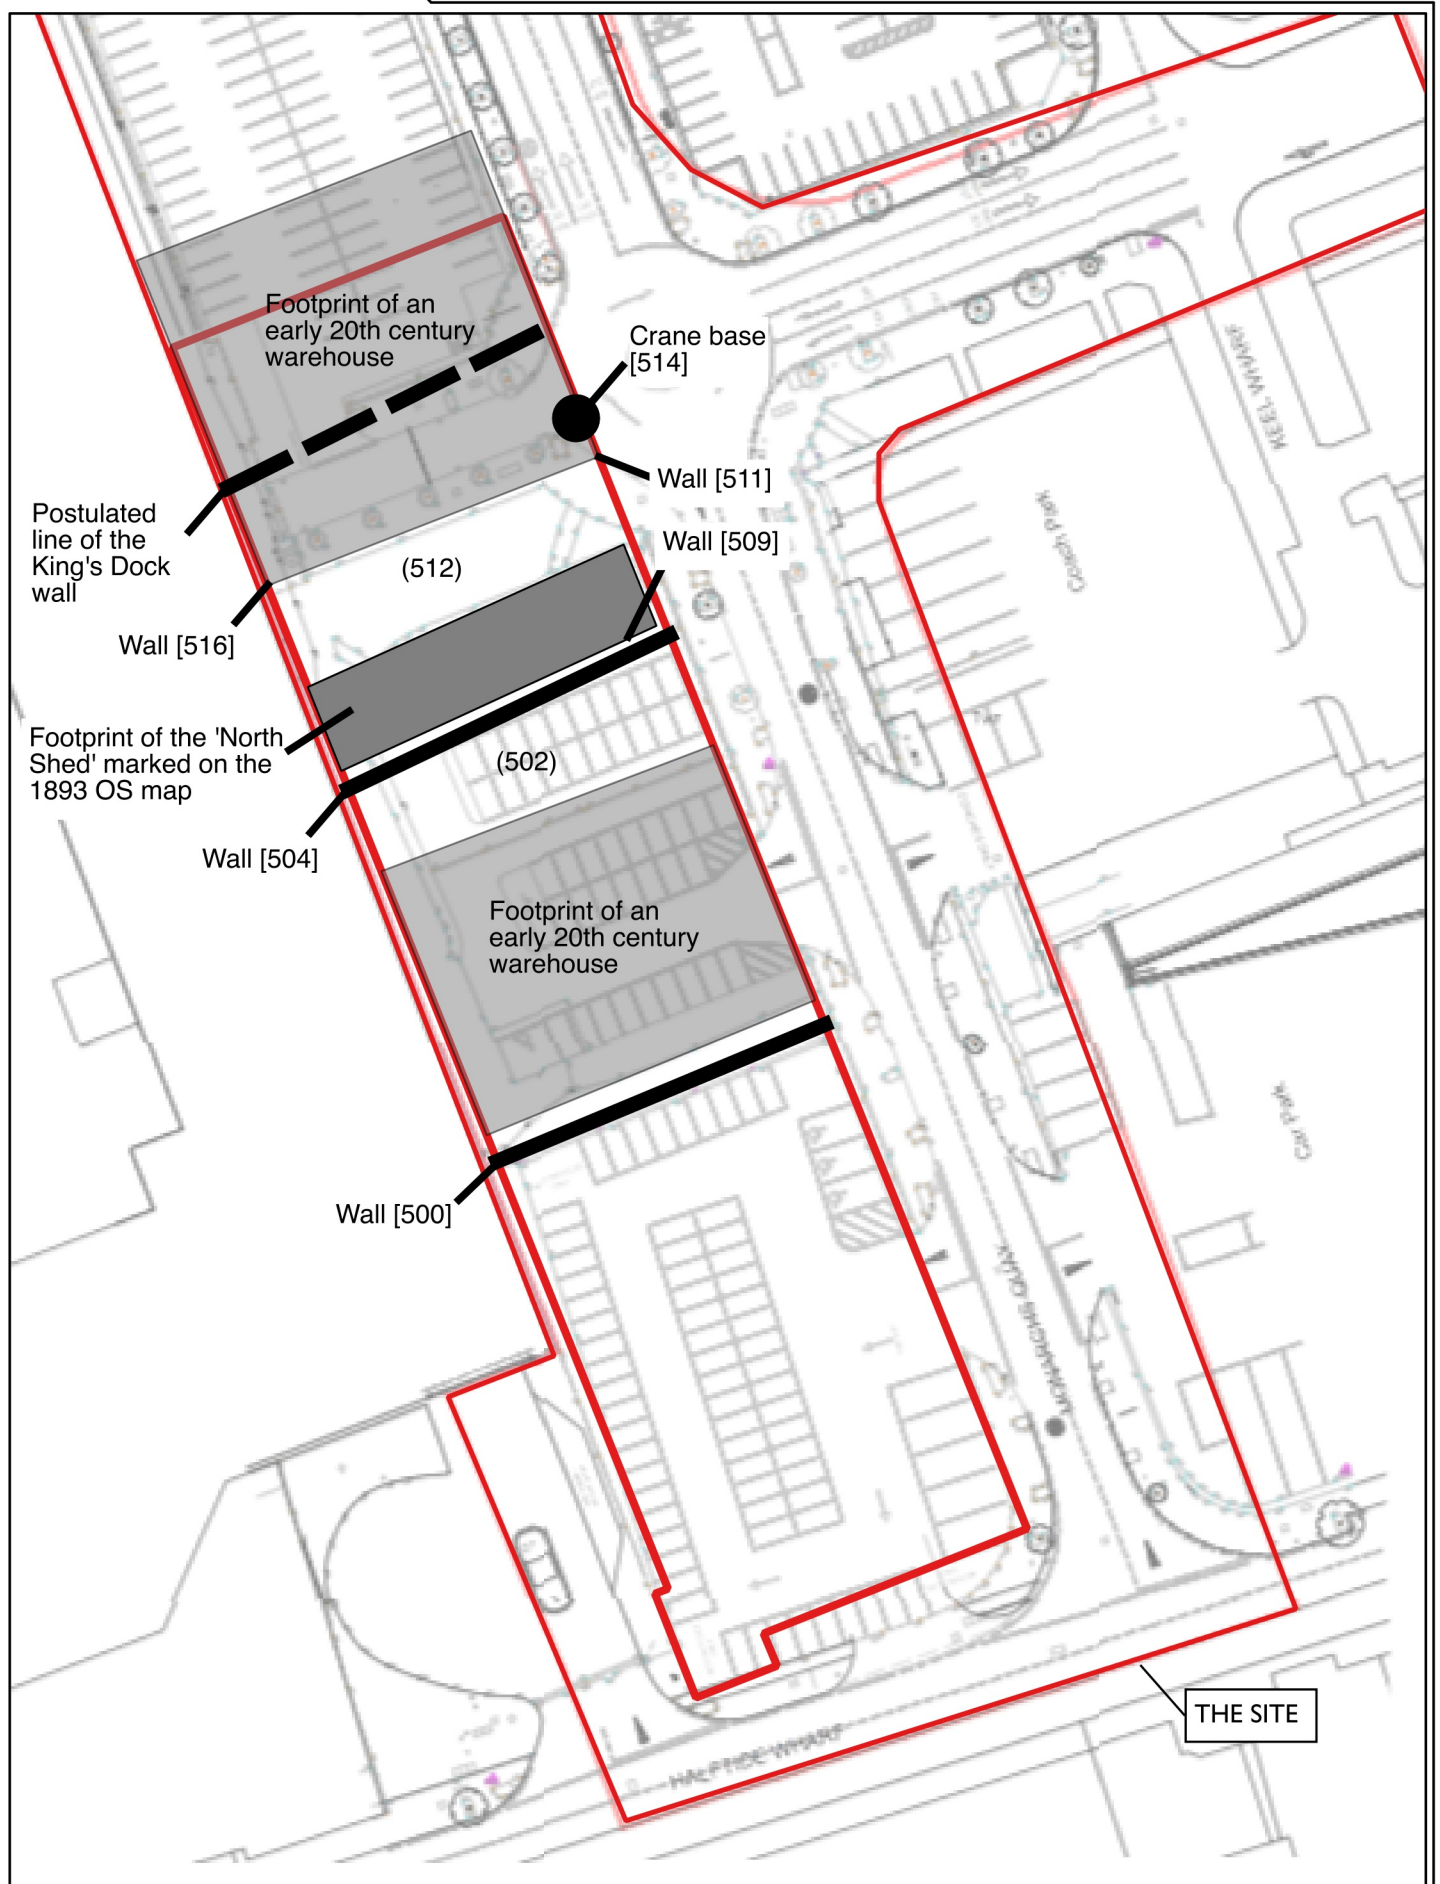
FIGURE 3 // Location - Archaeology

5.2. In this section the results are presented under four sub-divided areas: the south, west, east and north. This is in order to reflect how the groundworks were conducted/monitored and the sequence in which the various archaeological remains were recorded. The main archaeological features described in this section are located on FIGURE 3.

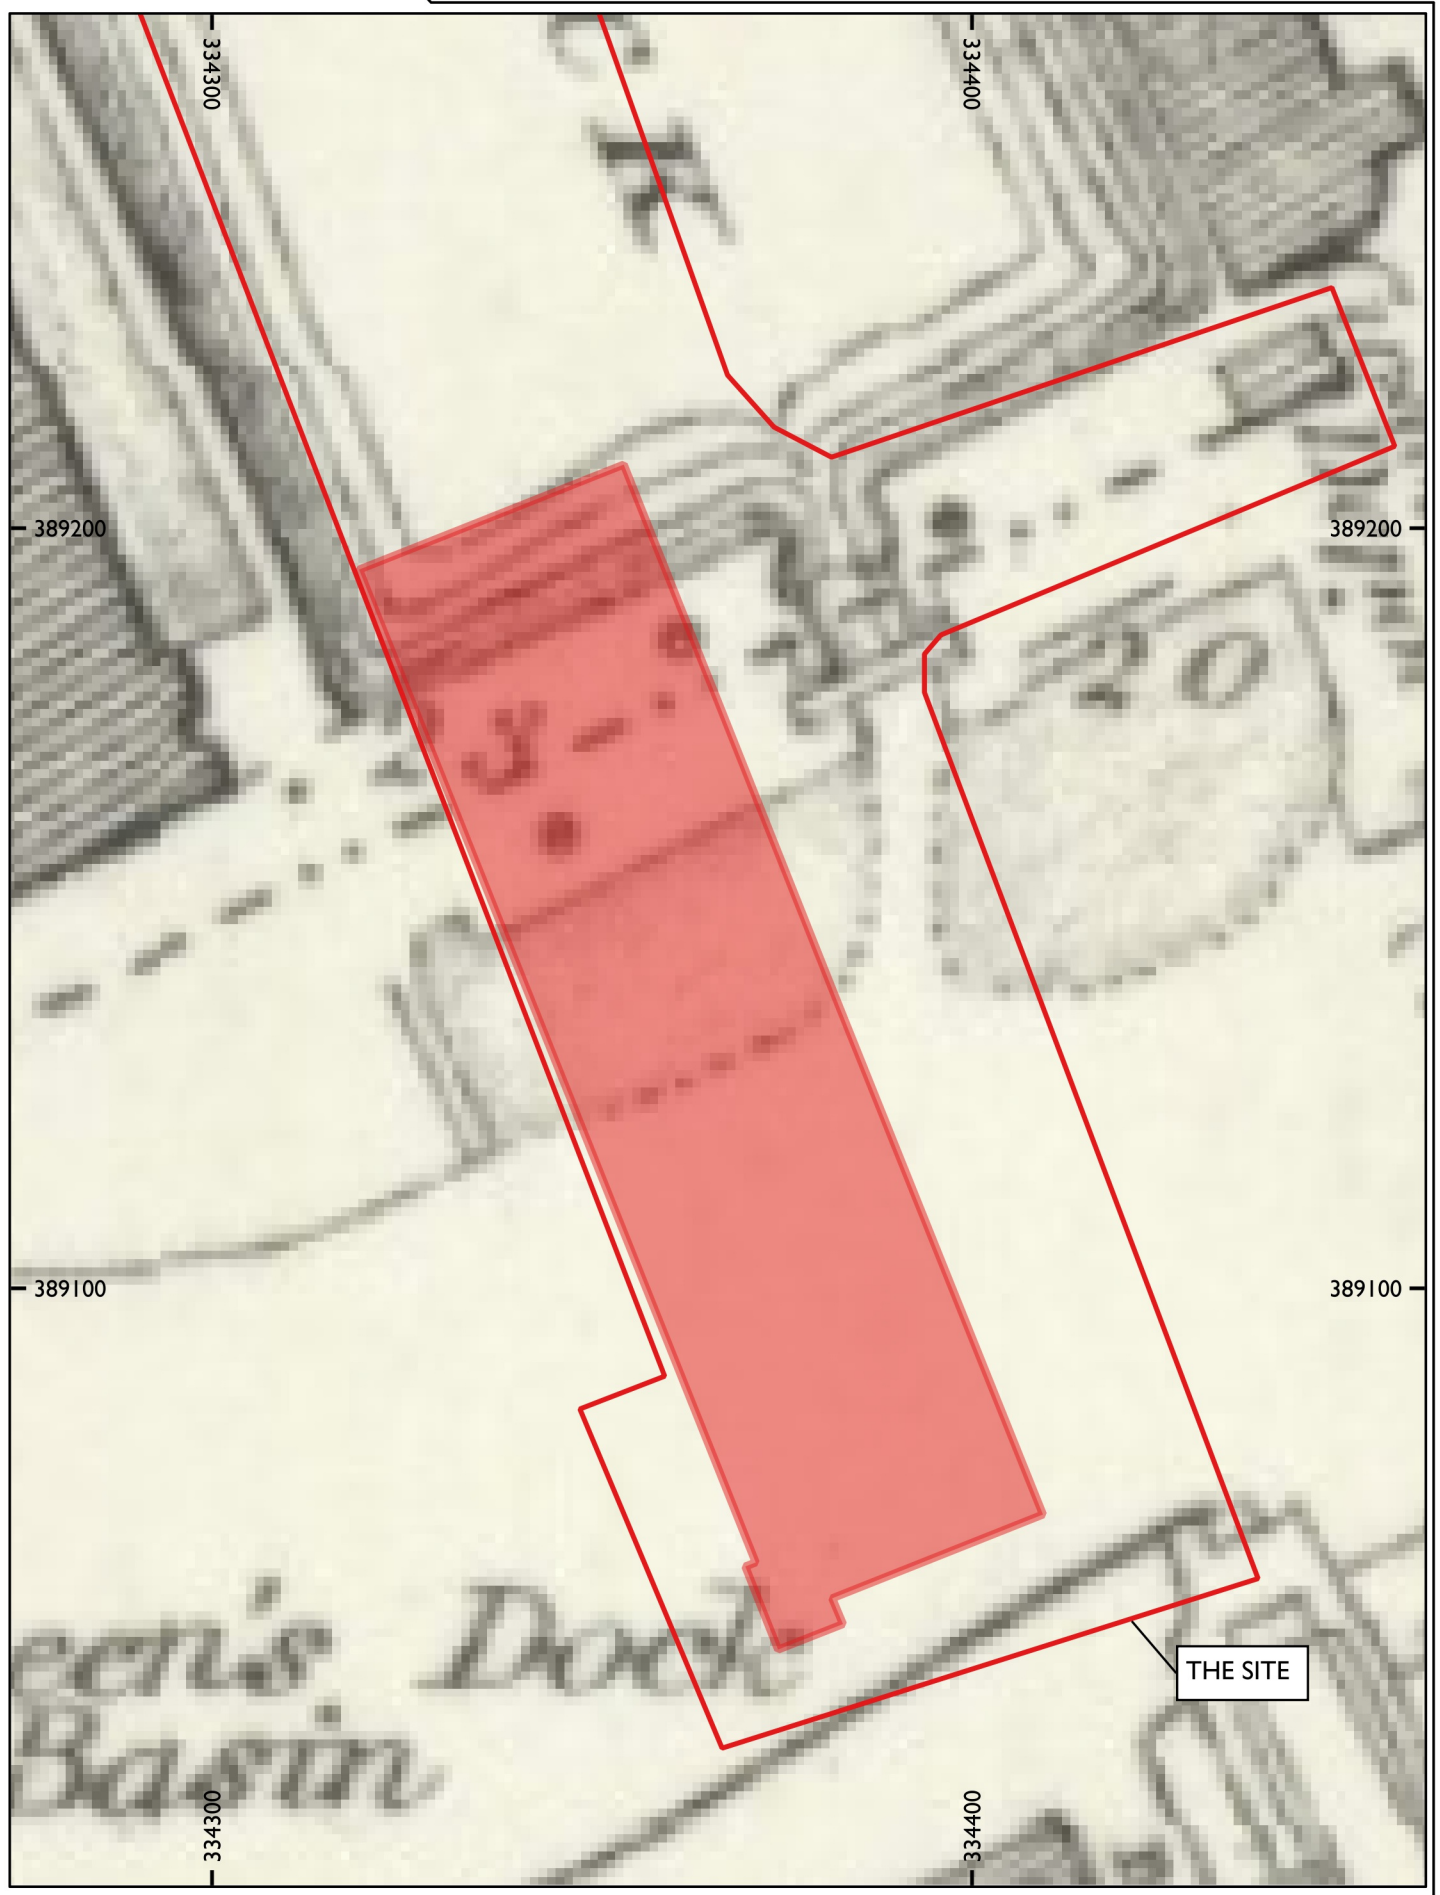
FIGURE 4 // 1882 OS map

Figure 4 - 1882 OS 6 inch map (Cheshire sheet XIII)

- 7.6. Further north the groundworks encountered the *in situ* remains of the southern face to the 19th century Queen's Basin/Half Tide Dock wall with evidence of later alteration and modern disturbance being noted (FIGURE 4). Contemporary 19th century dockside structures were evidenced by the brick and sandstone footings of the 'North Shed' shown on the 1893 OS 25 inch map (Lancashire sheet CVI.14) and the *in situ* remains of three possible crane bases (FIGURE 3 & 5). Within the footprint of the 'North Shed' a brick structure housing cast iron pipes was thought to be part of a hydraulic system designed to power lifting machinery. All of these structural elements were considered to be broadly contemporary with each other as they were constructed of similar bricks and bonded with a similar grey-blue mortar.
