Historic Building Recording of

FIELDS FARM ALDERSEY

Client:	Mr Alan Brickland
Local Authority:	Chester City Council
NGR:	346029,357050
Planning App:	07/02060/CAC
Author(s):	C Statter
Doc Ref:	LP0748C-HBR-v1.3
Date:	October 08
Site Code:	ALD/FIF 08

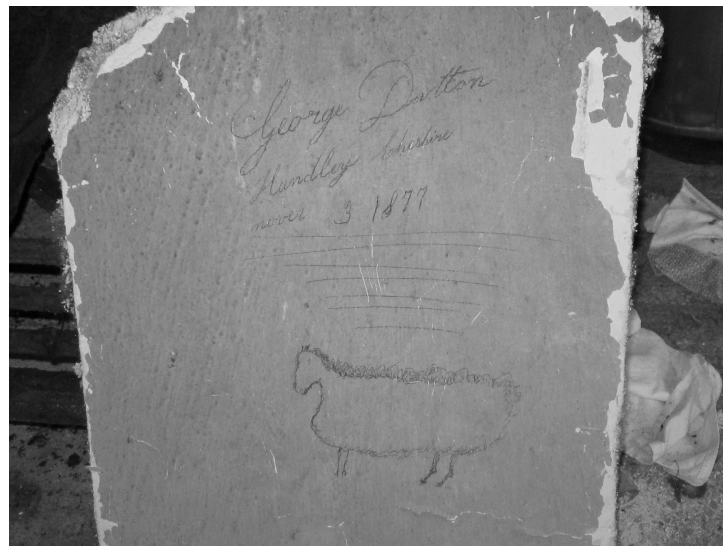
Plate 1 - George Dutton's drawing from Fields Farm

- 5.6.6. The drawing is of a sheep with the text “George Dutton, Handley Cheshire, nover 3 1877”. Brief research records George Dutton as being born in 1851 in Handley

- 5.6.5. Also recorded on the Tithe apportionment is a house and gardens on plot 1382. This plot, owned by Samuel Aldersey, was occupied by Joshua Dutton who was born and worked as a driver in Aldersey. Of interest is a drawing found on plaster during the demolition of Fields Farm in 2008.

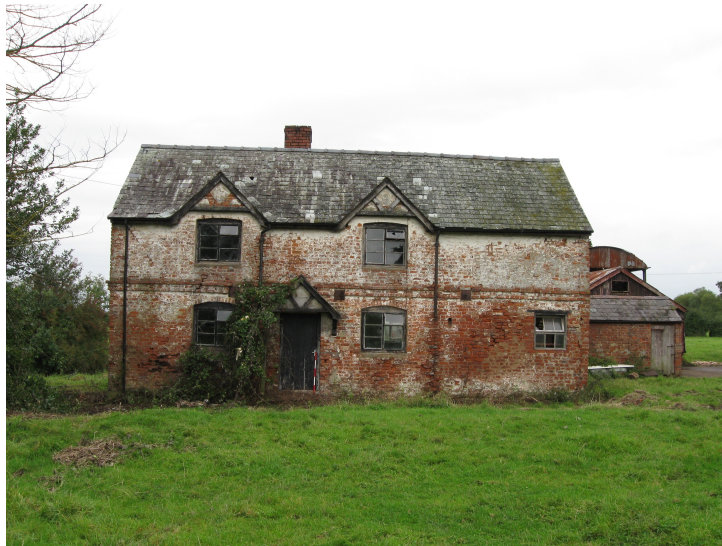
Plate 2 - South elevation of Fields Farm

- 6.5.1. This elevation of the the building is the main frontage, visible from the village and contains a centrally located front door.
- 6.5.2. The whole construction is of red brick, 230mm x 80mm x 110mm, with brick decorative banding one course above the ground floor windows. The construction of this elevation is of stretcher courses of brick randomly interspersed with header courses. This banding runs horizontally, set out in relief, and consists of two courses in relief with a single recessed course in the centre.

- 6.5.3. Along this elevation there are 5 windows, 3 on the ground floor and 2 on the first floor. The window at the eastern end of the elevation is an inserted window slightly smaller than the other 4. This window is 6 paned with a wooden framework with a thin wooden lintel above. The remaining 4 windows on this elevation are also 6 paned wooden framed. The ground floor windows have a thick stone sill, however the upper storey windows have a thin stone sill.

- 6.5.4. Above each of the remaining 4 windows a red brick, on end, single course arch is located.
- 6.5.5. The access door at the front of this property is wooden with a wooden frame and wooden decorative awning. This awning is constructed with a horizontal base beam with two angled support braces forming a V shape. This structure is matched in the two dormer roofs above the first floor windows.

- 6.5.6. Also along this elevation 3 square wall ties can be seen along the building within the red brick banding.

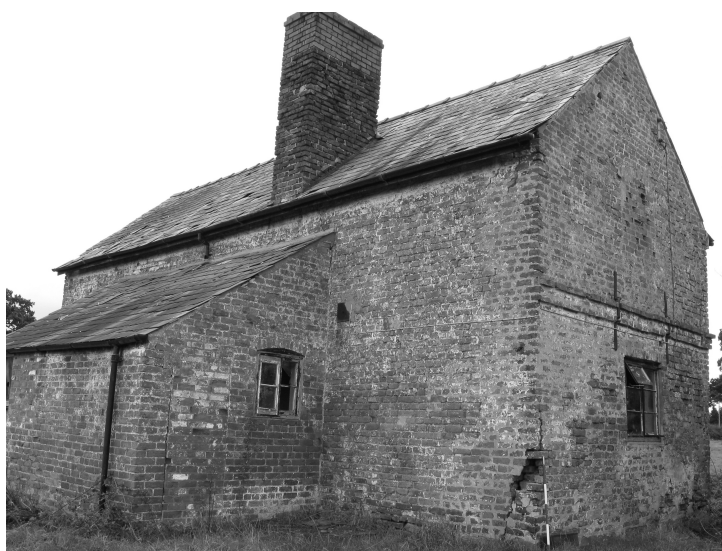
Plate 3 - North elevation, looking southeast

6.7.1. This elevation is constructed of red brick in the same random header and stretcher courses as the rest of the building. This elevation contains the single storey extension with a grey slate roof matching the roof of the main building.

6.7.2. The decorative band running along the southern and eastern elevation is not present on this elevation.

6.7.3. This elevation only contains two windows. The first within the main body of the building to the east of the elevation, this is a 6 paned wooden window matching that of the inserted window at the front of the building. The second window is located within the extension and is a single pane wooden window with no lintel or sill.

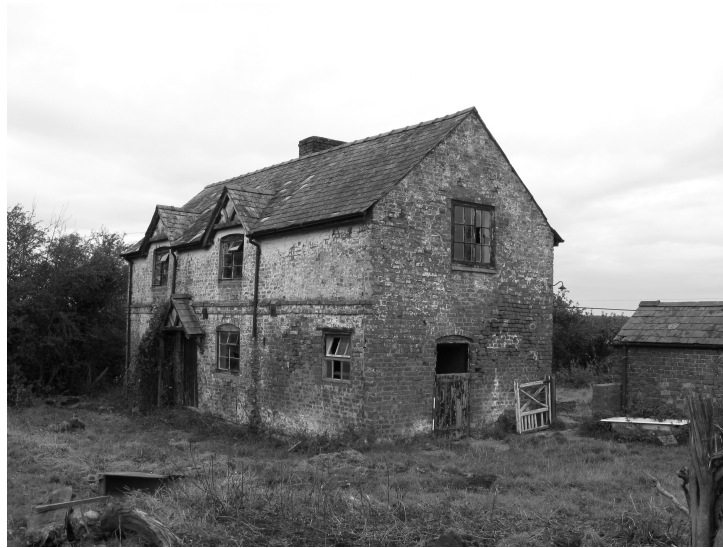
Plate 4 - Eastern elevation of Fields Farm

- 6.8.1. This elevation is constructed of red brick in random stretcher and header courses, the decorative banding is not present on this elevation.
- 6.8.2. This elevation has one first floor window located centrally. The window is a 12 paned wooden frame window with no lintel. The sill for this window consists of angled, red, tiles.

- 6.8.3. There is also a door located on the is elevation. The door is a two part wooden stable door with a red brick, header, arch lintel above matching the windows on the southern elevation.
- 6.8.4. This door and the location of the inserted windows indicated that this end of the building was once used to house livestock and was accessed separately from the main dwelling.

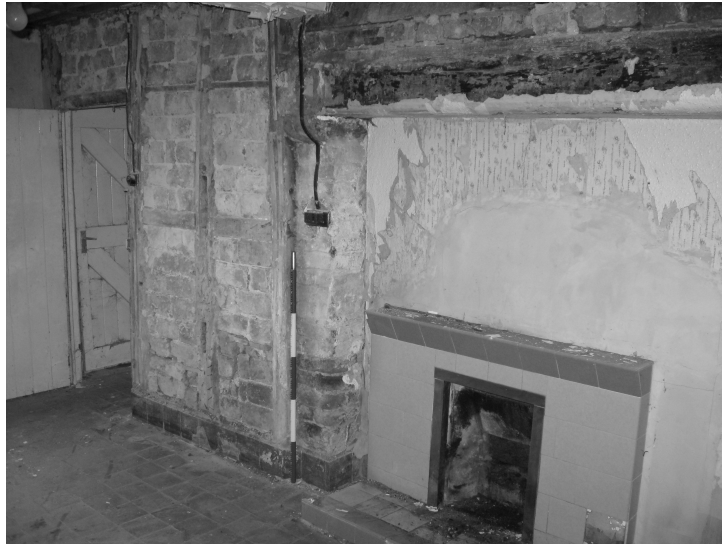
Plate 6 - Large timber beam in room G2

- 6.9.7. The one main feature within this room was a large chamfered beam on the western wall. Below this beam was a 20th century glazed tiled fireplace. It is thought that this beam is reused from an earlier building and would have been above a large open fire heating the majority of the structure. This fireplace may also have been the main cooking area in the building before the extension was built to the north.

- 6.9.8. There is also a large timber located within the northern wall of this room. This wall would have originally have been an external wall before the extension was erected. It is unclear as to the function for this timber.

- 7.5. The building did not reveal any significant features apart from the large beam above the fire on the ground floor. This beam appeared to predate the current building, it is possible that this beam had been reused in this building and had been salvaged from elsewhere in the village.

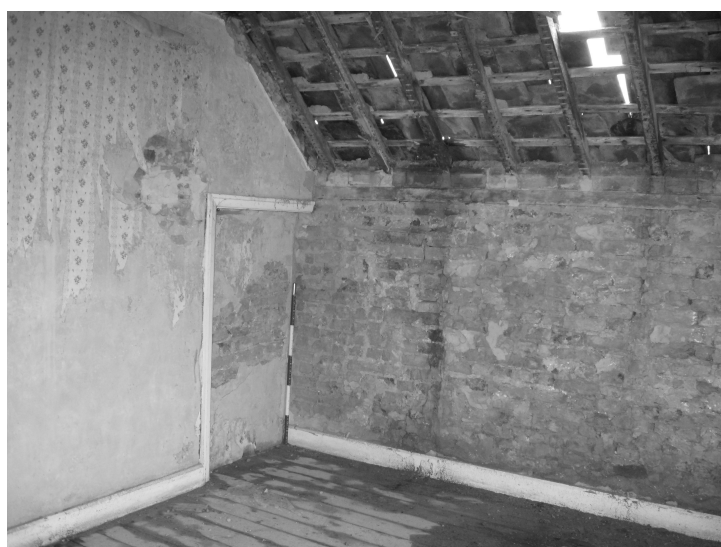
Plate 7 - Blocked doorway in room F1 facing north west

6.10.2. The floor in this room comprised wooden floorboards and the ceiling had been removed leaving the slate roofing and timber joists visible. The one feature in this room was a blocked doorway leading into room F2 in the north west corner of the room. The timber joists and struts for the roof are all machine cut and 20th century in date. This indicates that the roof was replaced in the 20th century.

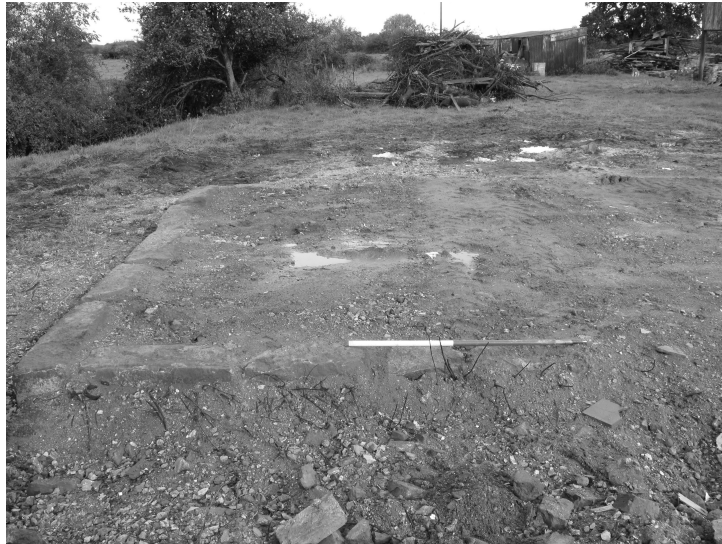
Plate 10 - Sandstone foundation looking north

6.11.3.To the western end of the building a single course of sandstone had been used as a foundation. This end of the building is close to a stream and it is therefore thought that sandstone was used here instead of brick due to the ground deposits. The presence of a stream here would indicate that the ground would be made up of looser silts rather than clay. The sandstone would therefore have given a stronger foundation base in this area than brick used for the rest of the building.
