Archaeological Investigation Report

# **40-42 PONTON ROAD LONDON SW8**

Doc Ref: LPI962L-AER-v3.6

Site Code: POT16

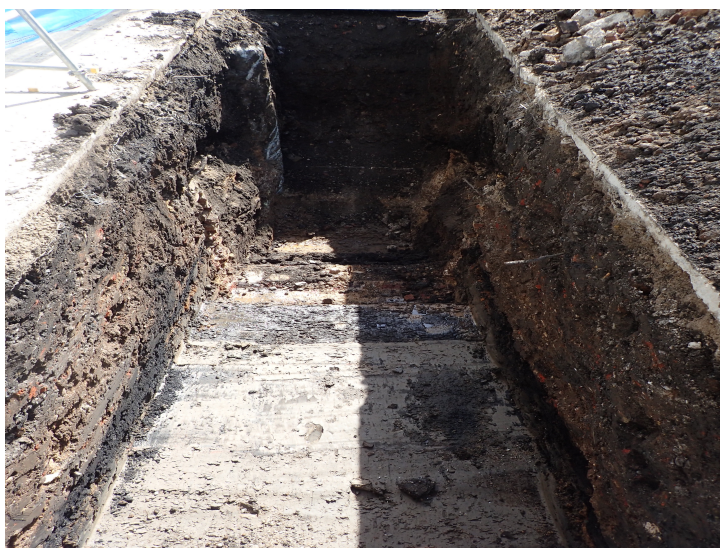
Plate 1 - General view of TR1 looking south west.

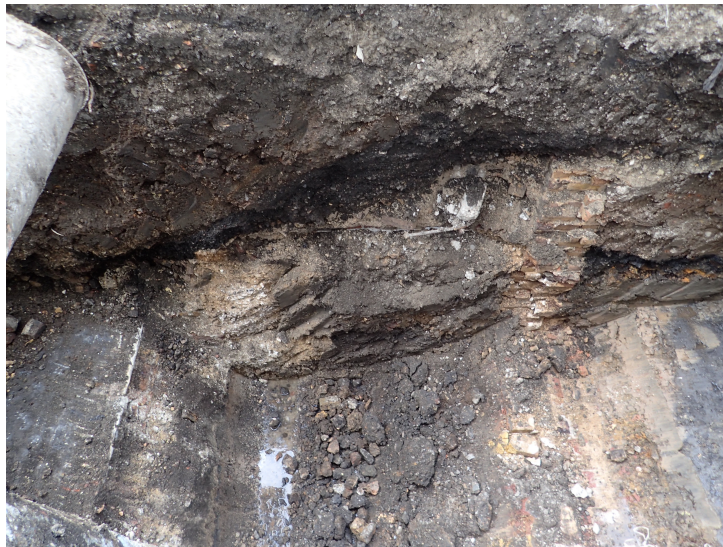
- 5.3.4. Cut into the natural geologies (105) and (108), was the construction cut [109] for a 20<sup>th</sup> century yellow stock and concrete wall footing 110. The cut was visible at 2.56m OD and was c.0.80m deep. The wall (PLATE 2) was a mixture of yellow stock brick and concrete and formed a foundation footing for a 20<sup>th</sup> century building. The surviving remains of the wall footing were c.1.84m deep and first detected at 3.48m OD.

Plate 2 - Yellow stock wall footing 110, with demolition deposit (111). Facing north east TR1.

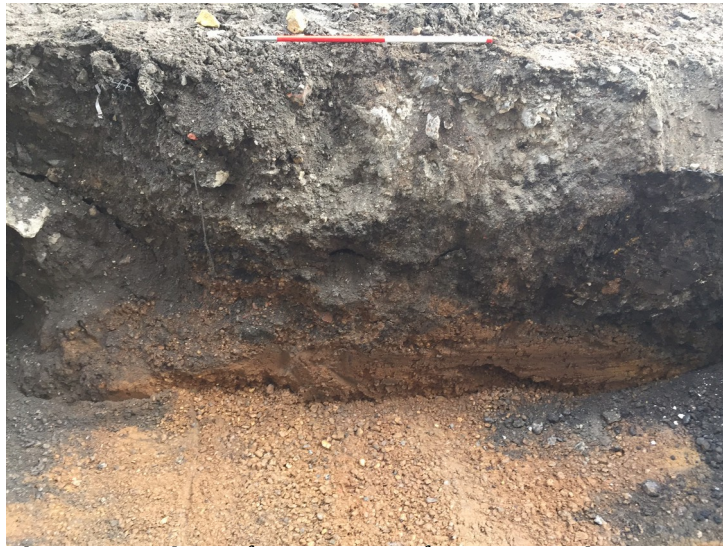
- 5.4.3. The natural gravel (205) was truncated by a horizontal truncation [206], the lowest point of the cut was at -0.40m OD.

Plate 3 - Southwest facing section of TR2. 1m scale.

- 5.4.4. A modern make up deposit (207) filled the truncation [206] to a thickness of 2.30m. This was in turn overlain by (202) a 3.0m thick modern make up layer. Both layers contained ash, soot and other debris thought to derive from the former land use of the site.

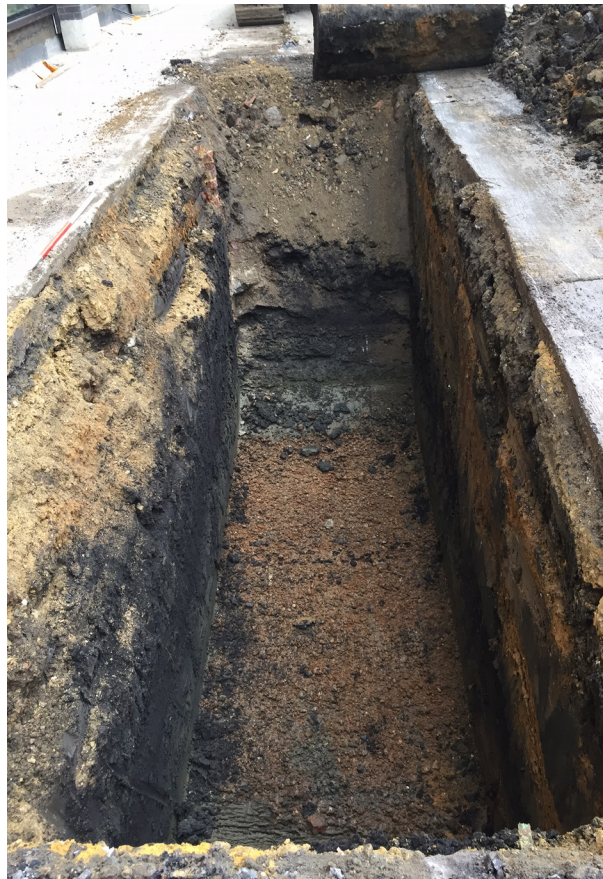
Plate 4 - TR4 under excavation. View from the north east.

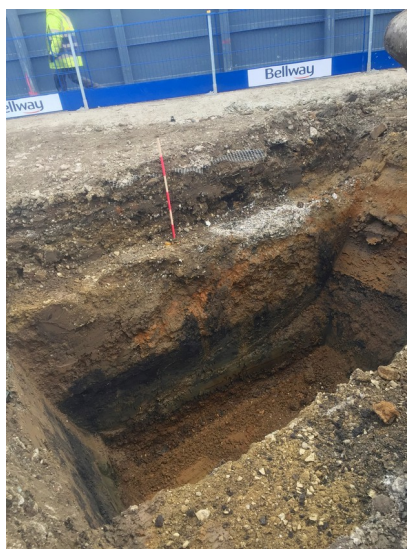
Plate 5 - General view of TR5 looking east. Scale 1m.

- 5.7.2. The earliest deposit encountered in TR5 was the natural terrace gravel (505). This is a mid yellow brown coarse flint gravel. The undulating surface of this gravel varied between c.1.30m OD and c.1.40m OD. This surface is interpreted as having been truncated during the modern period, perhaps as a result of former land uses on the site. This deposit was not fully excavated. Excavation ceased after it was determined that this deposit was a natural geological deposit.

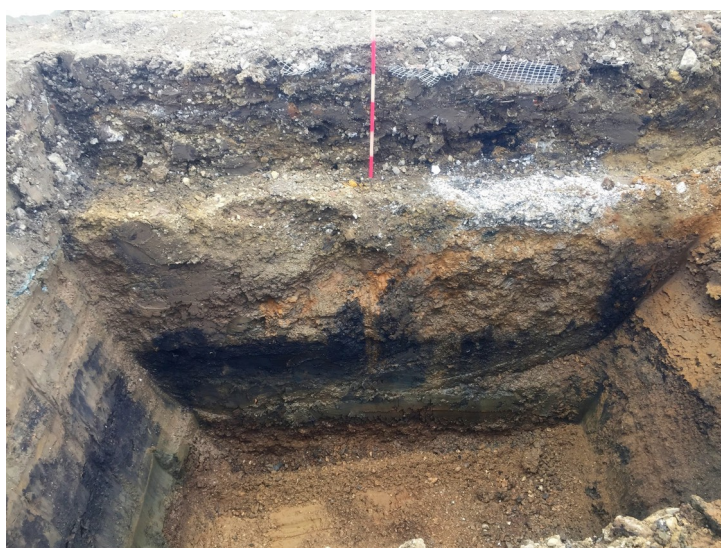
- 5.7.4. Overlying the disturbed natural was a c.0.8m thick deposit of very dark grey fine silt mixed with a fine inorganic black substance thought to be coal dust (503). This deposit is interpreted as a late 19<sup>th</sup> century or 20<sup>th</sup> century waste material deposit, resulting from former land uses on the site. The surface of this deposit was at 2.35m OD.

- 5.7.5. Deposit (502) was similar in nature to deposit (503) which it sealed. Deposit (502) appeared to contain a greater percentage of coal dust material compared to (503). The deposit was c.0.40m thick, the upper level of the deposit was at c.2.75m OD.

Plate 6 - West facing section of TR5. Scale 1m.

5.7.6. Sealing the entire sequence was a 1.75m thick deposit of modern make up (501). This was a mixed grey-brown/red-brown deposit composed of mixed silt, clay, sand and gravel. This deposit contained modern building materials. The upper level of this deposit was the present ground surface at 4.47m OD.

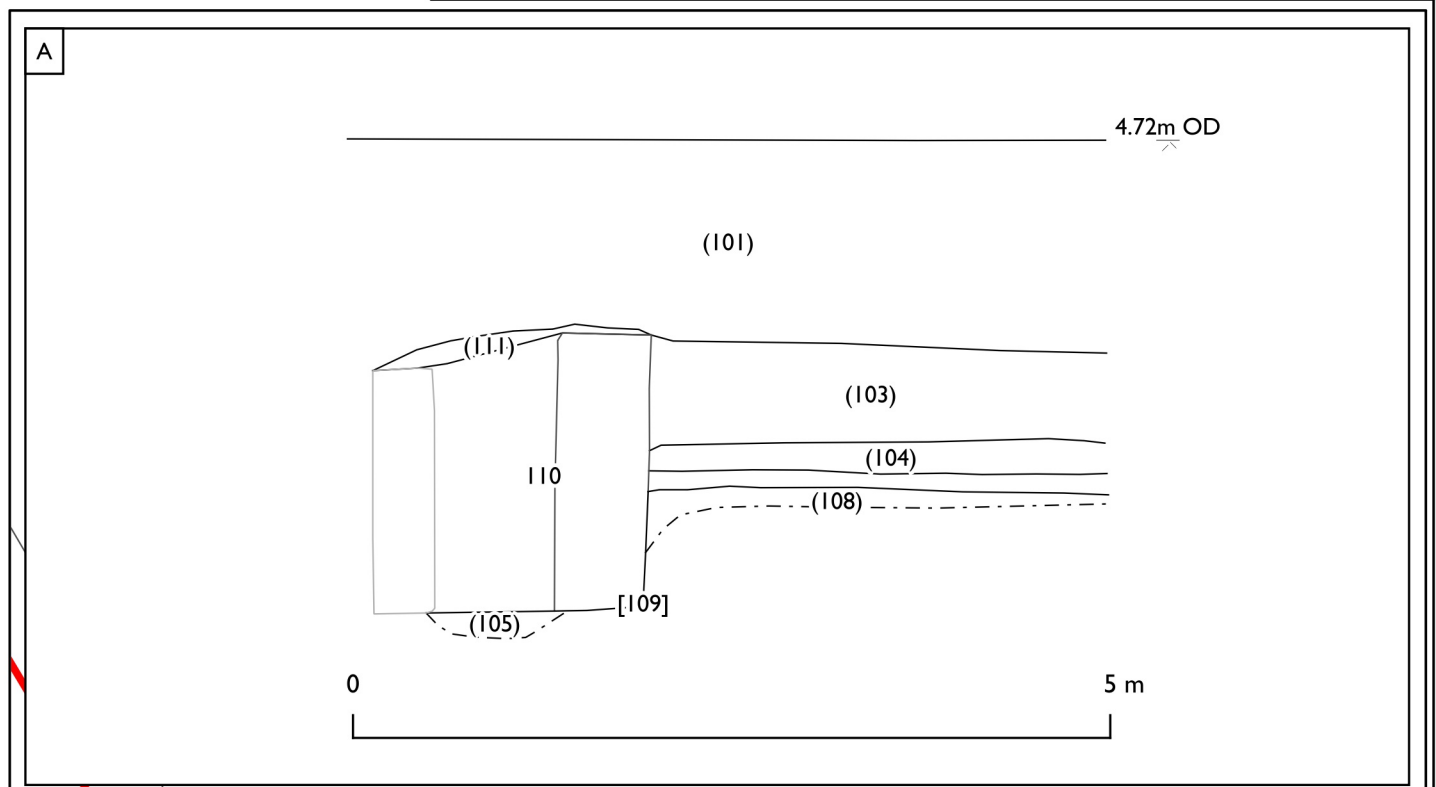
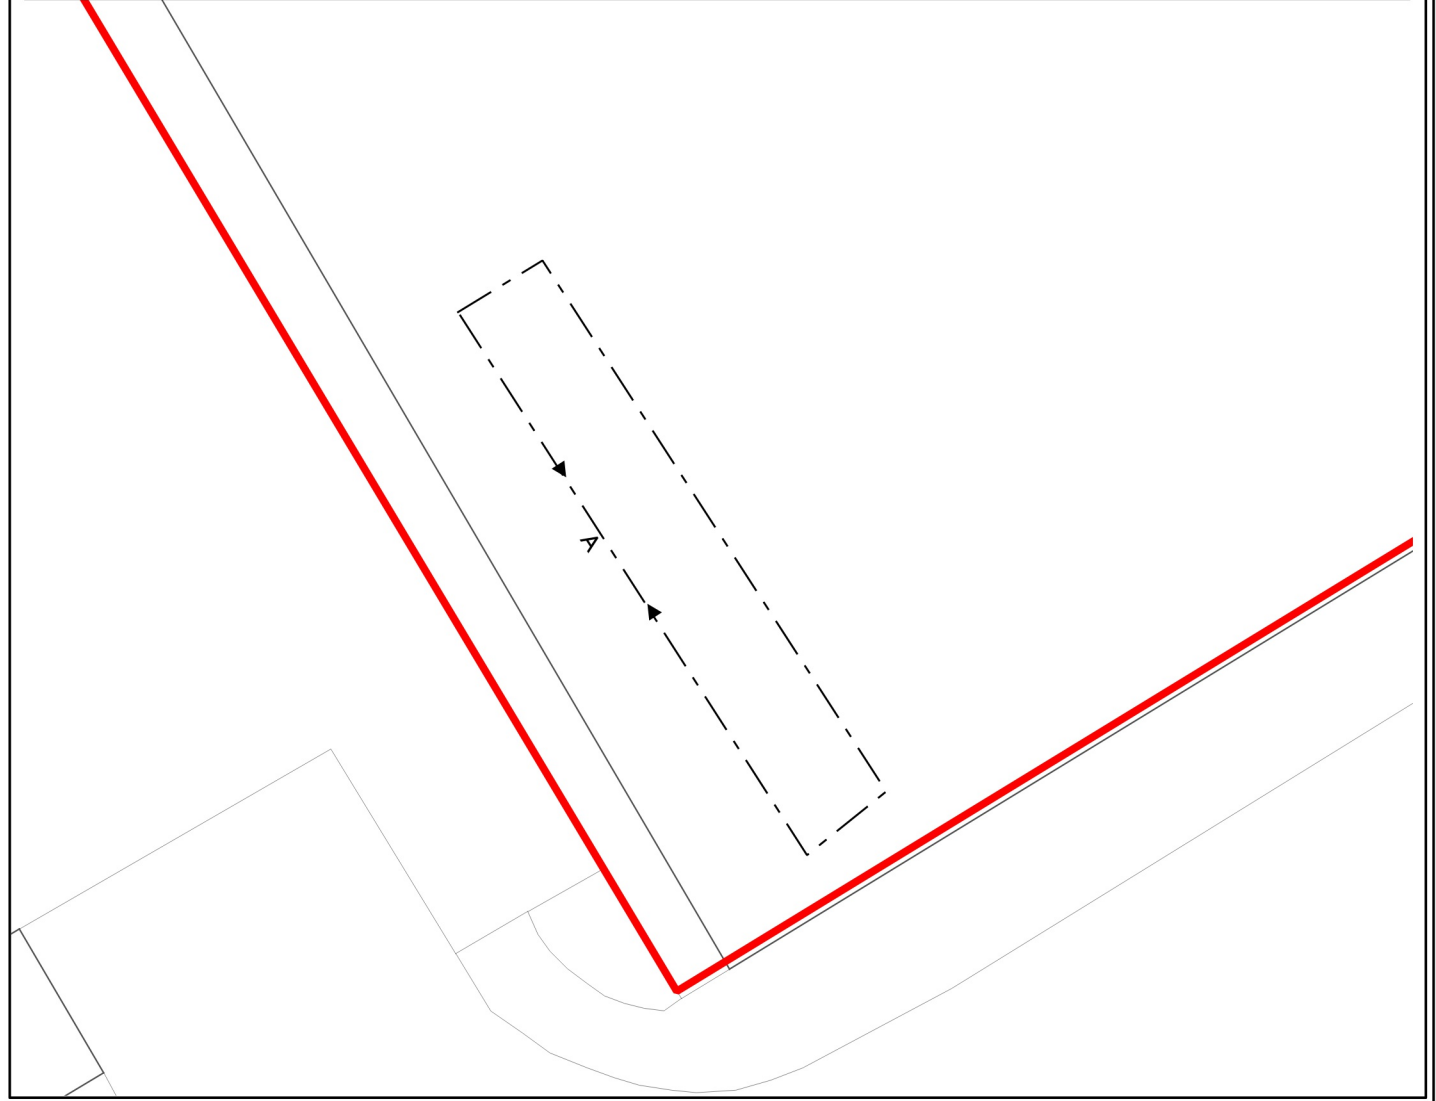
FIGURE 4 // Trench I Plan and Section

5.3.1. The location of TR1 is shown on FIGURE 3. The recorded deposits are illustrated in section in FIGURE 4. The stratigraphic matrix for this can be found in APPENDIX 1.

DESCRIPTION // Trench I Plan and North East Facing Section

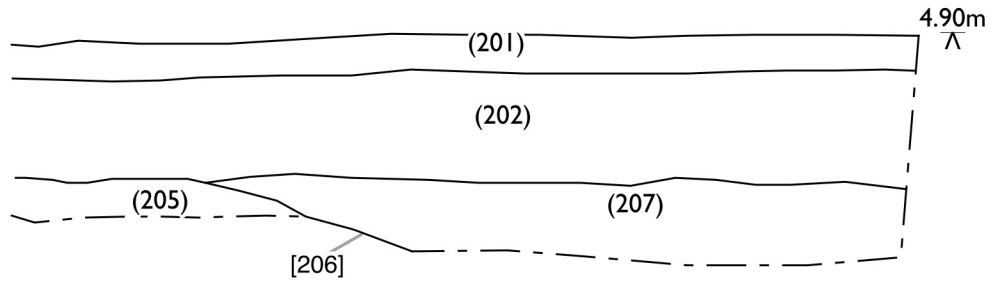
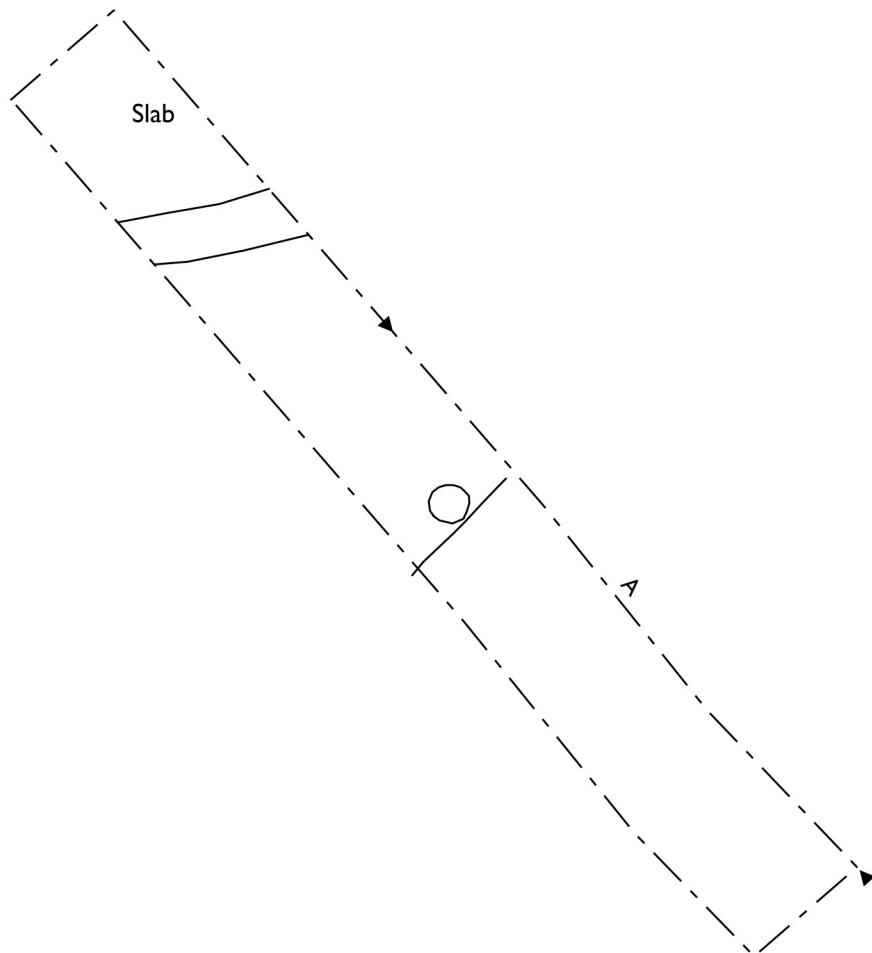
FIGURE 5 // Trench 2 Plan and Section

5.4.1. The location of TR2 is shown on FIGURE 3. The recorded deposits are illustrated in section in FIGURE 5. The stratigraphic matrix for this can be found in APPENDIX 1.

DESCRIPTION // Trench 2 Plan and South West Facing Section

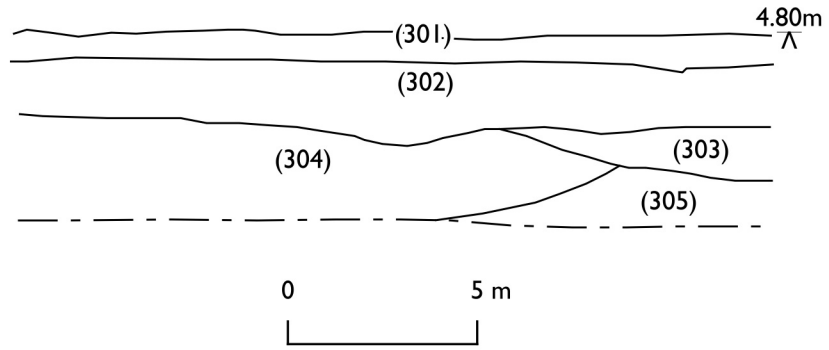
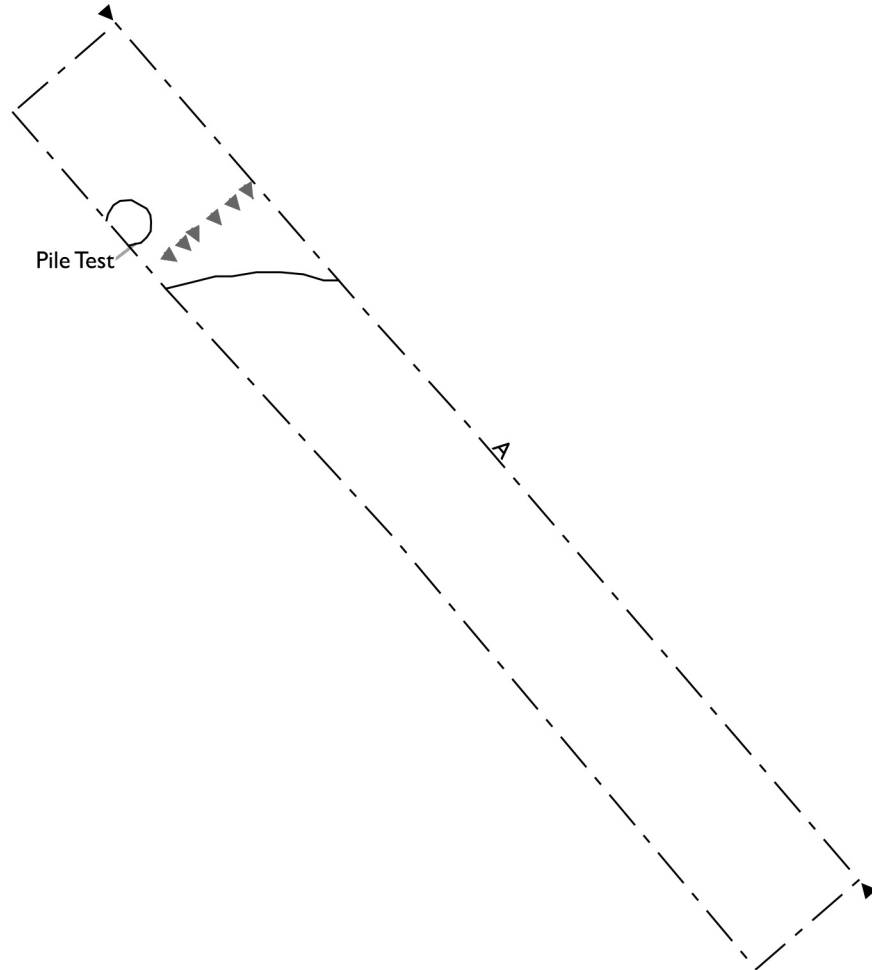
FIGURE 6 // Trench 3 Plan and Section

- 5.5.1. The location of TR3 is shown on FIGURE 3. The recorded deposits are illustrated in section in FIGURE 6. The stratigraphic matrix for this can be found in APPENDIX 1.

DESCRIPTION // Trench 3 Plan and South West Facing Section

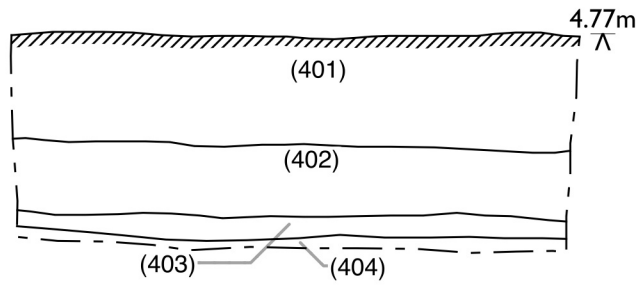
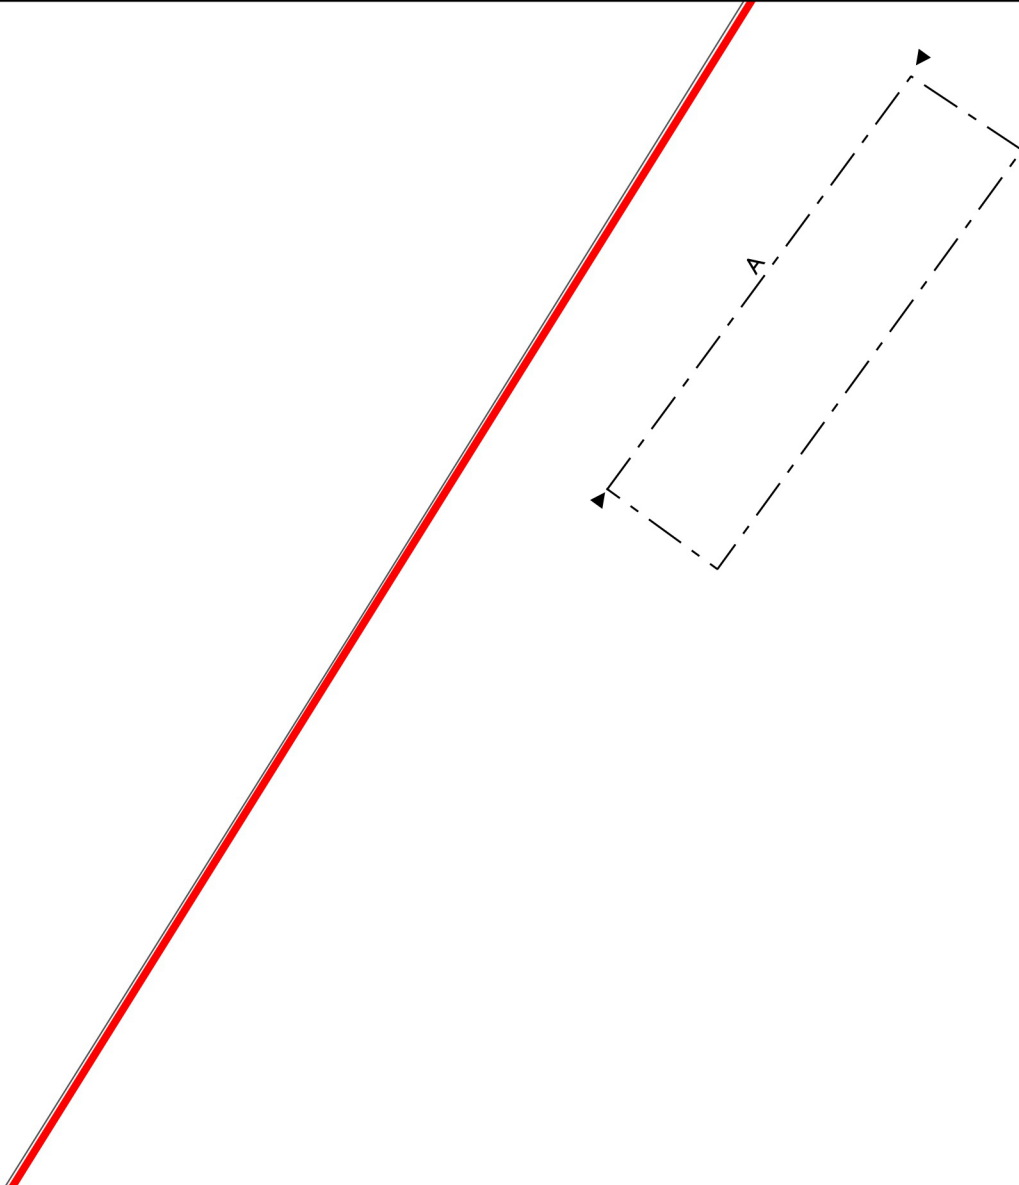
FIGURE 7 // Trench 4 Plan and Section

- 5.6.1. The location of TR4 is shown on FIGURE 3. The recorded deposits are illustrated in section in FIGURE 7. The stratigraphic matrix for this can be found in APPENDIX 1.
- 5.6.2. The earliest deposit encountered in TR4 was the natural terrace gravel (404). This is a mid red brown bedded coarse flint gravel. The natural survived to a truncated level of 2.1m OD across the trench area.
- 5.6.3. The truncated surface of the gravel (404) was sealed by (403) a dark grey clay containing brick rubble. This layer was 0.3m thick. This was overlain by (402) a mixed layer of clay containing black soot and charcoal 0.9m thick.
- 5.6.4. The sequence in this area was sealed by (401) a mixed layer containing clay and building rubble 1.4m thick. Modern ground level in this area was at 4.8m OD.

DESCRIPTION // Trench 4 Plan and South West Facing Section

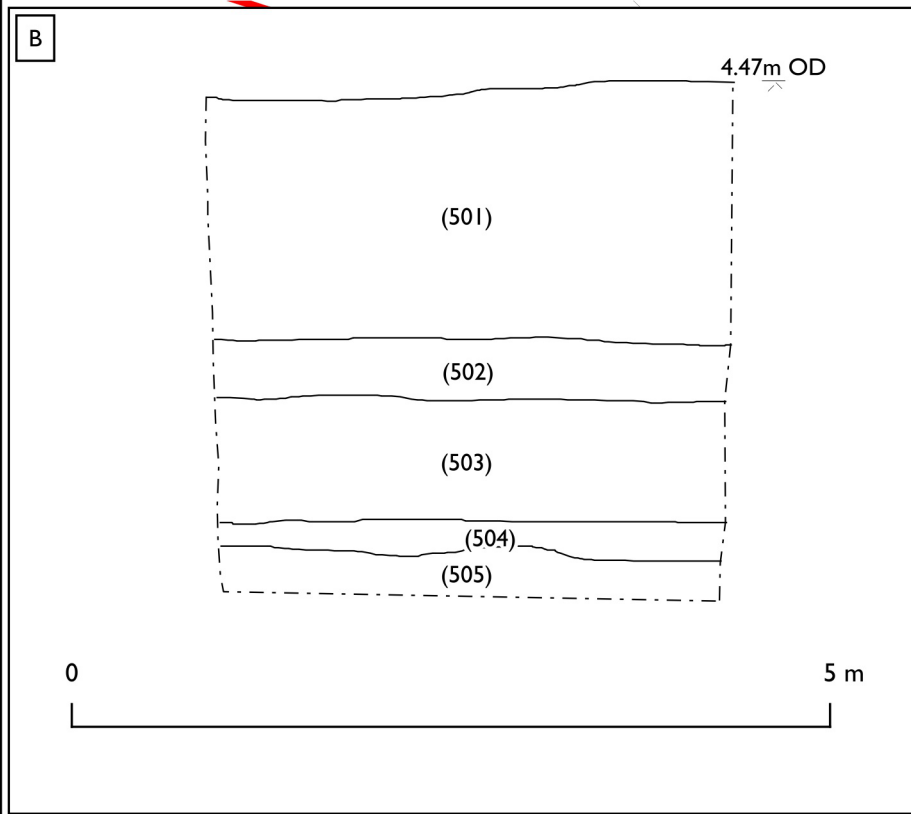
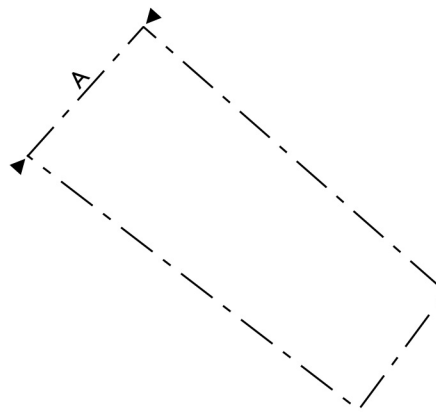
FIGURE 8 // Trench 5 Plan and Section

- 5.7.1. The location of TR5 is shown on FIGURE 3. The recorded deposits are illustrated in section in FIGURE 8. The stratigraphic matrix for this can be found in APPENDIX 1.

DESCRIPTION // Trench 5 Plan and South East Facing Section

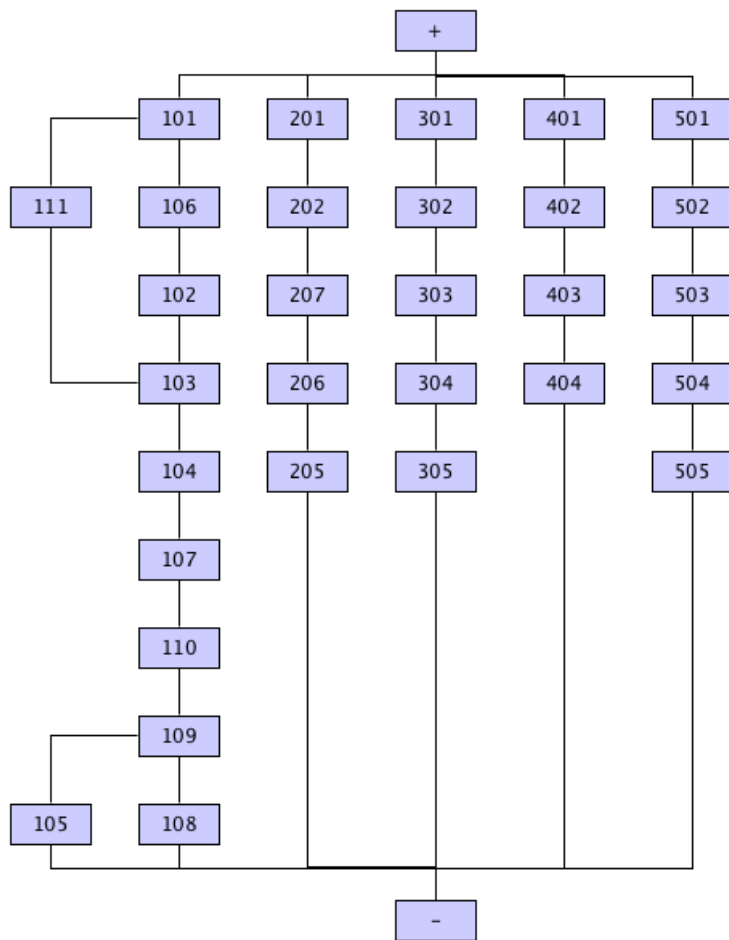
## APPENDIX I

# MATRIX DIAGRAMS
