Historic Building Recording at

**55 - 57 TOWER BRIDGE RD  
BERMONDSEY**

Doc Ref: LPI878L-HBR-v.1.2

Date: September 16

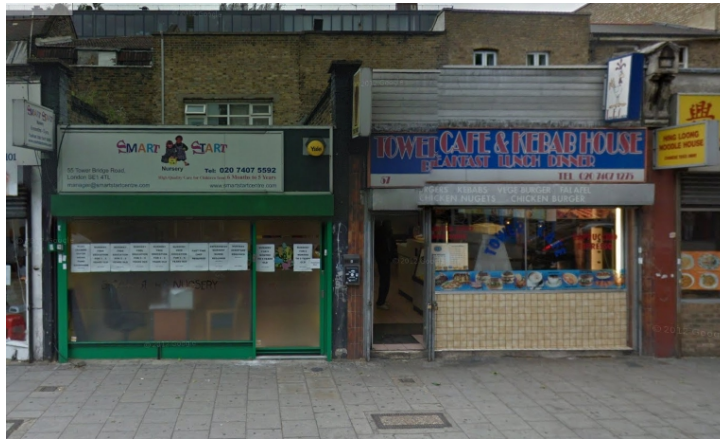
Plate 1 - Front elevation of 55 (left) and 57 (right) Tower Bridge Road, facing west

- 4.2.1. The front elevation of the building faces west on to Tower Bridge Road. The upper storey is just viewable from across the road. It has a flat roof and a stock brick elevation that appears to be a modern refronting. A large four panelled wooden framed window occupies the centre of the upper elevation and sits beneath a substantial concrete lintel.

- 4.2.2. The ground floor elevation is dominated by the early 20<sup>th</sup> century extension providing a 'shop front.' The flat roofed extension has a large window and doorway set in aluminium framing. It recently provided access to Smart Smart Day Nursery.

4.3.1. The front elevation of the building faces west on to Tower Bridge Road. It has a flat roof and a stock brick elevation that appears to be a modern refronting. There is a clear 'join' in the coursing of the brickwork between 55 and 57 indicating that the elevations were not constructed concurrently.

4.3.2. The ground floor elevation is dominated by the early 20<sup>th</sup> century extension providing a 'shop front.' The level of this facade is higher than that of number 55 as to provide a screen for the hidden catering extraction fans that site on the roof behind.

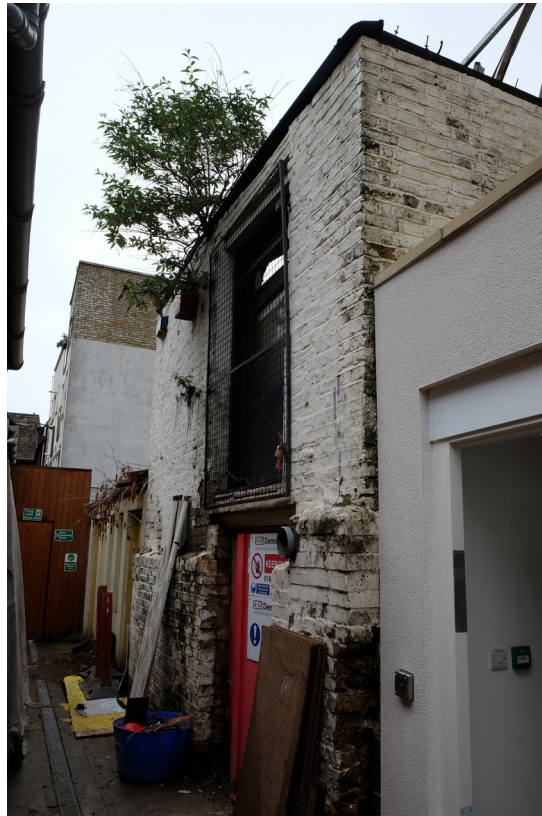
Plate 2 - Rear elevation of number 55,

- 4.2.3. The rear elevation was difficult to view due to the lack of perspective available from the rear alley way. Limited examination concludes that the rear yard had been built over to two storeys in height by a brickwork extension with a gabled roof. This structure is in a poor state of repair .

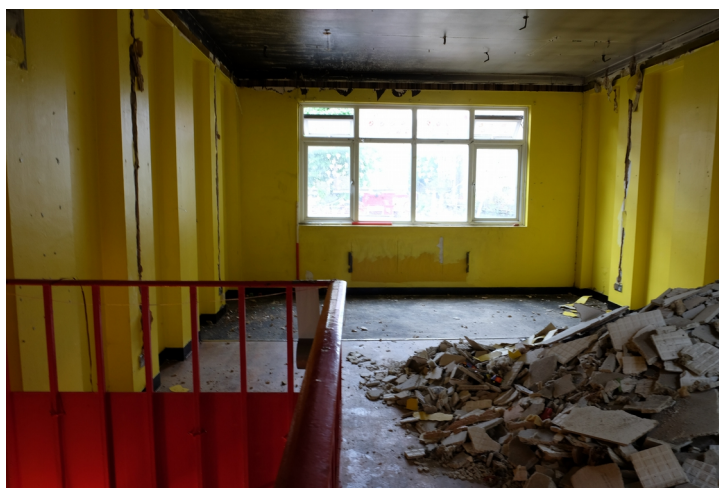
Plate 3 - Eastern room on first floor, facing east (2 x 1m scale)

- 4.2.4. The upper storey has 3 rooms, all of which have been heavily modified and are devoid of any original fixtures and fittings.
- 4.2.5. The east room fronts onto Tower Bridge Road and has two large, white painted wooden windows on the east and western elevations. Until recently it was divided by modern plasterboard partitions. The north and south elevations of room have supporting piers evenly spaced along each wall. Each wall was rendered and painted and it was not possible to ascertain further indications of age and construction.

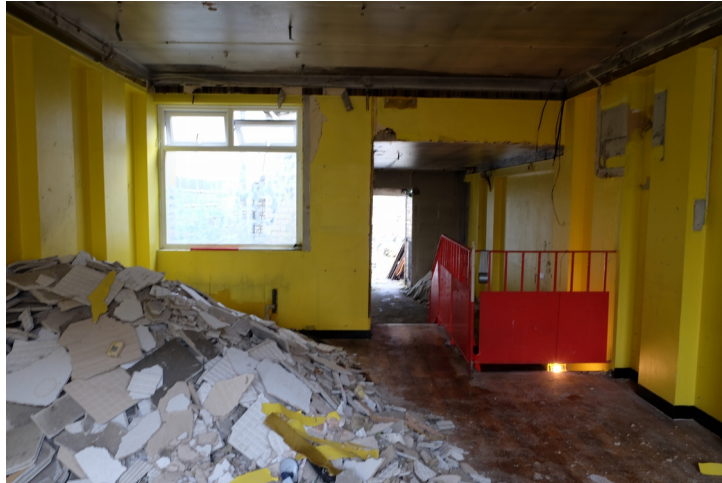
Plate 4 - Eastern room on first floor, facing west (2 x 1 m scale)

- 4.2.7. The central room on this floor occupies the rear of the original structure. No original materials, fixtures or fittings remain. The room now functions as a landing at the top of the staircase for access to the rear extension and the east room. The staircase is encircled by a steel balustrade (PLATE 4).

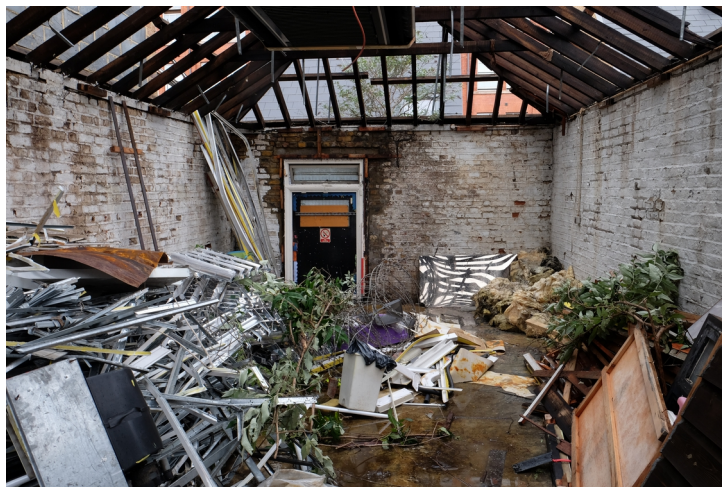
Plate 5 - West room in first floor extension (unsurveyed)

4.2.9. The rear extension, or west room, is accessible via a small external bridge. It exists as a stand alone structure in what was the rear yard of the property. It is in poor condition and was not fully surveyed due to health and safety advice. It was possible to ascertain that this structure was built the early to mid 20<sup>th</sup> century based upon brick work and sawn wooden purlins within the roof structure, which are typical of the period. No covering of the roof remains and

the room is open to the elements.

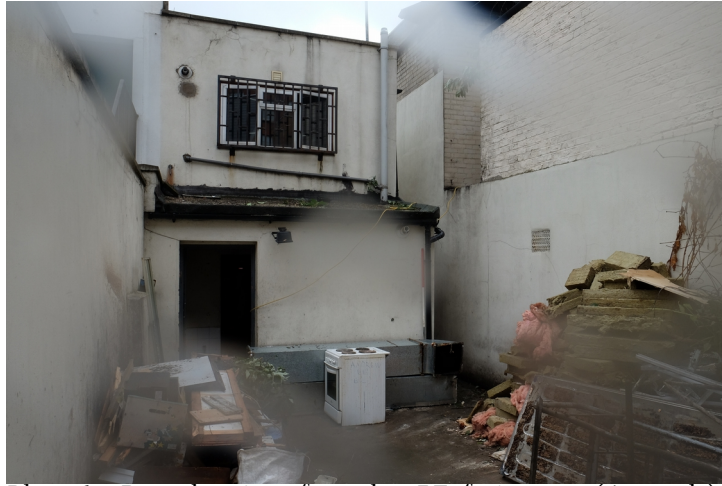
Plate 6 - Rear elevation of number 57, facing east (1m scale)

4.3.3. The rear elevation of the building is viewable from the rear yard of the property which is surrounded by a high brick wall (PLATE 6). The elevation is rendered in a plain fashion with one large uPVC framed window occupying the centre of the upper story and a door way on the ground floor beneath a shallow cat-slide roof extension. The window is covered by security bars and

other elements of the elevation include vents relating to the buildings last use in the catering industry. Access to the first floor and living area is by means of a metal fire escape on the southern side of the property.

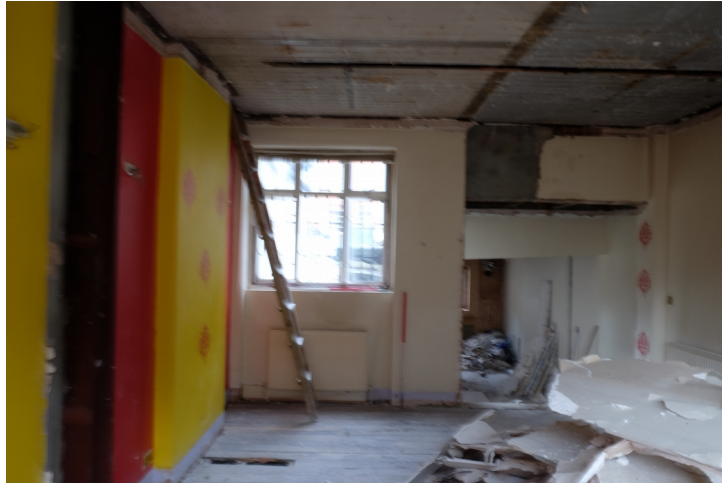
Plate 7 - First floor of number 57, facing west 2 x 1m scale)

- 4.3.4. The upper storey consists of rooms that were residential in purpose, all of which have been heavily modified and are devoid of any original fixtures and fittings.
- 4.3.5. Until recently this storey was divided by modern plasterboard partitions, into distinct living areas. These partitions were removed in the soft strip (PLATE 7). Similar to number 55, there are windows at either end of the enlarged room, both constructed from modern materials. The change in floor level is also present, as was identified in the constructions of 51, 53 and 55.

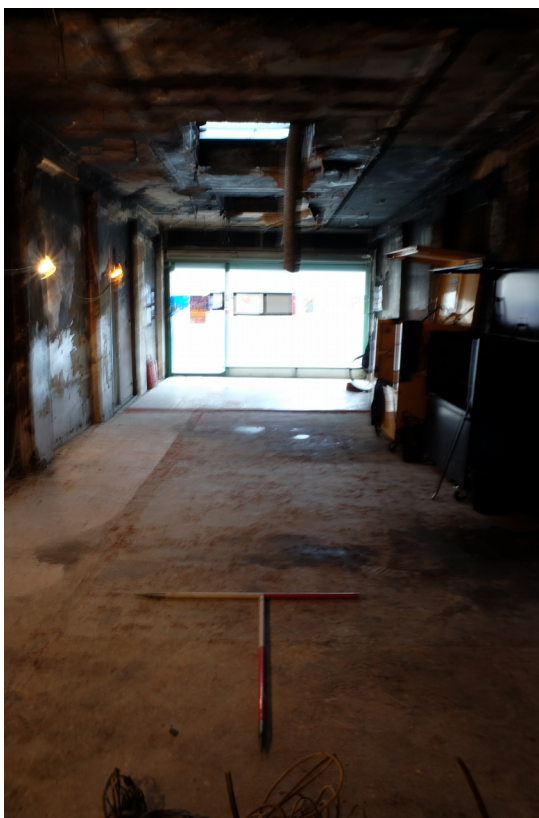
*Plate 8 - Ground floor of number 57, facing east (2 x 1m scale)*

- 4.3.7. The east room of the ground floor is situated within the early 20<sup>th</sup> century extension of the property over the original garden (PLATE 8). Until recently it held the restaurant of the kebab shop and remnants of the extraction fans associated with fast food restaurants are visible in the roof. No original fixtures or fittings remain but it does retain its 'shop-like' proportions.

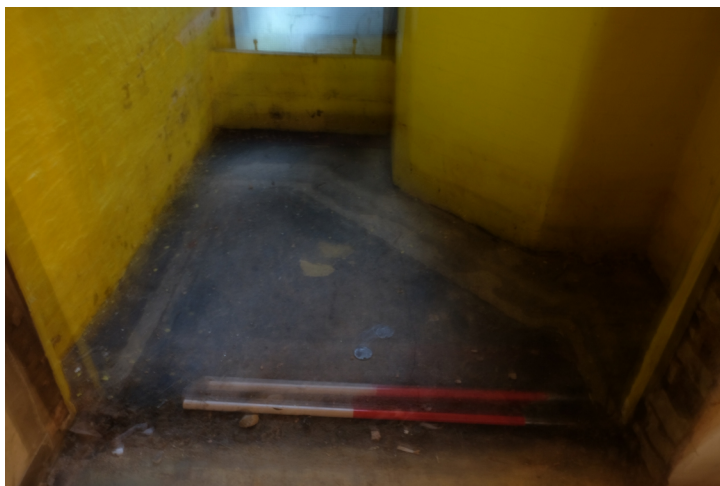
*Plate 9 - Ghosting of original fireplace (1 x 1m scale)*

- 4.3.8. A storage area on the internal side of the staircase to the residential unit above retains a ghosting on the floor of the original fireplace that once stood here (PLATE 9). The extensive alterations to the property removed all chimney stack material that may have been typical of a Moxon type house.
