Archaeological Post Excavation Report

**HAMPTON COURT PALACE
RING MAIN REPLACEMENT
PHASE 1**

For Historic Royal Palaces

Doc Ref: LP2567L-PXA-v1.10

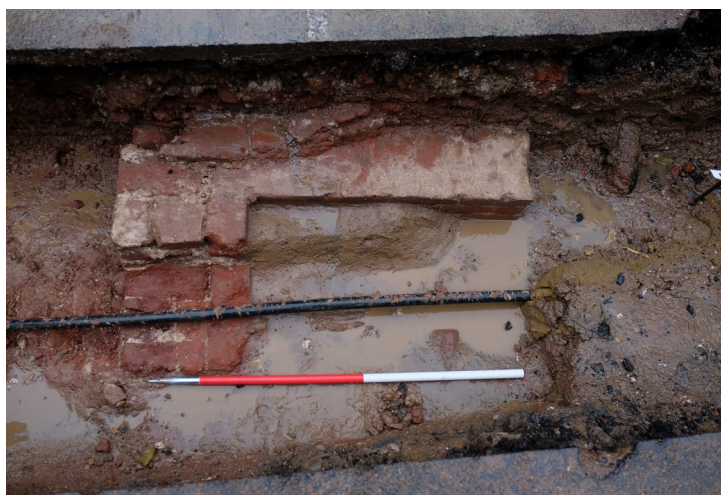
Plate 1 - Bowling Alley eastern wall and buttress {SGR: 21}. Photograph taken facing north, 1m scale.

- 5.2.2. In Area 9 a small section of brick wall foundation and a buttress {SGR: 21}, composed of contexts 9009 and 901Z, were excavated in the eastern part of Tennis Court Lane (PLATE 1). This brickwork measured 1.30m east-west and 0.68m north-south, being truncated at its southern extent (FIGURE 4). The foundations were first encountered at 8.90m OD. These have been interpreted

as the remains of the Tudor bowling alley built for Henry VIII that is known to have been located in this area. The bowling alley is understood to have been built in 1536 (THURLEY 1988: 19). The foundations present in the trench likely formed the eastern wall of the structure as well as part of an internal wall. Although not directly datable in this excavation, these structural remains were overlain by deposits of demolition material which contained bricks that have been dated to 1500-1528 (SECTION 5.2.12). This provides some clues to the date of the structure, but the possibility remains that this demolition dump was unrelated to these foundations, and the dating of bricks must be treated with caution as bricks are frequently reused in later periods.

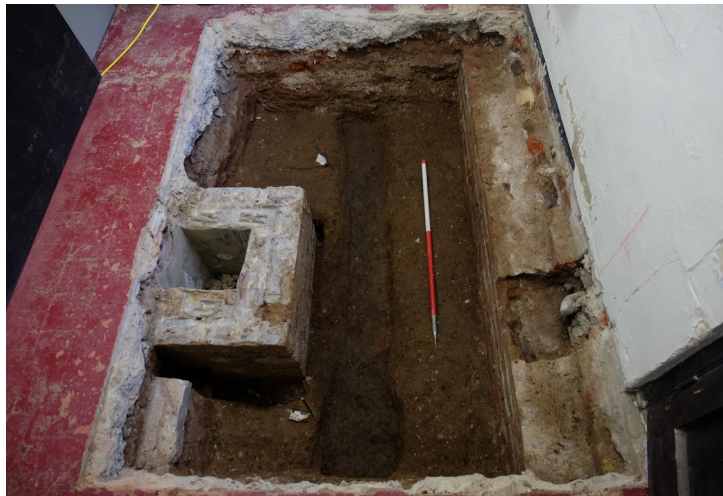
Plate 2 - East-west bedding trench {SGR: 4} in Area 8.
Photograph taken facing east, 1m scale.

- 5.2.6. External cultivation layer {SGR: 3} was cut by an east-west aligned bedding trench [8012] (FIGURE 5) (PLATE 2). This bedding trench was 0.38m wide and 0.26m deep. The upper fill (8011) of the bedding trench contained pottery sherds dating from the 15th to 17th centuries. Furthermore, a clay tobacco pipe found within the bedding trench has been dated to 1660 to 1680, giving a relatively tight date range for the use of this area for cultivation. Given the proximity to the kitchens of this feature it seems likely that it may have been associated with some form of kitchen gardening.

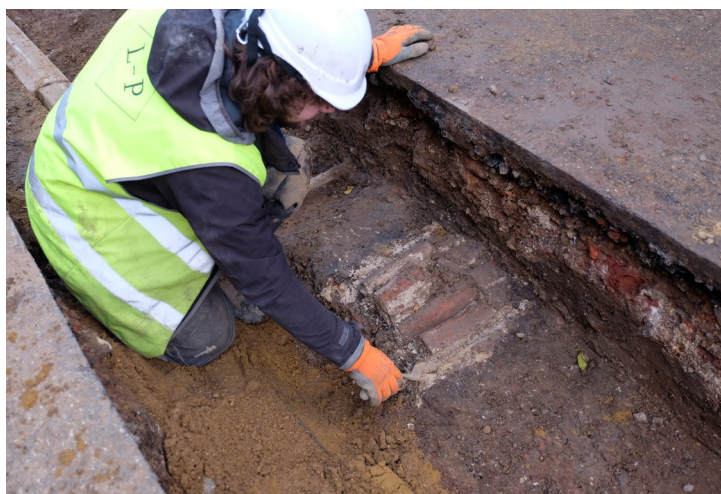
Plate 3 - The excavation of culvert {SGR: 16}, the culvert had been truncated to the south by the cut for an electrical cable. Photograph facing north-west, working shot featuring Aaron Clarke.

- 5.2.7. Towards the eastern end of Tennis Court Lane one of the earliest deposits encountered was an external dump {SGR: 15}. This deposit can be said to post date 1580 as clay tobacco pipe stems were found in it.
- 5.2.8. Cutting into dump {SGR: 15} was a north-south oriented brick culvert {SGR: 16} (FIGURE 6). This culvert was built with single brick thick walls and

an arched roof, giving it a width of 0.54m. The base of the drain was lined with tiles, 9013. The drain, 9004, likely would have extended across the full width of the trench, continuing beyond the limit of excavation to the north and truncated by modern services to the south (PLATE 4) (PLATE 5). Spot dating of the bricks from the culvert gave a date range of 1501 to 1528, which given its stratigraphic position would suggest that they may be reused. Due to the culvert's proximity to the remains of the Tudor bowling alley (SECTION 5.2.2) it may have been built to drain waste away from the bowling alley and into one of the Palace's major culverts. No finds were present within the fill of the culvert, and there was insufficient volume present to take an environmental sample.

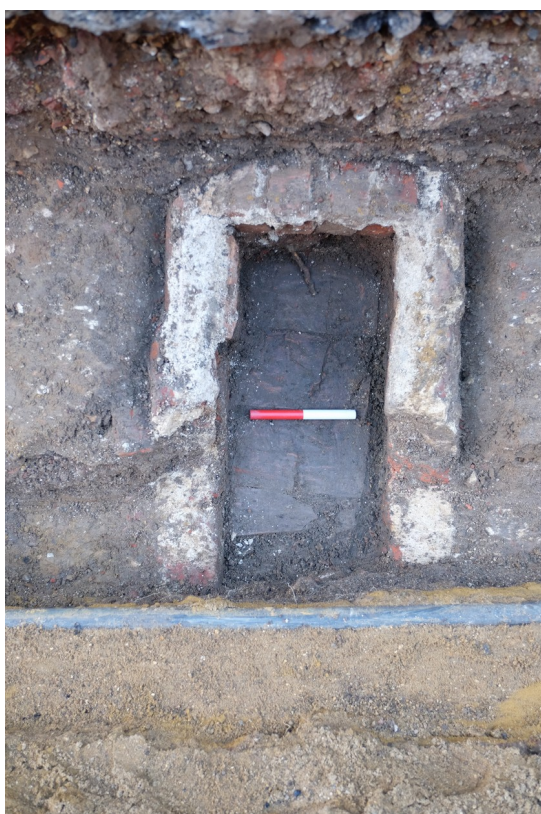
Plate 4 - Culvert {SGR: 16} with the roof removed. Photograph facing north, 0.2m scale.

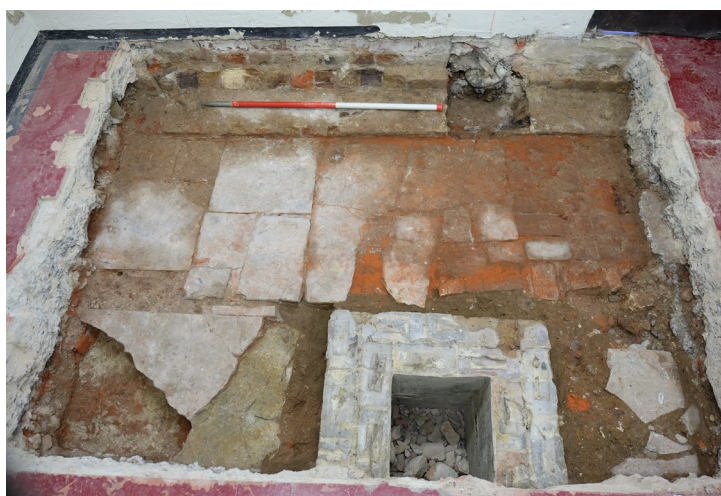
Plate 5 - Former brick and flagstone floor surfaces {SGR: 8} in Area 8.

5.2.15. Located in Area 8, ground raising deposit {SGR: 6} was cut by the construction cut for the extant range of buildings {SGR: 7}. The Ford (1996) phase plan has interpreted that this range was built sometime between the 19th century and 1912. This range of buildings incorporated the existing east-west boundary wall. Evidence of a previous brick and flagstone floor surface, {SGR: 8} comprising contexts 8002 and 8003, was also recorded within this building (PLATE 5) (FIGURE 7).

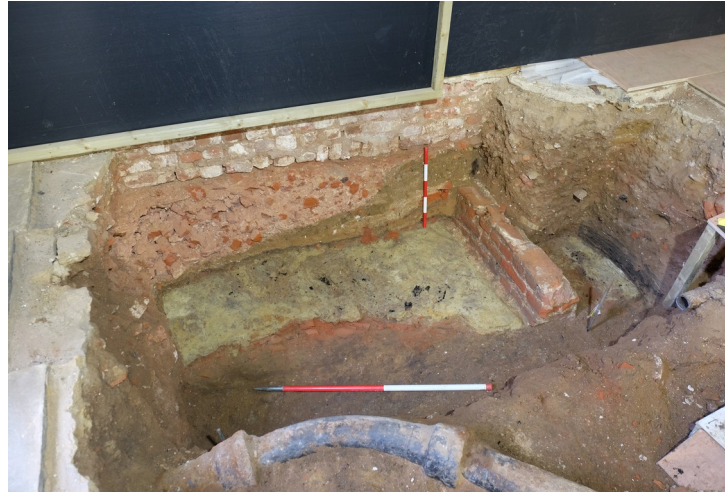
Plate 6 - A pale green silt deposit {SGR: 29}, likely formed of upcast material from the clearing of the moat. Photograph facing north-east, 1m and 0.5m scale

5.3.3. This yard surface was sealed by a dump of redeposited water lain material (6029). Environmental assessment, see (SECTION 12.3.3), of this deposit suggests that this may have been upcast material from the dredging of the moat. The layer consisted of a distinctive yellowish green well sorted silty sand (PLATE 6),

no direct dating evidence was found within the layer. This layer was encountered at 8.77m OD.

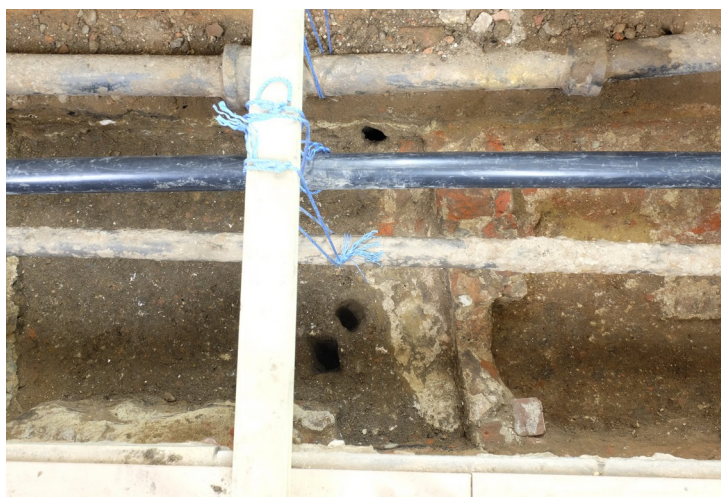
Plate 7 - Three stake holes {SGR: 69}. Photograph taken facing west, no scale.

- 5.3.6. Cut into trample {SGR: 2} were three stake holes {SGR: 69}, comprising contexts [2027], [2029] and [2031]. Two were wholly visible within the trench and one was partially obscured by a later pipe (FIGURE 8). Of the two that could be clearly observed, one was square in plan and the other was circular (PLATE 7). Each had a diameter of approximately 0.10m. The three

small stake holes form a rough line on an approximate east-west axis. No dating evidence was present in any of the backfill deposits of these post holes. However, a layer composed of sandy clay (2025) interpreted on site as packing around the stakes {SGR: 51}, did contain pottery that has been dated to 1200-1399.

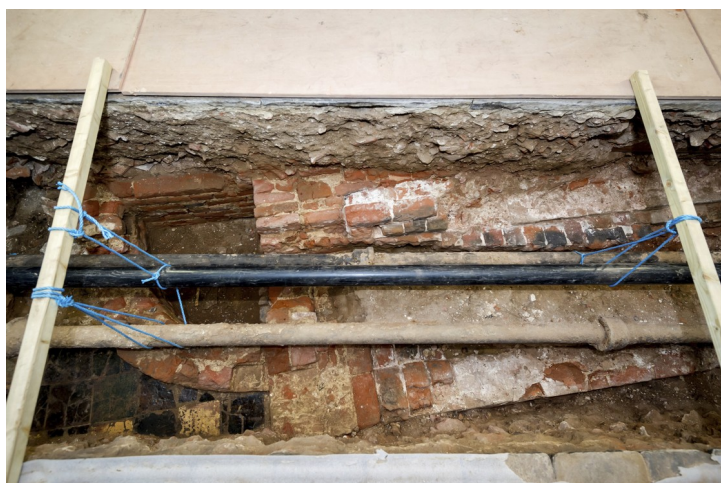
Plate 8 - The north side of the chimney breast {SGR: 54}, with the internal hearth structure {SGR: 55} to the south of it. To the north glazed tile floor {SGR: 61} and structure {SGR: 60} area also visible. Photograph taken facing east, no scale.

- 5.3.7. Built on top of external surface {SGR: 57} was the structure of a brick hearth. The construction of this began with the deposition of a levelling makeup deposit of sand and mortar {SGR: 59}, and the construction of the foundations for the chimney breast {SGR: 54}, consisting of contexts 2014 and 2045 (FIGURE 9). Chimney breast {SGR: 54} was built from a mixture of orange-red and purple-red bricks, bonded with a greyish yellow sandy lime mortar (PLATE 8). The hearth within the chimney breast walls had an internal width of 4.25m (14 ft). The structure was on north-south alignment, with the hearth facing west.
- 5.3.8. Built within the chimney breast {SGR: 54} was an internal hearth furniture structure {SGR: 55} constructed from brick (FIGURE 9). This consisted of a back wall 2011, on the east side, of purplish red bricks laid in header course and

bonded with a greyish white lime mortar (PLATE 8). The back wall of the hearth exhibited evidence of *in situ* burning (PLATE 9). On the west side of the hearth was a course of bricks laid on bed 2044, but on an angle to form a shallow gully approximately 0.06m deep. This may have been a feature to prevent ashes spreading out into the room and to aid cleaning.

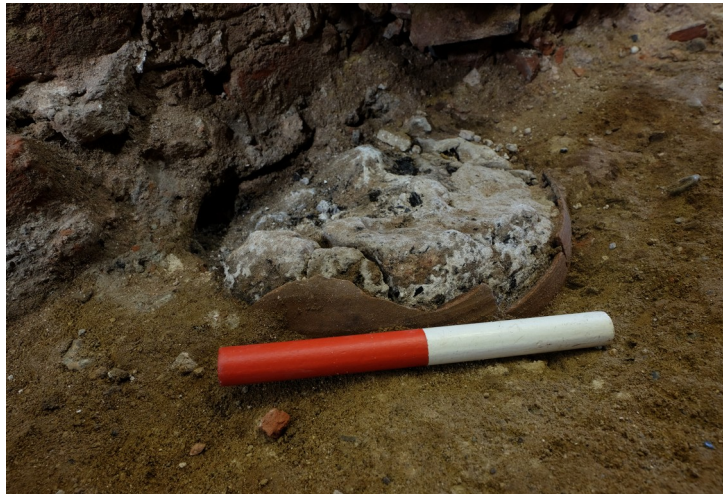
Plate 10 - Mortar filled pot {SGR: 58}. Photograph taken facing north-west, 0.2m scale.

5.3.9. A pot filled with mortar (2060) was found in a cut {SGR: 58} directly below the hearth's internal structure {SGR: 55} (FIGURE 10). Due to later truncations by services and the demolition of this phase of buildings it is not possible to say with absolute certainty whether the hearth was built on top of this buried pot, or if it was inserted at a later date. In either case the pot appears to have been deliberately deposited into a purpose excavated cut. The pot was filled with mortar, see (SECTION 6.3.4), and had likely been used as a mixing bucket, possibly for the construction of the hearth. The pot has been dated to the 16th to 18th centuries.

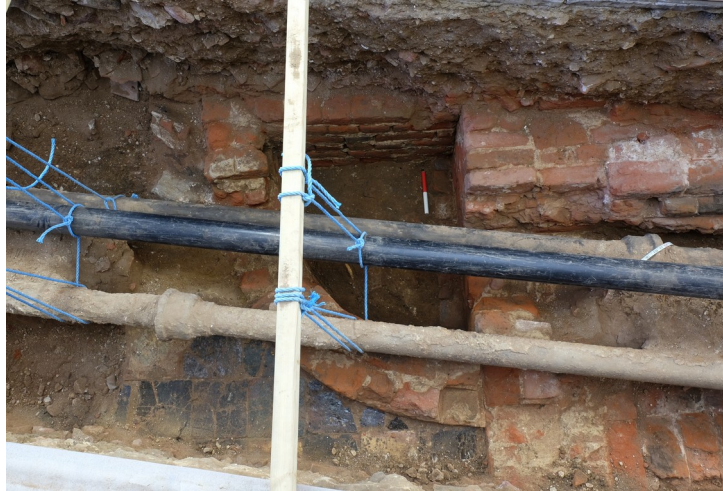
Plate 11 - Brick structure {SGR: 60} abutting the north end of the chimney breast. Photograph taken facing east, 0.2m scale.

5.3.10. Built abutting the north side of the chimney breast {SGR: 54} was a quarter-circular structure of brick {SGR: 60}. The brick structure, 2009, was built from orange-red bricks bonded with a brownish yellow lime mortar (PLATE 11). This may have been the foundation for a bread oven or warming cupboard, or it may perhaps have been the base for some sort of storage cupboard or work surface.

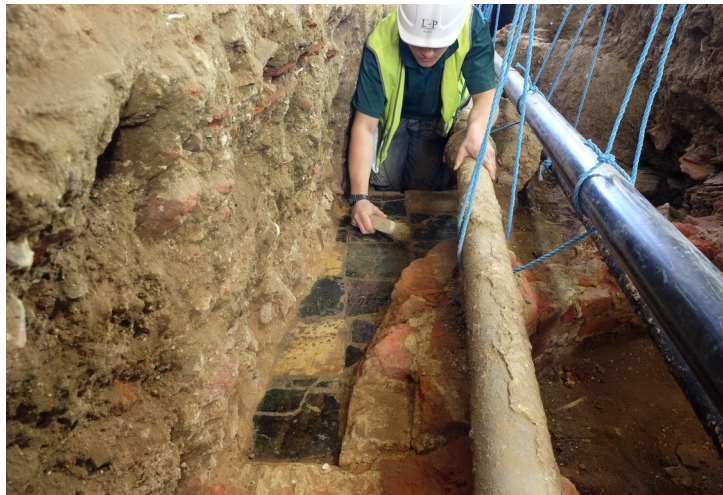
Plate 12 - Glazed tile floor {SGR: 61}. Photograph taken facing north, working shot featuring Rory Falconer.

blackish brown (SECTION 9.4.2). The extent of this floor surface continued to the west beyond the limit of excavation, but had been truncated to the east. The surface of the floor sat at 8.72m OD. Elsewhere in Area 2 the only evidence of the floor surface which survived was the sand bedding {SGR: 47}.

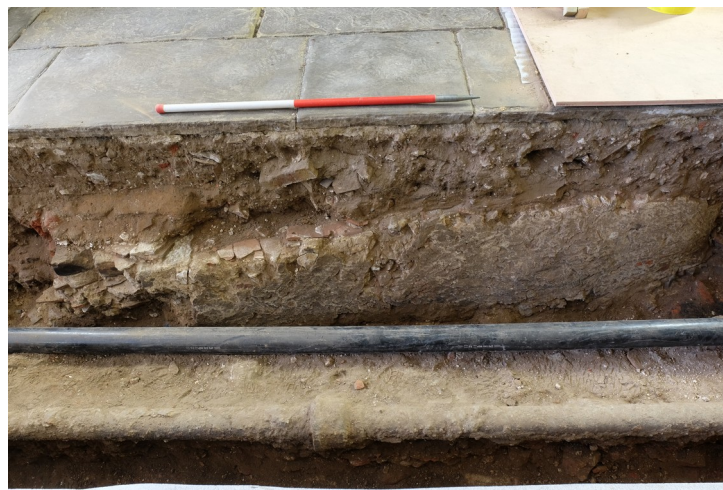
Plate 13 - Rendered masonry {SGR: 64}, possibly a kitchen counter similar to those present in the extant kitchens. Photograph taken facing east, 1m scale.

5.3.15. Built on top of the drainage structure {SGR: 65} was the base of a possible counter or food preparation bench {SGR: 64}. This structure was stratigraphically later than the north side of the chimney breast and continued on the same north-south alignment for 4.3m, before turning to the east, across the trench, and then continuing beyond the limit of excavation (FIGURE 11). It is possible that this structure would have been built up against the walls and would have run along the side of the room. Therefore this turn could be evidence of the edge of the room. No remains of foundations of a wall were present, but these may have been fully truncated in the area of the trench, and are therefore no longer visible. The structure was built from a mixture of materials that included reigate stone, chalk, brick, peg tile and sandstone, which had been bonded with a grey-white sandy lime mortar. These mixed materials had then been rendered to give a uniform finish (PLATE 13). Bricks from context 2008 within this sub-group have been dated to 1500 to 1528, see (SECTION 9.2).

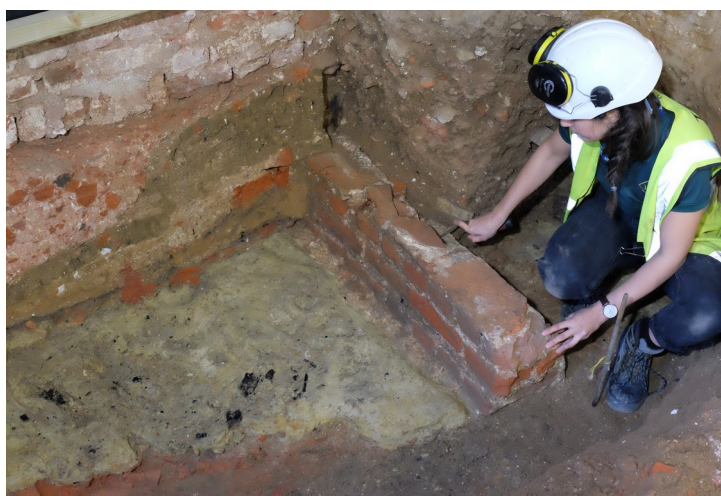
Plate 14 - Truncated remains of north-south wall {SGR: 30}. Photograph taken facing north-east, working shot featuring Florence Laino.

5.3.20. In Area 6, built on top of Medieval layer {SGR: 29} (SECTION 5.3.3) were the remains of a brick wall {SGR: 30} (FIGURE 13). This wall, 6020, was on an approximate north-south alignment, and had a fair fair face on the west side (PLATE 14). To the south and east the wall had been truncated leaving only two rows of bricks surviving. The wall continued beyond the limit of excavation to the north. The surviving wall consisted of three courses of bricks built in english bond on a bedding deposit of mortar, and topped by a course of tiles. The western 'real' edge of this wall lines up with the projected line of the western wall of a kitchen seen in an excavation in 1978 (THURLEY 2003: 61). This then may be a truncated fragment of that same western kitchen wall, that formed the western boundary to the kitchens until 1529 when Henry VIII is documented to have extended the kitchens to the west (SECTION 5.3.23).

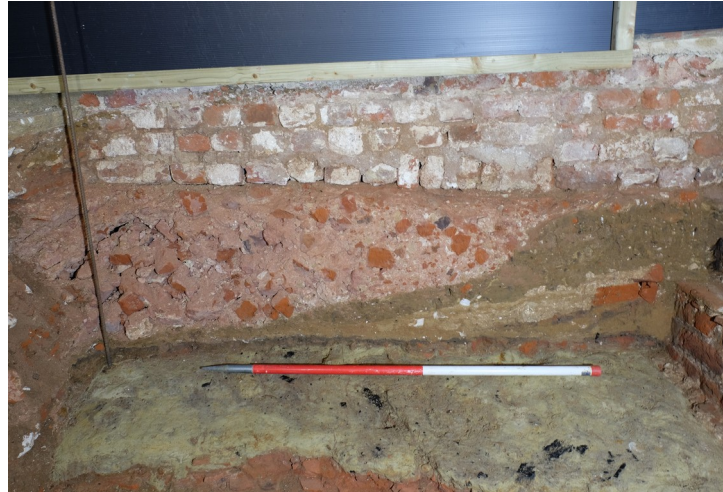
Plate 15 - The build up of layers {SGR: 33} to construct the Henrician extension of the kitchens. Photograph taken facing north, 1m scale.

area. Within {SGR: 33} was a deposit of construction debris (6007) which consisted of a mix of mortar and CBM fragments.

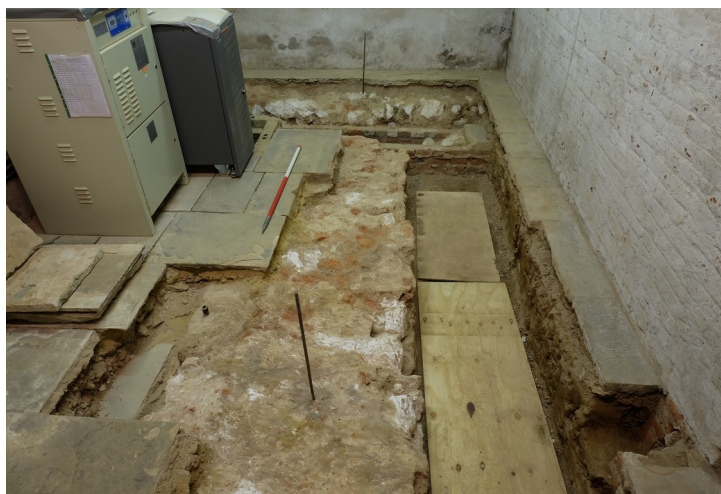
Plate 16 - Rammed chalk raft foundation below the modern floor in the Great Hall undercroft. Photograph taken facing east, 1m scale.

5.4.4. In Areas 4 and 5 the excavations recorded the foundations of the former Great Hall {SGR: 23}, comprising contexts 5003, 5007 and 5012. These foundations consisted of a rammed chalk raft, with occasional inclusions of brick fragments and flint nodules. The foundations had been lain into construction cuts which were cut into natural geological deposits (SECTION 5.4.2). The foundations were on an east-west alignment and were present in the excavation with a length of 3.90m and a width of 1.20m, the full surviving thickness was not seen during the excavation, but was at least 0.25m (FIGURE 17). The foundations had been truncated to the west, north and east, with the real edge of the foundation surviving on the south side. The foundations are present on the exact alignment anticipated by the Ford (1996) phase plan for the footings of the previous Hall. The phase plan gives the footings for the previous Hall found to the west a date of “Pre-1515”, as no dating evidence was recovered during the excavation in this area then we are unable to refine this further from the excavated evidence.

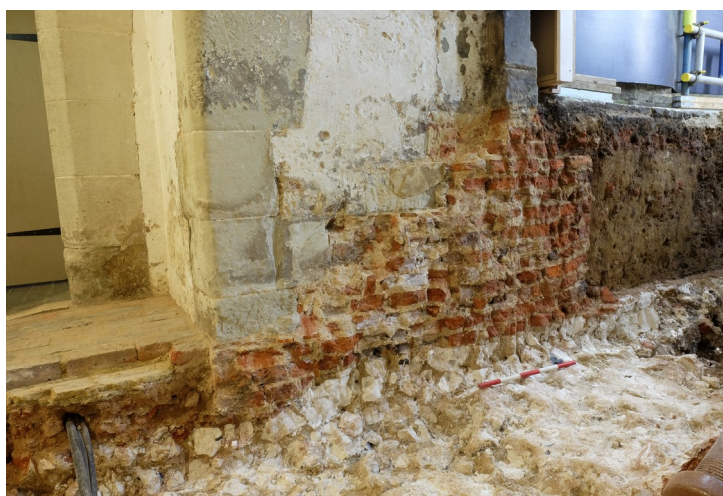
Plate 17 - Foundations for the Henrician Great Hall {SGR: 70}, seen in section following the removal of the stairs
Photograph taken facing north-west, 0.5m scale.

5.4.6. The accounts of the Palace record that bricklayers were working on the construction of the foundations of the present Great Hall by March 1532 (THURLEY 1988: 10). Part of this wall {SGR: 70} was recorded in elevation in Area 5 of the excavation (PLATE 17). The wall was revealed by the removal of the present stairs that descend from the North Cloister into the cellars of the Great Hall. The east face of the wall within the doorway was recorded. The wall is 1.5m thick, and built from bricks laid in English bond. Below the level of the present stairs, there was some evidence of a thin coat of plaster, which may have been painted white. Also visible in section in the area of the stairs were the remains of an earlier staircase {SGR: 70} that had been truncated by the construction of the later staircase. This earlier phase of stairs into the undercroft had been built with Reigate stone treads laid on a bed of bricks (PLATE 18) (PLATE 19). It was necessary to remove the staircase in order to create the new cable route.

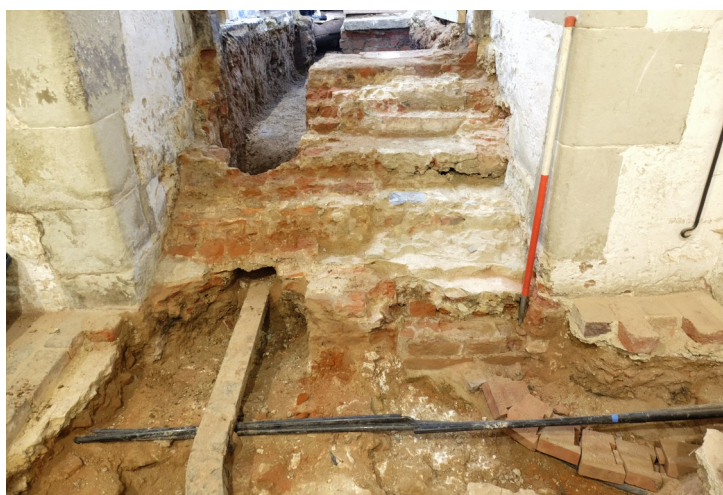
Plate 18 - Remains of the brick staircase {SGR: 70}.
Photograph taken facing north, 1m scale.

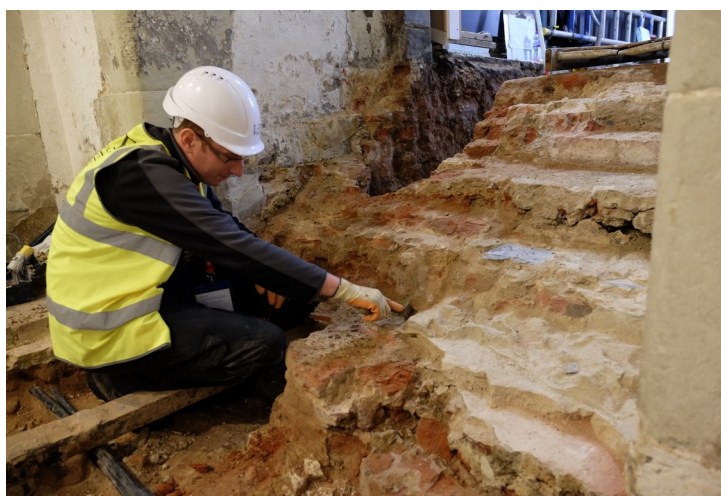
Plate 19 - The stairs {SGR: 70} were built from a foundation of bricks with reigate stone treads. Photograph taken facing north-west, working shot featuring Daniel Bateman.

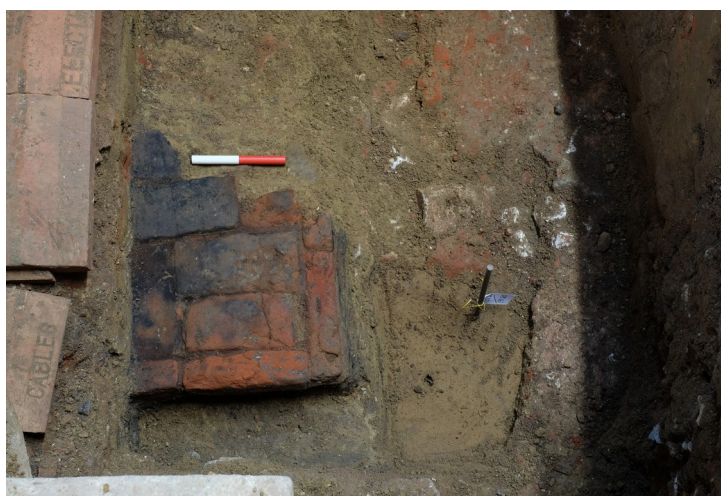
Plate 20 - Truncated remains of a brick floor {SGR: 73}.
Photograph taken facing south, 0.2m scale,

- 5.4.9. Above the sand makeup deposit was a brick floor {SGR: 73}, which may date to the Tudor phase of the Great Hall. The floor consisted of unglazed orange-red bricks laid on bed. The floor was later removed in a robbing out event {SGR: 74}, that left only a small area remaining *in situ*, the surviving floor measured 0.54m x 0.44m (PLATE 20).

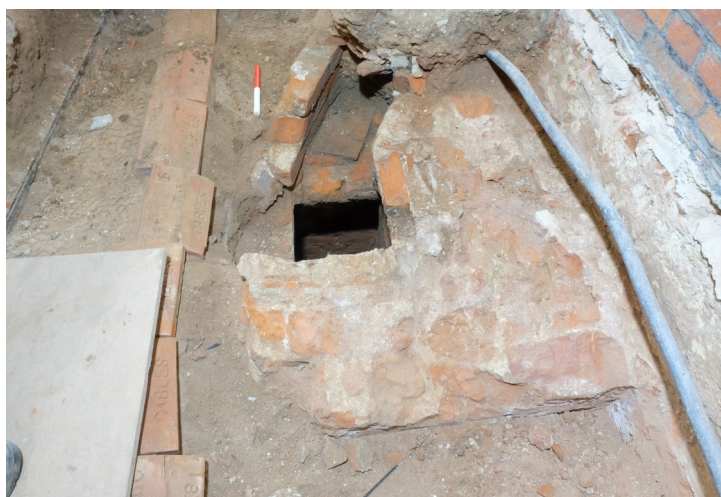
Plate 21 - Brick culvert {SGR: 88}. Photograph taken facing north, 0.2m scale.

5.5.1. The excavation in Area 10 uncovered the inlet of a brick culvert {SGR: 88} (FIGURE 20). The extent to which the main body of this culvert could be recorded was limited by its inaccessibility. It was possible to observe that the culvert was built from brick with an arched roof 10004. Water originally drained into the culvert through a down chute and sluice (PLATE 21).

5.5.2. Internally the culvert had entirely silted up at this inlet, and two distinct layers of silting were present. A grey-brown sandy silt (10006) overlay a grey-black silt deposit (10007). An environmental sample was recovered from deposit (10007) (SECTION 12.3). Post Medieval pottery dated to the 16th to 18th centuries was recovered from (10006). In addition to this a clay tobacco pipe was also found within this deposit, the pipe dates to 1778 to 1800 (SECTION 7.1.4). Suggesting that this part of the Palace's culvert system may have gone out of use in the late 18th or early 19th centuries.

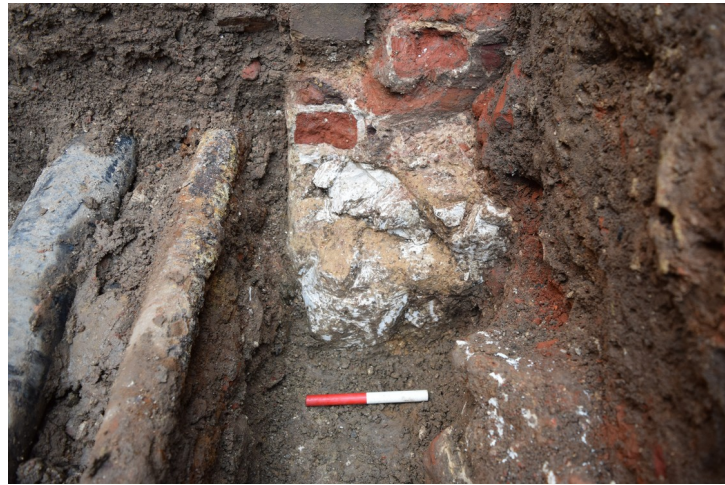
Plate 22 - North Cloister buttress {SGR: 13} in Carpenters Court. Photograph taken facing east, 0.2m scale.

5.6.4. Located at the east end of the trench in Area 11 were the foundations of a buttress at the threshold into the North Cloister {SGR: 13} (FIGURE 21). These foundations, 11004, were built from an irregularly coursed mixture of brick

and chalk bonded with a white-grey sandy lime mortar (PLATE 22).

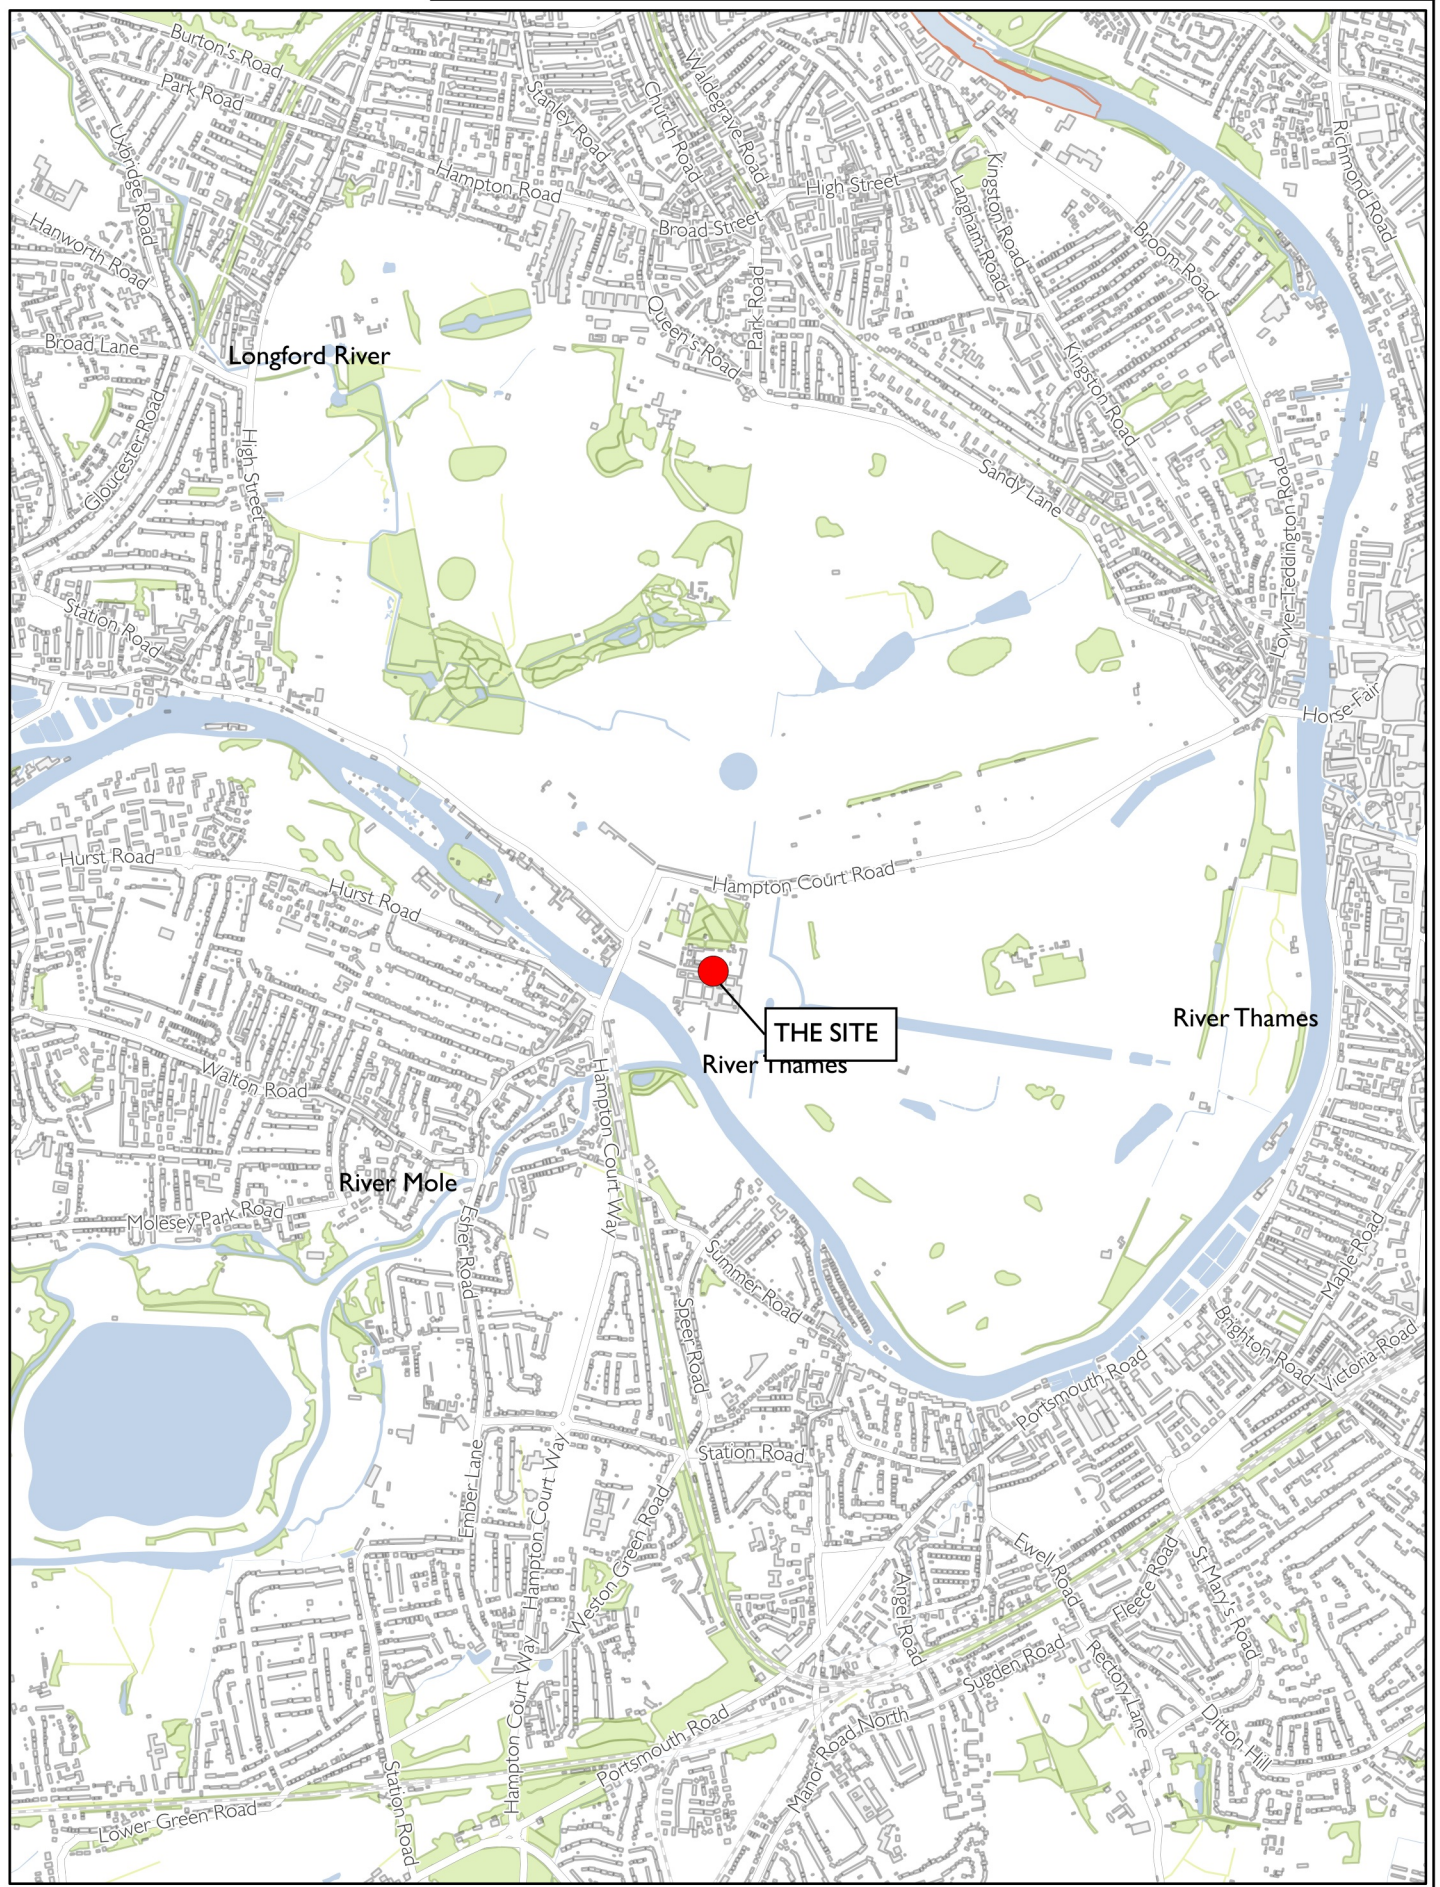
FIGURE I // Site Location - General

DESCRIPTION // Site Location

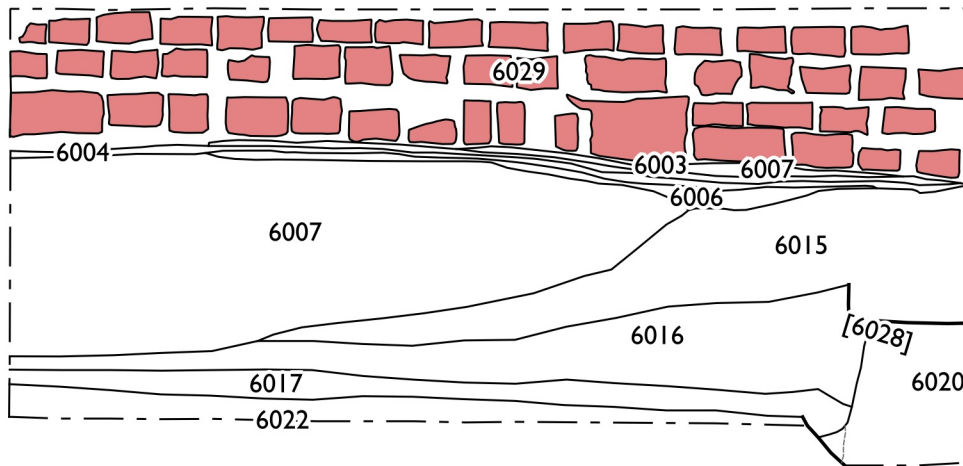
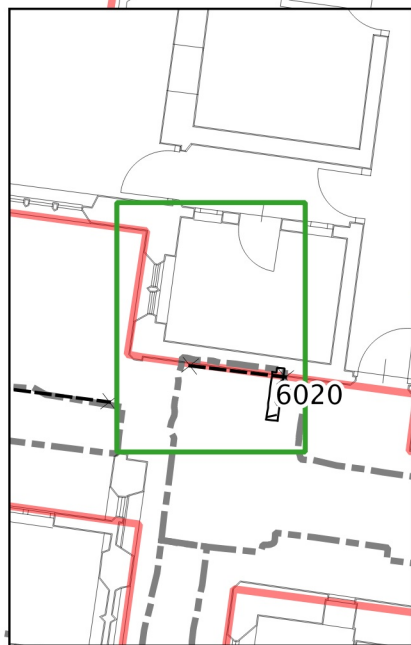
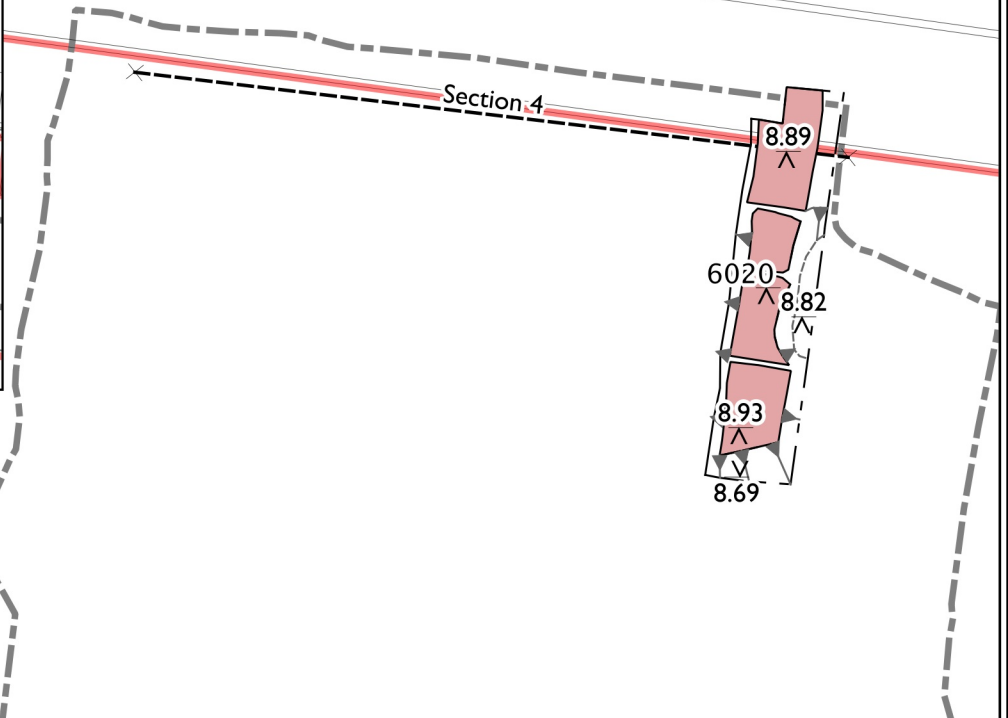
DESCRIPTION // Wall {30} in Area 6 shown in plan and section

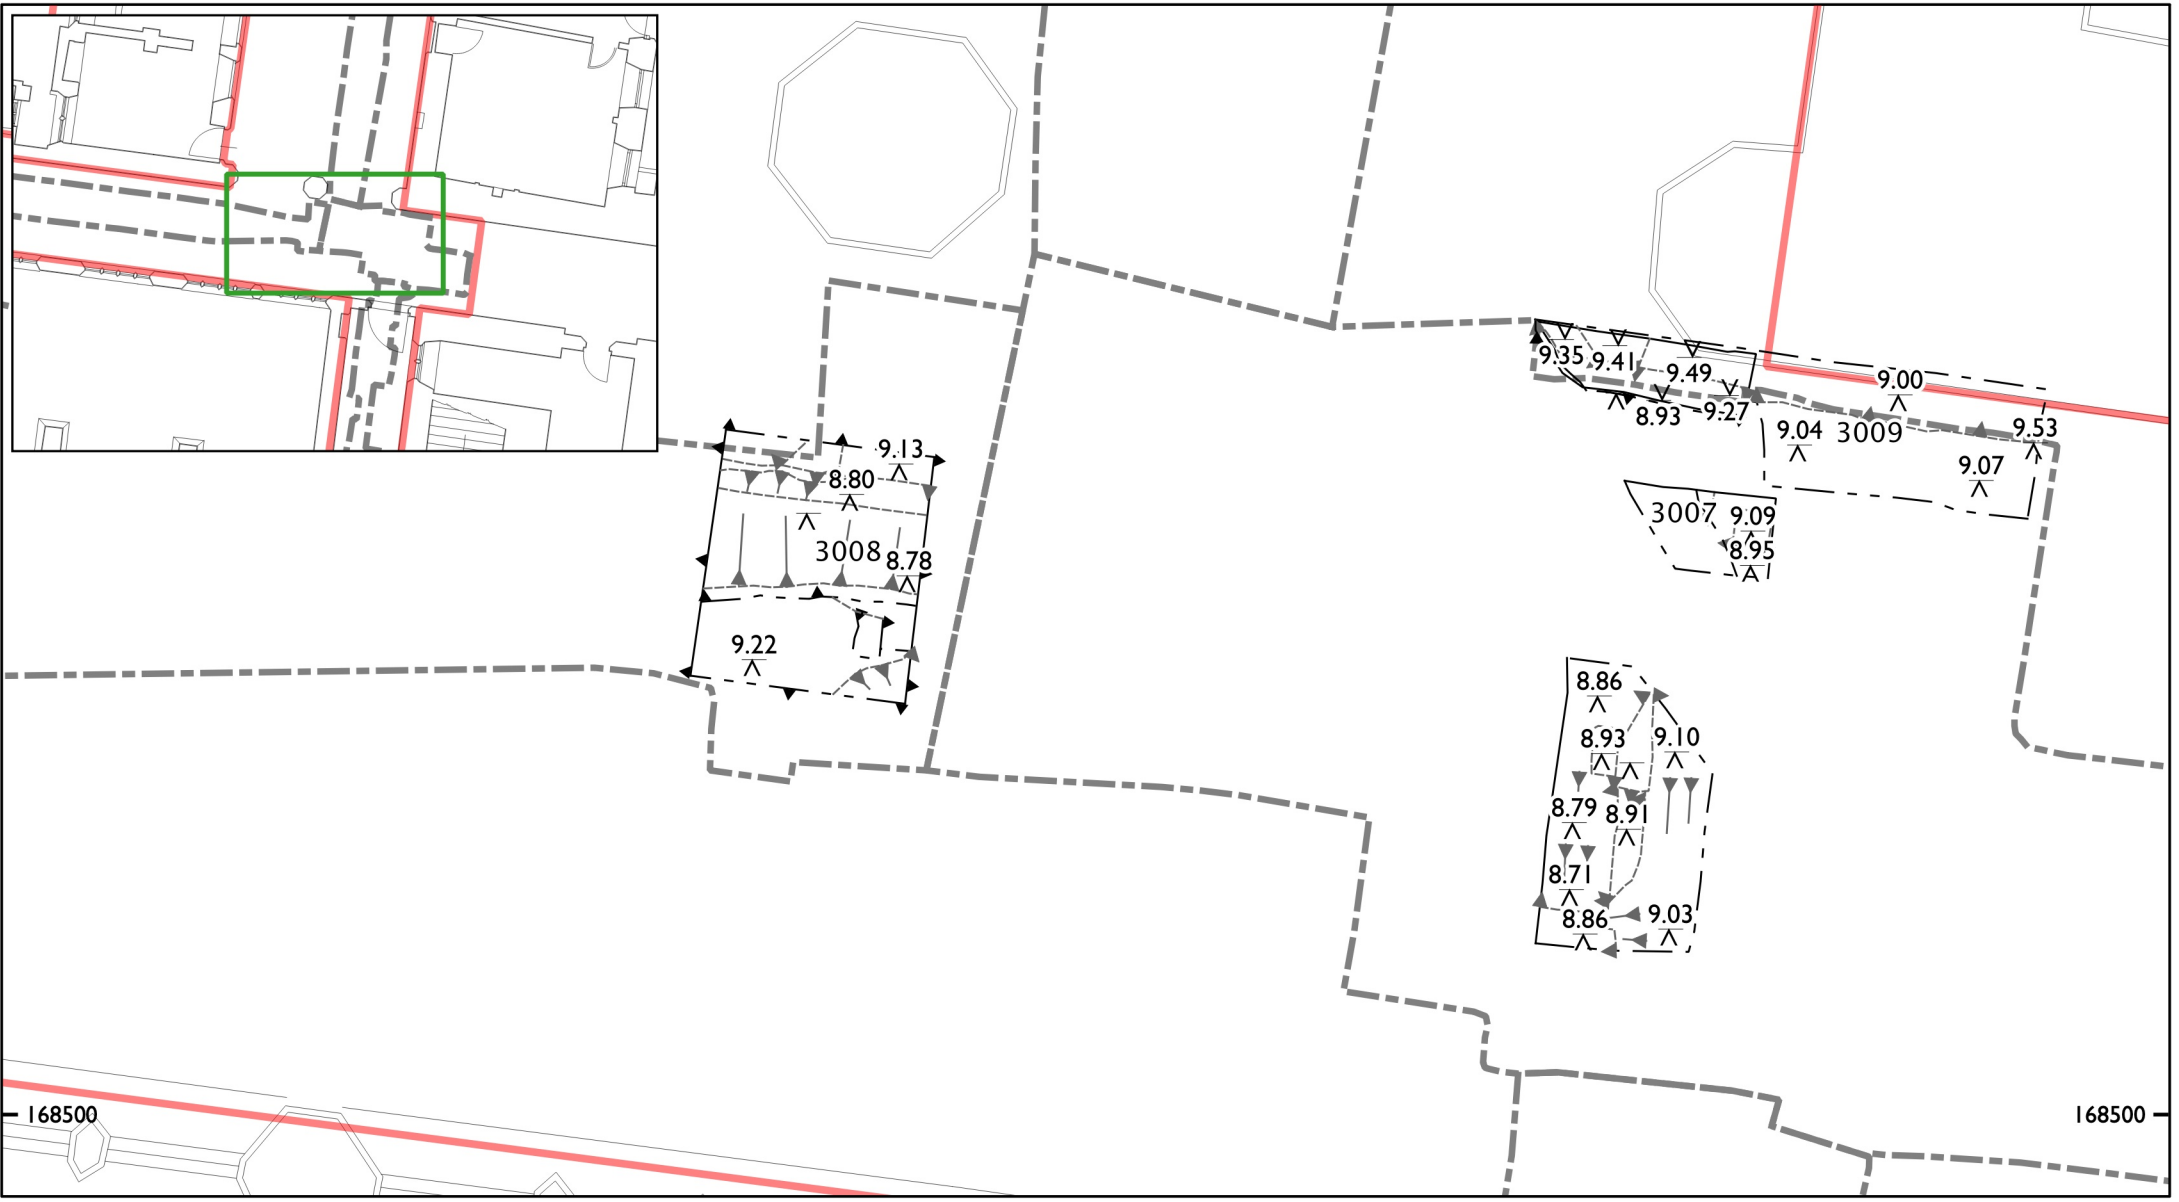
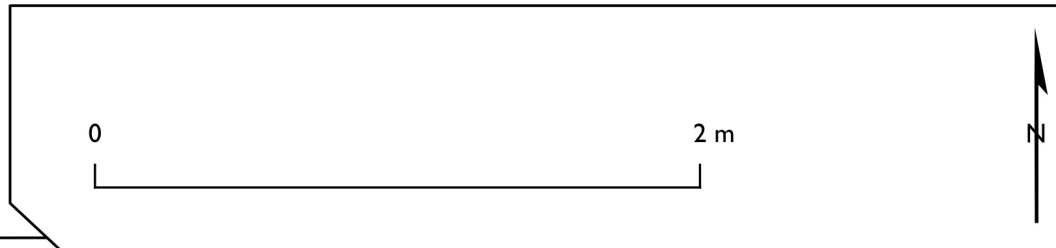
FIGURE 15 // Brick Foundations in Area 3

DESCRIPTION // Foundation {81}, {82} and {85} in Area 3

5.3.31. In a construction cut which cut into the possible robbing event {SGR: 80} were the foundations of a brick pier base 3010 {SGR: 81} added to the south-east corner of the Servedy corridor (FIGURE 15). The Ford (1996) phase plan suggests that a decorative arch was added to the opening at the southern end of the Servedy between 1800 and 1912, and this brick pier may have been built

5.3.32. Also cut into robber cut {SGR: 80} was the construction cut for a brick pad 3007 {SGR: 82} built to the south of the Servedy arch (FIGURE 15). The construction of this structure appears to be Victorian in character. Its function is not entirely clear due to later truncations by modern services, but it may have been a reinforcement to the foundations in the North Cloister.

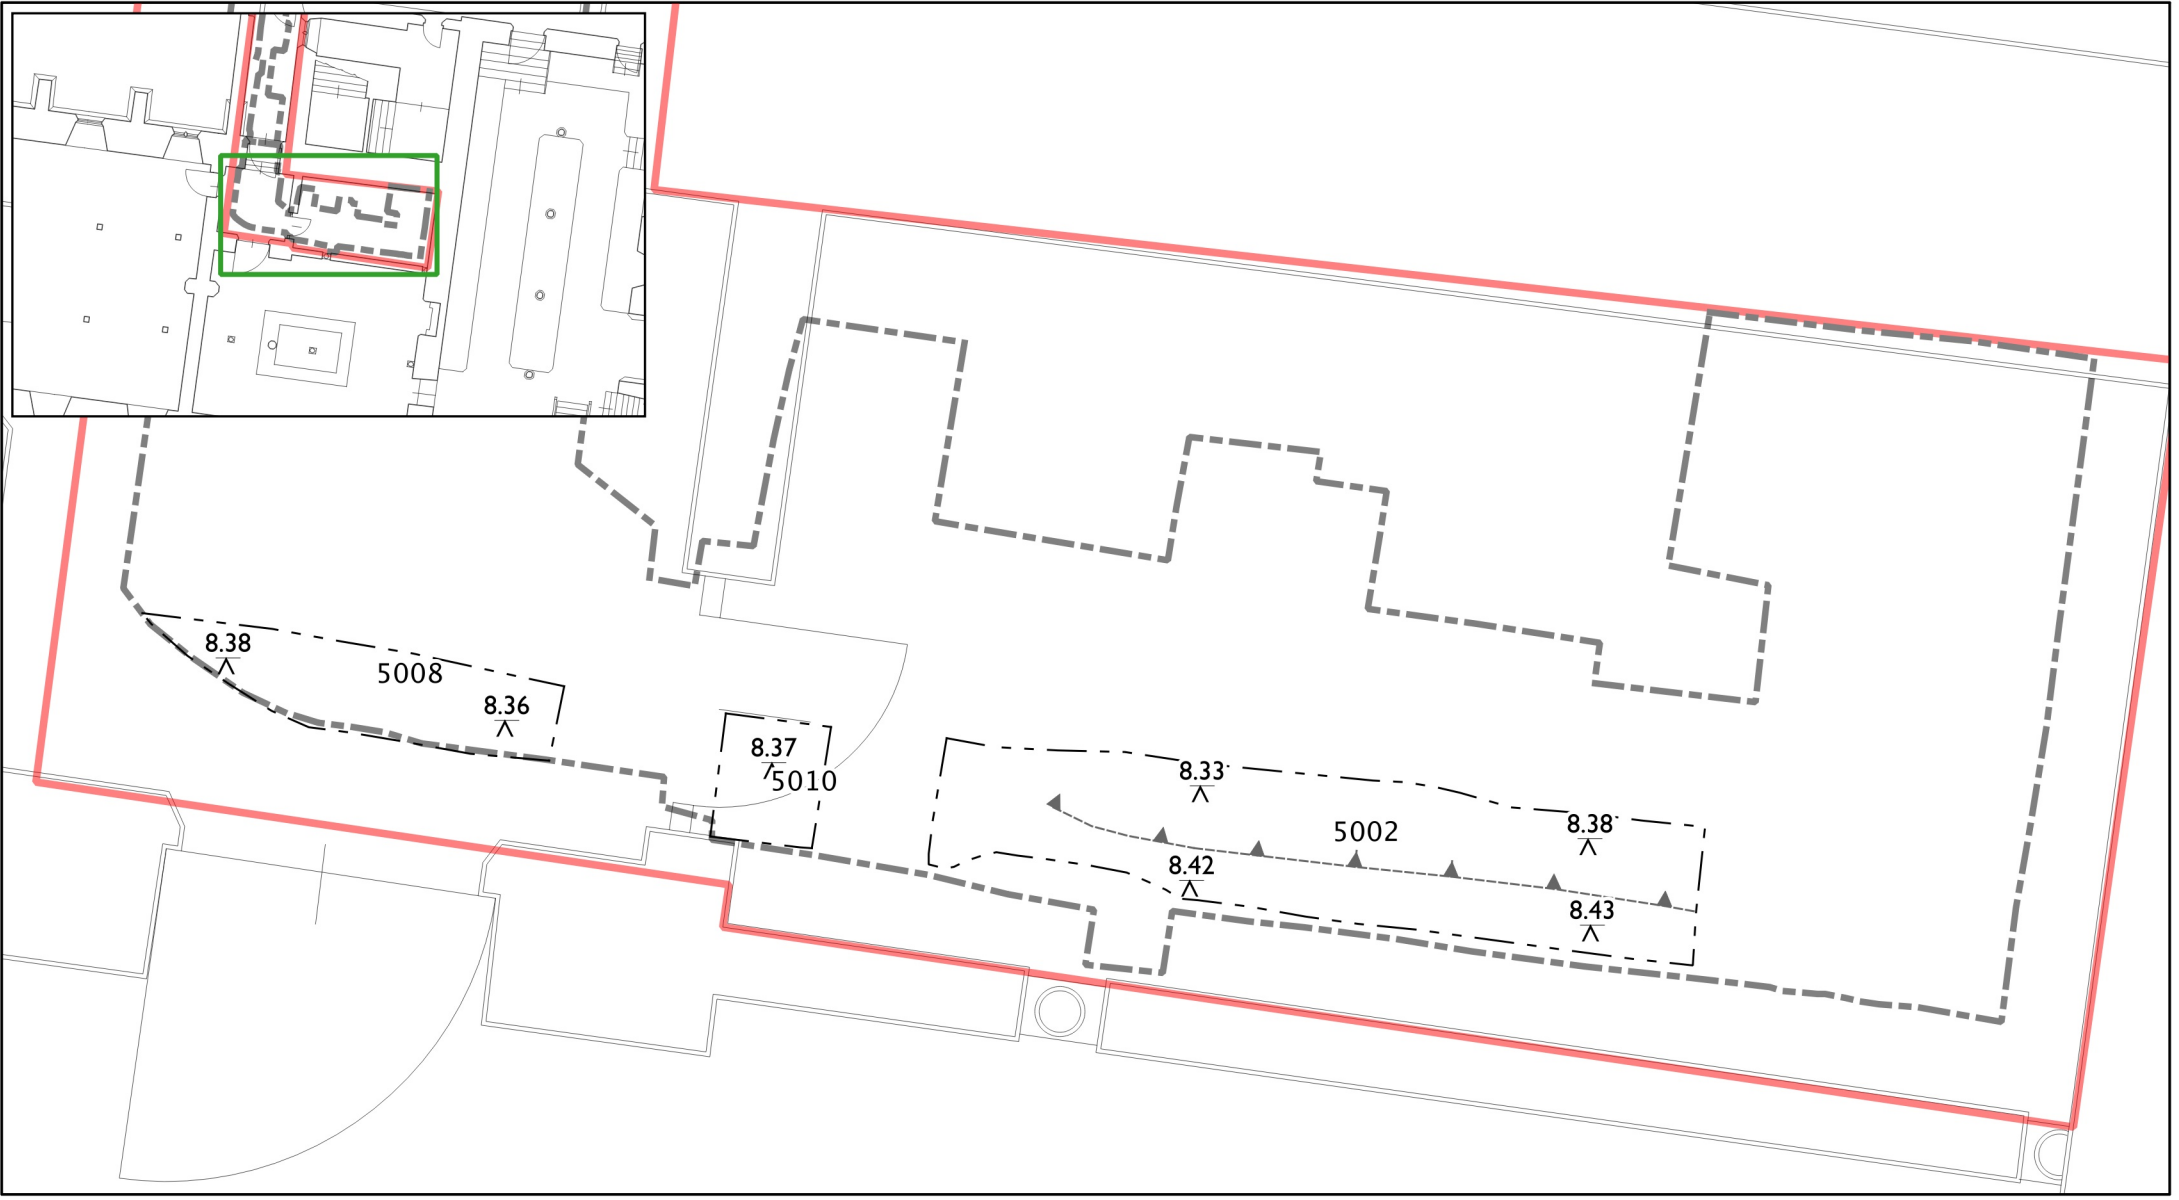
FIGURE 16 // Natural deposit {22} in Area 5

DESCRIPTION // Natural deposit {22} in Area 5

5.4.2. Generally natural deposits were not encountered during the excavation, however, the earliest deposits encountered in this area were natural river terrace deposits {SGR: 22}, composed of context (5002), (5008) and (5010). These deposits were present in Areas 4 and 5. These consisted of homogenous deposits of orange-brown silty sand, which contained no inclusions. The surviving natural geological deposits were encountered between 8.36m OD 8.43m OD (FIGURE 16).
