Archaeological Post Excavation Report

**HAMPTON COURT PALACE
RING MAIN REPLACEMENT
PHASE 1**

For Historic Royal Palaces

Doc Ref: LP2567L-PXA-v1.10

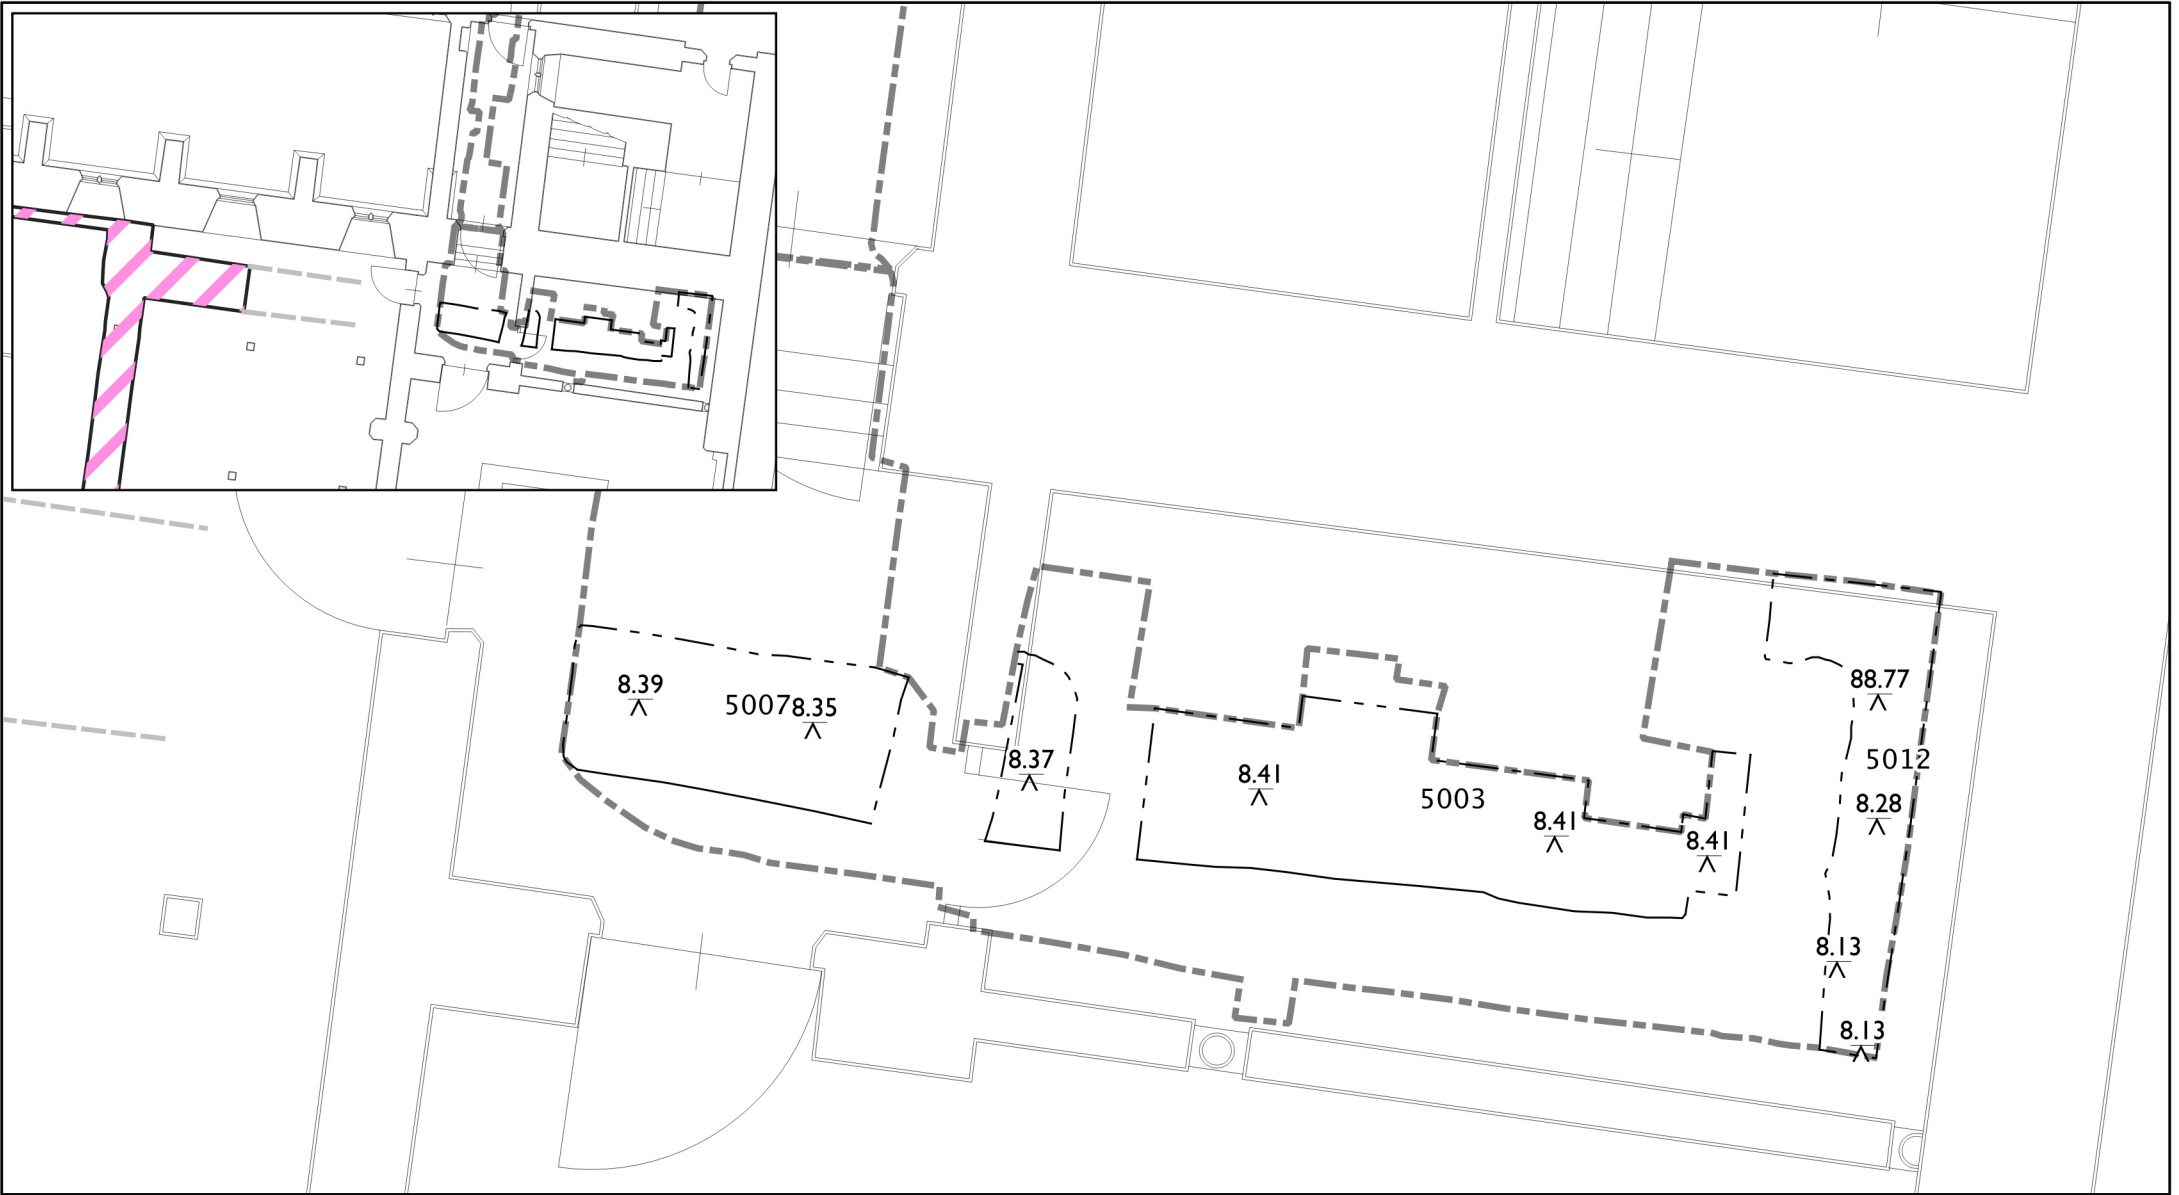
FIGURE 17 // Foundations of Great Hall {23}

Previously Excavated Foundations

5.4.4. In Areas 4 and 5 the excavations recorded the foundations of the former Great Hall {SGR: 23}, comprising contexts 5003, 5007 and 5012. These foundations consisted of a rammed chalk raft, with occasional inclusions of brick fragments and flint nodules. The foundations had been lain into construction cuts which were cut into natural geological deposits (SECTION 5.4.2). The foundations were on an east-west alignment and were present in the excavation with a length of 3.90m and a width of 1.20m, the full surviving thickness was not seen during the excavation, but was at least 0.25m (FIGURE 17). The foundations had been truncated to the west, north and east, with the real edge of the foundation surviving on the south side. The foundations are present on the exact alignment anticipated by the Ford (1996) phase plan for the footings of the previous Hall. The phase plan gives the footings for the previous Hall found to the west a date of “Pre-1515”, as no dating evidence was recovered during the excavation in this area then we are unable to refine this further from the excavated evidence.

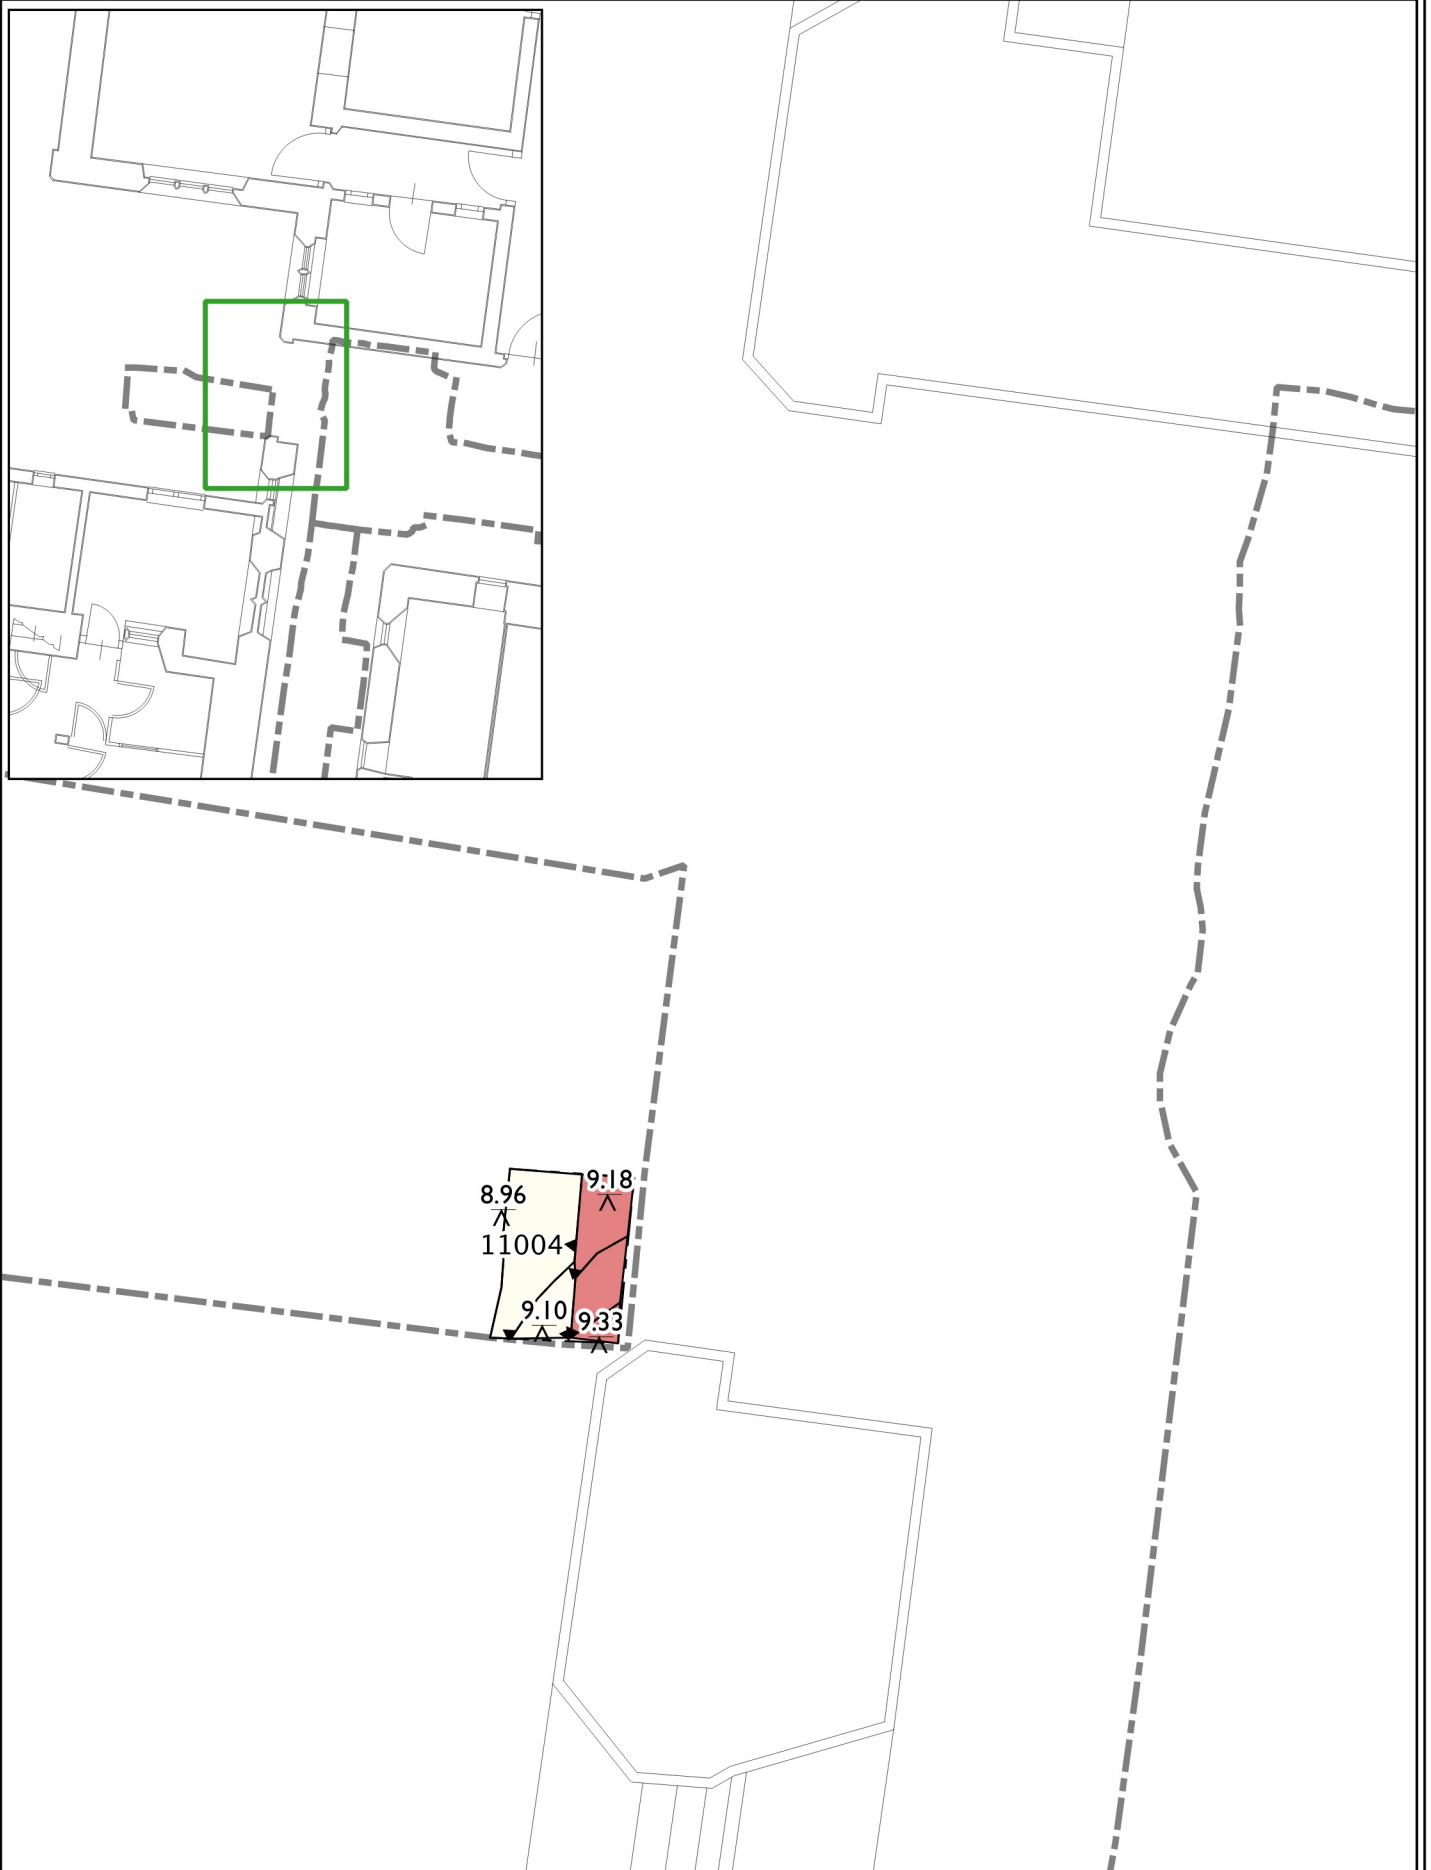
FIGURE 21 // Buttress Foundation in Area 11

DESCRIPTION // Buttress Foundation in Carpenters Court

5.6.4. Located at the east end of the trench in Area 11 were the foundations of a buttress at the threshold into the North Cloister {SGR: 13} (FIGURE 21). These foundations, 11004, were built from an irregularly coursed mixture of brick
