Historic Building Assessment

# FOREST MILL BACUP

For Orion Heritage

Doc Ref: LPI967C-HBR-v1.3

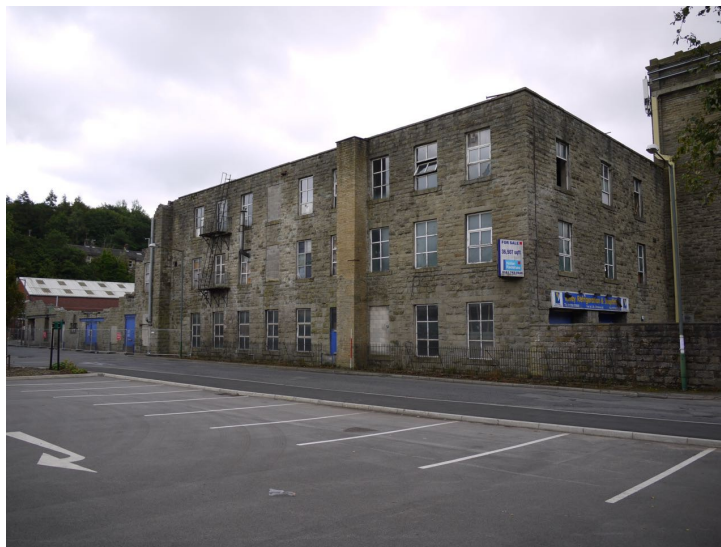
Plate 1: Northern elevation of the mill

4.3. The northern elevation (PLATE 1) fronts onto Henrietta Street and is an impressive 18 bay, three storey, façade of regular coursed grey Haslingden Flag stone with a traditional pitched face dressing (FIGURE 11). The stonework varies in length, with individual stones measuring between 300mm long to 600mm long, bonded by a hard dark grey mortar.

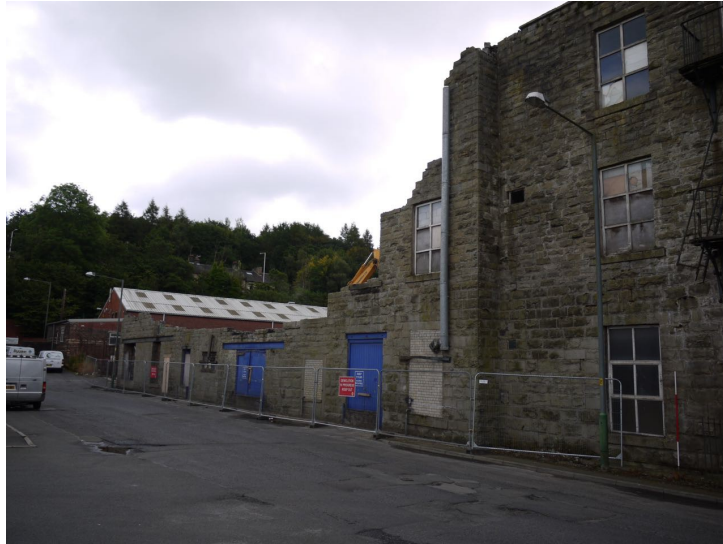
Plate 2: Eastern extent of the northern elevation

4.4. The eastern extent of the northern façade had already undergone some demolition works at the time of survey. However, the ground floor and part of the western extent of the first floor was still visible in this area (PLATE 2 & FIGURE 11).

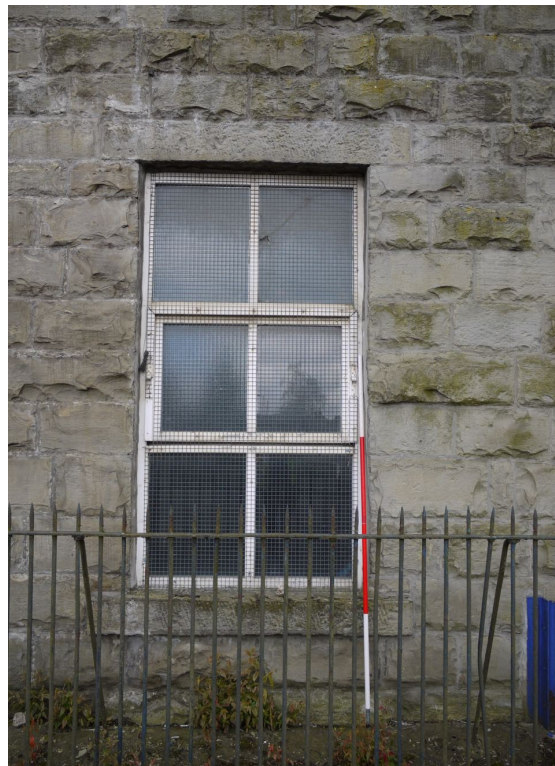
Plate 3: Window form, northern elevation

4.5. The fenestration was of a single type, consisting of rectangular stone lintels and

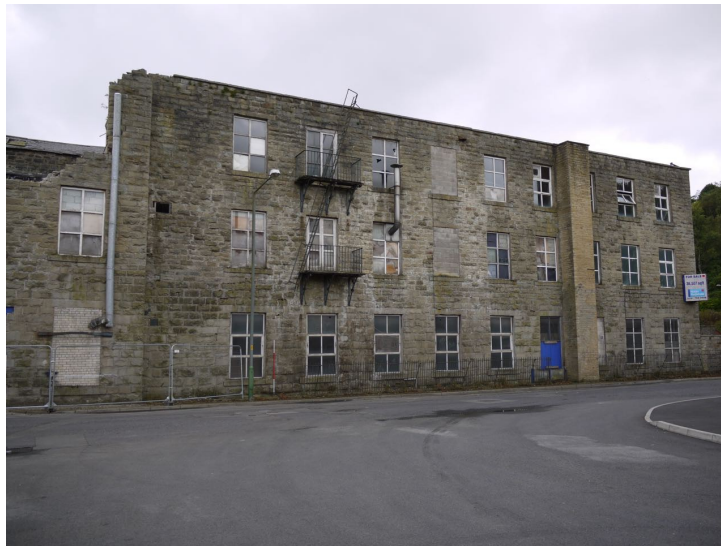
Plate 4: Northern elevation

4.6. Between bays three and four a yellow brick buttress (PLATE 4) had been built against the elevation. This was not keyed into the structure, rather it had been bonded by mortar joints. It is likely that this represents an enclosed vent for the mill and matches the location of toilets on the ground floor layout (FIGURE 15).

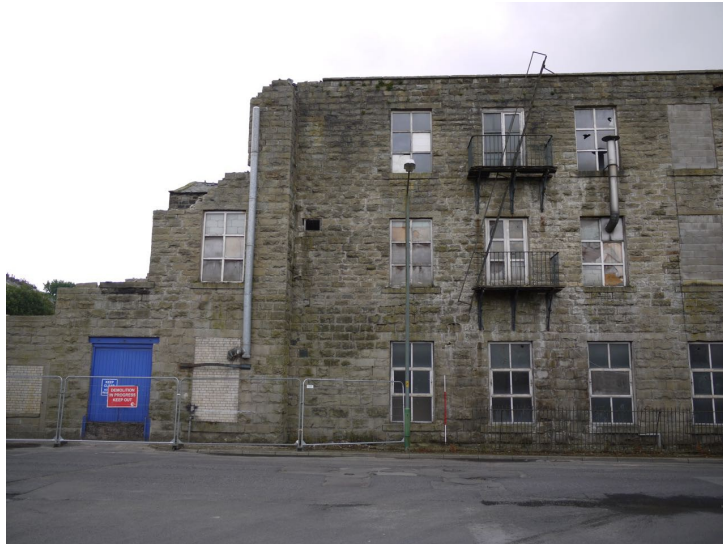
Plate 5: Junction of eastern and western parts of the northern elevation

4.8. At the eastern end of the western section on this elevation, at first floor level, was a small metal gridded vent that had been cut into the stonework (PLATE 5). This is clearly a later modification to the structure. Directly below it, at ground floor level was a smaller metal gridded vent, also cut into the elevation as a later modification. These appear to be 20<sup>th</sup> century in date, likely part of late 20<sup>th</sup> century modernisation works.

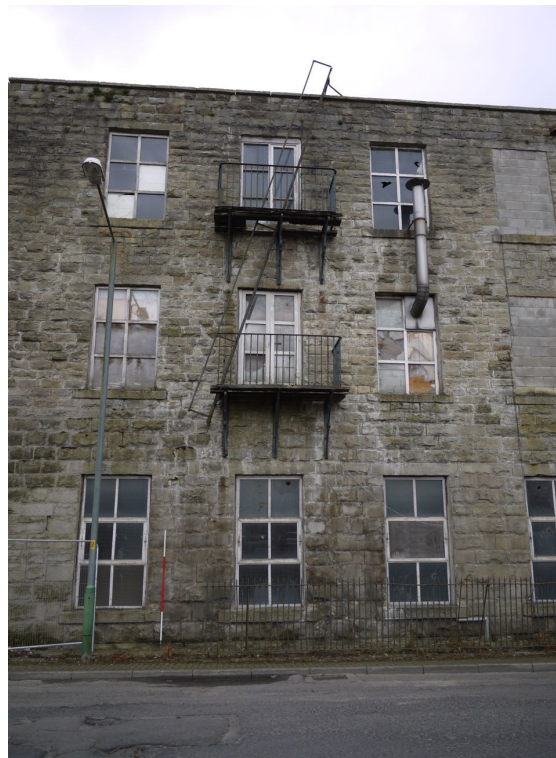
Plate 6: Fire escape on the northern elevation

4.9. Sited at first and second floor level, at bay eight was an iron framed fire escape (PLATE 5). The style of the fire escape was typical of early 20<sup>th</sup> century designs, with squared brackets for exit balconies and square cross section railings on the balcony (PLATE 6).

4.10. The ladder railings were of matching square section rods and the system was bolted

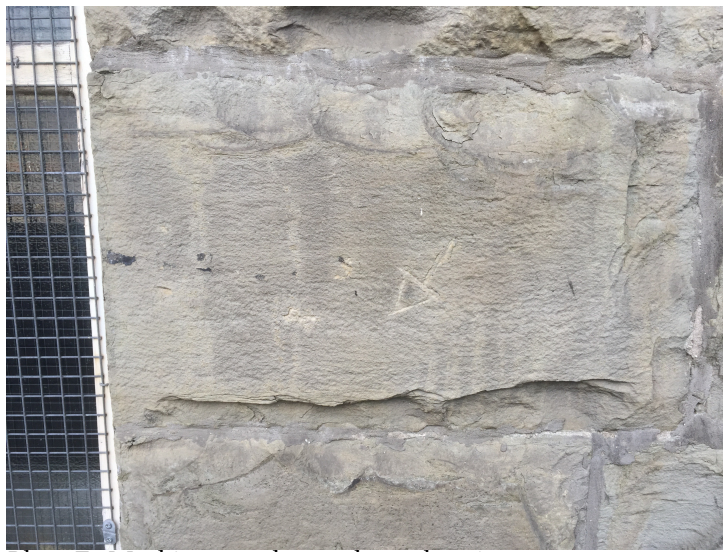
Plate 7: Markings on the northern elevation

4.11. A cluster of marks carved into the stonework at ground floor and first floor level were noted mid point between the fire escape and buttress. These comprised a combination of arrow symbols, pointing in numerous directions, crosses, and hachure symbols (PLATE 7). Initially these were thought to be masons marks. However, they appear to be more recent, some quite fresh, and appear on the façade, not normally a place masons would leave their marks. As such it is likely that these represent a form of graffiti.

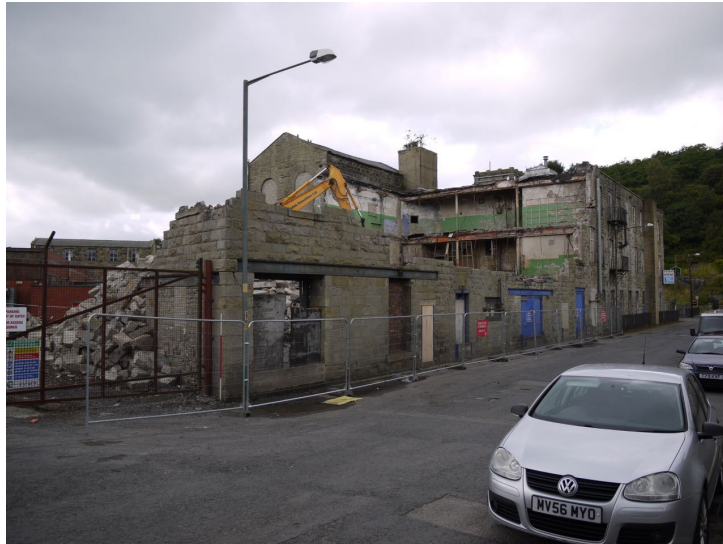
Plate 8: Eastern extent of the northern elevation

4.12. The eastern section of the north elevation, as noted above, had undergone some demolition; as such, only the ground floor survived in any discernible way (PLATE 8). Although the stonework and fenestration of the northern elevation was consistent, the eastern extent of the façade stepped out by 860mm. It is likely that following a large fire in 1870 the building was extended to the east. This would account for the stepped façade. The short timeframe between construction phases, 1854 to 1870, would account for the similarity in workmanship and materials.

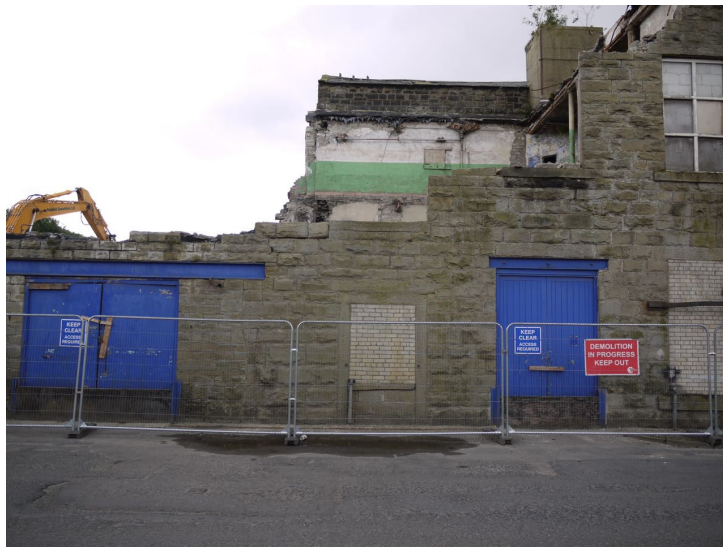
Plate 9: Eastern section of the northern elevation, showing modifications

4.13. Along this section of the elevation were a series of doors and blocked windows. No original features had been preserved to any significant degree in this area, each window void either blocked by brickwork or converted to a doorway (PLATE 9).

4.14. The conversions included insertion of steel lintels to support the widened doorways, with wooden frames, and use of modern thermalite bricks to block up the windows. The materials used in the modifications are typical of the late 20<sup>th</sup> century and this may relate to upgrading works when the council took control of the property in the 1960s.

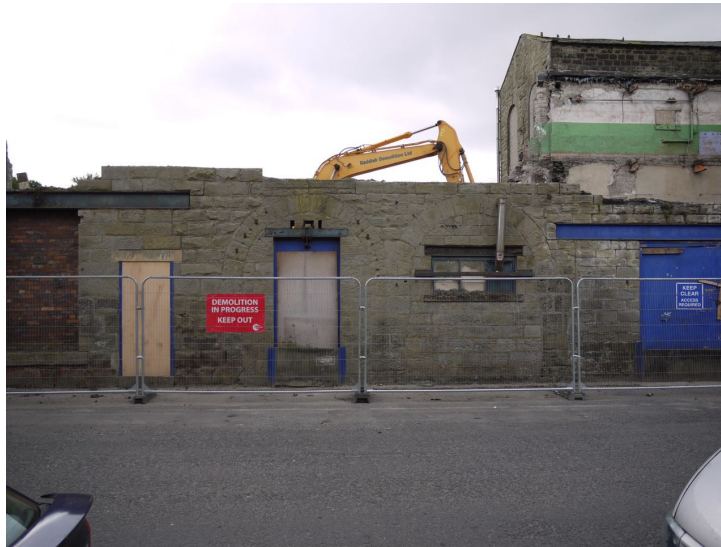
Plate 10: Blocked arches on the northern elevation

including a small bricked up opening and two modified arches (PLATES 9 & 10). The blocked opening is shorter than the window forms and is marked by upright stones either side, with a stone lintel. The opening had been bricked up with thermalite bricks. The lower section comprised three courses of the local stone, with a coping course. The uprights and lintel appear to be an original feature, however the low stone coursing is of a different dressing form and in ashlar bond, suggesting it has been inserted. This is thought to be an earlier side entrance, which went out of use in the early 20<sup>th</sup> century.

- 4.16. The blocked arches (PLATE 10) measure 3.5m in height and are each 2.7m wide. These are thought to be blocked up entrances originally used for vehicular access. Stone has been used to infill the arches and a door and window occupy the east and west arch respectively. Both door and window are clearly later modifications to the structure.
- 4.17. There is significant repair work in this area, and the inserted double door to the west of the arches occupies a large area of later stonework (PLATE 11). This may suggest that there were originally four arches present and that the western arches were replaced by the large double doors (requiring a steel lintel); and as such, evidence of the arches has since been destroyed. Although this is conjecture, the scale of disturbance in this area matches the proposed extent of two additional arches.

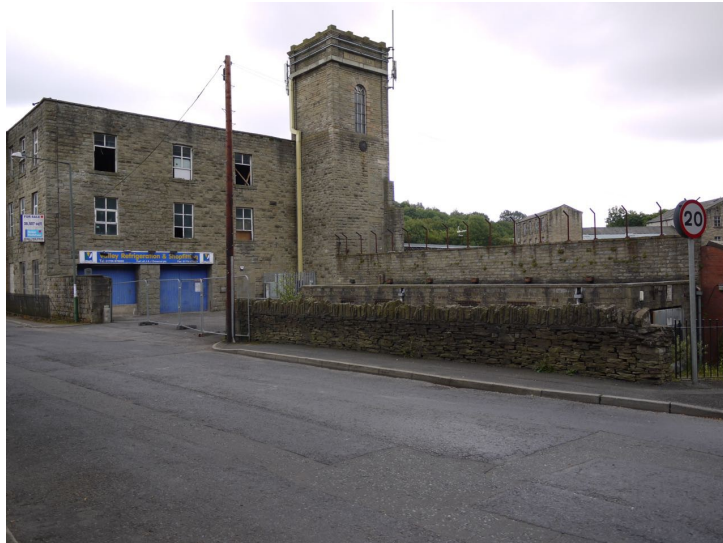
Plate 12: Western elevation of the mill

4.18. The western elevation fronted onto Market Street and represents the public façade seen from the main road passing the mill (PLATE 12 & FIGURE 12).

4.19. It should be noted that the ground floor of the current elevation dates to the late 20<sup>th</sup> century. Cartographic research suggests that the mill was extended off this elevation between 1894 and 1912; and then this extension was subsequently demolished between 1962 and 1977. Scarring on the standing elevation suggests that the extension was only a single storey structure, with the first and second floor continuing to show the original features of the mill.

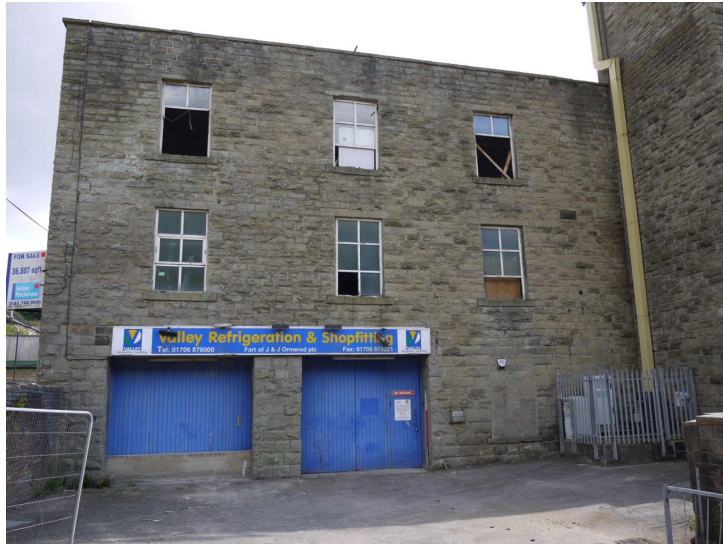
Plate 14: Western elevation

- 4.22. The fenestration matches that of the northern facade with six pane wooden framed windows, stone lintels, and stone sills. At ground floor level a window has been blocked using the same stone seen in the main repair of this façade (PLATE 14).

- 4.23. At ground floor level two large wooden doorways can be seen, divided by a large stone pillar. Above the doors is a large rectangular sign for valley Refrigeration and Shopfitting. The doors form part of the late 19<sup>th</sup> to early 20<sup>th</sup> century modifications and, although mainly obscured by the sign, a large concrete lintel can be seen. This differs from the steel lintels seen associated with the late 20<sup>th</sup> century modifications. The use of concrete suggests 20<sup>th</sup> century modifications, rather than late 19<sup>th</sup> century, pushing the date closer to 1912.

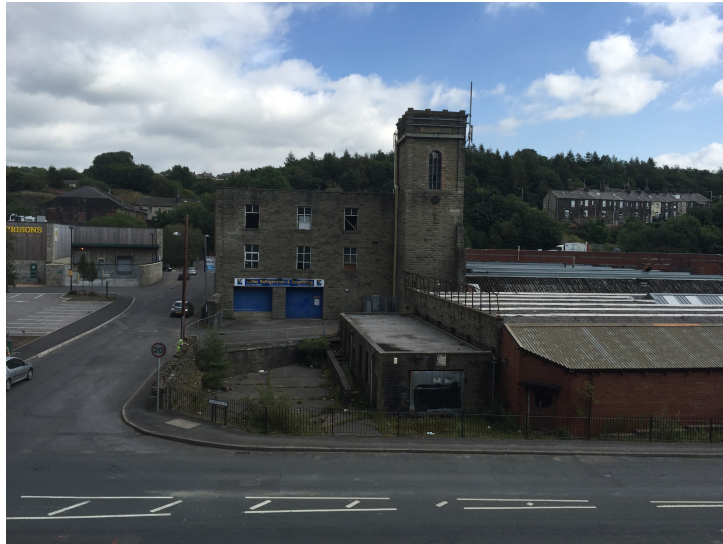
Plate 15: *Western elevation of water sprinkler tower*

4.26. The water sprinkler tower is visible from north, west and east elevations, however its full height can only be seen on its western elevation (FIGURE 12 & PLATE 15).

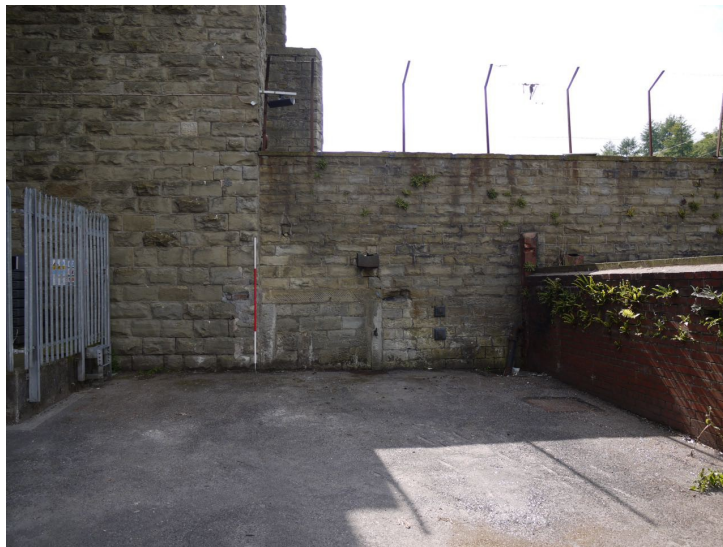
Plate 16: *Wall for the southern extension, as viewed from the courtyard*

4.27. The tower has a square footprint and is of the same stone construction as the northern and western elevations and forms a visible landmark in the area. The ground floor section of the tower is obscured by a 3m high wall (PLATE 16).

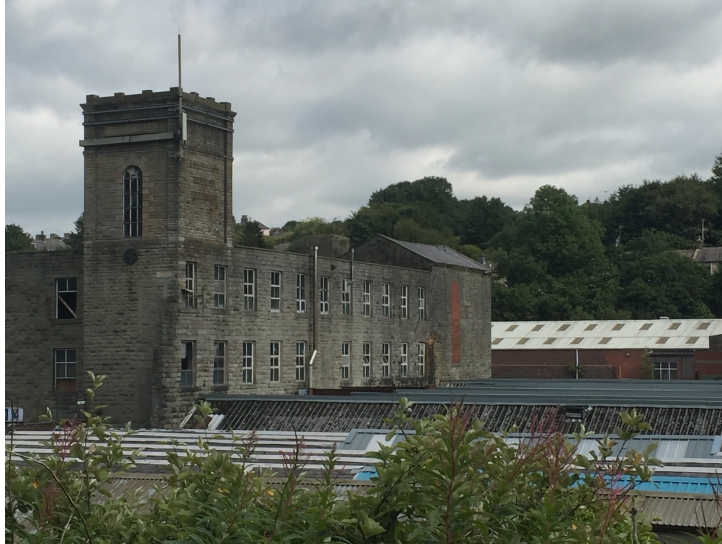
Plate 17: Southern elevation of the mill, showing fenestration of the tower

4.29. The tower is keyed into the building and forms part of the complete southern elevation suggesting that it is a contemporary element of the building from the original construction phase (PLATE 17). On the southern elevation the tower has two windows at first and second floor levels. These windows match the form seen on the northern and western elevations, of six pane, wooden frame, windows with stone lintels and sills.

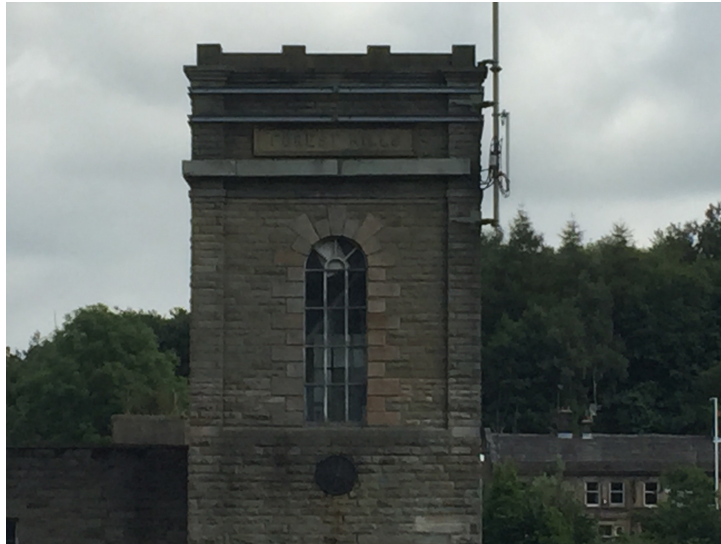
Plate 18: Third floor of the water sprinkler tower

4.30. On the western elevation of the tower, at third floor level, is a large, thin, arched window. This is of wooden frame with stone quoins forming upright decoration either side of the window and a single course stone archway above the window (PLATE 18). The window sits in a recessed area of stonework, which forms a sort of frame for the window, with the appearance of columns at the edges of the tower. This recess is also present on the southern elevation at third floor level (PLATE 17).

- 4.31. Below the arched window on the western elevation is an iron faced clock. Within the recessed stonework on the western elevation is a large stone nameplate, above the arched window, which reads 'FOREST MILLS'.
- 4.32. The top of the tower is marked by a series of four merlons dividing three embrasures over a stepped series of three stone string courses (FIGURE 12). These are thought to surround the water tank.
- 4.33. The tower is an impressive symbol typical of the approach to industrial building construction of the mid to late 19<sup>th</sup> century. The mill buildings dominated the surrounding area and the mill owners were proud of their mills. Although industrial in function these buildings were constructed with a decorative style that hinted at the owner's wealth and status, as well as serving as an advert to traders.

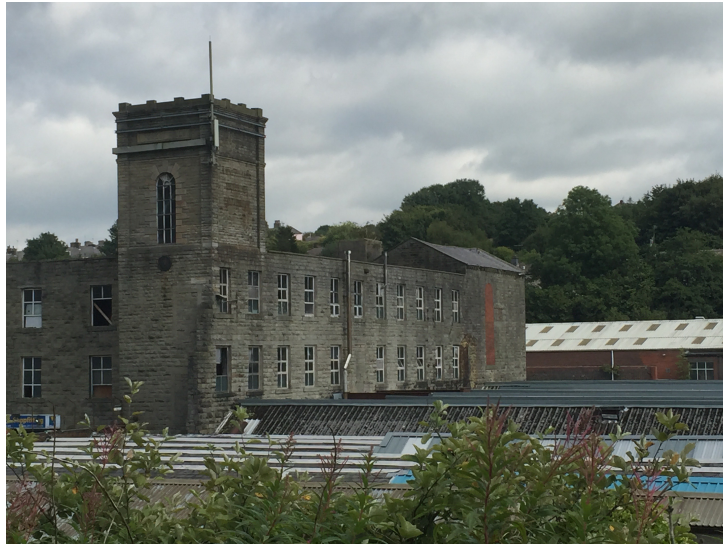
Plate 19: Southern elevation of the mill

- 4.34. The southern elevation of the mill building was not accessible as the yard to the south, and the single storey extension, were in use by a third party and had been locked up. As such, a total station survey was carried out on the accessible areas and a photographic survey was taken from appropriate vantage points.
- 4.35. This elevation comprised three main surviving sections. The water tower formed the western two bays, with a further nine bays forming the main body of the mill. At the eastern end a large extension forms the final section of the mill. This extension measures approximately three bays (PLATE 19 & FIGURE 13).

- 4.36. The main body of the mill matches the northern façade, with evenly spaced six pane, wooden frame, windows at first and second floor levels, each with stone lintel and sill. The stone is pitch faced local Haslingden Flag in regular courses, with a stone coping course at the top of a short parapet wall.

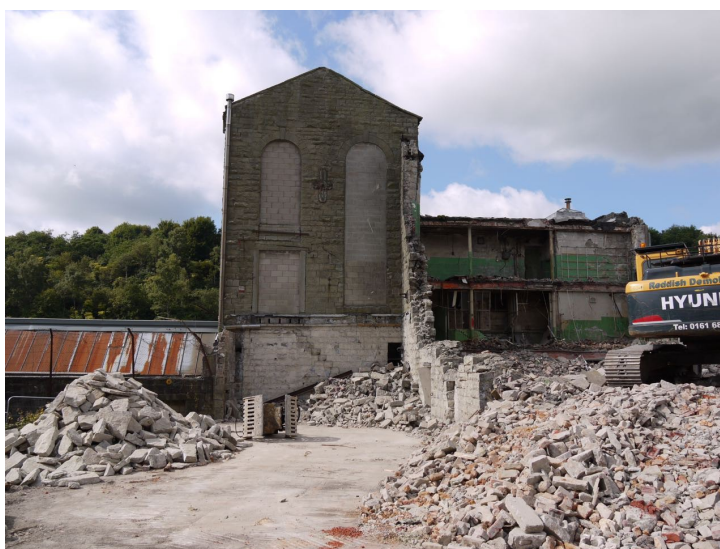
Plate 20: Eastern elevation of the engine house

4.42. The eastern elevation of the engine house was of the same regular course stonework as seen previously and the upper wall of the eastern end of the mill could be seen to be tied into the construction of the engine house. This shows that these two areas were built contemporaneously.

4.43. There are three main features of this wall. Two arched windows and a doorway (PLATE 20). A large cross shaped wall tie is present at second floor level between the two windows. The southern window is a double height arched window with a single course stone arch at the top and no surviving sill. However, brick repair suggests that there was originally a sill present. The northern window matches the form and dimensions of the large window seen on the southern elevation of the engine house (FIGURE 13). This also has a single course brick arch lintel and its stone sill survives in tact.

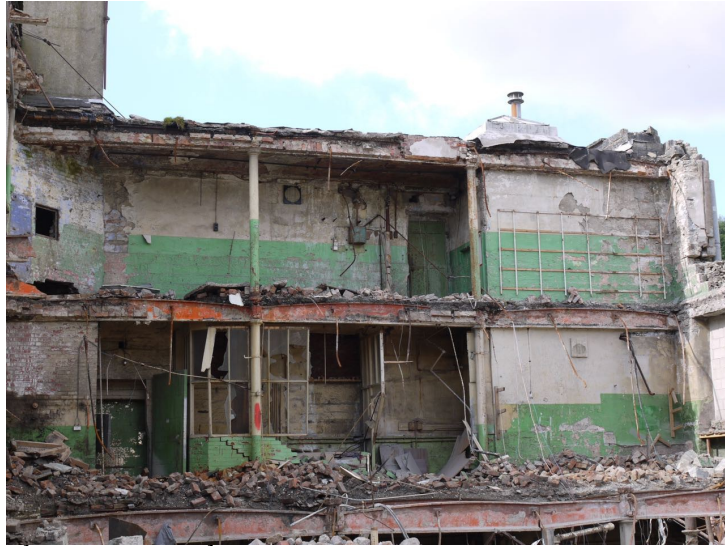
Plate 21: Exposed eastern cross section

- 4.45. The cross section of the building revealed a system of arched steel girders sitting on evenly spaced steel upright columns (PLATE 21). Brick internal dividing walls were also visible. At second floor level a blocked window was identified, mainly obscured by plaster and paint, to the immediate north of the angled brick wall bounding the engine house wall. This suggests that this wall may have originally been an external wall and further supports the theory that the mill was extended prior to 1894.

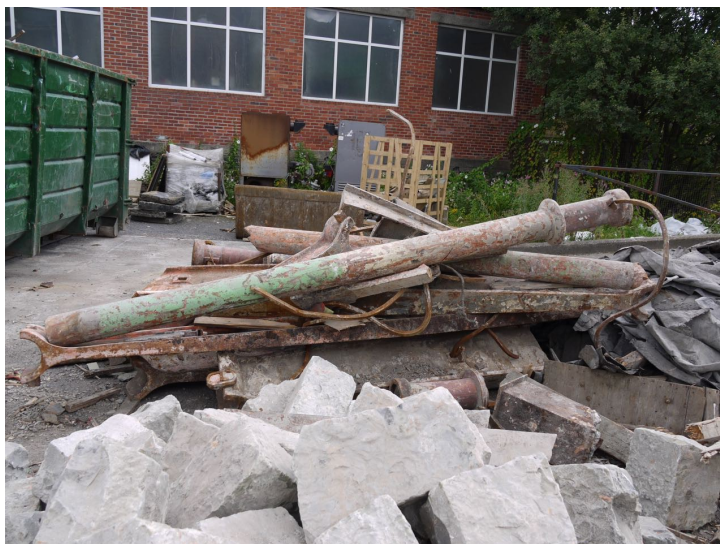
Plate 22: Column and girder type

4.46. Examples of the column and girder type were identified within the demolition debris on site (PLATE 22).

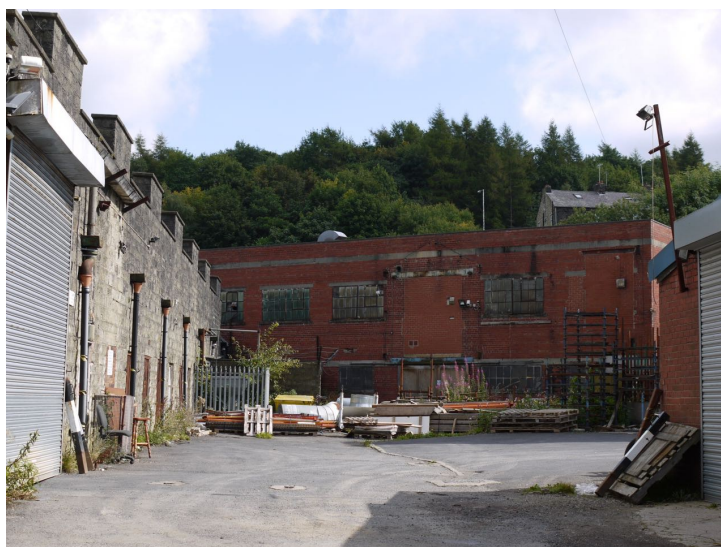
Plate 23: Western elevation of extension D

4.47. The mill has a series of extensions, which date to between 1870 and 1962. These have been given identifying letters from A to E (FIGURE 14) and will be discussed below. Extension D was not examined due to access issues. The visible elements of extension D could be seen to be of red brick in English Garden Wall bond, with concrete lintels and sills surrounding metal framed, small pane, windows (PLATE 23).

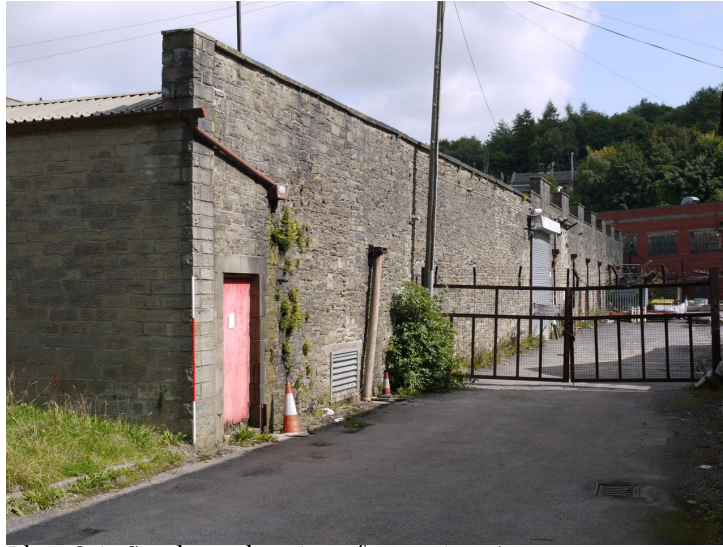
Plate 24: Southern elevation of extension A

4.48. Extension A has been separated into two areas, the large southern extension to the mill and a smaller area at the southwestern corner of the mill, A1 and A2

respectively. A2 was initially an outbuilding, however following later extension construction it now forms part of the body of the mill (PLATE 24).

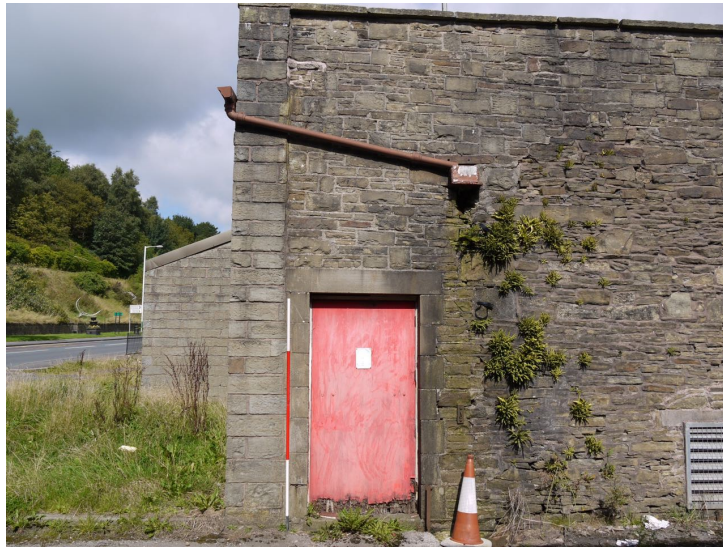
Plate 25: Southern elevation of extension A2

door openings seen elsewhere on the main mill building, with stone lintels and uprights.

4.53. The western end of the elevation shows a different stone finish, where the western elevation begins. This suggests that the frontage onto Market Street was refaced when the outbuilding became part of the mill.

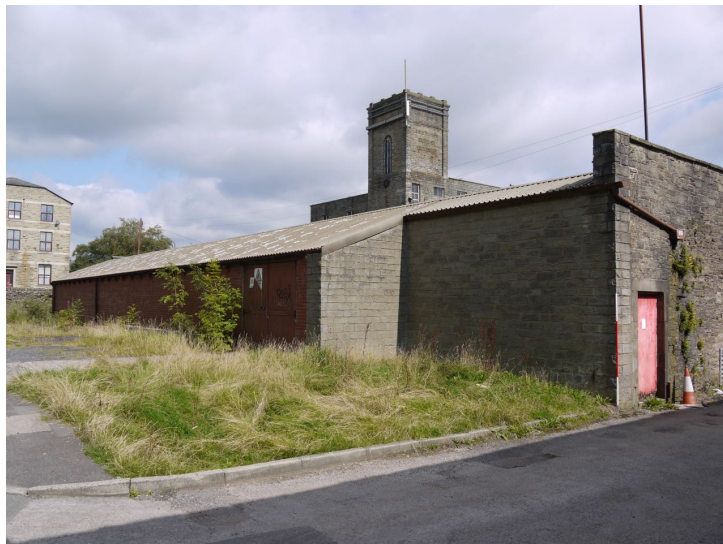
Plate 26: Western elevation of extension E

4.54. The western elevation of the extension mainly comprises extension E, the 1956 to 1962 extension to the structure (PLATE 26).

4.55. The southern extent of this elevation is of high quality local stone, in regular courses and represents part of extension A2, an 1870 to 1894 outbuilding. The

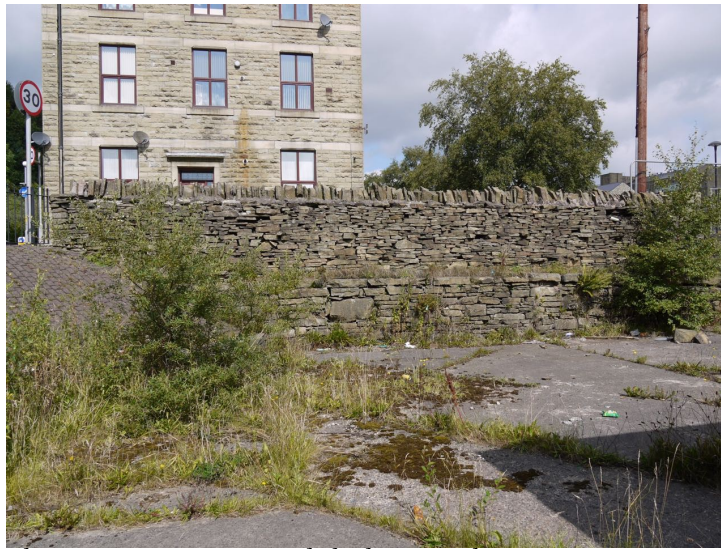
Plate 27: Lower courtyard, looking north to Henrietta Street

4.56. In this area the land slopes down into a low courtyard to the north of the extension (FIGURE 14). In this area a stone retaining wall marks the barrier between Market Street/Henrietta Street and the lower courtyard (PLATE 27).

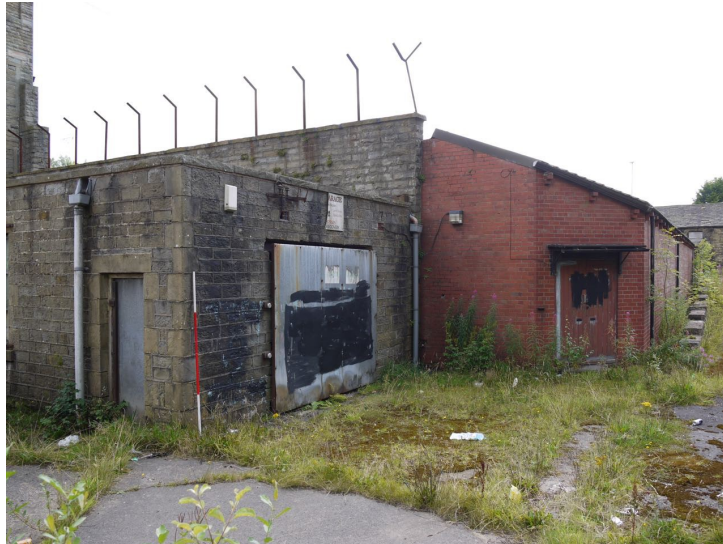
Plate 28: Junction of extension C and E, looking south

4.57. An angled wall forms the northern extent of extension E, which turns east to lead to extension C (PLATE 28).

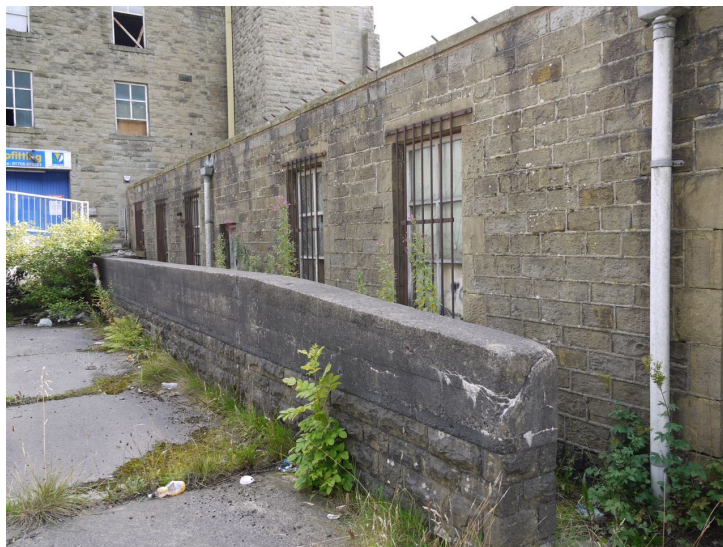
Plate 29: North elevation of extension C

4.58. This extension has been built in an attempt to match the main body of the mill (PLATE 29) and first appears on the 1962 OS map. However, the construction form matches that of earlier extensions and is not thought to be contemporary with extension E, which dates to between 1956 and 1962. It is thought that this stone extension dates to an earlier construction phase.

4.59. The façade of C is of local stone in regular courses and a short parapet with coping stone course can be seen at the top of the wall. The roof is a flat roof, leading to the main wall of extension B, where it is bonded to, not keyed into, extension B.

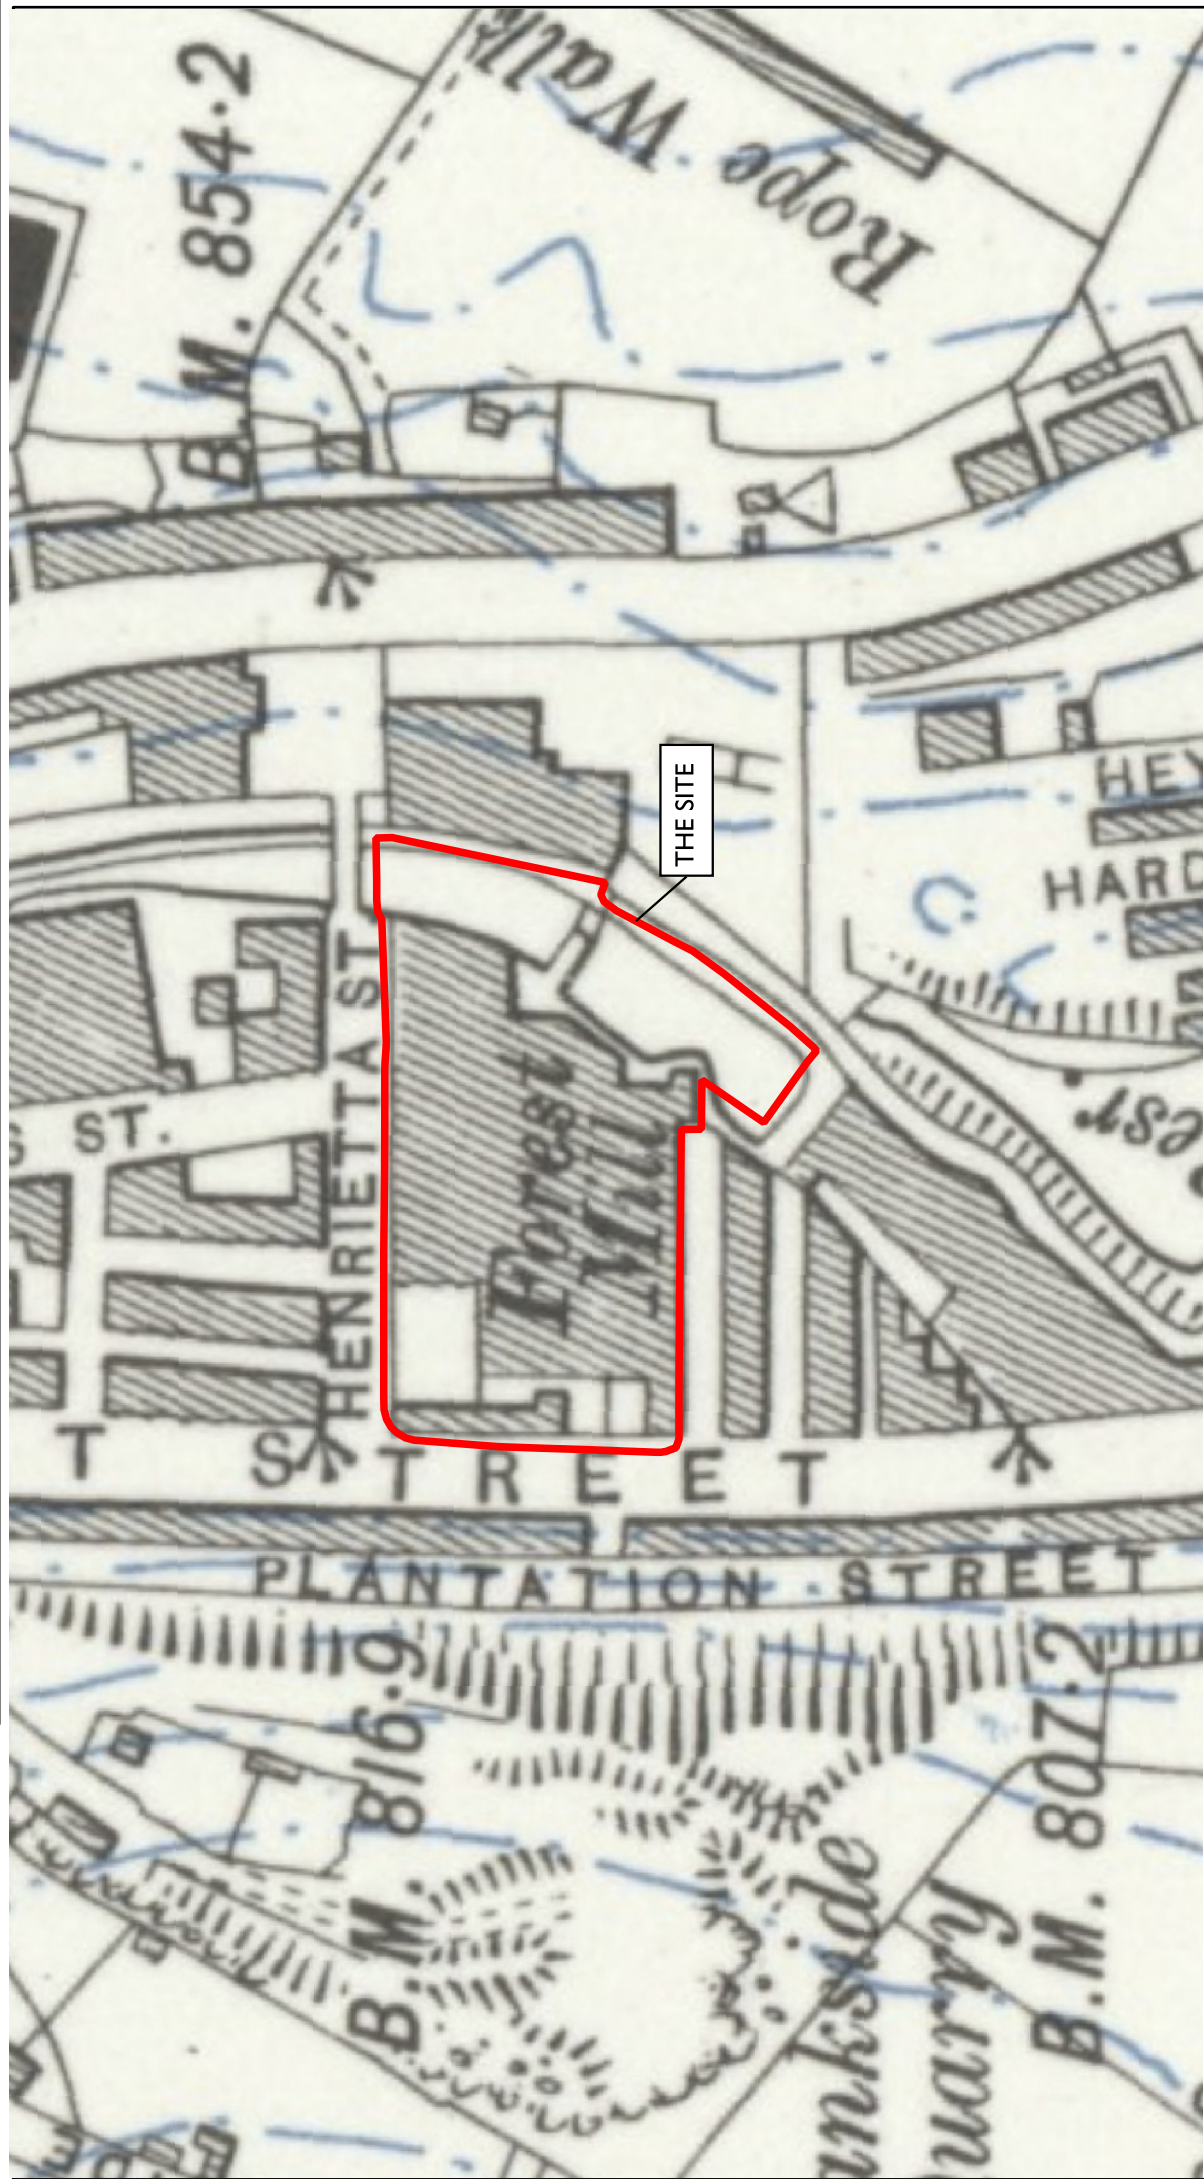
FIGURE 4 // 1912 OS Map

- 3.17. The 1912 OS map (FIGURE 4) is the first to refer to the mill as Forest Mill. By this time the building has expanded to enclose the open yard area to the west of the mill. A small extension has been added on the south side of the building. The two smaller buildings along Market Street, have been connected to create one long L-shaped building, now the only outbuilding. In 1902 Messrs Riley Brothers bought the mill, notably with the intention of updating the building. The changes in the mill are most likely associated with this period of expansion and new ownership. The mill changed hands again in 1905 to Mr Thomas Houghton of Oswaldtwistle, while no building work is mentioned in reference to him, he could have also made structural changes to the mill.
