Historic Building Assessment

ABBEY INN & DOG AND DUCK

Doc Ref: LPI722C-HBA-v1.2

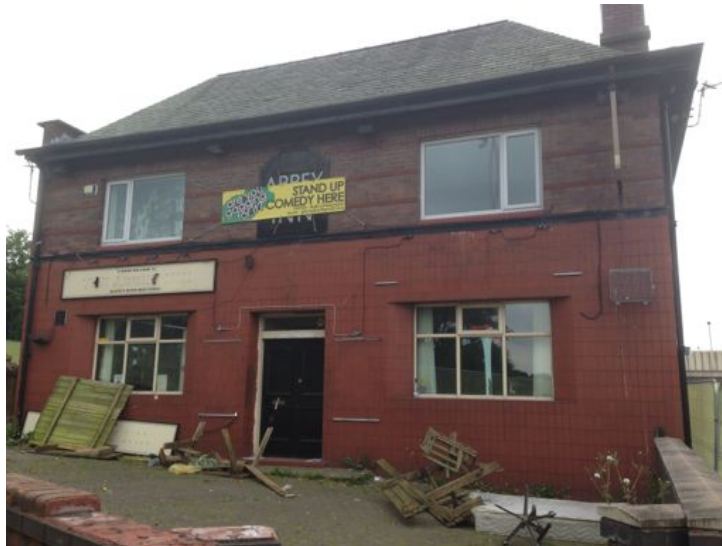
Plate 1: Abbey Inn, north elevation

5.4. The fenestration is simple with four evenly spaced, large, windows; two at each floor level. The first floor windows have been replaced in the late 20th century with white PVCu frames. The lintels above the first floor windows are on end red bricks. The sills are chamfered glazed red brick. The ground floor windows are wooden frame six pane windows, with awning lights in the upper central area. The windows are set back from the facade via chamfered tiles to each side. There are no visible sills or lintels.

5.5. At ground floor the central doorway is a wide wooden frame opening with a narrow transom light above the doorway (PLATE 1).

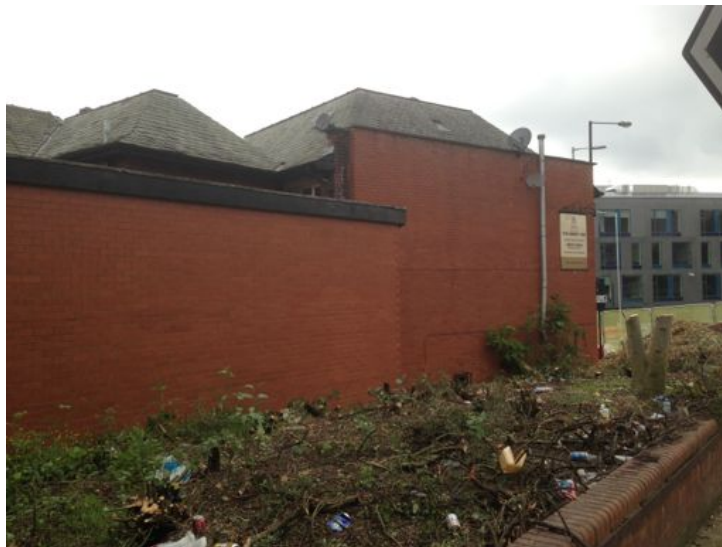
Plate 2: Abbey Inn, east elevation

5.6. The east elevation fronts onto King Street (formerly St Domingo Street) and is a simple elevation of smooth red brick with no decoration, windows or doors (PLATE 2).

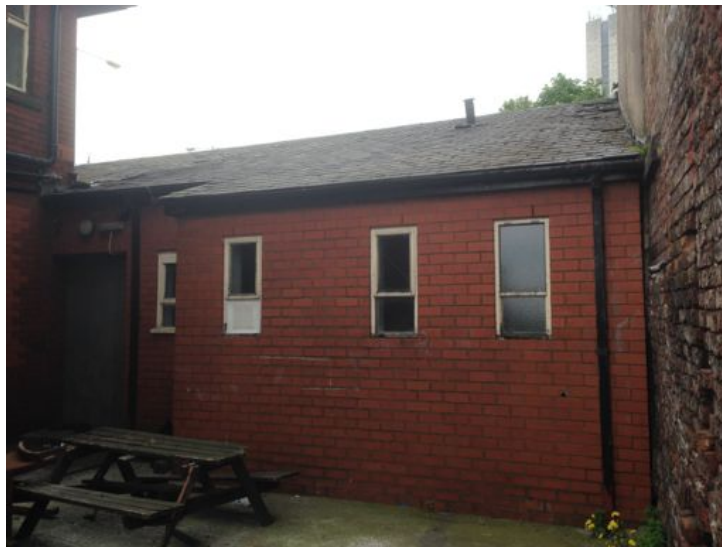
Plate 3: Abbey Inn, courtyard

fenestration follows that of the ground floor of the north elevation, with wooden frame windows housing fixed panes in the lower section and awning lights in the central upper sections. The panes are decorative privacy glass of the late 20th century. The doors have large wooden frames with transom lights above.

5.8. There is evidence of late 20th century modification to this facade, with blocked up windows, which appear to have been replaced with smaller windows. The lintels and sills are concrete formed slabs on the main structure. The rear extension does not have any decorative sills or lintels.

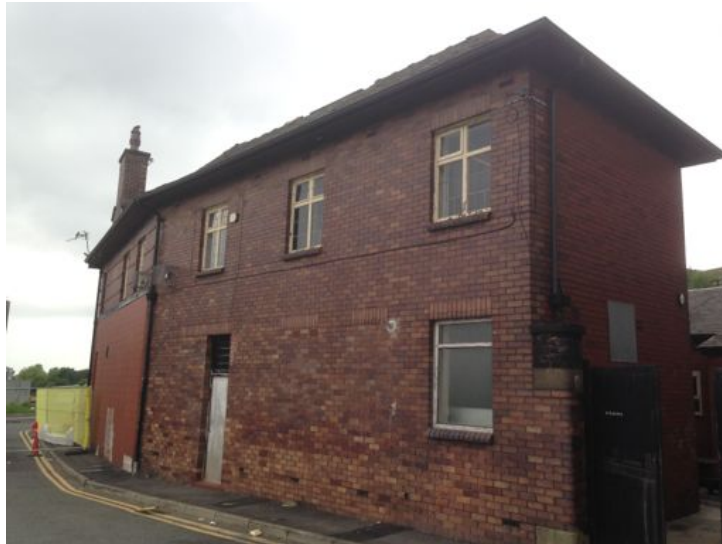
Plate 4: Abbey Inn, west elevation

5.9. The western elevation fronts onto Eagle Street and can be divided into two main sections. The facade follows the street line and as such has a dog leg in it (FIGURE 2). The northern half of the facade matches that of the northern frontage, with the ground floor covered in terracotta glazed tiles, and the first floor on red brick, with three string courses of brighter red brick.

5.10. The southern half of this elevation is less decorative with the same red brick structure of stretcher courses, wooden frame simple windows and a central wooden frame doorway. The windows at both ground floor and first floor have brick, on end, lintels and chamfered brick sills (PLATE 4).

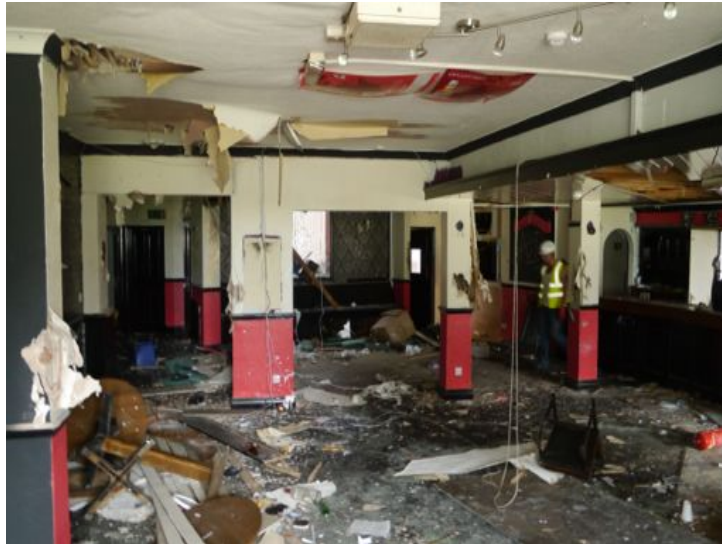
Plate 5: Abbey Inn, ground floor

5.13. The ground floor is mainly open plan, with a large bar area accessed via the Middleton Road frontage. Several supporting columns can be seen throughout this floor, creating the open plan layout (PLATE 5).

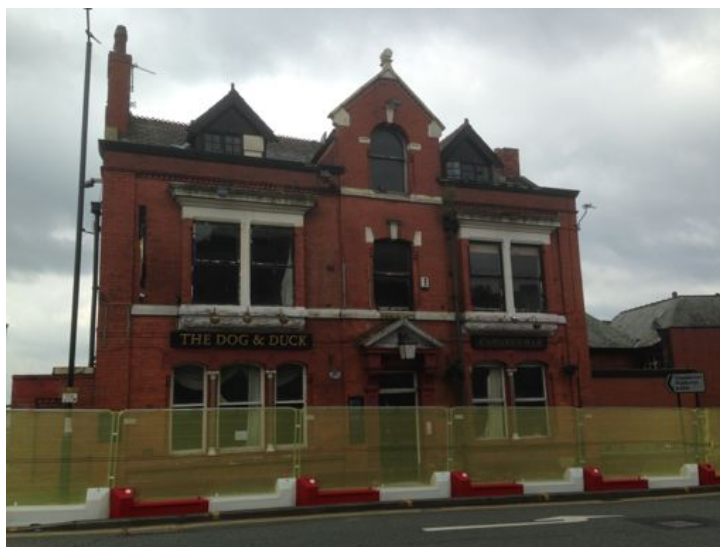
Plate 6: Dog and Duck, east elevation

5.17. The Dog and Duck dates to 1898 and is an example of late Victorian architecture (YORKE 2009). The main facade fronts onto King Street (formerly St Domingo Street) to the east (PLATE 6).

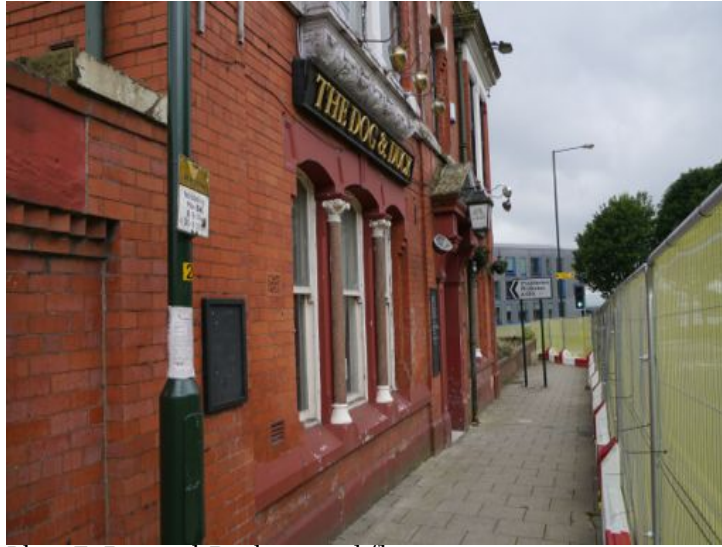
Plate 7: Dog and Duck, ground floor

5.20. The ground floor windows are highly decorative with a three section window to the south and two section window to the north. The window frames were wooden

with a chamfered stone sill and arched stone lintel. Dividing the windows were marble columns with stone capitals and bases, painted white (PLATE 7).

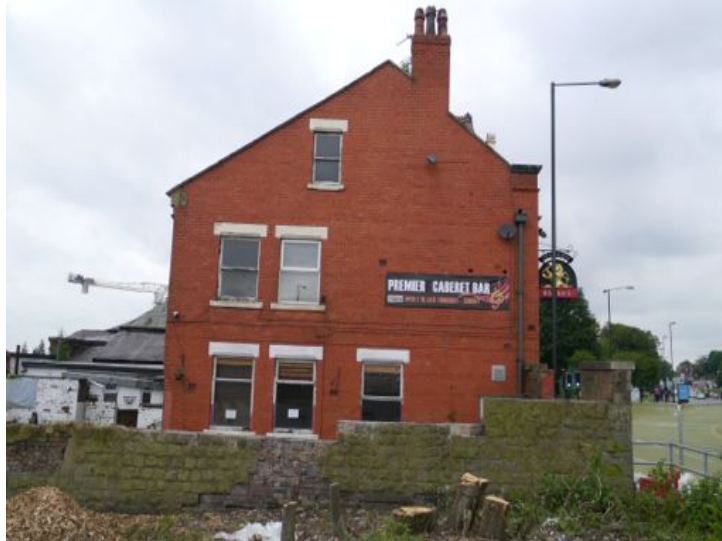
Plate 8: Dog and Duck, south elevation

5.22. The southern elevation is much more simple in nature than the main facade and is of red brick in an English garden wall bond. The asymmetrical gable can be seen clearly on this facade, with a longer pitch to the west. The windows are two pane wooden frames, with chamfered stone sills and lintels (PLATE 8).

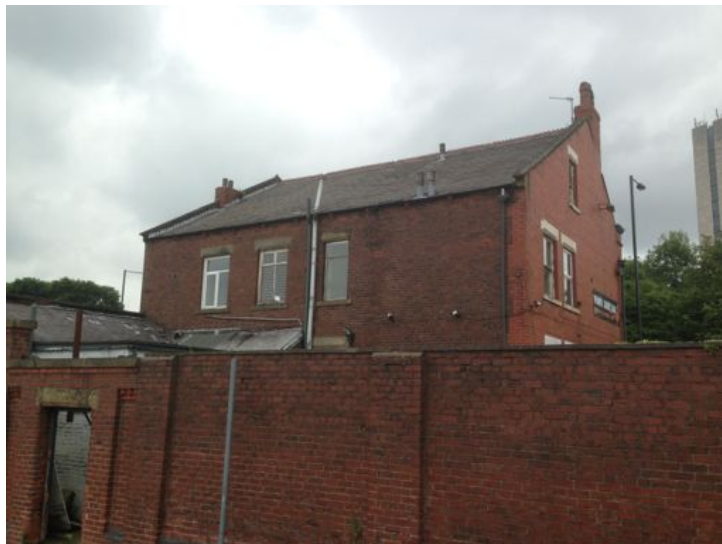
Plate 9: Dog and Duck, west elevation

5.23. The west elevation of the Dog and Duck overlooks a small courtyard and extensions. The fabric is a lower quality red brick that that seen on the east and south elevations, although it is still in English garden wall bond. The fenestration matches that of the south elevation with wooden frame windows with stone sills and lintels (PLATE 9).

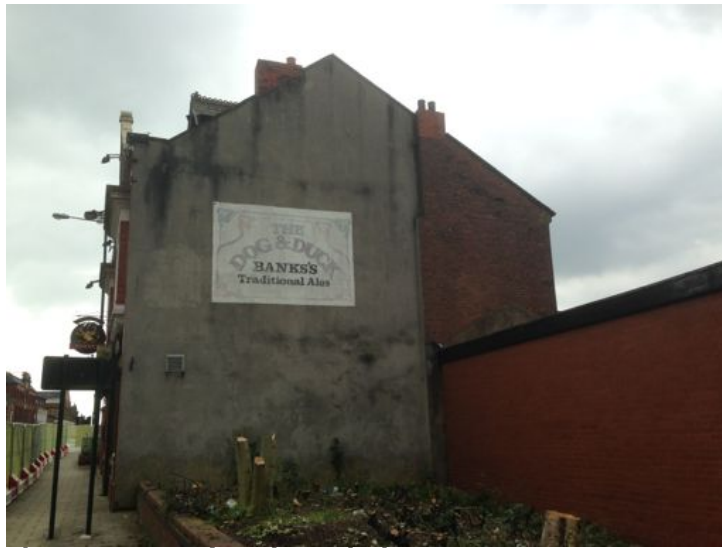
Plate 10: Dog and Duck, north elevation

5.25. The north elevation forms the boundary with the Abbey Inn and would have also bounded the terraced building off St Domingo Street, prior to their demolition. The eastern section of this elevation, where the terraces were situated, has been rendered, obscuring the construction material. This has a large logo for the Dog and Duck painted on the render (PLATE 10), which must be late 20th century in date, post dating the demolition of the terraces.

5.26. The western section of this elevation shows the same lower quality brickwork as the west elevation. There are no doors, windows or decoration of this elevation.

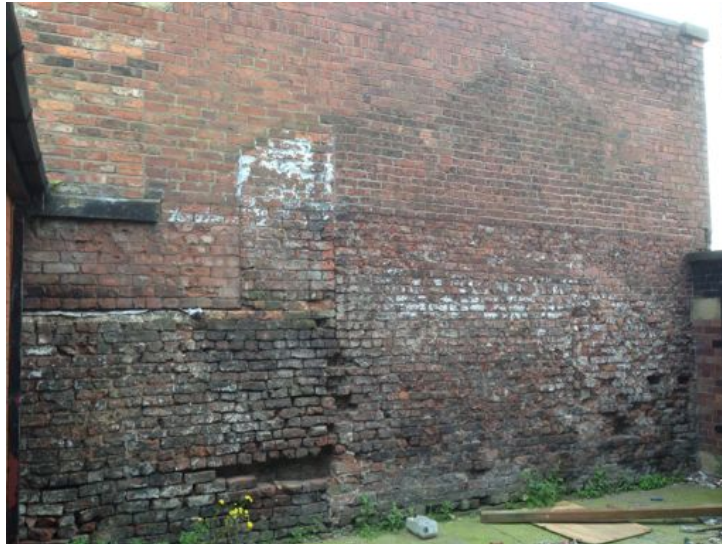
Plate 11: Boundary wall of Dog and Duck and Abbey Inn, looking southwest

5.27. Within the courtyard for the Abbey Inn part of the lower western section of the north elevation can be seen to be of a different construction material. Historic research shows that the earlier Dog and Duck fronted onto Eagle Street, not St Domingo Street. It is likely that this material forms part of the previous structure, dating from the early 19th century, and was left incorporated in the boundary wall when the new Dog and Duck was built in the late 19th century (PLATE 11).

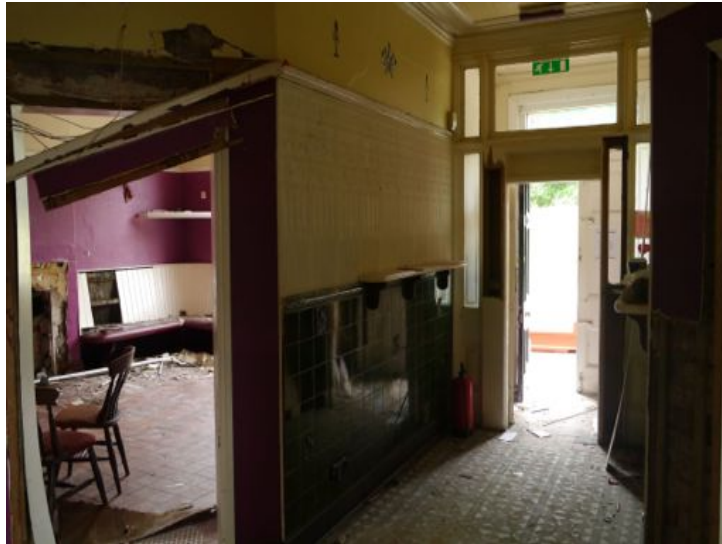
Plate 12: Entrance to Dog and Duck

- 5.31. The ground floor can be divided into two distinct parts. The original 1898 public house and the western extension. The main body of the public house maintains a great deal of its original layout. A small vestibule forms the entrance, which leads to an open bar area along the western wall (PLATE 12). The floor of this vestibule is of decorative tiles typical of the Victorian period.

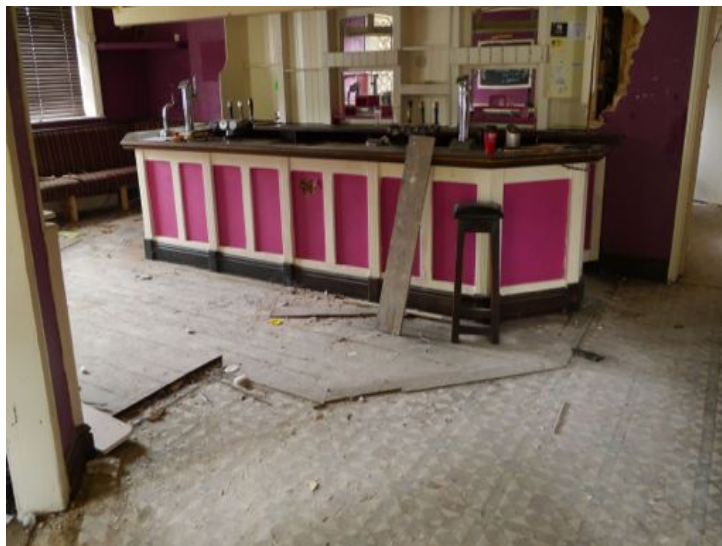
Plate 13: Main bar area

5.32. The main bar area has an inserted wooden bar along the west wall, with a later inserted storage pelmet above it (PLATE 13).

5.33. The floor around the bar area is of wooden boards, and an angular demarcation can be seen between the tiled entrance and the wooden floor of the bar area. Interestingly this is also reflected in the cornice on the ceiling. This suggests that the entrance was once separated from the bar area entirely.

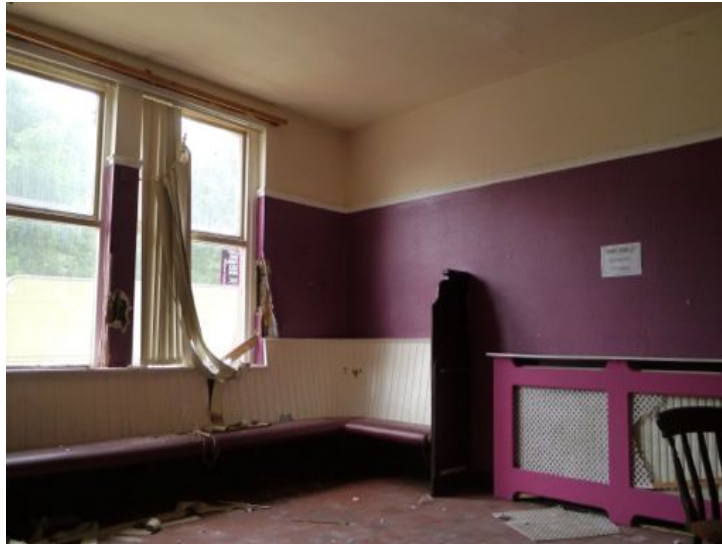
Plate 14: North room, ground floor

5.34. The eastern side of the ground floor is taken up by two separate areas, each side of the entrance. To the north is the smaller of the two front rooms. This is half panelled around a seating area with red tiled floor and picture rail (PLATE 14). It is thought that this would have been the lower class drinking room.

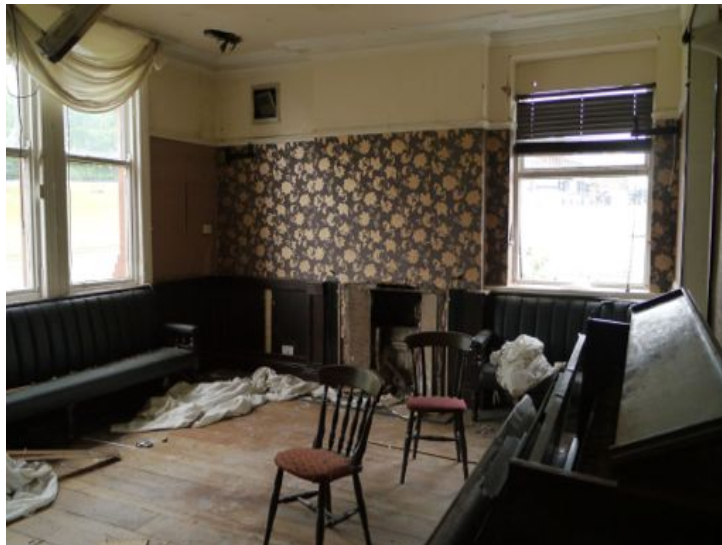
Plate 15: South room, ground floor

5.35. To the south of the entrance is the larger room of the ground floor (FIGURE 13). This appears to be of a higher status than the northern room, with wooden floorboards, half panelling, picture rail, and an opening into the main bar area, and more windows. Both rooms show evidence of fireplaces that have been removed (PLATE 15).

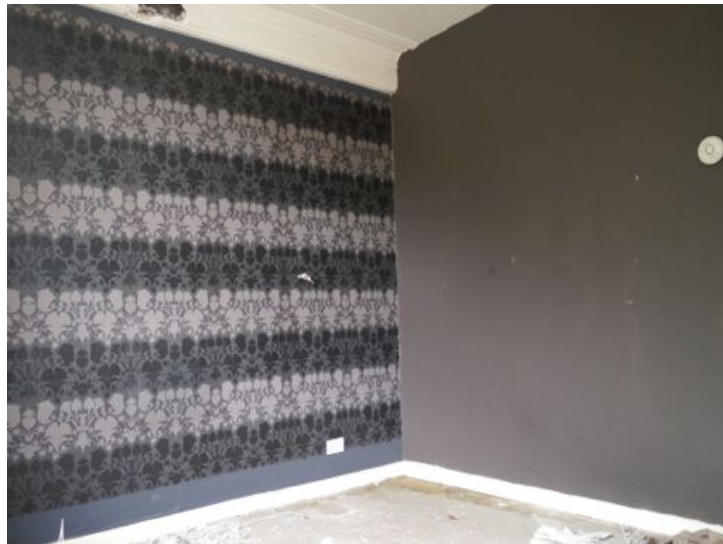
Plate 16: Northeast room of first floor, showing cornice

5.40. To the east of the landing is a double width doorframe, which leads to what would have been a suite of three adjoining rooms. A partition wall has been erected to divide them into three distinct rooms. However, the cornicing and picture rails, where they survive, show the original layout clearly (PLATE 16).

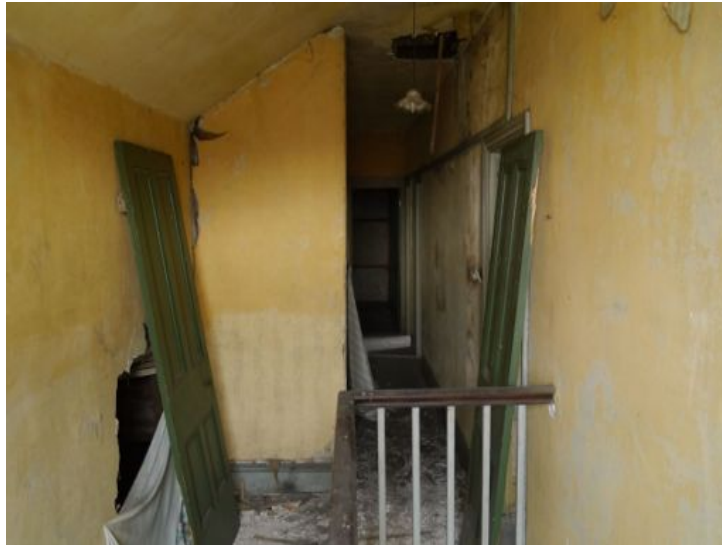
Plate 17: Second floor corridor

5.42. The second floor (FIGURE 15) is thought to have originally been staff accommodation. The rooms are significantly less decorative, with high, small, windows giving little light. These rooms are accessed via a narrow corridor which leads from the staircase at the south. Rooms are only present on the eastern and northern sides of the building. The steep pitch of the roof means that there is only room for some storage on the western side. This storage is accessed via a small hatch at floor level on the western wall of the corridor (PLATE 17).

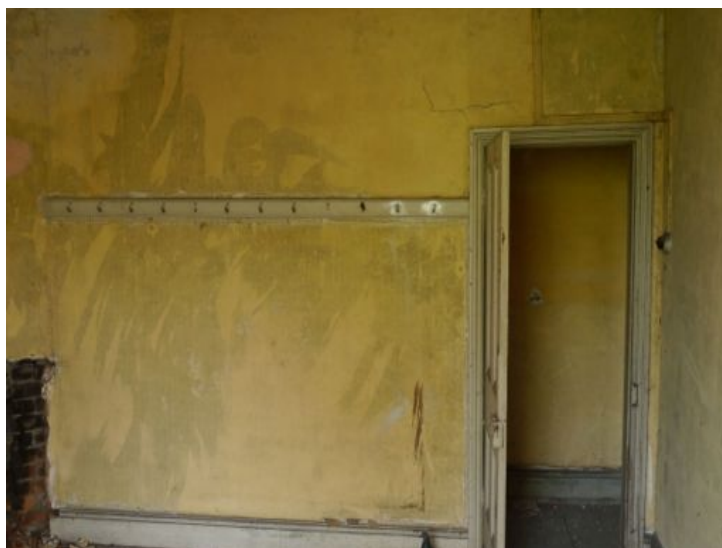
Plate 18: Southern room of second floor

5.43. The Rooms still retained much of the historic fabric, such as the door frames, window frames and floor boards (PLATE 18), however it is clear that they were less decorative than their ground and first floor counterparts.

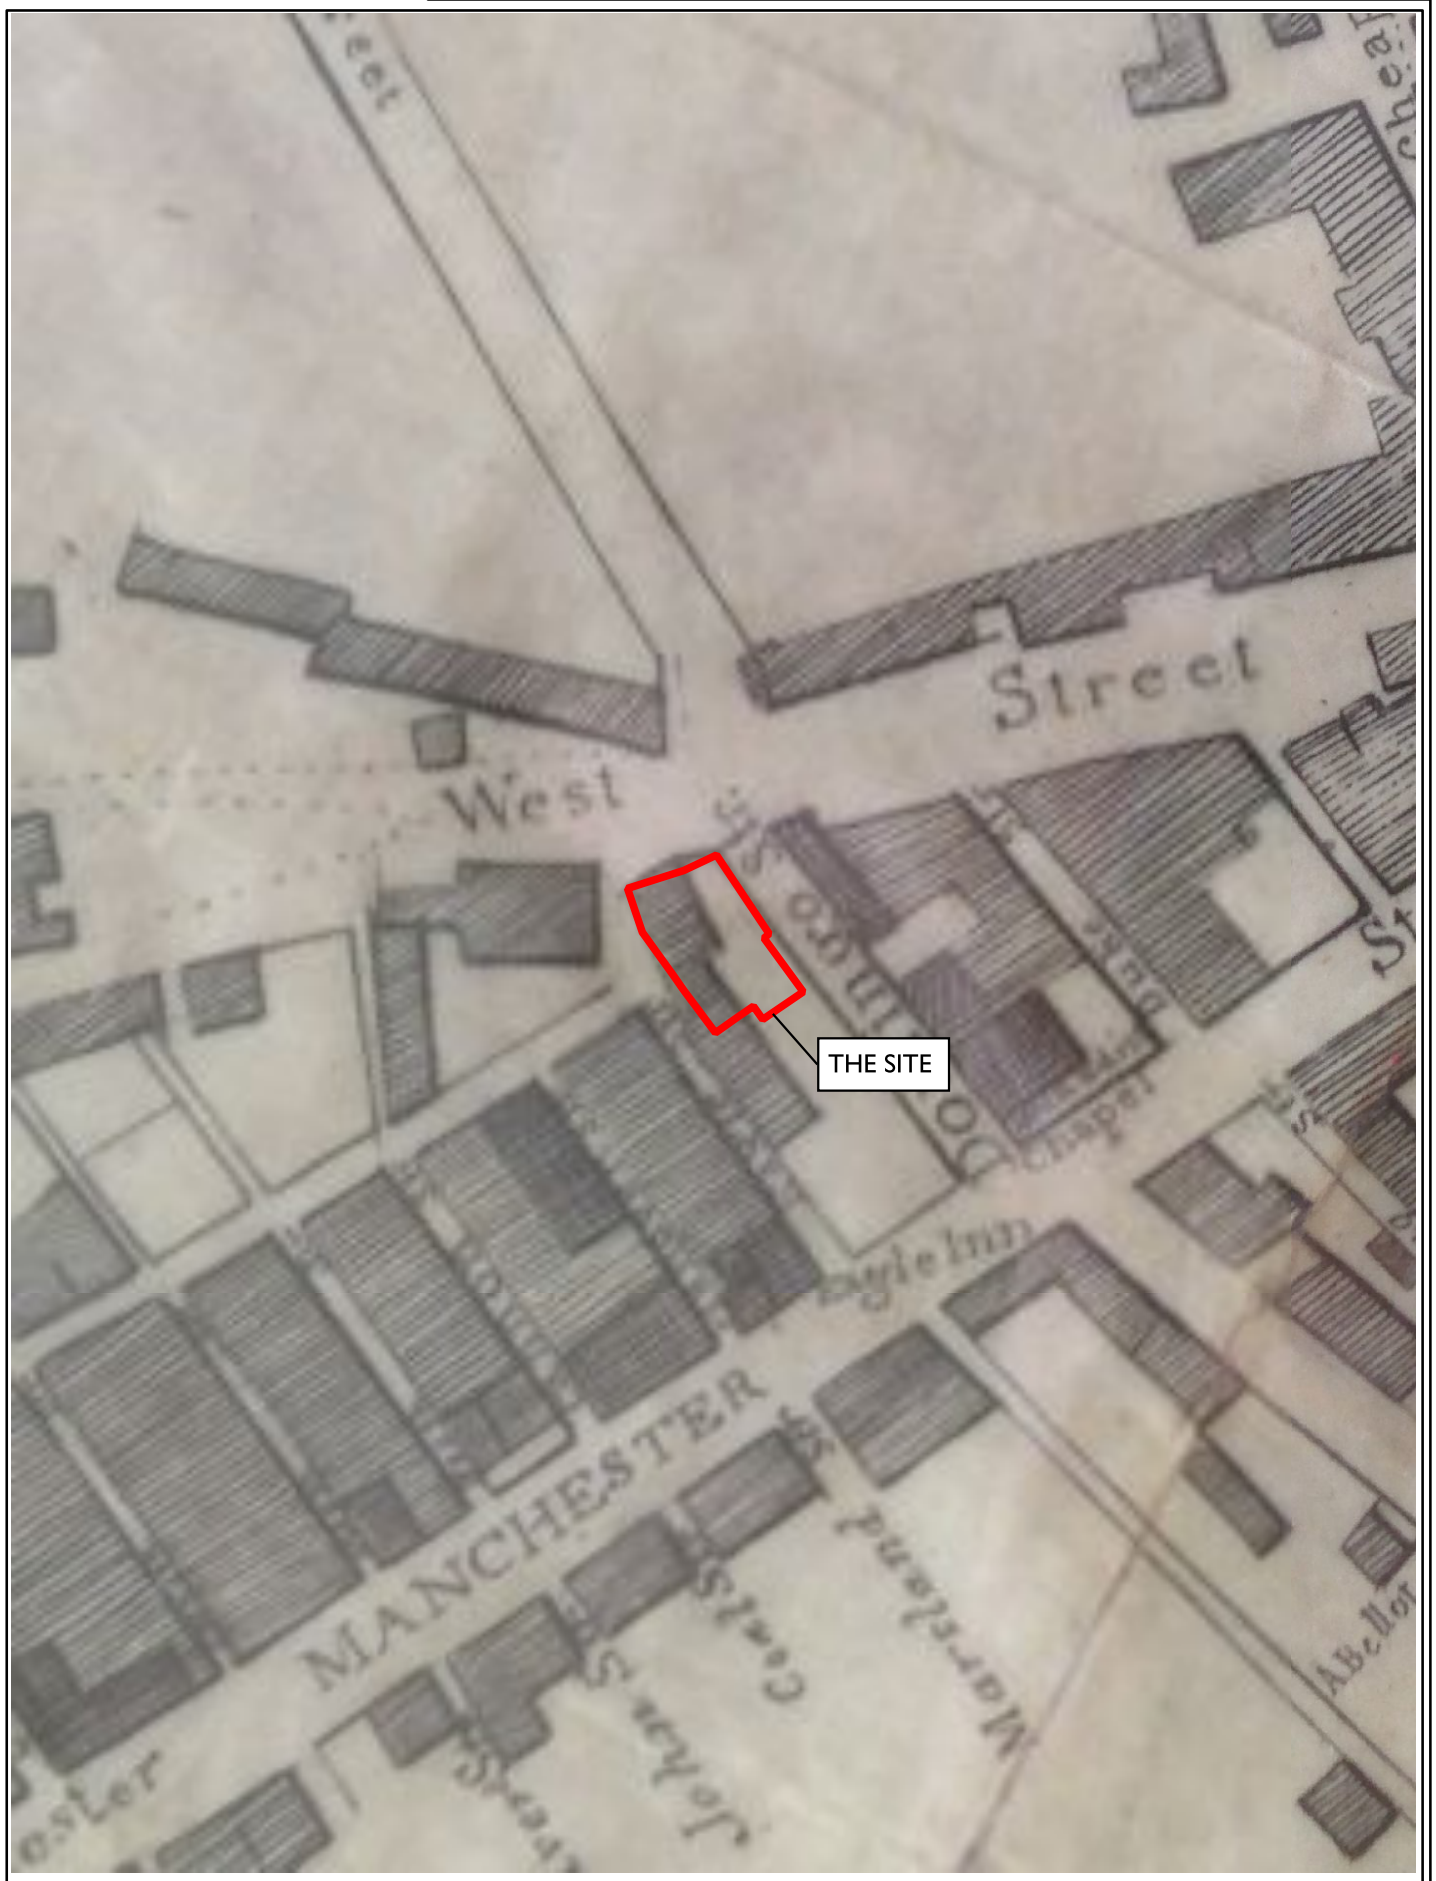
FIGURE 4 // Map of Oldham 1817

4.22. The earliest map of Oldham readily available dates to 1804 and shows the commons and waste lands in Oldham (JONES 1804). This map does not show the site in detail, however it does indicate that the site area was part of the established township at that time. The next available map dates to 1817 (BUTTERWORTH 1817) and clearly shows the site (FIGURE 4). Both buildings can be seen to front onto Eagle

Street at this time, with the Abbey Inn lying in the same position as it stands today. The Dog and Duck is shown occupying a different location to the standing building.

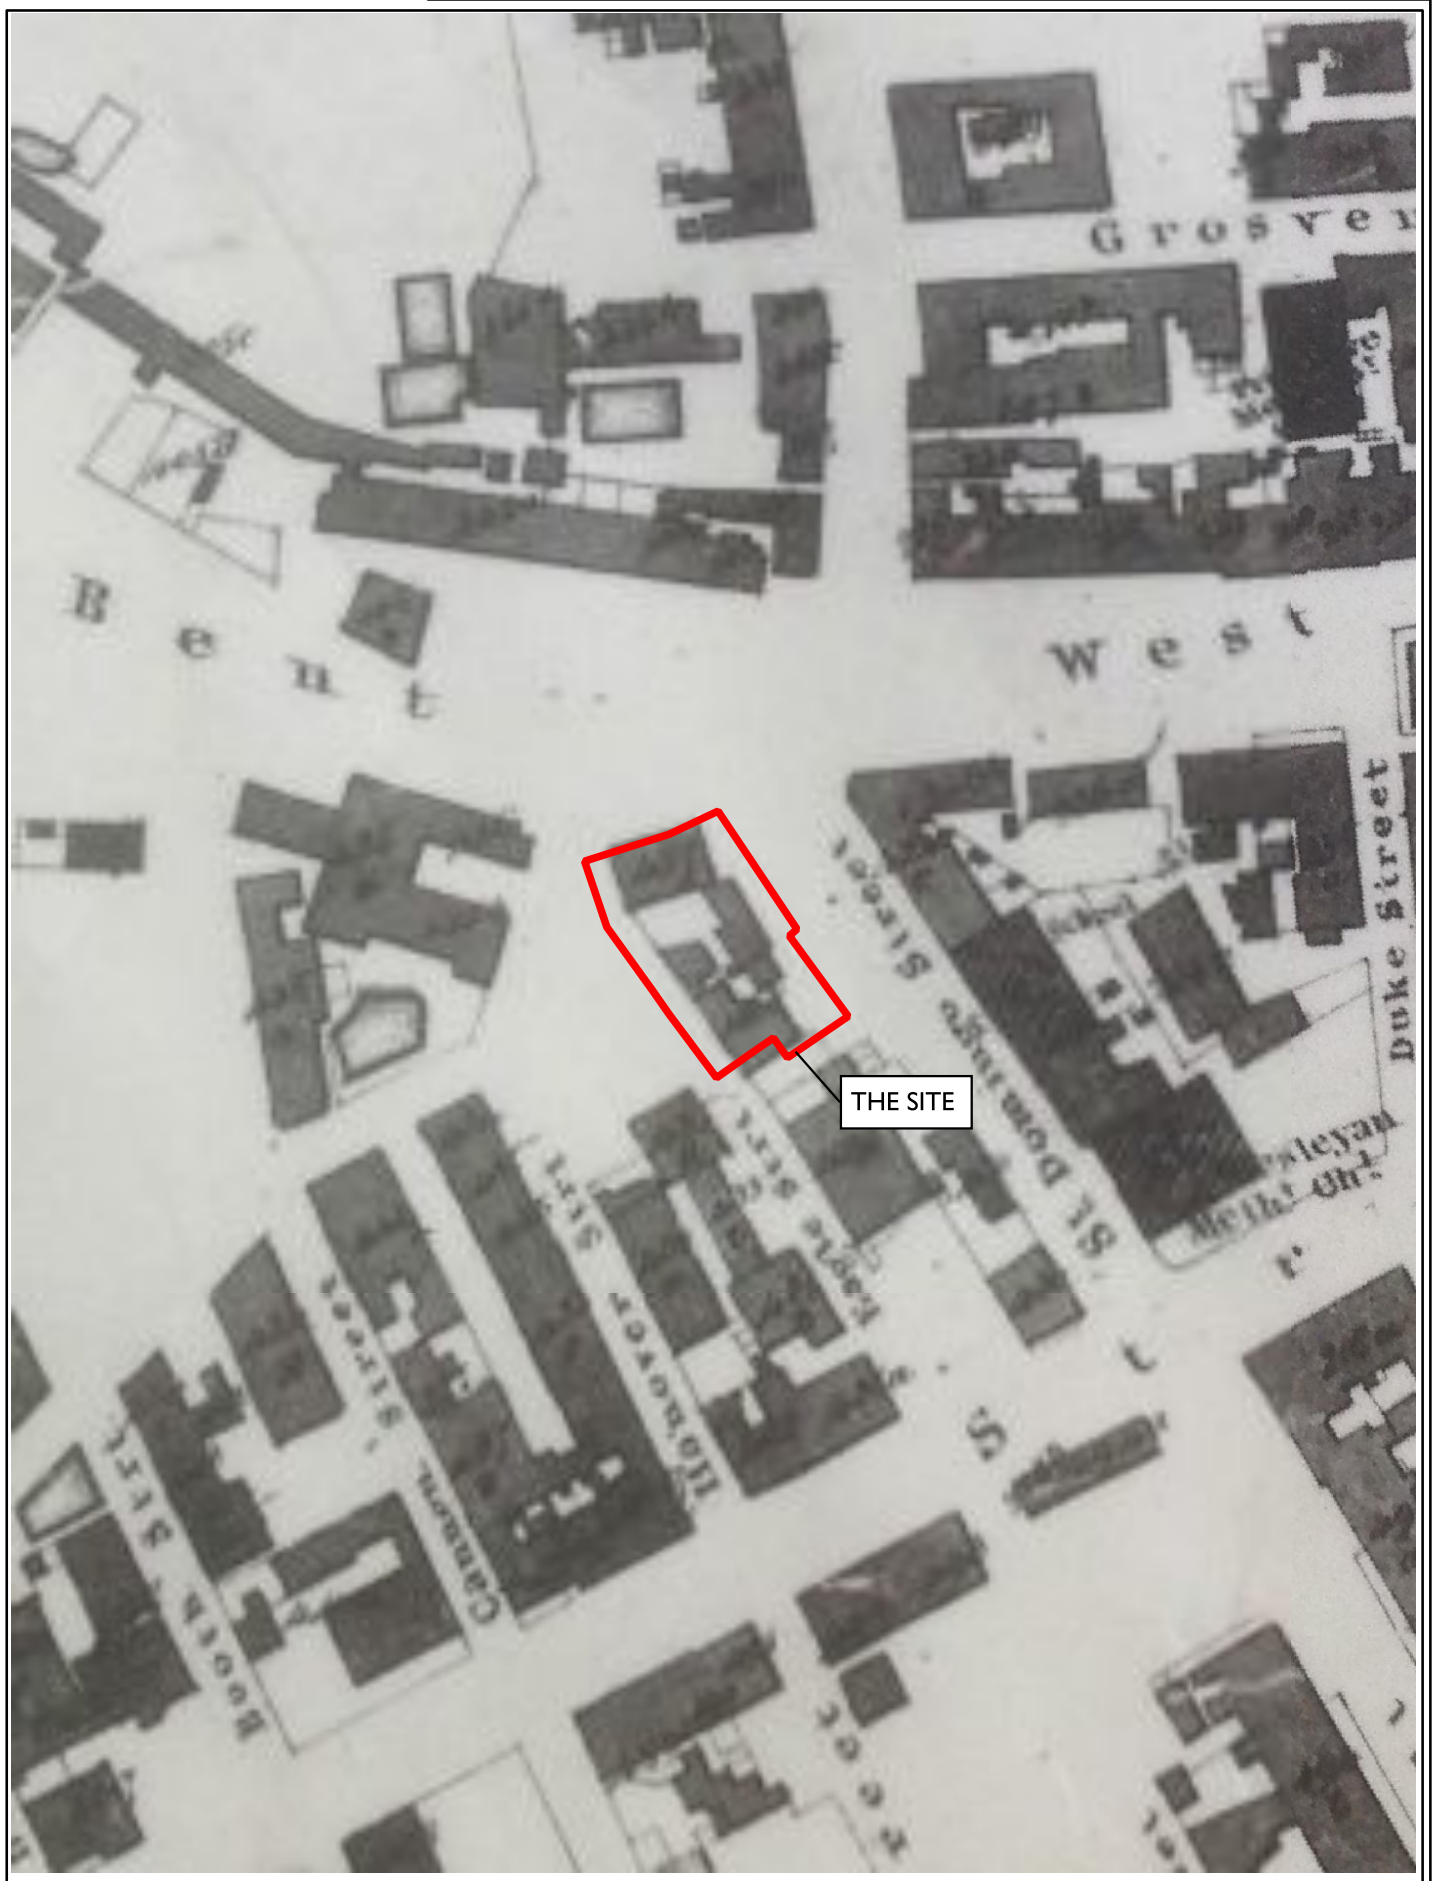
FIGURE 5 // Map of Oldham 1829

4.23. The 1829 map of Oldham (DUNN 1829) also shows the buildings in detail (FIGURE 5). Although the Abbey Inn is in a similar location, the footprint shown does not respect the current footprint. The Dog and Duck is still shown as fronting onto Eagle Street at this time.

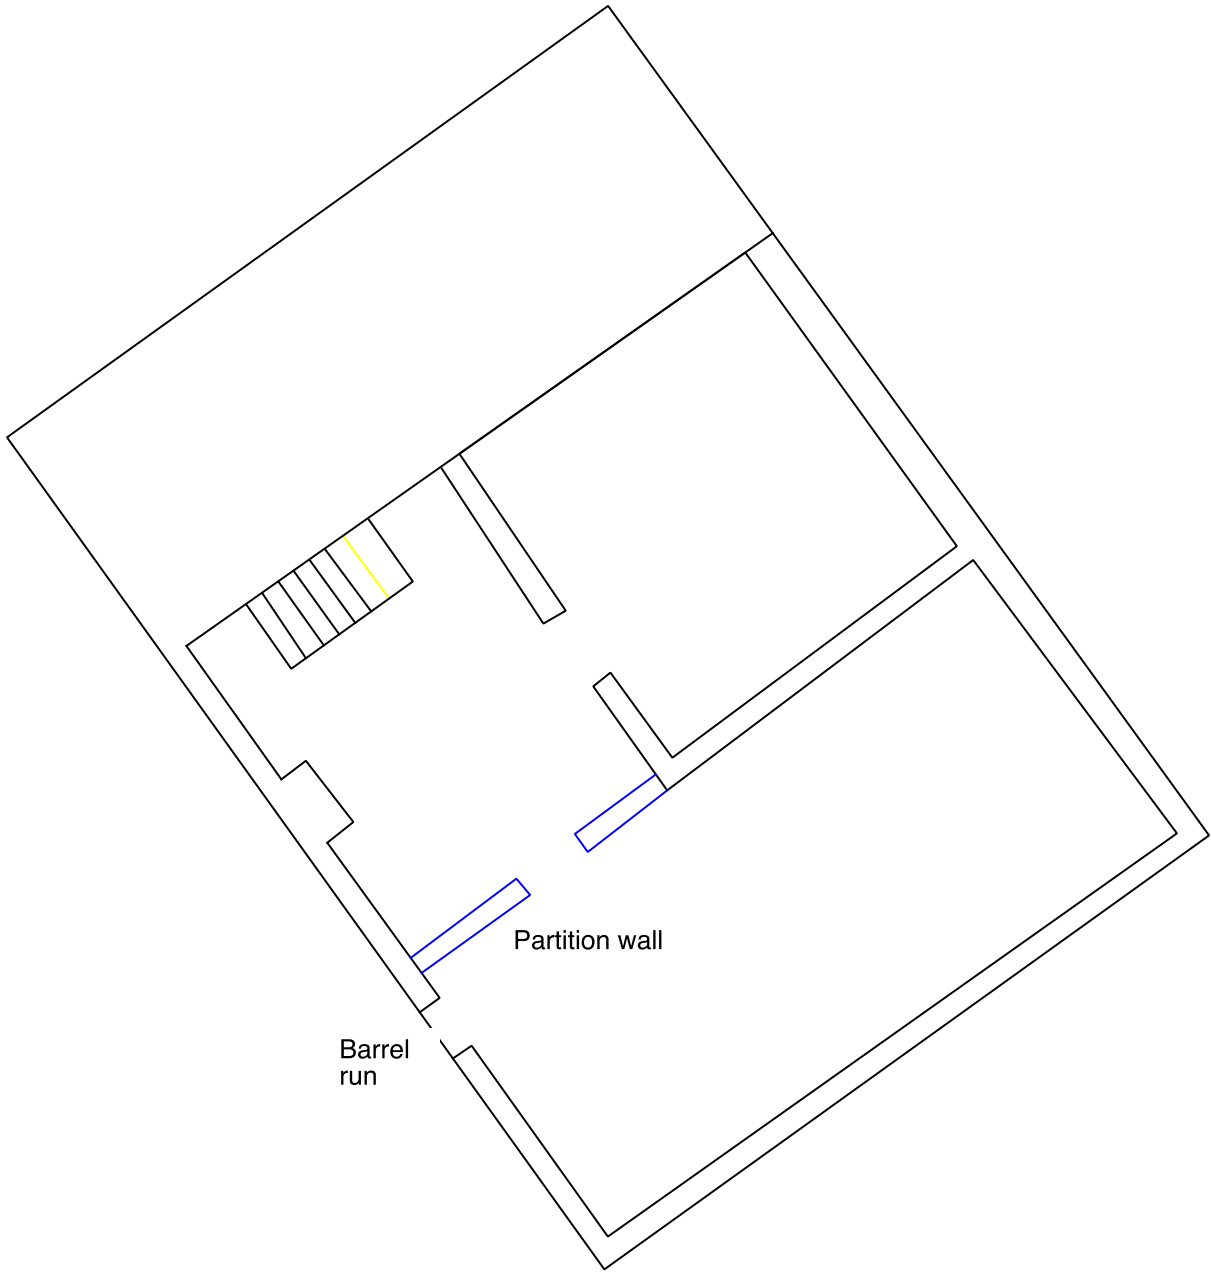
FIGURE 12 // Dog and Duck Cellar Plan

- 5.29. A barrel run can be seen at the western side of the southern room and blocked light wells can be seen along the southern wall.
- 5.30. It should be noted that the cellar does not occupy the full footprint of the property (FIGURE 12).

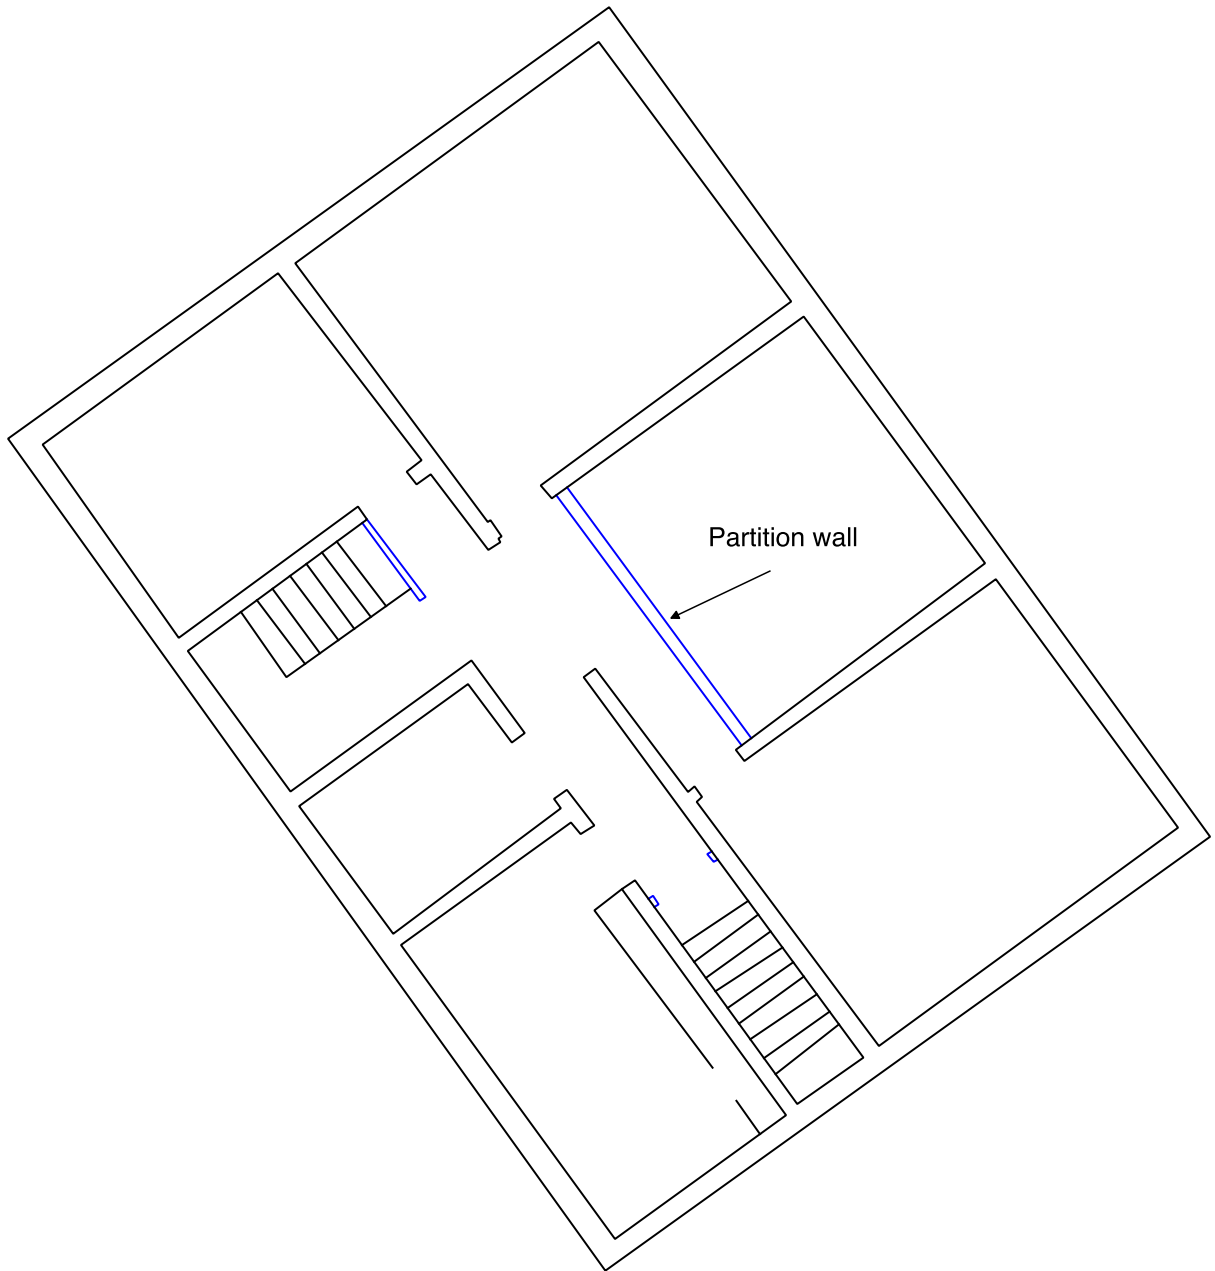
FIGURE 14 // Dog and Duck First Floor

5.39. The first floor (FIGURE 14) also retains evidence of its original layout, showing some later modifications. The stairwell is thought to be an original feature, which leads onto a landing facing east. To the north of this is a small room currently used as a kitchen. This retains cornicing and a picture rail as well as a decorative doorframe that appears original.
