Archaeological Watching Brief Report for Land at

DINGLE BANK CHESTER

For Dwr Cymru

Client:	Dwr Cymru
Local Authority:	Chester City Council
NGR:	340157,365494
Planning App:	N/A
Author(s):	B Poole
Doc Ref:	LP0792C-AWB-v1.2
Date:	December 08
Site Code:	CHE//DIN 08

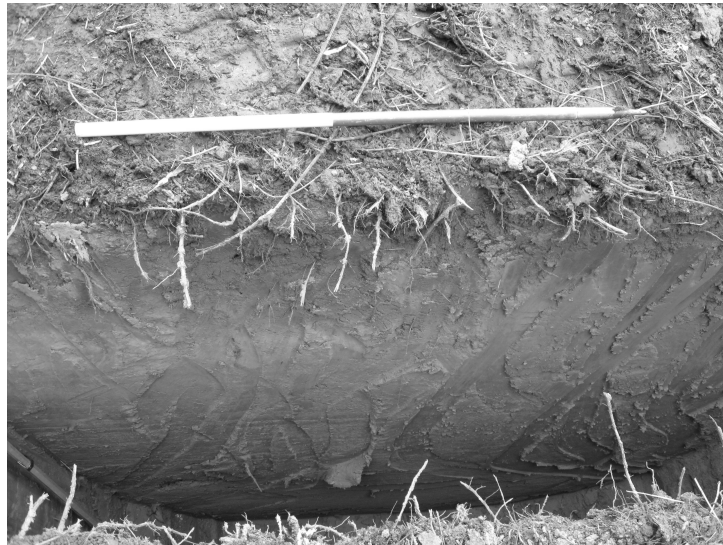
Plate 1 - Southwest facing section of Trench 1, 1m scale

5.8. The majority of the trench was taken up by a 2.12m deep layer of laminated grey silt (103). This silt deposit could be seen to be associated with the river and was sterile in nature, producing no finds or root activity. The laminations present in the silt

indicates that this area has undergone regular flooding events.

5.9. Context (103) was a firm deposit of grey silt, distinct from (103) only by its compact nature. This deposit extended beyond the base of the trench at 3.27mOD, 2.44m below the current ground level.

5.10. Trench 1 contained no archaeological features and was made up of deep, naturally occurring, alluvial silts associated with the river. Above these silts was a 0.76m high earthwork containing redeposited silts and a mid 20th century service pipe.

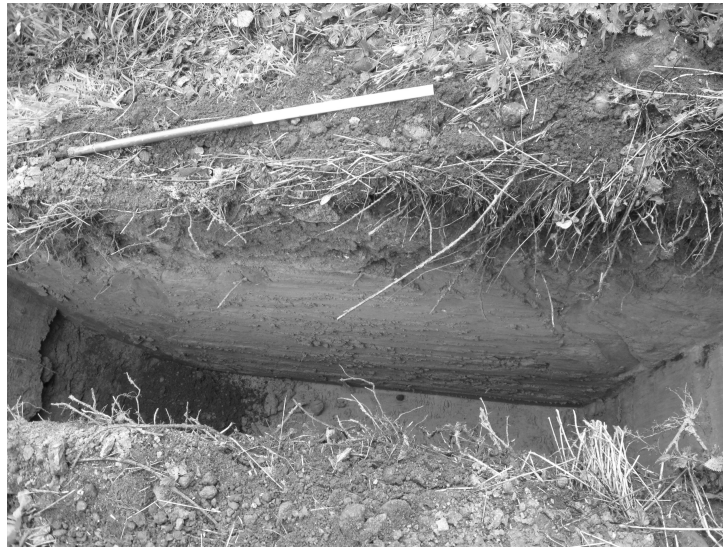
Plate 2 - North facing section of Trench 2, 1m scale

5.13. Sealed by (201) was 2.18m thick layer of laminated grey silt (202). This silt

deposit could be seen to be the same as (103) identified in Trench 1 and was associated with the river. The context was sterile in nature as was (103).

- 5.14. Underlying (202) was a firm deposit of alluvial grey silt (203), distinct from (202) by its more compact nature. This deposit, thought to be the same as (104), extended beyond the base of the trench at 3.37mOD, 2.5m below the current ground level.
- 5.15. Trench 2 contained no archaeological finds or features and comprised a thin covering of topsoil overlying a deep laminated silt flood plain deposit associated with the river Dee.

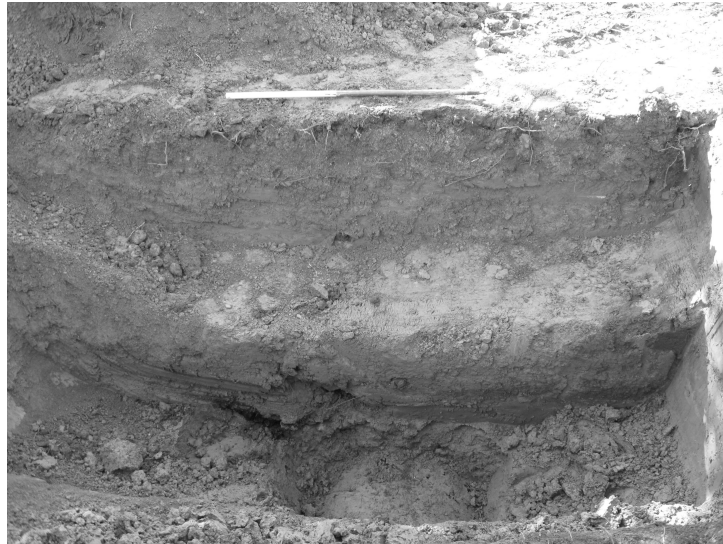
Plate 3 - North facing section of Trench 3, 1m scale

- 5.16. Trench 3 was located 99m to the southwest of the southern abutment of Grosvenor Bridge and 74m to the northwest of the iron frame pedestrian bridge crossing Dingle Bank (FIGURE 8). The trench measured 3.3m by 0.6m in plan along an east west alignment and was excavated to a maximum depth of 4.49mOD, 1.42m below the current ground level (FIGURE 11).
- 5.17. The uppermost context (300) was a 0.04m thick deposit of dark brown humic silt loam topsoil with a turf covering. This deposit was a continuation of (100) identified in Trench 1. This sealed a 0.08m deep layer of loose dark brown humic loam (301) which contained root activity, 20th century metal and ceramic fragments. This deposit could be seen to be a humic loam subsoil and was a continuation of the natural subsoil identified in Trench 2 (201).

- 5.18. Context (301) was 1.3m deep layer of redeposited grey silt (302), the fill of a large service trench. This deposit sealed a 0.92m diameter gas pipe at a depth of 4.49mOD, 1.42m below the current ground level. The cut for this service trench, [303], was only identified at the eastern edge of the trench, cutting deposit (304).
- 5.19. Context (304) was a laminated grey silt deposit, an extension of deposit (103) identified in Trench 1, associated with the alluvial river silts.
- 5.20. Trench 3 contained no archaeological finds or features and comprised a deep layer or redeposited silt within a large 20th century service trench.

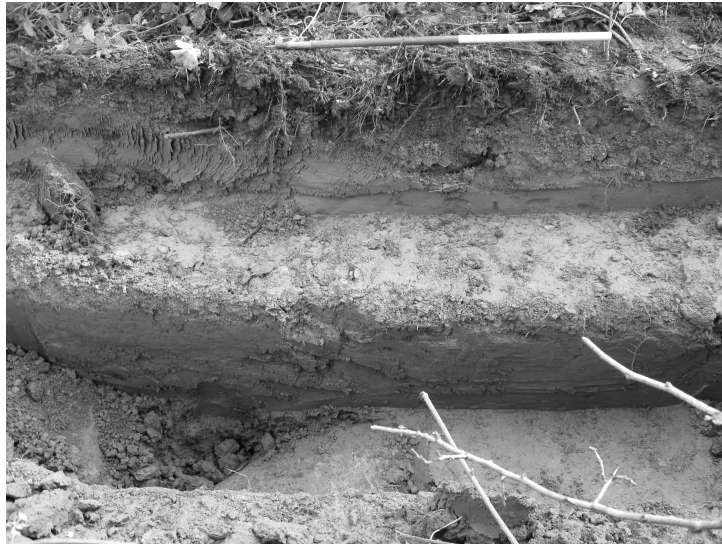
Plate 4 - Northwest facing section of Trench 4, 1m scale

5.23. Below (401) was 0.84m deep layer of redeposited grey silt (402), the fill of a large service trench. This deposit overlay a 0.53m diameter gas pipe at a depth of 4.82mOD, 1.1m below the current ground level. The cut for this service trench, was not identified within the trench.

5.24. Trench 4 contained no archaeological finds or features and comprised a deep layer or redeposited silt within a large 20th century service trench.

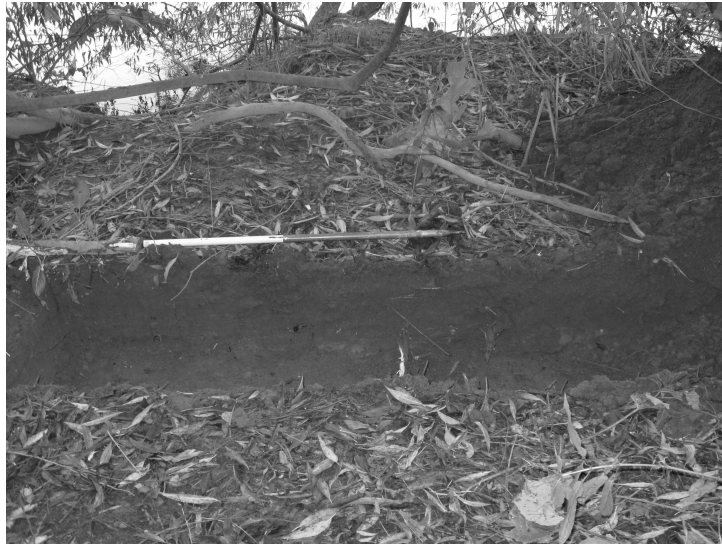
Plate 5 - South facing section of Trench 5, 1m scale

5.27. A very thin, 0.02m layer of detritus and dark brown loam (500) was spread across the surface of the river bank and sealed the dark brown river silt (503). The dark colouration of the silt is thought to be due to minerals leaching from the detritus into the soils as the materials decompose.

5.28. The river silt (503) extended beyond the base of the trench at a depth of 5.9mOD.

5.29. Cut into (500) was a 0.4m wide service trench, [502], running northwest southeast, which contained a 0.2m diameter plastic service pipe. The service trench had steep, almost vertical sides, and was filled with redeposited dark brown silt (501).

5.30. Trench 5 contained no archaeological features or finds and could be seen to be made up of the alluvial river silt. A late 20th century service trench, running northwest southeast, cut into the natural silt.

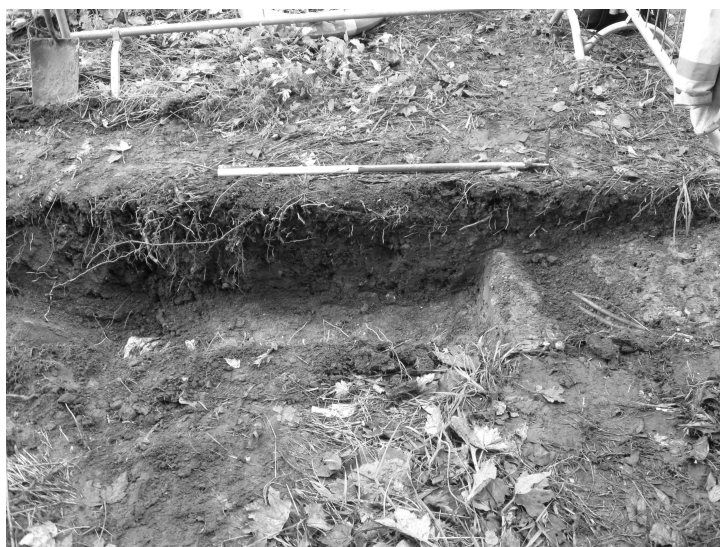
Plate 6 - West facing section of the northern area of Trench 6, 1m scale

5.32. The uppermost deposit was a 0.08m thick spread of topsoil and gravel (600). Below the topsoil were 2 service trenches [602] and [604]. Service trench [602] was extremely shallow and contained the electrical cable feeding the now defunct, lighting system for the Grosvenor bridge. This measured 0.2m wide by 0.1m deep and was filled with a mixed backfill of ash and silt (601).

5.33. Service trench [604] contained two high voltage electric cables and was much deeper and wider than [602]. The service trench, [604], measured 0.66m wide by

0.78m deep and was backfilled with fine grain, sterile, yellow sand (603).

- 5.34.Both [602] and [604] cut a loose silt loam deposit (605) which measured 0.18m deep. This deposit is a late 20th century make up deposit used to level the path and surrounding river bank.

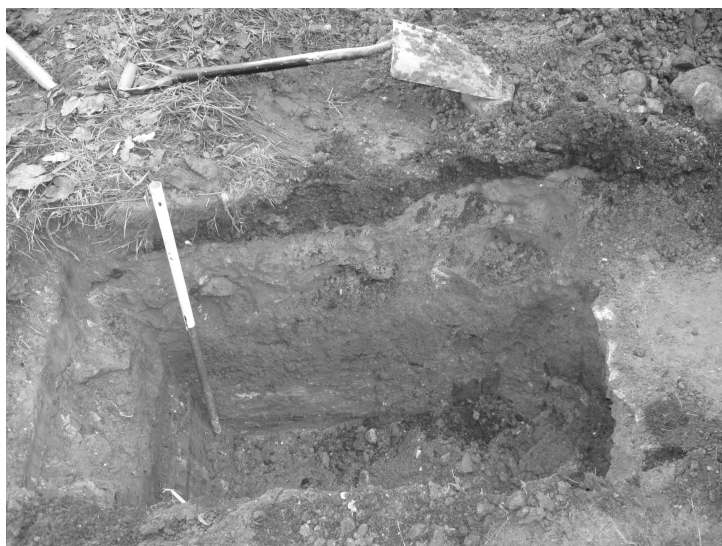
Plate 7 - West facing section of the southern area of Trench 6, 1m scale

- 5.37.A deeper sondage was excavated within the northern section of Trench 6 which revealed a different stratigraphic sequence (FIGURE 14). Underlying (605) in the northern area was a 0.24m deep layer of red sandstone fragments and brick rubble (608). This deposit overlay a loose brown silt deposit which contained brick fragments, slate and 19th century ceramic sherds.

- 5.38.Below (609) was a deep deposit of friable grey silt clay (610) which contained red brick and rubble fragments. This deposit extended beyond the base of the trench at 5.2mOD, 1.1m below current ground level.

5.39. It is thought that deposits (608), (609) and (610) represent rubble and debris relating to the construction and make up around Grosvenor Bridge.

5.40. Trench 6 contained no archaeological features of significance. The northern section of the trench contained make up deposits and rubble associated with the construction of Grosvenor Bridge. However the southern section contained 19th century and later, make up deposits associated with the footpath leading from Dingle Bank to Handbridge.

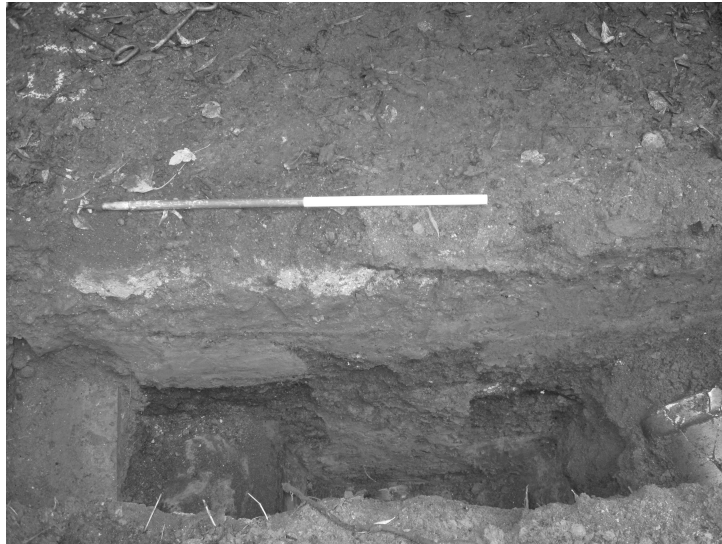
Plate 8 - Southwest section of Trench 7, 1m scale

5.42. The top deposit was a 0.08m thick spread of silt loam and gravel (700) which overlay a 0.06m spread of dark brown humic loam (701) to the west edge of the trench. Located centrally in the trench was a spread of mortar and brick within a silt matrix (702). This measured 0.1m thick and underlay (701), however these two deposits may be contemporary in date.

- 5.43. Underlying (702) was a 0.6m deep layer of loose grey silt (703). This could be seen to be a make up deposit and contained fragments of concrete, 19th century ceramic and an electricity cable, covered by warning tiles.
- 5.44. Sealed by (703) was a 0.4m thick deposit of dark brown silt and ash (704) which contained brick and rubble fragments. This context was also a make up layer and in turn sealed a re-deposited clay fill (705) which contained a 0.3m diameter service pipe. The trench was bottomed at 4.75mOD, 1.7m below the current ground level, where the service pipe was encountered.
- 5.45. No archaeological features were identified within Trench 7 as all deposits encountered formed back fill and make up above a 19th century, water, service pipe.
