Archaeological Evaluation Report

# **FORMER ORB MILL OLDHAM**

For Oldham Council

Doc Ref: LP0975C-AER-v1.2

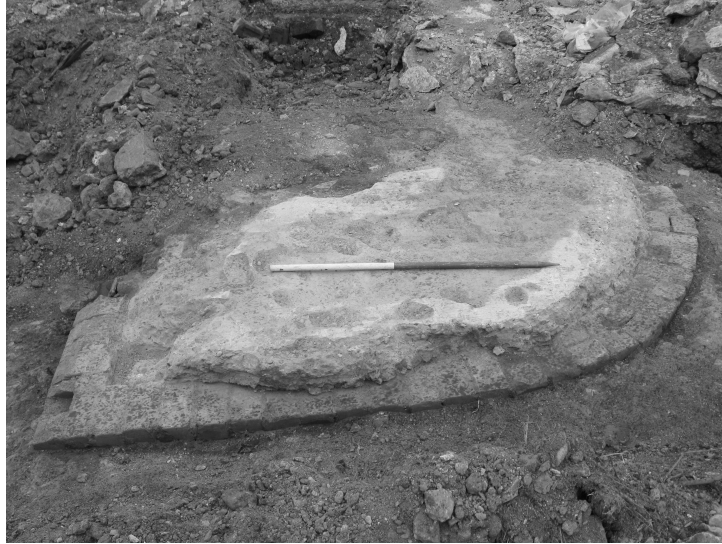
5.2.3. Sealed by (101) at the west end of the trench was 103 a red brick lined structure which had been later filled with concrete. As seen this structure was two courses wide and one course deep. The structure was square at the west end however curved to the north at its eastern extent. The radius of this curve was 1.5m. It is thought that this structure relates to the workings of the mill and may be housed within the engine house/room although this is not clear.

Plate 1 - 103 facing north. 1m scale.

- 5.2.5. Tr. 1 was extended 5m to the north at this point in order to ascertain the extent of 103. The extension of the trench showed that only the area already uncovered remained. The rest had been removed or severely damaged during demolition of the mill.

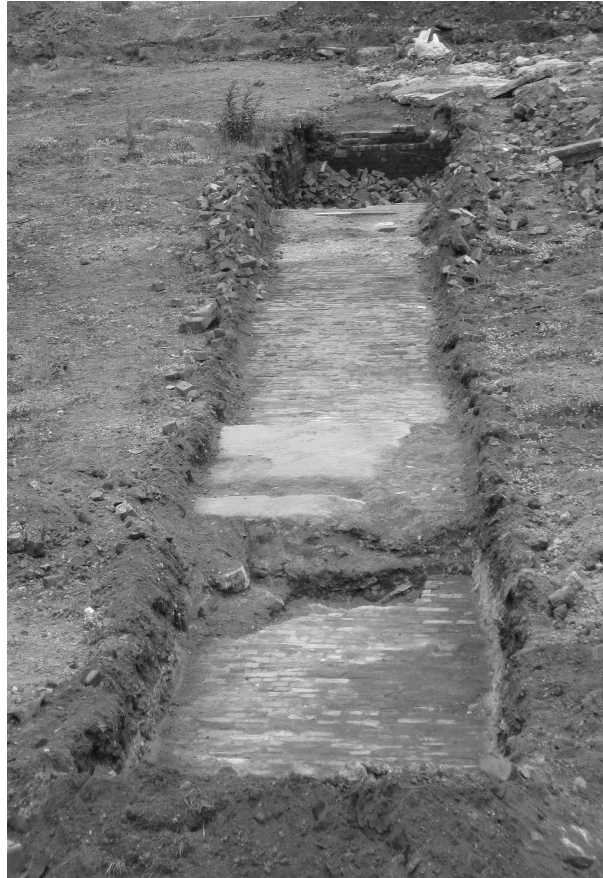
5.3.4. Both [211] and [215] cut 203 a red brick floor. The floor consists of smooth red bricks measuring 230mm by 90mm by 110mm laid on edge bonded with a soft grey mortar. As seen the floor extended beyond the sides of the trench and measured 14.4m north south. It is uncertain at present what this floor represents however from examining the original drawings for the mill it is

certain that the floor is within the engine area of the mill. This is also evidenced by three metal fixings built into the floor at the north end. Each fixing measured 0.09m in diameter.

Plate 2 - Floor 203 cut by concrete 205. Facing south. Scale 1m.

- 5.3.5. With the disturbance of 203 caused by the insertion of 205 it could be clearly seen that floor 203 sealed 204, a hard red stone and concrete base for the floor. The presence of this concrete indicates that this area of the mill would have housed a significant amount of machinery in order to warrant this level of support.
- 5.3.6. At the southern end of Tr.2 below the redeposited clay (201) was (206) a loose light brown silt and rubble deposit with brick and concrete fragments inclusions. This has been interpreted as a further layer of demolition debris moved around site.

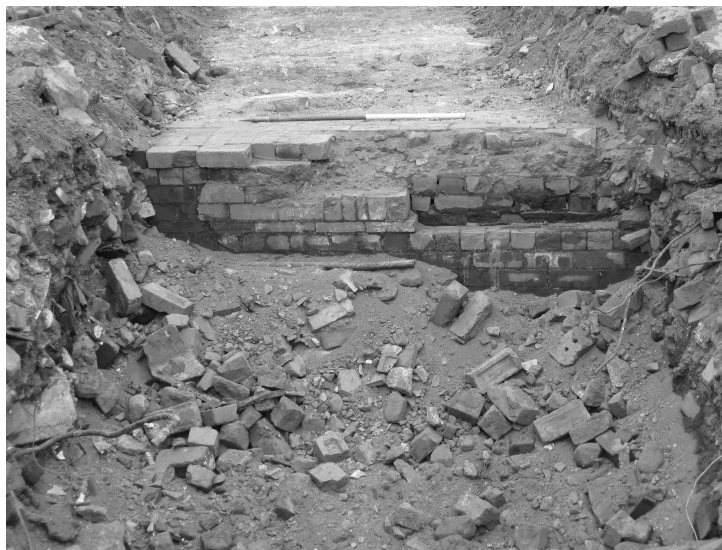
5.3.8. Wall 207 bounded northern extent of (210) with 208 bounding it to the south. Wall 207 comprised smooth red bricks bonded with hard grey mortar in an English Garden Wall form. Unusually there was a coursing band of red tiles recorded four courses below the surface. This is a possible decorative feature which does not however appear in wall 208.

Plate 3 - Wall 207 showing (210) in the foreground.  
Looking North. Scale 1m.

5.3.9. Wall 208 was again constructed of smooth red bricks with a hard grey mortar in an English Garden Wall bond. Both walls 207 and 208 were aligned east west with (210) filling the void between them. A member of the local community informed us that the canteen for the workers at Orb Mill was located within this area and was housed in a cellar. It is possible that this deep area bounded by walls 207 and 208 make up the cellar area of the mill.

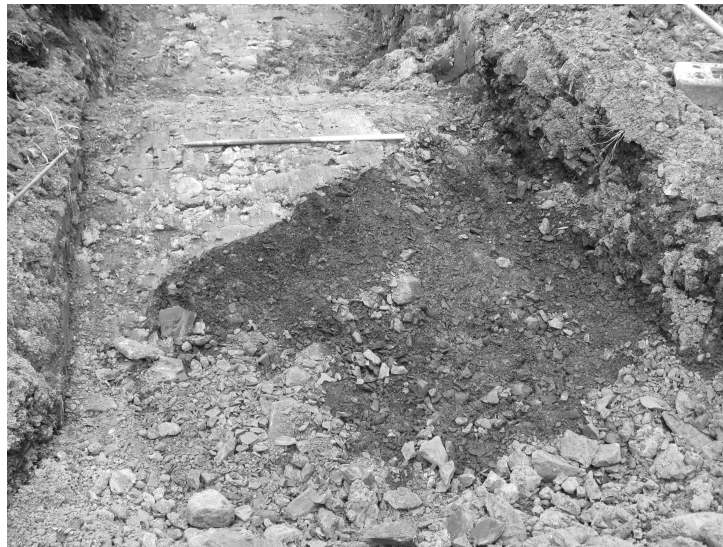
- 5.4.3. Sealed by (301) within the initial 2.2m at the northeastern end of the trench was (302) a loose black cinder with shale making up more than 50% of the deposit. As excavated the deposit measured 0.5m thick however it did extend below the base of the trench at 1.7m BGL. Deposit (302) is thought to be a waste dump relating to the colliery.

Plate 4 - Context (302) facing southwest. Scale 1m.

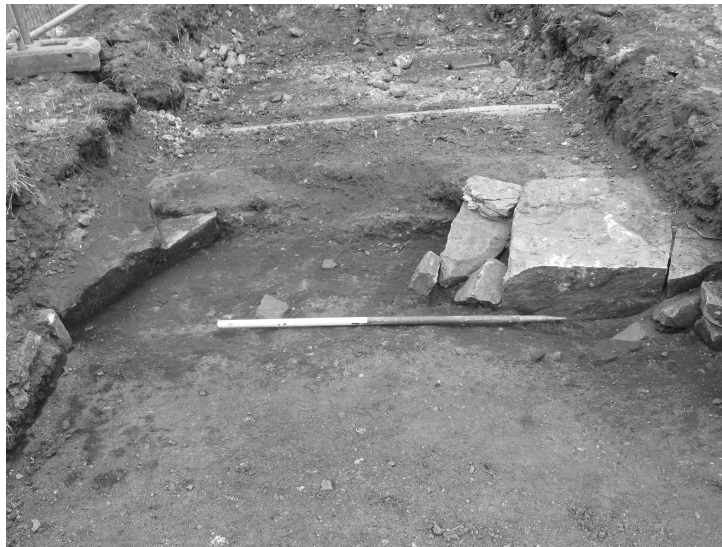
5.5.3. Below (401) was 406 a yellow stone wall with an average block measuring 0.56m by 1.56m by 0.23m, smaller fragments of stone are also included within the construction. This wall was aligned east west and is thought to be the northern wall of the Sunday School. The majority of the wall has been removed by demolition and only the base foundations seen here remain.

Plate 5 - Wall 406 facing north. Scale 1m.

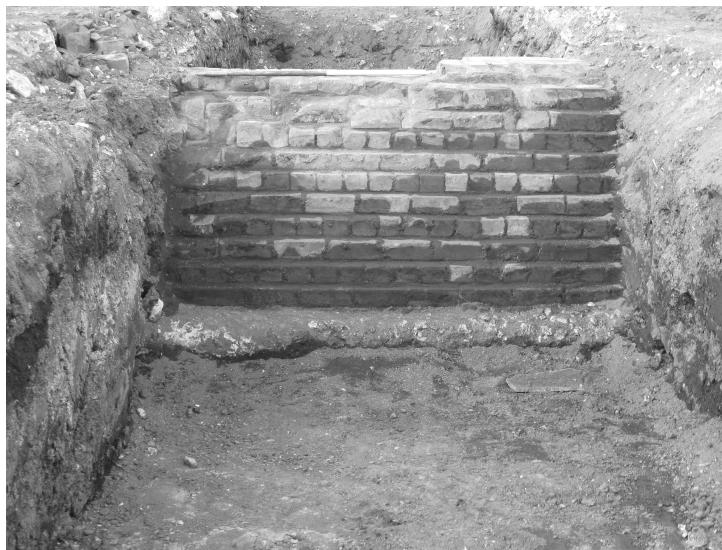
5.6.5. Below both (502) and (503) was 505 a red brick foundation wall with a concrete base. Eleven courses of this foundation wall survived each of which stepped out 50mm. The wall itself was constructed in English bond and measured 1.8m wide by 0.8m high. The concrete base for the bricks measured 2.4m wide by 0.12m thick. These foundations are very substantial and from looking at the location map (FIGURE 8) it can be certain that 505 is the main front wall for Orb Mill.

Plate 6 - Wall 505 facing north. Scale 1m.

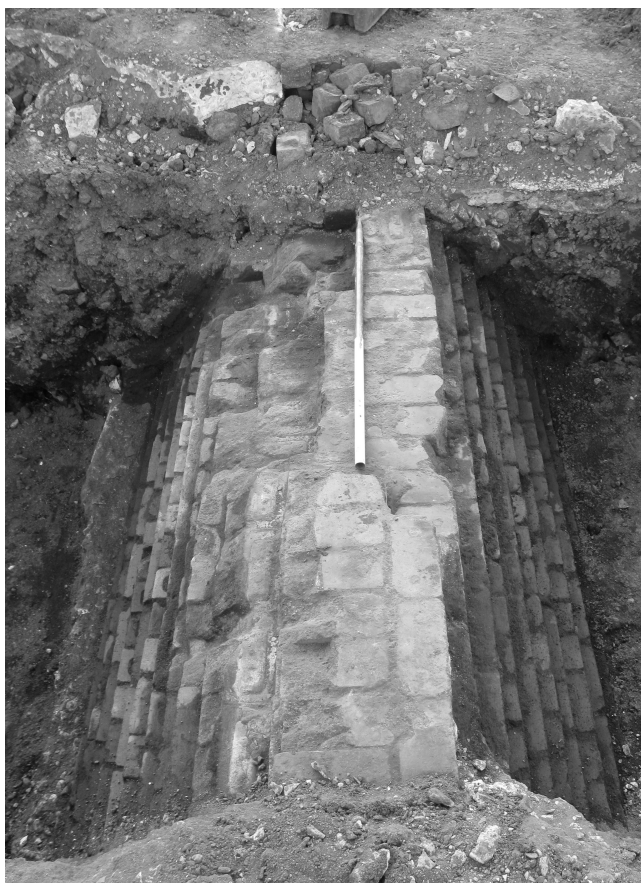
Plate 7 - Wall 505 facing west. Scale 1m.

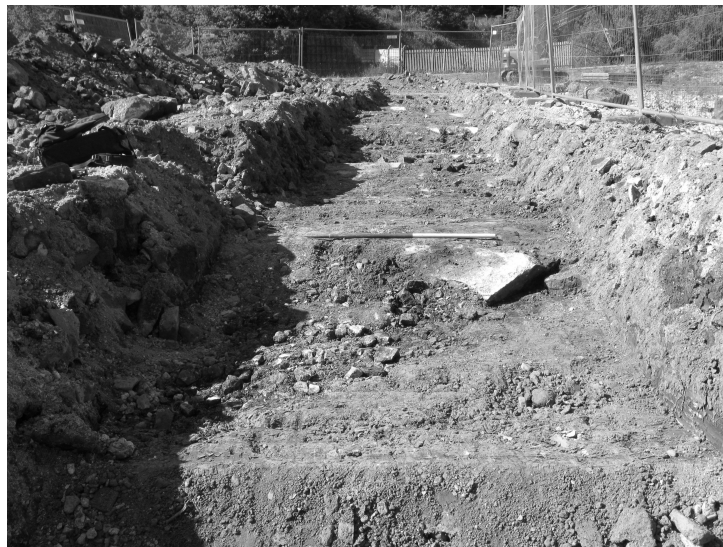
5.7.4. Also below (603) was 605 one block of stone measuring 0.95m north south by 0.14m thick, its east west extent was not seen within the trench. One stone block remained in situ and makes up part demolished wall running northeast southwest. It is unclear as to what this wall relates to as it is c. 15m to the north of the back wall for New Royd Mill.

Plate 8 - Wall 605 facing north. Scale 1m.

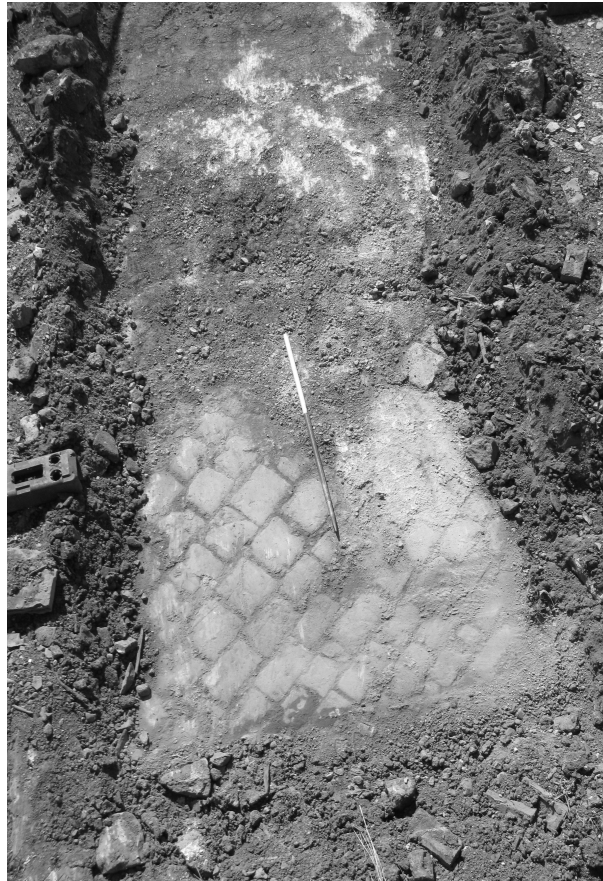
- 5.8.3. Also sealed by (700) at the eastern end of the trench was 702 a cobbled floor surface made up of rounded square grey cobbles measuring an average 0.25m by 0.25m. As seen this surface extended beyond the sides of the trench at 2.2m north south and measured 2m east west. The floor did however extend beyond the eastern extent of the trench. This floor is thought to be an internal floor within New Royd Mill.

Plate 9 - Cobbled floor 702. Scale 1m.

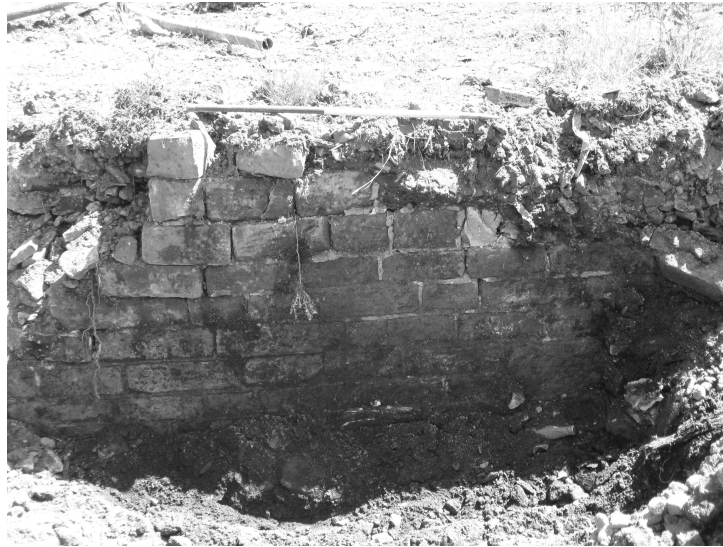
5.10.5. At the south of the trench several stone blocks could be seen to be running in a northeast southwest orientation below (903). It was decided on site to extend the trench by 3m in a southwesterly direction to chase these blocks. This extension revealed a stone block wall 906. 906 comprised dressed stone blocks constructed in regular form with a soft grey mortar bond. Historic maps reveal that this wall most likely the northwestern wall of New Royd Mill. The remainder of the mill has been removed during demolition however this wall appears to have survived.

Plate 10 - Wall 906 facing southeast. Scale 1m.
