Archaeological Evaluation Report

# 1 - 9 FARNHAM PLACE SOUTHWARK

Doc Ref: LPI029L-AER-v1.2

Site Code: FAPI0

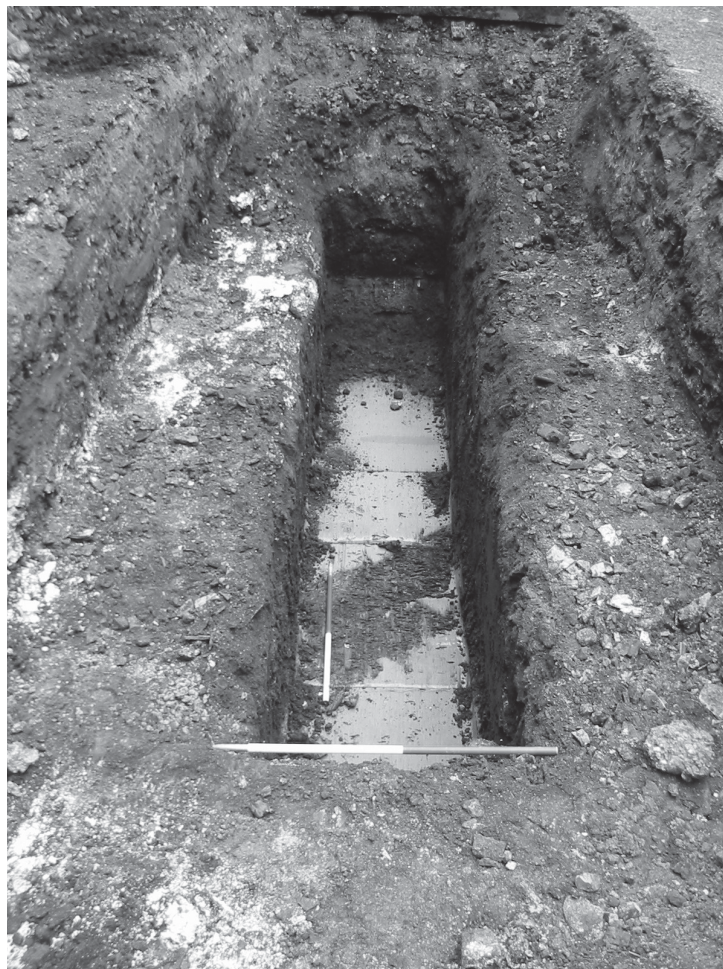
*Text 1: Plate 1-Evaluation trench from west, 2x1m scale*
