ST MARY SOMERSET TOWER DRAINAGE WORKS
Lambeth Hill
London
EC4V

Archaeological watching brief report

December 2017

Site Code LHI17
NGR 532160 180881
OASIS reference molas1-296911

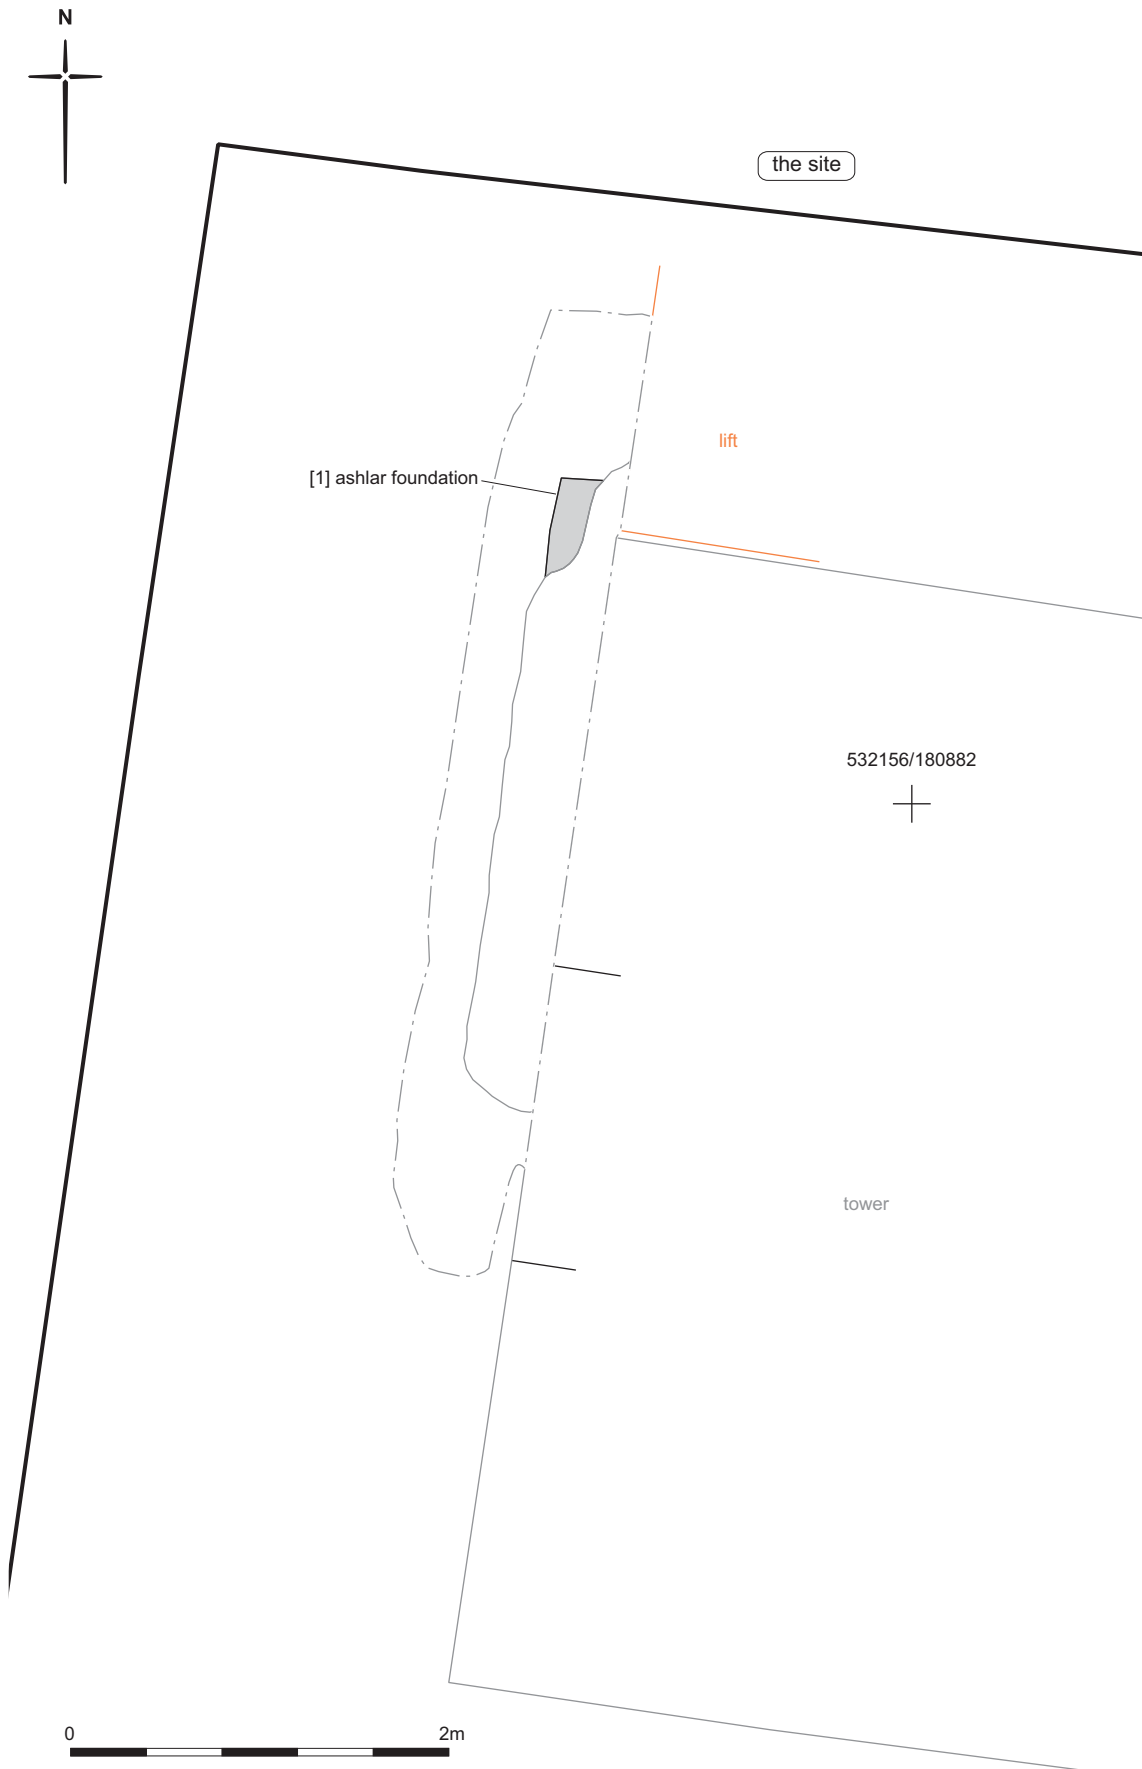
Fig 4 Drainage trench location and location of ashlar foundation [1]

- 4.1.1 The trench was located on the western side of the church tower and was excavated up to a depth of 1.4m at the south (see Fig 4 and Fig 5). Within the trench a concrete slab c 0.75m deep overlay a mixed made ground deposit c 0.50m thick which contained modern inclusions suggesting a date of the mid-20th century.

- 4.1.2 No features were evident over the majority of the trench except towards the northern end where a stone ashlar foundation [1] was observed protruding from the north-west corner of the original line of the tower (see Fig 6 and Fig 7). These were encountered at 0.8m below ground level (bgl) and the exposed blocks were bonded together with a hard light grey lime mortar. The ashlar foundation extended 0.40m to the west and 0.28 north of the edge of the tower wall and are evidence of the below ground 17th-century tower foundations.

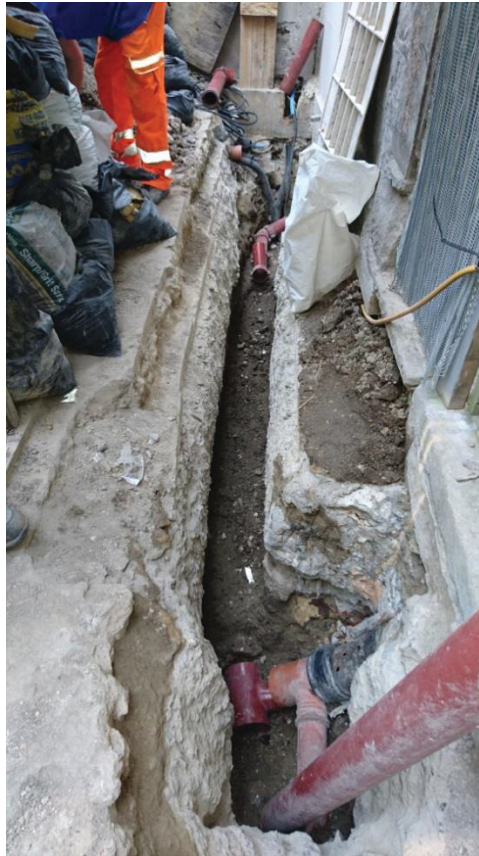
Fig 5 Excavated drain run looking north

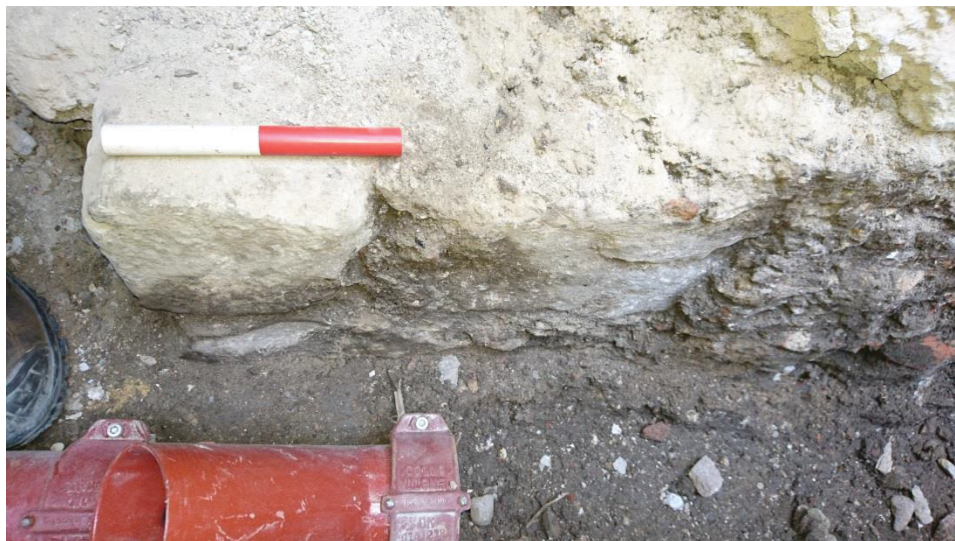
Fig 7 Detail of ashlar foundation at north-west corner of St Mary Somerset (0.2m scale)

5.3.2 The drainage works also established that areas of the original the 17th-century tower foundations remain below the modern concrete slab at the north-west corner of the tower.
