TOWER OF ST MARY SOMERSET
Lambeth Hill
EC4

An archaeological evaluation report

November 2005

Site Code: SYO03

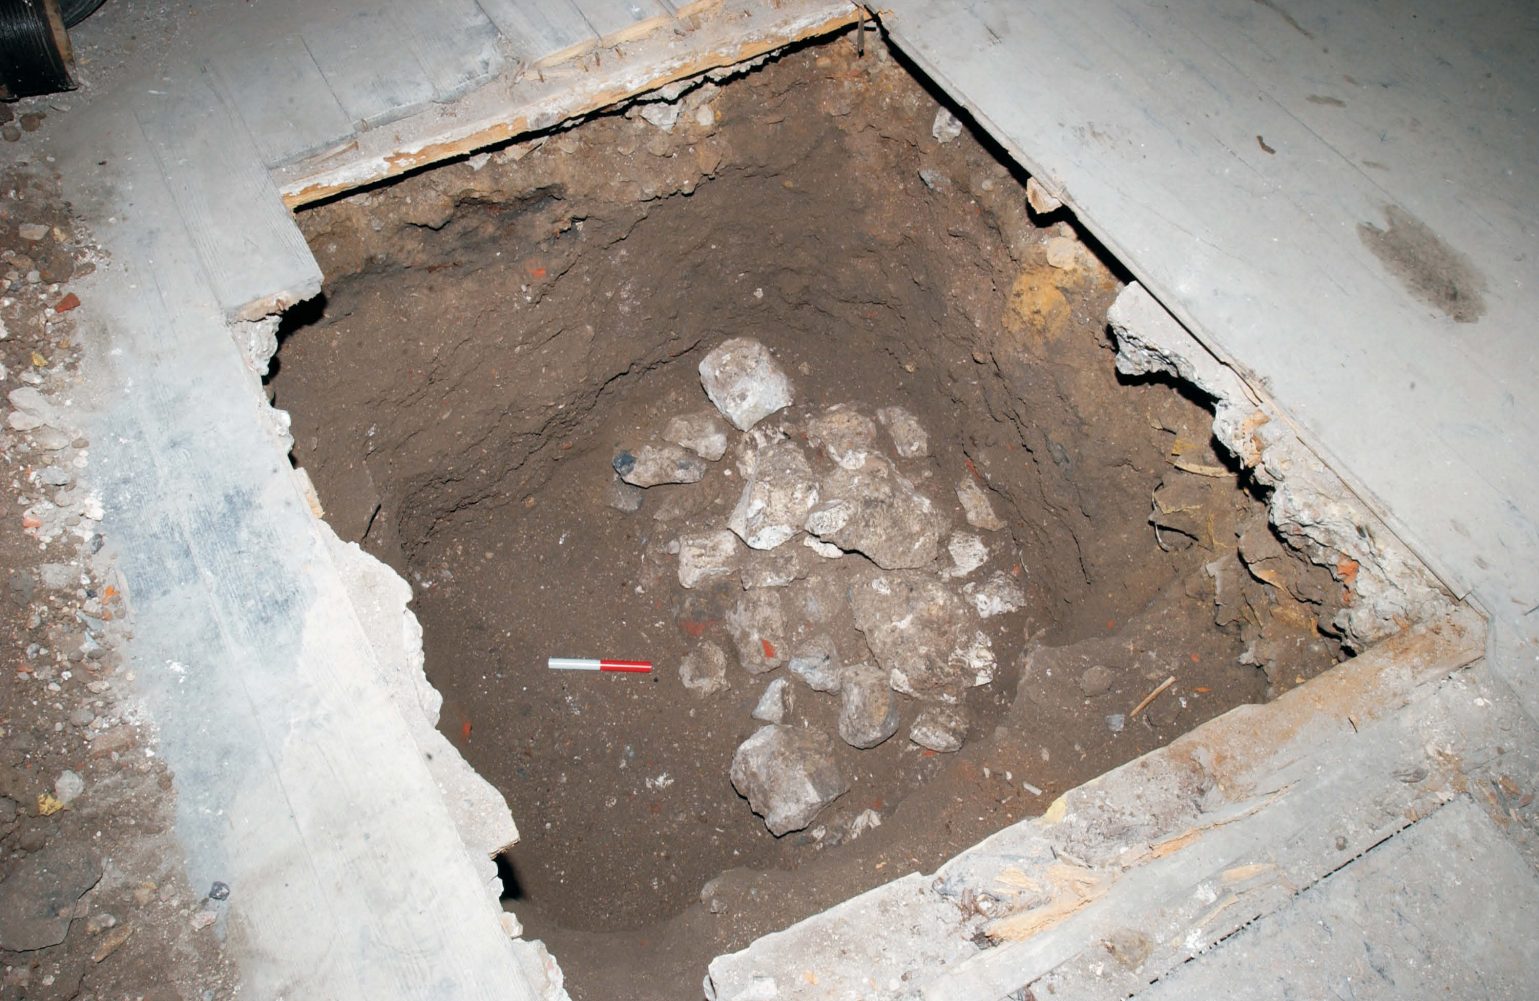
Fig 4 Foundation in test pit 3 looking south-east

Below the cut for a drain (0.75m below floor level) a ragstone, chalk and flint foundation was revealed (Fig 4). Dump material to the north was subsequently removed in order to establish the nature and extent of this foundation material. Excavation revealed the feature lay on a roughly east-west alignment. The largest blocks were of unfaced chalk, measuring c 0.30 x 0.30 x 0.15m and smaller ragstone blocks of 0.20m x 0.15m x 0.10m were mainly unfaced, although two were noted as being faced on at least two sides. There were also occasional flint nodules within the structure.

The foundation appeared to have been heavily disturbed and was in a fragile state, probably due to construction of the 19th century drain above and possibly also to the earlier activity associated with dumps to the north. The feature was not dated and no excavation of the material took place. No cut was evident and the observed remains may represent a partially or completely collapsed, or redeposited feature. However the extent of any disturbance could only be confirmed by further excavation of the surrounding deposits. The alignment of the feature suggests it may represent remains of the original 12th century church.

During excavation of a pit within the tower a disturbed ragstone, chalk and flint foundation was revealed (Fig 4). The foundation lay on a roughly east-west alignment. The largest blocks were of unfaced chalk, measuring c 0.30 x 0.30 x 0.15m and smaller ragstone blocks of 0.20m x 0.15m x 0.10m were mainly unfaced, although two were noted as being faced on at least two sides. There were also occasional flint nodules within the structure.

The foundation appeared to have been heavily disturbed and was in a fragile state, probably due to construction of the 19th century drain above and possibly also to the earlier activity associated with dumps to the north. The feature was not dated and no excavation of the material took place. No cut was evident and the observed remains may represent a partially or completely collapsed, or redeposited feature. However the extent of any disturbance could only be confirmed by further excavation of the surrounding deposits. The alignment of the feature suggests it may represent remains of the original 12th century church which is known to have existed on this site.

Experience from other sites has shown that isolated and exposed blocks of stratigraphy can be vulnerable to damage during construction work. The foundation recorded in test pit 3 was in a disturbed and fragile state and further work in the surrounding area may cause more damage.
