BASEMENT VAULTS AT NO 8 BALDERTON STREET London W1

Standing building survey

Standing Building Survey Report

Site code: BAL11

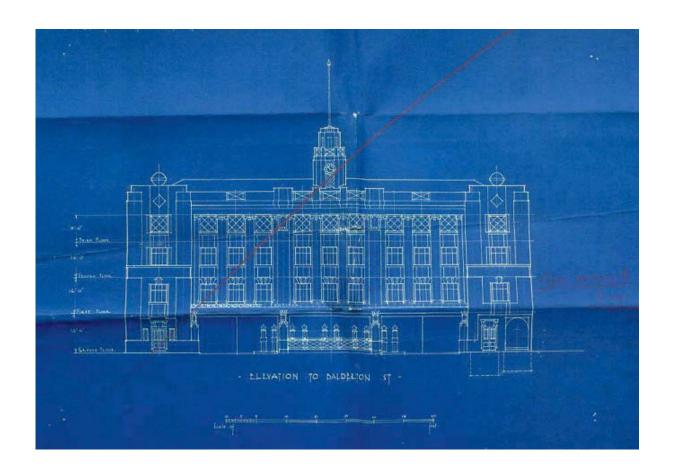
Front cover: Architect's blueprint of the front elevation of the garage, showing the basement vaults in section to the north, with dashed lines, 1925 (Heyne Tillett Steel 2009)

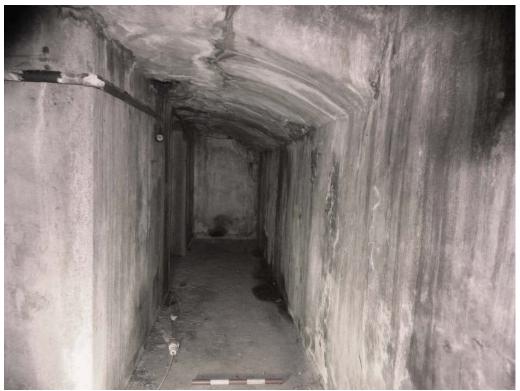
Fig 14 The half-vault, looking north (MOLA image 19)

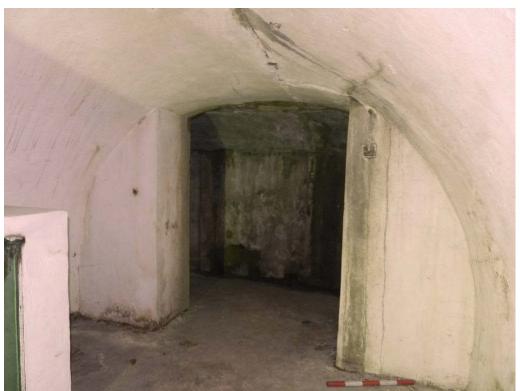
Fig 15 Connection between the northern vault and the half-vault, looking north-east (MOLA image 25)

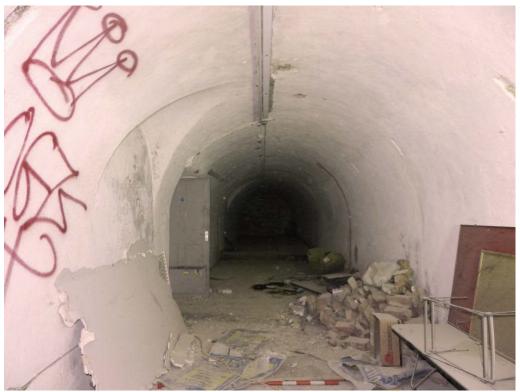
A doorway was cut into the south wall of the northern vault at a distance of about 14.4m from the west end of the vault and 7.5m from the east end (Fig 17). This doorway was squared, about 0.9m wide, with the soffit of its concrete lintel at a height of 1.8m from the basement floor, and closed with a plain four-panelled timber door. This doorway led into the northern vault from the foot of a flight of granolithic steps constructed at a distance of 0.59m to the south of the vault. These steps led eastwards up to the ground floor of the garage.

Fig 17 The northern vault looking west, showing an opening on the south groined into the vault, later blocked, and the entrance of 1925–26 (MOLA image 35)

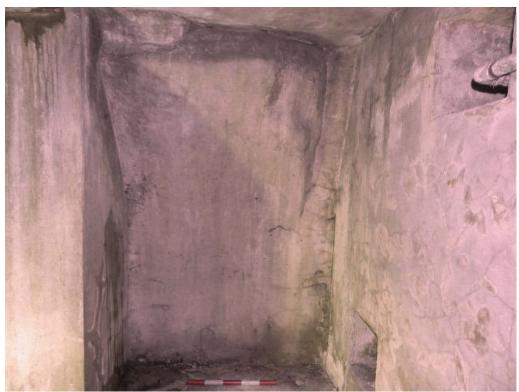
Fig 18 The east end of the southern vault, looking south, showing broken south wall (MOLA image 14)

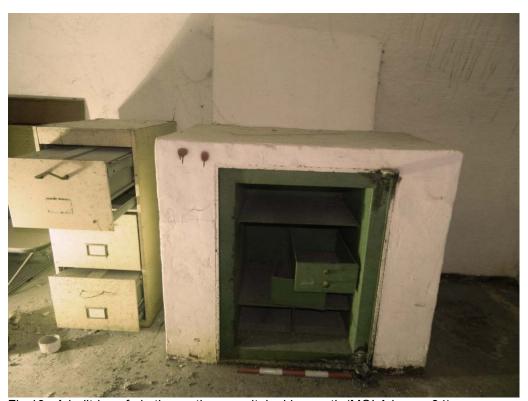
Near the east end of the northern vault a brick buttress had been added to the north sidewall so as to create a solid vertical backing for a large steel safe, which was flanked by brick walls and thus firmly built into the vault (Fig 19; sheet 3).

Fig 19 A built-in safe in the northern vault, looking north (MOLA image 34)

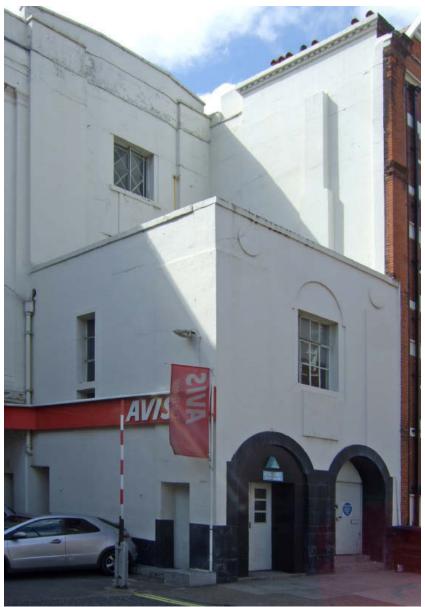
The upper floors of the new garage also extended over the passage to St Mark's church (Fig 20).

Fig 20 Exterior of the garage on Balderton Street and the east opening to the ground-level passage to St Mark's Church, looking south-west (Heyne Tillett Steel 2009)
