QUEBEC WAY Canada Water London SE16

Evaluation and Watching brief report

Site Code QBW13

Report on archaeological evaluation and watching brief

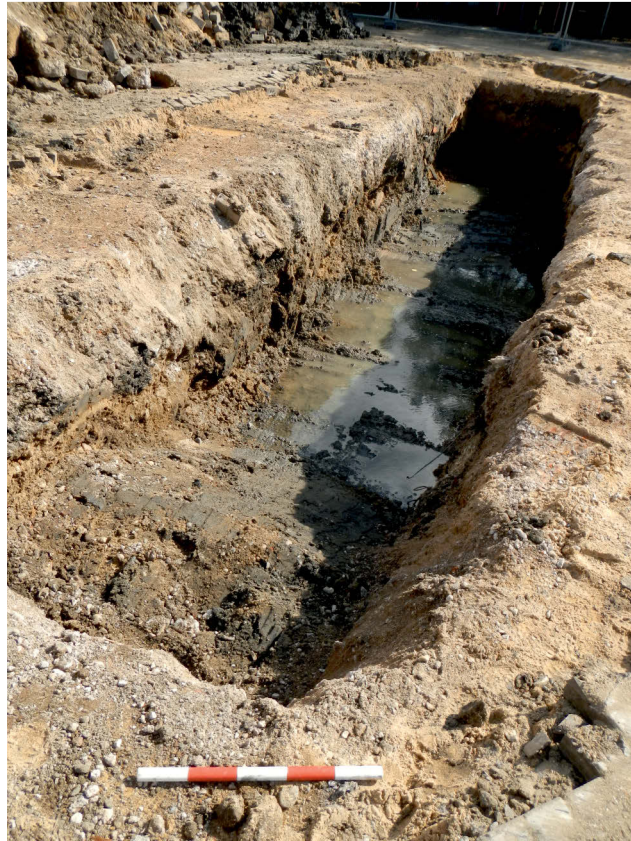
Fig 3 Trench 1, general view; facing SE

<i>Evaluation Trench 1 (see figs 3 & 4)</i>	
Location	Southern area of the site, in the car park
Dimensions	11.30 m by 2.20 m by 3.50 m depth
Modern ground level/top of slab	4.85 – 4.95 m OD

The earliest feature recorded in Trench 1 was a modern concrete surface situated at 1.45 m OD. It was partially observed in a sondage excavated to c 2m depth from the base of the trench. Its full extent or function is unknown. The auger holes attempted within the trench (AH's 1 and 1a) hit this obstruction at c 2m depth from the base of the trench, suggesting that the concrete did extend across at least the majority of the trench length. The concrete slab may be the floor of a deep storage tank associated with former dockside structures.

The concrete slab rested below c 2m of variable made ground consisting of dark grey silty clays containing gravel and fragments of concrete and brick. The deposits are likely to represent an episode of deliberate backfilling following the disuse of the structure associated with the concrete slab.

The upper subsurface deposits consisted of a modern consolidation layer overlain with concrete and thin sand bedding for the modern brick paving. No archaeological structures or deposits were observed.

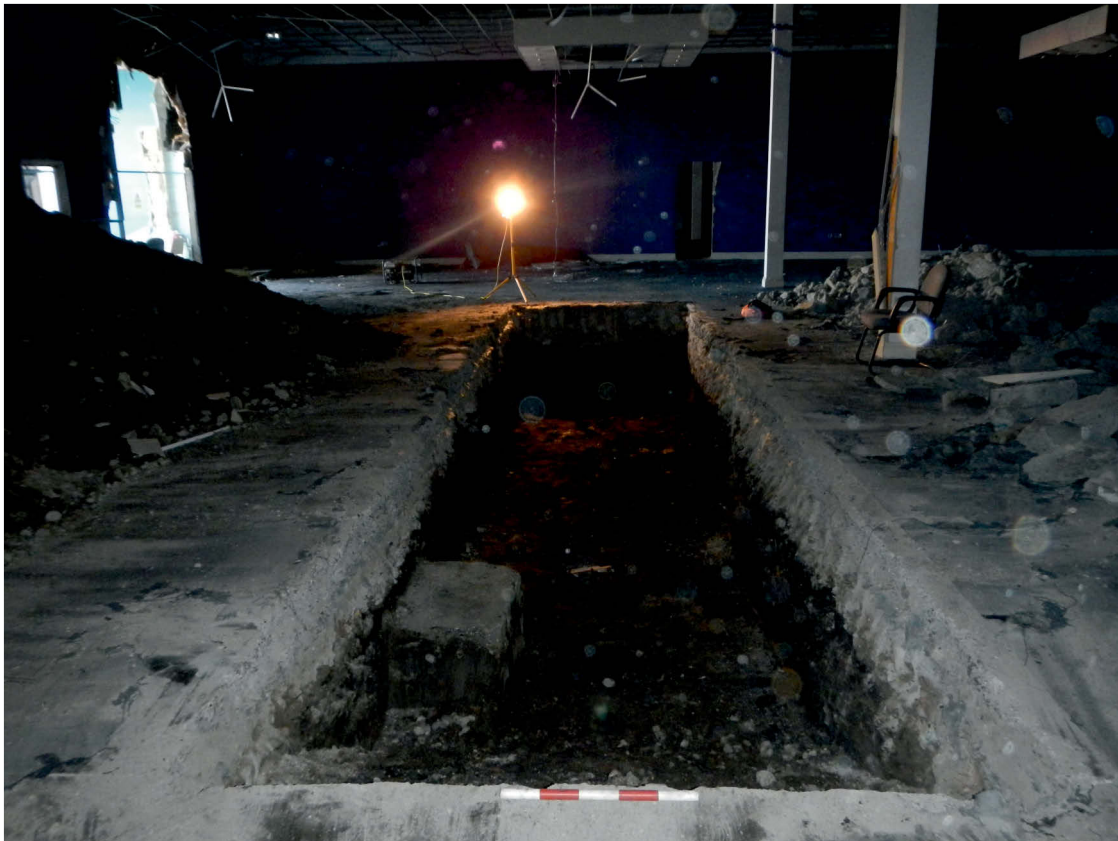
Fig 5 Trench 2, general view; facing E

<i>Evaluation Trench 2 (see figs 5 & 6)</i>	
Location	Southern/central area of the site, inside the church building
Dimensions	10.30 m by 2.30 m by 4.50 m depth
Modern ground level/top of slab	5.22 – 5.24 m OD
Base of modern fill/slab	2.30 m OD
Depth of archaeological deposits seen	None observed
Level of base of deposits observed and/or base of trench	n/a
Natural observed	2.30 m OD

The natural sequence was overlain by several layers of modern made ground (c. 1.75m thick in total) which included; mid yellow brown silty sand and gravel with occasional fragments of mortar (from 0.30 to 0.70 m thick). This was truncated by a small concrete stanchion (0.90 m long, 0.40 m wide and 0.70 m high; at 4.54 m OD; continued below the limit of excavation) as well as a modern intrusion filled with dark grey silty sandy clay with gravel, fragments of ceramic building material, fragments of concrete and occasional timber. This was overlain by 0.3m of concrete crush and sealed by a reinforced concrete slab c 0.20m thick.

No archaeological deposits or structures were observed.

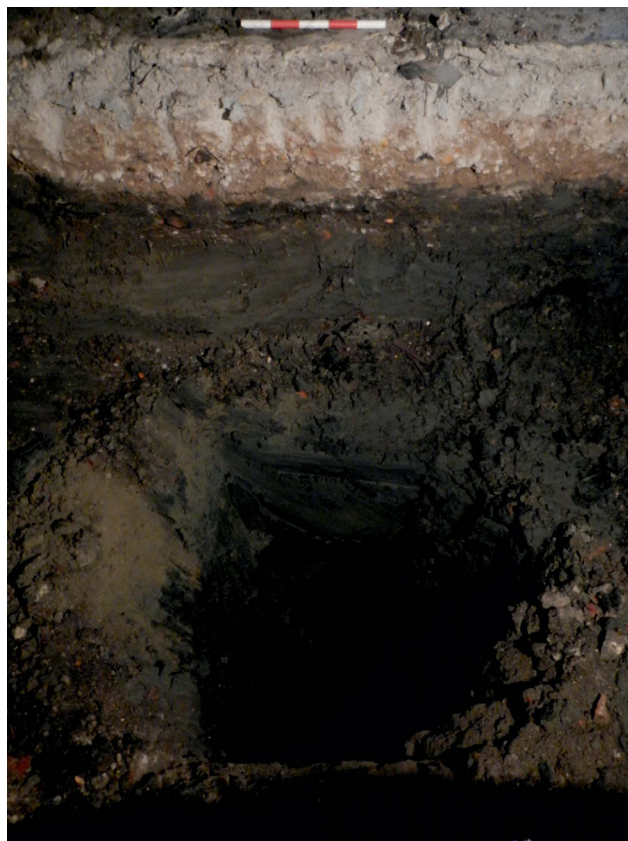
Fig 6 Machine slot in Trench 2; facing N

The basal deposits in Trench 2 consisted of a fine to medium densely packed gravel at – 0.52 m OD. It was only reached in AH2, and not in the 3 m deep sondage excavated in the base of the trench. This gravel deposit represents the Shepperton floodplain gravels, deposited approximately 15–10,000 years ago within a braided river channel during the Late Devensian glacial period.

The gravels were overlain by a layer of greenish grey fine to medium sand with occasional gravel. These were observed in the auger hole at –0.34 m OD. The sands are fluvial in origin and were likely to have been deposited within a single threaded or anastomosing channel during the Lateglacial to Early Period c 10,000 years ago. The next deposit in the recorded sequence was a light greenish grey silty clay, at 2.30 m OD, tending towards a dark grey colour towards the base. These deposits probably represent the formation of mudflats and salt marsh within an intertidal fluvial regime, and probably date from the Late Prehistoric (i.e. Iron Age) to historic (i.e. medieval) periods. An organic clay band measuring 0.20m thick was observed at c 1.43m OD. The organics may represent the development of a semi terrestrial vegetated horizon

Within this deposit a band of dark bluish grey sandy clay with a small lens of light grey sand was observed in the sondage, at approximately 1.33 m OD. The change in clast size from finer clays and silts to sands probably represents episodic increases to channel flow velocity, entraining and depositing coarser bed load deposits. The alluvial sequence measured c 2.70m in total thickness. It was overlain by a layer of dark grey to black sand with occasional lumps of clay (at 3.04 m OD). This material represents disturbed/redeposited alluvium.

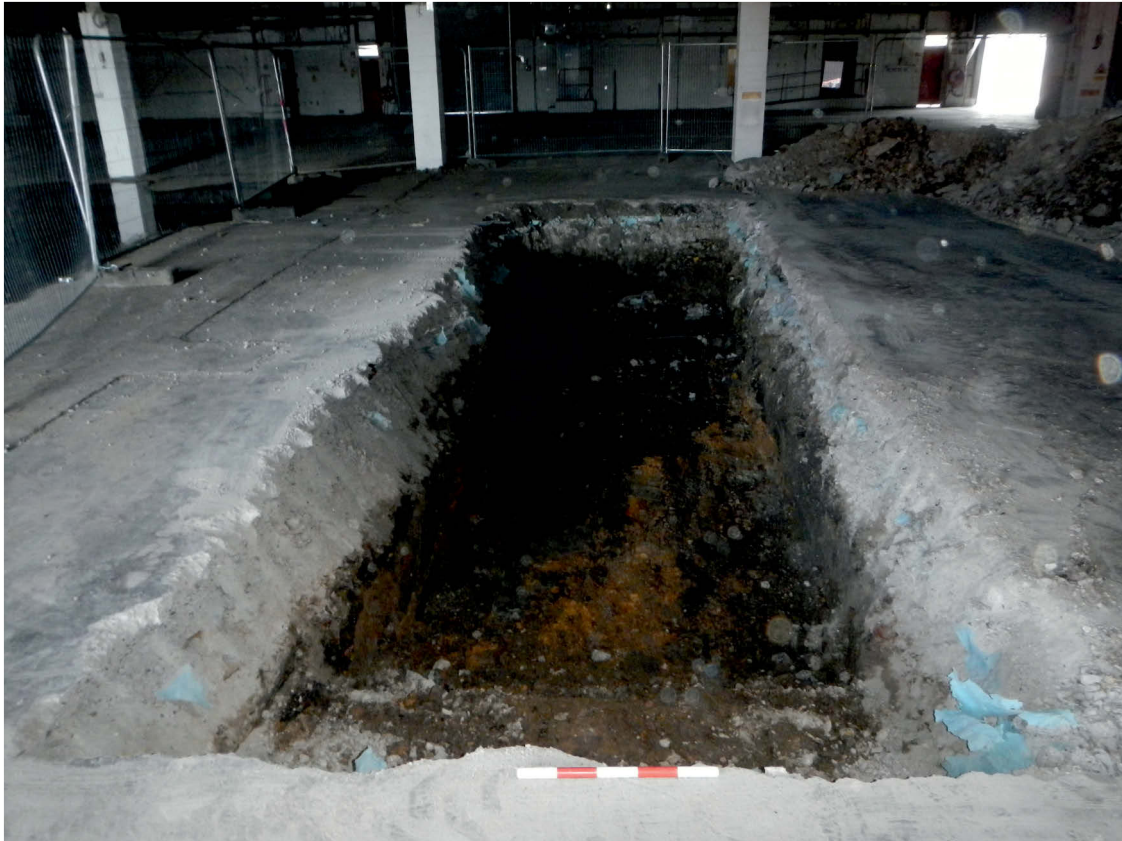
Fig 7 Trench 3, general view; facing N

<i>Evaluation Trench 3 (see fig 7)</i>	
Location	Centre of the site, inside the warehouse building
Dimensions	10.25 m by 2.80 m by 2.60 m depth
Modern ground level/top of slab	5.20 – 5.21 m OD
Base of modern fill/slab	1.44 m OD
Depth of archaeological deposits seen	None observed
Level of base of deposits observed and/or base of trench	N/a
Natural observed	1.44 m OD

The basal deposit in Trench 3 consisted of the floodplain Shepperton Gravels, which occurred at –0.59m OD. This was overlain by a 0.9m thick unit of greenish grey sands occurring at 0.31 m OD. The sands here were higher than observed in Trench 2, suggesting that the sands formed a channel bar feature. The sands were overlain by a 1.1m thick unit of mid grey silty clay, occurring at c 1.41 m OD. As with the fine grained units observed in Trench 2 these deposits mostly likely accumulated within intertidal mudflat or salt marsh environments. All the above deposits were observed in the auger holes (AH3) only.

The natural floodplain sequence was overlain by a c 1.60m thick deposit of redeposited alluvial material containing fragments of ceramic building material and mortar. The upper surface of the deposit occurred at 3.01m OD. The deposit was observed in the sondage and AH3. This deposit was overlain by a 1.70 m thick deposit of dark brown sandy silty clay with frequent fragments of ceramic building material, lenses of yellow sand and light greenish grey clay. This rested directly below a make-up of crushed concrete and brick for the floor surface of the existing building in the form of reinforced concrete slab (0.50 m thick in total).

No archaeological structures or deposits were identified.

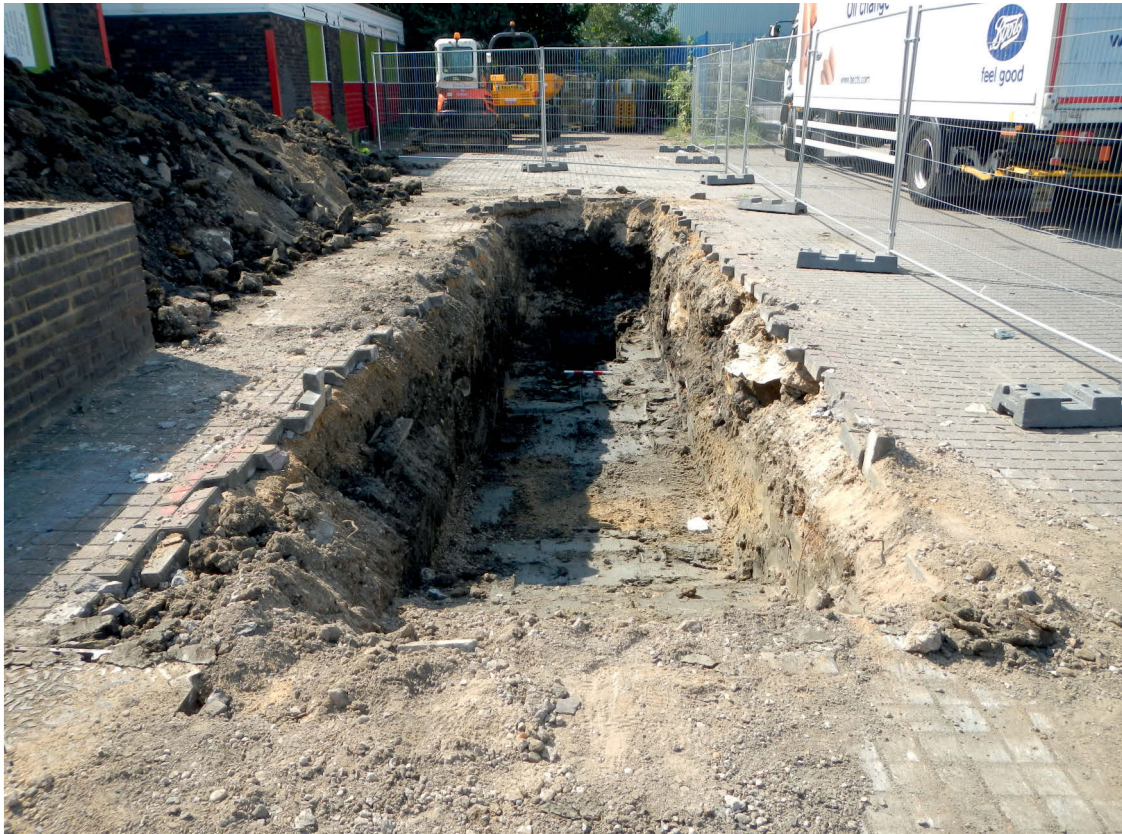
Fig 8 Trench 4; general view; facing W

<i>Evaluation Trench 4 (see fig 8 & 9)</i>	
Location	Centre of the site, in the car park on the northern side of the warehouse building
Dimensions	10.30 m by 2 m by 3.30 m depth
Modern ground level/top of slab	5.03 m – 5.05 m OD
Base of modern fill/slab	2.65 m OD
Depth of archaeological deposits seen	None observed
Level of base of deposits observed and/or base of trench	N/a
Natural observed	2.65 m OD

The alluvial stratigraphy was overlain by modern made ground, at 4.63 m OD, in the form of a thick deposit of dark grey alluvial clay mixed with black sand, brick fragments, and occasional large fragments of sandstone. The uppermost deposits consisted of 0.40 m thick concrete make-up, overlain with a thin layer of sand supporting the brick paving.

No archaeological structures or deposits were recorded.

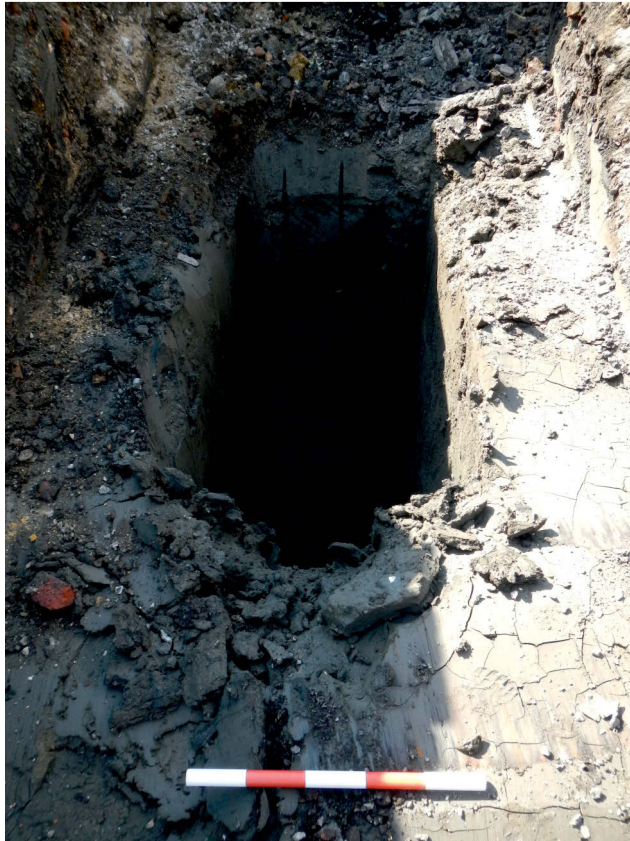
Fig 9 Machine slot in Trench 4; facing W

The basal deposits recorded in Trench 4 consisted of the Shepperton Gravels occurring at –0.49 m OD. These were overlain by a dark brown, slightly organic fine to medium sand that tended towards an inorganic light greenish grey sand towards the base. The top of the sands was observed at c 0.59m OD. The sands were overlain by a dark grey silty clay that tended towards an organic silty clay towards the base of the unit. Occasional molluscs were observed throughout. This unit was observed at 2.65 m OD.

The presence of organics within the top of the underlying sands and the base of the finer silty clays is indicative of semi terrestrial vegetated horizons forming within channel marginal areas. The sands on this part of the site were higher than observed elsewhere suggesting a general increase in the elevation of the topography towards the northern part of the site. As mentioned previously it is likely that the elevated sands formed a channel bar feature. Following a reduction in discharge rates, due to the amelioration of the climate during the Lateglacial/Early Holocene transition, the surface of this channel bar feature probably became exposed for prolonged periods of time allowing vegetation to colonise the upper surface of the channel bar.
