A targeted investigation of the historic carpentry of the Central Roof of the nave of St Pauls Cathedral

City of London

Standing Building Survey Report

November 2013

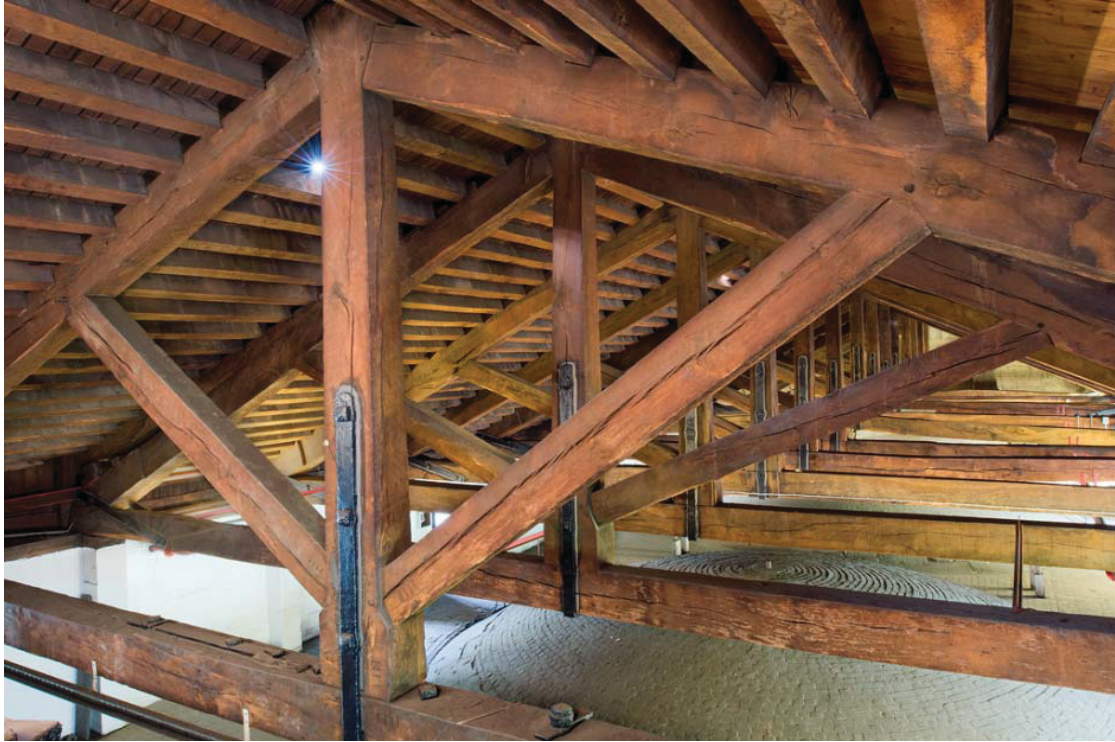
Fig 5 General photograph of the form of the horizontal tie beam roof trusses of St Pauls nave central roof looking east with Truss 14 in the foreground. Showing part of the through splayed bolted scarf in the, slightly wider, western, Truss 14 and the unscarfed 14.08m (46' 2") long tie beams used in the eastern trusses. Also visible are the chisel cut, combined truss and joint numbers in 2" and 1" sizes.

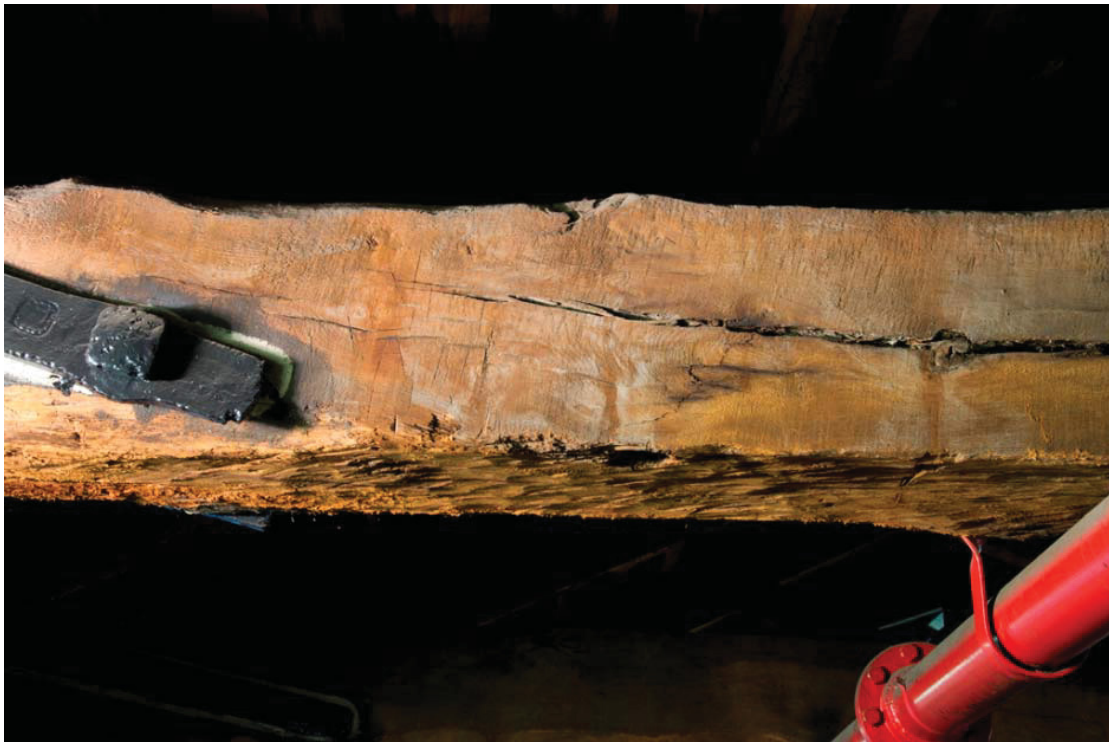
Fig 11 Detailed photographs showing the south end of the Truss 9 tie beam with its sawn side axe hewn lower face

It is quite clear from the irregular scalloped surfaces of the smaller ends of many of the longer nave roof timbers that 'hewing' was the technique used to remove sapwood, bark and waste heartwood where the parent logs were only just big enough. Several meters of the smaller ends of many of the single piece eastern tie beams had moderately roughhewn faces with some sapwood left on the corners. A clear example of such axe hewn surfaces surviving on the south end of the tie beam of Truss 9 is shown in Figure 11. The hewing was only moderately regular not finished by smooth broad axe work, as it normally was in medieval London carpentry. Detailed recording of post-medieval carpentry work in southern England has shown that by the 17th century hewn surfaces were typically not expected to be very smoothly, broad axe finished but a moderately flat, regular surface was generally adequate (Goodburn 2009, and archive reports on 17th carpentry at Middle Temple, and St Ethelburgas church, Goodburn and Minkin 1996). No evidence for the shipwright's practice of surface smoothing with an adze was found on any of the St Pauls timbers.

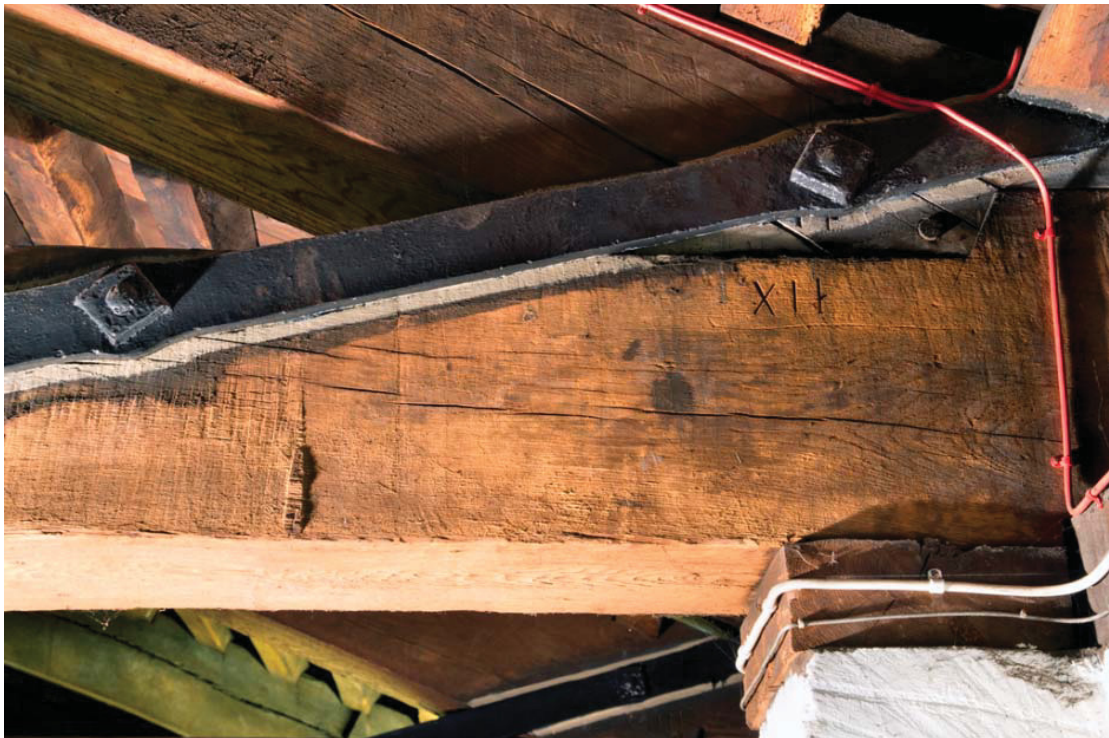
Fig 12 Detailed photographs showing of Truss 9 looking west, shows a ridge left where sawing out the face from both ends converged but did not quite meet, probably indicative of sawing on two high trestles. Also showing a combined joint and truss number cut with a 2" chisel and given a 'tag'.

Also unpublished work by some of the new wave of English timber framers has shown that following marking out a log, firmly held in place, it was then scored at intervals with a heavy, felling-type axe. This was followed by using the same tool to split off large amounts of waste, close to the full depth of the scores (photos available if needed). The rather rough, uneven surface that generally then resulted was then chopped i.e. hewn back with axe blows at a shallower angle, using a plumb bob

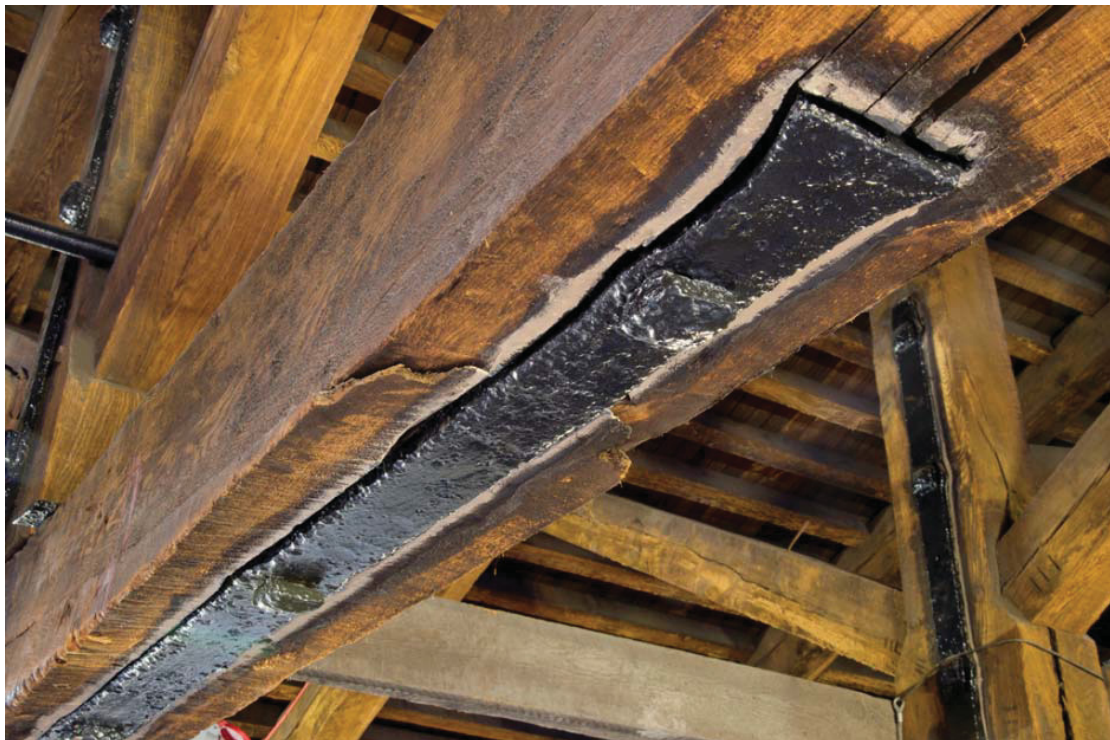
Fig 13 Photograph showing details of the simple through splayed scarf and original inset iron reinforcing strap, in the soffit of the tie beam of Truss 20. Shows how recessing of the dovetail ended iron strap was crudely done with a slack fit and cutting away of the ends of the scarf joint. The paint is modern

A cogged type of scarf was found and sketched by Hewett, used in broadly contemporary carpentry in Westminster Abbey work which it seems likely that Wren or some of his team should have been aware of (Hewett 1985, p224). The very crude recent addition of unnecessary grey and black paint on the straps makes the appearance of this even uglier (Fig 13).

Although much of the initial work, such as the sawing of the timbers and joint cutting, was carried out to a high standard some other aspects of the work were less carefully executed, such as the crude scarfing and fastening of the horizontal tie beams in the wider western trusses. Evidence of aspects of building site practice that resulted in minor damage to the carpentry of the roof through wear by hauling ropes used by the bricklayers is also described. Perhaps these strands of evidence indicate less close supervision on-site by Wren and his team or reflect the fact that towards the ends of the project he must have been much less able to examine the work carried out at height. Evidence was also recovered for step wise phases in the building of the roof in the form of partially blocked, temporarily used, mortise joints showing that in the area of the western dome the work of the carpenters was well ahead of the bricklayers and masons.

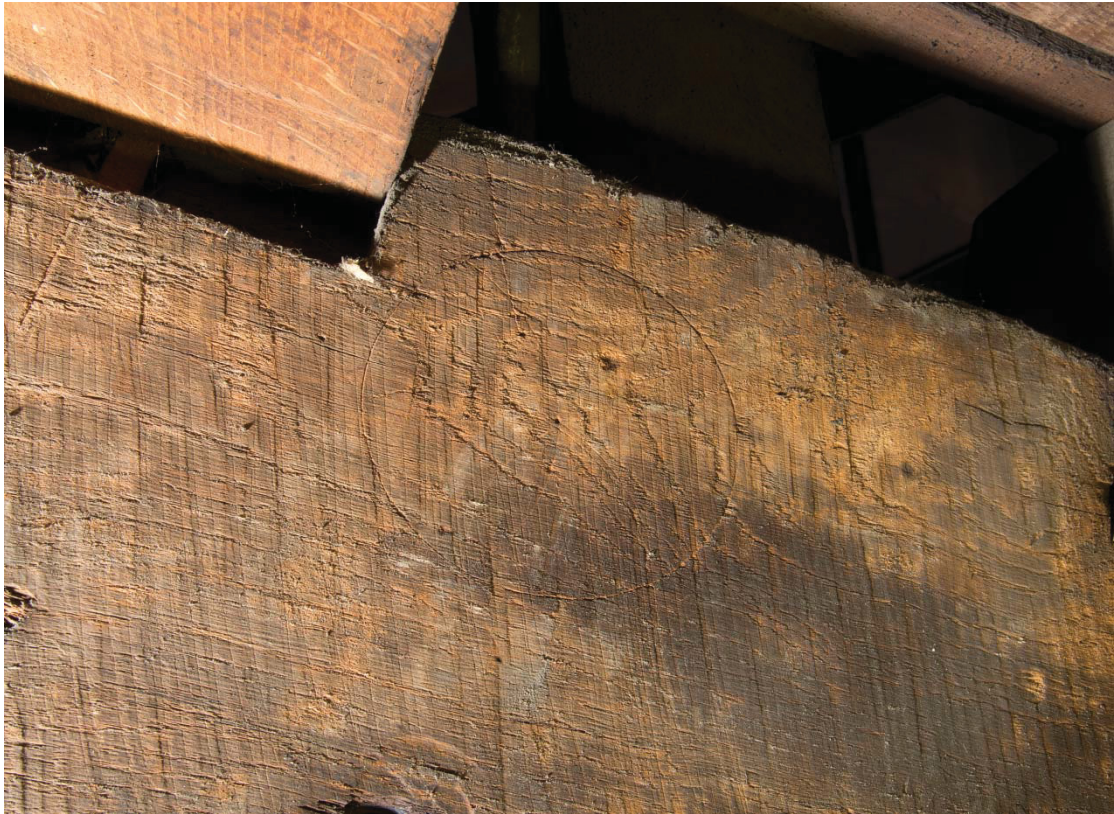
Fig 15 close up of a large historic oak rafter of St Pauls cathedral type reused in recent additional truss 22b over the portico roof. The faint outline of part of a compass drawn daisy wheel, possibly a 'witch mark' is visible cutting through the pit saw marks

During the final stages of the one day long investigation of the St Pauls central nave roof it was possible to rapidly examine some of the roof carpentry of the extreme western part of the roof where it extends over the portico. This work was particularly hurried and the lighting poor, but the existence of a pair of relatively recent, rather crudely made, $\frac{1}{2}$ trusses was established (Trusses 22a and b Fig 1). The tool mark evidence and patina of some of the oak timber found in these additions, such as circular saw marks, isolated the most recent timbers (The work is thought to possibly date as late as 1903, J Scofield, Pers. com.). However, some of the oak timbers had relict joints, traces of pit sawn conversion and a patina just like that of the, in-situ historic roof timbers of the nave central roof. One on the north side (Truss 22b) had simple lap joints and proportions similar to those of the rafters in the central nave roof trusses. It would appear to have been originally a rafter from a common rafter roof in another area of roofing at St Pauls. A very brief application of low angle torch light revealed a faintly scribed 'daisy wheel' mark (Fig. 15) on this timber, which although cutting through the pit saw marks, appeared to be ancient i.e. dating to the c. 1690's to early 1700's. These marks were made with compasses, which were used first to scribe a circle and were then set to the radius of the circle and used to scribe a series of petal-like arcs within it. The daisy wheel marks are often found on historic building timbers and there are two schools of thought as to their meaning and use. One school suggests that they were marks designed to guard against bad hexes from witches (Hence they are sometimes called 'witch marks' Easton 1998). The alternative view sees them as geometrical design aids used to develop accurate angles and shapes by carpenters and masons (Smith 1997). The first named writer has seen much variation in the execution of these marks and their location and would suggest that both explanations could apply, depending on the location and execution of the marks. In the case of the daisy wheel on the reused rafter type timber from in Truss 22 b, it's very faint execution might possibly indicate that it was trial work by an apprentice trying to learn the skill of accurate scribing with a compass, on hard oak timbers.
