**HARFORD FARM
Forest Green Road
Holyport**

Evaluation report

**HARFORD FARM
Forest Green Road
Holyport
Berkshire
SL6 2NN**

Report on an archaeological evaluation

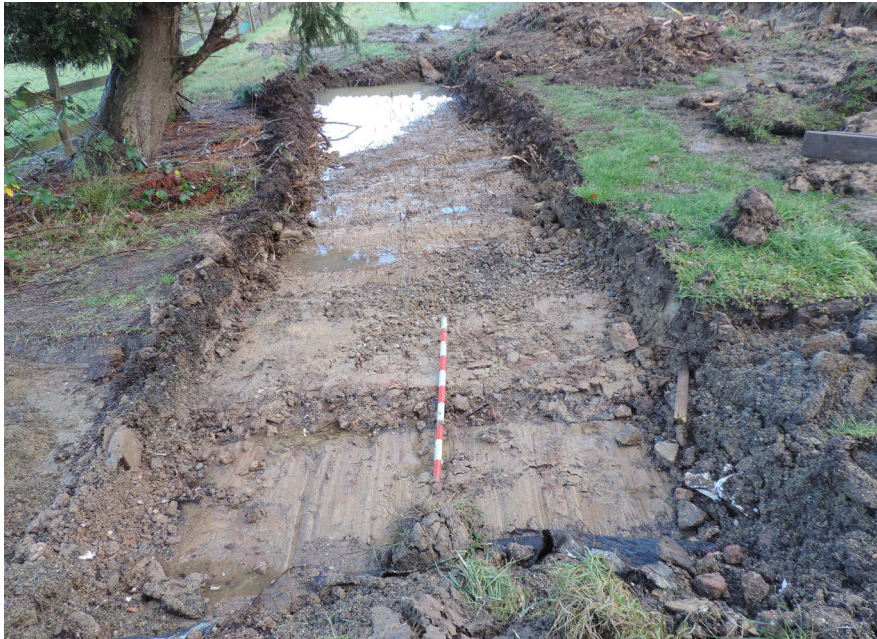
Fig 3: Trench 1, facing north

Location	West of existing barn
Dimensions	10m x 2m x 0.30m
Modern ground level	N: 45.19m OD, S: 45.74m OD
Base of modern turf	N: 45.09m OD, S: 45.64m OD
Depth of archaeological stratigraphy above natural (if any)	none
Level of base of lowest features or deposits observed	N/A
Top of surviving natural observed at	N: 45.09m OD, S: 45.64m OD
Level of base of trench	N: 44.92m OD, S: 45.40m OD

- 4.1.1 Naturally deposited weathered London Clay was observed at 45.64m OD, sloping northwards to 45.09m OD. Cut into the natural clay was an east-west aligned land drain filled with compacted gravel. Overlying this was 0.10m thick layer of turf (Fig 3).
- 4.1.2 No archaeological deposits or features were observed in Trench 1.

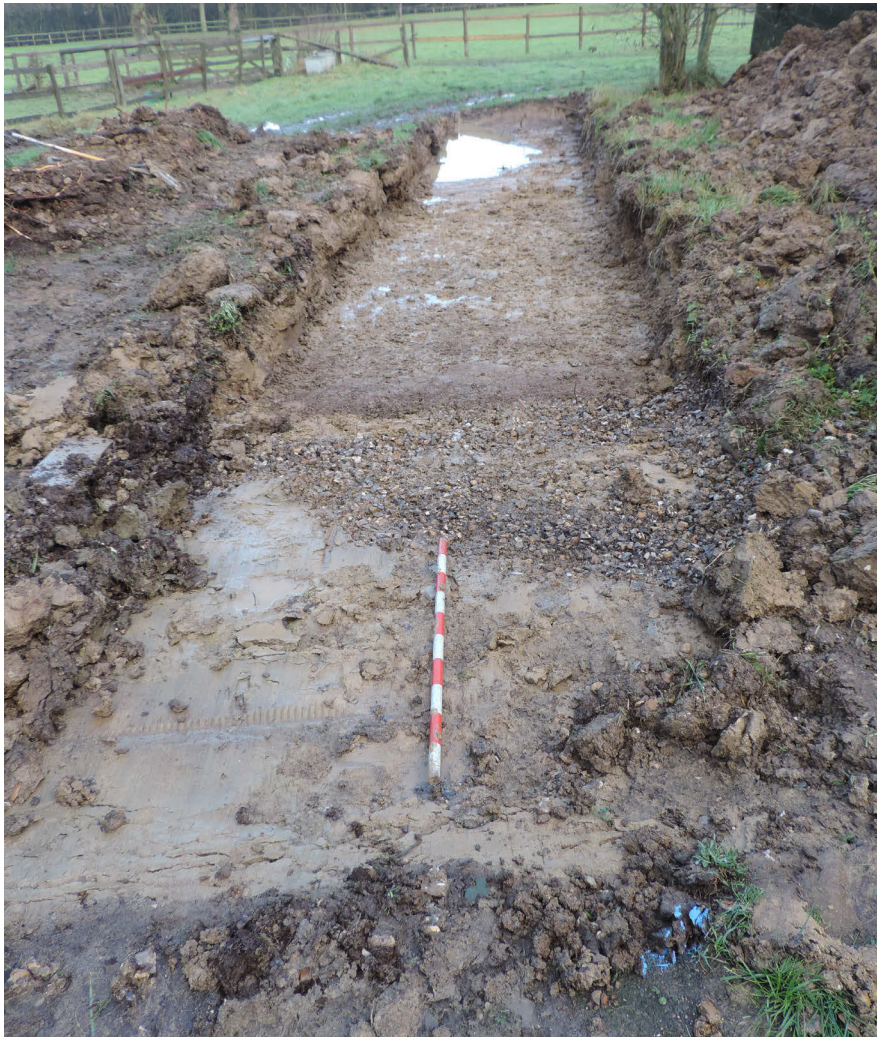
Fig 4: Trench 2, facing north

Location	West of existing barn
Dimensions	14m x 2m x 0.40m
Modern ground level	N: 45.56mOD, S: 45.99m OD
Base of modern turf	N: 45.46mOD, S: 45.89m OD
Depth of archaeological stratigraphy above natural (if any)	None
Level of base of lowest features or deposits observed	N/A
Top of surviving natural observed at	N: 45.46mOD, S: 45.89m OD
Level of base of trench	N: 45.24mOD, S: 45.79m OD

4.2.1 Naturally deposited weathered London Clay was observed at 45.89m OD, sloping down northwards to 45.46m OD. Cut into the natural clay was an east-west aligned land drain filled with compacted gravel. Overlying this was 0.10m thick layer of turf (Fig 4).

4.2.2 No archaeological deposits or features were observed in Trench 2.

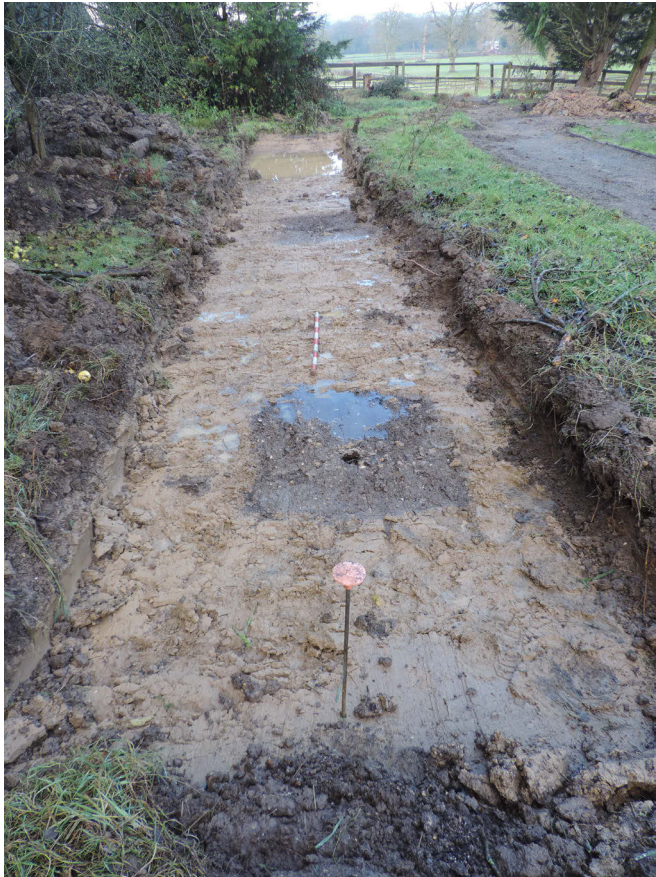
Fig 5: Trench 3, facing west

Location	North of the existing pool
Dimensions	14m x 2m x 0.40m
Modern ground level	E: 46.76m OD, W: 46.05m OD
Base of modern turf	E: 46.56m OD, W: 45.85m OD
Depth of archaeological stratigraphy above natural (if any)	None
Level of base of lowest features or deposits observed	N/A
Top of surviving natural observed at	E: 46.56m OD, W: 45.85m OD
Level of base of trench	E: 46.35m OD, W: 45.85m OD

4.3.1 Naturally deposited weathered London Clay was observed at 46.56m OD, sloping down westwards to 45.85m OD. Cut into the natural clay were three modern rectangular tree pits, the trees having been removed during the trench clearance. Overlying this was 0.20m thick layer of turf (Fig 5).

4.3.2 No archaeological deposits or features were observed in Trench 3.

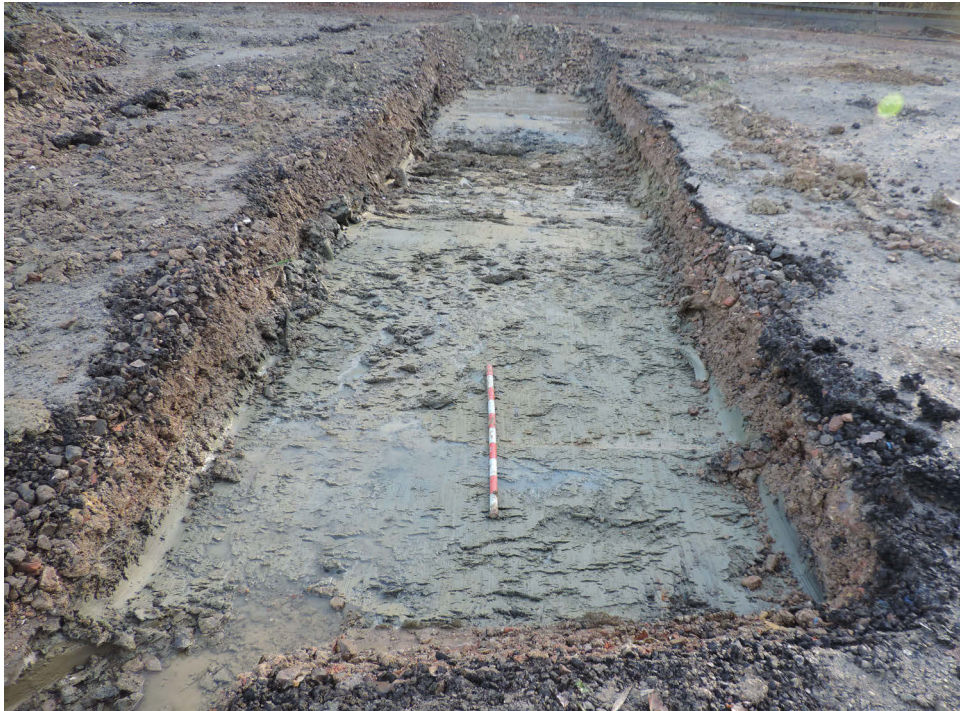
Fig 6: Trench 4, facing east

Location	NE corner of the existing barn
Dimensions	8.70m x 2m x 0.40m
Modern ground level	46.68m OD
Base of modern tarmac	46.58m OD
Depth of archaeological stratigraphy above natural (if any)	None
Level of base of lowest features or deposits observed	N/A
Top of surviving natural observed at	46.28m OD
Level of base of trench	46.19m OD

4.4.1 Naturally deposited London Clay was observed at 46.28m OD within the western half of the trench. Cut into the natural clay to the east was modern linear cut filled with black waterlogged clay with wood and other organic inclusions. A frogged brick dates the feature to the 20th century. Overlying this was 0.30m of a levelling deposit consisting of crushed concrete and ceramic building material (CBM). Sealing this was a 0.10m thick surface layer of tarmac (Fig 6).

4.4.2 No archaeological deposits or features were observed in Trench 4.

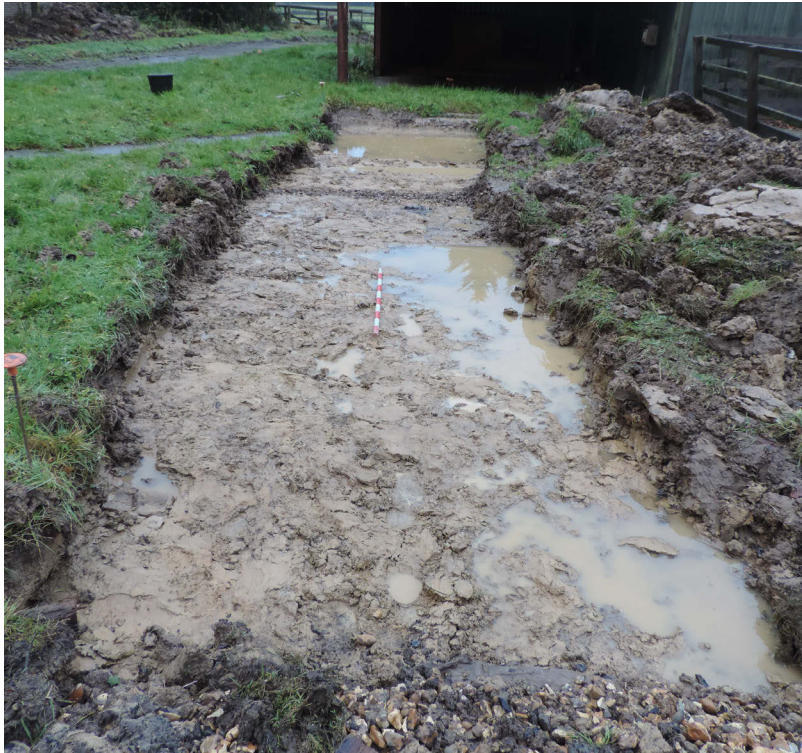
Fig 7: Trench 5, facing west

Location	SE corner of existing barn
Dimensions	8.50m x 2m x 0.30m
Modern ground level	E: 47.02m OD, W: 46.75m OD
Base of modern turf	E: 46.92m OD, W: 46.65m OD
Depth of archaeological stratigraphy above natural (if any)	None
Level of base of lowest features or deposits observed	N/A
Top of surviving natural observed at	E: 46.92m OD, W: 46.65m OD
Level of base of trench	46.75m OD

4.5.1 Naturally deposited London Clay was observed at 46.92m OD, sloping down westwards to 46.65m OD. Cut into the natural clay was a north-south aligned land drain filled with compacted gravel. Overlying this was 0.10m of turf (Fig 7).

4.5.2 No archaeological deposits or features were observed in Trench 5.

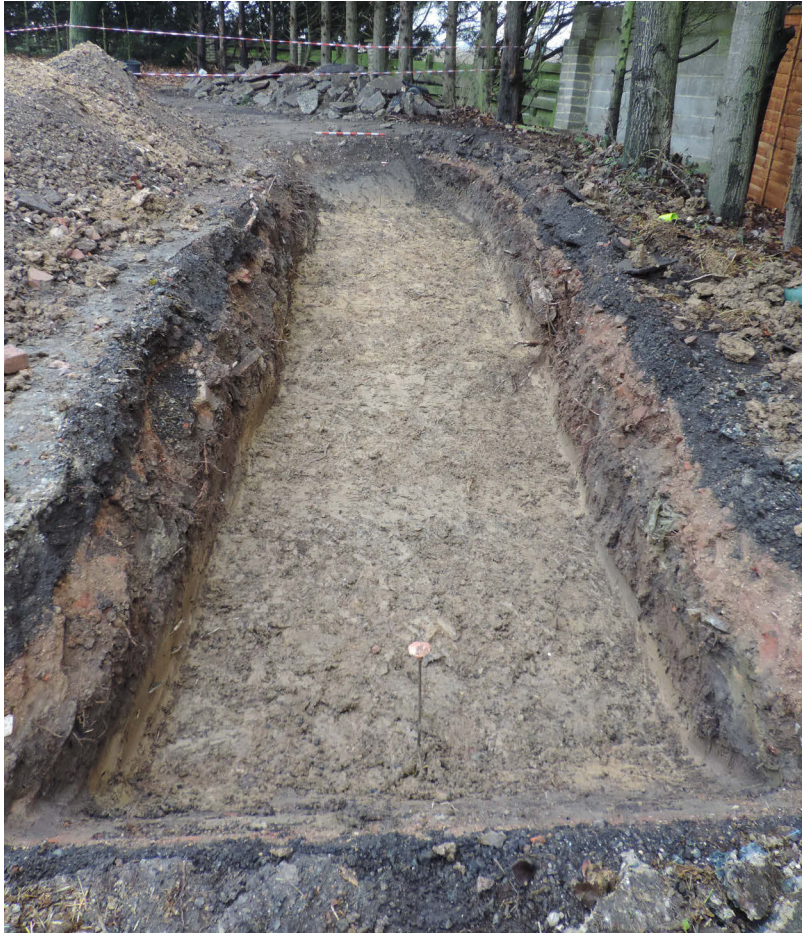
Fig 8 Trench 6, facing east

Location	By the stables
Dimensions	10m x 2m x 1.26m
Modern ground level	46.64m OD
Base of modern slab	46.58mOD
Depth of archaeological stratigraphy above natural (if any)	None
Level of base of lowest features or deposits observed	N/A
Top of surviving natural observed at	45.64mOD
Level of base of trench	45.34m OD

4.6.1 Naturally deposited weathered London Clay was observed at 45.64m OD. Overlying the natural clay was a 0.60m deep layer of dark brown-black silty clay with occasional metal, pottery, CBM and plastic inclusions. This layer was sealed by a 0.20m thick levelling layer consisting of crushed concrete and CBM, and a further 0.20m thick band of tarmac. The trench was sealed with a 0.06m deep concrete slab (Fig 8).

4.6.2 No archaeological deposits or features were observed in Trench 6.
