**Regent Oil/Texaco Warehouse  
Stolthaven Dagenham Ltd  
Dagenham RM9**

24 January 2014

Site code: DAG13

A standing building survey report

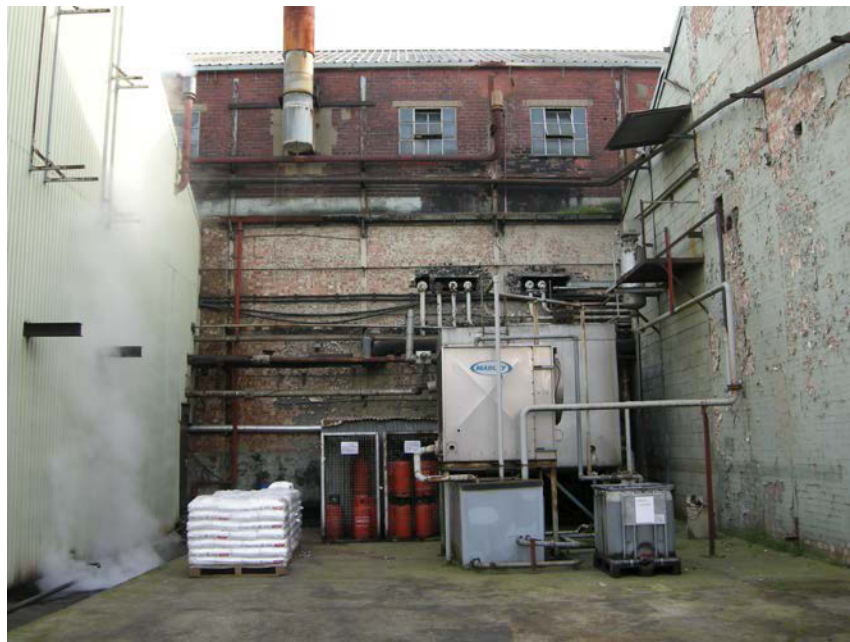
The main warehouse is of two storeys (the upper storey triple-height to incorporate machinery) and built in a machine-made red brick. At ground floor level, the building is surrounded by other warehouses, but its upper level (Fig 5—7) is observed to hold a series of regular windows, each of 4x3 lights with a central 2x2 casement and concrete header. The roof of the building could not be closely observed but appeared to be made of corrugated tin.

The other warehouses (as seen partially in Fig 5 and 6) are constructed of a mixture of brick and steel-frames holding corrugated tin walls.

*Fig 5 West elevation of the main warehouse (MOLA 2013)*

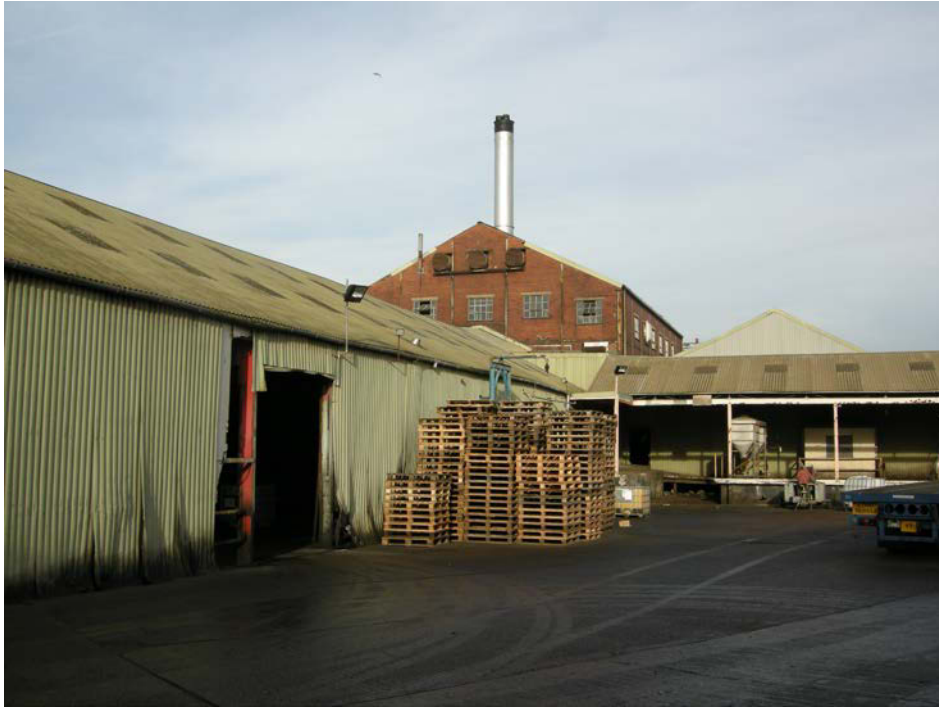
*Fig 6 South elevation of the main warehouse (MOLA 2013)*

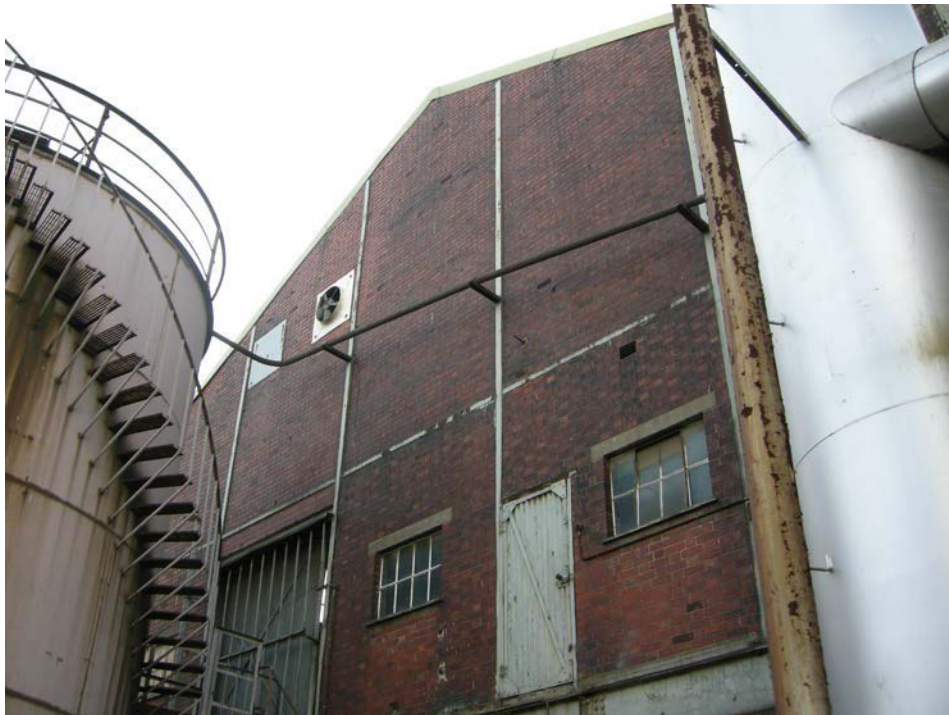
Only the northern elevation (Fig 7) was visible in its entirety. It demonstrates the construction of the building as being a combination of load-bearing brick and a steel frame, this elevation presumably strengthened due to being the main loading bay of the building. It also showed a ghost line of a pre-existing fire escape.

*Fig 7 North elevation of the main warehouse (MOLA 2013)*

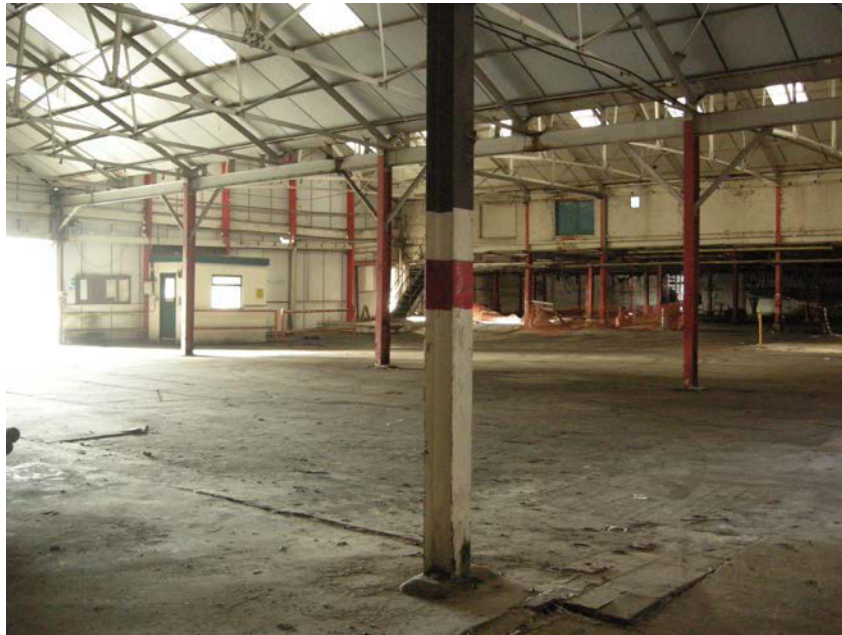
Internally, the main warehouse is seen to stand on a series of steel I section columns (Fig 8). At ground floor level, the west and north walls are in brick while the south and east are open to other warehouses. This level contains the remains of some machinery likely to have been part of the packaging of oils produced in the room above.

*Fig 8 Ground floor looking towards main warehouse (MOLA 2013)*

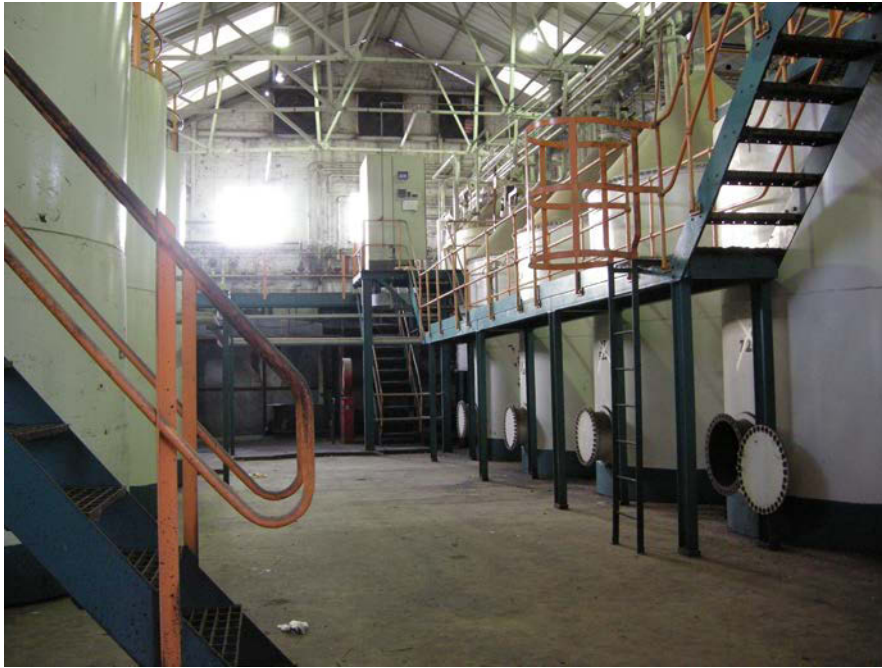
*Fig 9 First floor of main warehouse (MOLA 2013)*

The only first floor on the site is within the main warehouse, this accessed by a set of iron steps from the south-west corner of warehouse east. The room contains, in its west, an arrangement of ten steel tanks with associated raised walkways. A control panel at the upper level connects this machinery to the 'Linseed Oil Process'. To the east of the space, a further three tanks. The south wall of the room holds a number of valves which allowed oil from the tanks to run to the ground floor via a series of pipes for packaging. Power was provided by a series of generators in the space's south-west corner.
