former MIDDLESEX HOSPITAL ANNEXE
(previously Central London Sick Asylum,
Strand Union workhouse infirmary,
Covent Garden workhouse)
44 Cleveland Street
W1

Standing building assessment

June 2008

Site Code: MEX08
National Grid Reference: 529260 181810

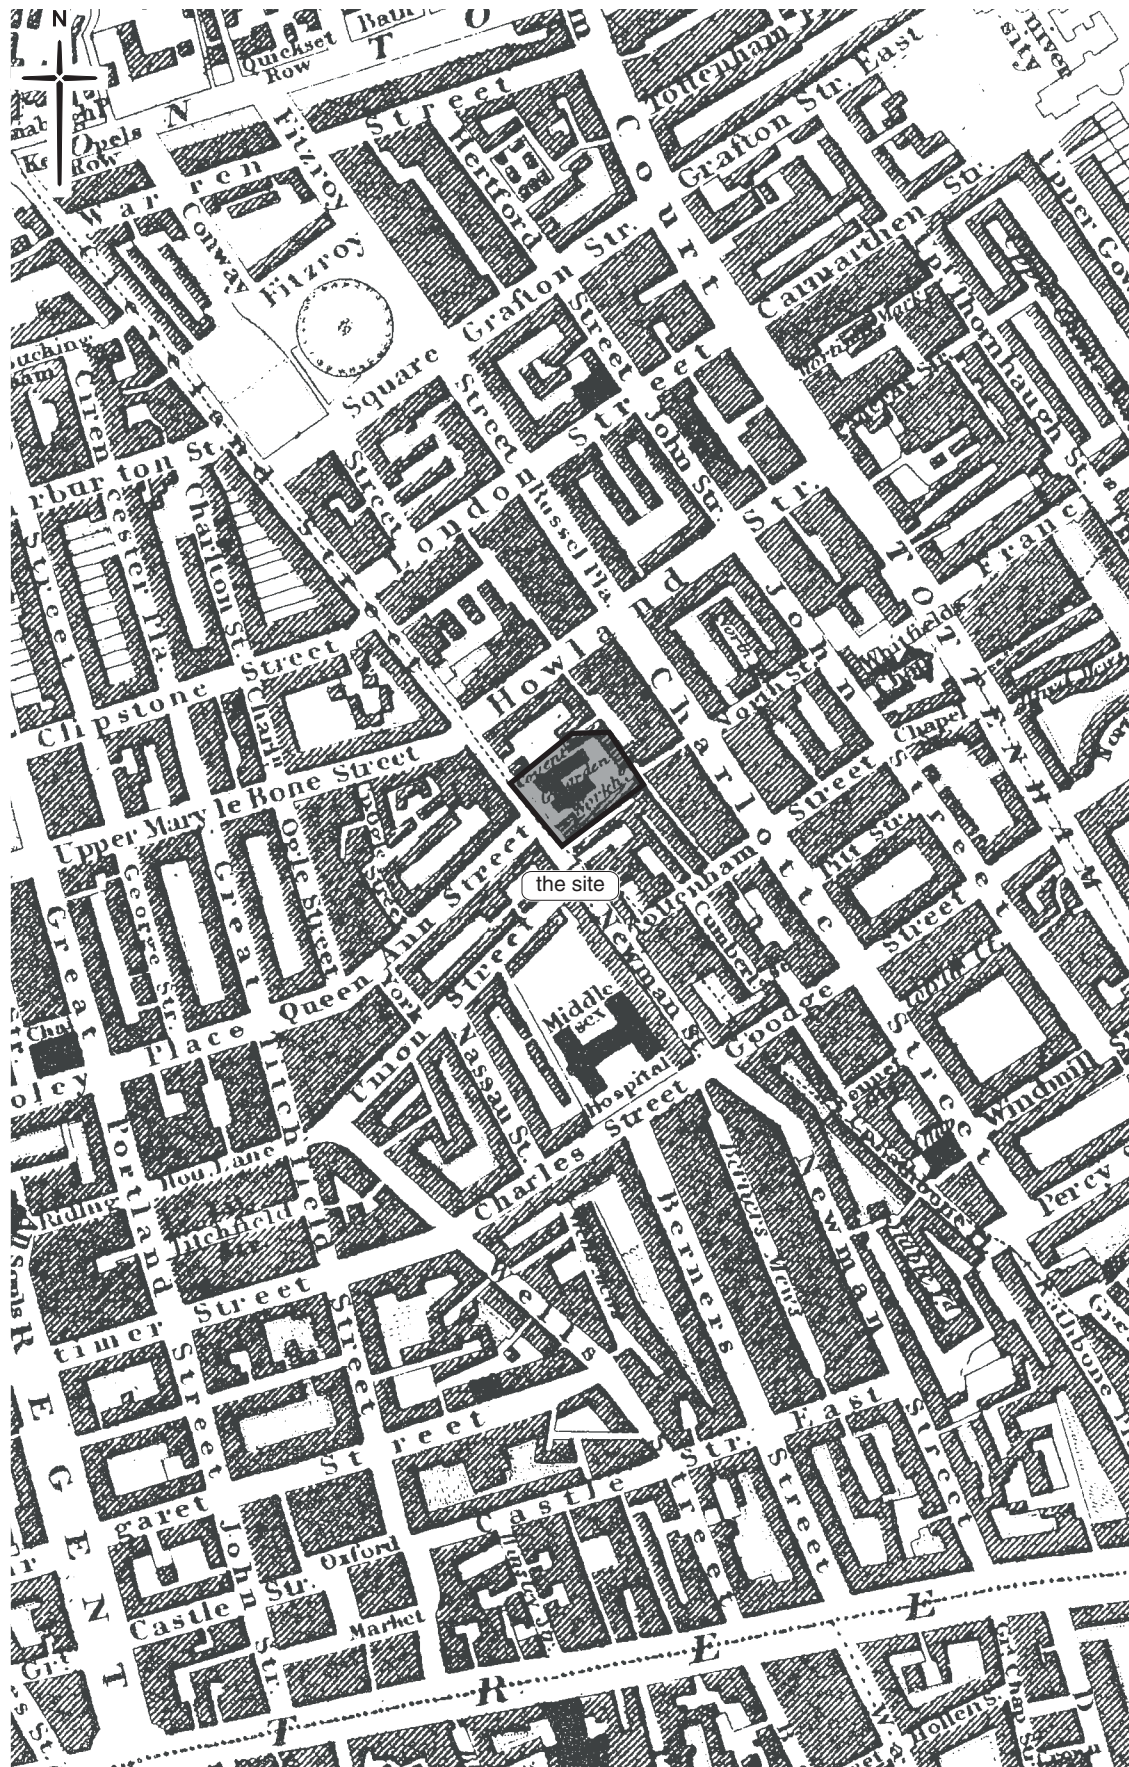
Fig 5 Map of the area in about 1799 (Horwood)

Horwood’s map of c.1799 (Fig 5) shows ‘Covent Garden Workhouse’ on the present site, in the form of a large building, H-shaped in plan, the north and south wings extending to the rear for about three times the distance they project to the front, towards the street. The map shows another, much smaller building in the south-west corner of the site, end-on to the street, with possibly a wall or gate connecting it to the main building. Around the north-east corner of the site two adjoining terraces of buildings, apparently stables or carriage houses fronting on to Howland Mews to their north, seem to encroach a little on to the workhouse site. (A join between two sheets of the map runs through the site; discrepancies between the two sheets do not seriously affect the site.) Tompson’s map of the parish of St Pancras, 1801 (Insall 2006, fig 2), shows the same two buildings, and repeats a detail of the principal building which is also on Horwood’s map, the junction of the wings and the central block of the principal building at the rear being marked by rectangular projections. The layout around the north-east corner of the site appears simpler than in Horwood, suggesting that any buildings there formed part of the workhouse.

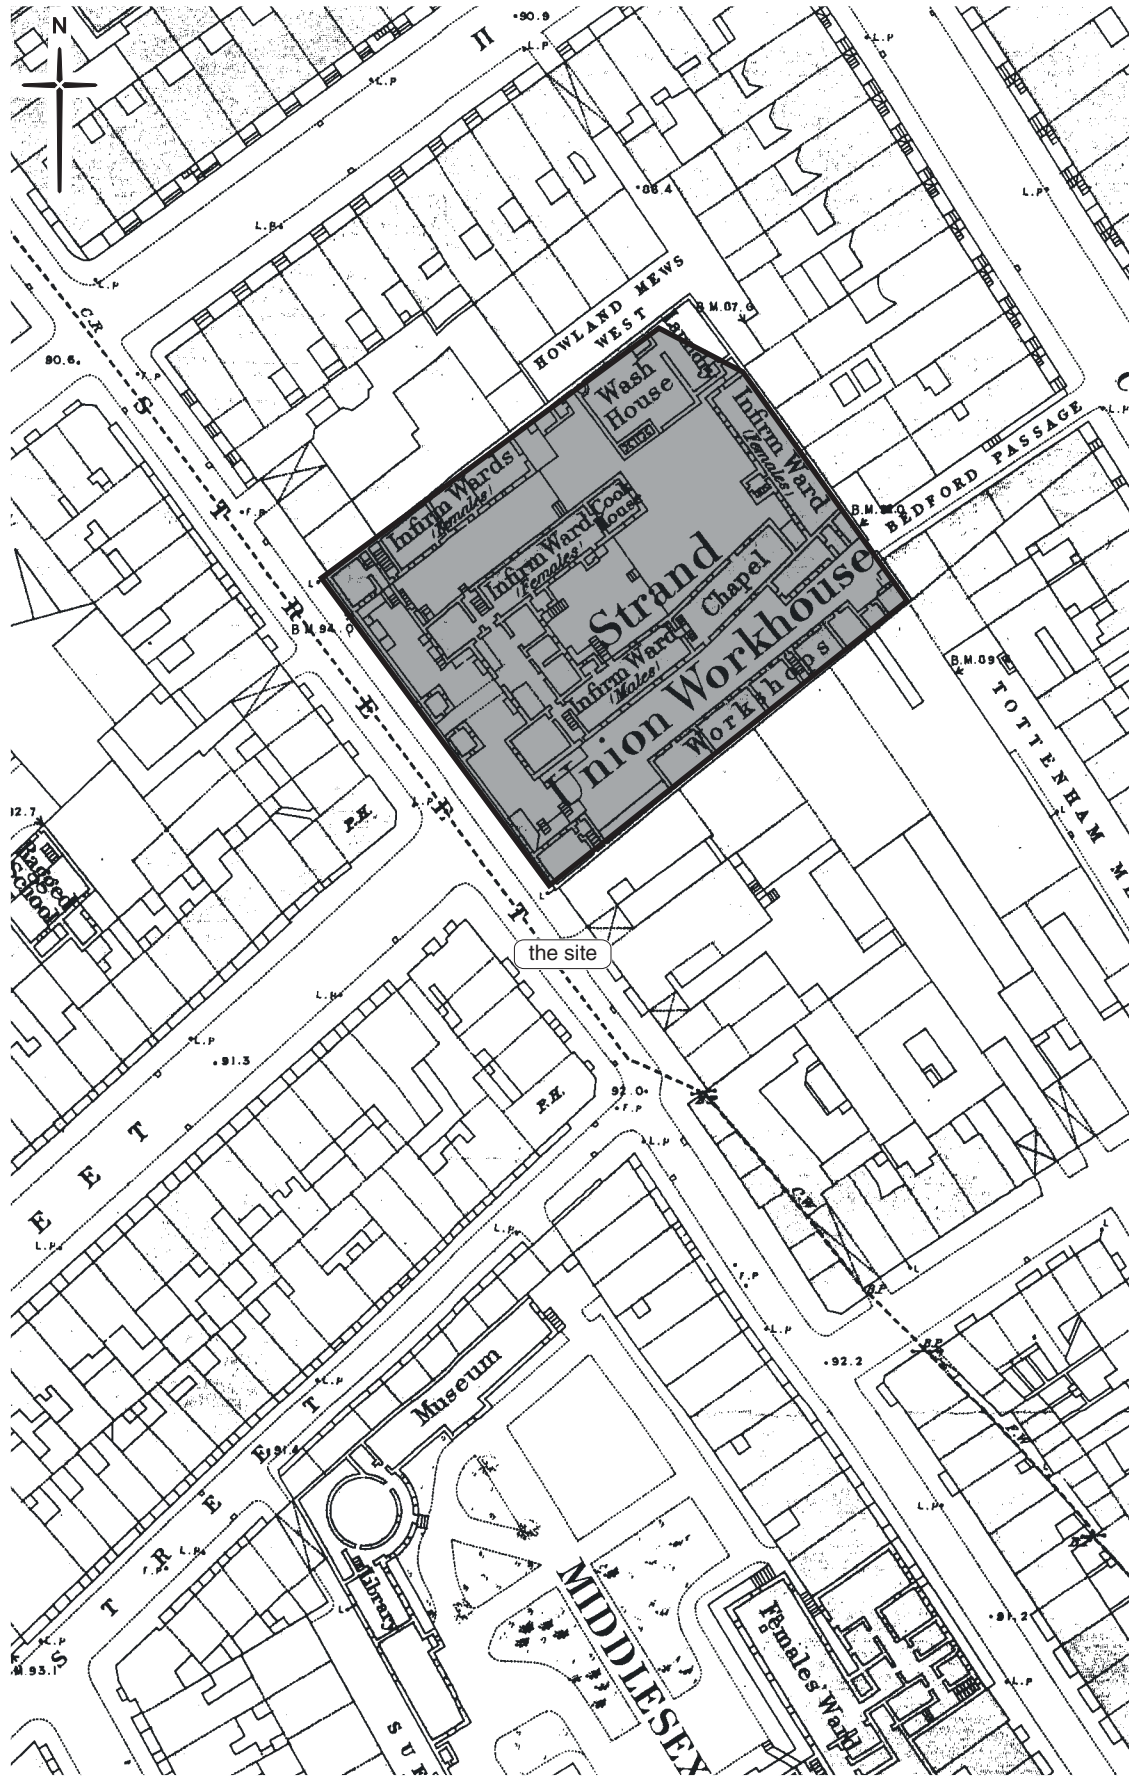
Fig 6 Map of the area in about 1830 (Greenwood)

Greenwood’s map of 1824–26 (Fig 6) shows much the same layout as Horwood’s, except that the north wing of the principal building is shown as extending further to the east than the south wing. While it is possible that at least one of Hardwick’s buildings was simply an addition to the existing building, it seems more likely that Hardwick was expected to design separate buildings, especially if they were to house people with infectious diseases. The 1824–6 map is at too small a scale to be sure of other possible alterations, but a later map on a much larger scale (Fig 7) indicates the internal layout of the principal building, possibly its original layout, and locates two detached ‘infirm wards’ on the north and east boundaries of the site; either or both of the latter may have been Hardwick’s buildings.

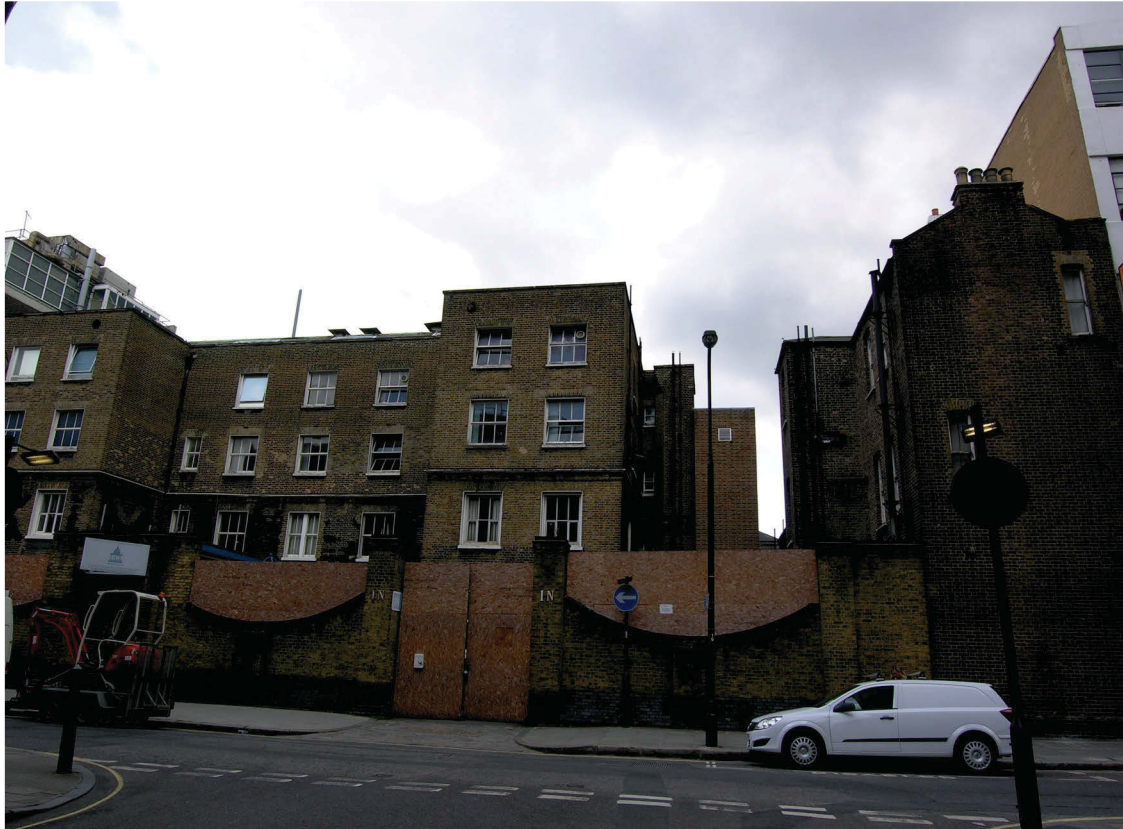
This building is H-shaped in plan, with a short central block flanked by north and south wings that project to the west, towards the street (Fig 10). The building is of yellow-brown brick, on four storeys and a basement. The principal front, facing the street across a forecourt, is symmetrical, with a central doorway. Most of the window openings are original although the windows themselves are not. Cellar windows flank the central doorway. The only decoration is a moulded stone string course over a brick plat band, running at 2nd-floor level and returning to the sides of the building around the north and south wings.

Fig 10 Main front of the 18th-century building (left) and the gable end of the late 19th-century south range (right), on Cleveland Street

- Repair of wartime bomb damage, most of which was minor and secondary (Fig 8). The main elements of the street facade of Building 1, for instance, were restored and the roof of Building 1, when it was replaced, retained its former roof line (Fig 10).

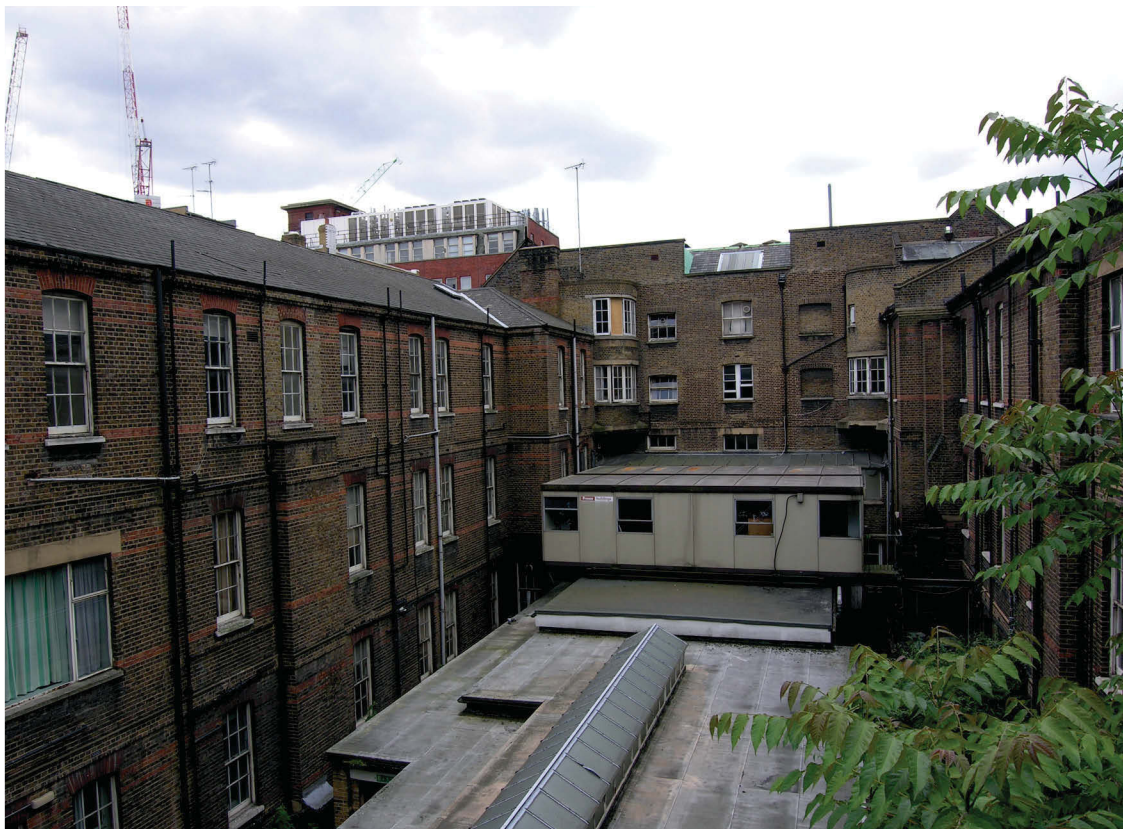
The rear of the central block, at least, of this building survives and three window bays are visible externally above the level of the 1st floor (Fig 11). The windows in the northernmost bay have been blocked, probably for insertion of a lift just behind them.

These buildings are of brick, on three storeys with a basement at their west end, and they enclose between them an internal yard, now containing Building 8 (Fig 11). Buildings 2 and 3 are linked by a high wall along the eastern boundary of the site, against which two open, iron-railed galleries run, connecting the buildings at 1st and 2nd-floor levels (Fig 20). The buildings have abundant windows, originally all sash windows with segmentally-arched window openings and stone sills, and occasionally enlarged windows with concrete lintel beams (as in Building 1). The internal layout of both buildings is similar, based on a long corridor running the length of the building with rooms to either side, or successive large rooms filling the width of the building, and both buildings have their own staircases at either end. The roofs are gable-ended, with a hipped projection from Building 3, and originally slated; the roof of Building 2 has been rebuilt and covered with asbestos tiles (Watts 2007, 3). Both buildings have sanitary towers attached to their outer sides, i.e. north

Fig 11 Rear of the 18th-century building (centre), with two late 19th-century wings extending from its south and north ends

- Ancillary single-storey buildings have been erected in the north-east of the site, Building 7, and in the central yard, Building 8 (Figs 11 and 20). The latter may have replaced an earlier building of uncertain function in much the same position, which appears on 20th-century maps until about 1991 (Insall 2006, annexe 3). These latest buildings appear to consist for the most part of prefabricated system-built components, typical of NHS buildings of the 1970s and later.

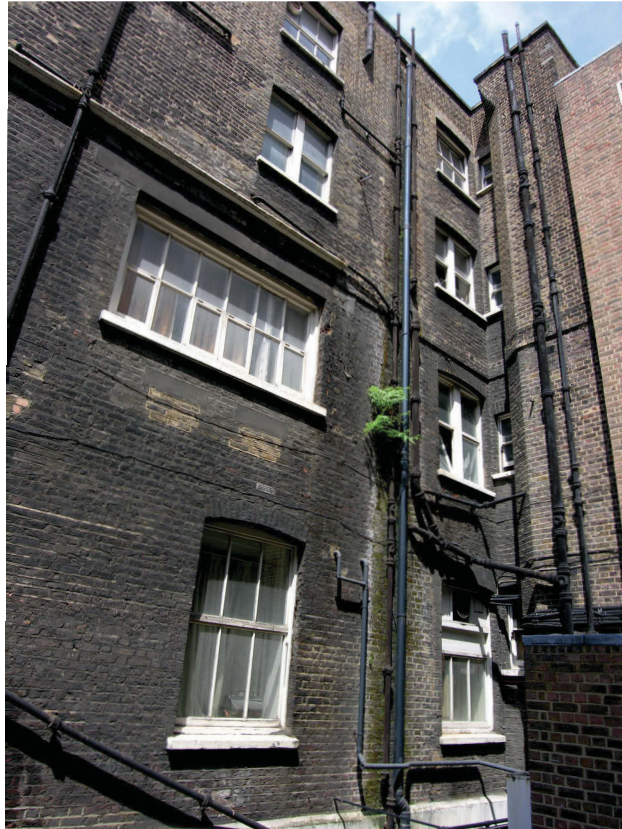
Fig 12 South wing of the 18th-century building, south elevation, showing junction with later additions (right)

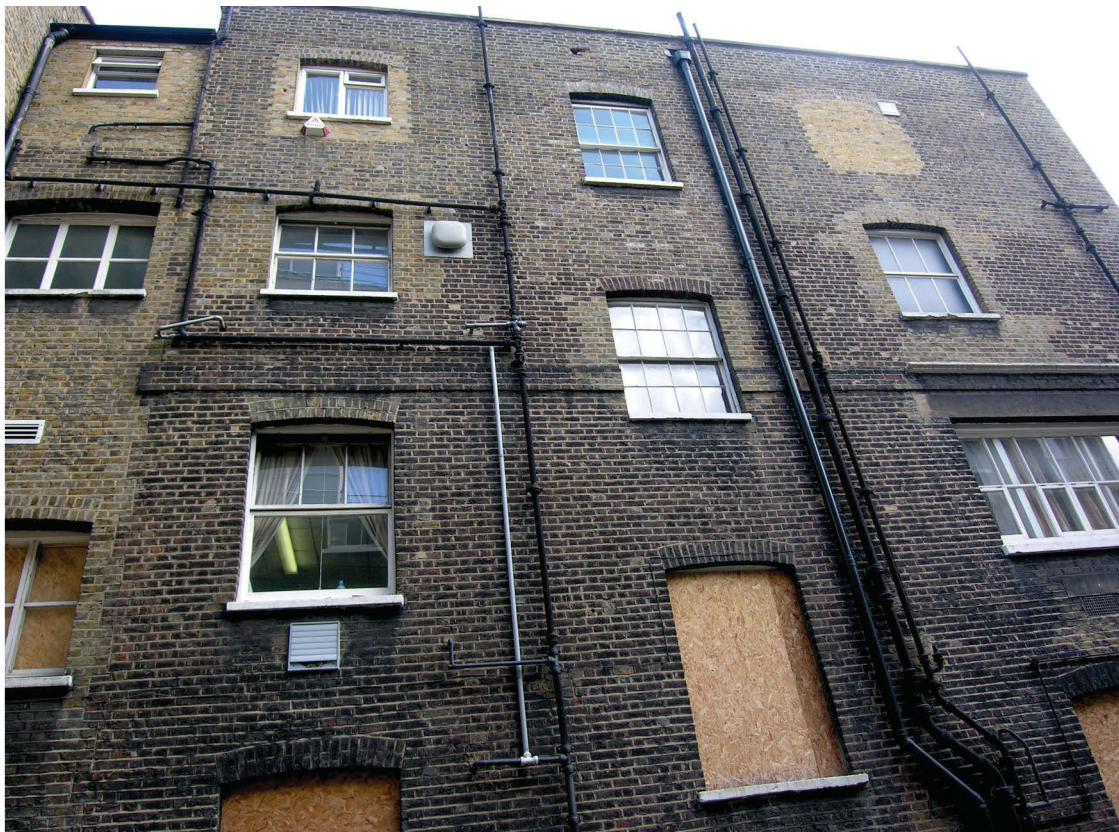
Map evidence suggests that originally the north and south wings of this building projected to the east at least as much as they still do to the west (see below). The arrangement of windows and bays on the outer sides of these wings differs on the south (Fig 12) from the north (Fig 13). Less of the original elevation survives to the south, where a lift shaft has been added externally. More of the original elevation survives on the north side, the windows lighting stair landings on the 2nd and 3rd floors being early, if not original, 8-over-8-pane sashes without horns, although the 2nd-floor window opening seems nevertheless to have been rebuilt (Fig 13). The other windows are sashes or bottom-hung

Fig 13 North wing of the 18th-century building, north elevation, showing junction with later additions (left) and original or early 8-over-8 sash windows on upper staircase landings

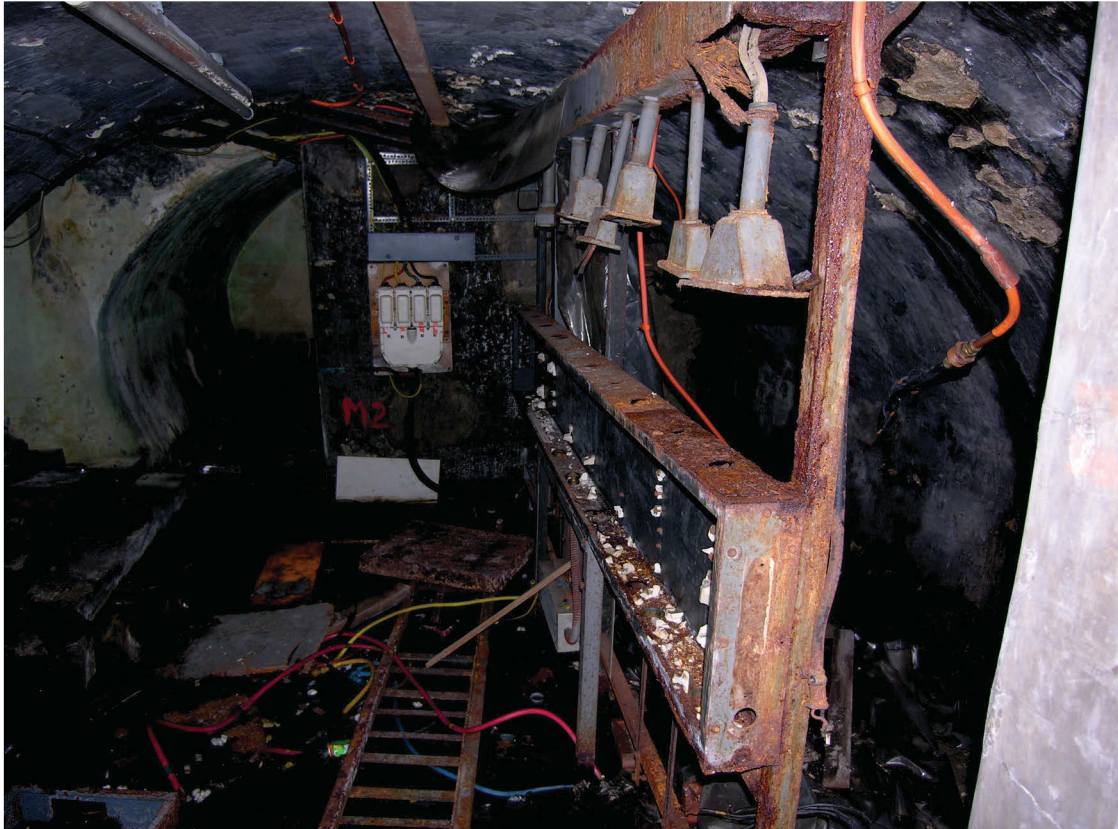
A vaulted cellar, with coal holes in its crown, runs from north to south under the forecourt, at a slightly lower level than the basement under the standing building (Fig 14), and a side-vault runs to the street. The north–south vault has been altered at its extremities, and cement-rendered. At basement and at ground and 1st-floor levels a corridor runs from north to south immediately to the east of the central block. The west wall of this corridor contains three wide openings, symmetrically arranged about the centre-line of the block; the central opening is a doorway and the two to the side are splayed (Fig 15). These openings may line up with window-bays on the floors above, or with internal walls implied by map evidence such as that of 1870 (see below, Fig 7), and may represent internal divisions, or an external wall, in the original building. There may be comparable evidence in the fabric of the building, for instance in the form of the roof, which is different to north and south, and in the foundations, for the surviving extent of the 18th-century building. Noticeable changes in floor level also probably indicate where additions have been made to the original building, and therefore indicate its surviving limits.

Fig 14 Vaulted cellar under forecourt of 18th-century building, with 20th-century electrical switchgear

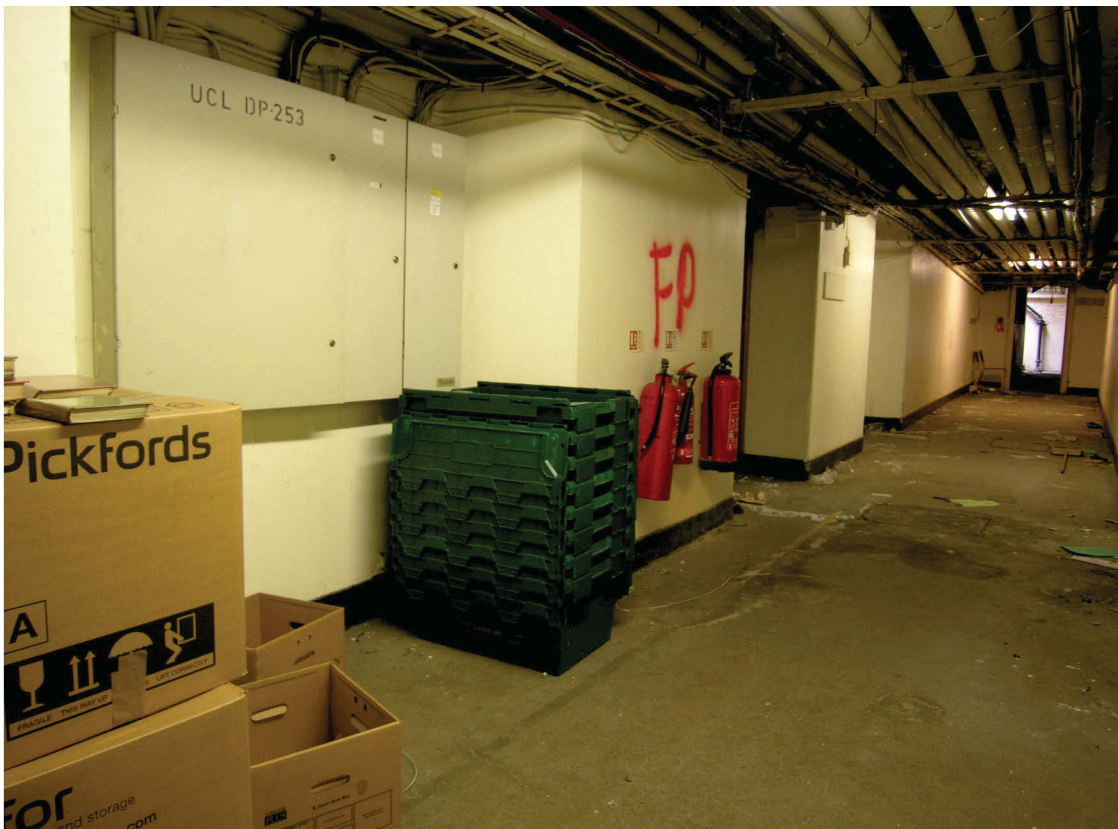
Fig 15 Basement corridor with splayed openings, probably in rear wall of 18th-century building, originally external

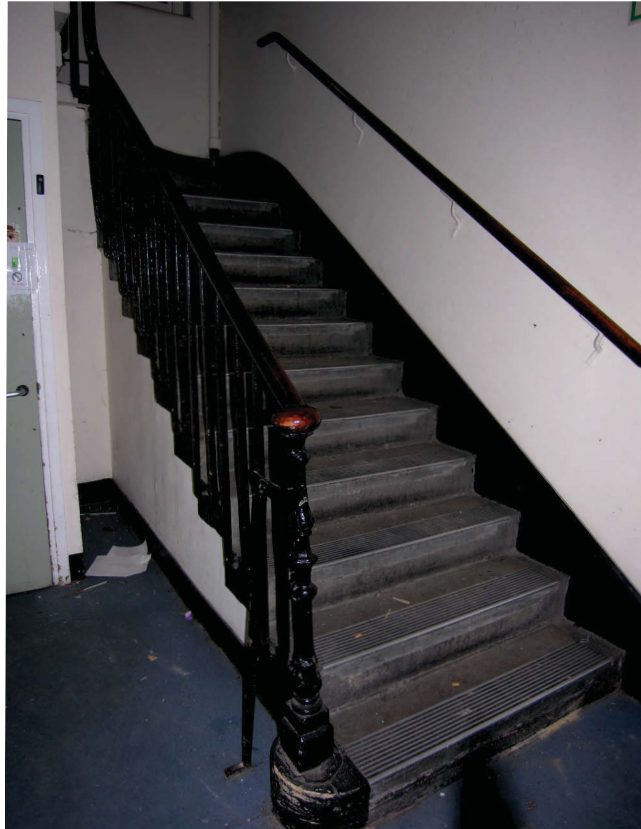
The interior of this building probably contained large rooms originally, suggested by the spacing of the windows as well as by documentary evidence (see below). A staircase exists in the north wing, with stone steps in the flights between at least the basement and ground floor (Fig 16) and wrought-iron balusters throughout of early date, if not original to the construction of the building. A similar staircase may have been situated originally in the south wing but, if so, this has since been removed. The wrought-iron, however, may have been reinstated in another, replacement staircase a short distance away in the later extension of this wing to the east, Building 3.

Fig 16 Staircase in north wing of 18th-century building: stone steps from basement to ground floor, and wrought-iron balusters

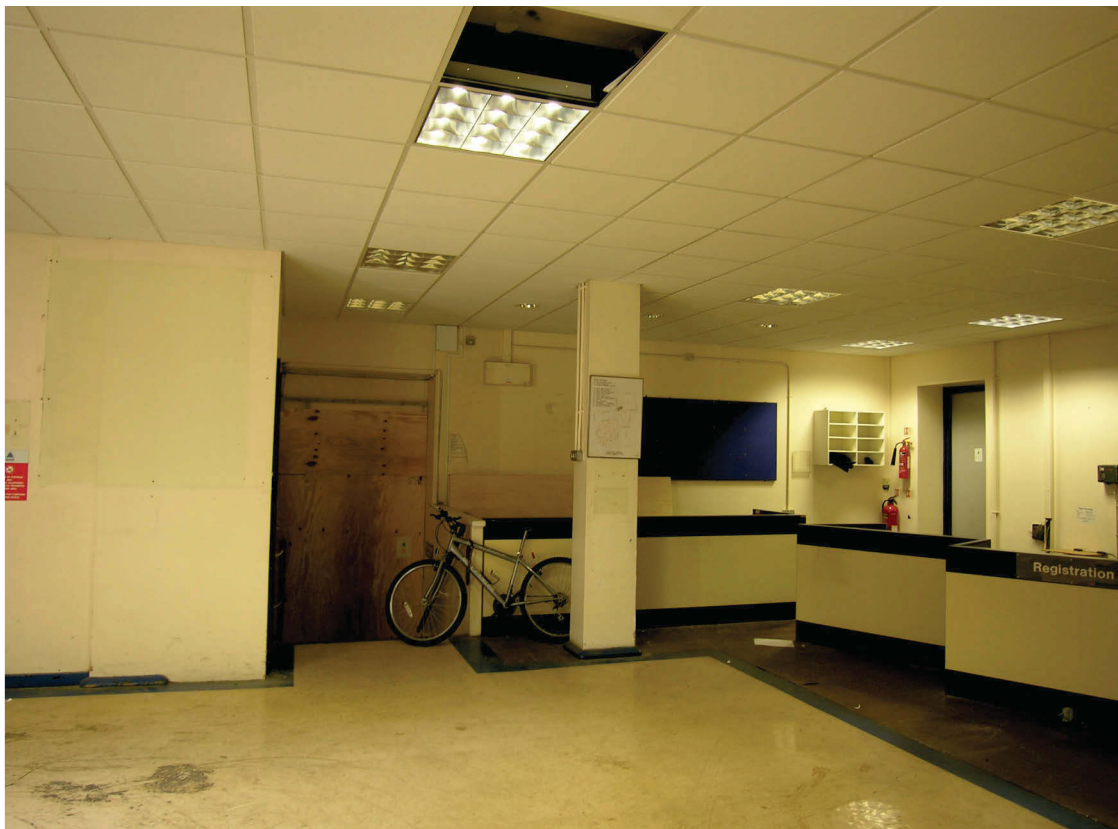
At present the spaces of the building are subdivided, and the walls of many of the rooms are lined, with suspended ceilings. The ground-floor entrance hall, for instance, contains a modern reception desk and a lift inserted in its north-eastern corner (Fig 17); steps down to a doorway in the east wall probably mark the rear wall of the original building. No obvious sign of fireplaces or chimney stacks were seen in this building, although presumably they existed originally.

Fig 17 Ground-floor entrance hall in 18th-century building, showing internal additions and alterations. Note steps down to rear inside the line of the rear wall

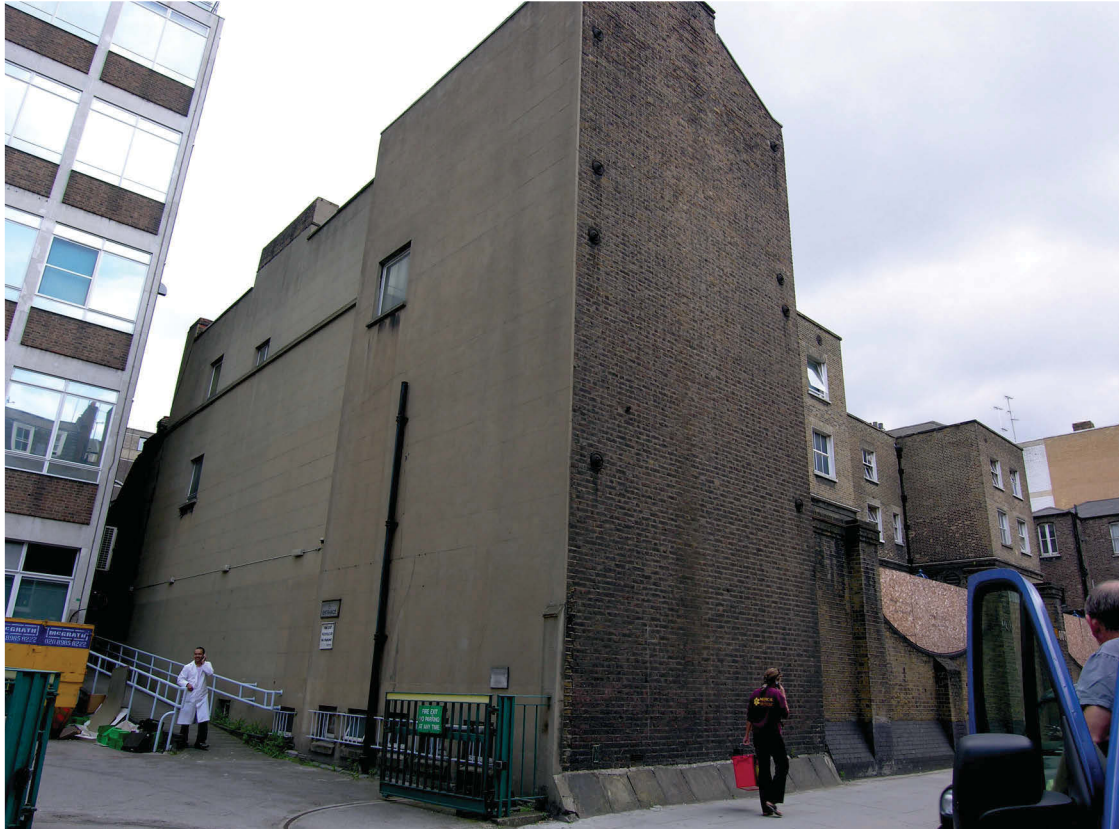
Fig 18 Late 19th-century north range: north elevation and windowless gable end on Cleveland Street

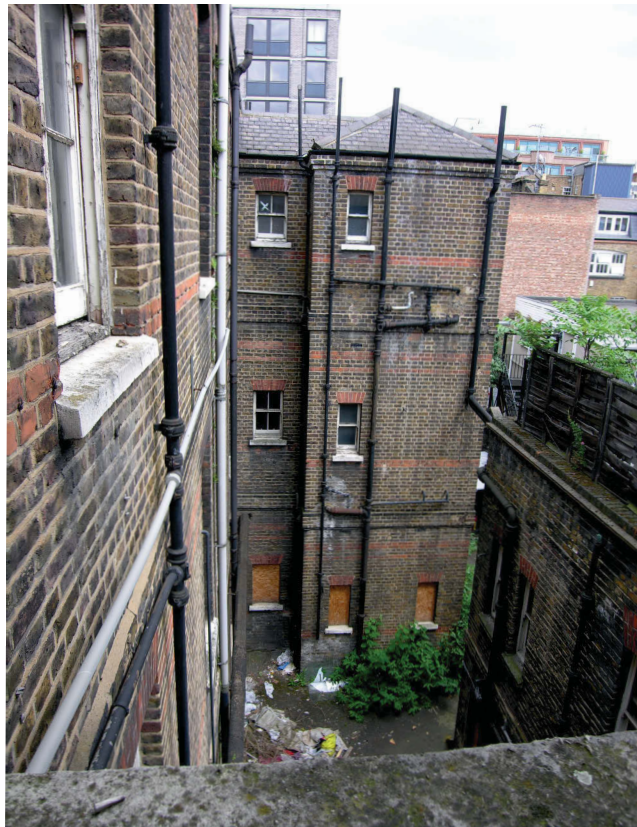
of Building 2 and south of Building 3 (Fig 19), which contain wash-rooms and WCs. There are few fireplaces and chimney stacks in evidence, although traces of stacks, later cut down, may be seen on the roof ridge at the east gables, and corner fireplaces exist in some rooms.

Fig 19 Sanitary tower attached to south side of late 19th-century south wing

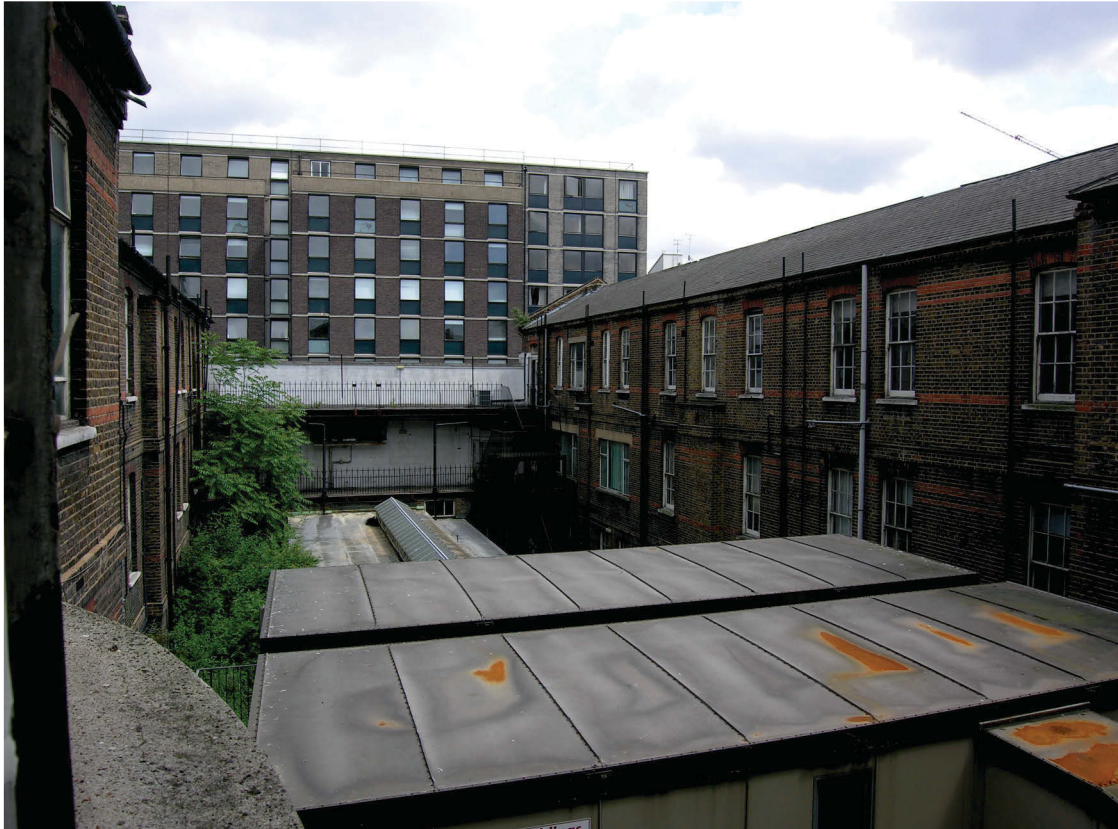
Fig 20 Open galleries against high boundary wall at east end of site, closing off central yard

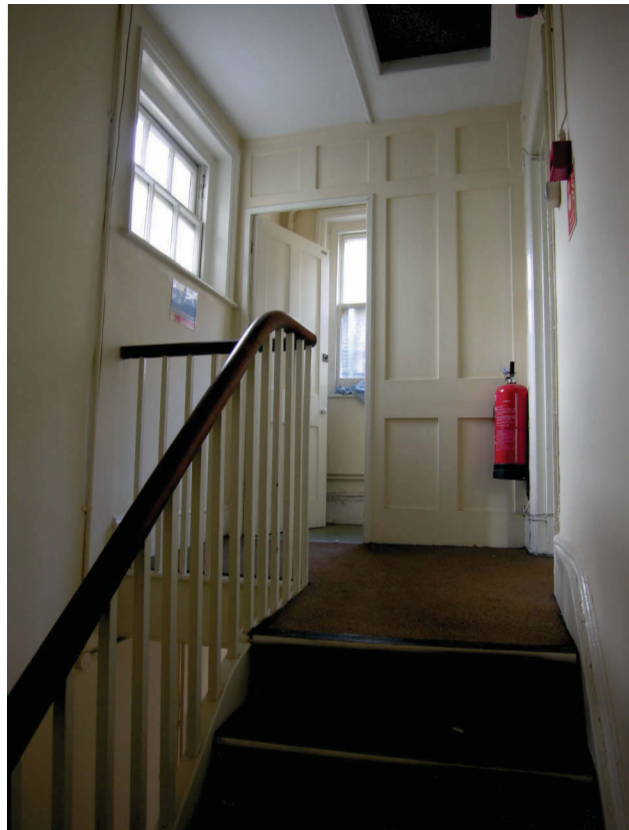
These buildings are of brick, on three storeys with a basement at their west end and on two storeys further to the east; they do not extend to the east as far as the sanitary towers projecting from Buildings 2 and 3. The buildings front on to the interior of the site, and present blank, or nearly blank, walls to the exterior of the site and to Cleveland Street (Fig 18). Externally Buildings 4 and 5 closely resemble Buildings 2 and 3, all having similar brown brick with decorative bands of red brick, and similar fenestration. The internal layout of Buildings 4 and 5 is slightly more complicated, although, like Buildings 2 and 3, they have ground-floor entrances and staircases to both west and east. They also have more obvious fireplaces and chimneys, with more decorative fire surrounds, and their staircase balusters and newels are also more decorative. The arrangement of the west staircase in Building 5 in relation to floor levels is noticeably awkward, perhaps attributable to constraints of space. Few early or original features appear to survive internally; a WC is situated on the 2nd-floor landing of the east staircase in Building 4, separated from the staircase by a timber-panelled partition wall (Fig 21), and this may be an early fixture.

Fig 21 Late 19th-century north range: WC fitted on stair landing at top of east staircase, behind timber panelled partition wall

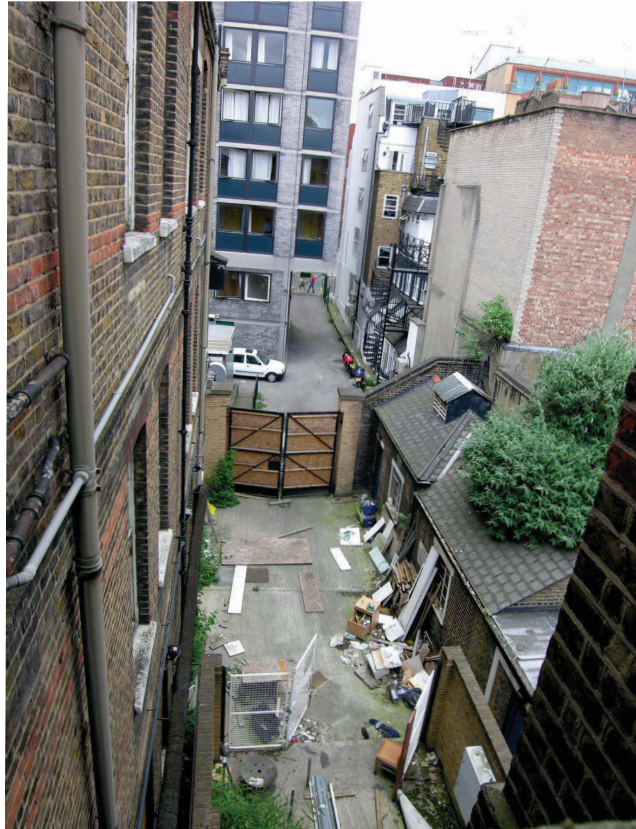
A short range of at least two brick single-storey buildings, end-to-end with pitched slated roofs of different heights, backs on to the southern boundary wall at the south-east corner of the site (Fig 22). This range was not entered. The eastern of these buildings has a lantern ventilator in its roof. The rear entrance to the site is by a vehicle gate in the south end of the eastern boundary wall, between Buildings 6 and 5; this formerly gave access to Bedford Passage, now gated, and thence to Charlotte Street, further to the east.

Fig 22 Rear entrance in east boundary wall, leading to Bedford Passage (now gated) and Charlotte Street. Separate late 19th-century single-storey sheds against the south boundary wall (right) probably included a mortuary

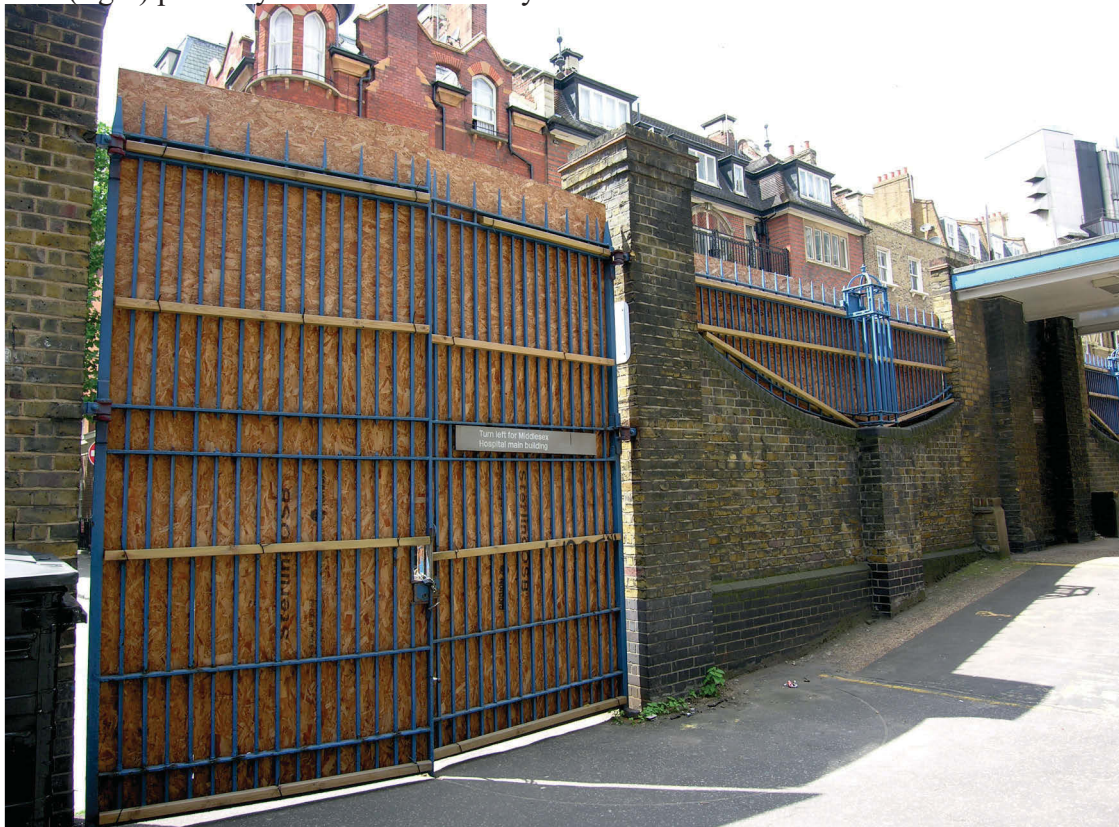
Fig 23 20th-century wall and railings on Cleveland Street frontage and vehicle canopy over main entrance (extreme right)
