RIVER WALL
Old Royal Naval College
Greenwich
SE10

An archaeological watching brief report

November 2006

Site Code: RNT06
National Grid Reference: 538530 178010

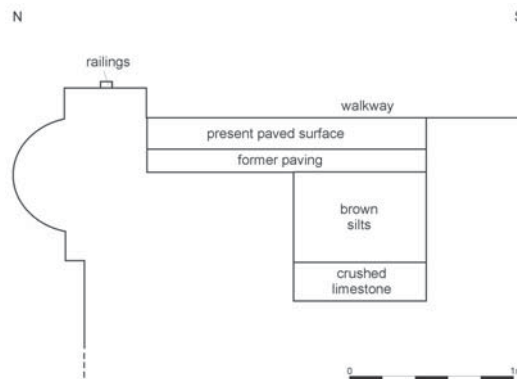
Fig 1 Sketch section of river wall and Trench 2.

This trench was located on the walkway 7.9m east of the east steps at a height of 4.34m OD. The 'trench' measured 0.84 by 0.80m. The surface paving was 0.09m thick and lay directly on fragmentary earlier paving that was 0.06m thick. This overlay a 0.38m thick layer of mixed brown silts. At an average of 0.54m below the surface, there was a layer largely composed of crushed limestone though its full depth was not ascertained.

This ‘trench’ was located on the walkway 6.4m east of the east steps at a height of 4.34m OD. The ‘trench’ measured 0.62 by 0.84m. The surface paving was 0.09m thick and lay directly on fragmentary earlier paving. No further excavation was undertaken.

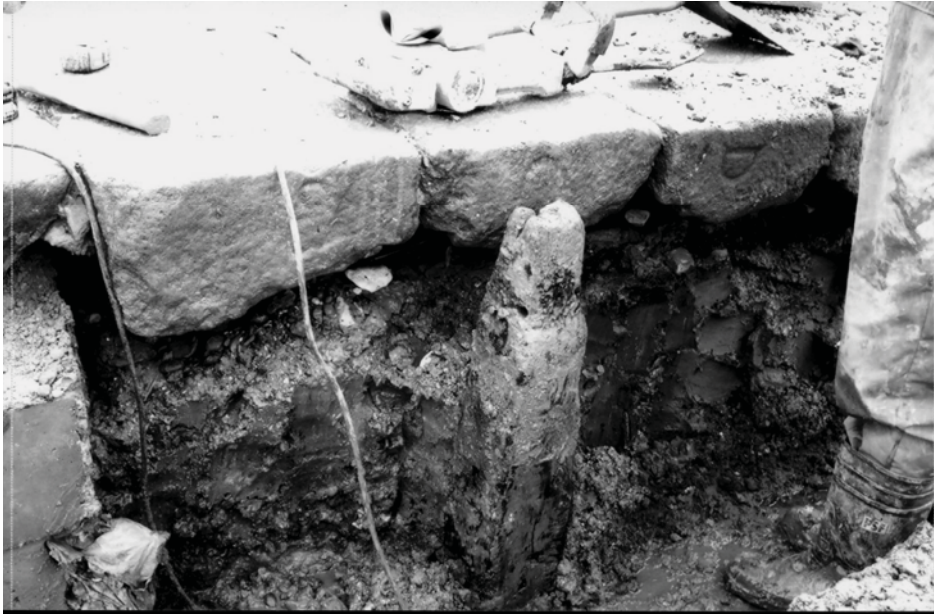
Trench 3 was located against the north side of the platform in front of the west steps at a height of +0.12m OD. This excavation conducted at low tide, was for the insertion of concrete underpinning. The granite paviments of the step bases appeared to rest directly onto river clay, though it is probable that timber piles were placed below. It is possible that some of the stones were reused but they were sequentially lettered for laying as a platform.

One timber remained *in situ* against the paviments (Fig 2) but another was retrieved as a broken fragment (Fig 3). This was a piece of elm, squared at average 6" (0.15m) but chamfered at one end, with an iron nail projecting sideways from the chamfer. Damian Goodburn suggests that because the timber had a chamfered rather than pointed end it came from the top of the timber as it would have been *in situ*. Thus it was likely to have been an anti scour pile which would have protected the bottom of steps from erosion. The remaining timber *in situ* is likely to be one of a series.

Fig 2 Timbers recorded against the wharf in Trench 3.
