LEYTONSTONE FIRE STATION London E11

Report on an archaeological evaluation

**Leytonstone Fire Station
466 High Road
London E1 3HN**

Site Code HLE14
NGR 539355 186550
OASIS reference molas1-204365

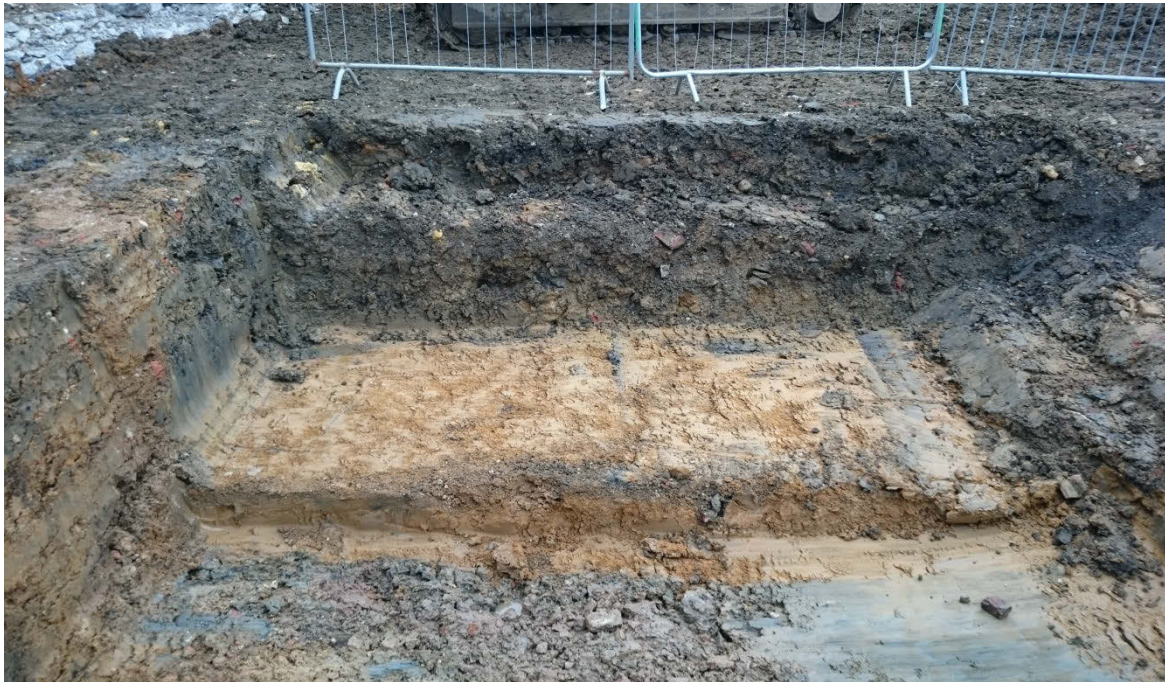
Photo 1 Trench 1, natural deposits exposed in the extended trench, and pit/ditch [4] at bottom right, looking east

- 4.1.1 Significant archaeological remains were limited to a waterlain feature [4] in the south-west corner of the Trench recorded between 15.00 and 14.24m OD. The only fill [3] consisted of a dense mid blue-grey sterile clay. No dateable evidence was recovered associated with the feature, and it was assumed to date to the post-medieval period, although it may be earlier. The southern edge curved gently to the west disappearing into the section at 14.86mOD. The northern edge was truncated by a 19th-century or later foundation trench (see *Photo 1* bottom right, probably for a water tower. The base of [4] was exposed in a machine excavated slot (*Photo 2*), and appeared relatively flat. It is possible that what was exposed within the trench

was the corner of a considerably larger pit or ditch, which continued into the bulks to the south, and west. There was tentative evidence for management along the eastern edge, in the form of a rudimentary fence or some form of lining (possible for a pit). Two enigmatic lines of stakes, or possible roots, perpendicular to the edge of [4] may be the remains of a fish trap or bush/shrub.

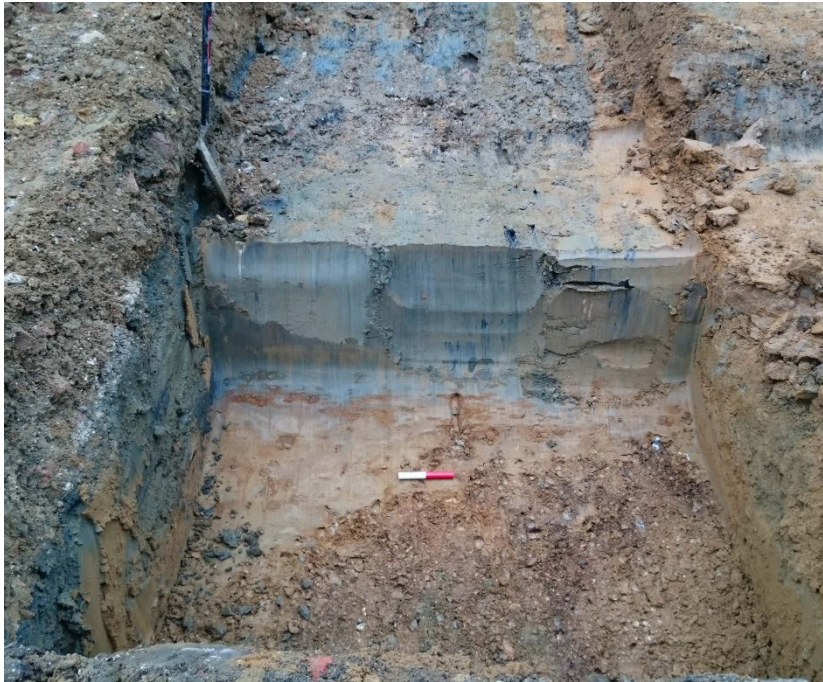
Photo 2 Profile of pit or ditch [4], looking north.

- 4.1.2 This feature may potentially represent a roadside ditch, or quarry pit associated with a Roman Road, which it has been hypothesized (but not archaeologically confirmed) followed the line of Leytonstone High Road.

4.4.1 The undated waterlain feature [4] in Trench 1 between 15.00 and 14.24m OD may be Prehistoric, Roman (relating to the north-south road to the west) or early post-medieval. It is very likely that it predates the mid 18-century building development depicted in Rocque's map of 1746. Although it is possible (but less likely given the sterile nature of pit/ditch [3]), that it was in fact a pit, or pond located within the allotment or gardens of domestic premise that fronted the high street during the mid-

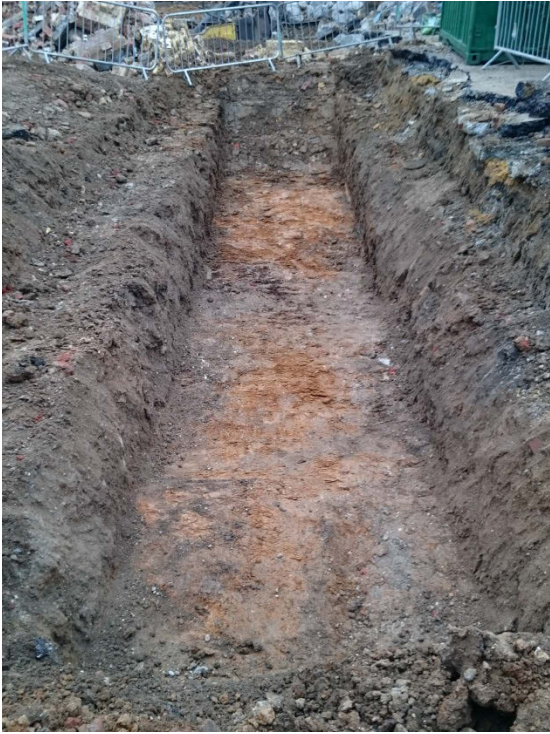
Photo 3 Trench 2, brickearth exposed along the base of the trench, with the occasional modern disturbance, looking east.

4.2.2 The remainder of the Trench was pock-marked with modern truncations, mostly situated in the south and south-west.

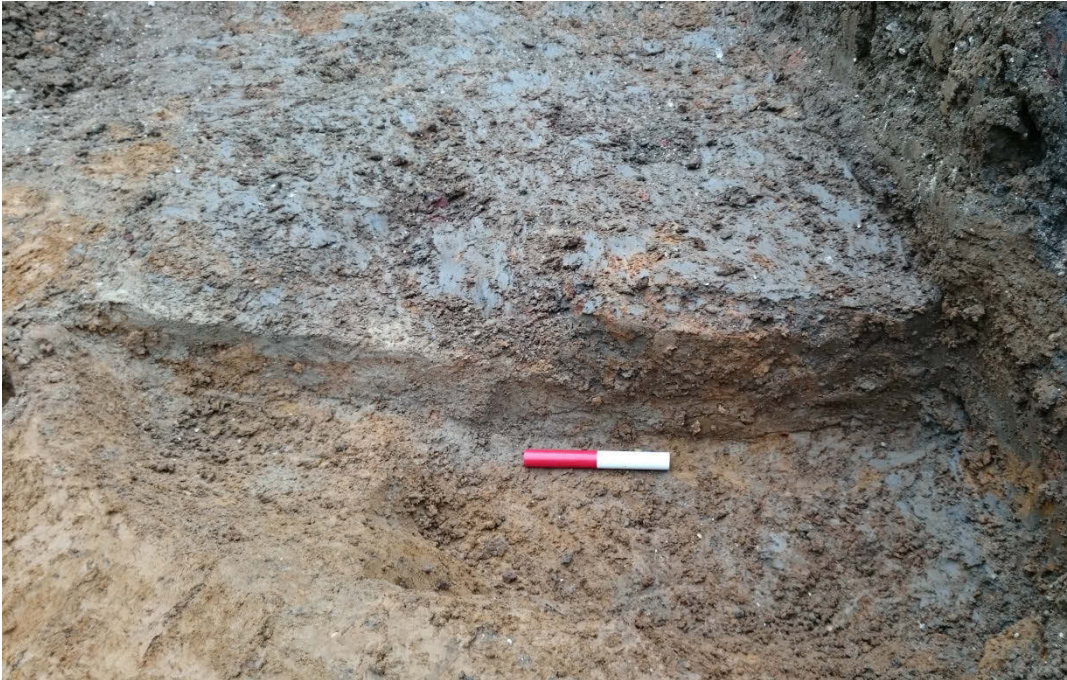
- 4.2.1 A semi-circular feature [2] (*Photo 4*) in the centre of the trench was partially excavated, and survived between 15.10 and 14.64m OD. The base was flat, with evidence of rooting, suggesting it may be a tree throw (caused by a falling tree, and the resulting hollow forming a circular shaped pit) or a rubbish pit. This measured 1.8m east-west, 1m north-south and 0.55m deep, and continued into the northern section. Finds from the light blue-grey sand and clay fill [1] included pottery dating from between the 17th and 18th centuries, tobacco pipe, a fragment of brick (16th–17th Century) and the end of a glass bottle dated 1650–1700. Together the dated finds suggest this feature was formed and backfilled prior to 1700. The laminated nature of the fill suggested it may have been formed by intermittent flooding. The finds likely represent rubbish discarded in the immediate area, which probably found their way into the hollow depression through natural processes.

Photo 4 Partially excavated clay filled hollow [2], looking west.

- 4.4.2 The single feature in Trench 2 appears unrelated (although it may be contemporary), and given its irregular base, is probably a tree throw, although it may be a rubbish pit. The historic assessment placed the site within woodland during the later medieval period, and this may be the source of this feature. Either way it appeared to have been slowly backfilled possibly during intermittent episodes of flooding between the 16th and 18th century, prior to the development of the surrounding area in the mid-18th century.
- 4.4.3 Results from the two evaluation trenches suggest that 19th-20th century activity has removed all stratigraphy, with only relatively deeply cut features surviving at a maximum height of 15.30m OD. Generally deeper truncation below 15.30m OD was limited to an area in the north-west of Trench 1.

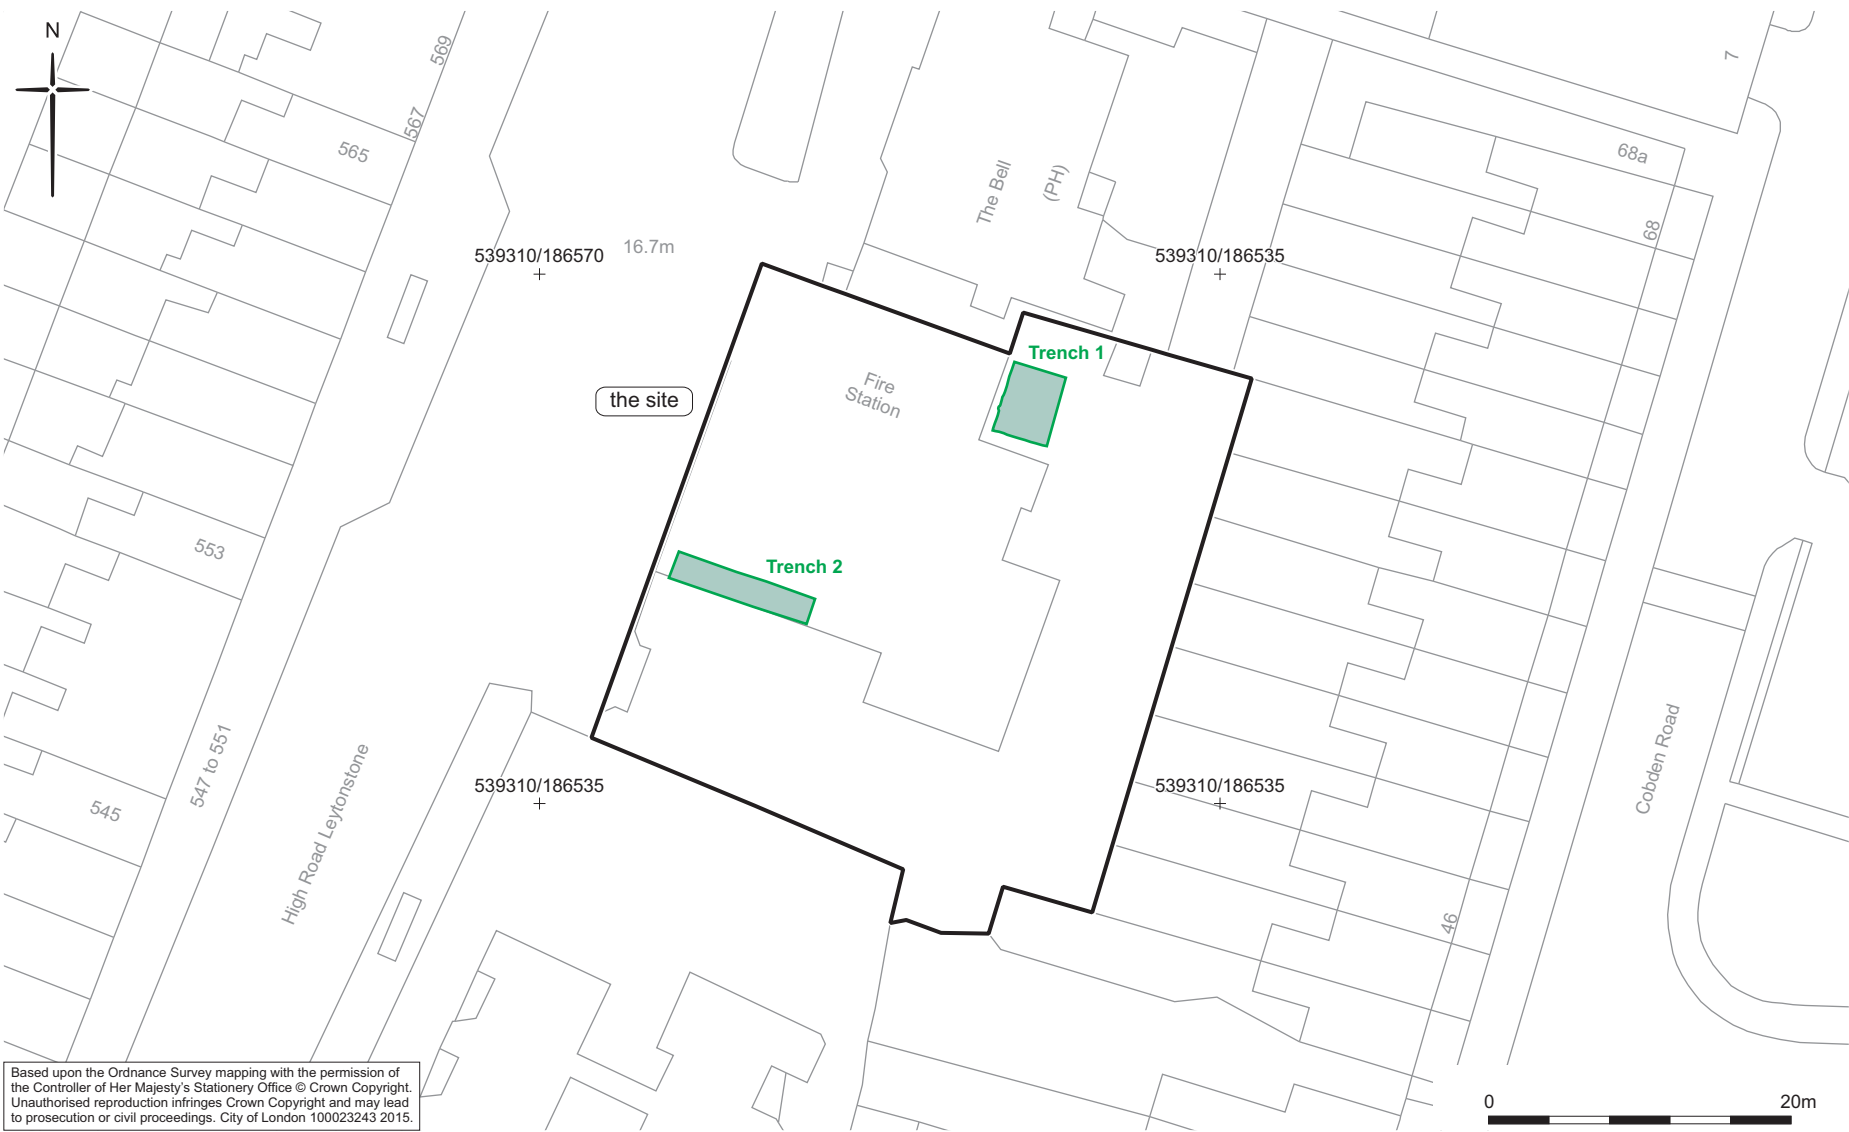
Fig 2 Areas of evaluation

- 5.4.1 The evaluation consisted of 2 trenches, located in the north-west and west of the site. Trench 1 was extended to the east, and Trench 2 was located approximately 2-3m further north than originally planned, to allow for vehicular access. Trench 2 in particular was located to evaluate activity fronting the High Street. The centre, east and south-east areas of the site were not evaluated as they had already been designated as either contaminated (south-east) or previously truncated.

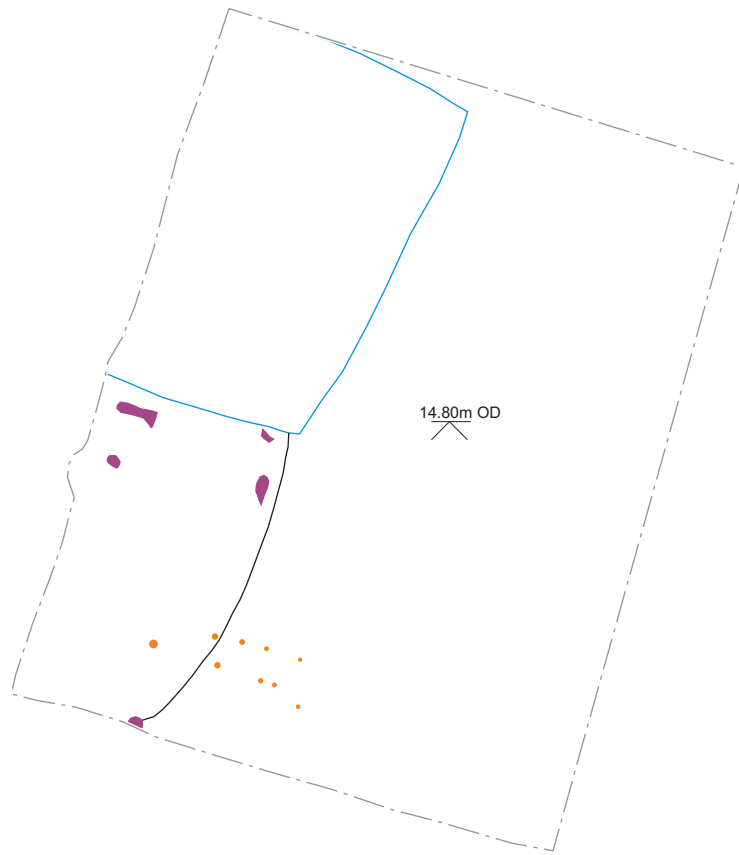
Fig 3 Trench 1

Location	North of the site (Fig 3) (Photo 1, Photo 2)
Dimensions	4.7m by 3.90m by 1.5m depth
Modern ground level/top of slab	16.80mOD
Base of modern fill/slab/turf	16.40mOD
Depth of archaeological stratigraphy above natural (if any)	No stratigraphy, but feature [4] cut into the natural to a depth of 0.6m.
Level of base of lowest features or deposits observed	14.24 mOD
Top of surviving natural observed at	15.00mOD
Level of base of trench	14.86m OD

- roots, possible postholes [4]
- roots, ? fish trap
- 19th-century intrusion

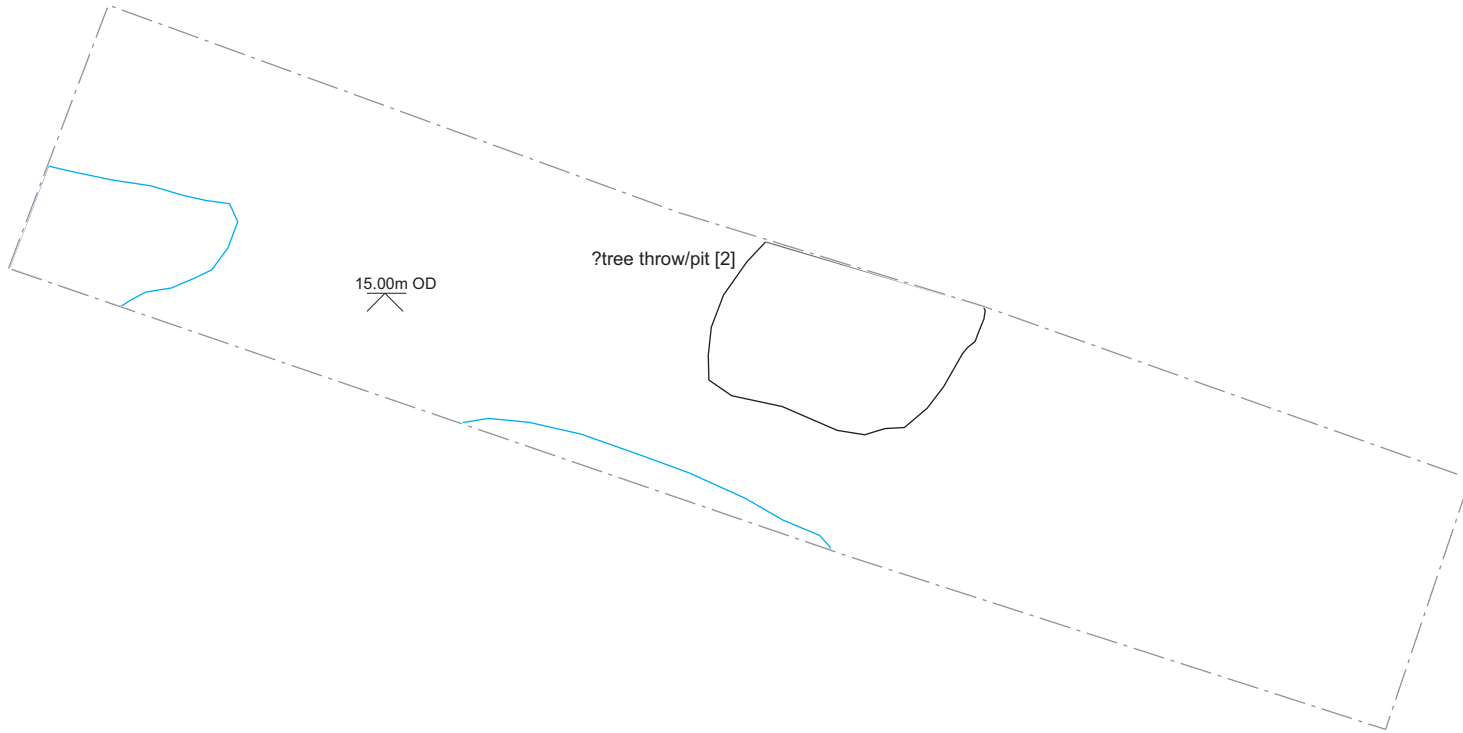
Fig 4 Trench 2

Location	West of the site (Fig 4) (Photo 3, Photo 4)
Dimensions	9.8 by 1.85 by 0.75m depth
Modern ground level/top of slab	16.78mOD
Base of modern fill/slab	16.55mOD
Depth of archaeological stratigraphy above natural (if any)	Stratigraphy consisted of 19th/20th-century ground levelling to a depth of 1.5+
Level of base of lowest features or deposits observed	14.64 mOD
Top of surviving natural observed at	15.30mOD or N/A
Level of base of trench	15.04mOD

19th-century intrusion
