KENNINGTON PARK LODGE

Kennington Park Place

Site Code: NES15
NGR: 531566 177901
OASIS reference: molas1-210275

Report on a standing building survey

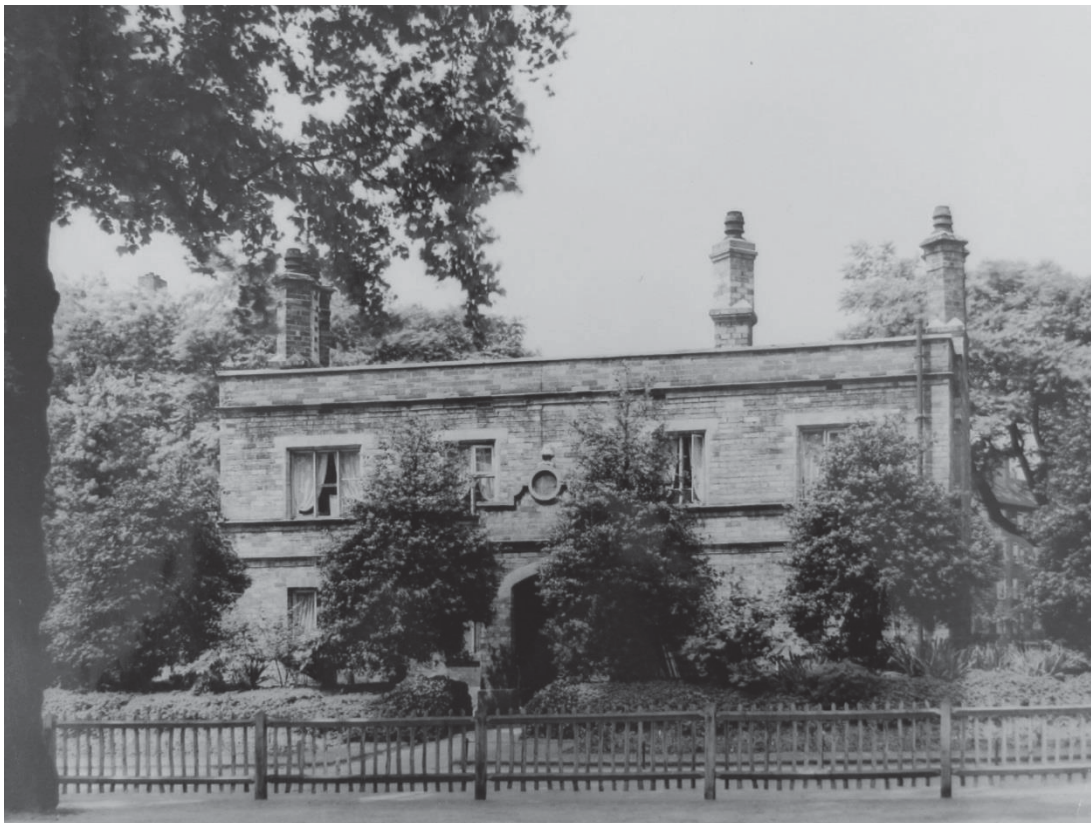
Fig 2 The park façade of the Prince Consort's Lodge (LMA SC/PHL/02/1114-1120)

- 3.1.3 Prior to the construction of the lodge, the keeper of Kennington Park resided at the nearby Prince Consort's Lodge (Fig 2), which is located to the west of the centre of Kennington Park Road and overlooks Kennington Park Road. The former lodge, which is statutorily listed at Grade II*, was first erected at Hyde Park for the Great Exhibition of 1851. It was commissioned by Prince Albert and designed by architect Henry Roberts as an example of model housing for the working classes (Pevsner, p. 362).

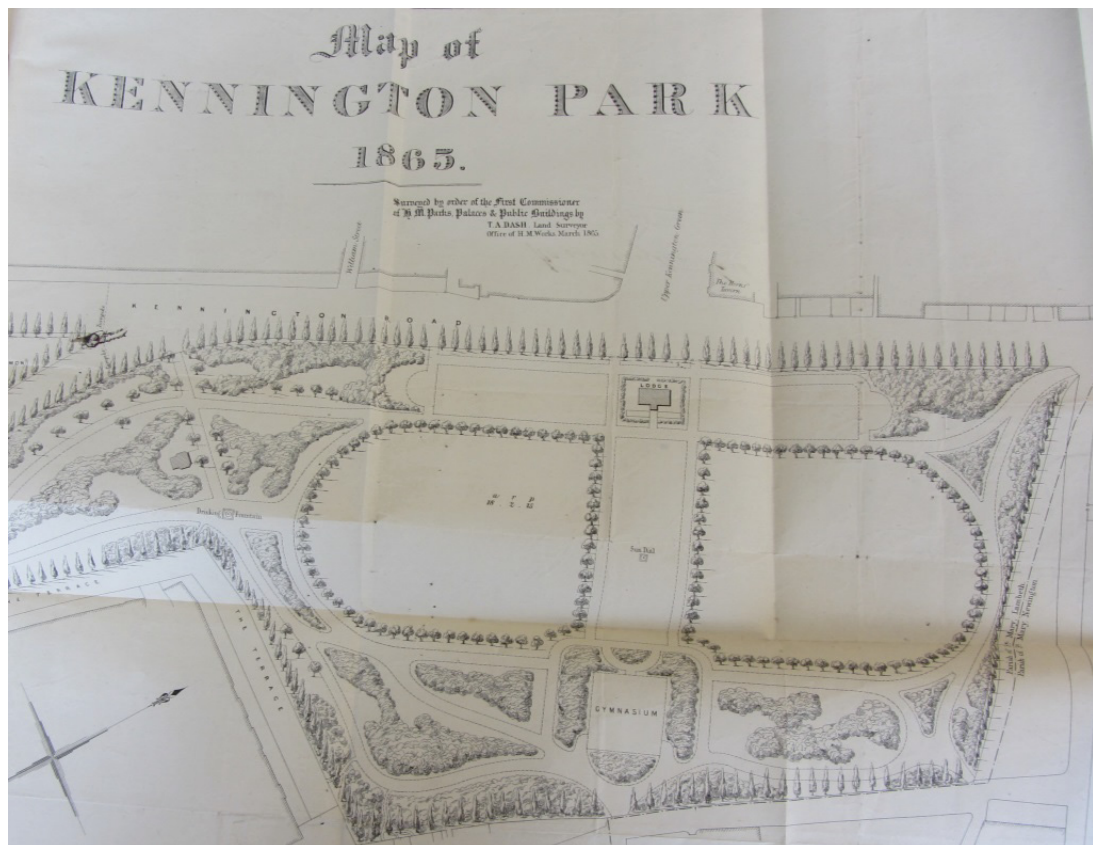
Fig 3 A 1865 map by T.A. Dash, showing the location of the Prince Consort's Lodge; the 1930s park keeper's lodge was built at the north-east corner of the park (LMA MBW/OW/KP/001)

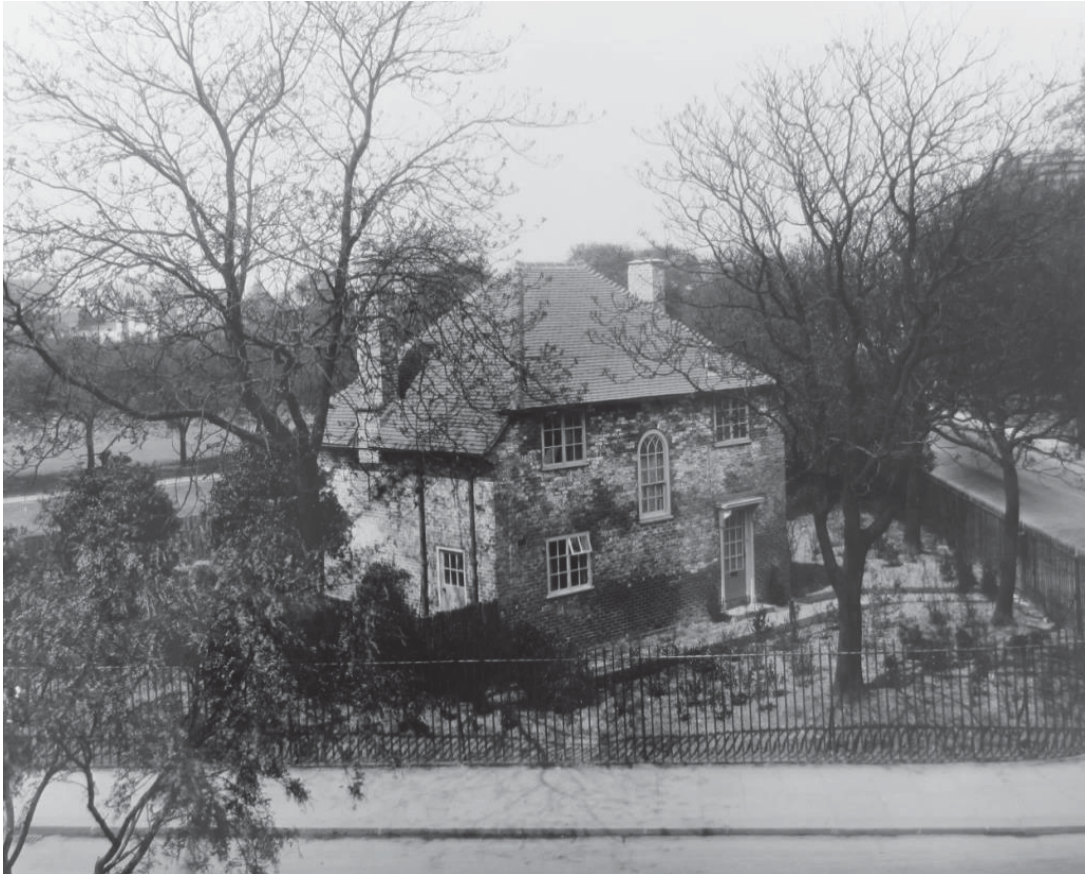
Fig 4 The east elevation in the 1930s (LMA SC/PHL/02/1114-1120-14)

4.2.2 At ground floor level is the entrance doorway to the lodge (Fig 7), along with a window opening. The entrance doorway is positioned underneath a projecting timber porch canopy that is supported by a pair of wooden brackets. The roof of the porch canopy is lined with lead flashing to resist water ingress. The doorway rests on a concrete plinth above a brick doorstep, which abuts the exterior wall and is evidently a later addition to the entrance. The original door, which is shown in the historic photograph of the lodge as a wooden panelled door with windowpanes (Fig 4), has been replaced with a UPVC door.

- 4.3.2 The main entrance doorway on the east elevation of the lodge opens into the hall (Fig 12). The original wooden door and frame displayed in the historic photograph of the lodge (Fig 4) have been replaced by a UPVC door and frame. The staircase extends along the east wall of the hall and a service box, which the London County Council plans show to date from the construction of the lodge, abuts the first step of the staircase (Lambeth Archives, LBL/DES/PK/1/106, not reproduced in this report). A door opening on the south internal wall provides access to the kitchen, and door openings on the west internal wall provide access to the living room and parlour. The north internal wall of the hall has been replaced by a partition wall (with a thickness of 0.1m), as part of the insertion of the ground floor W.C. The floor of the hall is covered with modern carpet.

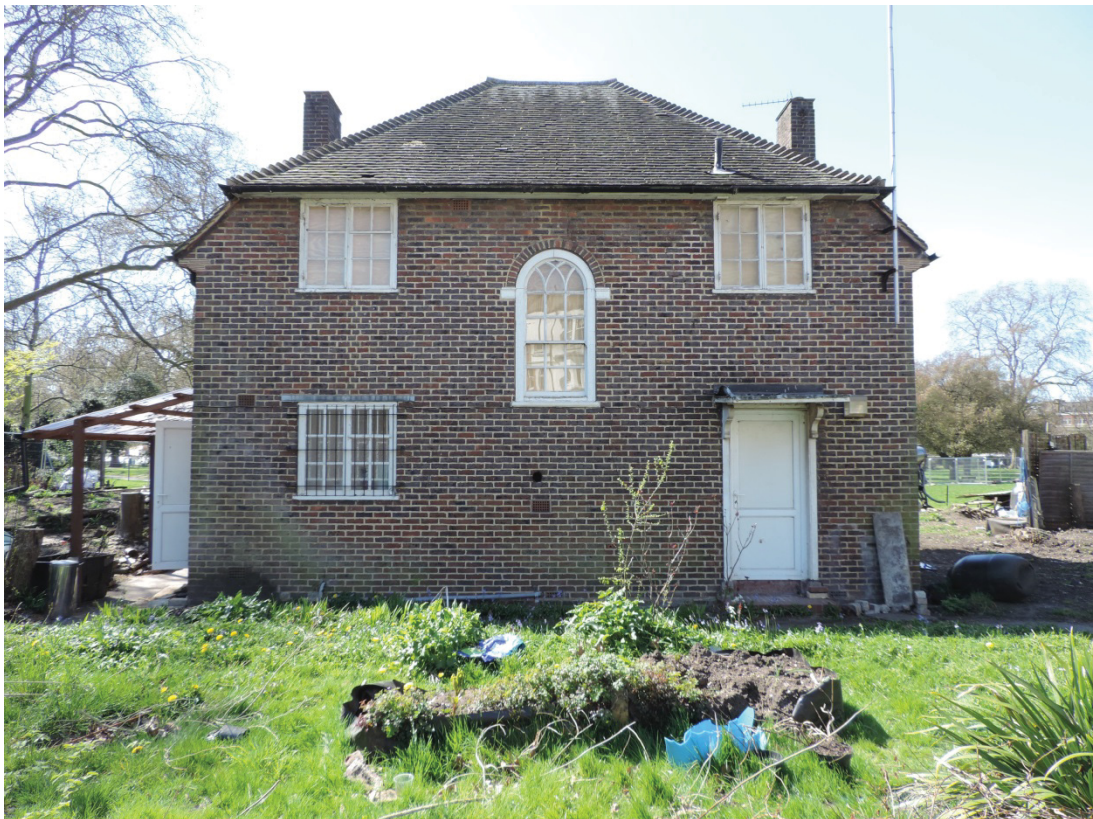
Fig 6 The east elevation of Kennington Park Lodge

- 4.2.1 The east elevation of Kennington Park Lodge (Fig 6) overlooks Kennington Park Place and serves as the principal frontage of the building. It is composed of two storeys and is lent a balanced, orderly appearance by the symmetry of the design.

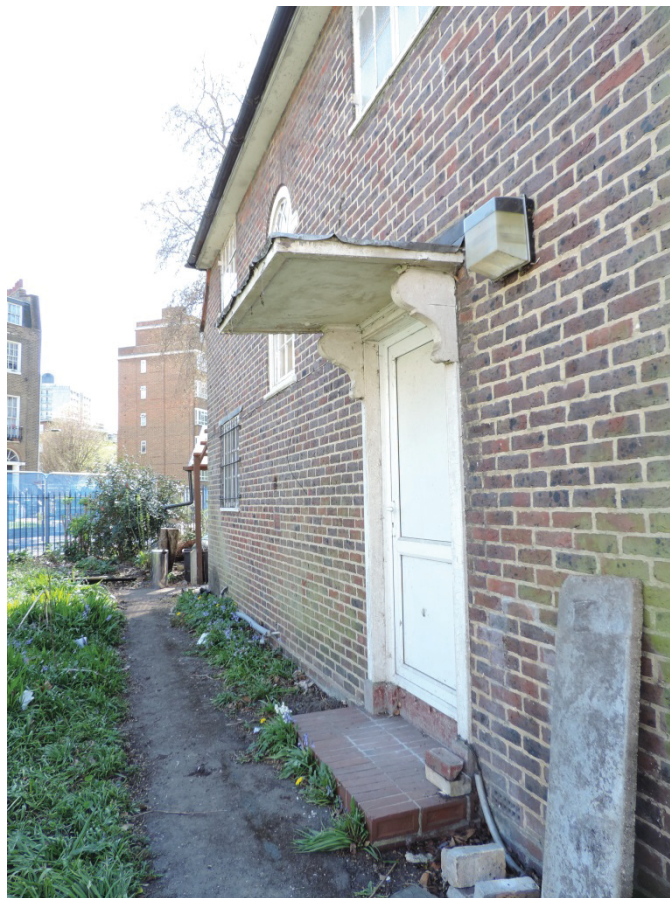
Fig 7 The entrance porch canopy and doorway on the east elevation

4.2.3 The window opening at ground floor level is slightly recessed (by approximately 30 mm) and displays its original timber frame and sill. A drip groove on the underside of the sill encourages rainwater to run off. A strip of lead flashing has been added to the lintel of the window opening to resist water ingress. The metal grille fixed to the exterior of the window opening is another later addition that was attached to provide security.

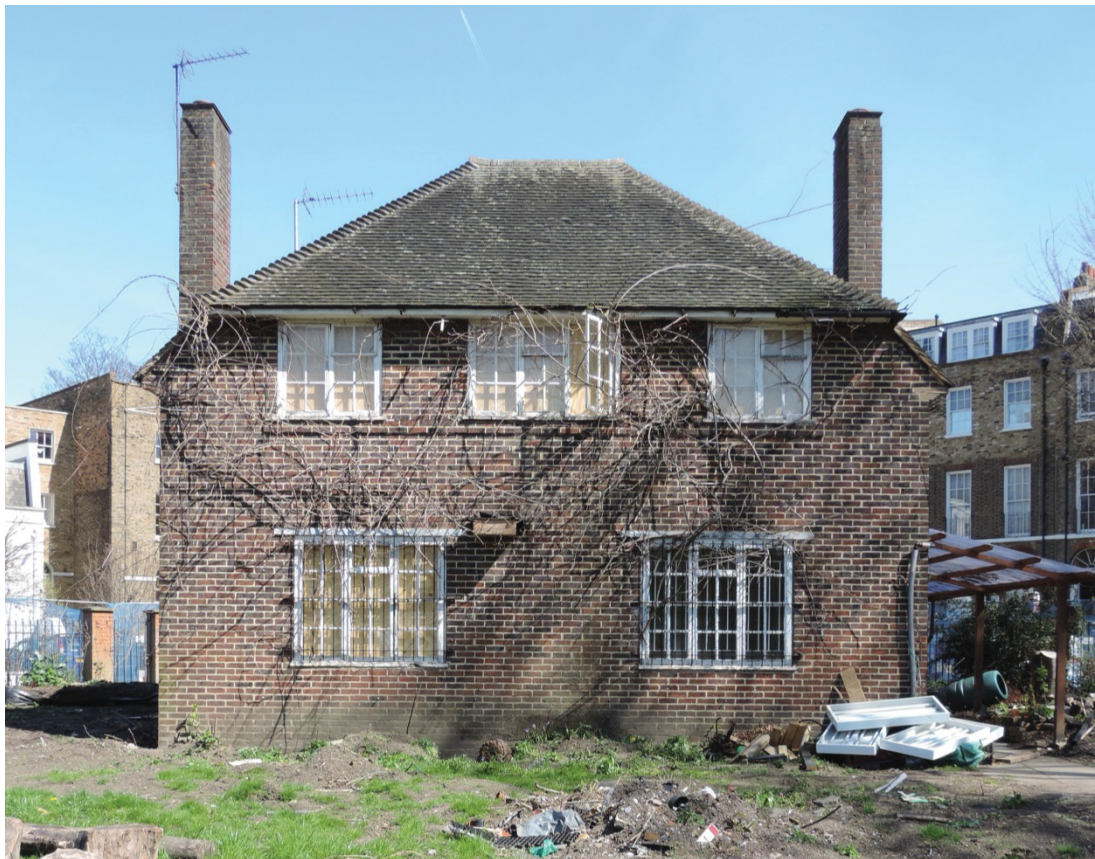
Fig 8 The west elevation of Kennington Park Lodge

- 4.2.5 The west elevation of Kennington Park Lodge (Fig 8) overlooks a small garden to the rear of the building that adjoins Kennington Park. The original plans demonstrate that when the lodge was built, the park keeper's garden was contained by a fence with a garden gate leading to the park beyond.

- 4.2.6 The ground floor level of the elevation comprises two identical window openings illuminating the parlour and the living room. The window openings are slightly recessed (by approximately 30mm) and display their original timber frames and sills with drip grooves. A strip of lead flashing has been added to the lintel of each window opening to prevent water ingress. The strips of lead flashing are slightly flared to throw off the rainwater. A pair of metal grilles has been fixed to the exterior wall to improve security.

- 4.2.7 The first-floor level of the west elevation comprises three evenly-spaced windows illuminating the first and second bedrooms. The window openings are slightly recessed (by approximately 30mm) and display their original timber frames and sills with drip grooves. The central window opening is larger than the window openings that flank it on either side. A raised brick string course runs underneath the sills of the three windows, adding a degree of variation to the repetitive stretcher bond of the façade.

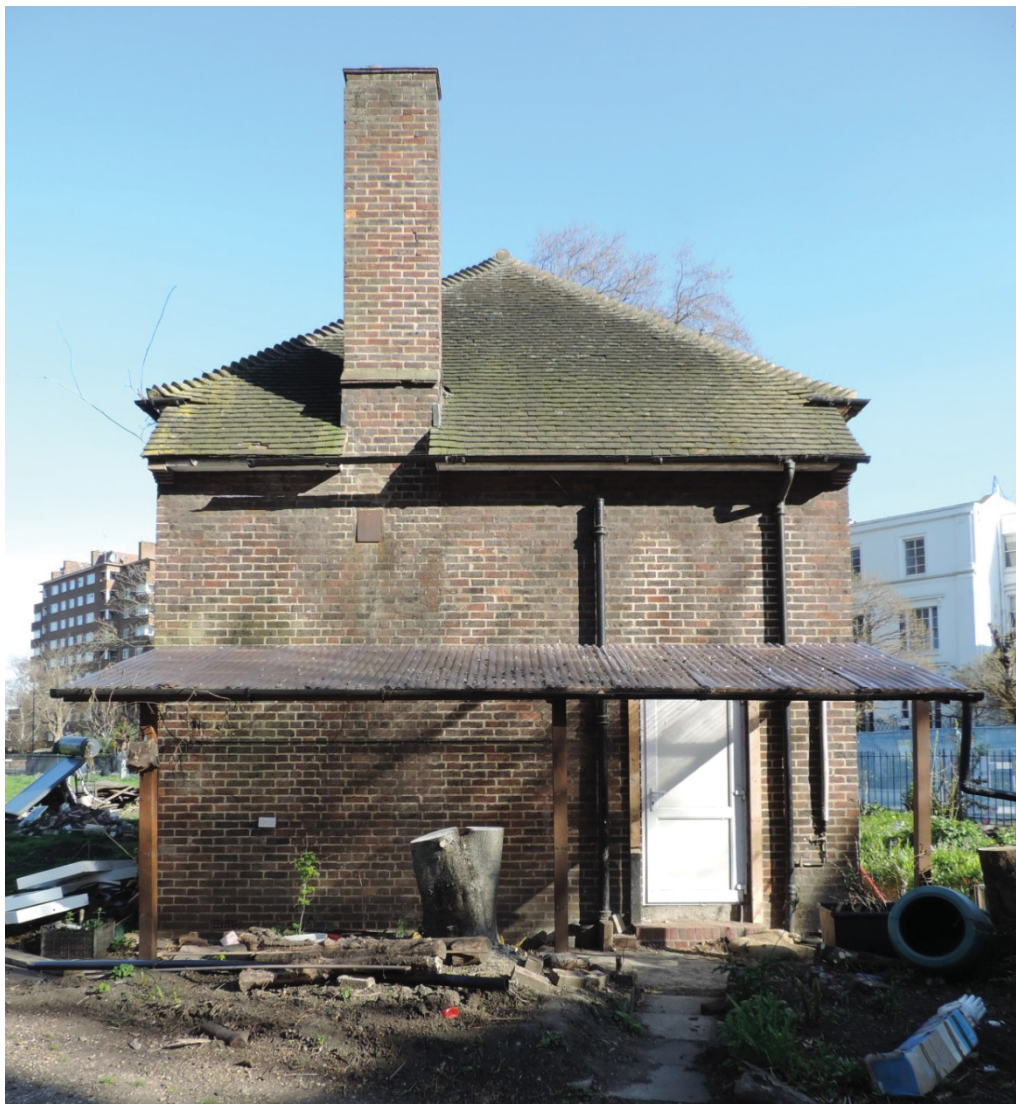
Fig 9 The south elevation of Kennington Park Lodge

- 4.2.8 The south elevation of Kennington Park Lodge (Fig 9) comprises two storeys and is of brick construction. At ground floor level, a door opening provides access directly to the kitchen. The doorway rests on a concrete plinth above a brick doorstep, which abuts the exterior wall and is evidently a later addition to the entrance. The original door, which is depicted in the historic photograph of Kennington Park Lodge (Fig 4) as a wooden panelled door with panes of glass, has been replaced with a modern UPVC door. Another later addition to the ground floor level is the lean-to veranda (Fig 9 and Fig 10), which is of timber construction with a corrugated plastic roof. The structure extends along the width of the south elevation. The original drainpipes, with London County Council markings, rise to eaves level from either side of the door opening.

- 4.2.9 A chimney stack rises through the height of the elevation; the brick courses of the lower part of the stack are laid in English bond to support the tall structure above, and the brick courses of the upper part of the stack are laid in stretcher bond to reduce its weight (Fig 10). The courses of English bond rise to the height of the tiled corbels on the chimney stack. A metal flap is positioned on the chimney stack at second floor level, probably to allow for cleaning.

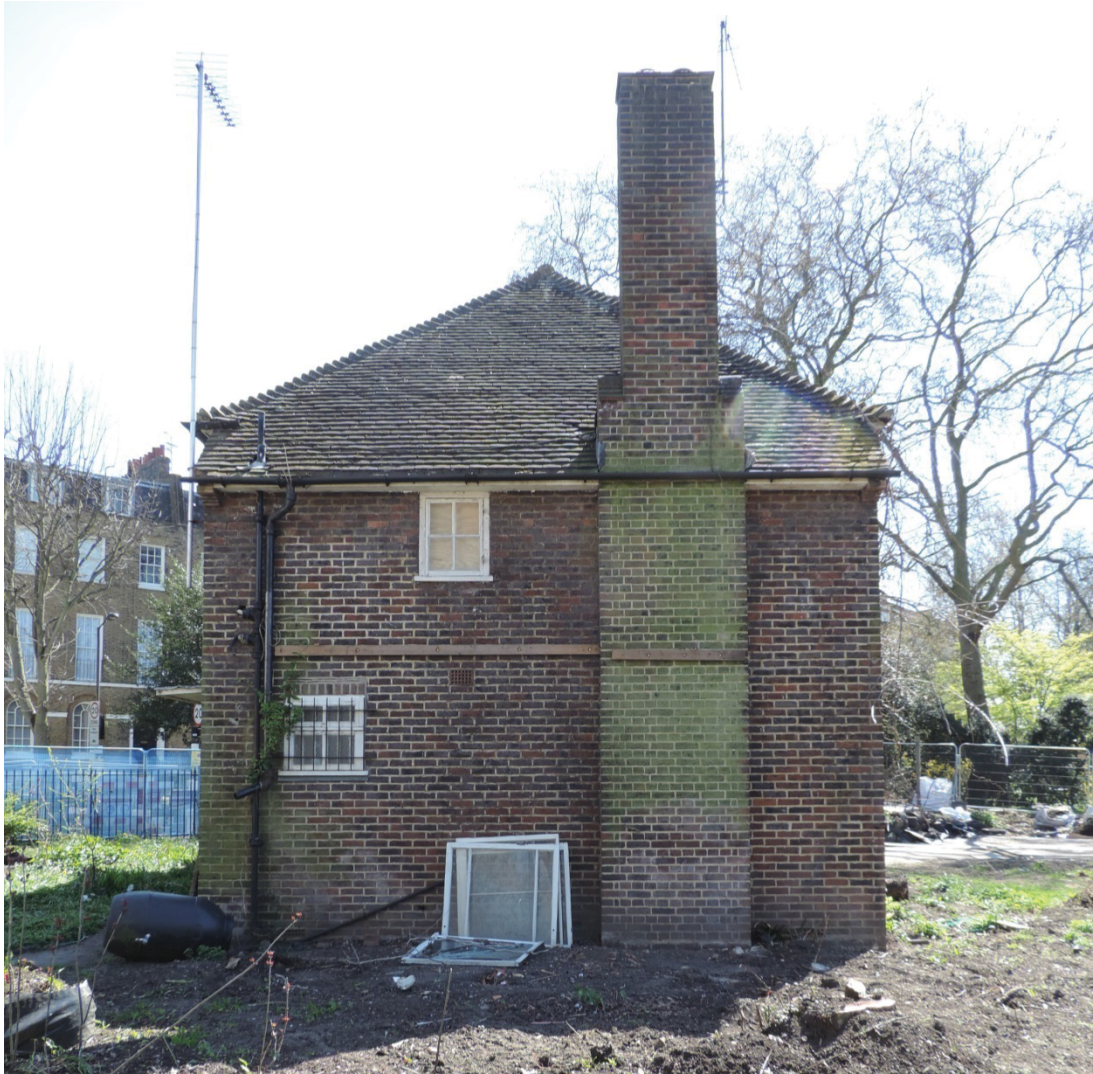
Fig 11 The north elevation of Kennington Park Lodge

- 4.2.10 The north elevation is composed of two brick-built storeys. The ground floor level of the elevation features an inserted window opening with a wooden frame and sill. The window was probably added when the broom cupboard and adjoining cloakroom were replaced by the W.C. The brick lintel of the window opening comprises a course of headers below two courses of tiles. A set of metal grilles has been fitted to the exterior wall to provide the window opening with additional security. The window sill has a drip groove to encourage rainwater run-off. To the left of the window opening, the original drainpipe (with London County Council markings) rises to eaves level.

- 4.2.11 The first floor level comprises an original window opening that provides light to the bathroom. The window opening is slightly recessed (by approximately 30mm) and displays its original wooden frame and sill with drip groove. It is likely that a lean-to veranda (similar to the structure fixed to the south elevation of the lodge) was once fitted to the elevation, as timber fixings are visible.

- 4.2.12 The chimney stack protrudes from the main body of the façade by approximately 0.41m. Like the chimney stack on the south elevation of the building, the brick courses of the lower part of the chimney stack are laid in English bond to support the tall structure above. The courses of English bond rise to the level of the tiled corbels on the chimney stack. The brick courses of the upper part of the chimney stack are laid in stretcher bond to minimise the weight of the stack.

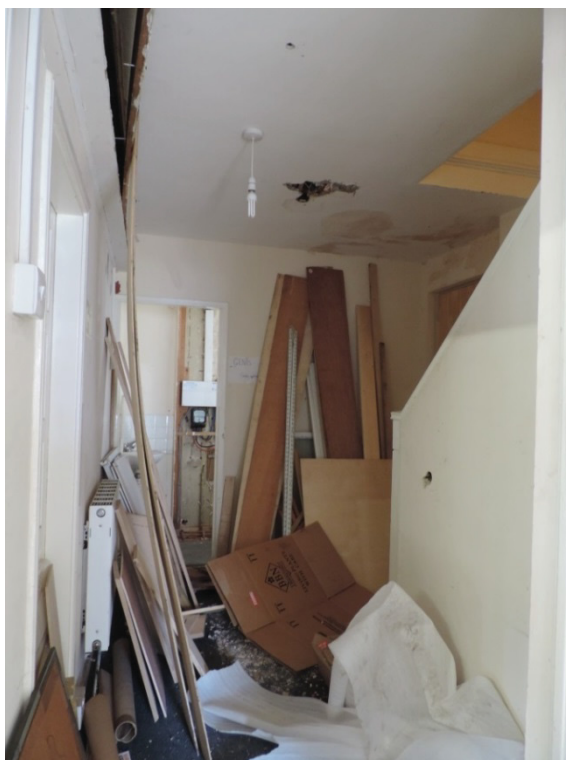
Fig 14 A view of the hall, facing north towards the ground floor W.C.

- 4.3.3 As previously discussed, the original plans for the building show that the small W.C. on the ground floor has replaced the former broom cupboard and coat cupboard (Lambeth Archives, LBL/DES/PK/1/106, not reproduced in this report). A window with wooden frames has been inserted on the north external wall of the room. A service box, which is a later insertion, is positioned to the west of the window opening. The walls of the W.C. are partially tiled and the floor covered with linoleum.
- 4.3.4 The cupboard positioned underneath the staircase in the hall was designed to function as the fuel store for the lodge (Fig 15 and Fig 16). It is accessed from the hall via a door opening with its original wooden door and frame. The walls of the cupboard have exposed brickwork and the floor is concrete. An opening in the external wall of the cupboard was probably added to insert a pipe.

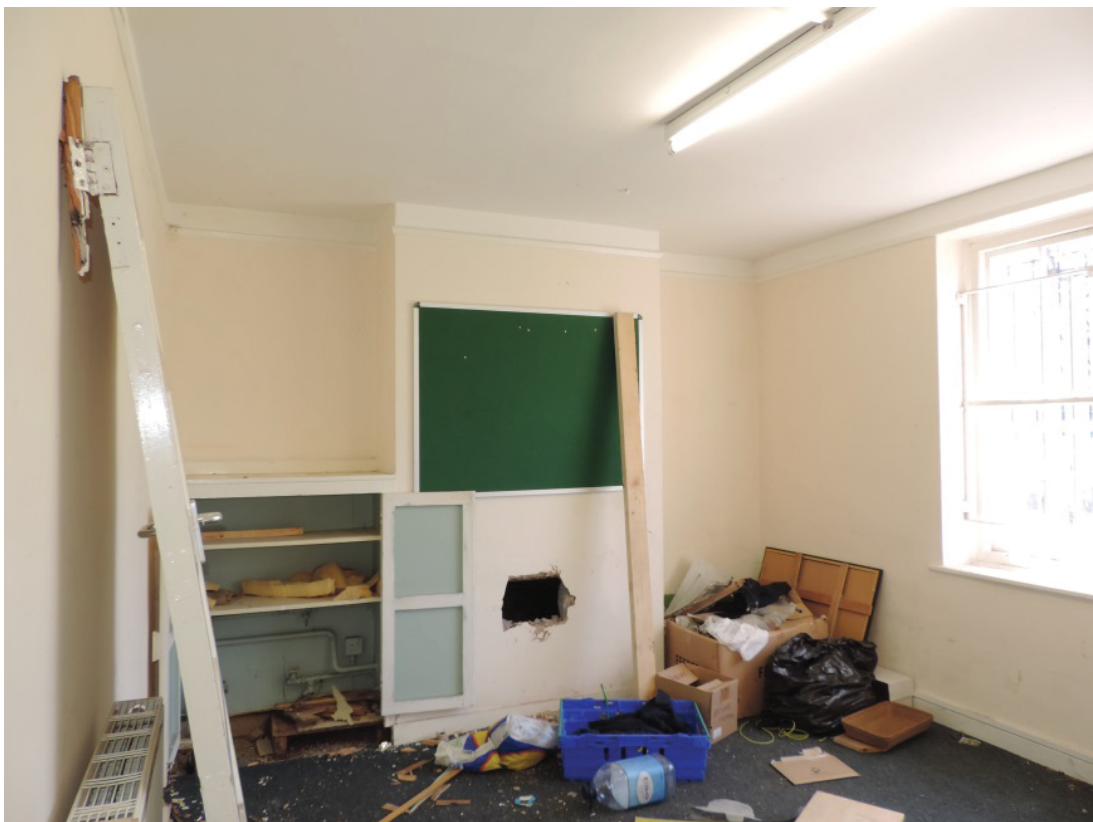
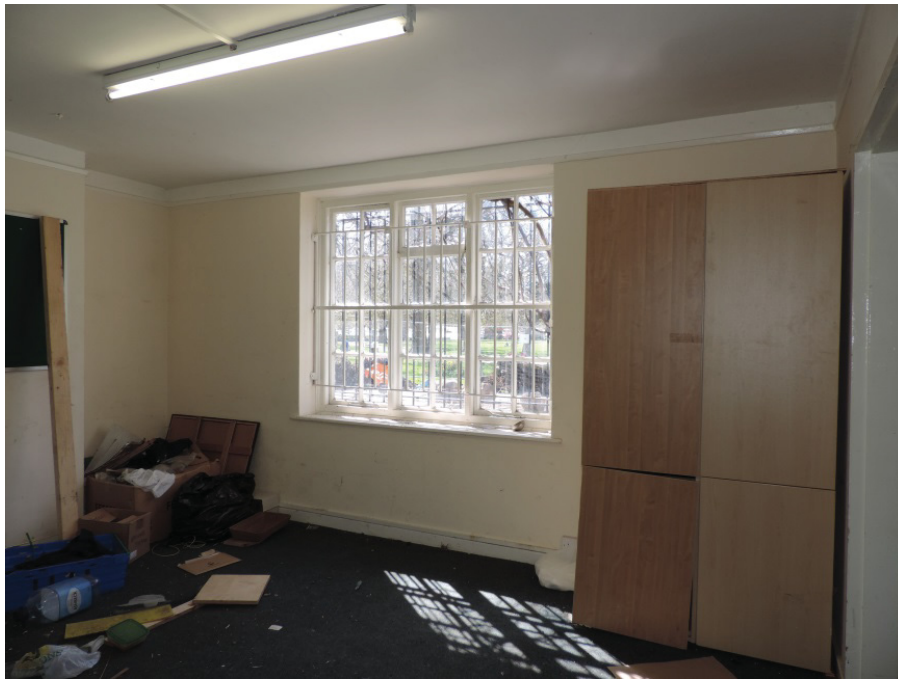
- 4.3.5 The living room (Fig 17 and Fig 18) is a brightly-lit room that is roughly 4.5m by 3.5m in size. The south wall of the room has a protruding chimney breast, with a blocked fireplace. The alcove to the east of the chimney breast contains a fitted wooden cupboard, probably a later addition to the room. A large window opening positioned on the west external wall illuminates the living room and overlooks the former garden to the rear of the lodge. The hinges of the window are rather unusual, as they permit the fully-opened window to rest directly against the external wall. Although the window opening retains its original timber frames, its appearance has been altered by the insertion of internal and external metal grilles to improve security. The north wall of the room features a large opening into the parlour; the London County Council plans for the lodge indicate that the living room was originally separated from the parlour by a pair of doors (Lambeth Archives, LBL/DES/PK/1/106, not reproduced in this report). Simple skirting boards and a picture rail extend along the internal walls of the living room. The floor of the room is covered with modern carpet. The LED lighting suggests that the living room was converted from domestic use into an office or community space.

Fig 17 The living room, facing south towards the blocked fireplace

Fig 18 The living room, facing west

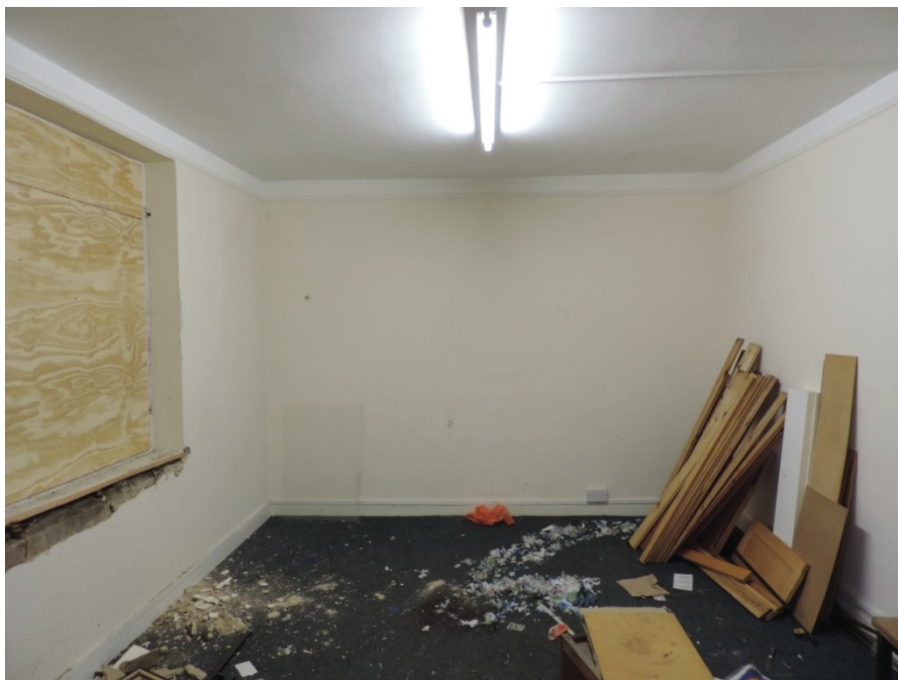
Fig 19 The former parlour, facing north towards the blocked fireplace

- 4.3.6 The parlour (Fig 19) is of similar size and proportions to the adjoining living room. It also has a large window opening on the west wall that overlooks the rear garden to the lodge. The original plans for the lodge indicate that the fireplace on the north wall of the parlour has been blocked (Lambeth Archives, LBL/DES/PK/1/106, not reproduced in this report). The window opening in the parlour also has unusual hinges that allow for the fully-opened window to rest directly against the external wall. On the east wall of the room, a door opening provides access to the hall. The original wooden frame and door are intact. The floor of the parlour is covered with modern carpet, and simple skirting boards and a picture rail extend along each of the internal walls. The LED lighting suggests that, like the living room, the parlour has recently been used as an office or community space.

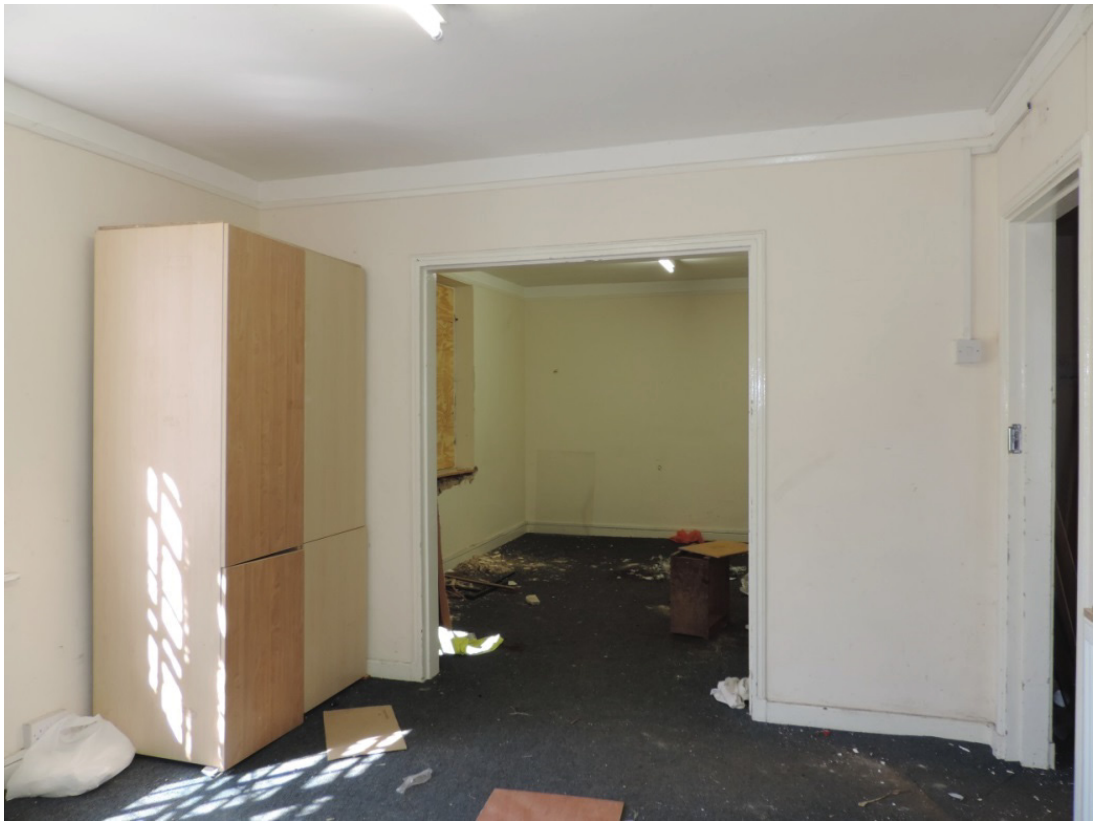
Fig 20 A view facing north into the former parlour from the living room

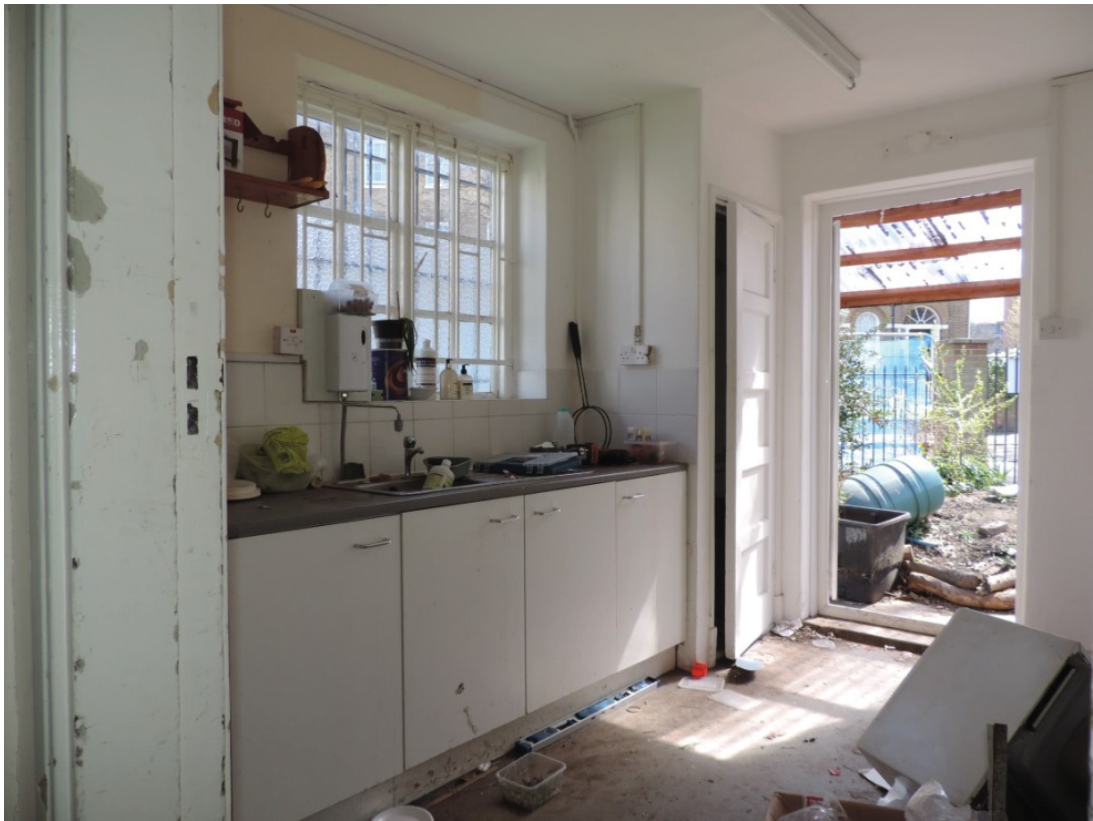
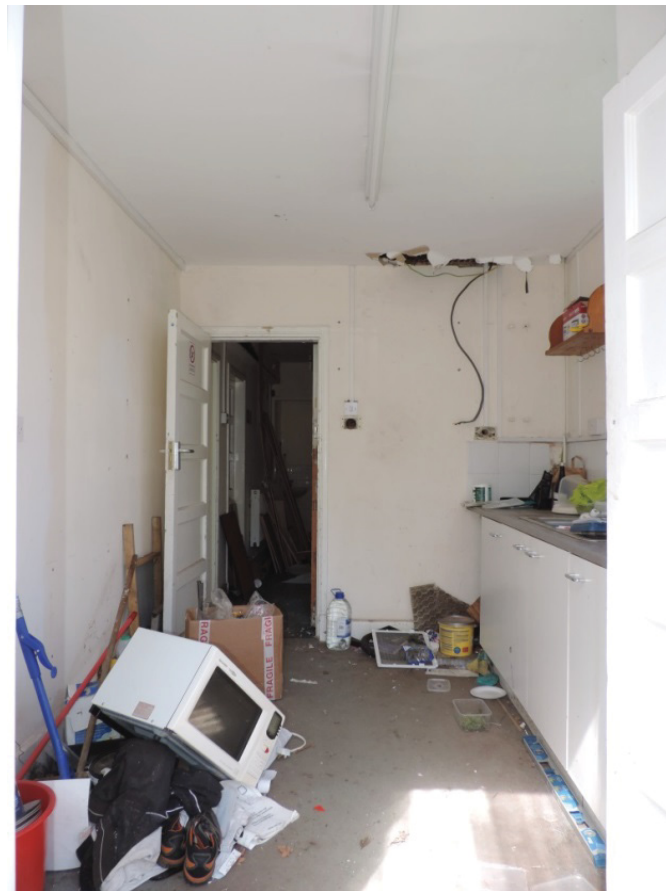
- 4.3.7 The original plans for the lodge show that the layout of the kitchen (Fig 21 and Fig 22) has not altered significantly since the lodge was constructed (Lambeth Archives, LBL/DES/PK/1/106, not reproduced in this report). The kitchen is entered from the south façade by a door opening, which has a UPVC door and frame in place of the wooden fittings displayed in the historic photograph of the lodge (Fig 4). A larder, with its original wooden door and frame intact, is positioned to the east of the external door. The appearance of the window opening on the east elevation has been altered by the insertion of external and internal metal grilles for security. A door on the north internal wall of the kitchen provides access to the hall and displays its original wooden fittings. The room has tiled skirting; although the tiles were painted at the time of the survey, they were formerly dark red in colour. The floor of the kitchen is covered with linoleum.

Fig 21 A view of the kitchen, facing south-east

Fig 22 A view looking north into the kitchen towards the hall

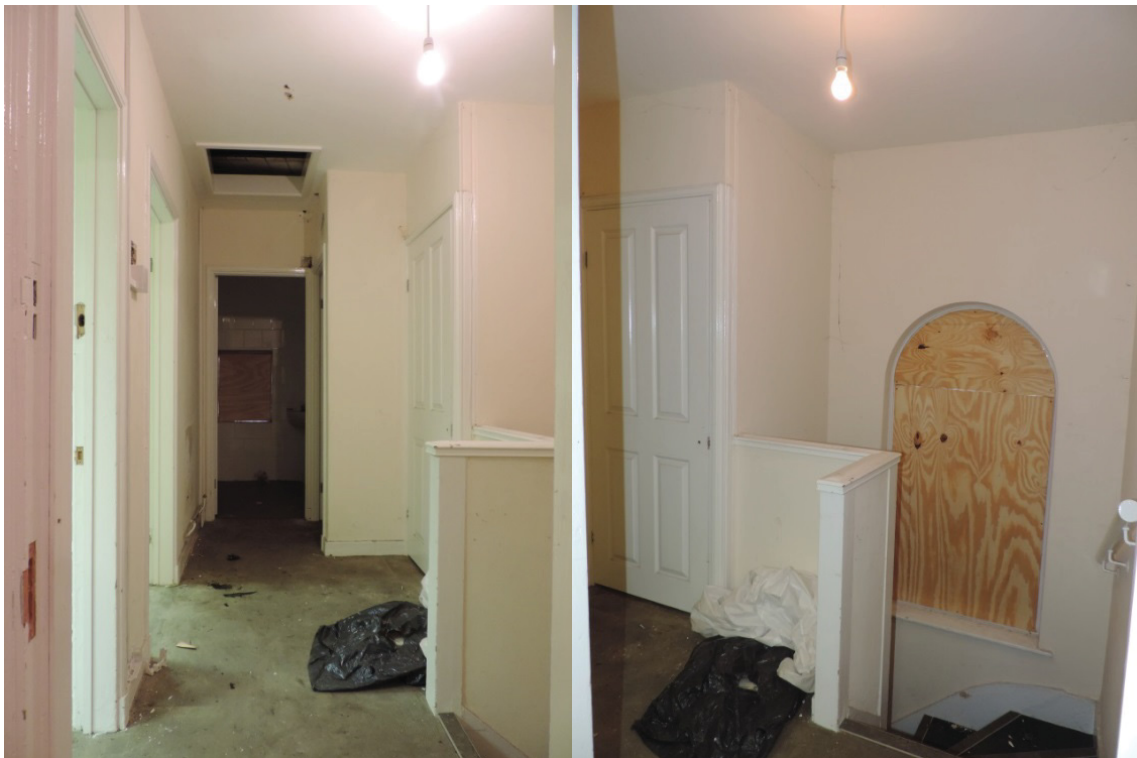
Fig 23 and Fig 24 The first-floor hall, facing north and north-east

- 4.3.9 The first-floor hall comprises a narrow landing that runs alongside the adjacent rooms on a north-south axis (Fig 23 and Fig 24). It is accessed from the ground floor by a staircase and lit by the large semicircular-headed window positioned at the centre of the east external elevation. The internal door openings providing access to the bedrooms retain their original wooden doors and frames, whilst the door openings for the hall cupboard, bathroom and W.C. contain modern doors. At the north of the hall, a hatch provides access to the loft. Simple skirting extends along each of the internal walls. At the time of the survey, the floor of the hall was stripped.

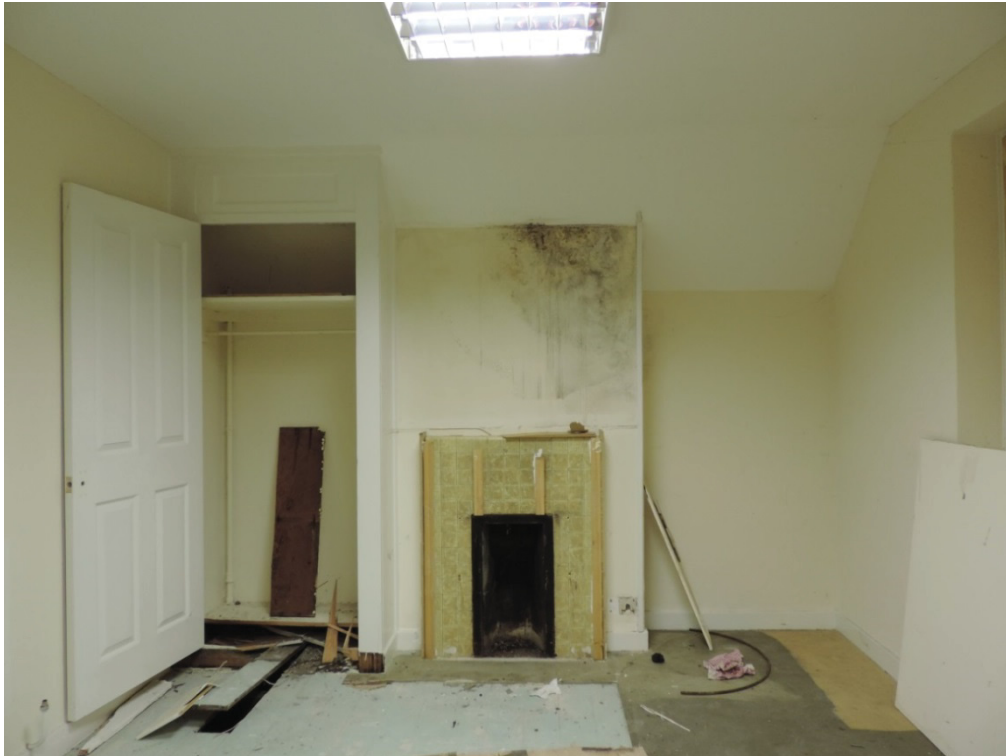
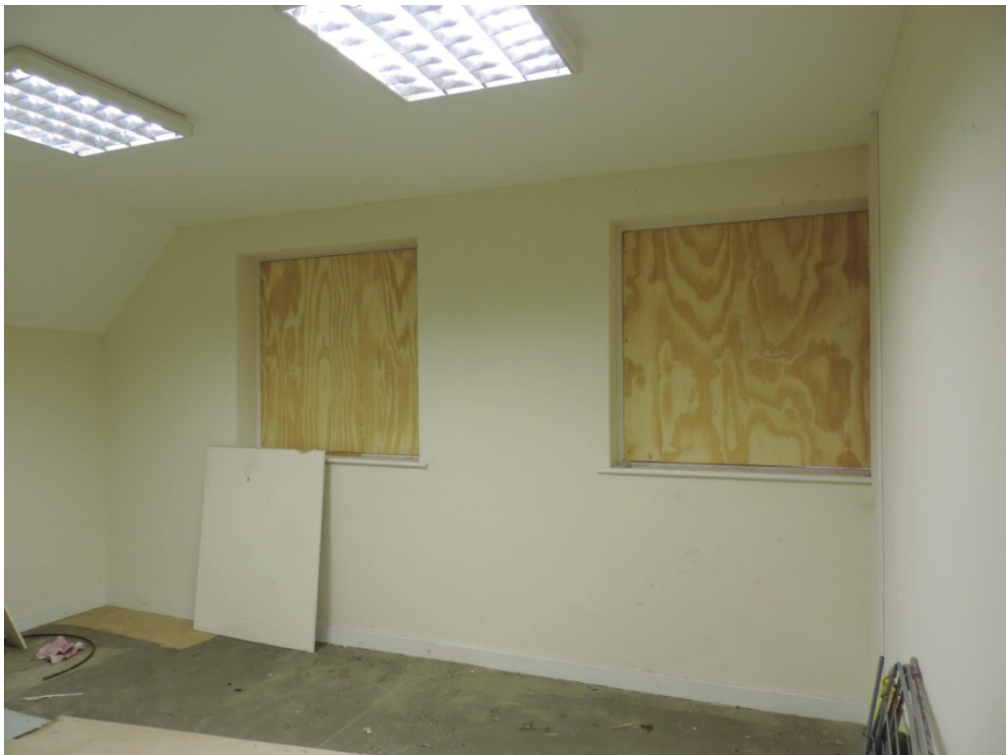
- 4.3.10 The first bedroom (Fig 25 and Fig 26) has a chimney breast and (formerly blocked) fireplace on its south wall, which retains its original tiles. The wardrobe adjacent to the fireplace is a later insertion, as demonstrated by the London County Council plans for the lodge (Lambeth Archives, LBL/DES/PK/1/106, not reproduced in this report). The ceiling of the room slopes towards the south wall to account for the pitch of the roof. Two window openings are positioned on the west wall of the room; the window opening that adjoins the north internal wall is shared with the second bedroom. The London County Council plans show that this unusual window arrangement was part of the original design, perhaps with the aim of maximising light to the first floor bedrooms (Lambeth Archives, LBL/DES/PK/1/106, not

reproduced in this report). At the time of the survey, the floor covering in the room had been stripped to reveal wooden floorboards running in a north-south direction. Simple skirting extends along each of the walls. The LED panel lighting demonstrates that the room has not functioned as a bedroom for some time, and has possibly been used as a small office.

Fig 25 The first bedroom, facing south towards the fireplace and cupboard

Fig 26 The first bedroom, facing the windows on the west elevation

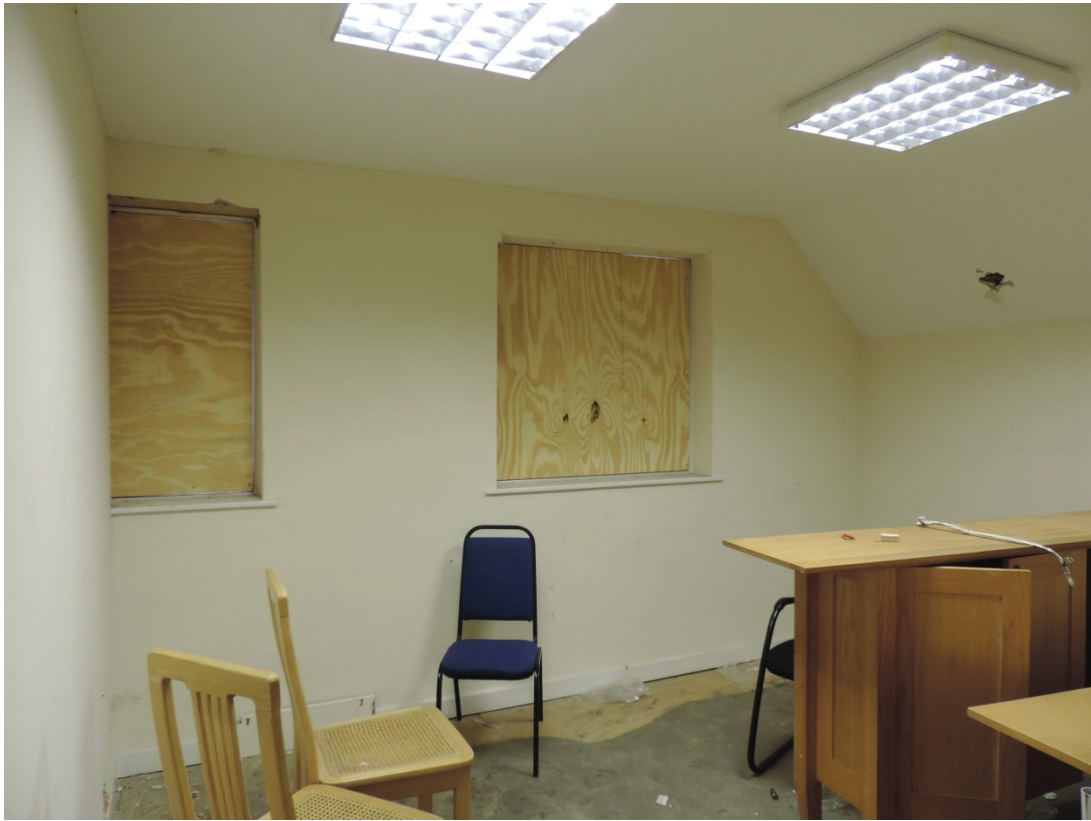
Fig 27 The second bedroom, facing the windows on the west elevation

- 4.3.11 The second bedroom (Fig 27) is of similar size and proportions to the first bedroom. The ceiling slopes towards the north external wall to account for slope of the roof. Two window openings are positioned on the west wall of the room; as previously mentioned, the small window opening is shared with the first bedroom. At the time of the survey, the floor covering in the room had been stripped. Simple skirting extends along each of the walls. The LED panel lighting demonstrates that, like the first bedroom, the room has possibly been in recent use as an office.

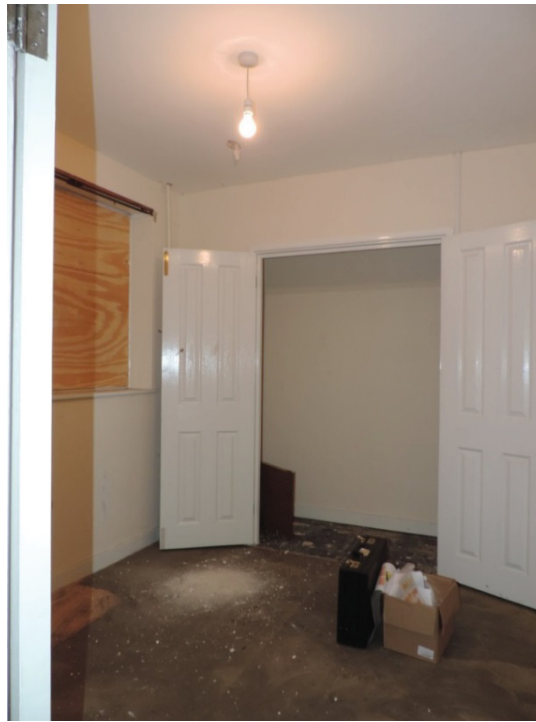
Fig 28 The third bedroom, facing south towards the inserted wardrobe

- 4.3.12 The third bedroom (Fig 28) is smaller than the other bedrooms and has a window opening on the east external wall. A partition wall has been inserted at the south end of the room to create a large cupboard space with a pair of modern doors. Simple skirting boards extend along each of the internal walls of the room. At the time of the survey, the floors in the room were stripped.

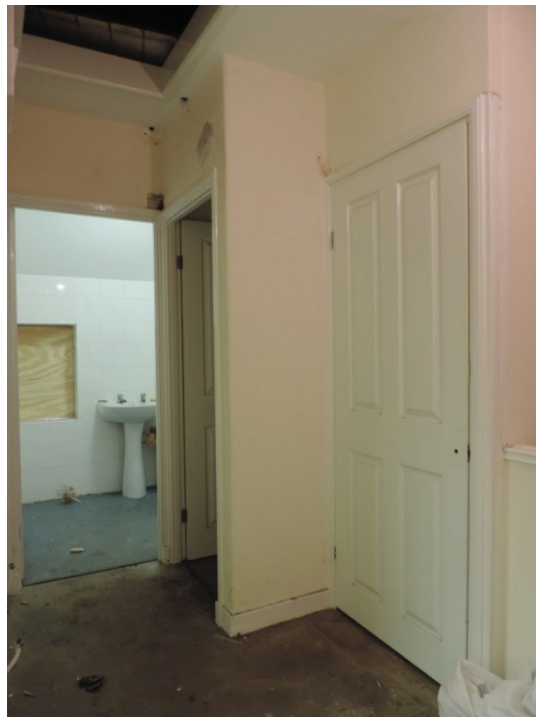
Fig 29 The hall, facing north towards the first-floor bathroom and separate W.C.

- 4.3.13 The London County Council plans for the lodge show that the small bathroom and W.C. (Fig 29) at the north end of the first-floor hall were designed as separate rooms, and therefore it seems that the original floor plan has not been altered (Lambeth Archives, LBL/DES/PK/1/106, not reproduced in this report). The bathroom is lit by a small window on the north external wall and another small window on the east external wall, which is shared with the adjoining W.C. Both rooms are tiled and have linoleum floor coverings.

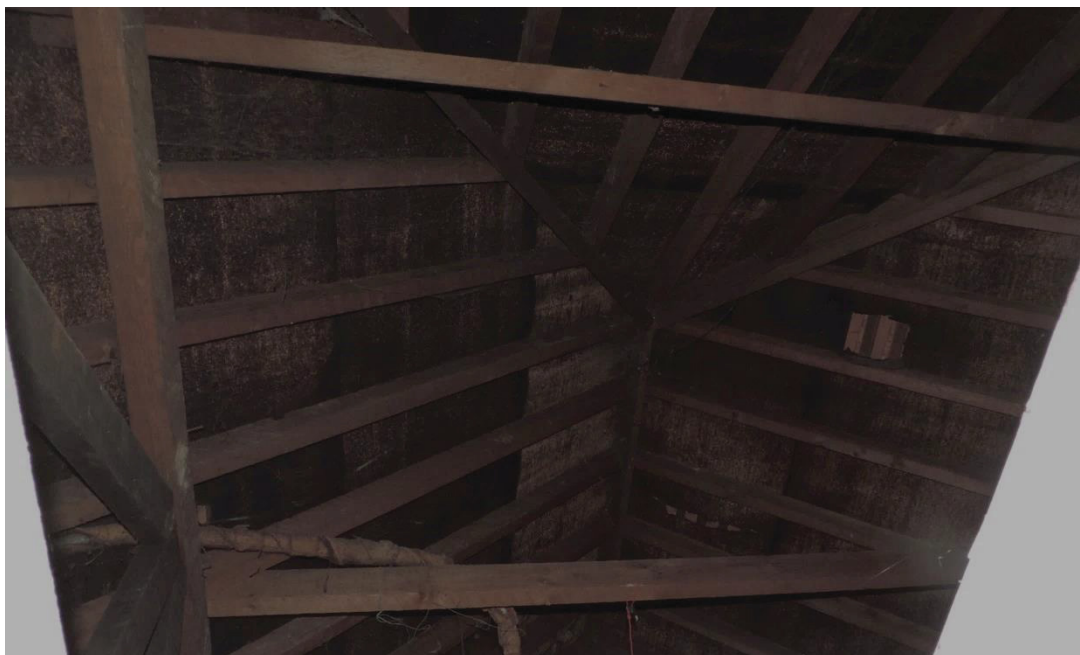
Fig 30 A view into the loft from the hatch in the first-floor hall

- 4.3.14 The loft (Fig 30), which extends across the footprint of the lodge and is exposed to the timber-framed hipped roof, was not inspected due to lack of access. The original plans for the building demonstrate that it held an 80 gallon water tank.
