CURTIS GREEN BUILDING London SW1

Archaeological watching brief report

**Curtis Green Building
Whitehall
London SW1**

Report on an archaeological watching brief

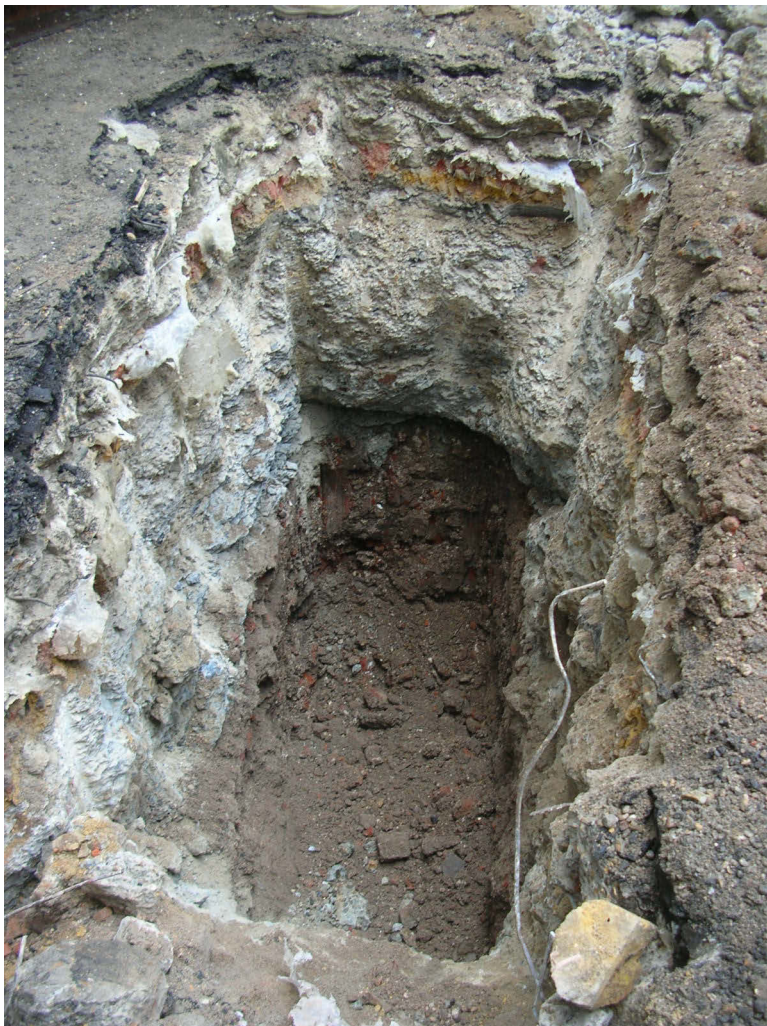
- 4.1.1 The only deposit in this trench was [20], a dump of demolition material that continued below the base of the trench. This was dated by pottery to 1770-1800 and included a clay tobacco pipe dated c 1660–80.

Trench W1 looking west

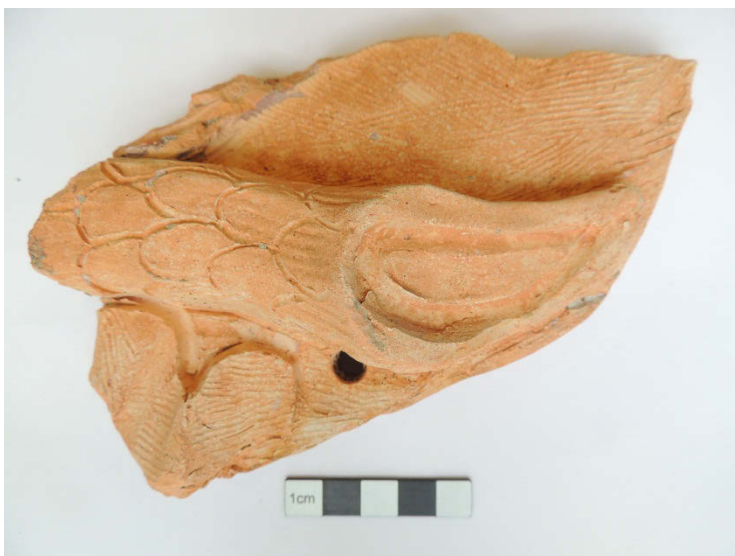
Tudor Terracotta fragment

- 4.22.2 A remarkable piece of terracotta moulding was recovered from dumped demolition material (context [23] <9>). This is made from cream and orange fired clay. The moulding comprises a flat base with small decorative elements. Larger hand-moulded decoration was fixed separately. The latter has what may be scales suggesting it may be a dragon or similar beast. The surviving area could be part of a tail or the base of a leg with a hoof. The background and smaller decorative elements are covered with fine combing. Next to the tail/leg is a small 8mm diameter hole situated near the edge. This edge has the remains of a textile impression. There are small areas remaining of what is almost certainly paint. The flat combed background has traces of dark red paint whilst the tail/leg may have been pale blue.

- 4.22.3 There is only three pieces of terracotta known from Britain which are even remotely similar. These all came from Richmond Palace in Surrey (Smith 2001, 36-38). Although the decoration is very different, they show two pairs of centrally ribbed leaves springing from ribbed stalks, these too have holes and painted decoration. The three Richmond Palace examples, all identical, would each have had three round holes which Smith (2001, 38) believes were added to facilitate firing. As the moulds are relatively thin this would seem unnecessary, instead it is far more likely they were added to allow each moulding to be attached in some way. Smith suggests the Richmond Palace examples were set internally, decorating a screen or set horizontally in a decorative ceiling. The fine detail on the Curtis Green example suggests this too was set internally. The Richmond place tiles have the remains of blue paint, whilst some of the terracotta from St John's Clerkenwell, London has the remains of red, white and yellow paint.

- 4.22.4 The Curtis Green and Richmond Palace pieces are clearly the products of the same group of terracotta manufacturers which, as such pieces are unknown elsewhere, were probably based either in London or located somewhere close by. They represent a brief fashion during the period c 1515-1540 among the nouveau riche in south-eastern England and East Anglia to adorn their houses, both internally and externally, with decorative terracotta (Smith and Watson 2014, 120). The most likely building near the Curtis Green site to have installed such elaborative decoration was Henry VIII's Whitehall Palace.

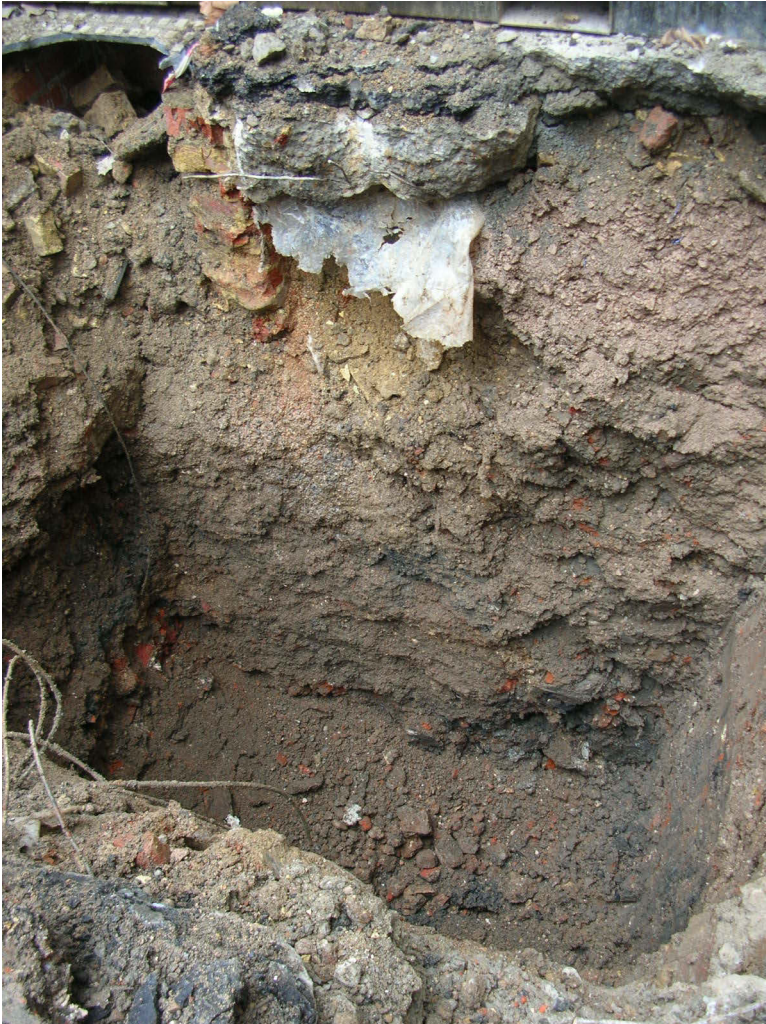
4.4.1 The only deposit in this trench was a clayey silt [25] with brick and tile fragments, that continued below the base of the trench.

Trench W4 looking north

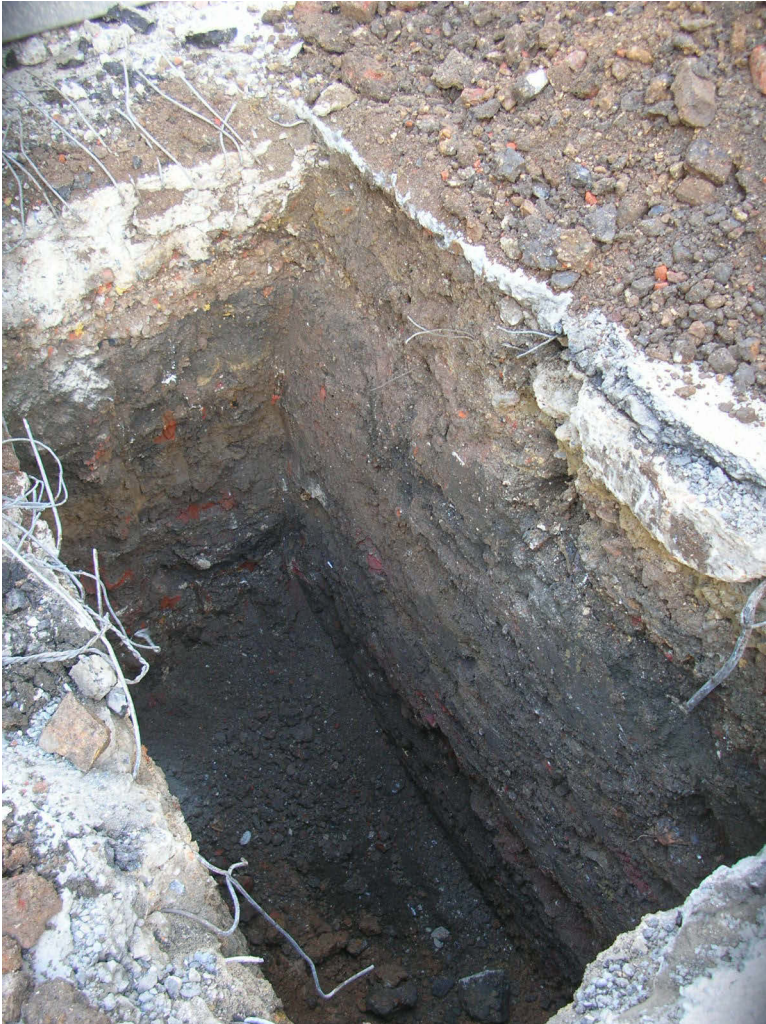
- 4.10.1 See *Fig 4*
- 4.10.2 The lowest deposit [33] was an orange grave with brick fragments that continued beyond the base of the trench. This was overlain by a ground raising dumps [32] and [31]; the latter is dated by finds to the mid-late 19th century.

Trench E7 looking south west

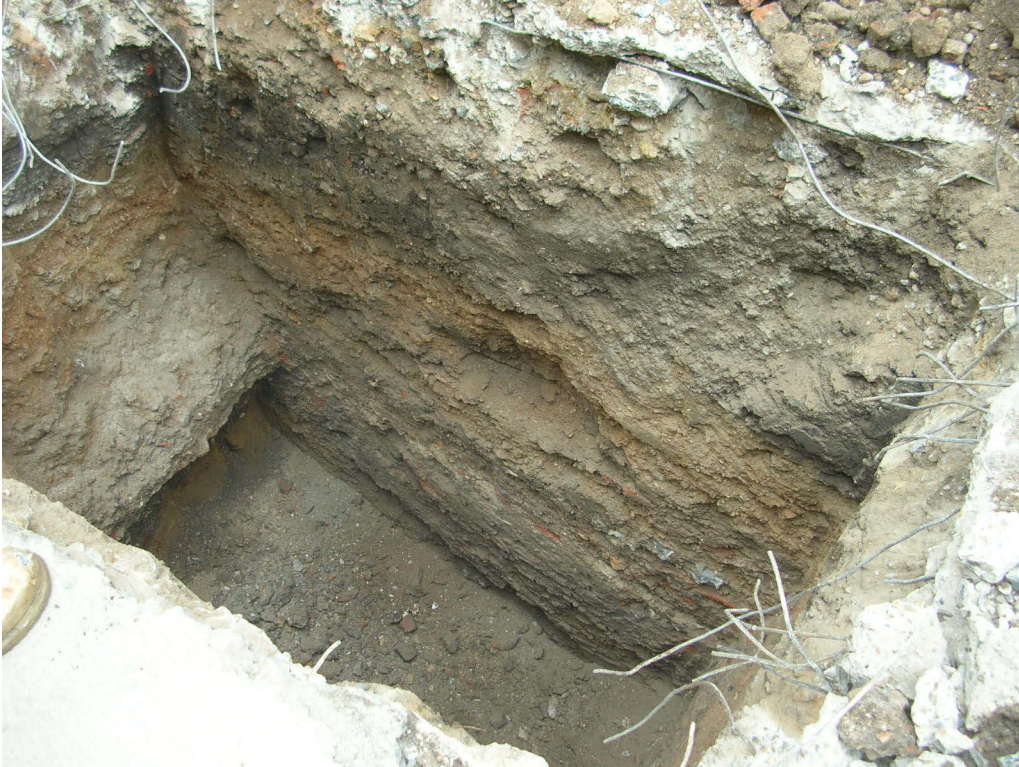
- 4.12.1 The lowest deposit was a ground raising dump [38] that continued beyond the base of the trench. This was overlain by a deposit [37] that lacked any obvious inclusions so may be a modern screened deposit.

Trench E9 looking west

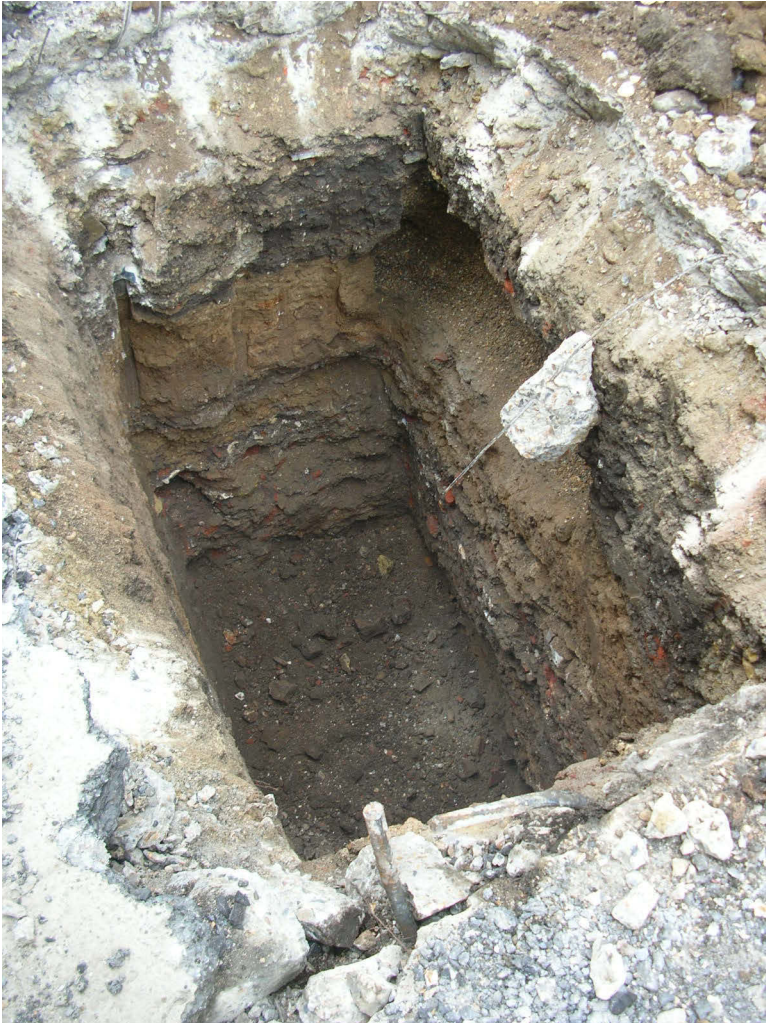
4.14.1 The lowest deposit was a ground raising dump [45] that continued beyond the base of the trench. This was overlain by a yellow sandy clay deposit [44].

Trench E11 looking south west

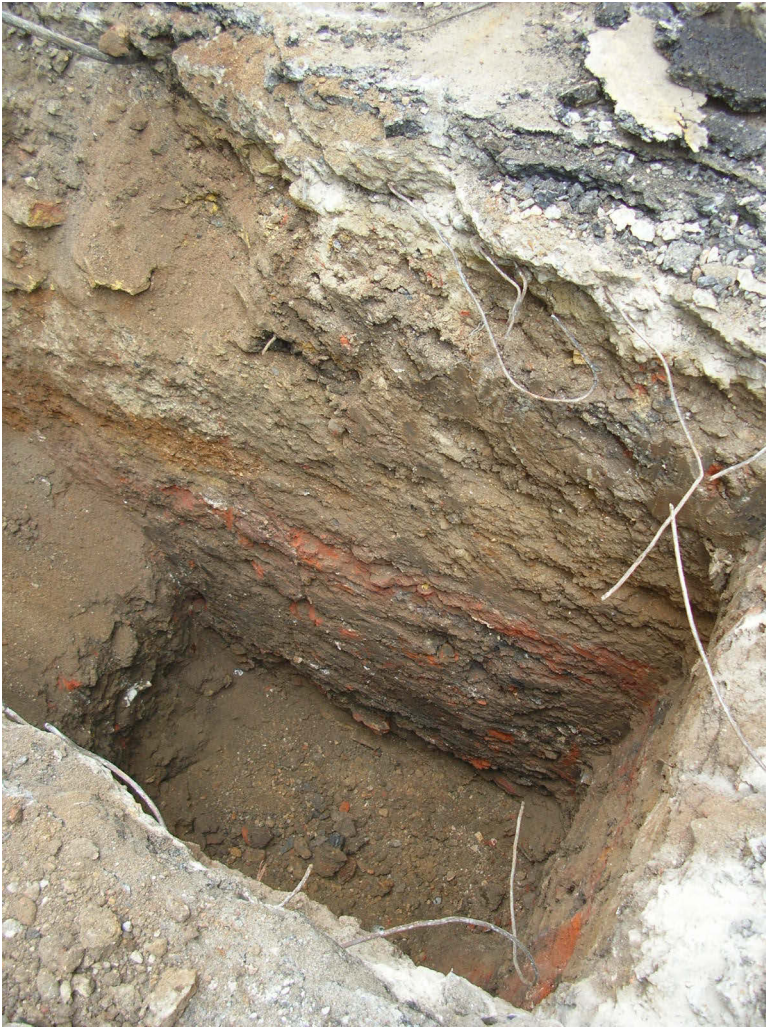
4.15.2 The lowest deposit was a ground raising dump [40] with masonry fragments that continued beyond the base of the trench. This was overlain by a dump [39].

Trench E12 looking north east

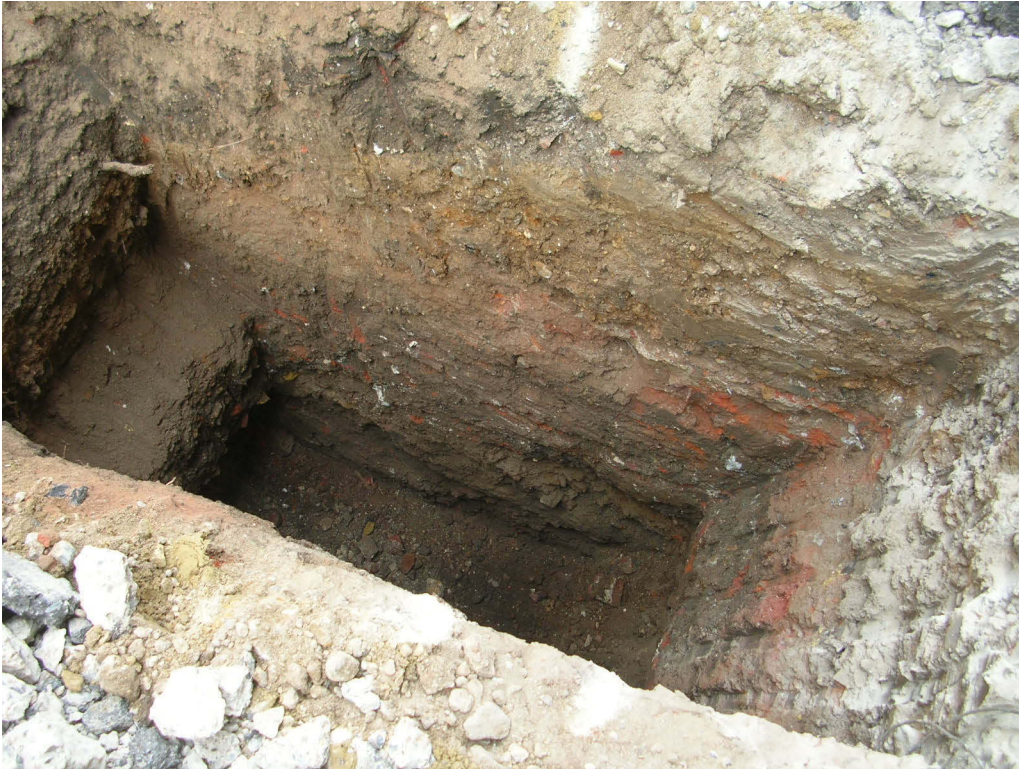
- 4.19.1 See *Fig 6*
- 4.19.2 The archaeological sequence was slightly different the lowest deposit was a silty dump with brick rubble [41] that continued beyond the base of the trench. Then was overlain by the same sequence of [40] and then dump [39].

Trench E16 looking north

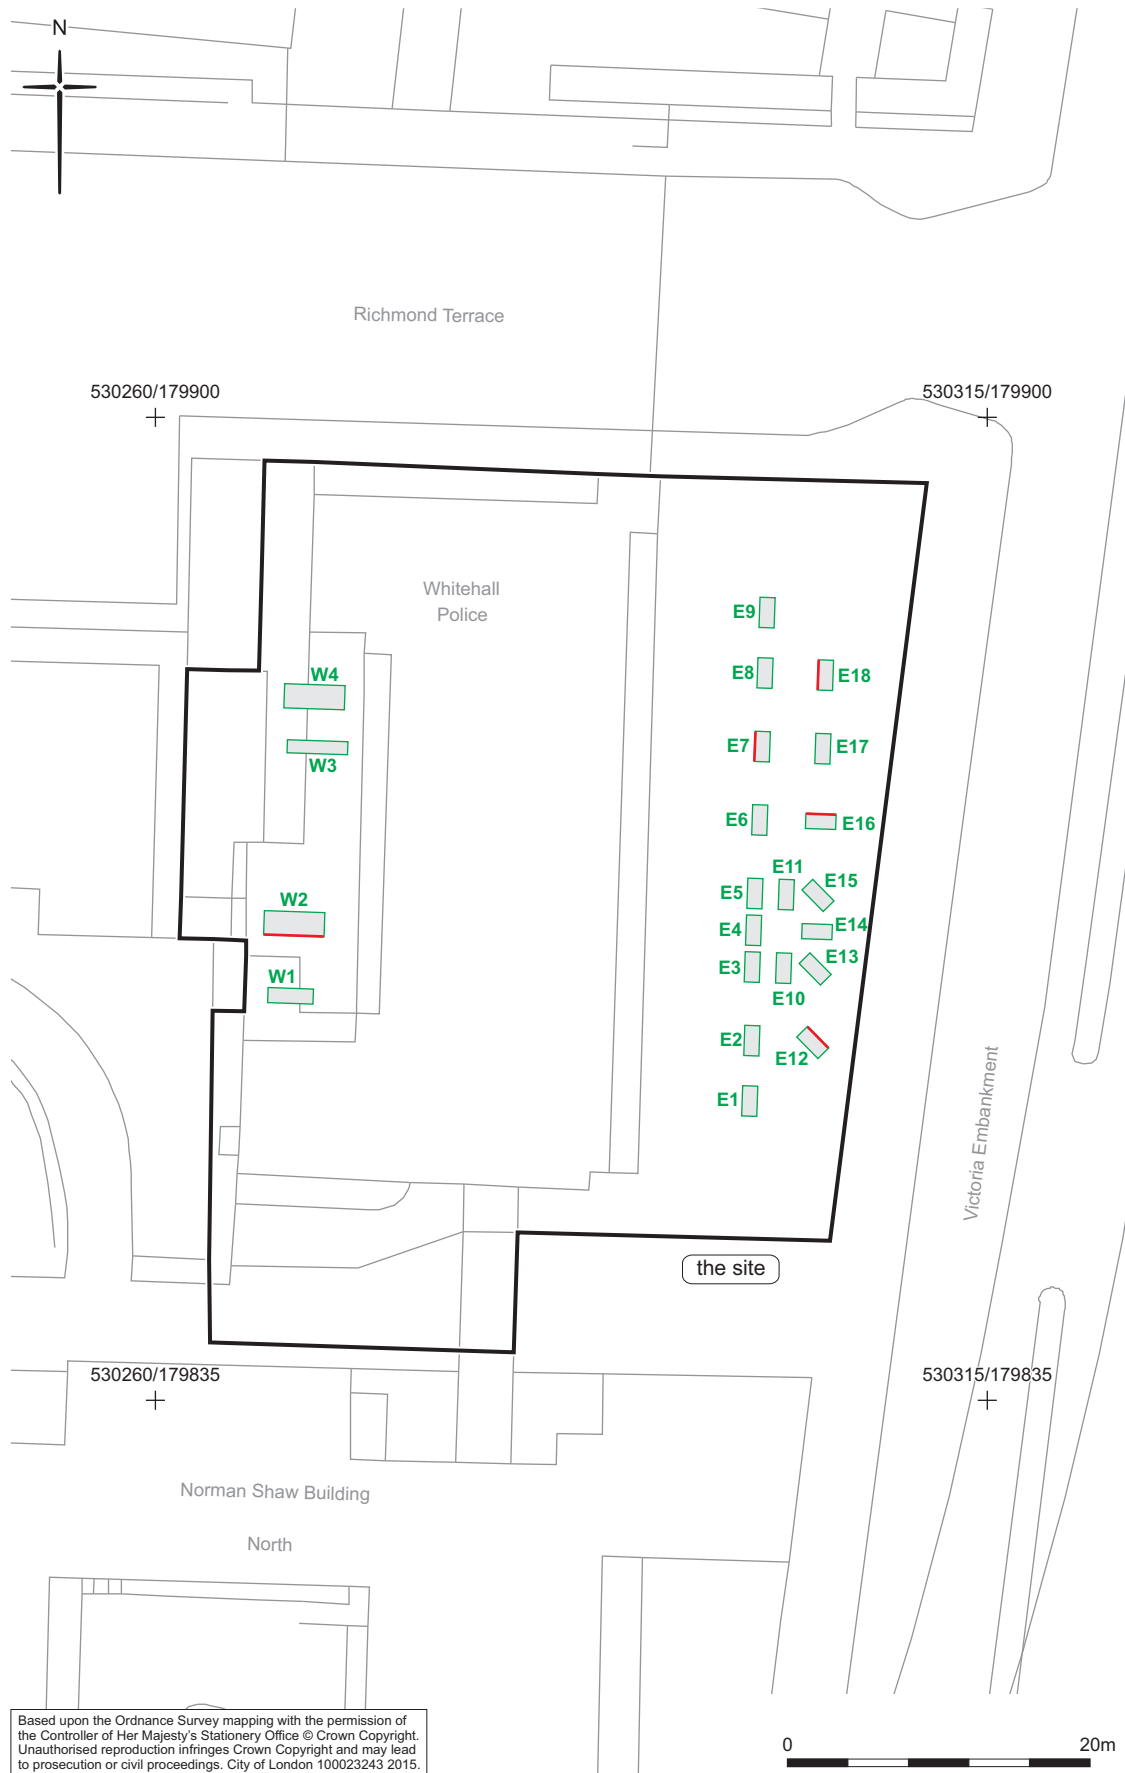
Fig 2 Areas of investigation

- 3.1.1 A series of machine dug trenches for new pile locations were observed and recorded by MOLA between 07/02/15 and 01/04/15. In total 22 trenches were recorded, 4 (W1–W4) were located in the western courtyard and 18 (E1– E18) were located to the east of the current building.
- 3.1.2 Trench locations were plotted on plans provided by the client using an ‘offset methodology’ and subsequently tied to the OS grid by MOLA Geomatics.
