## 1–7 Aylesbury Street London EC1

Watching brief report

**1-7 Aylesbury Street  
London  
EC1R 0DR**

Report on an archaeological watching brief

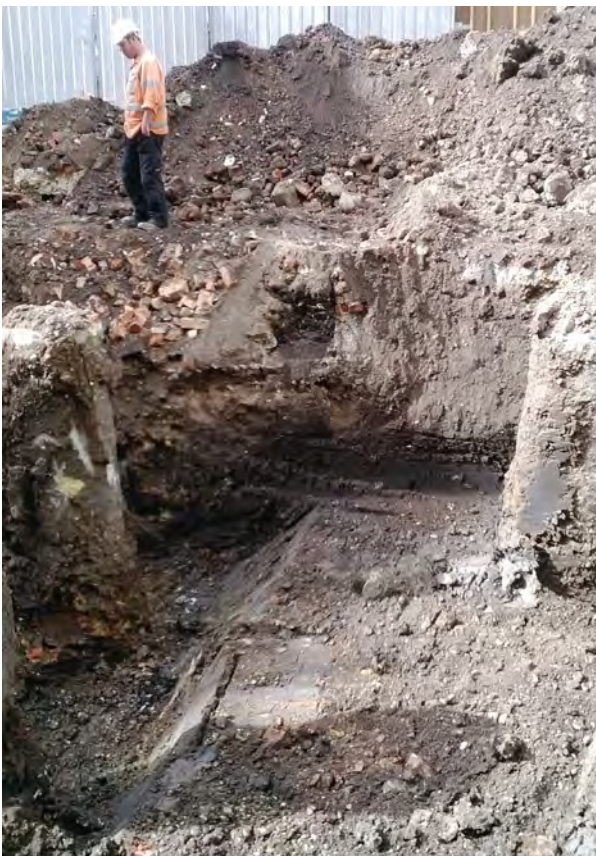
Fig 7 Photograph of north facing section of lift pit 2, view to north

4.2.1 The excavation of this lift pit did not extend down to natural deposits as the finished level for its base was specified at 17.9m OD and there was no obstruction as had been seen in lift pit 1. Instead the sections were seen to contain disturbed ground on all sides, with modern rubble directly below the piling mat to a depth of 17.9m OD

(Fig 7). The post-medieval garden soil seen elsewhere across the site was not observed at this level. The eastern side of the site appeared to have seen more extensive disturbance than elsewhere, presumably associated with the construction of a light well and other structural elements along the eastern party wall.

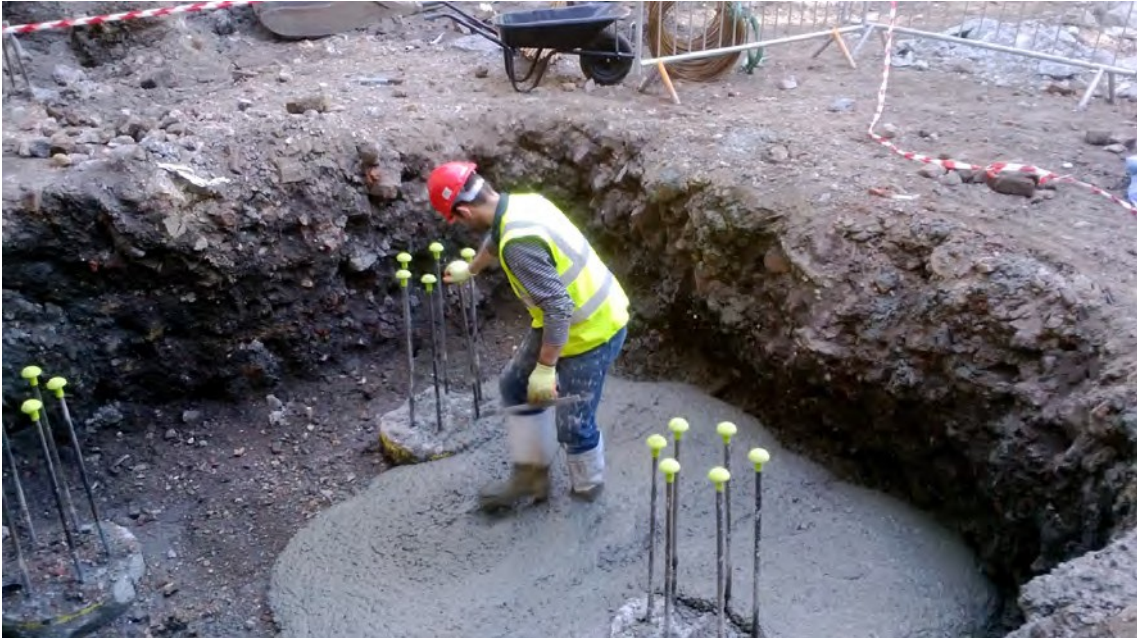
Fig 8 Photograph of east-facing section of pile cap 3, view to west

- 4.3.1 These pile caps were generally triangular in shape, with a square cap towards the southeastern corner of the site (Fig 2). They all had 0.40m depth of a loose modern make-up of brick rubble below the ground surface, above a deposit of dark brown silt, also containing brick rubble and other construction debris. This was not earlier than 19<sup>th</sup> century in date and presumably related to the early 20<sup>th</sup> century phase of activity during which the site was remodelled to include the addition of a public house with a cellar.

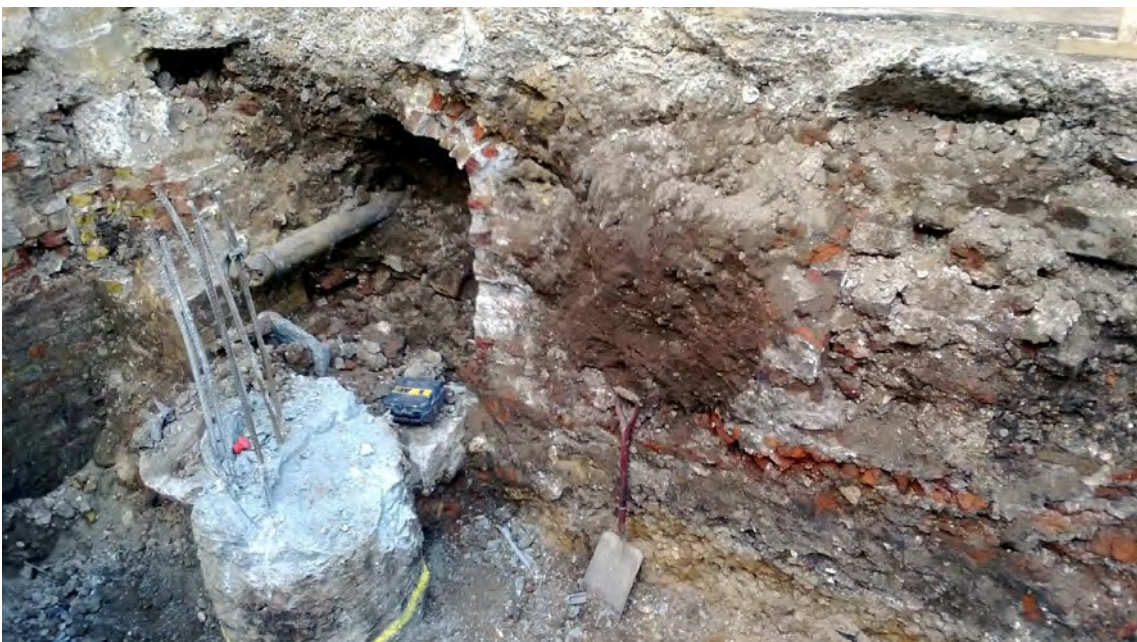
Fig 9 Photograph showing western end of south-facing section in trench along northern street frontage (secant pile trench 7), view to south

- 4.5.2 At the western end of the trench a brick vaulted service duct was seen, containing several disused iron drains and other pipes, presumably originally leading the services from the site to the mains below the road directly to the north. To the east of this and 1m below ground surface (ie 18.2m OD) was a loosely laid possible floor of Victorian bricks. This probably relates to the series of terraced buildings on the site as shown on the Ordnance Survey maps of 1871 and 1916. Below this was a silty soil which may represent the garden soil seen elsewhere on the site. This was above a loose orange gravel, which may be the natural strata, surviving to a higher level below the street frontage.

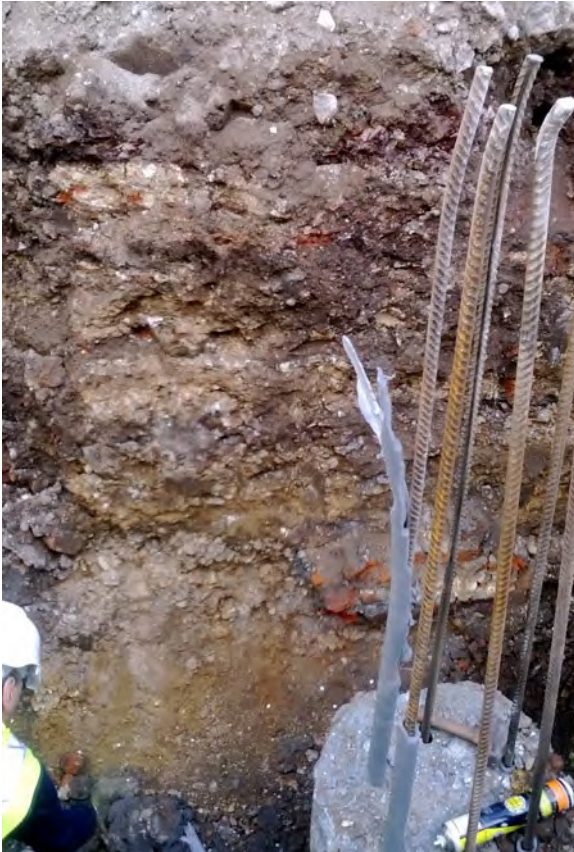
Fig 10 Photograph showing eastern end of south facing section in trench along northern street frontage (secant pile trench 9), view to south

- 4.5.3 At the east of this section was a deposit of loose mortar silt with fragments of chalk within it (Fig 10). This appeared to be medieval demolition material, and although it was not in situ as it directly overlay a post-medieval brick footing, it does indicate that there were medieval buildings in the vicinity which had been demolished and the rubble distributed across the general area.

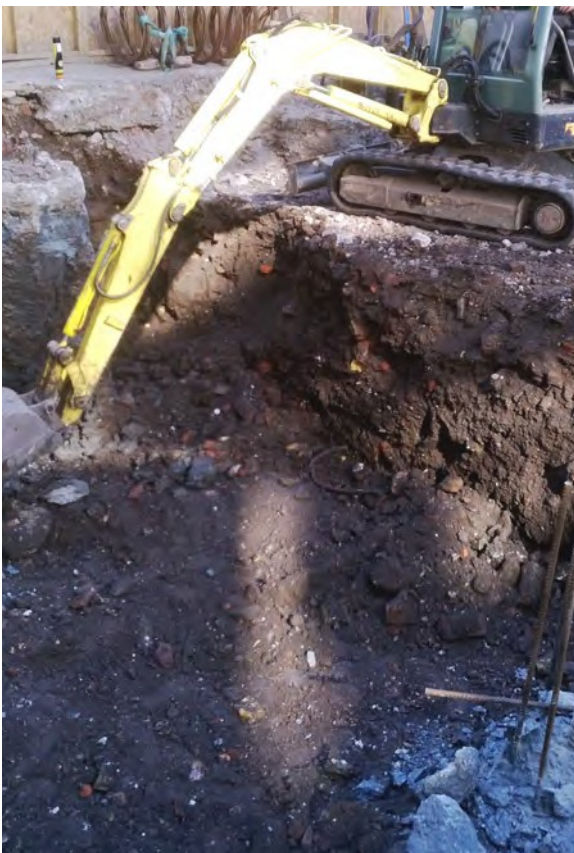
Fig 11 Photograph showing typical pile cap at west of site (pile cap 5), view to east

- 4.4.1 Similarly, these pile caps were triangular in shape where adjacent to the LoE, with square caps towards the centre of the site (Fig 2). They also generally had 0.40m depth of a loose modern make-up of brick rubble below the ground surface, above a

deposit of dark brown silt, also containing brick rubble and other construction debris (Figs 11, 12). This was not earlier than 19<sup>th</sup> century in date and presumably related to the early 20<sup>th</sup> century phase of activity during which the site was remodelled to include the addition of a public house with a cellar.

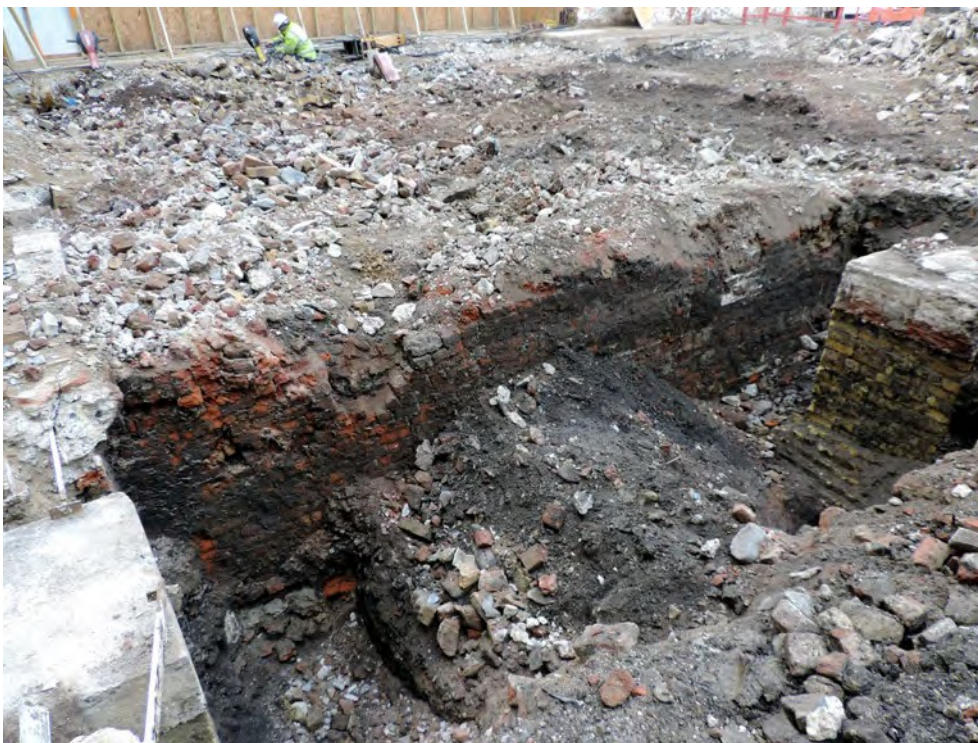
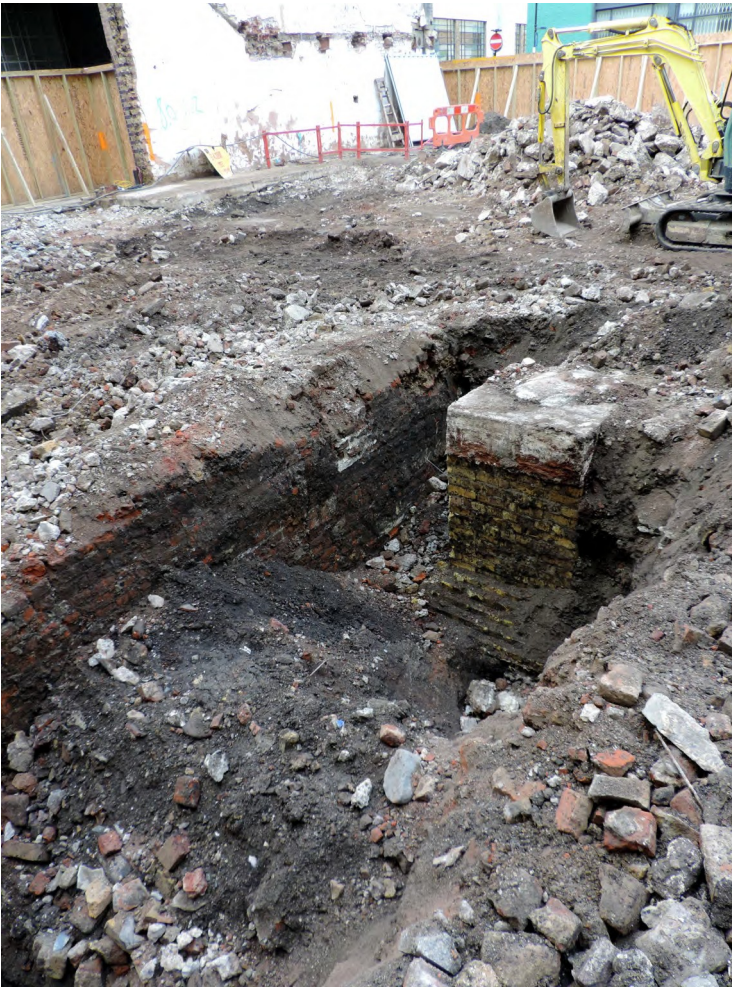
- 4.3.2 During the general ground reduction to enable the installation of the piling mat a wall of red brick was observed in this area (Fig 2, Fig 13, Fig 14). The top of the wall was seen as high as 18.80m OD, and it was seen for a depth of 1.3m. It ran north-south and a total length of 6m was observed; truncated at either end. The base of the wall sat directly on top of a black silty deposit seen elsewhere across the site and interpreted as a garden soil dating from the late medieval or early post-medieval period.

- 4.3.3 The backfill surrounding the wall contained 19<sup>th</sup> century brick fragments and other rubble, and presumably relates to the demolition of the building of which the wall formed part.

Fig 13 Brick wall running north-south across southern part of the site, view to northwest

Fig 14 Brick wall running north-south across southern part of the site, view to north
