GARDEN MUSEUM Lambeth Palace Road London SE1

Evaluation report

SGM15 NGR 530600 179000 OASIS reference molas1-226285

Report on an archaeological evaluation

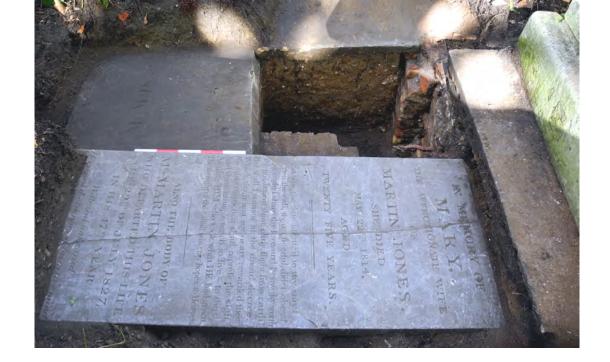
| Sumi | mary | 2 |
|---|--|--|
| | of Illustrations at cover: One of the burial ledgers uncovered within GTP 5 | |

- 4.5.3 A ?granite ledger for Mary and Martin Jones (see cover) was uncovered in the south of the evaluation pit, and although it overlies vault [19] it appears to be too small to be directly associated with it and was most likely re-located from another part of the cemetery garden.

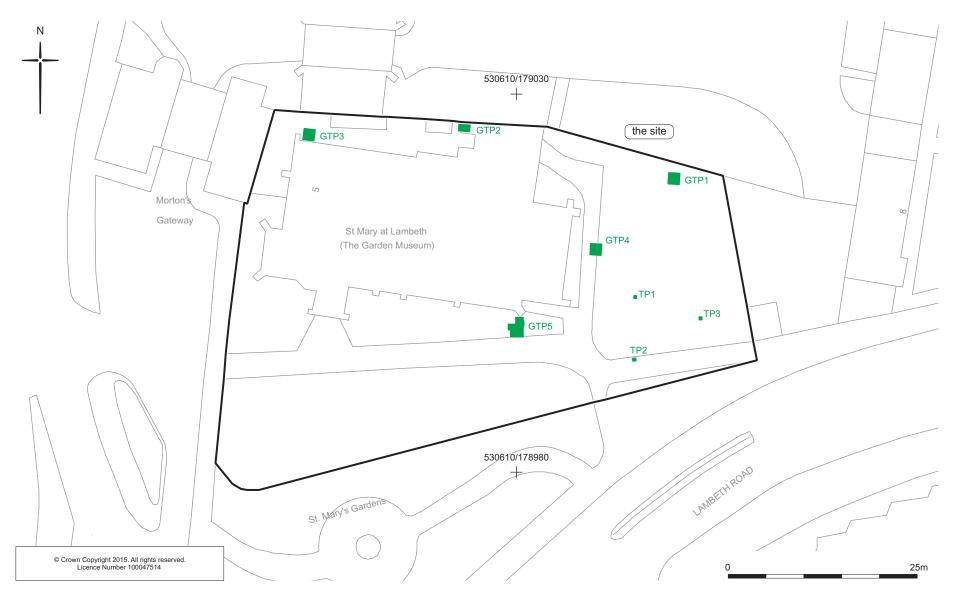
Fig 2 Location of the evaluation trial pits GTP1-5

The following is a brief description of the archaeological features recorded from the archaeological trial pits (GTPs). GTP has been used to distinguish the evaluation pits of this phase of the archaeological investigation from the archaeological pre-determination investigation pits (MOLA 2013), and to maintain the consistency with the Geotechnical pit numbering designated by the contractors (Rooff Ltd). For pit locations see *Fig 2*.

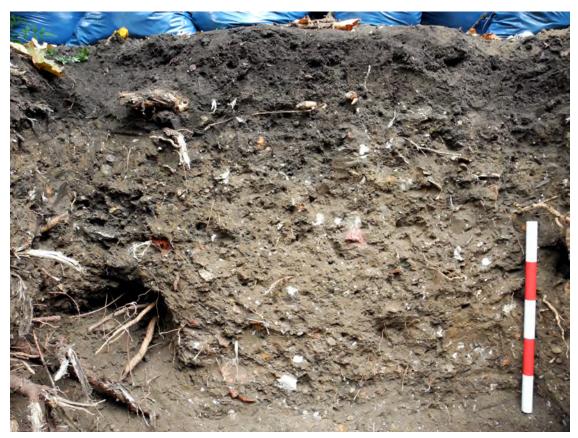
Fig 3 South facing section of GTP 1

- 4.1.1 Mid greyish brown cemetery soil was uncovered in the base of the GTP at 4.84m OD. The cemetery soil extended throughout the intervention and deeper than the base of the trench. This deposit had been heavily disturbed by root action (*Fig 3*) and was notable as a relatively large assemblage (119 segments) of disarticulated human bone, numerous corroded coffin handles, coffin studs and several fragments of degraded lead, identified as coffin lead (A Miles, pers. comm).

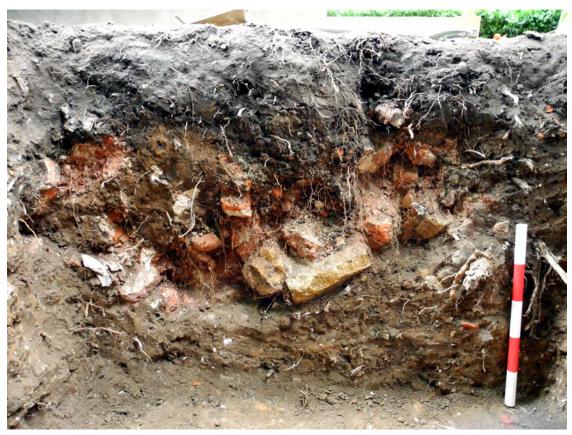
Fig 4 North facing section of GTP 1

- 4.1.2 A deposit of brick or brick rubble and further coffin lead fragments were also recorded within the north facing section of the GTP (*Fig 4*). The interpretation of this brick feature is not certain, although it is suggested that these may represent the remains of a heavily truncated brick vault.

Although not seen within the GTP the north facing section of GTP1, in the north east of the garden, showed an area of disturbance. As the area contained coffin lead this is possibly from a brick vault, disturbed during the 1980's landscaping works.

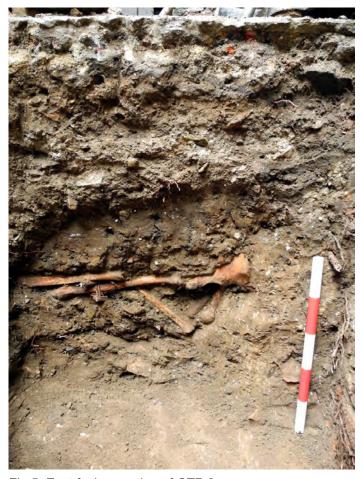
Fig 5 East facing section of GTP 2

- 4.2.1 The greyish brown cemetery soil was uncovered at 4.44m OD in this GTP. This deposit also produced disarticulated human bone although considerably less (41 segments in total) were recorded. This part of the site has been heavily truncated by modern drainage works, some of which were still in use.
- 4.2.2 Re-deposited disarticulated human bone was recorded in the west facing section of the GTP (*Fig 5*). This assemblage appears to have been deposited within a cut at 4.24m OD. Given the limits of the GTP it was not possible to discern if this was a grave cut or a much later trench cut for modern utilities. If the former this observation may indicate the presence of articulated burials to the west of GTP2.

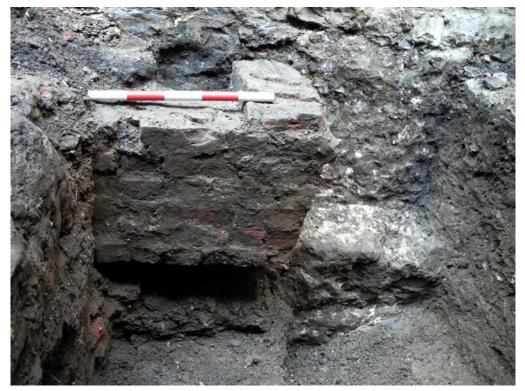
Fig 6 Brick structure within GTP 3

- 4.3.4 The area was disturbed by a 19th century brick structure (now disused) of unknown function but possibly for drainage. This feature was constructed over a church wall foundation also recorded within the GTP (*Fig 6*).

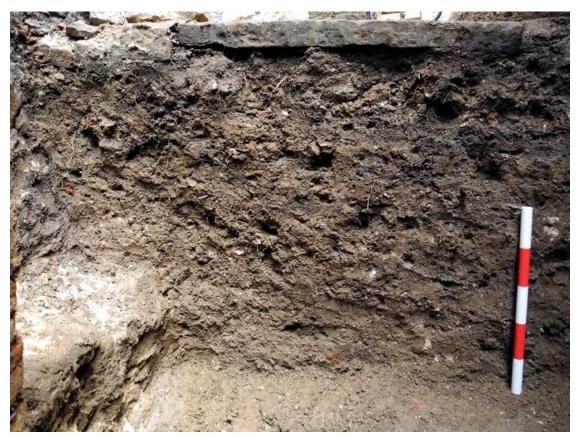
Fig 7 East facing section of GTP 3

- 4.3.5 The cemetery soil and brick structure were overlain with a sandy silt bedding layer for York stone paving slabs and re-laid grave markers (*Fig 7*).

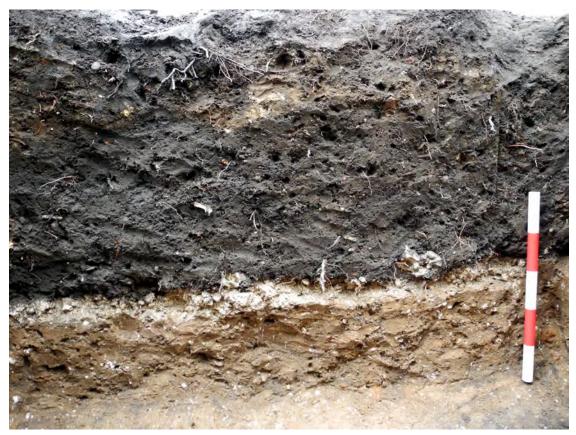
Fig 8 West facing section of GTP 4

- 4.4.2 At 4.28m OD a thin layer (60mm) of loose concrete and stone rubble was found (*Fig* 8) which had possibly been used as a sealing layer over the cemetery soil.

- 4.4.3 A thick deposit of dark topsoil was observed within this GTP (Fig 8). This deposit directly overlay the rubble layer and in-situ cemetery soils and is notable as it probably represents either heavily disturbed or imported soil derived from the relandscaping works undertaken for the Tradescant Gardens in the 1980s. The cemetery soils survive at a slightly lower level in this part of the site (4.3m OD on average) and most likely extend north, south and eastwards across the existing garden area. Occasional disarticulated human bone was also found within this deposit, probably upcast by root action and the Tradescant landscaping works.

- 4.7.5 GTP 4, in the west of the central garden, has a much greater depth of topsoil. This indicates that the central section of the garden was much more heavily disturbed by the 1980s landscaping, but this disturbance doesn't appear to extend as far north as GTP1. Although this landscaping works could have been the cause of the brick and rubble deposit recorded in its north facing section.

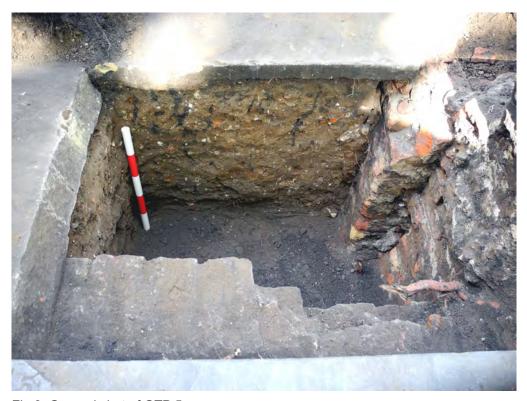
Fig 9 General shot of GTP 5

- 4.5.2 Three brick structures [19], [21] and [23] (*Fig 9-11*) were partially uncovered beneath a re-laid ?York stone grave marker (*Fig 9*). Structure [23] is a possible brick vault which abuts [21] to the south. Vault [21] underlies an in situ stone table tomb that was partially defined by excavation of the evaluation pit. Vault wall [21] has undergone repair work which probably took place at the same time [23] was constructed (*Fig 10*). The construction cut for [21] truncated (removed) the eastern extent of [19], which may be the northern wall of an earlier brick vault (*Fig 11*). All of the vault structures recorded appear to date to the 19th century. None of the features were excavated and it was not possible to ascertain if they contained in-situ burials

- 4.5.4 The ?York stone grave marker (engraved MM 1830), to the north of the Jones ledger, overlies vault structures [19] and [23]. This was also probably moved and relaid, possibly to create a pathway, before being covered with topsoil.

- 4.7.4 The uncovered ledger in GTP5, although overlying a potential burial vault, has been re-laid along with another grave marker and paving slab most likely to create a pathway similar to that seen in the north yard. This was later covered with topsoil to create a planting area.
