MONTROSE HOUSE Montrose Place Belgravia London SWI

An archaeological evaluation and watching brief report

Site Code: MCE06 National Grid Reference: 528400 179540

A report on the excavation and watching brief

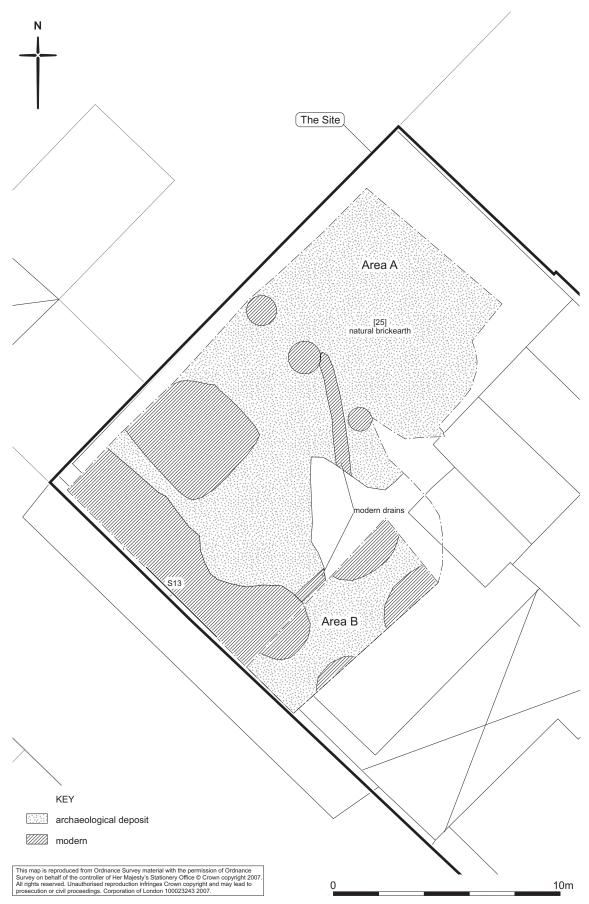
Fig 2 Areas of investigation showing modern intrusions

Areas A and B were subject to an excavation, Area C was monitored during the groundworks. For locations see Fig 2. A brief description of the findings follows below.

Area A was located on the northern side of site and measured approximately 10 x 18m. Deposit survival occurred on the eastern side only. Banded terrace gravels were seen at 5.40m OD, underlying natural brickearth which was present between 6.19 and 6.32m OD. No archaeological features were observed at this level. A blueish grey clayey soil horizon (likely to be post-medieval in origin) overlay the brickearth at 6.50m OD. This was covered in turn by 1m thick 19th-century dump layers containing a considerable quantity of building rubble. The remaining 0.5m to present ground level on site consisted of modern disturbance associated with the present groundworks.

The western side of Area A revealed deep modern intrusions which had removed any potential archaeological deposits or features. A small strip (6 x 1m) of truncated natural brickearth remained in between these intrusions at 5.84m OD, no features were seen within it. A machine-dug sondage through the eastern intrusion revealed natural gravel and the remains of a concrete pile associated with the former Montrose House at 5.48m OD. The western intrusion carried on into Area B and will be discussed below. These intrusions contained concrete fragments and re–bars to confirm their recent origin.

Area B was located immediately southwest of Area A (being, in fact, an extension of it) and measured approximately 11 x 6m. Machining down to the potential archaeological levels revealed the continuation of the deep modern intrusions seen in Area A. The small area of natural seen in the western side of Area A continued south for another 5m into Area B. It was truncated from above and to the east, west and south sides by the modern intrusions. The height of this natural brickearth lay between 6.11 and 5.58m OD, the gravel inclusions within becoming more frequent the lower the deposit. A machine-dug sondage through the intrusions revealed their bases to be at c 4.00m OD. At this level it was also possible to observe the circular holes left after the removal of the piles associated with the former Montrose House. These holes contained modern backfill and continued to a depth of 3.00m OD.

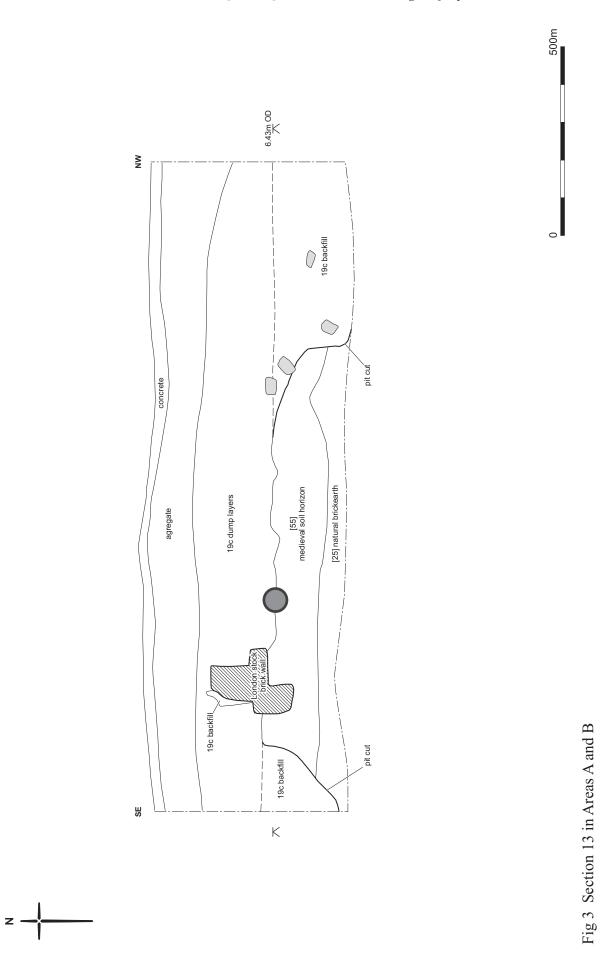
A very similar sequence of deposits was observed in the section running parallel to the pavement of Montrose Place, spanning excavation Areas A and B. No archaeological features were observed in the brickearth, but the overlying postmedieval soil horizon was cut by two probable quarry pits. These pits had been backfilled with 19th century debris.

Whilst these modern intrusions had destroyed any potential archaeology it was possible to observe some deposits and features in the east facing section (see Figs 2 and 3) which ran parallel to the pavement of Montrose Place. The same sequence was seen as on the eastern side of Area A: i.e. brickearth at 6.20m OD, overlain by the post-medieval soil horizon at 6.43m OD. This deposit was cut by two pits to the north and south. The pits were backfilled with 19th century building debris and are likely to be quarry pits dug for the extraction of clay – Rocque's map of 1747 shows the area of the site adjacent to a brick kiln. The remains of a stock brick wall at 6.90m OD was also seen in this section, probably aligned roughly east–west. It is likely to have been associated with the residential housing on the site in the Victorian period.

Between modern intrusions it was possible to observe a post-medieval soil horizon overlying the natural brickearth. Two pits filled with 19th century rubble were observed cutting into this layer. These are likely to be quarry pits associated with brick production that occurred in the area in the 18th century.

No further evidence was found for the Public House that once stood on the site but a stock brick wall seen in section only is likely to have been associated with Victorian housing on the site.
