HEADSTONE MANOR Pinner View London HA2

Post-excavation assessment

Site code HED14
NGR 514070 189670

Post-excavation assessment report

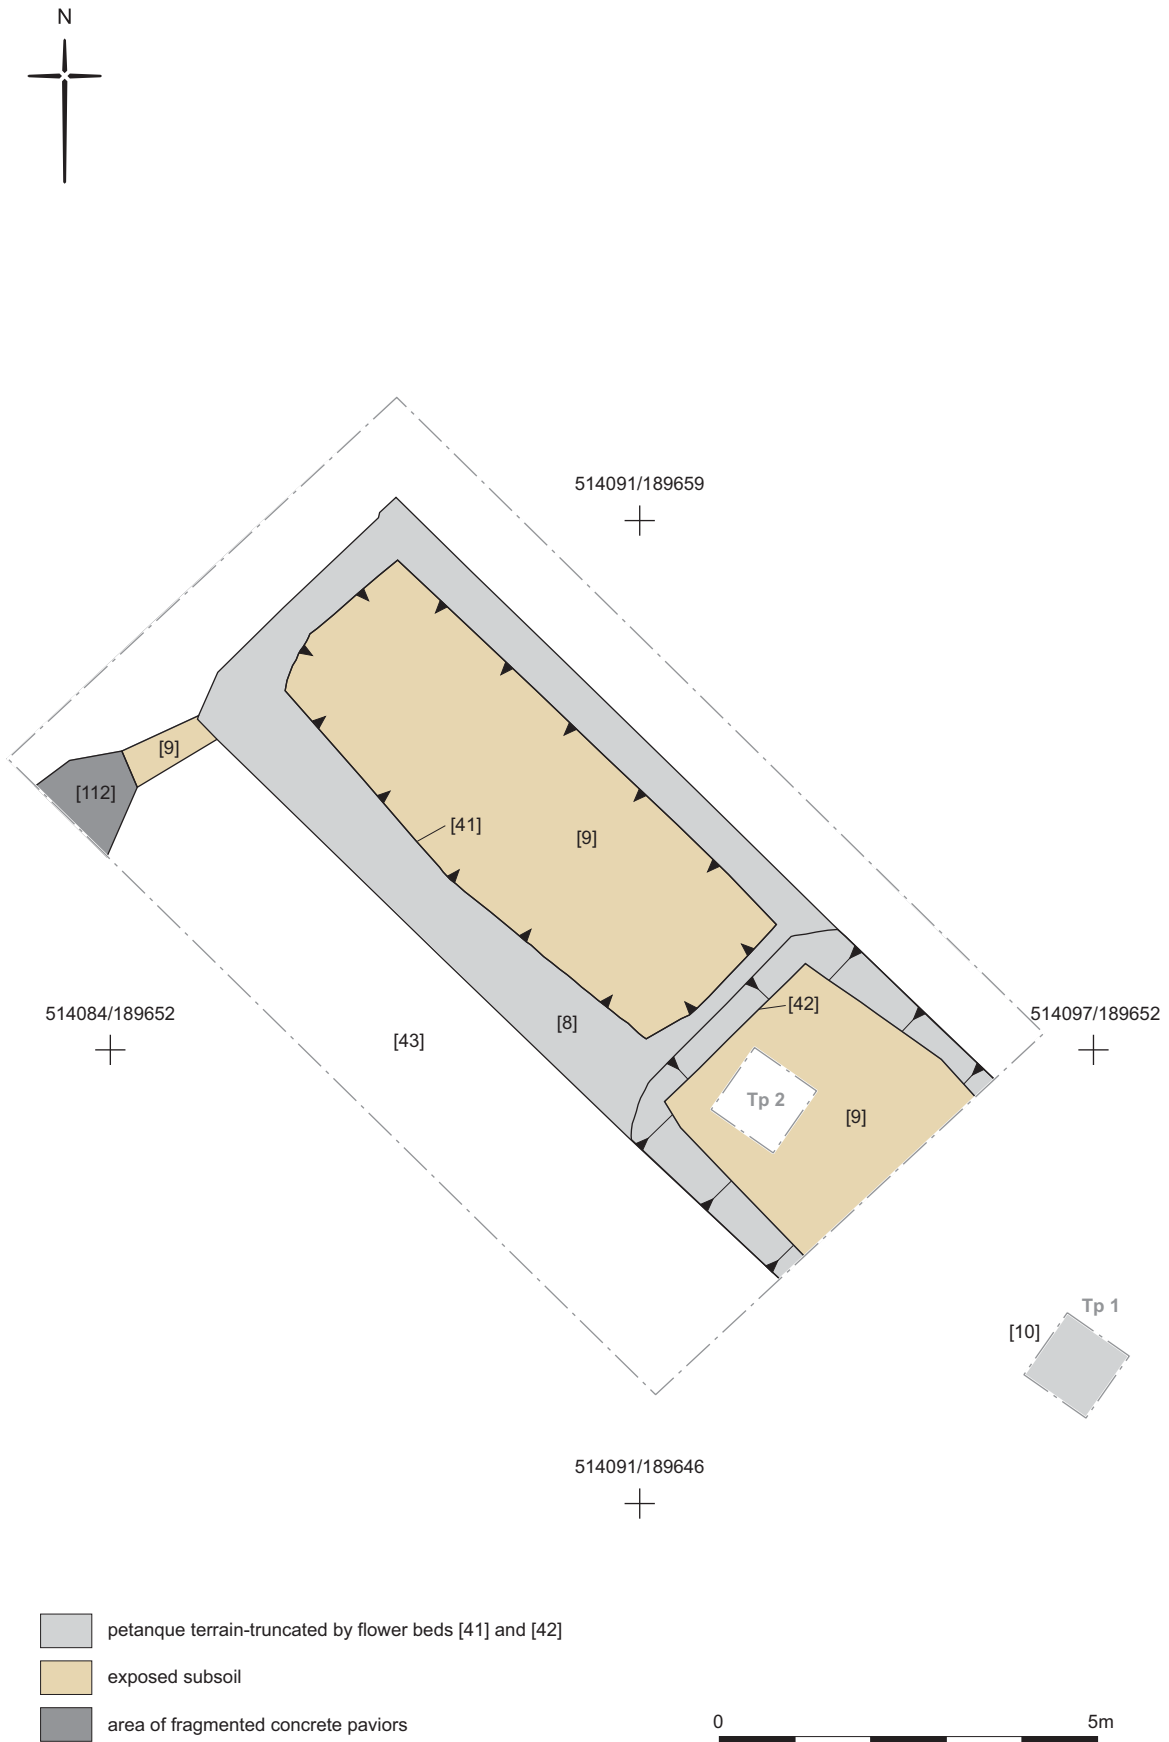
Fig 3 Area A: plan of trench at end of excavation, showing north end of petanque terrain [8] together with adjoining perimeter deposits and later intrusive flower bed cuts [41] and [42]

- 4.3.2 The subsequent excavation in the expanded schools trench was undertaken almost exclusively within the uppermost subsoil and topsoil horizon. It was apparent at an early stage of the excavation, that the outer edges of the two central 2m-wide grid squares almost perfectly mirrored the east and west sides of external surface [8] described above (Fig 3). The entire surface was framed by edge-set boards that were nailed in place to externally set wooden stakes. Cutting into the surface, and a layer of geotextile that it was found to be laid on, were two large shallow sub-rectangular cuts [41] and [42] – interpreted as flower beds.

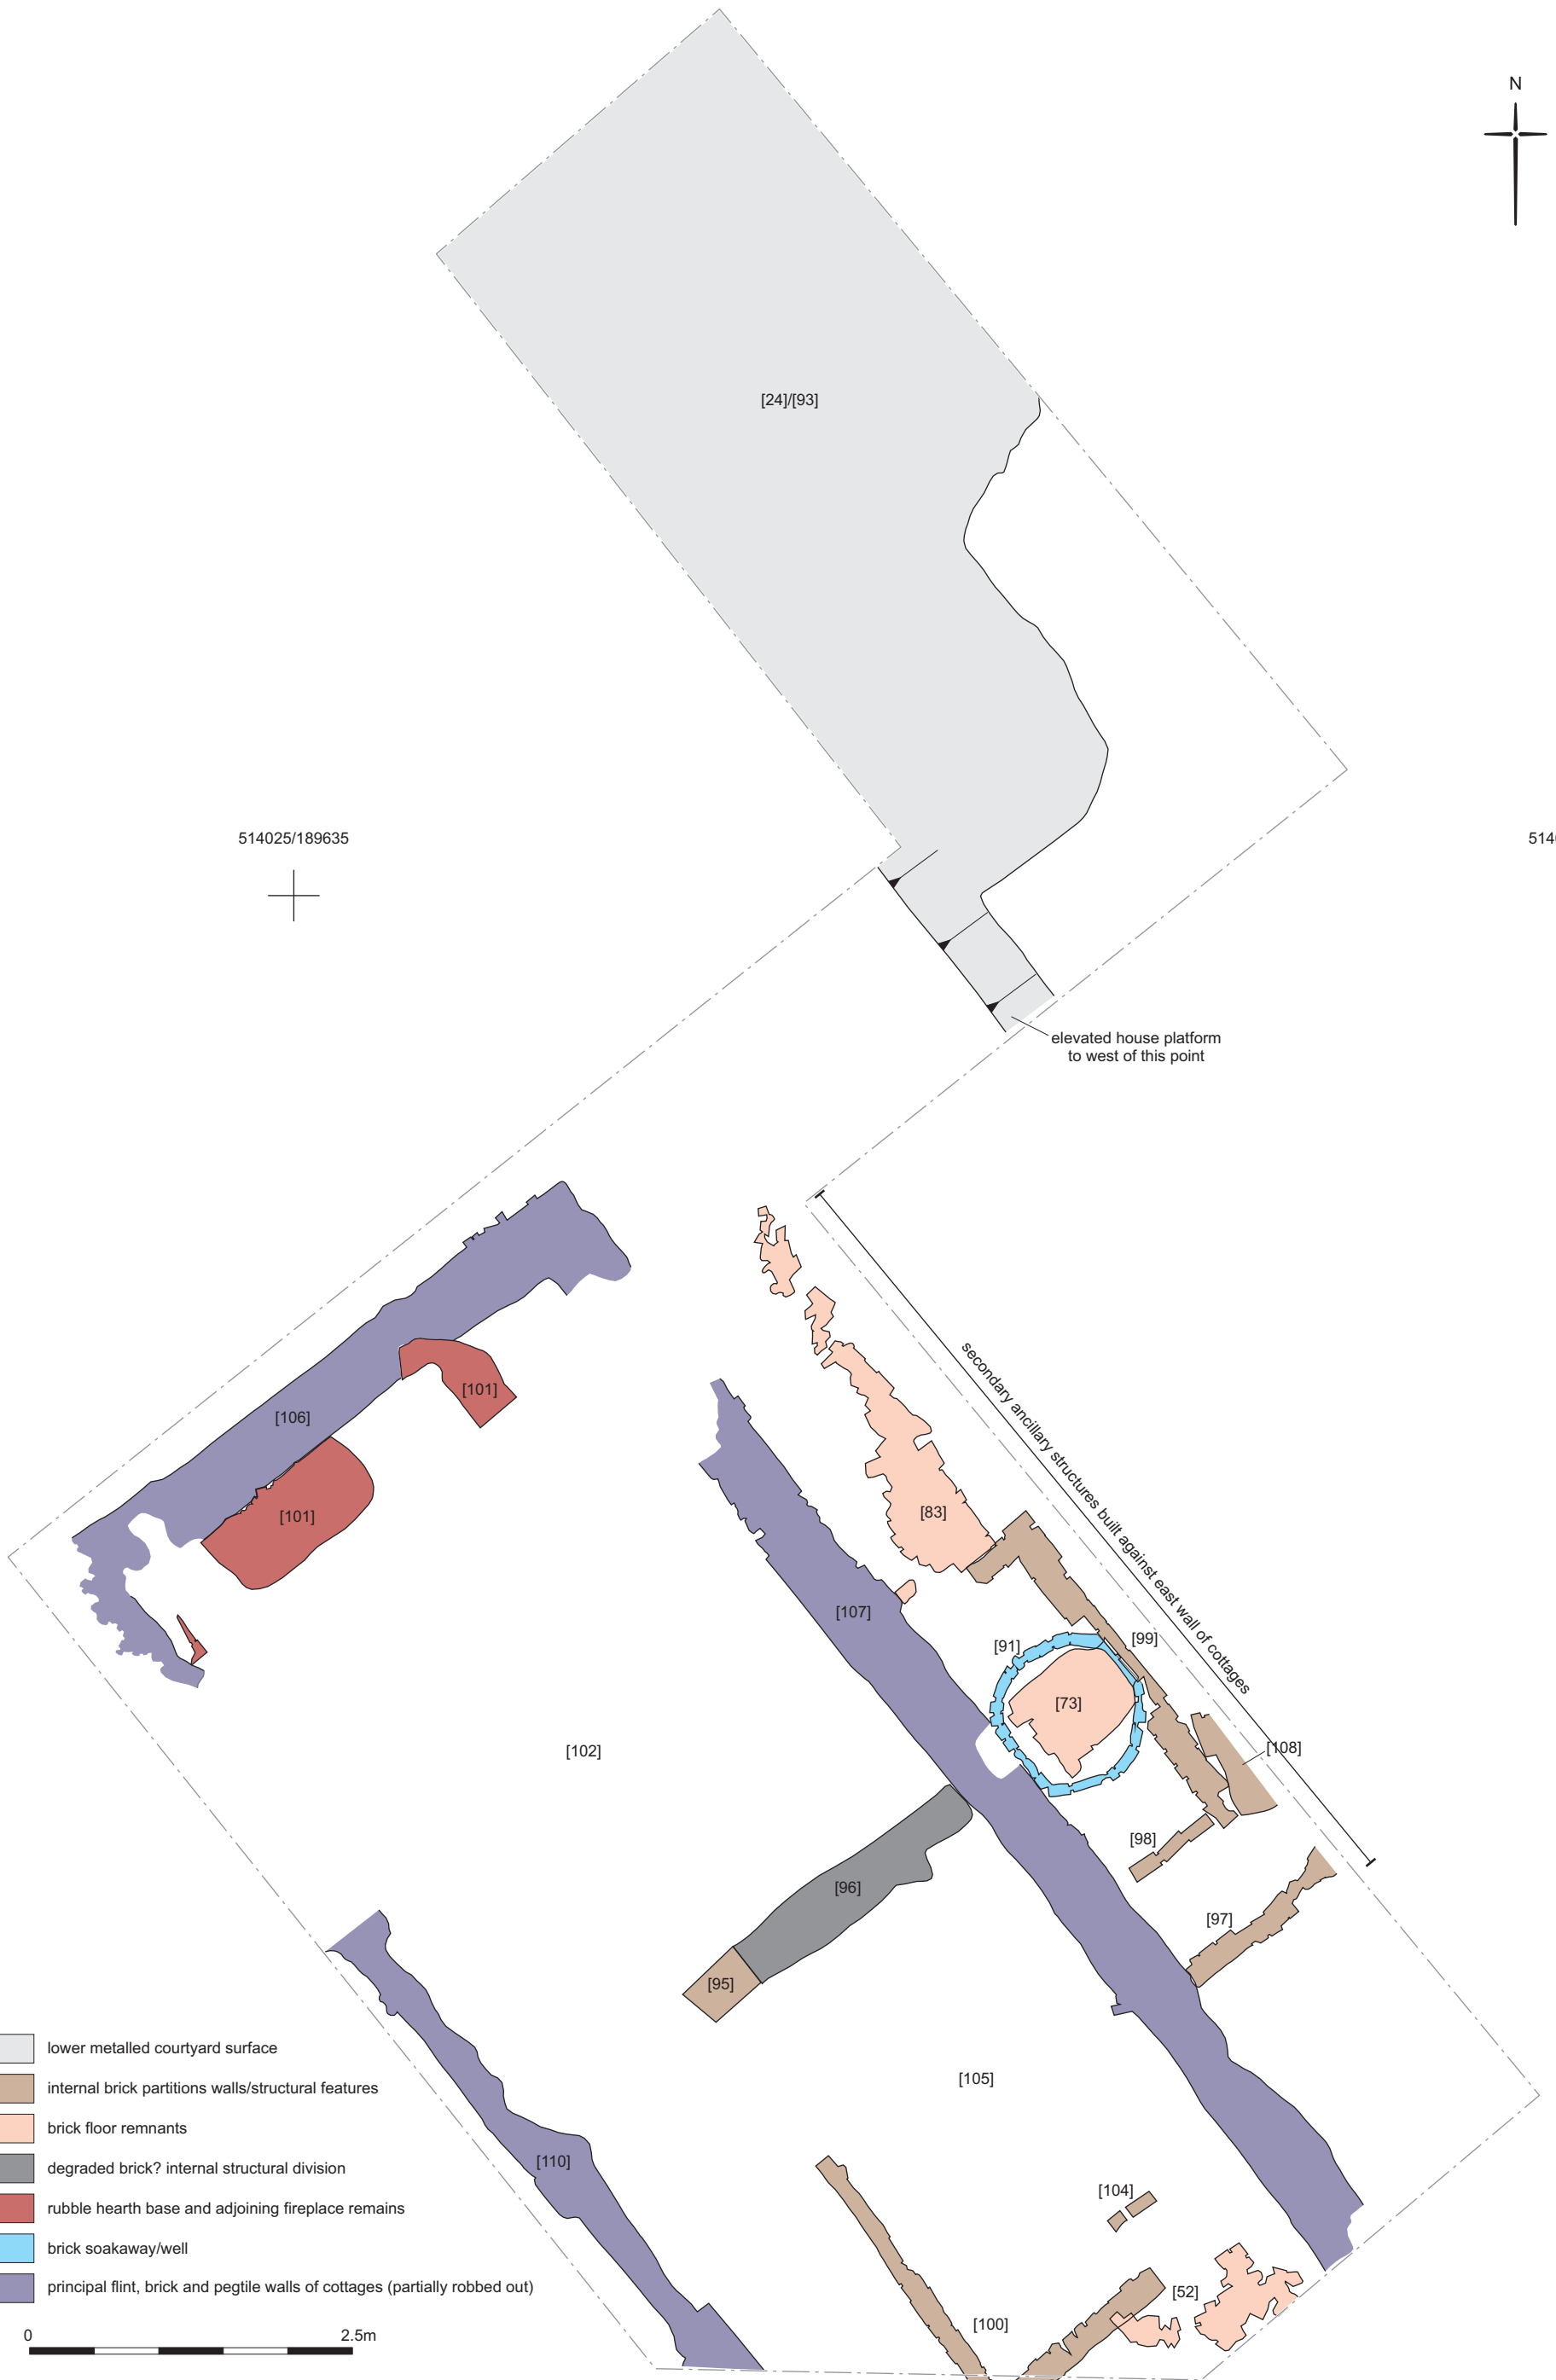
Fig 4 Area B: plan showing structural remains of postulated south-east wing of Headstone cottages – preserved in situ at the end of excavation

- 4.4.5 The main structural remains consisted of three walls [110], [106] & [107] which collectively made up a single bay of the cottages (Fig 4, Fig 7, Fig 8 & Fig 9). The wall foundations were rustic in appearance and composed of a random mix of flint, brick, ragstone and peg tile – with all of the footings having been subject to some degree of piecemeal robbing [86]/[60] (not illustrated). At the time of excavation, the more substantial north and east walls [106] and [107] were thought to represent the north-east corner of the cottages – although a subsequent comparison with the 1865 (OS) mapping, suggests that the found remains have a better fit with, and could be part of just the south-east bay of the house (Fig 14). This will be discussed in greater detail below once all of the disparate parts of the structure have been described in full.

- 4.4.18 Immediately to the south, was a similarly insubstantial east-west aligned structural feature composed of peg tile and brick [97] (Fig 4 & Fig 9). Although this feature could represent the footing or setting for a timber floor joist or partition, the use of peg tile for its base, with two parallel rows of displaced edge set bricks above – suggests that it may have been a rudimentary drain. The presence of a single brick on a similar alignment immediately to the west of the main east wall of the cottages [107], together with a noticeable scar through the foundation at this point, suggests that the feature originated inside the building.

cottages was a section of a poorly constructed brick floor [83] – which was laid against the north face of wall [99] (Fig 4, Fig 8 & Fig 10). The surface was defined at c 51.90m OD, and was composed of a mix of reused whole and part bricks, with a relatively straight east side – suggesting that there was originally a shallow-founded north–south wall or structural division at this point which had been robbed. This postulated wall line would have essentially formed a continuation of the east wall of [99] immediately to the south.

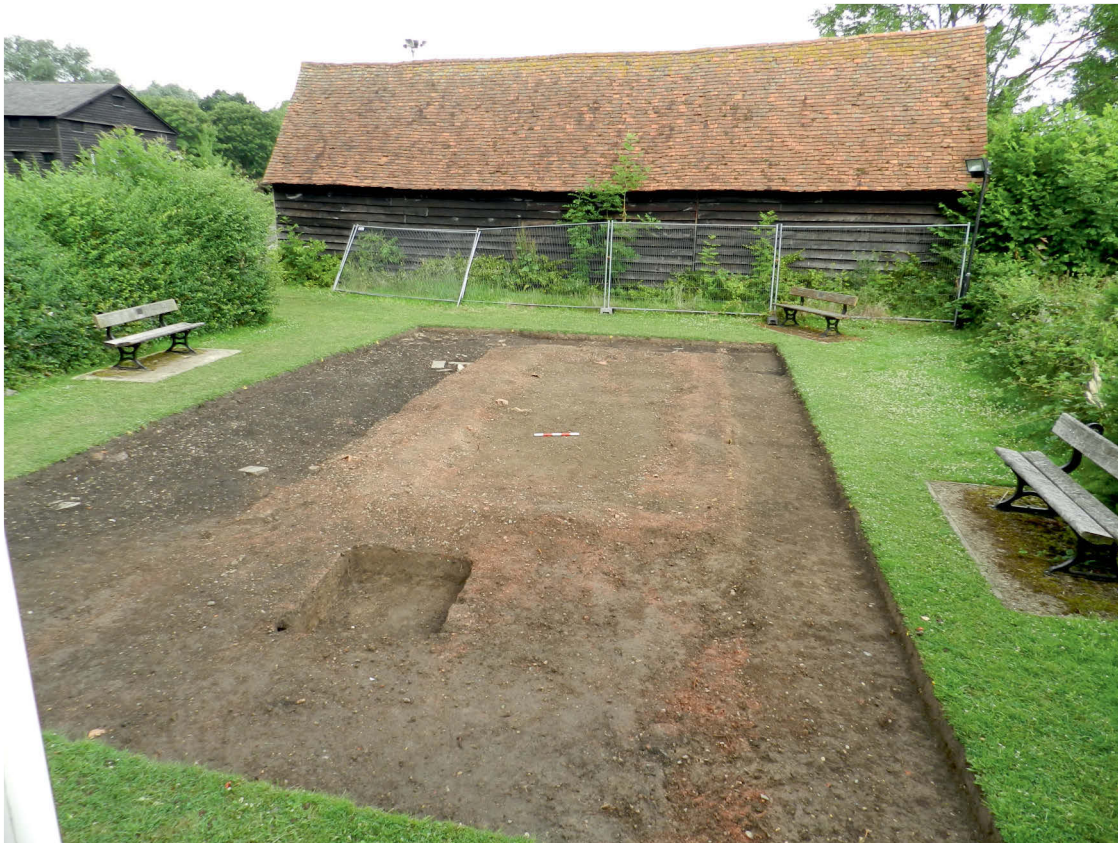
Fig 5 Photo of Area A showing truncated surface [8] of petanque terrain with small barn in the background (looking north-west)

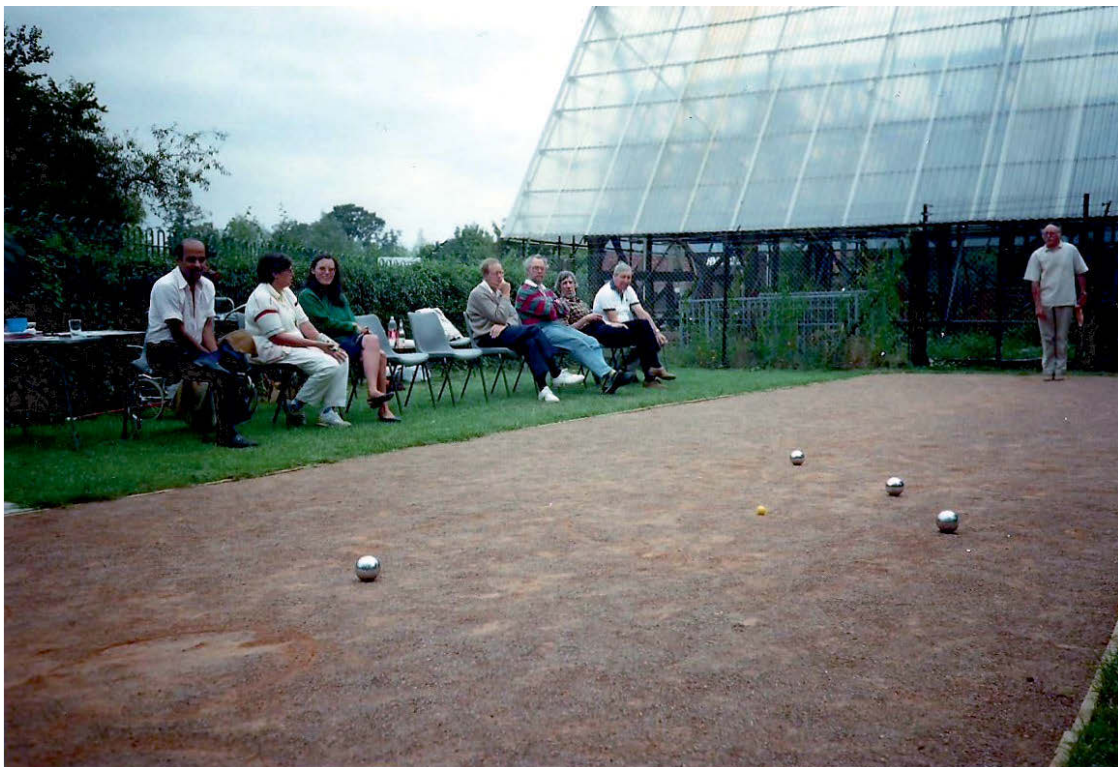
Fig 6 Photo showing members of the Harrow Petanque Club playing on the Headstone Manor terrain around 1989 – note the burnt-out remains of the small barn under a temporary roof in the background (looking north-west)

- 4.3.5 The uniformity of the width of the surface, led us first to look into the dimensions for pétanque playing surfaces –found to be 15m x 4m for a single lane for International Competition and National Championships. The area where a pétanque game is played is called a ‘terrain’ but is also known as ‘courts’ or ‘pistes’. A subsequent search led to the site of the Harrow Pétanque Club (currently based further along Pinner View to the south of Headstone Manor) – and finally to communication with Joe Hoyle, the clubs current President. Following on from a visit to the site, and subsequent conversations with some of his older members, he was able to confirm that the area behind the small barn was definitely the original site of Harrow Pétanque Club (Fig 6).

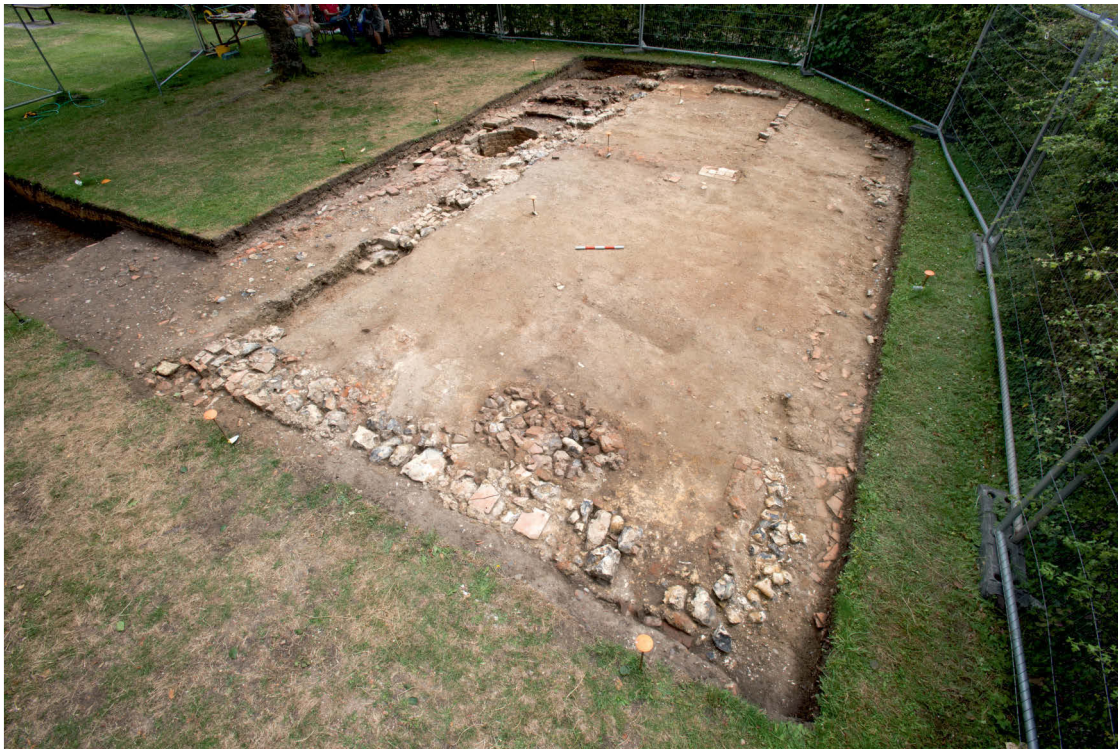
Fig 7 Area B: Exposed remains of east side of Headstone cottages and ancillary lean-to structures beyond. Note rubble hearth base [101] set against wall [106] in foreground of photo (looking south-east)

- 4.4.10 There was no indication that the larger room to the north (measuring c 5.04m by 4.12m) had been subdivided in similar fashion, and the only structural element to be defined was the rubble base [101] for a hearth of a fireplace – set against the north wall of the room (Fig 4 & Fig 7). The footing was composed of unmortared large flint nodules and smaller fragments of brick – which had been tightly packed into a sub-rectangular construction cut. Defined roughly equally distant on either side of the hearth, were the ephemeral remains of two areas of degraded brick, which are likely to represent the basal remains of the sides of the fireplace – with an internal width of c 2.74m.

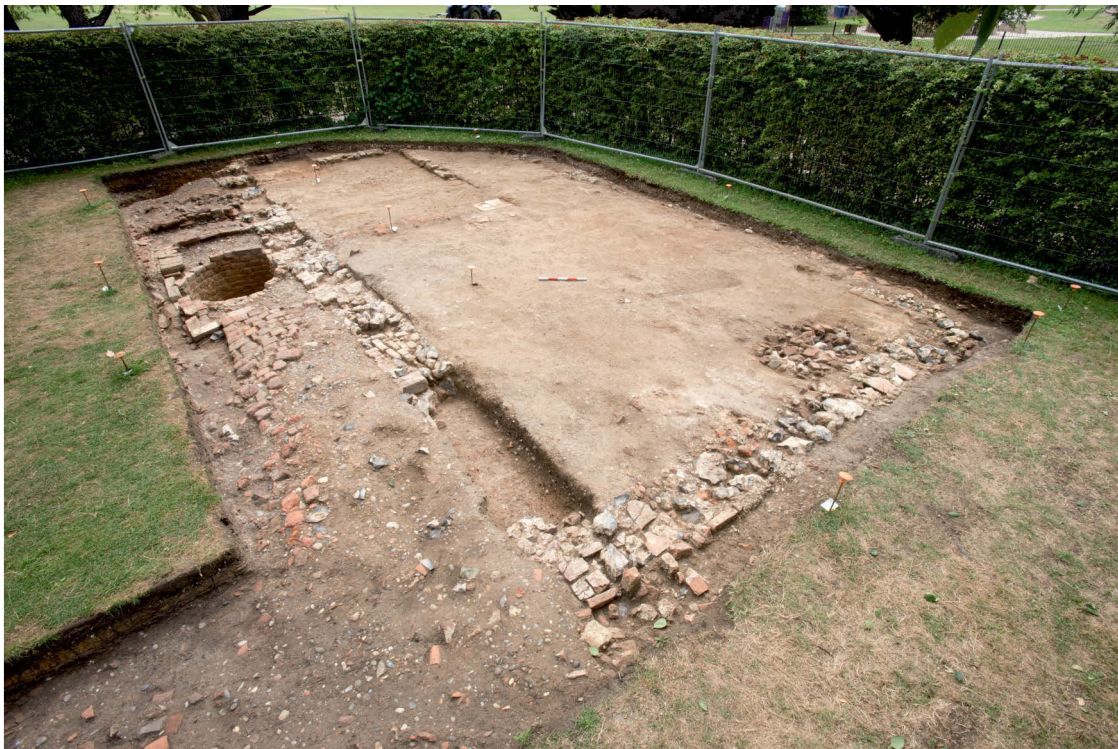
Fig 8 Area B: Exposed remains of east side of Headstone cottages and ancillary lean-to structures (looking south-west)

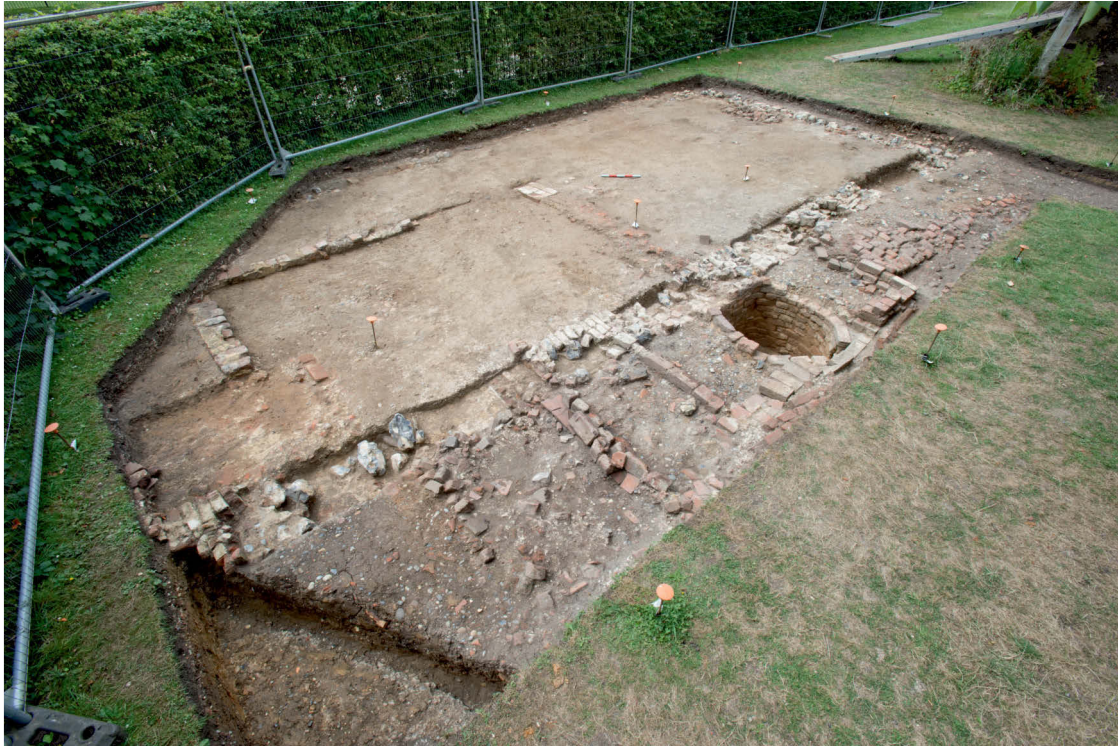
Fig 9 Area B: Exposed remains of ancillary structures built against the east wall of Headstone cottages. Note the rectangular footprint of the internal south-east room in the main body of the house beyond (looking north-west)

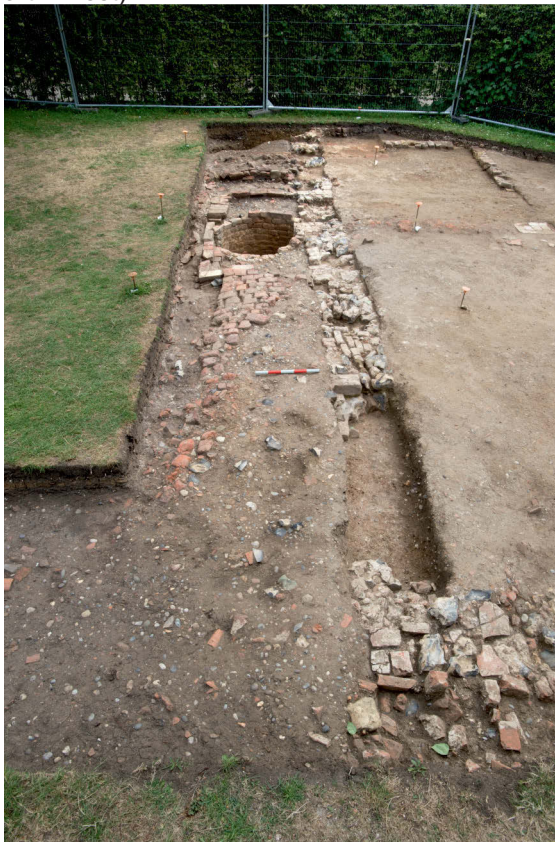
Fig 10 Area B: Remains of poorly constructed ancillary structures built against the external east wall [107] of Headstone cottages (looking south)

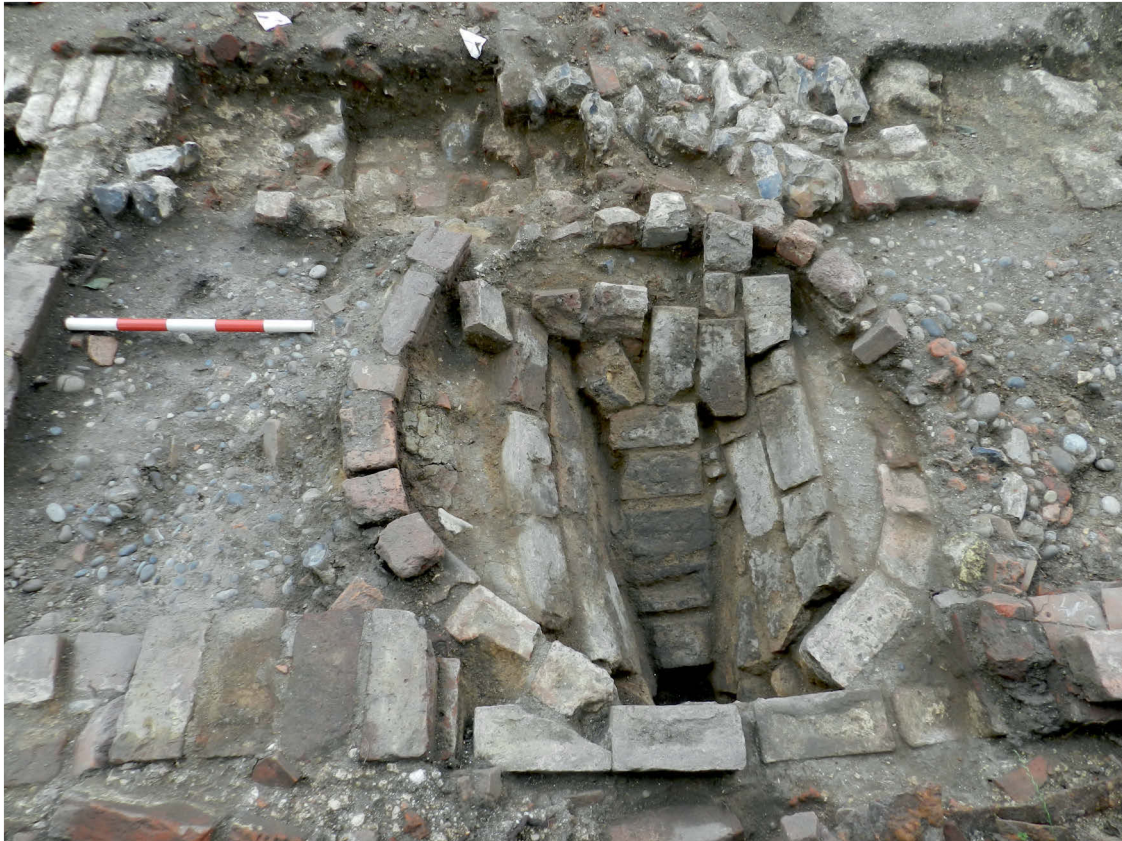
Fig 11 Secondary brick drainage chute [73] set into upper levels of partially consolidated brick lined soakaway or well [91] (looking west)

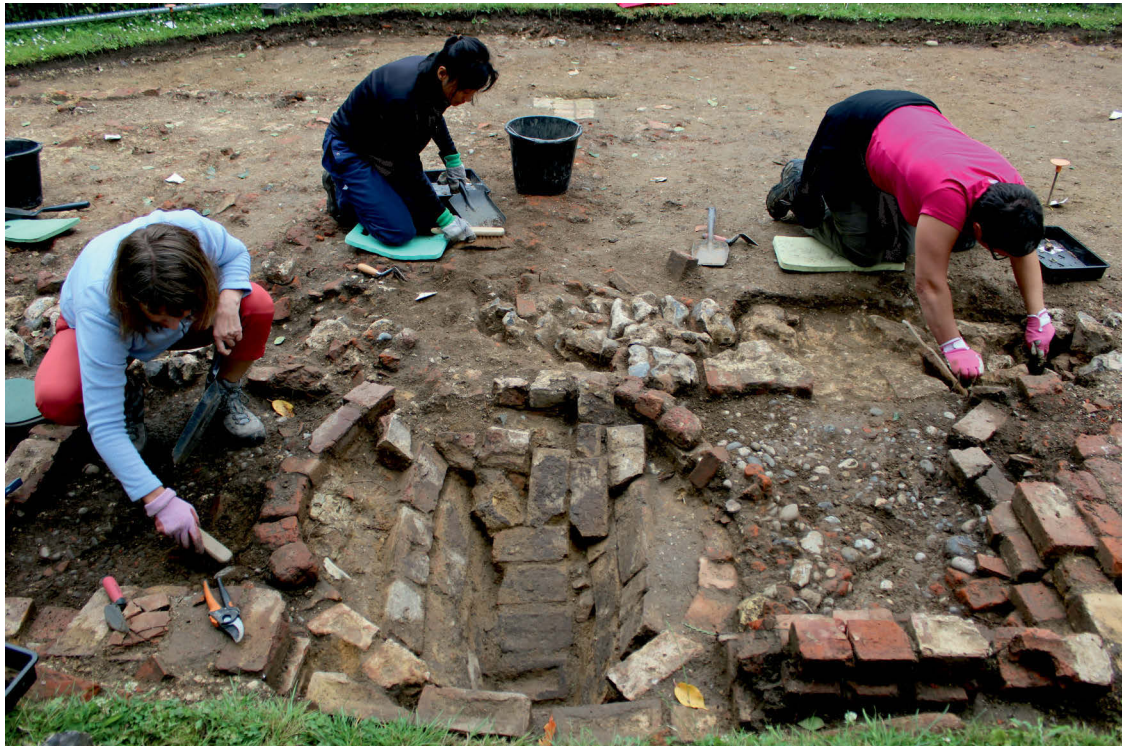
Fig 12 Excavation in progress around brick lined soakaway or well [91] – note the earlier unexcavated external gravel surface beneath the secondary brick wall [99] at the right of the photo (looking west)

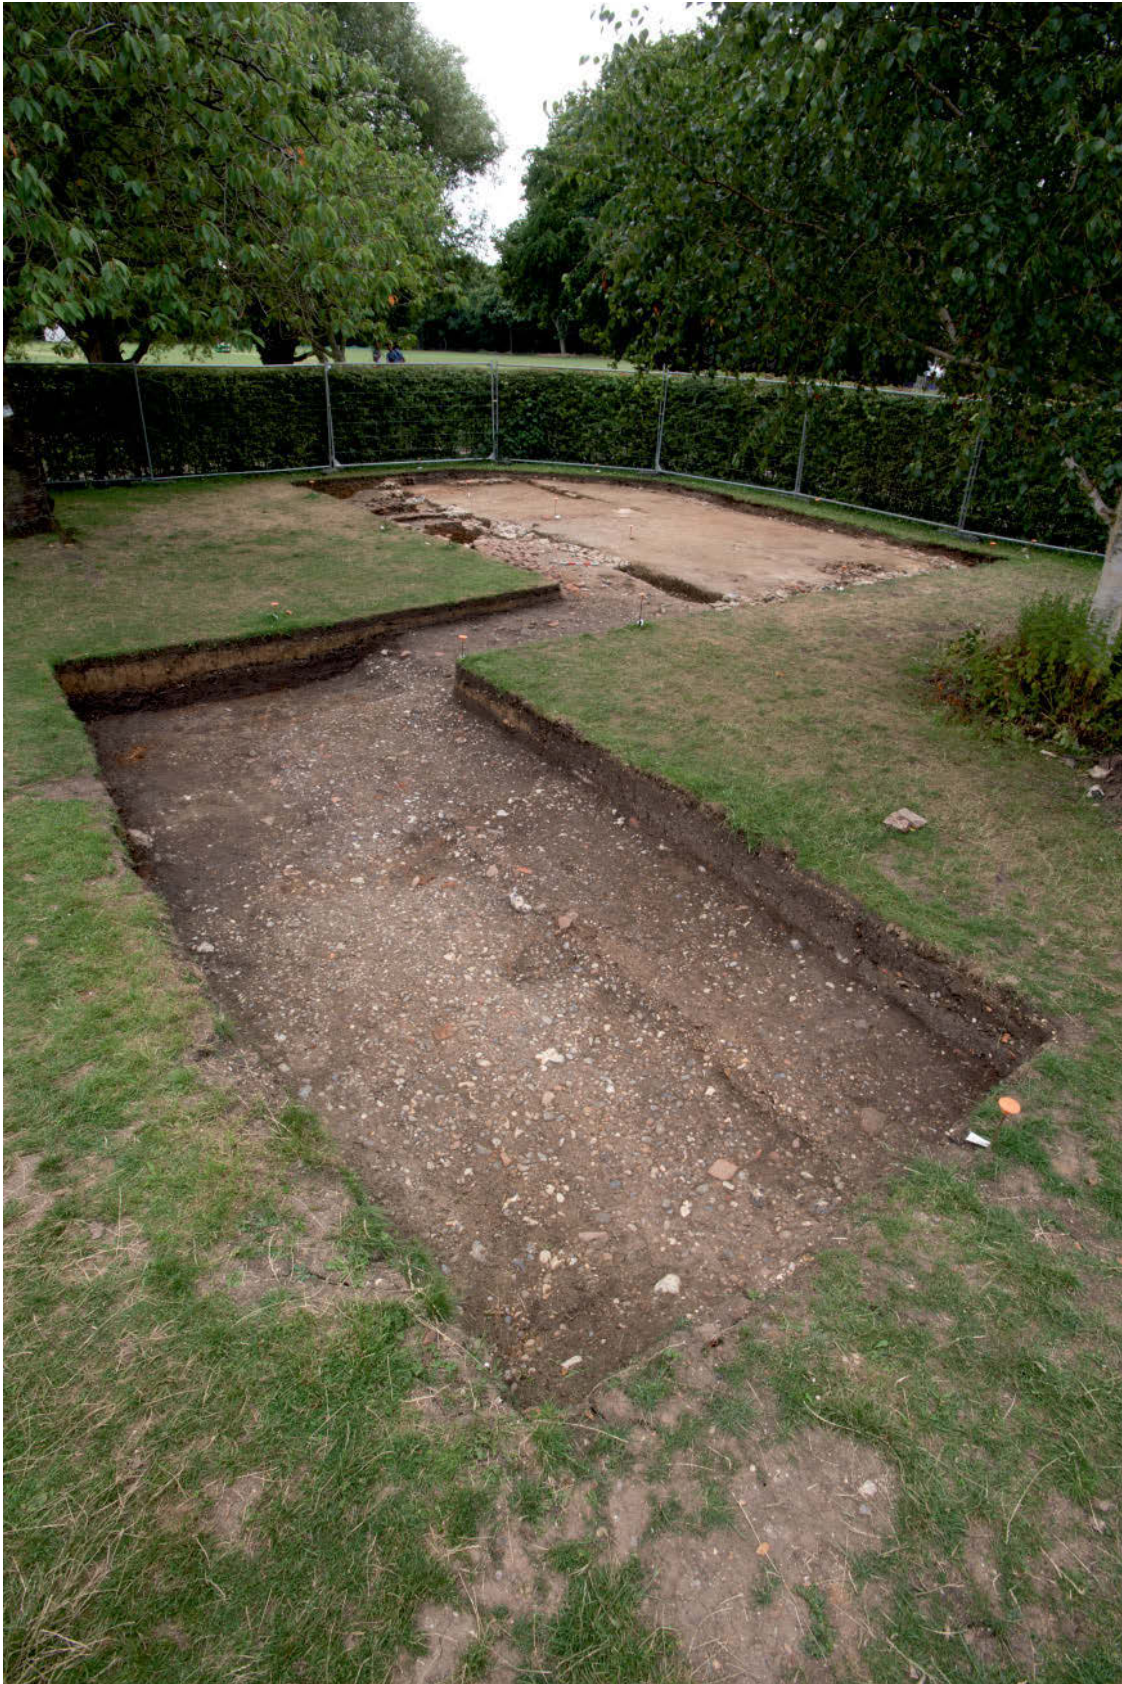
Fig 13 Area B at the end of excavation: showing lower external metallised surface [24]=[93] in foreground, with elevated house platform for Headstone cottages beyond (looking south-west)

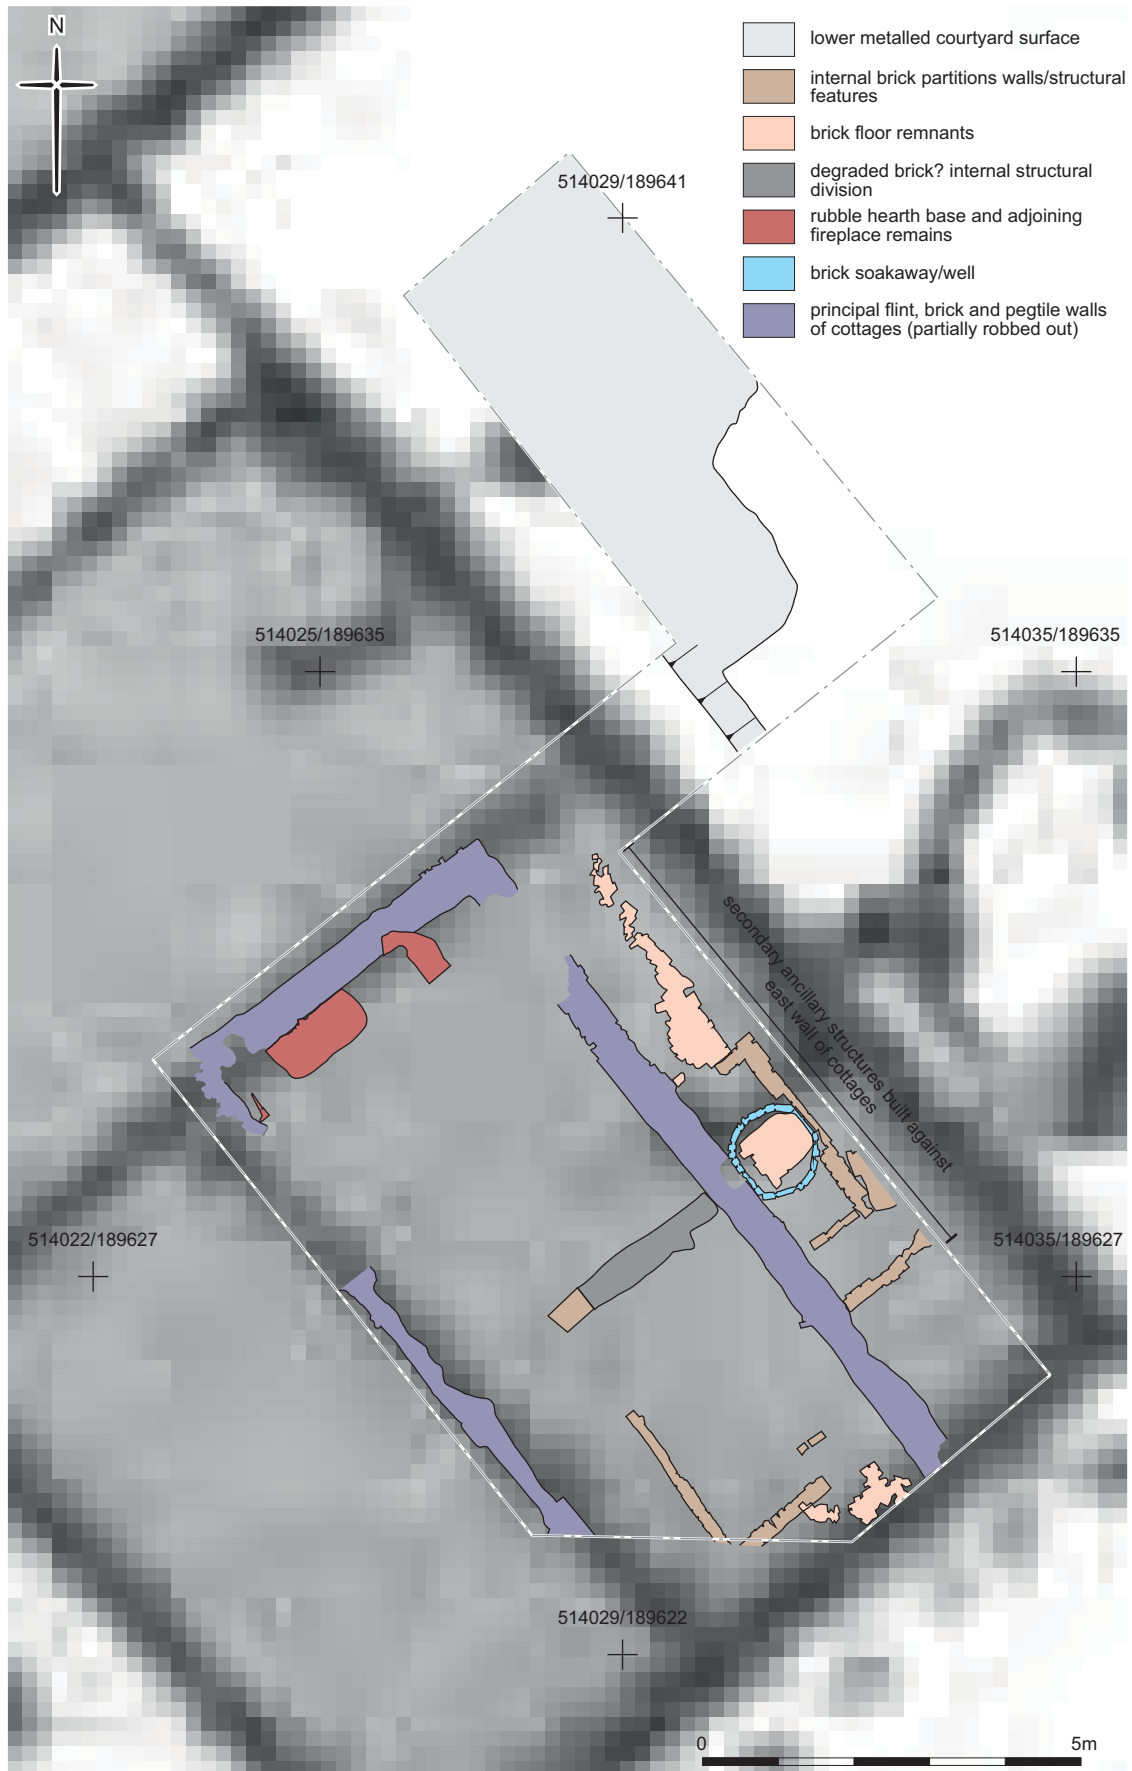
Fig 14 Structural remains of Headstone cottages recorded in Area B best-fitted and superimposed with relevant section of 1865 OS map showing footprint of existing buildings in south-west corner of the site

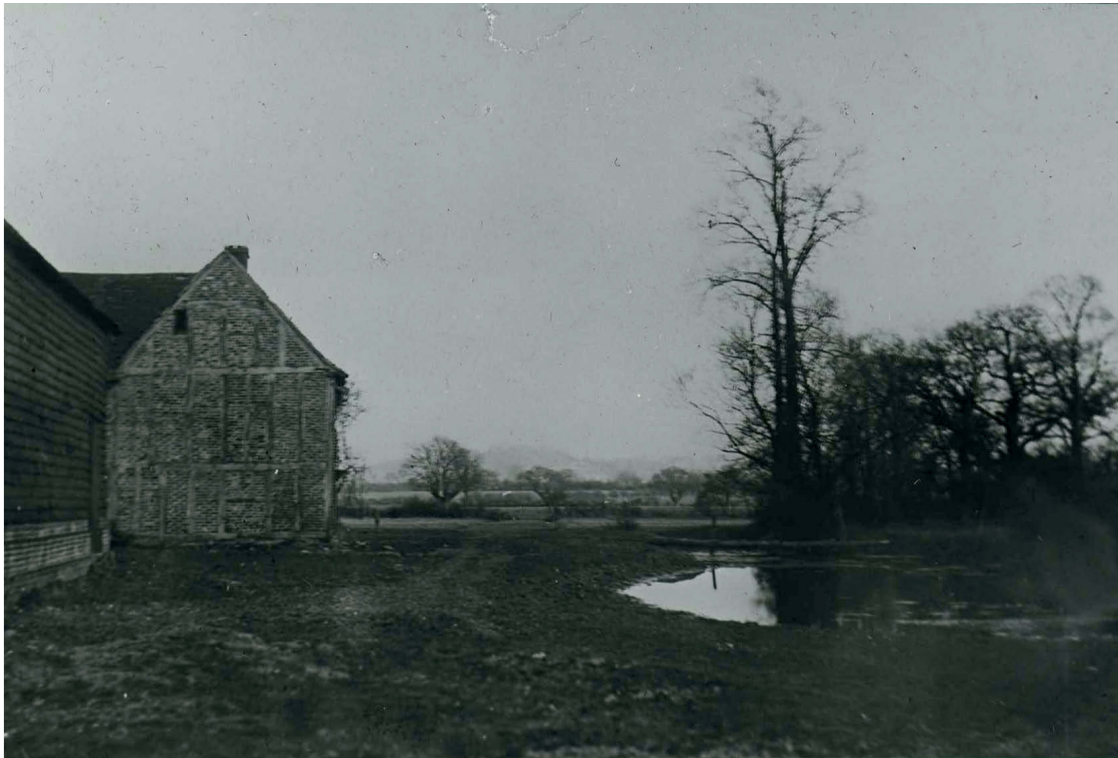
Fig 15 Photo of Headstone cottages about 1905. The chimney stack and the doorhood silhouetted at the right of the gabled building suggest that it is a wing of the cottages just outside the farmyard. The weather-boarded structure is the rear of the stock barn, which was built a few feet from their north-west side. View looking south-east (Courtesy of Harrow Reference Library)
