### 12 KINGSTON ROAD Tolworth London KT5

Archaeological Evaluation Report

February 2016

Site Code KRD16 NGR 519903 165574 OASIS reference: molas1-240866

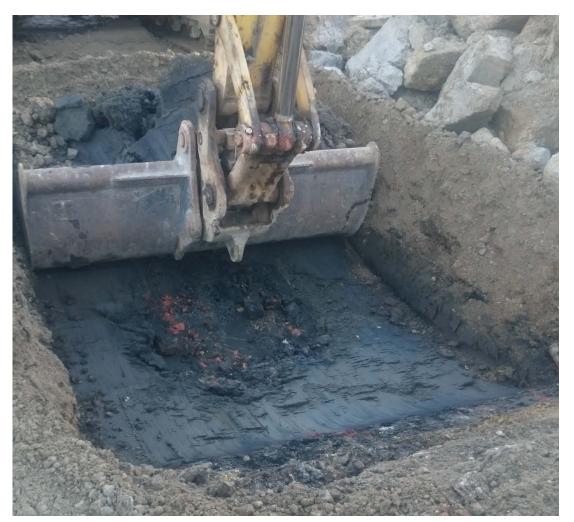
Photo 1 Trench 1, during excavation, London Clay is visible truncated by what appeared to be a manhole or soakaway, looking east.

4.1.1 Trench 1 was located in the centre of the site, near the proposed location of Trench 2 shown in the WSI, but was aligned east-west. London clay was observed at the base of the trench at *c* 24.40m OD. This appeared fairly clean, although close

inspection was not possible. It was apparent that fairly recent (20th-century) horizontal truncation had removed all archaeological potential to the top of the natural geology. A manhole or soakaway visible at c 0.5m below ground level, in the approximate centre of the trench, was probably contemporary with the 1960's petrol station. The trench was backfilled immediately after excavation due to health and safety concerns as the modern deposits were evidently contaminated.

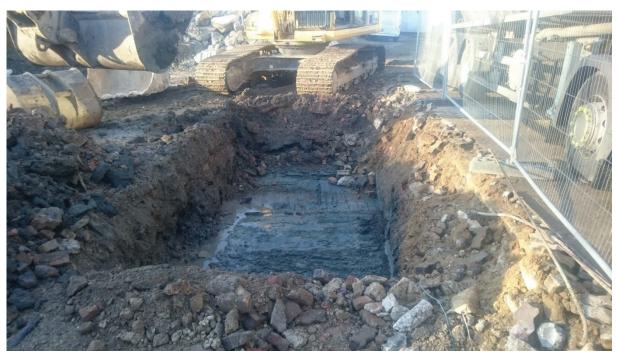
Photo 2 Trench 2, natural London Clay exposed across the trench base at c 24.50m OD, looking south-west.

4.2.1 Trench 2 was located parallel to, and 3m south of, the proposed location of trench 3 as shown in the WSI. Blue grey London Clay was exposed across the base of the trench. This was flecked with very small particles of what appeared to be chalk. Although close inspection of this deposit was not possible, there was no evidence it had been redeposited. Small fragments of ceramic building material were also evident within this top layer of natural geology, likely residue from 20th-century construction. As in trench 1 modern ground work had removed any potential archaeology, truncating to natural geology. The trench was backfilled immediately after excavation due to health and safety concerns.

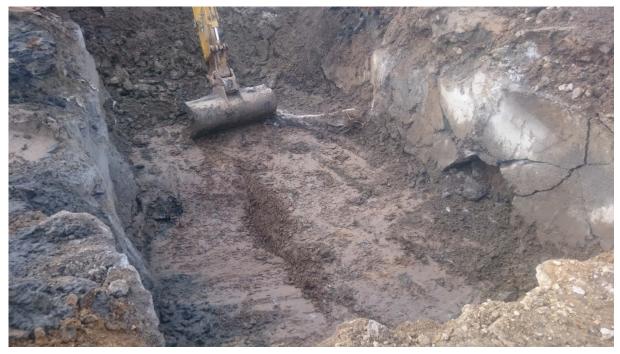
- 4.3.2 Whilst onsite MOLA observed the breaking out and excavation of tanks in the southeast of the site. This allowed for observation of the sequence of relatively modern deposits overlying the truncated natural geology. The deposits observed were consistent with those seen within the evaluation trenches, suggesting that the sequence was consistent across the site.

Photo 3 London clay observed at the base of the diesel tanks in the south-eastern part of the site.

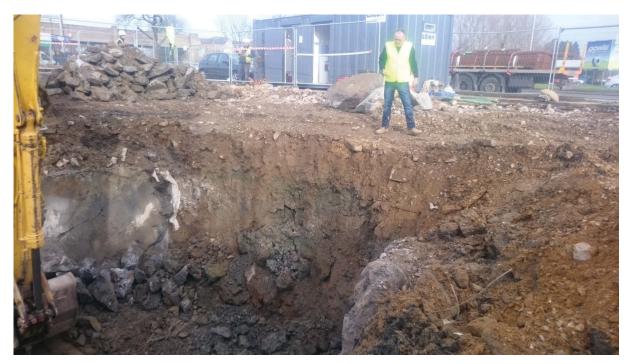
Photo 4 During removal of the concrete diesel tanks London clay was exposed in section beneath approximately 0.5m of modern material, looking north
