**Ensign Court  
28 Ensign Street  
London E1**

Report on archaeological evaluation

May 2016

Site Code: EGN15  
NGR: 534211 180714  
OASIS reference: molas1-251715

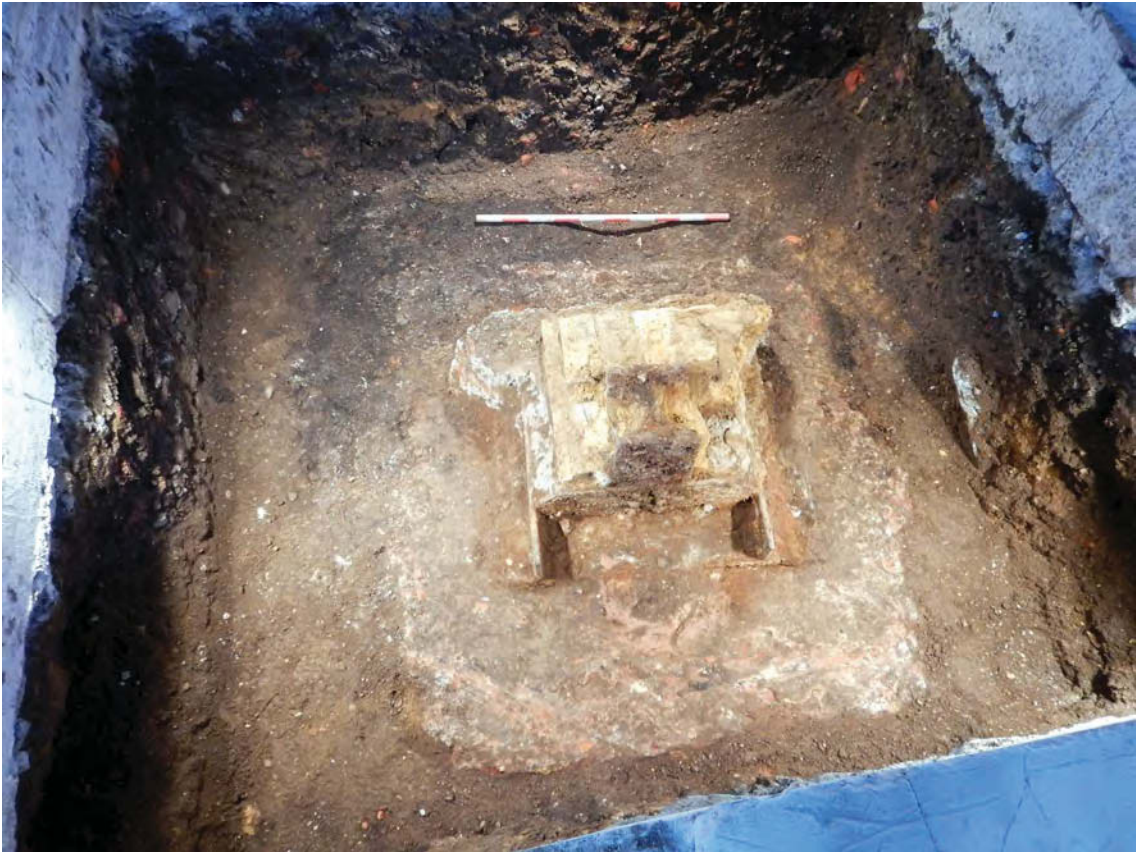
Fig 4 Victorian foundation in Trench 2, looking north (1m scale)

- 4.5.1 The existing concrete slab (with concrete bedding) extended to 0.48m bgl. It sealed a modern soil/rubble infill, machine/hand-excavated to a maximum depth of 2.2m bgl. The infill overlay a 19th or 20th century concrete and brick stanchion base (see Fig 4). The foundation measured 1.74m N-S by 1.6m, with a maximum height at 9.16mOD (0.72m bgl). It was not possible to break out the foundation and its full depth was not recorded although it was bedded on the surface of the natural gravel.
- 4.5.2 The foundation obstructed further excavation; subsequently BH5 was drilled in the north extent of the trench edge, to further investigate the archaeological potential in this part of the site. BH5 was drilled to 6.33mOD demonstrating modern made ground down to the top of natural gravels at 6.93mOD. No archaeological survival was apparent within this trench.

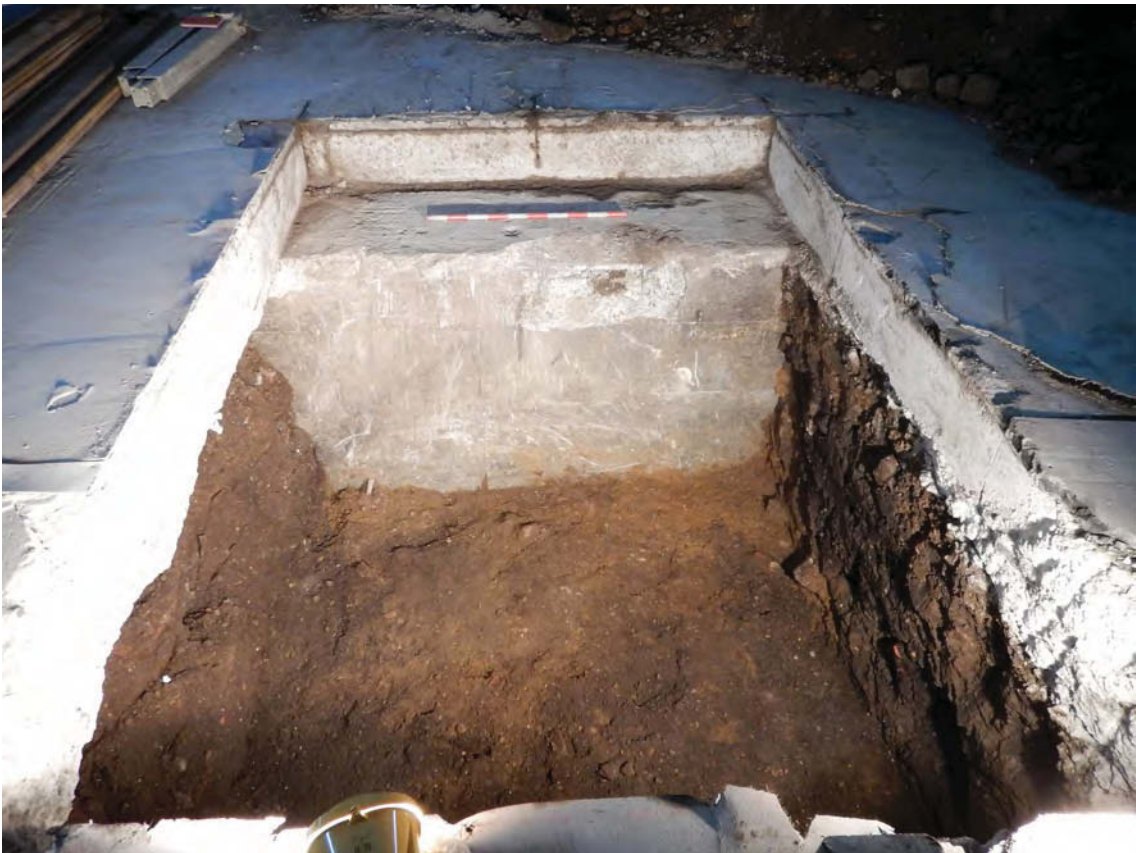
Fig 5 Reinforced concrete floor beam in Trench 4, looking SW (1m scale)

- 4.6.2 A reinforced concrete floor beam, set on a NW-SE alignment, was part-exposed, extending for 0.84m into the trench, parallel with its western edge (Fig 5). It was situated directly beneath the existing concrete floor slab (0.35m thick where it sealed the beam). The top of the beam lies at 10.05mOD. The beam was exposed for a depth c 1.8m bgl; its full extent was not identified.
