PARK VILLAS London TW7

Archaeological evaluation Report

**Park Villas
Park Road
Isleworth
TW7 6BB**

Site Code PKV14
NGR 516818 176171
OASIS reference molas1-266708

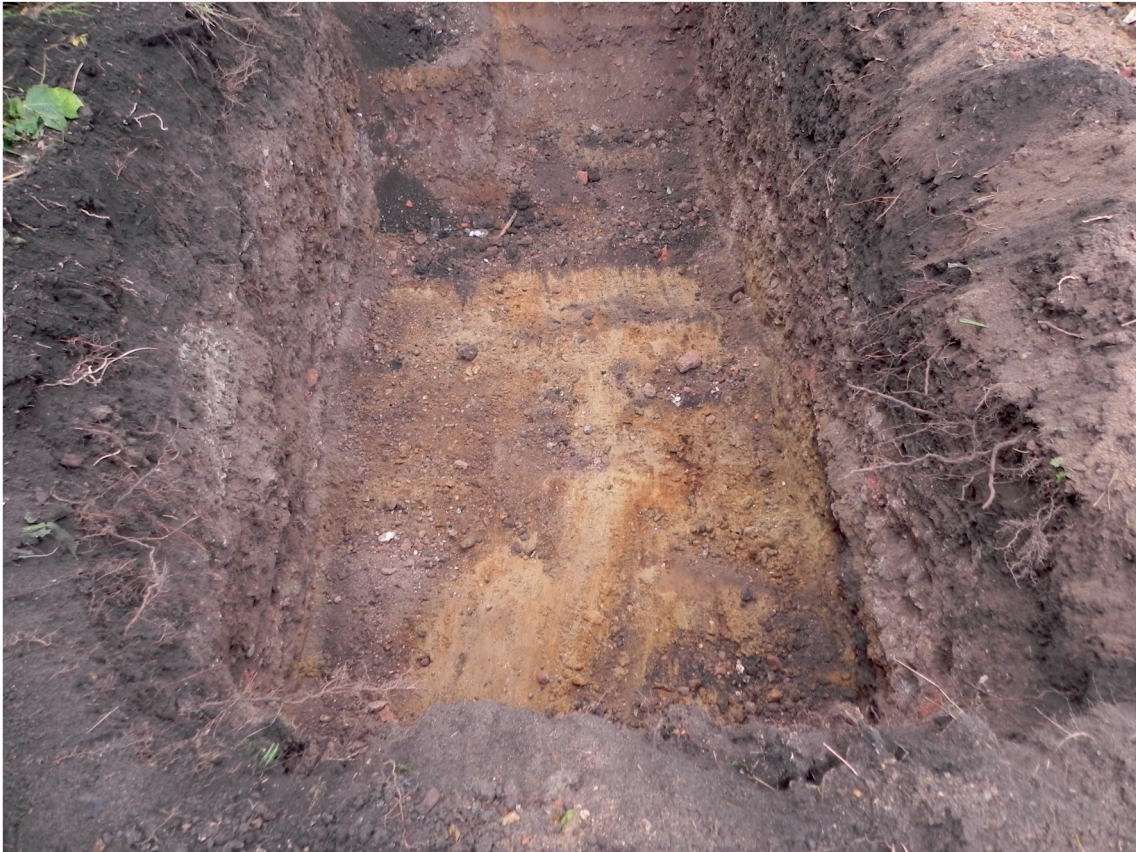
Fig 3 Photograph of Trench 1 facing northwest

Location	Northwest corner
Dimensions	2.2m by 5m by 1.9m-1.5m depth
Modern ground level/top of slab	5.50mOD
Base of modern fill/slab/turf	4.10-3.70mOD
Depth of archaeological stratigraphy above natural (if any)	N/A
Level of base of lowest features or deposits observed	N/A
Top of surviving natural observed at	4.10-3.70mOD
Level of base of trench	3.60mOD

- 3.2.1 The natural deposit is river terrace gravel and consists of light yellow brown sandy and gravel.
 3.2.2 Overlying this was approximately 0.4m of light grey brown sandy silt deposit with frequent chalk, CBM and stone inclusions and is likely post-medieval in date.
 3.2.3 Above this was 0.9m of a mid grey brown sandy silt deposit with brick, concrete and the occasional paint can inclusion. The paint can in particular suggests a more modern date for this dumping event.
 3.2.4 Sealing it all was 0.5m of a dark grey brown sandy silt topsoil.
 3.2.5 No archaeology or archaeological finds were observed.

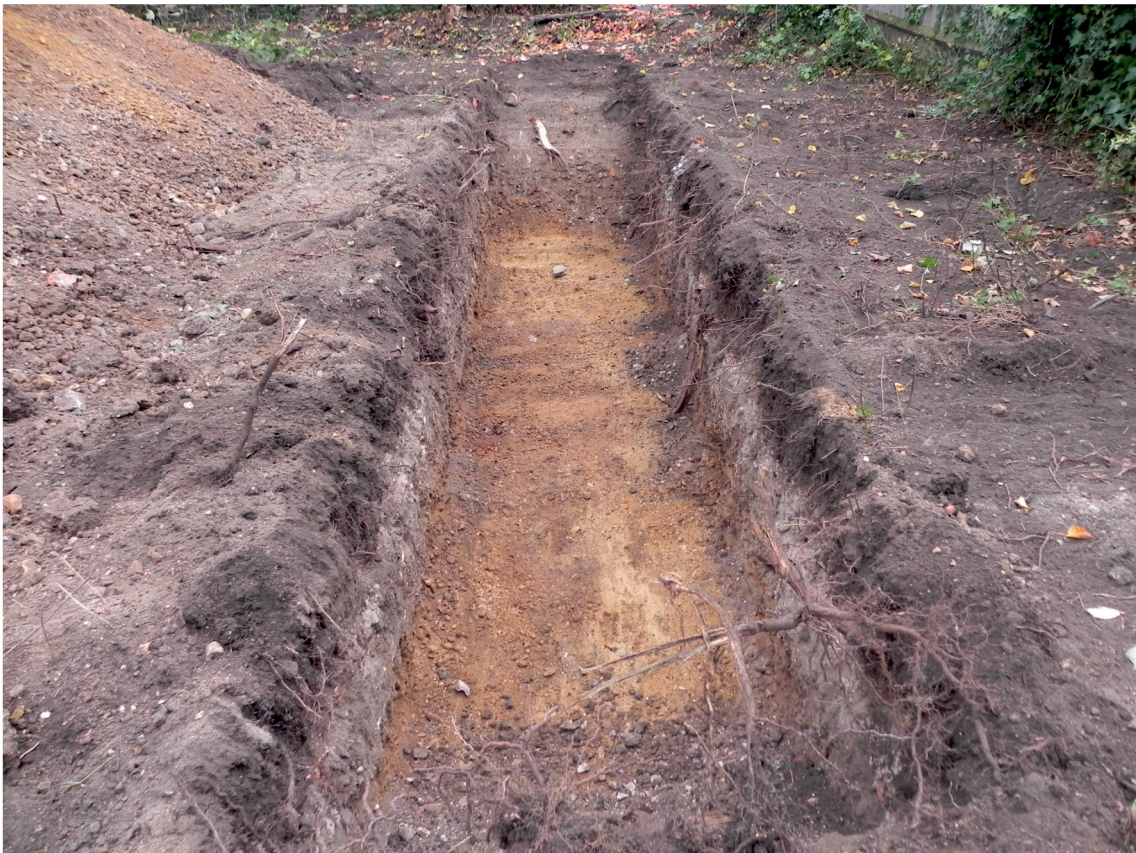
Fig 4 Photograph of Trench 2 facing northeast

Location	Southeast corner
Dimensions	1.5m by 6.5m by 1.1m depth
Modern ground level/top of slab	6.40mOD
Base of modern fill/slab	5.55mOD
Depth of archaeological stratigraphy above natural (if any)	N/A
Level of base of lowest features or deposits observed	N/A
Top of surviving natural observed at	5.55mOD
Level of base of trench	5.30mOD

- 3.3.1 Truncating the natural river terrace gravel was 0.6m of light grey brown sandy silt with chalk, CBM and stone inclusions. Likely the same or similar deposit to the post medieval dumping event observed in trench 1.
 3.3.2 Sealing this was 0.25m of the same dark grey brown sandy silt topsoil covering the whole of the site.
 3.3.3 No archaeological finds or features were observed.
