13-16 Dingwall Road Croydon CR9

Archaeological evaluation report

July 2007

Site Code: DWR07

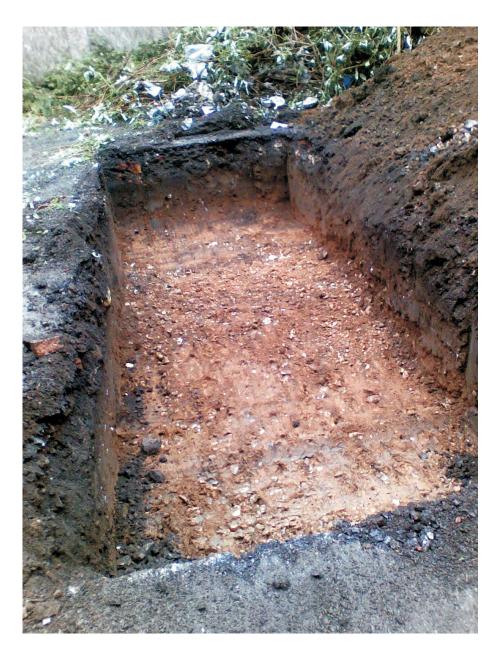
Fig 4 Trench 1, facing east

valuation Trench 1		
Location	Rear of 16 Dingwall Road; NE corner of	
	site	
Dimensions	5.5m by 2.1m by 0.8m depth	
Modern ground level	57.76m OD	
Base of modern fill	57.56m OD	
Depth of archaeological deposits seen	N/A	
Level of base of deposits observed and	56.96m OD	
base of trench		
Natural observed	57.06m OD

Undisturbed natural coarse, orange brown sand with gravel and flints was located at 57.06m OD. This was overlain by a buried subsoil deposit 0.5m thick, of mid grey brown, silty sand with occasional CBM (ceramic building material) fragments and small particles of chalk, gravel and charcoal. This was covered by a mixed rubble

deposit used as bedding for the disturbed and overgrown Tarmac surface (Figs 3 and 4).
