CRYSTAL PALACE PARK
Crystal Palace Parade
London
SE19
London Borough of Bromley

An archaeological evaluation report

Site Code: CYT07
National Grid Reference: 534000 171000

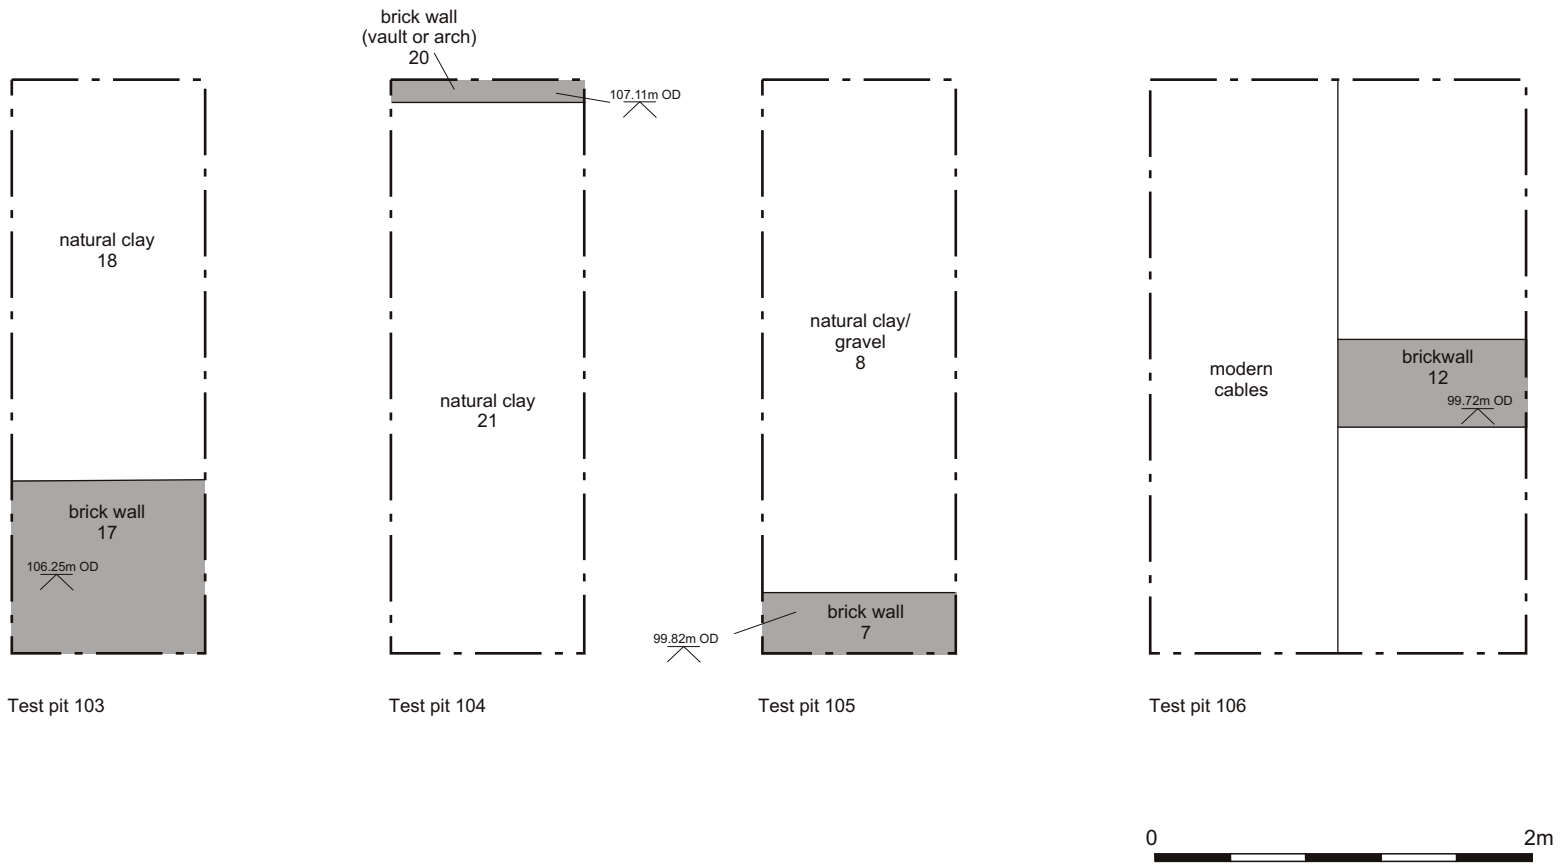
Fig 3 Plans of test pits 103–106, showing brick walls within the Palace

Fragmentary walls found in Test Pits 102, 103 and 104 are likely to relate to the main Palace building, suggesting, as elsewhere, that there is potential survival for much of the building foundations below the present ground surface. With further study, it may be possible to identify these features, particularly the (relieving) arch in TP104. In Trench 1A there is considerable survival of identifiable Palace structural remains. In this area only the easternmost elements were truncated by the creation of a bank within the new park layout.

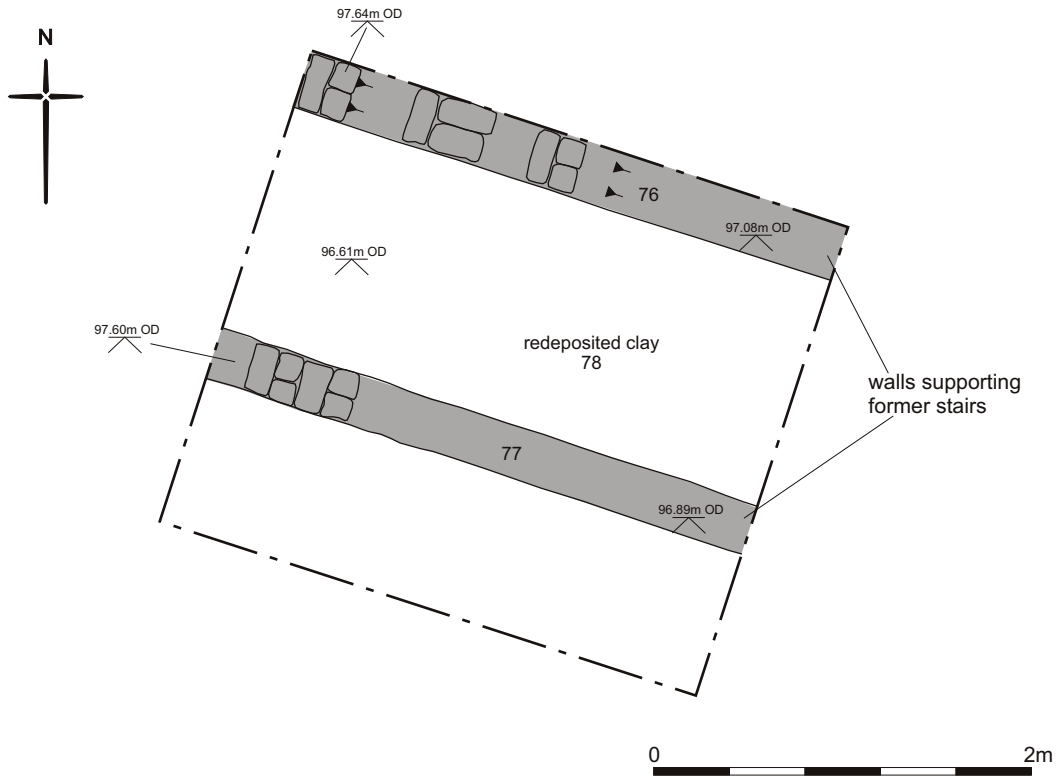
Fig 4 Test pit 1, plan of supports for former stairs

Natural clay [79] was recorded at a truncated level of 95.96m OD. Two east–west brick walls were recorded in the test pit, and a third presumed wall along the western edge of the pit was obscured by a modern concrete overhang. Against the northern edge of the pit, facing the stonework of the eastwards projecting bay, was wall [76]. 1.24m parallel to the south was wall [77] which was seen in the sondage to be founded at 95.58m OD.

It is probable that wall [77] was one of perhaps three brick foundations which originally supported a flight of steps descending eastwards from the Upper towards the Lower Terrace (as shown in *Fig 23*). The upper parts of these walls had however been partially demolished (probably when the staircase was removed) and so it was not possible to determine the original gradient of the steps. Laid against these walls, the upper fill of the test pit [78], comprised redeposited natural clay.

Thus only the damaged brick foundations of the stairs survive (at *c* 0.30m below present ground level), the stone treads and balustrades having been removed in the past.

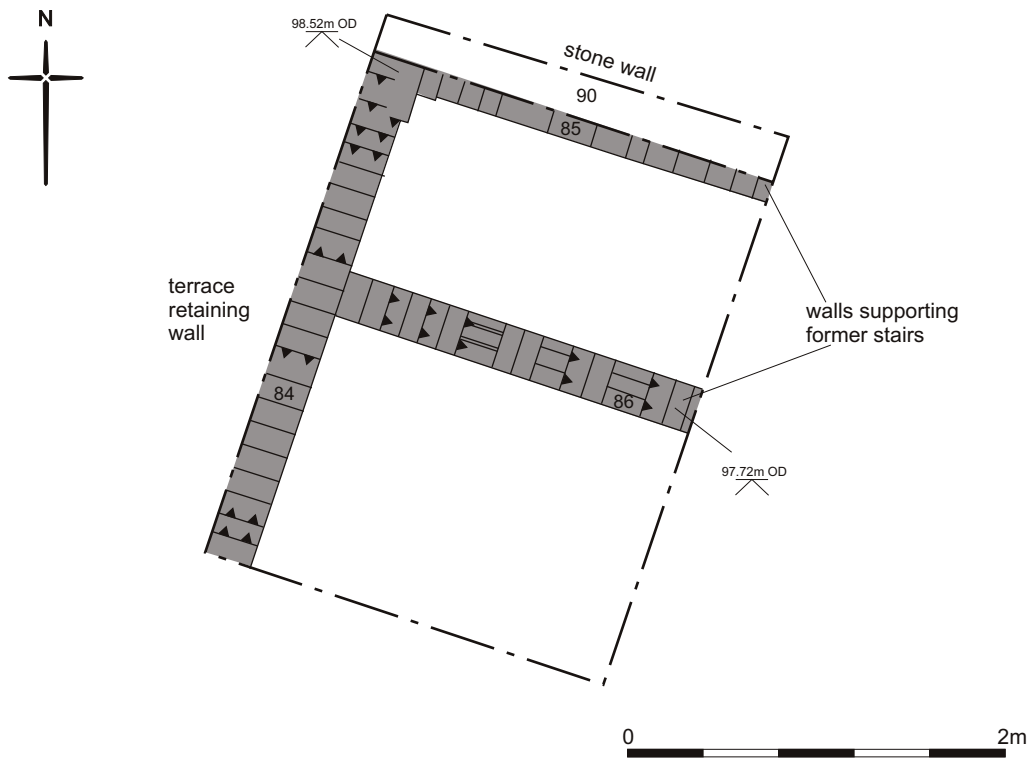
Fig 5 Test Pit 2, plan of terrace retaining wall and supports for former stairs

Along the western edge of the test pit was a north–south brick wall [84] (*fig 5*) which served as the main retaining wall of the Upper Terrace (in general, only the upper visible parts of the terrace structures were in stone, the foundations being brick). Bonded to this wall and forming the northern edge of the pit was an east–west wall [85] that appears to have been built against the stone bay. Also bonded to [84] and parallel 1.05m to the south of [85] was another brick wall [86] whose base was recorded at c 95.6m OD within the sondage.

These walls appear to have formed the brick foundations of a former flight of steps descending from the Upper towards the Lower Terrace, the general arrangement being shown in *Fig 23*. The upper parts of the walls had already been partially demolished (probably when the staircase was removed) and so it was not possible to determine the original gradient of the steps. The upper layer within this test pit was a backfill [87] against the structural elements – it largely comprised redeposited natural clay.

Thus only the damaged brick foundations of the stairs survive (at c 0.50m below present ground level), the stone treads and balustrades having been removed in the past.

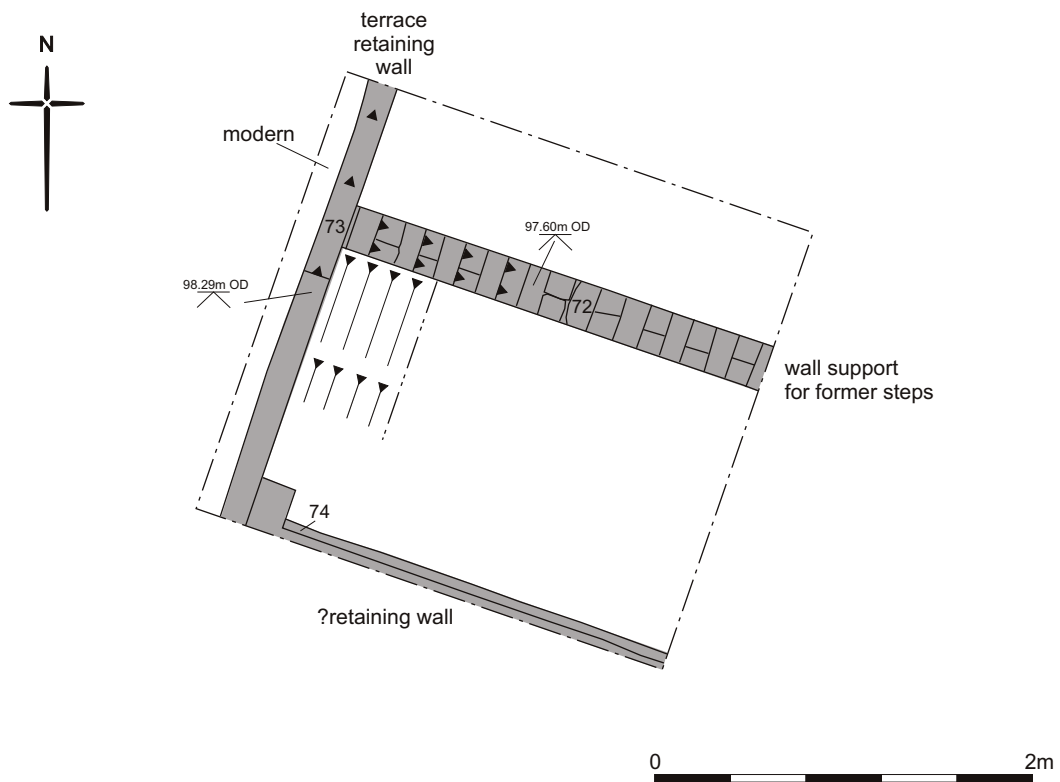
Fig 6 Test pit 3, plan of terrace retaining wall and supports for former stairs

Along the western edge of the test pit was a north–south brick wall [73] which served as the main retaining wall of the upper terrace (*Fig 6*). At the southern edge of the pit was an east–west wall [74], bonded to [73], that almost certainly retained the northern side of the adjacent bay extension. 1.46m north of [74], lay another east–west wall [72], also bonded to [73]. This was founded at approximately 95.63m OD – and it appeared that this was also the level at which wall [73] was founded.

The upper parts of the test pit were occupied by a redeposited clay fill [71], below modern dumping [70]. The latter was almost certainly associated with demolition and robbing of the former stone steps. It is probable that the east–west wall [72] was one of perhaps three foundation walls which, together with the edge walls, held the steps in place. The uppermost parts of these walls, however, had been partially demolished and so it was not possible to determine the original gradient of the steps.

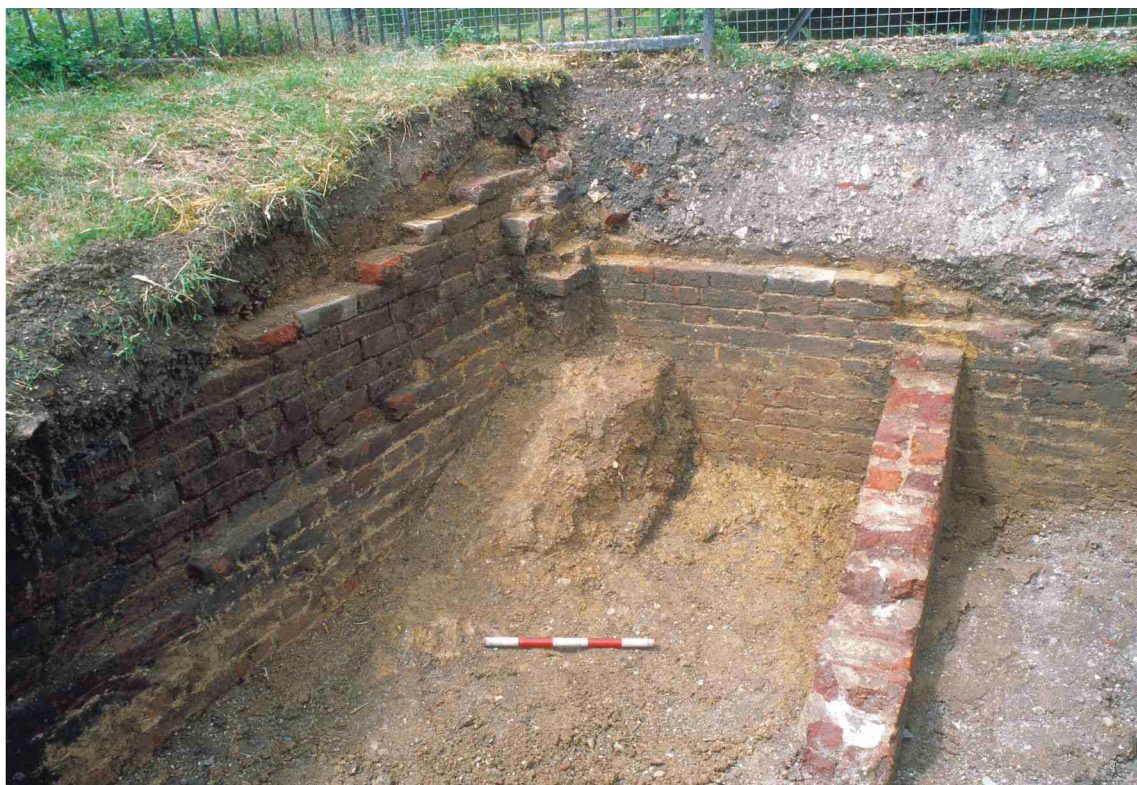
Fig 7 Test pit 3, terrace retaining wall and supports for former stairs, looking west

Thus, consistent with the results from TP1 and TP2, only truncated brick walls that originally supported the stairs survived (at *c* 0.60m below present ground level; *Fig 7*) the stone treads and balustrades having been removed in the past. Fragments of the original balustrade from the terrace retaining wall were found in the upper levels of this test pit (*Fig 8*). The current balustrade is a modern replacement.

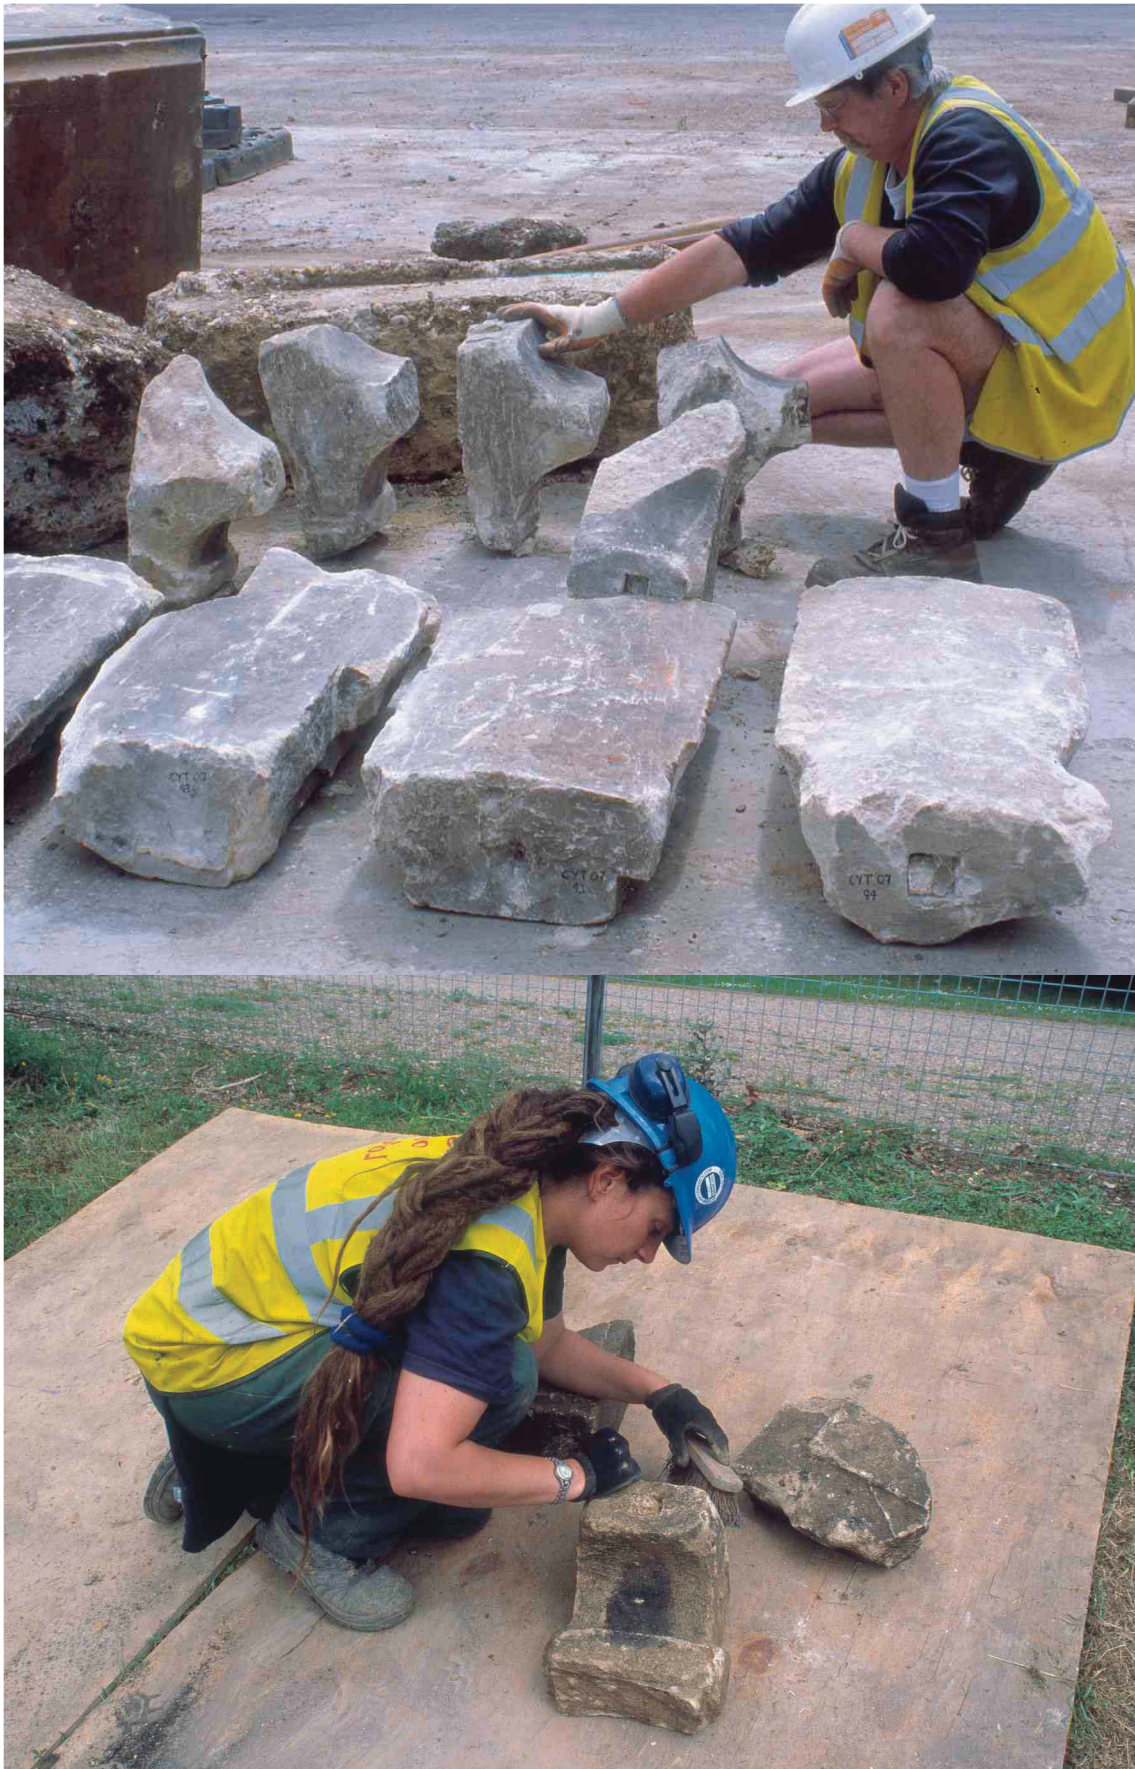
Fig 8 Sections of the original terrace balustrade, dumped over the former stairs in Test pits 1–4

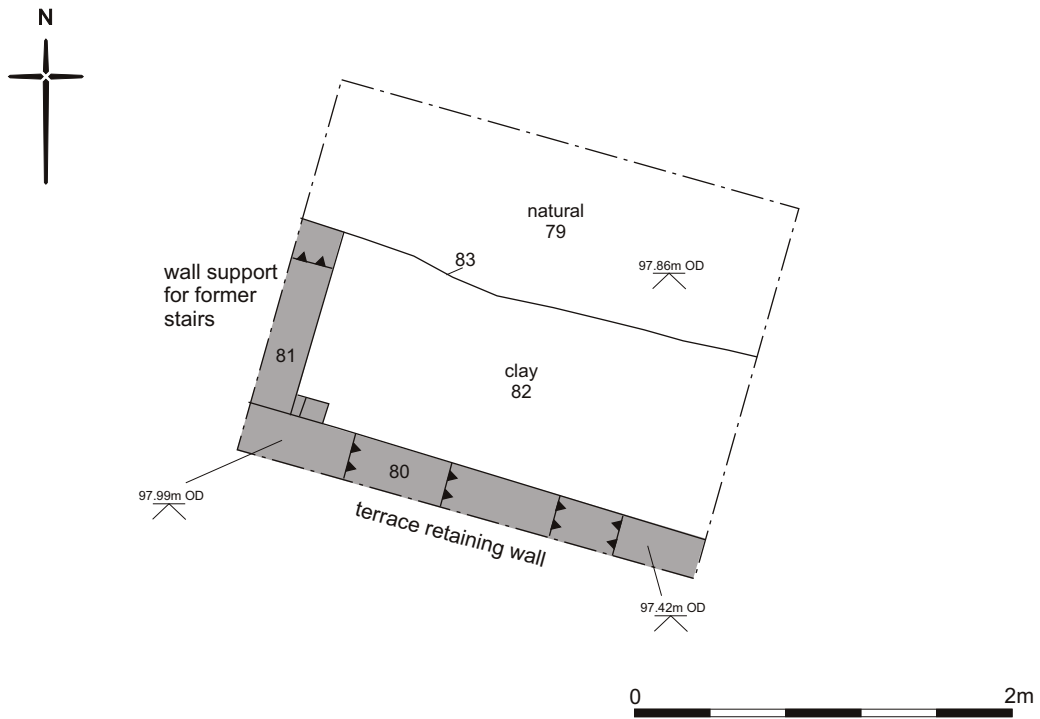
Fig 9 Test pit 4, plan of terrace retaining wall and supports for former stairs

A north–south brick wall [81] formed the main retaining wall for the Upper Terrace. Bonded to it at right angles, along the southern edge of the pit, was wall [80] one of the brick foundations that originally supported the staircase. These walls survived from immediately beneath the present ground level. Abutting them was a redeposited clay [82] that may have been the original fill. However, just 1m northwards a substantial more recent cut [83] had

truncated wall [81] and the fill. It is clear that not only the stone steps, but also most of the brick foundation walls in this location have been destroyed in the past.

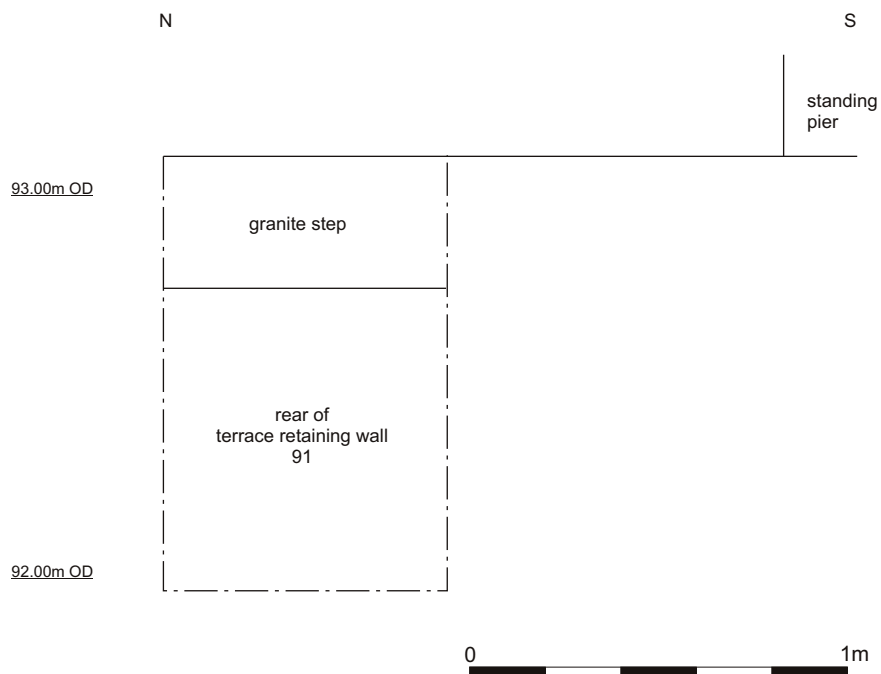
Fig 10 Test pit 7 , elevation of part of terrace retaining wall

Because of the extensive disturbance by services, the material seen within the test pit was recent made ground and there was no trace of any original terrace surfaces. Beneath the granite staircase block (recessed in 0.12m to the east) was the rear face of a brick foundation wall [91] – *Fig 10*. This is the main terrace retaining wall and was a vertical construction without apparent corbelling. Its full depth, likely to be over 2.5m, was not ascertained within the confines of the test pit.

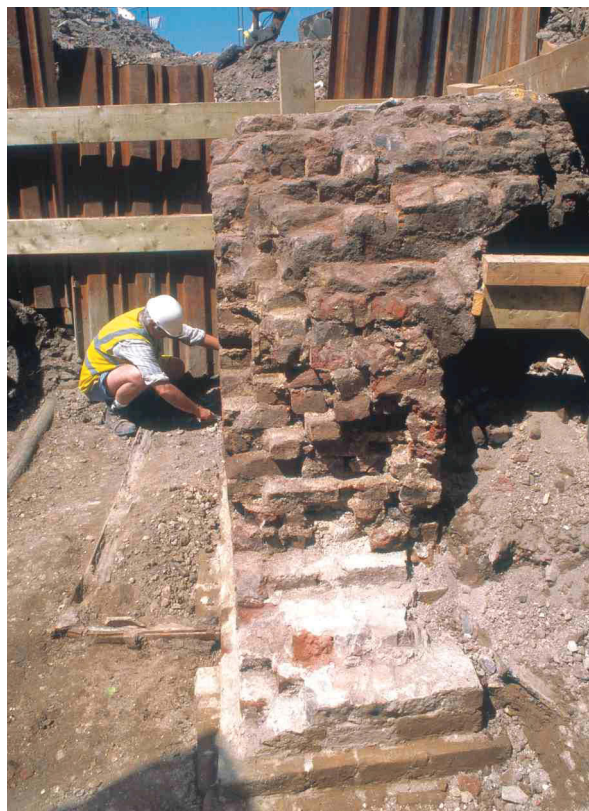
Fig 13 Test pit 9, base of south nave fountain, looking west

The substantial brickwork encountered represents the partially demolished remains of the basement-level services and foundations for the fountain basin (*Fig 13*). The latter had not survived, although the cement skim *c* 0.7m below modern ground level may represent the impression of the removed basin superstructure. The 1936 fire that destroyed the Palace was represented by the burnt debris [29], which included elements of the marble superstructure that had been discarded, perhaps during salvage operations before the basement was filled in.

Test Pit 9 was designed to examine what remained of the southern fountain in the nave of the Palace, where it crossed the South Transept (*Fig 23*). Loose fragments of marble within the fire debris were the only remnants of the fountain superstructure. However, the brick base of the foundation was found, with storage and service areas, containing a water pipe and electrical conduit at low level.

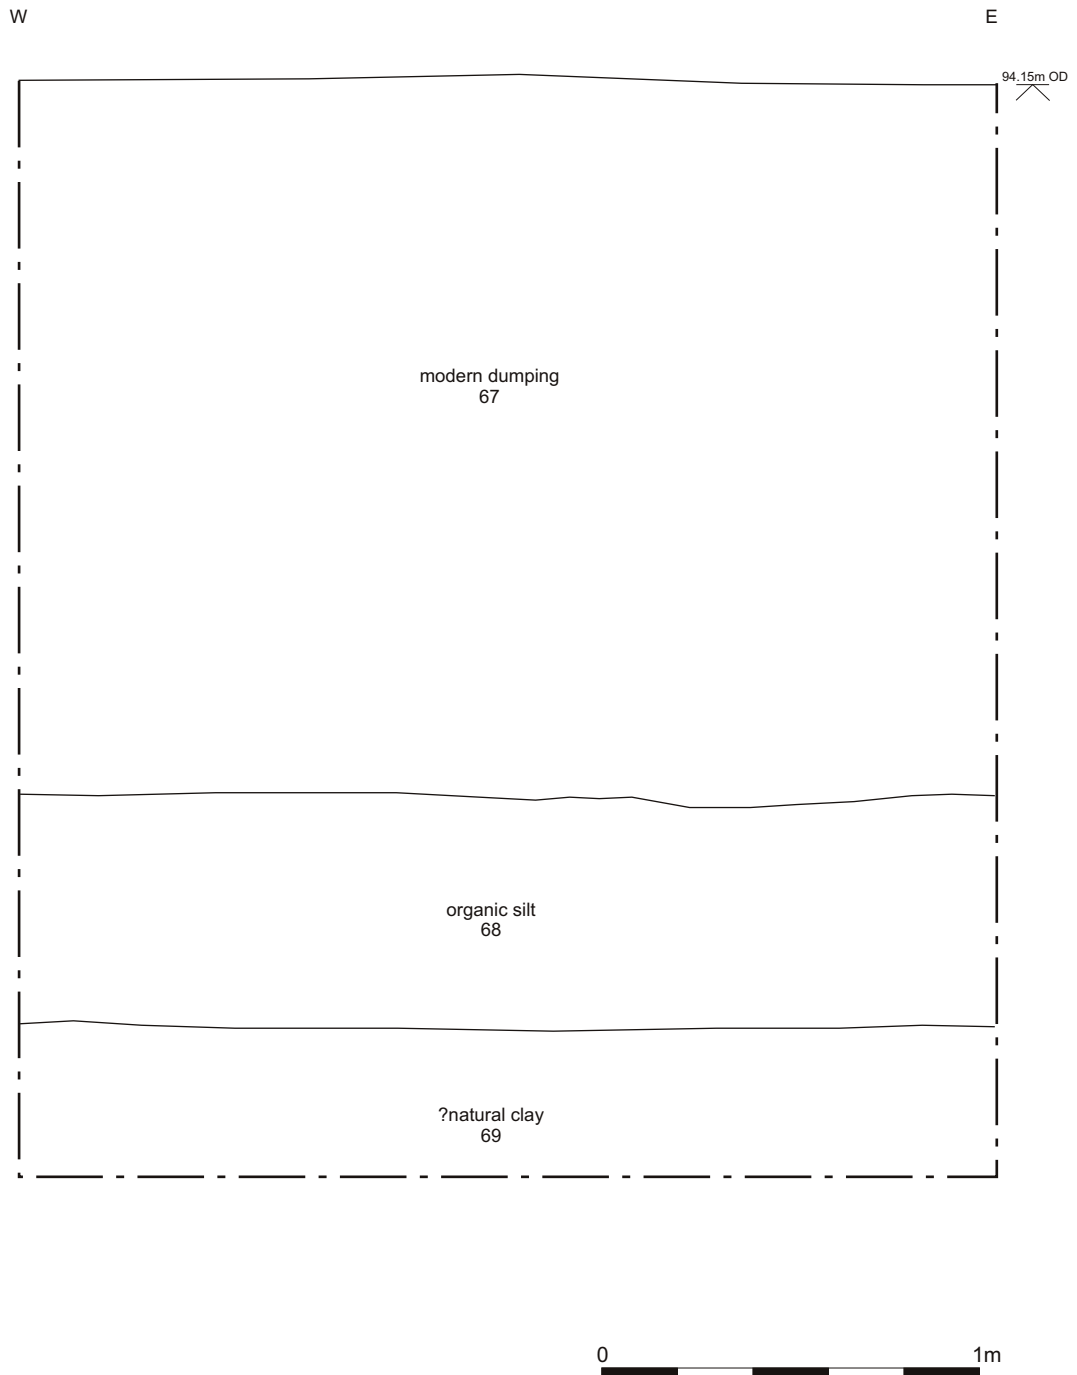
Fig 15 Test pit 12, section within fountain basin CP67

A natural light grey clay, probably truncated London Clay [69] was recorded at 91.55m OD. Above this was a 0.7m thick organic black silt [68] containing twigs, reeds, and grass, formed in anaerobic conditions as a result of localised waterlogging. This layer contained two loose large blocks of stone; one was plain and the other a plinth base for one of the statues that formerly stood on this terrace. The upper layer in this pit was a 1.9m thick mixed clay [67] containing modern debris.

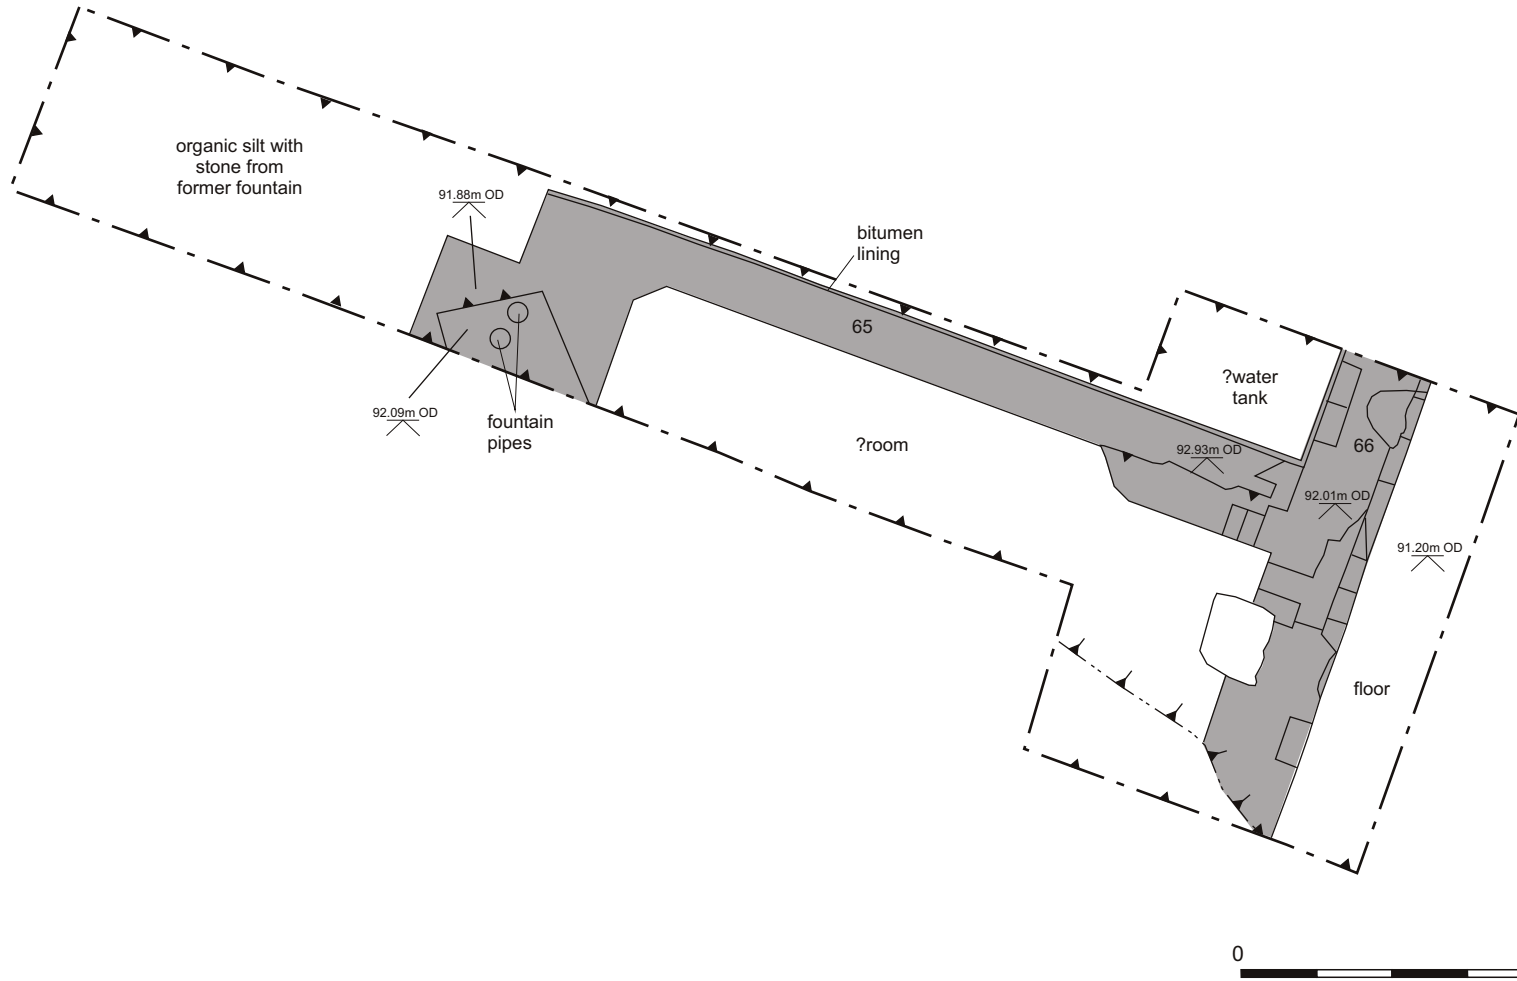
Fig 16 Test pit 13, plan of walls from fountain CP66 control room

The brick walls and concrete floor appear to be the remains of the control room that stood beneath the fountain basin. The upper level of this structure survived to *c* 1.8m below modern ground level. The fountain structure above had been removed, although redeposited metal parts survived in the control room. As in TP12, either the basin was lined with London Clay, or a floor had been truncated by modern disturbance. It is likely that the basin edges were formed of ornamental stonework, but again this is unlikely to survive *in situ*, as redeposited sections were found in the organic silt.

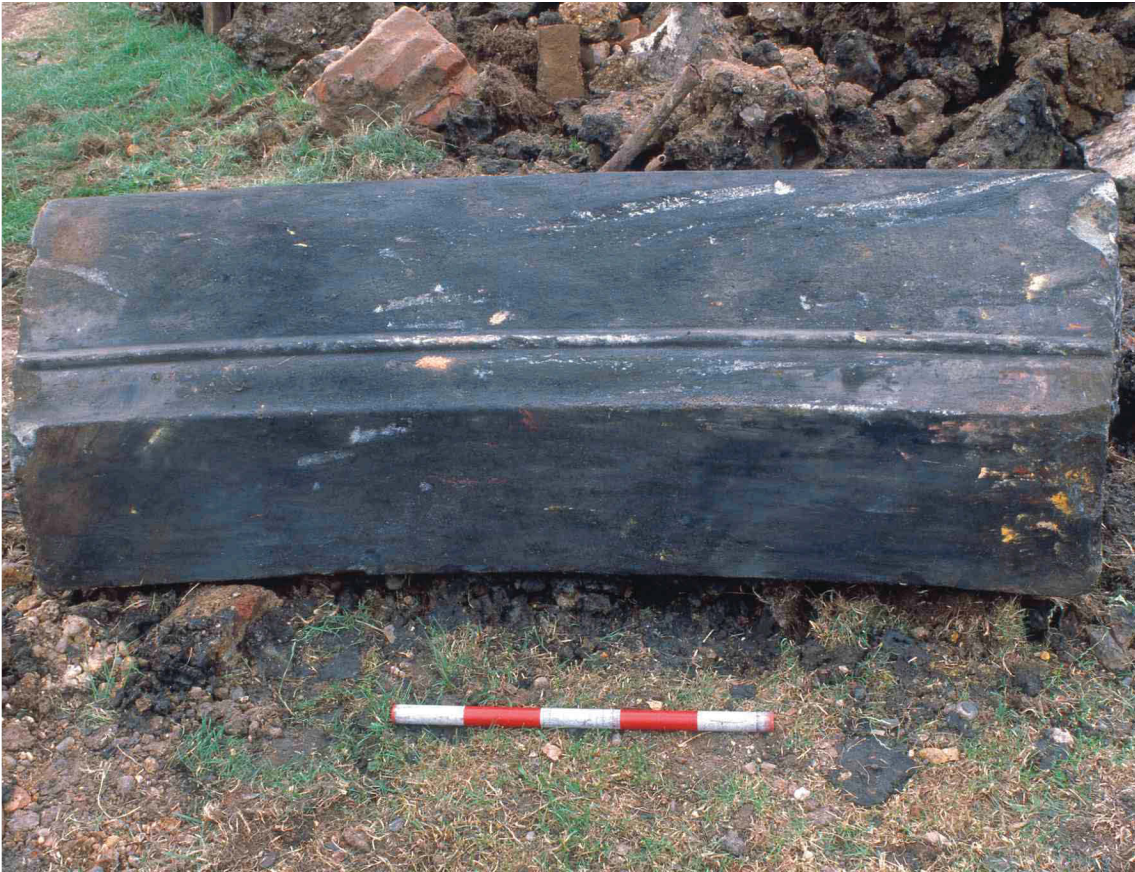
Fig 17 Edging block from former fountain CP66 found in TP13

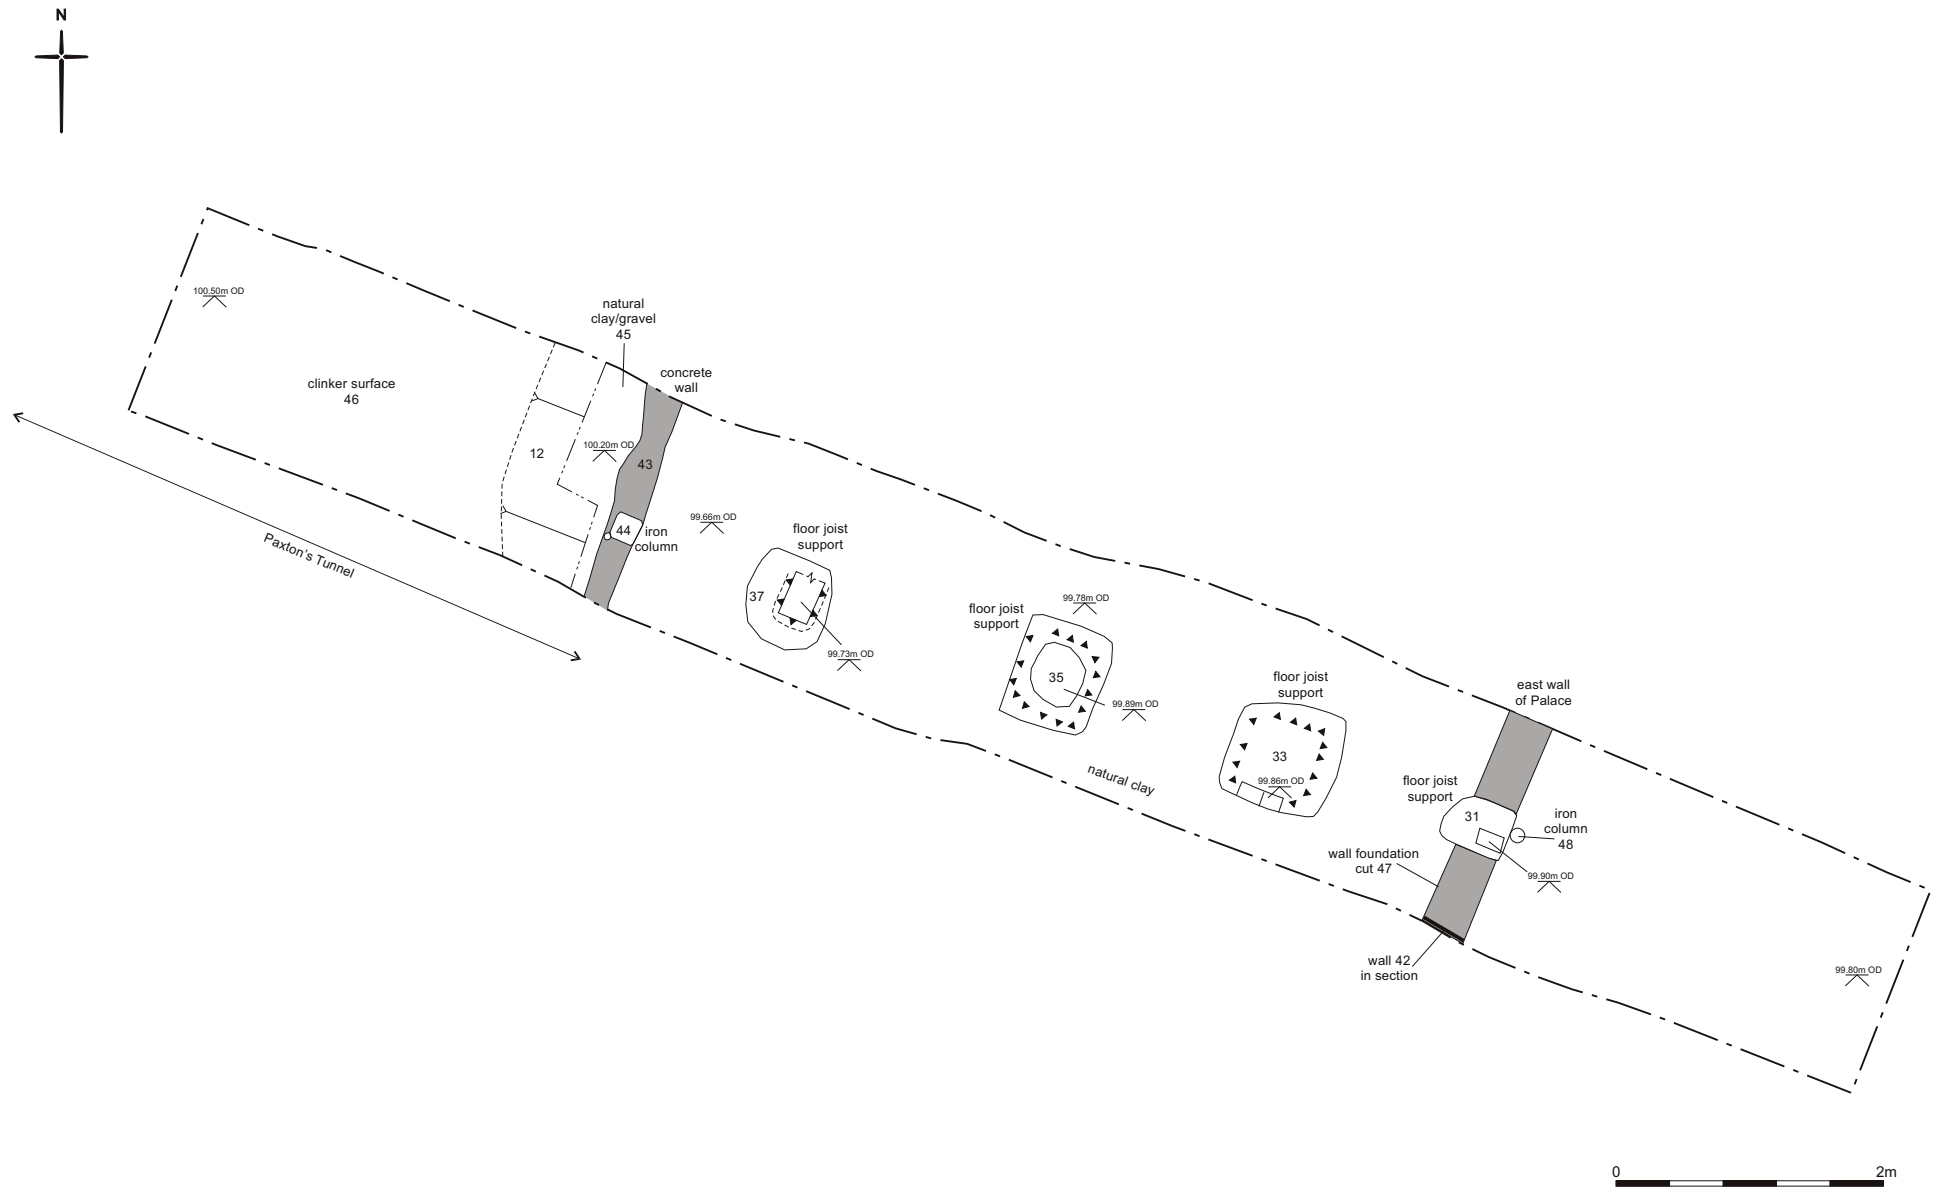
Fig 19 Trench 1B, plan of features from east side of the Palace and Paxton's Tunnel

At the eastern end of the trench, what appeared to be natural clay was revealed, cut into by the construction trench [47] for a brick wall [42] which only survived in section. This was crudely built on a foundation bed of chalk rubble founded at 99.74m OD. The construction cut incorporated a section of upright octagonal iron column [48]. This wall line probably represents the eastern side of the main palace building.

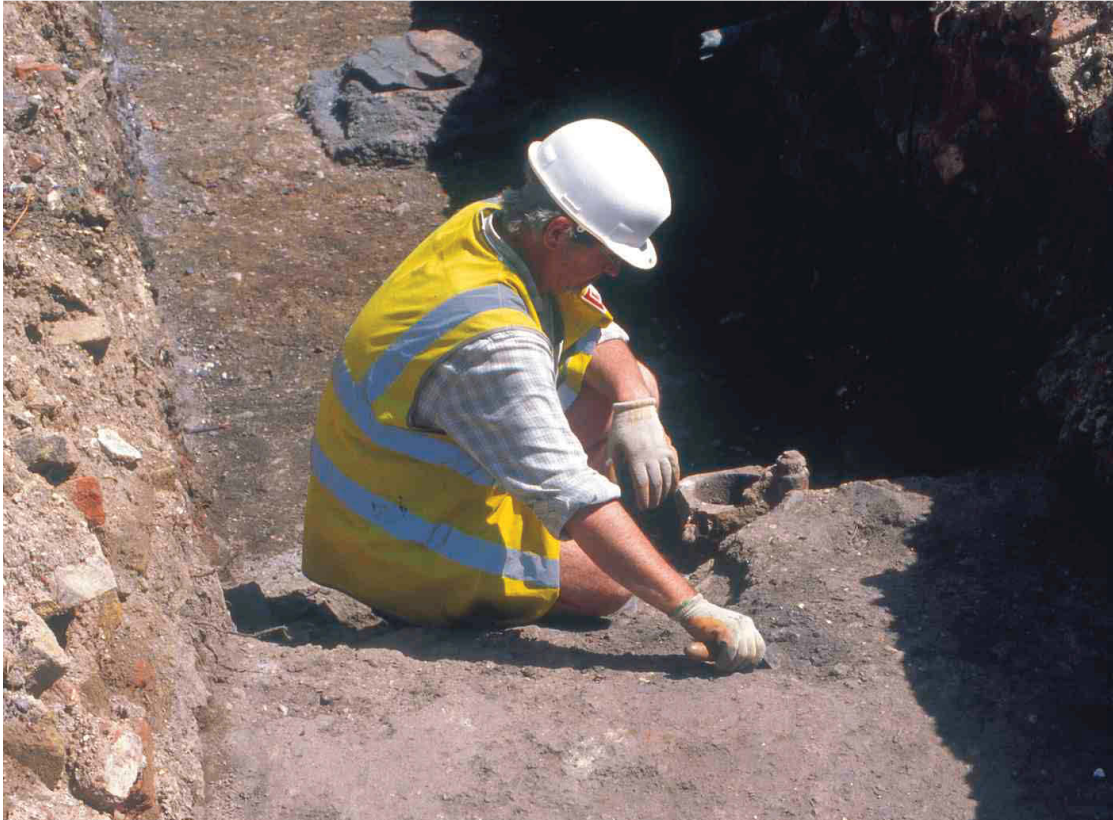
Fig 20 Trench 1B, crushed cinder floor of Paxton's Tunnel (46) with iron column (44) and joist support (37), looking east

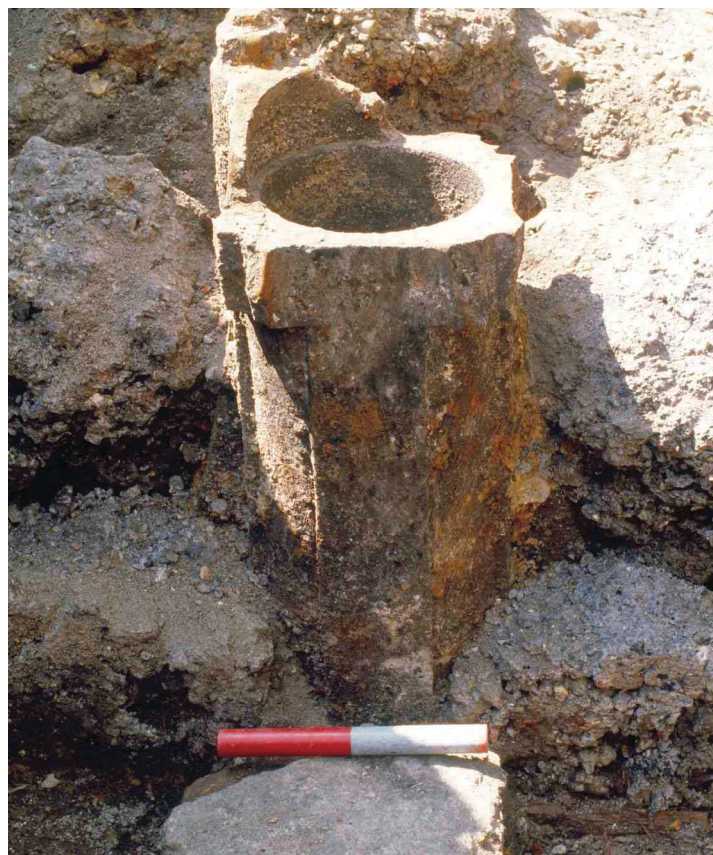
Fig 21 Iron column [44], set in concrete

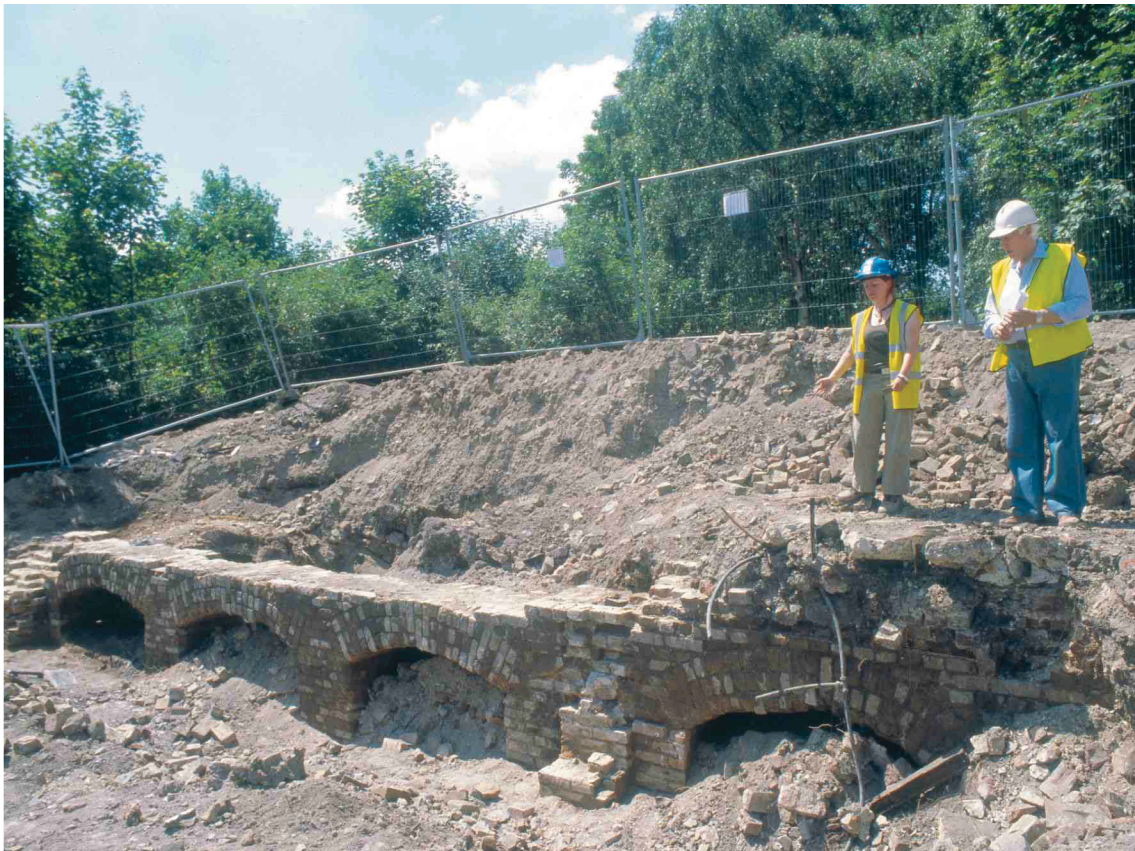
Fig 22 Arched brick wall [58] in Trench 1A

To the western end, a 10m stretch of north–south walling [58] was exposed, surviving to a maximum height of 107.39m OD (*Fig 22*). This substantial wall or foundation was built as a series of arches. Although it could not be investigated to any depth (because of the unstable fills at the top of the slope) this was clearly a main support wall inside the Palace. During clearance and recording, fragments of moulded stucco were retrieved from the modern rubble infill at its northern end.

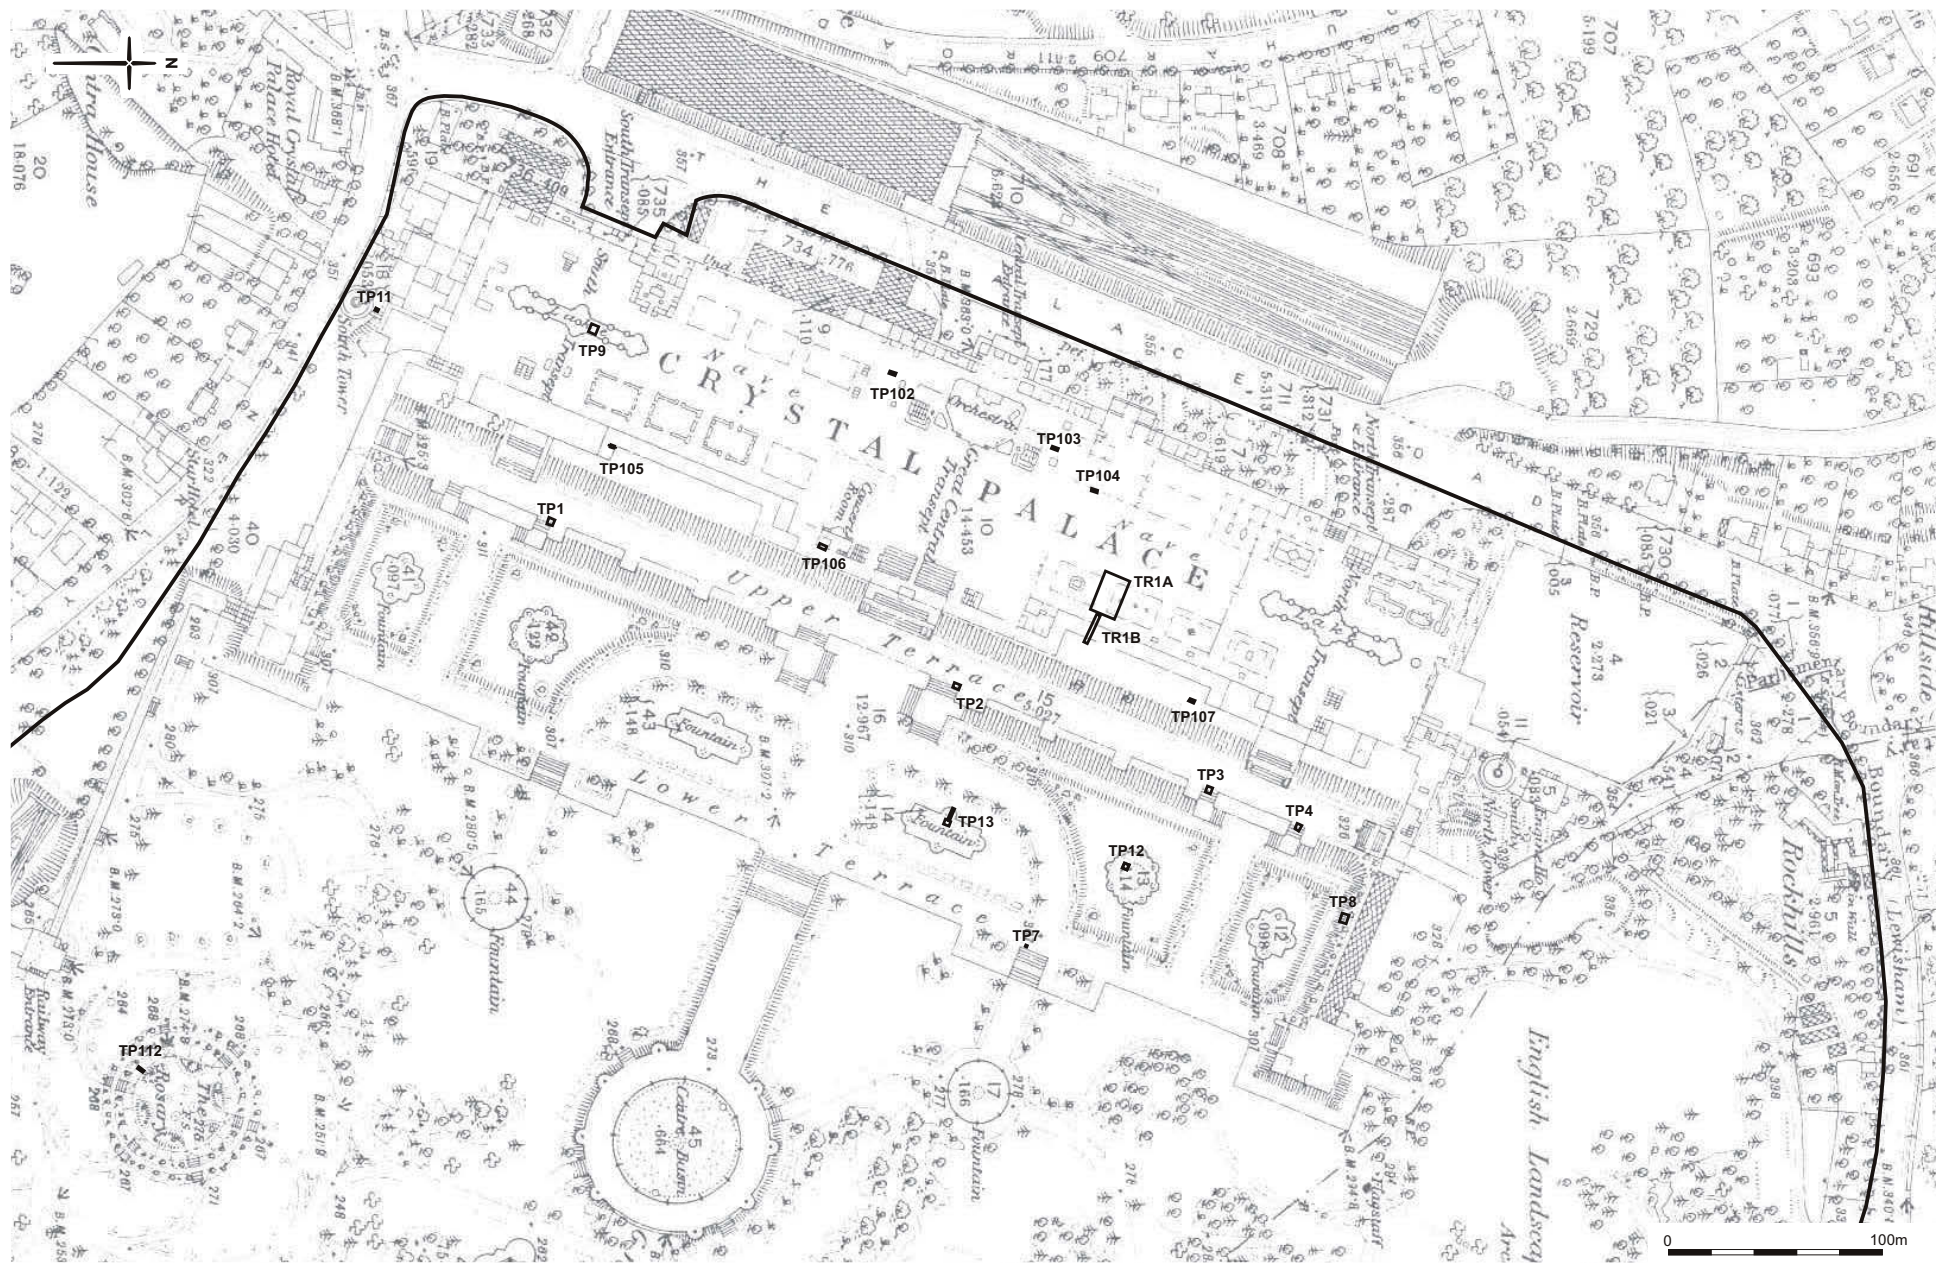
Fig 23 The evaluation Trenches and Test Pits superimposed on a plan of Crystal Palace (1871 Ordnance Survey)

This test pit was positioned over the former Rosary (an ornamental mound with terraces and steps: *Fig 23*), since heavily reconfigured. Due to the limited exposure, it is unclear whether the concrete foundation and deposits observed were part of the original mound structure or more recent works.

This test pit was situated on a sloping grass bank against the retaining wall of the Upper Terrace, where a projecting stone bay marks the former location of a staircase (*Fig 2 & Fig 23*). It was placed to examine any surviving structural evidence for these steps. Within the southern part of the test pit, a deeper sondage (smaller exploratory pit) was excavated by machine to determine the depth of the foundations.
