# No.1 Canon Row City of Westminster London SW1A 2JN

Site Code **CNO17** NGR 530236 179709 OASIS reference molas1-308029

Planning reference 16/07441/LBC Condition Number 10

Report on an archaeological watching brief

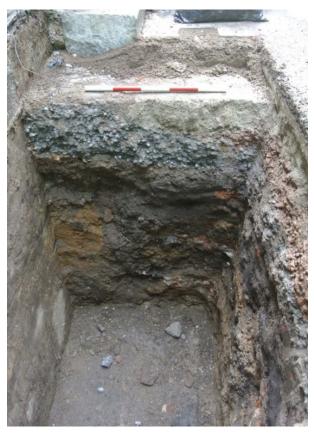
4.1.1 A banded reddish grey silt deposit [1] containing tile and white mortar fragments and occasional oyster shell, was seen from the base of the trench at 2.30m OD to a height of 3.00m OD. The deposit consisted of dumped demolition material mixed with domestic waste and earth and likely dates from the 18th century. There is the possibility that these finds are residual and the deposit has been reworked since the 18th century.

Plate 1TP1, north facing section. The sand filled construction cut for the basement of Canon Row Police Station can be seen at the left of the section against the exposed basement wall

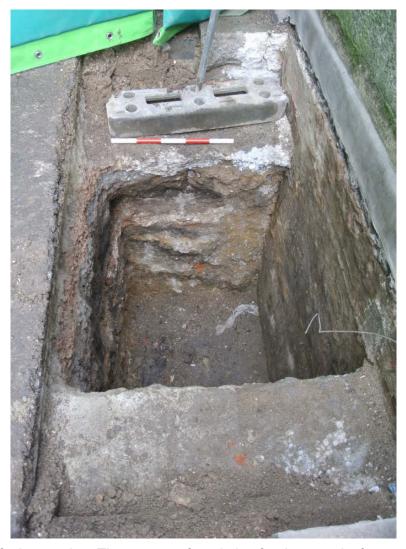
- 4.1.2 Above deposit [1] was a deposit of dark grey silt [2], c 0.30m thick containing occasional brick fragments and likely dating from the 19th century or beginning of the 20th century. Over this deposit was a bed of modern concrete c 0.30m thick for modern granite setts 0.10m thick and a modern granite kerbstone 0.20m thick.
- 4.1.3 There were two truncations seen in the trench. A sand filled construction cut for Canon Row Police Station was seen extending out 0.2m-0.3m from and parallel to the basement wall of the building. The base of this cut was not seen- the basement floor being below the level of the base of the trench. The northern face of the trench was occupied by the edge of the concrete foundation for one of the main metal posts of the adjacent modern security fence. The concrete foundation continued below the level of the base of TP1.

Plate 2 TP1, south facing section. The concrete foundation for the security fence can be seen extending below the base of the trench.

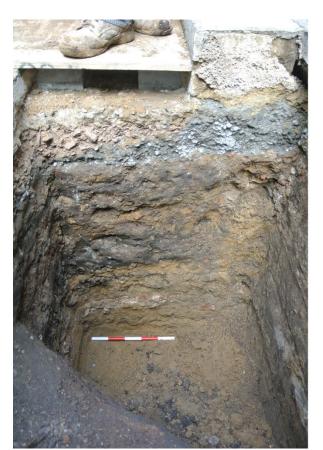
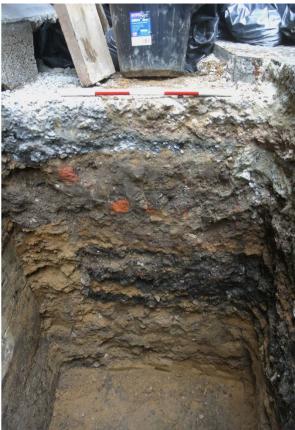
- 4.2.1 Redeposited, though clean, brownish yellow sand [3] was seen from the base of the trench at 2.08m OD to a height of 2.41m OD (see plate 3). Above this was seen a deposit of demolition material [4], 0.16m thick, consisting of light grey chalky mortar and pinkish orange brick fragments. This was sealed by a 0.25m thick layer of orange yellow gravelly sand banded with lenses of dark grey silt [5]. No finds were retrieved from deposits [3], [4] or [5].

- 4.2.2 Above deposit [5] was a 0.27m thick layer of dark grey silty sand [6], containing occasional fragments of orange red brick and roof tile, flecks and fragments of grey and creamy mortar, oyster shell, charcoal, coal and animal bone. The deposit likely dates from the 18th century, as indicated by scant pottery remains dating from between *c* 1600 and 1800. There is the possibility that these finds are residual and the deposit has been reworked since the 18th century.

- 4.2.3 Above deposit [6] was a 0.15m thick layer [7] of brownish yellow silty sand containing occasional fragments of orange red brick, below a 0.15m thick layer of yellowish brown sandy clay silt [8]. Both deposits ([7] and [8]) probably represent contemporary ground-raising in the 19th century or beginning of the 20th century, indicated again by scant pottery remains. Over this deposit was a bed of modern concrete c 0.30m thick for modern granite setts 0.10m thick and a modern granite kerbstone 0.20m thick.

Plate 3 TP2, south facing section (on left) and north facing section (on right)

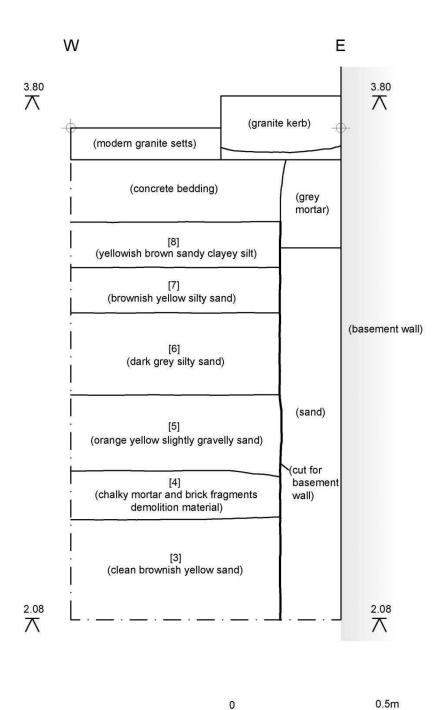
4.2.4 A sand filled construction cut for Canon Row Police Station was seen extending out 0.2m from and parallel to the basement wall of the building. The base of this cut was not seen, the basement floor being below the level of the base of the trenches. The upper portion of the construction cut had apparently been emptied of sand at one time and replaced with mortar, sand and gravel- possibly contemporary with the laying of the modern concrete bedding for the setts and kerb.

Plate 4 TP2, south facing section

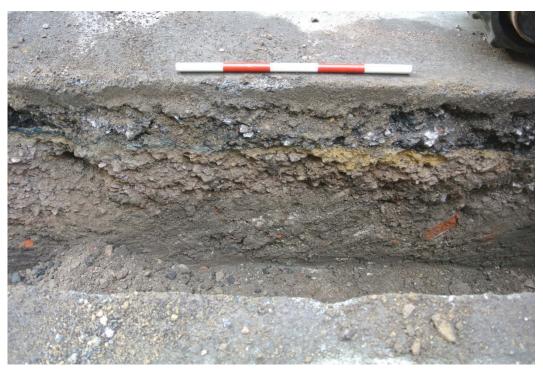
- 4.3.1 A deposit [9] of mid to dark brown grey silty sand was seen from the base of the trench to a height of *c* 3.44m OD in the southern part of the trench and *c* 3.31m OD in the northern part of the trench. The deposit containing occasional to moderate flecks and fragments of white grey mortar and occasional flecks and fragments of red and brown ceramic building material (cbm), as well as very occasional half bricks of the same material. No finds were retrieved from the deposit. The deposit was also seen in ST2, where it was contexted as [10].

- 4.3.2 Above deposit [9] in the southern third of the trench, Type 1 concrete, 0.14m thick, was seen below 0.05m of sand, above which tarmac, 0.17m thick, formed the road surface. Above deposit [9] in the middle third of the trench, Type 1 concrete, 0.15m thick, was seen below tarmac, 0.14m thick, which formed the road surface. Above deposit [9] in the northern part of the trench, Type 1 concrete, 0.29m thick, was seen below tarmac, 0.15m thick, which formed the road surface.

Plate 5 ST1 (southern portion), east facing section. Looking west

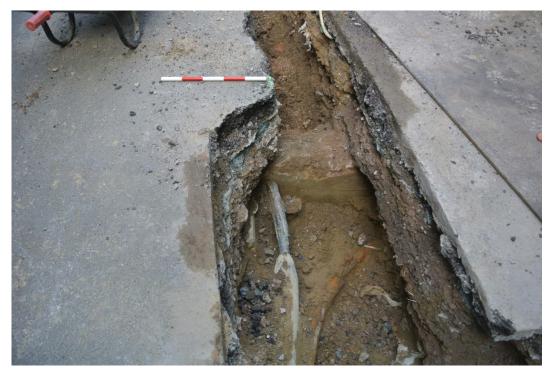
4.3.3 Several services were seen crossing the trench; some encased in concrete (see plate 6. Apart from in the very south of the trench, these services were fairly shallow, not extending below the base of the trench. In the very southern part of the trench, however, a modern concrete wall was seen crossing the trench, enclosing an area of much deeper services to its south. Truncation by services south of the wall went deeper than the base of the trench at 2.83m OD.

Plate 6 ST1, deep truncation in the southernmost part of the trench. Looking north

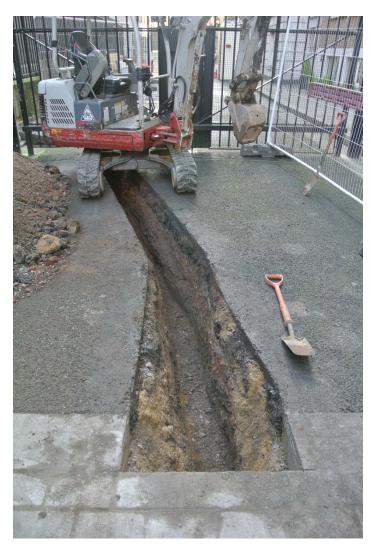
4.4.1 A deposit [10] of mid to dark brown grey silty sand was seen from the base of the trench to a height of c 3.18m OD in the southern part of the trench and c 3.10m OD in the northern part of the trench. The deposit containing occasional to moderate flecks and fragments of white grey mortar and occasional flecks and fragments of red and brown ceramic building material (cbm), as well as very occasional half

- bricks of the same material. No finds were retrieved from the deposit. The deposit was also seen in ST1, where it was contexted as [9].
- 4.4.2 Above deposit [10] in the southern part of the trench, Type 1 concrete, 0.34m thick was seen, above which tarmac, 0.23m thick, formed the road surface. In the northern part of the trench, concrete 0.60m thick was seen above deposit [10], below granite setts, 0.10m thick, which formed the road surface.
- 4.4.3 Several services were seen crossing the trench; some encased in concrete (see plate 7). These services were fairly shallow, none extending below the base of the trench.

Plate 7 ST2, partially excavated. Looking south

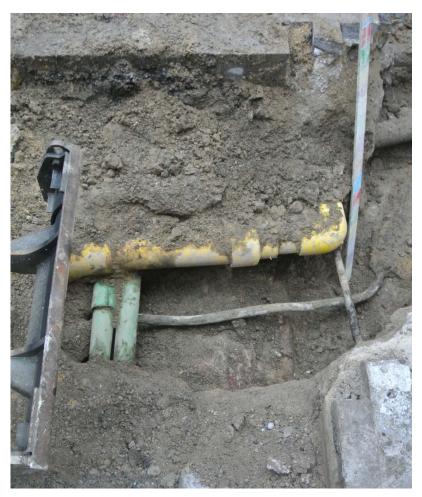
- 4.5.2 The northern half of the trench was dug as an extension in order to locate a connection point. The trench extension was dug to between 2.80m OD and 3.00m OD. In the base of the northern extension, a short length of an arched brick drain [11] was partially exposed, crossing the trench from west to east- parallel with Derby Gate (see plate 8). The drain or sewer could not be fully investigated as it was left in situ and was largely obscured by services, however likely dates from the 18th or 19th century. The drain or sewer was built of brownish, purplish red bricks and the top of the drain had been variedly truncated by modern services.

Plate 8 ST3, drain or sewer [11] partially exposed in the base of the trench. Looking east

No walls were identified during the watching brief, however, the truncated top of a likely 18th or 19th century arched brick drain or sewer [11] was exposed in trench ST3
