CRICKLEWOOD BUS GARAGE
329 Edgware Road
London
NW2

Archaeological evaluation report

November 2008

Site Code: CBJ07

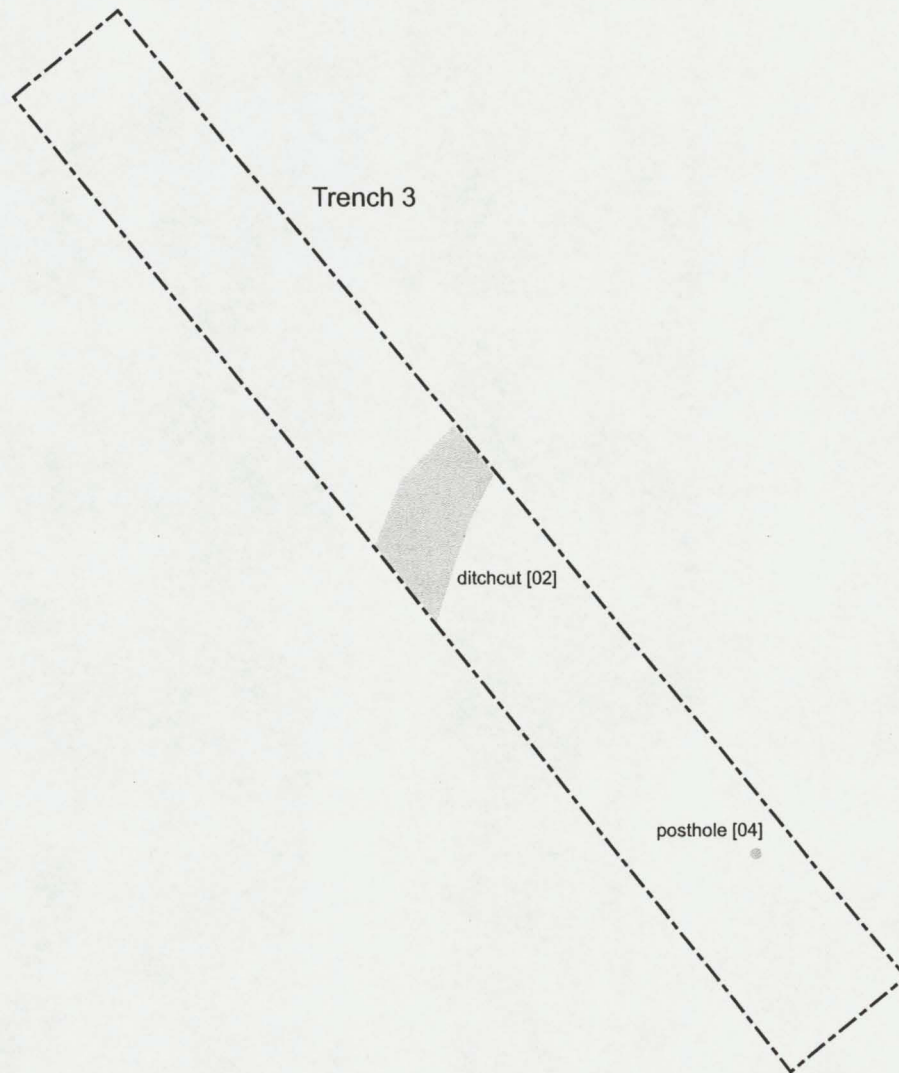
Fig 3 Archaeological features in Trench 3

<i>Evaluation Trench 3 (Fig 3)</i>	
Location	East central area of the site, slightly north east of trench 2
Dimensions	22.20m by 2.30m by 1.10m average depth
Modern ground level/top of slab	45.49- 45.61m OD
Base of modern fill/slab	44.66m OD (south) N/A (north, where truncated by modern intrusion)
Depth of archaeological deposits seen	0.97m deep
Level of base of deposits observed and/or base of trench	43.69m OD
Natural observed	44.66m OD

Natural clay [5] was recorded approximately 0.90m (44.66m OD) below the modern ground surface in Trench 3. The north end of the trench was further truncated by large deep modern truncation and natural deposits were not reached in that part of the trench.

A substantial, flat bottomed NNE-SSW running ditch [2] was recorded running across the trench at a top height of 44.66m OD. The ditch was 1.50m wide and 0.97m deep and its clayey fill [1] contained pottery of Roman date, AD50-400 (see Appendix I). The fill also contained occasional flecks of charcoal and was subsequently sampled. Another cut feature, a shallow posthole [4], was recorded in the southern end of the trench. The cut measured 0.35m in diameter and 0.10m in depth and its fill [3] contained no diagnostic or datable material.

Both features were sealed by a layer of contaminated clay, which may represent colluvial deposits, although, as with Trench 2, due to discoloration from the contamination any attempt at an interpretation is, at best, tentative.

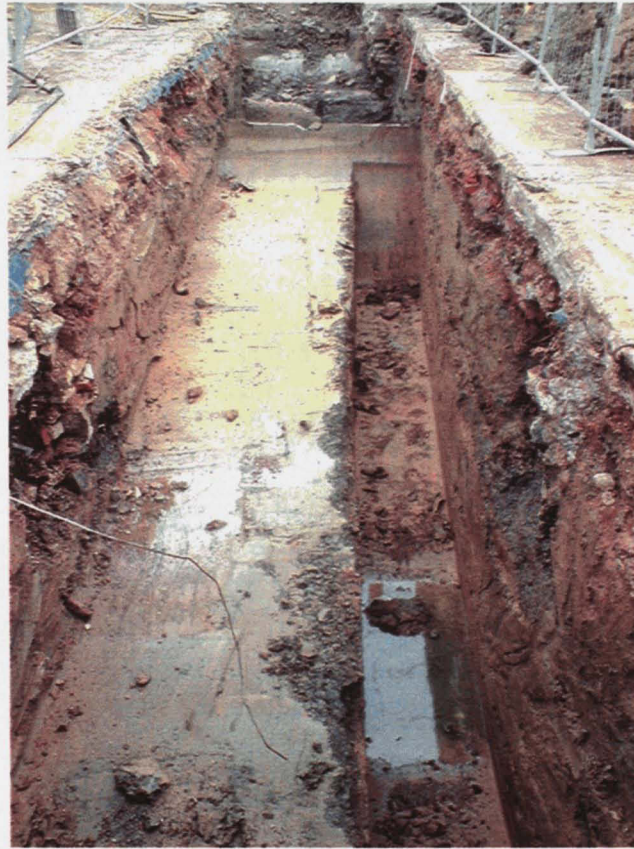
Fig 4 Trench 1, looking south

<i>Evaluation Trench 1; Figures 4 and 5</i>	
Location	South/central area of the site
Dimensions	21m by 2.0m by 3m depth
Modern ground level/top of slab	44m OD
Base of modern slab	43.80m OD
Depth of archaeological deposits seen	No archaeological deposits or features were observed
Level of base of deposits observed and	42.25m OD (modern construction debris truncation)
Natural observed	41.80m OD

To the east end of the trench, two metal fuel tanks were found buried 0.5m below slab level. These tanks occupied the first 4m of the trench's eastern end and were found leaking water mixed with diesel.

No archaeological deposits or features were encountered in Trench 1.

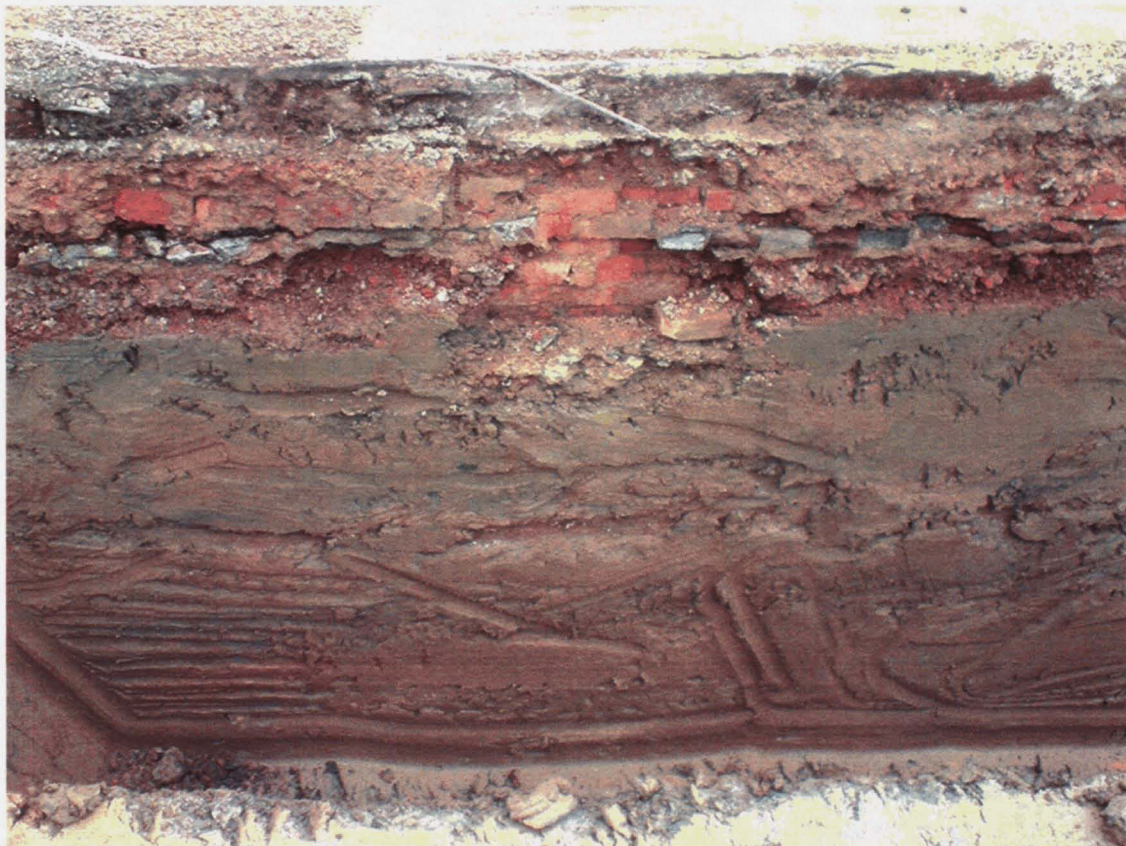
Fig 5 Trench 1, west-facing section

Above the clean natural clay, a light brownish-yellow in colour, was a substantially thick (1.4m) layer of contaminated dark brownish-yellow clay. This deposit, recorded at 43.20m OD was possibly natural subsoil, heavily contaminated by years of oil and diesel seeping to the ground, most likely leaking from the large metal tanks buried to the east.

The contaminated clay may represent colluvial deposits overlying the natural clay, but due to extensive staining caused by the contamination, this was inconclusive.

Overlying this clay was a layer of mixed concrete, brick and scrap steel rubble at 43.80m OD, with the remains of a possible clinker floor surface. This debris layer reached a depth of 1.75m below slab level, although its average depth of it was 0.7m.
