ST MARY MAGDALENE CHURCH
Paradise Road
London TW9

Watching Brief

**CHURCH OF ST MARY MAGDALENE
Paradise Road
Richmond upon Thames
London TW9**

Report on an archaeological watching brief

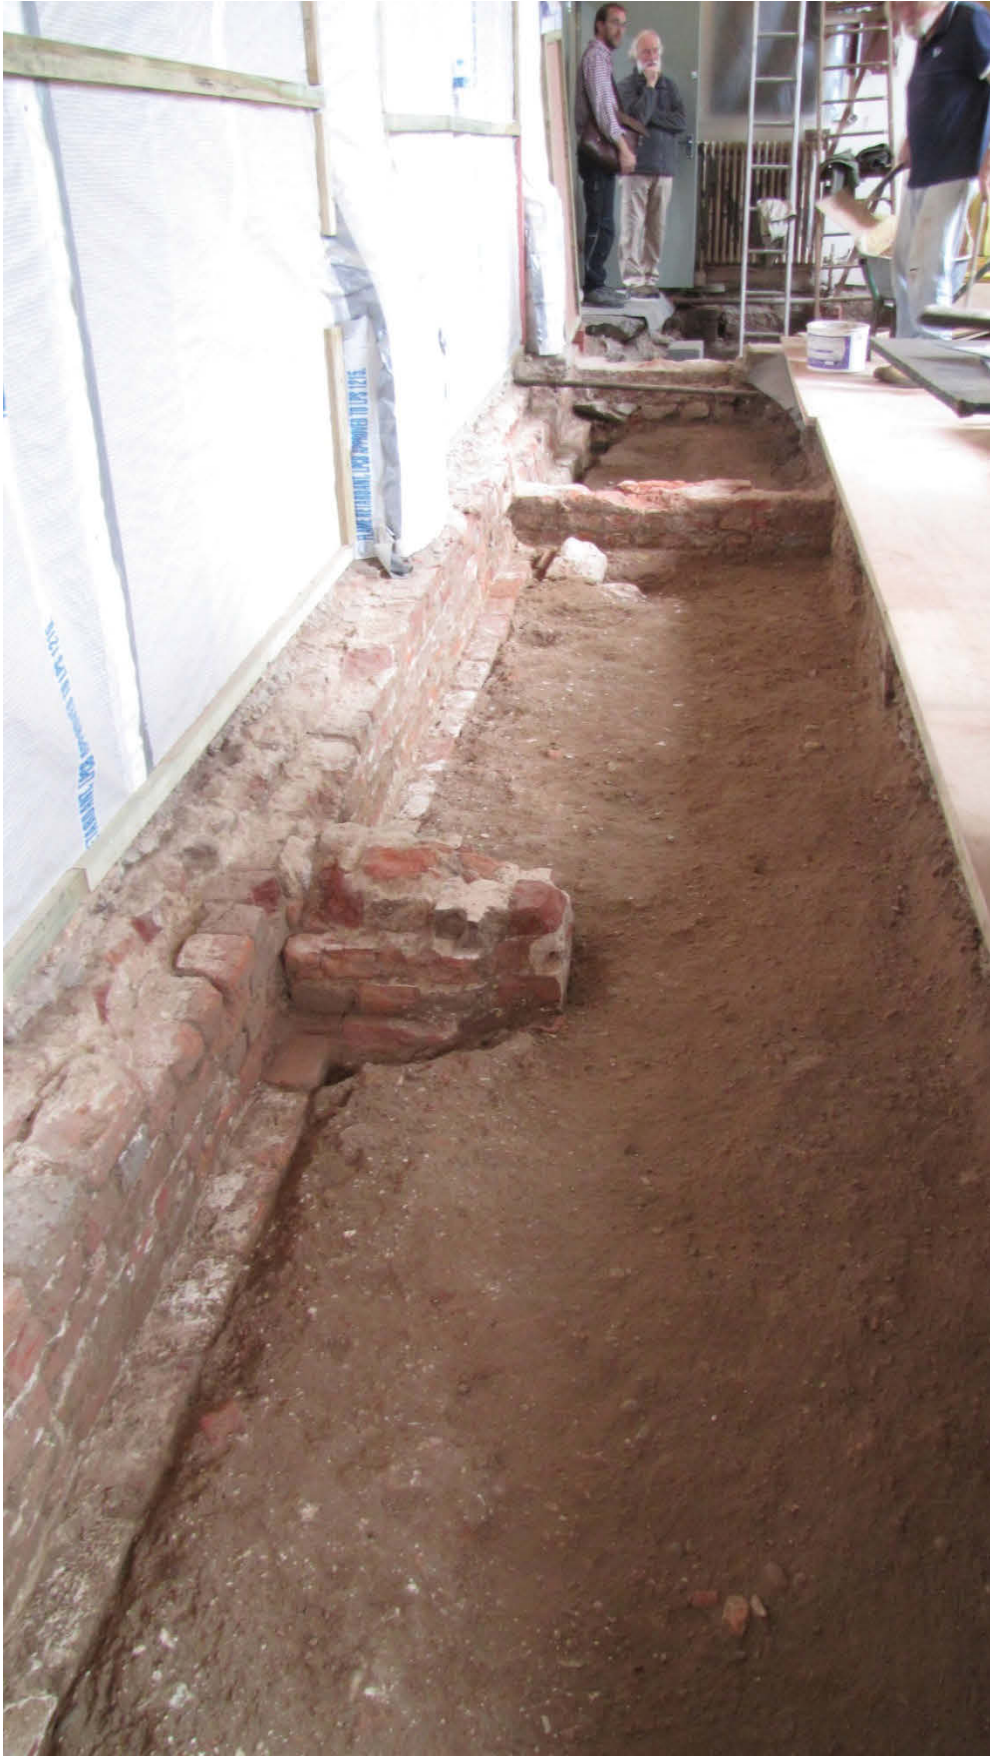
- 4.2.3 Stepped wall foundation [14] was probably one of the earliest structural features exposed (Photo 1). It currently supports the northern colonnade, but probably represents the truncated remains of the original north wall of the early-16th century church. It was made of orange-red to dark red bricks without frogs bonded with light greyish/buff mortar, but included at least one piece of roughly

Photo 1 Wall [14] with walls [16] and [18] looking west

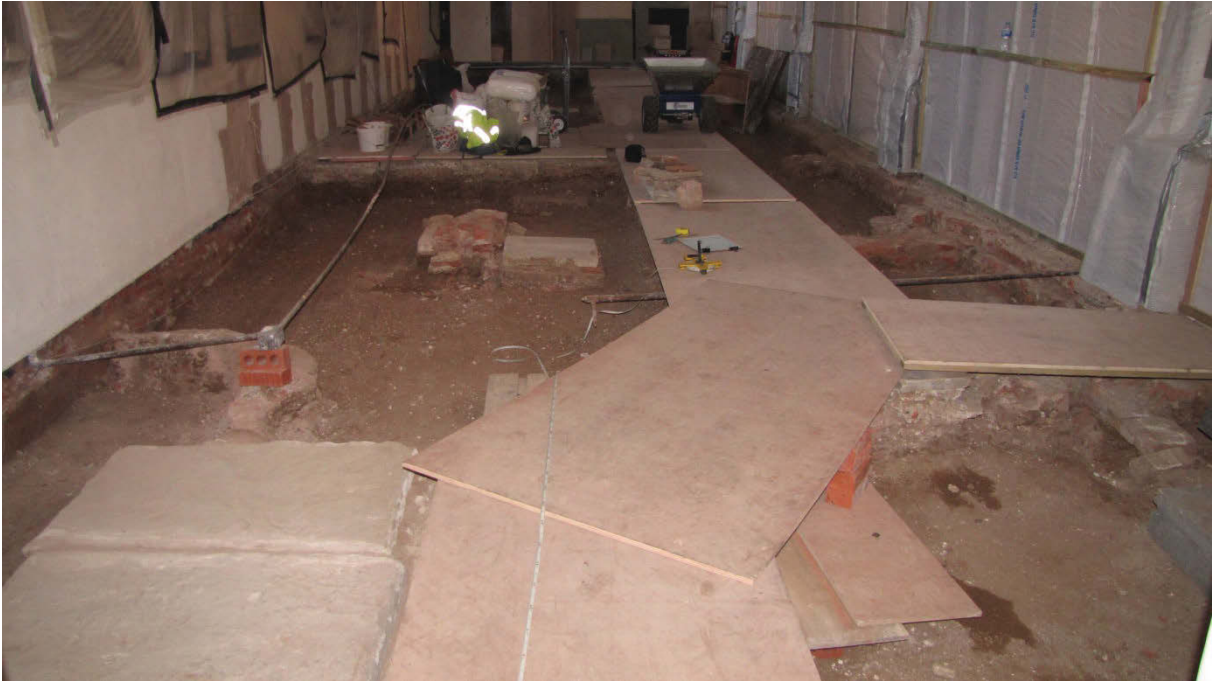
- 4.2.4 The truncated remains of two adjoining walls, [16] and [18], extended north from wall [14] (Photo 1 and Photo 2). They were made of similar red brick bonded and mortar. Wall [18] also included a fragment of Reigate stone. Wall [16] was aligned with a brick structure located to the north on an east–west alignment, [21]. They were constructed of similar materials. It is conjectured that these three structures might be remnants of a northern porch (Peter Bowyer pers comm), although their position is possibly a little too far to the west for this. The conjectured porch would have been about 3.75m square.

Photo 2 North aisle looking east showing walls [16], [18] and [21] in the middle distance

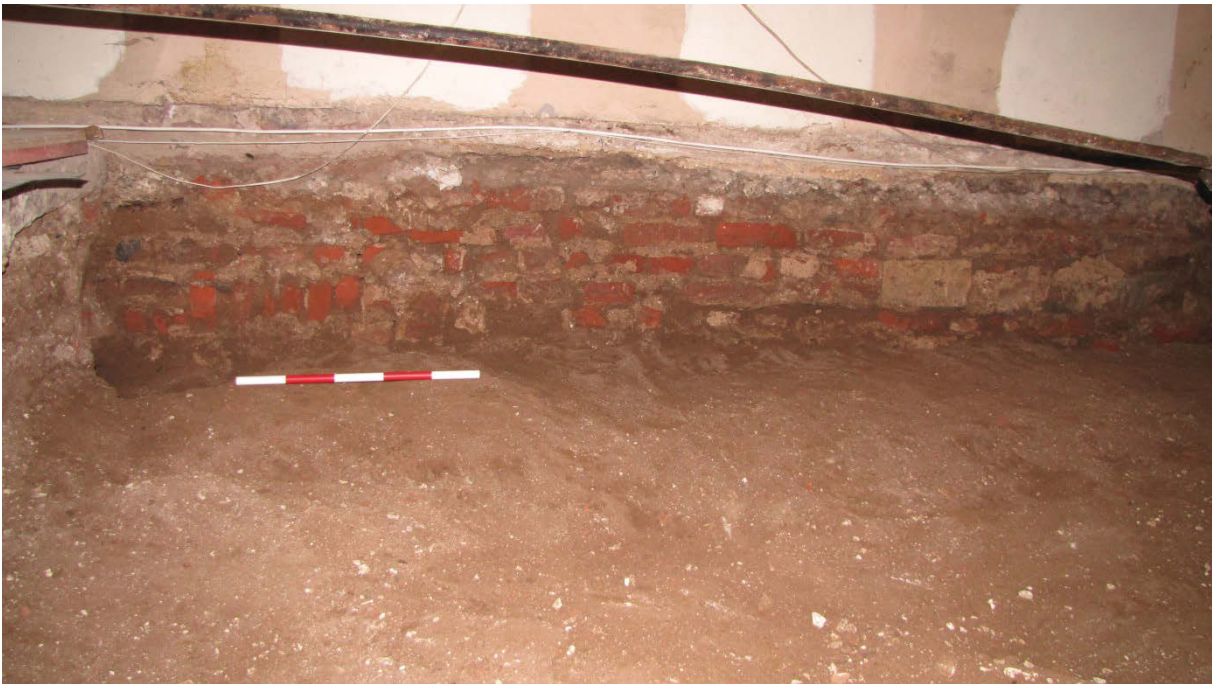
- 4.2.5 The ground reduction exposed masonry of the north wall of the church, [29], to a depth of 0.50m below floor level (the north elevation of this wall was recorded as context [1] in TPE1) (Photo 3). It was made mainly of red brick (B = 108mm, T= 58mm, L=220mm), but also included squared blocks of Reigate stone up to 0.56m across, built to courses and bonded with friable grey mortar flecked with lime. Its coursing was much less regular than that seen on the north face (context [1]) especially towards the east end of the north aisle. The nature of the masonry would accord with the proposed construction date of 1699.

Photo 3 Detail of wall [29] looking north

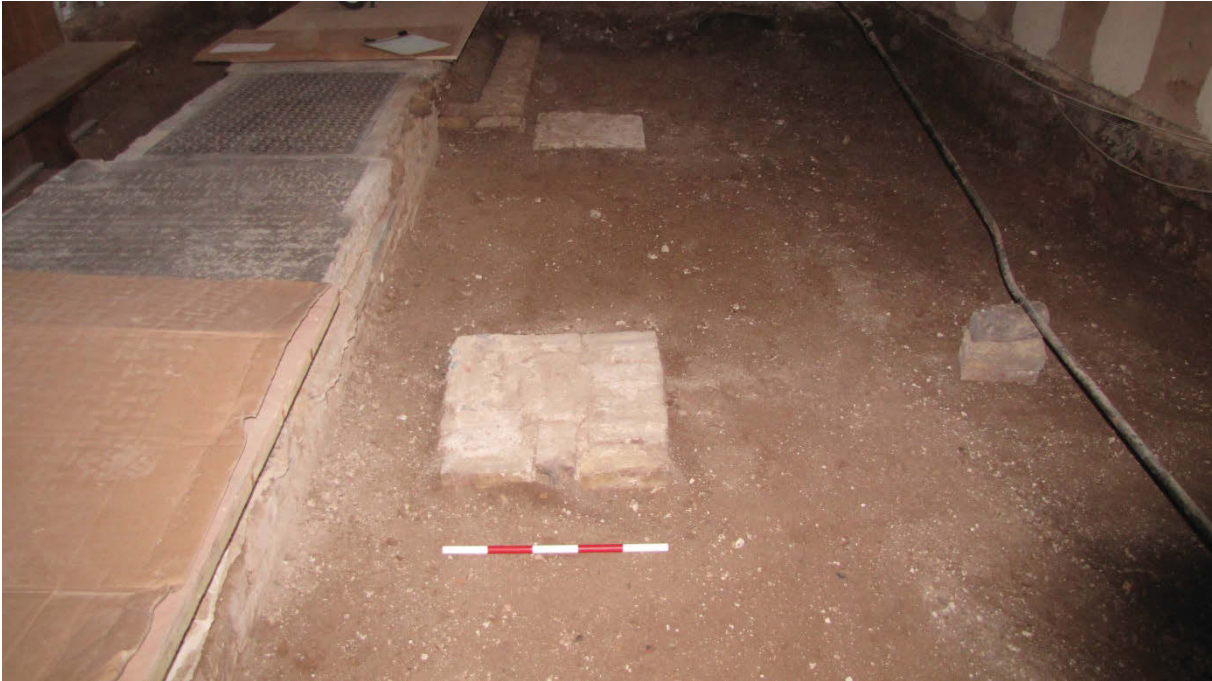
- 4.2.7 A row of four square bases, [22]–[25] (Photo 4), and one slightly larger roughly square robber/clearance pit on the same alignment, [36], lay approximately 2.0m south of the north wall of the church. The features mark the positions of five piers/columns that would have supported the northern gallery – built in 1864 and removed in 1904. The bases were made very dark red/purplish bricks with shallow frogs bonded with hard greyish brown mortar. Base [22] was capped by a roughly square stone, 75mm thick, and survived to a height of 10.10m OD. The others survived to heights of between 9.88 and 9.98m OD. The pit, [36], was filled with a mixture of loose brick rubble and silt [35].

Photo 4 North aisle, brick plinth [25] with plinth [24] in background, looking west

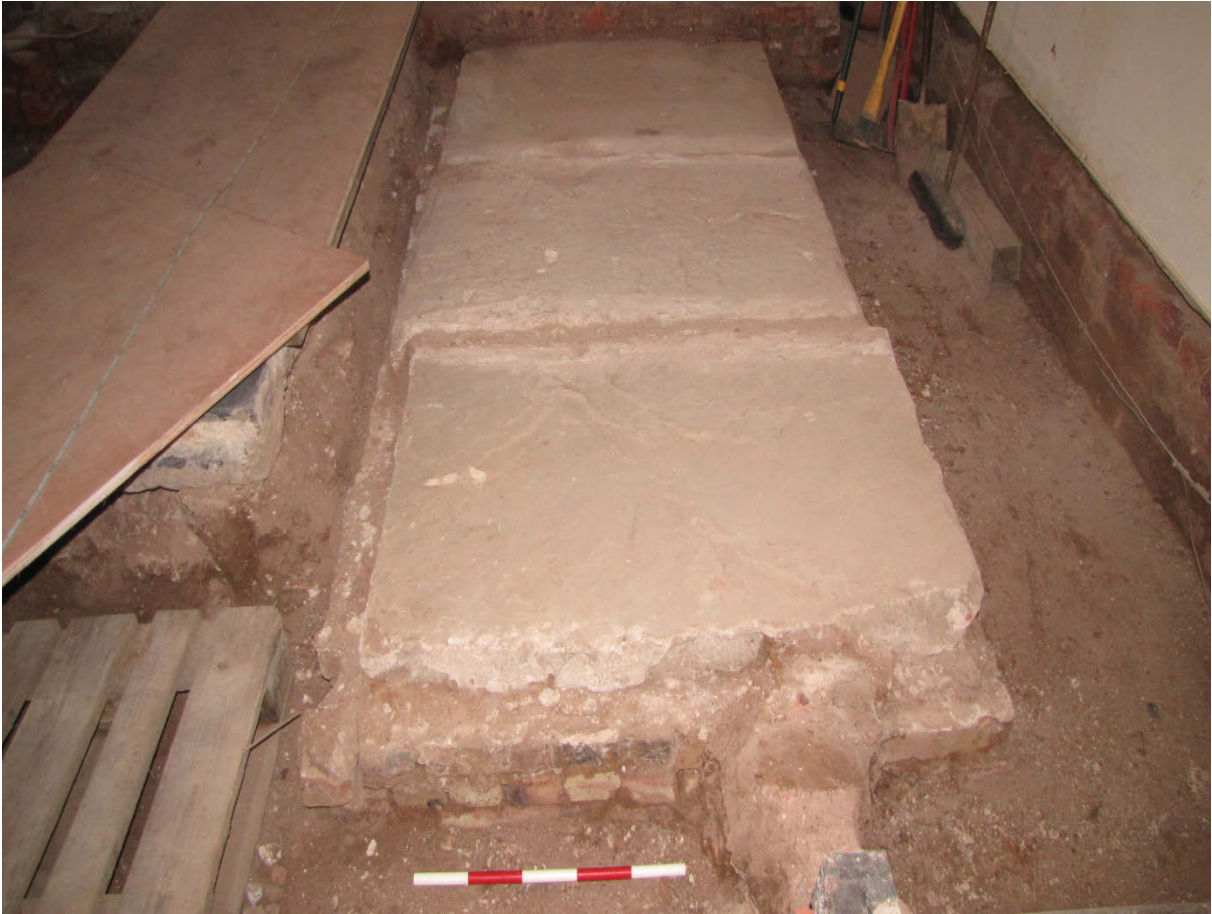
- 4.2.12 A burial vault, [20], was located near the north-west corner of the north aisle

Photo 6 North aisle, burial vault [20], looking west

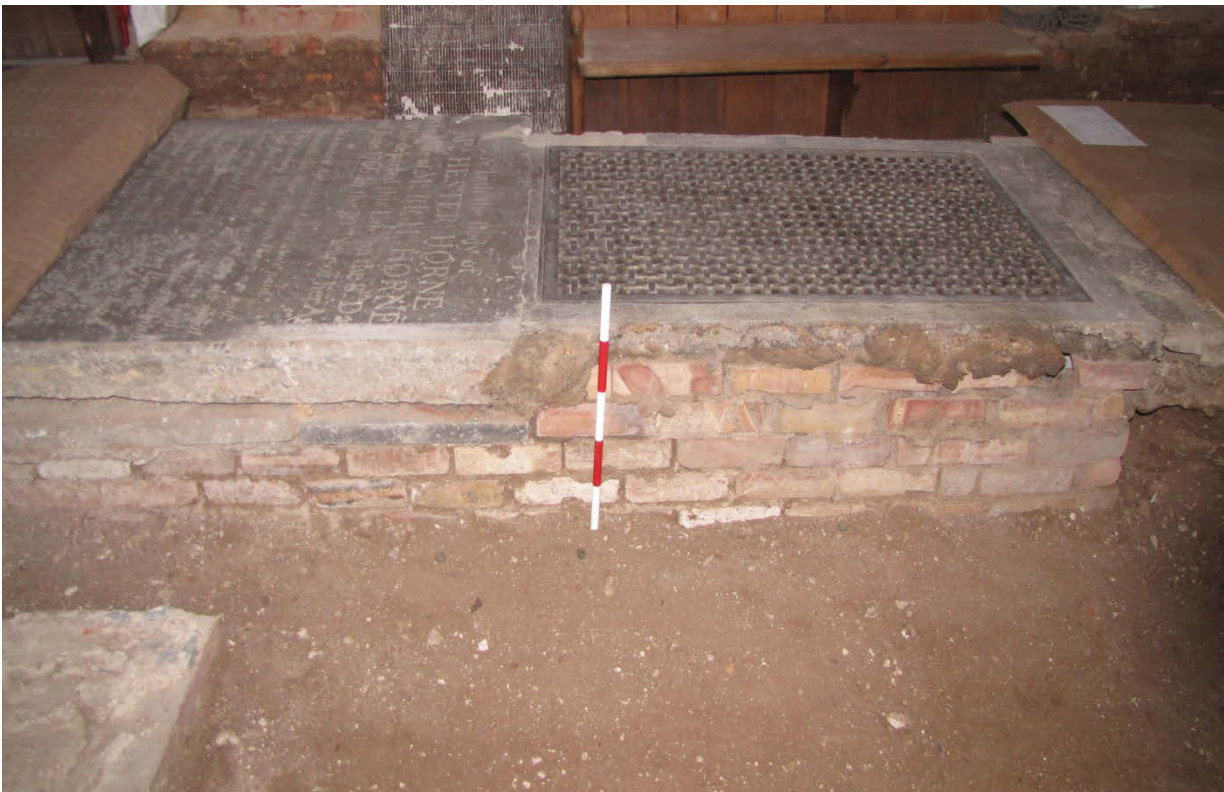
- 4.2.15 The trench built Edwardian underfloor heating duct, [30], was partially exposed in the eastern half of the aisle (Photo 7). Its walls were made of pink and yellow bricks bonded with hard greyish mortar. Its roof was made of ledger stones and stone slabs. Two rectangular iron grilles, 1.2m x 0.75m, were set in the roof. The floor of the duct lay at c. 9.50m OD. Assuming that the structure has a base about 0.30m thick the duct would have truncated deposits within its footprint down to approximately 9.20m OD.

Photo 7 North aisle, Edwardian heating duct [30] with metal grille, looking south

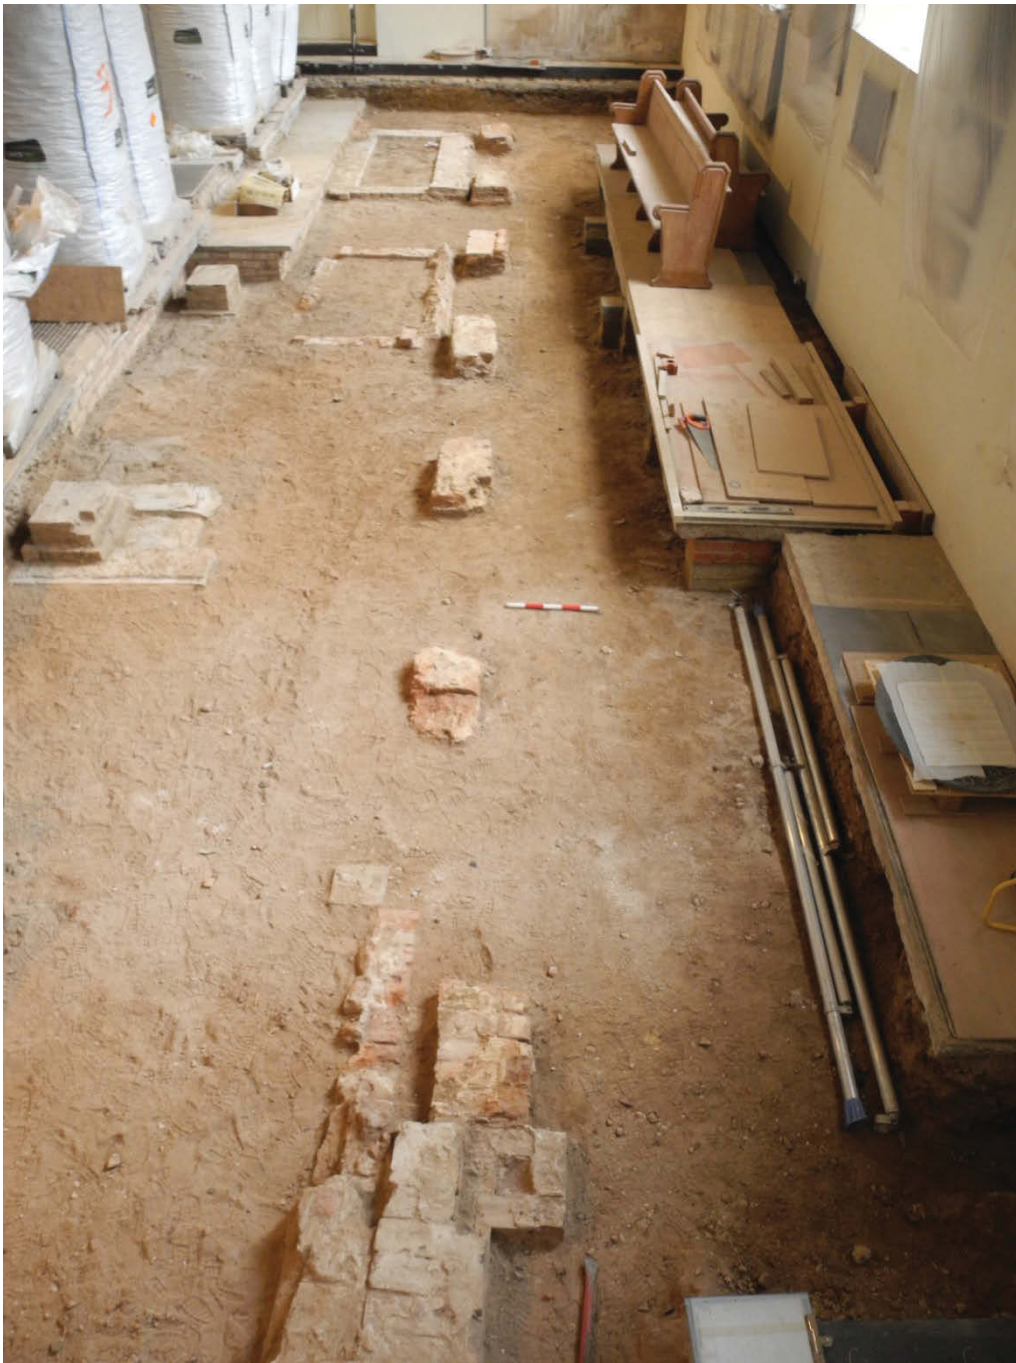
Photo 8 South aisle, vaults [46] and [47] with brick plinths [50] and [51], looking east

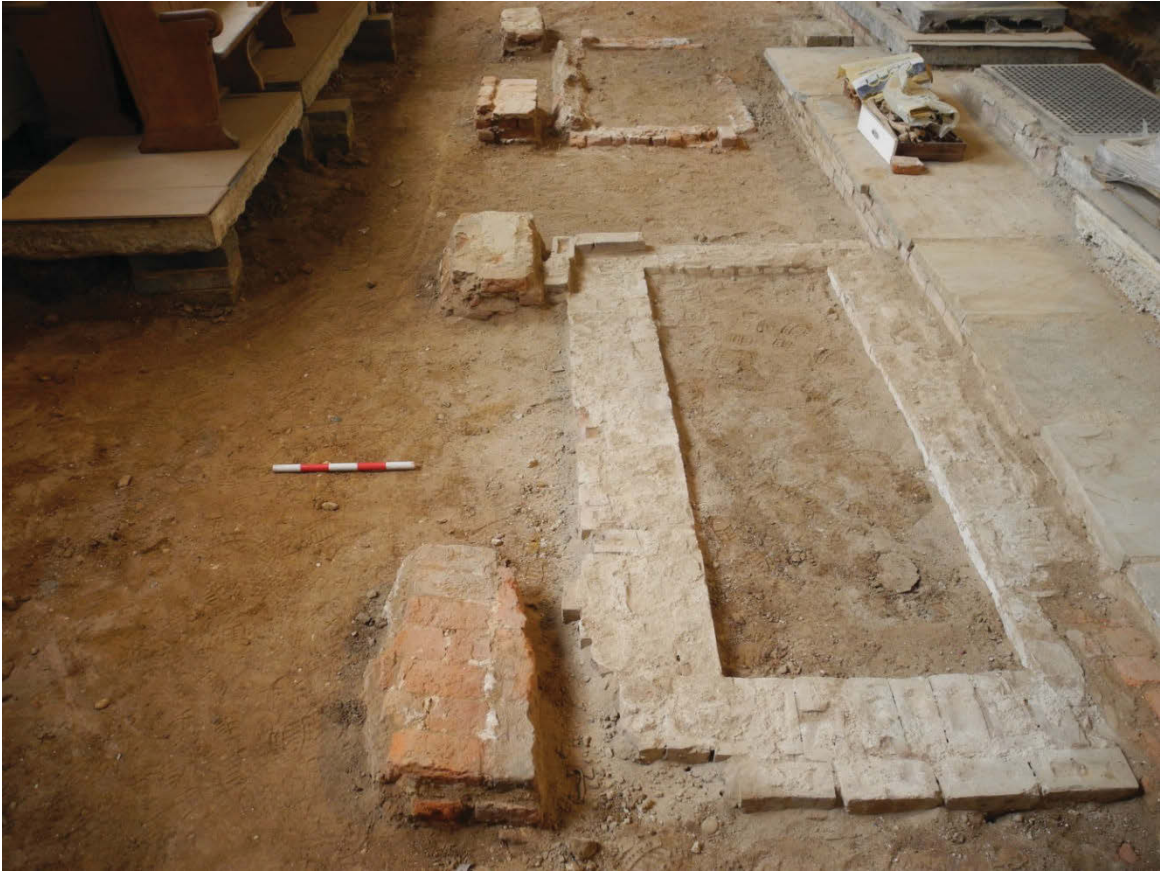
Photo 9 Vault [46] with row of brick plinths [51], looking west

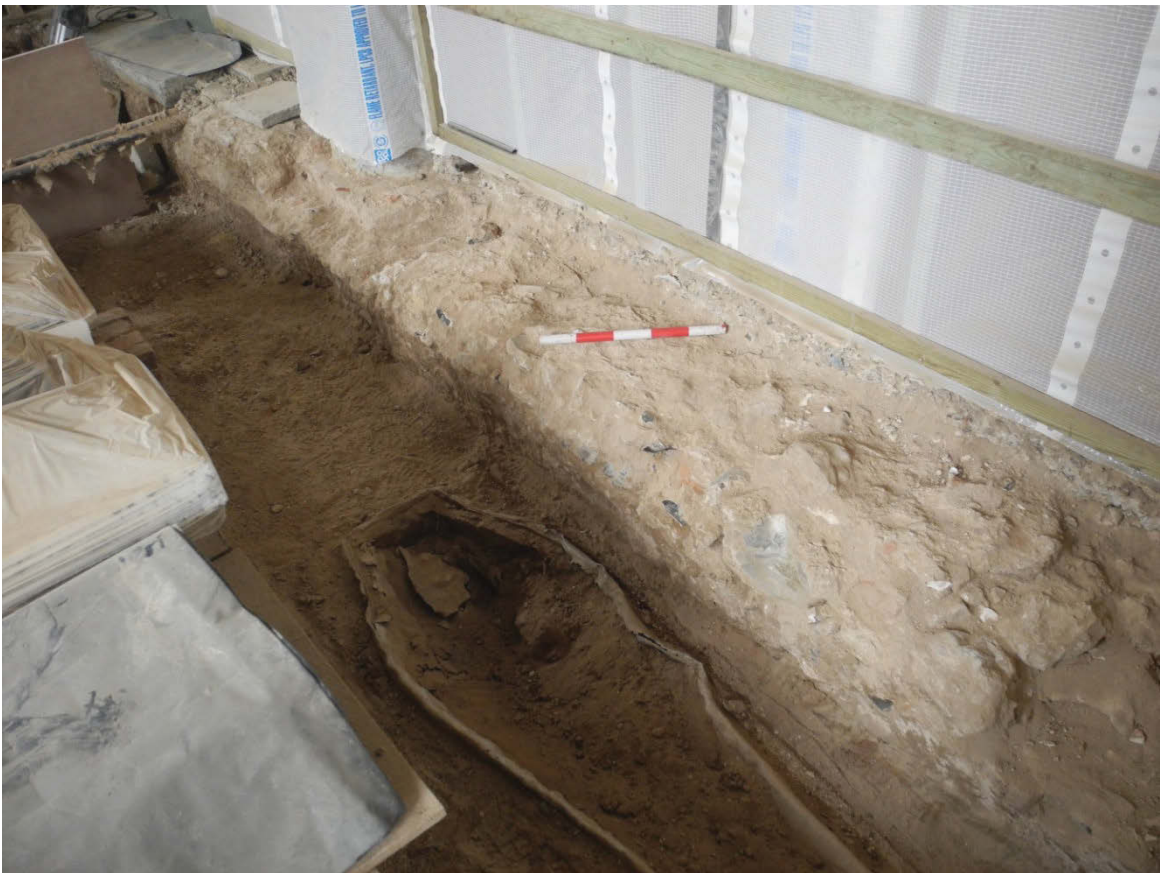
- 4.3.19 A lead coffin or shell [40], probably of 18th century date, was fully exposed at c 9.85m OD (Photo 10). This was laid east-west and was 2.06m long so presumably was for an adult. The lid was collapsing partially exposing an inner wooden coffin. No nameplate survived.
- 4.3.20 After the initial ground reduction in the south aisle, another lead coffin with a nameplate was found and is now commemorated with Guise Hall 1690–1761, carved in the new floor of the south aisle above its location (P Bowyer pers comm).

Photo 10 Mortared foundation [42] with lead shell [40], looking north-west

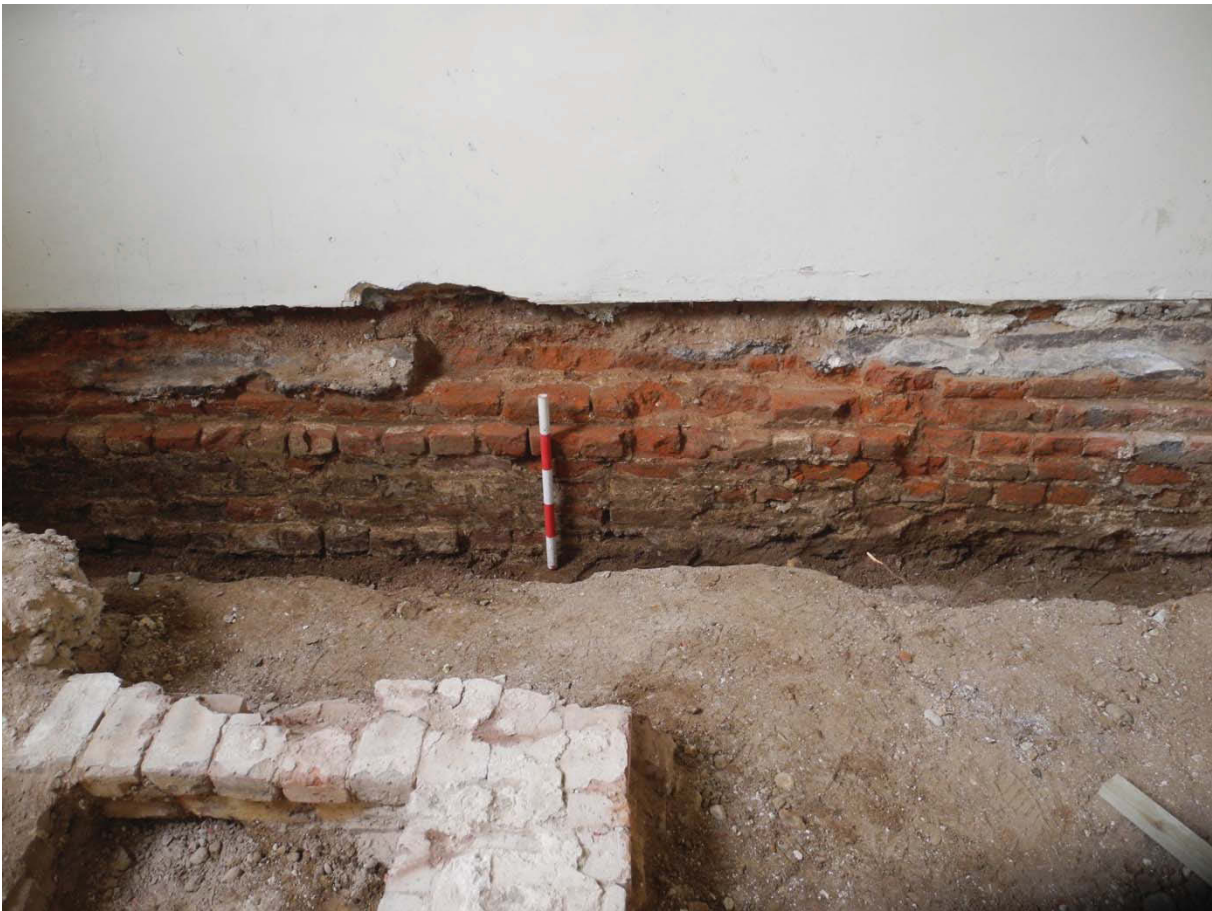
- 4.3.14 The south wall of the aisle, [56], runs east-west and is built of red bricks measuring 0.10m broad, 60mm thick and 0.22m long (Photo 11). The coursing is alternating courses of stretchers and headers and was built over foundation offsets with depth. This could be the 1617 build as the south aisle was rebuilt in 1750.

Photo 11 Detail of wall [56] looking south

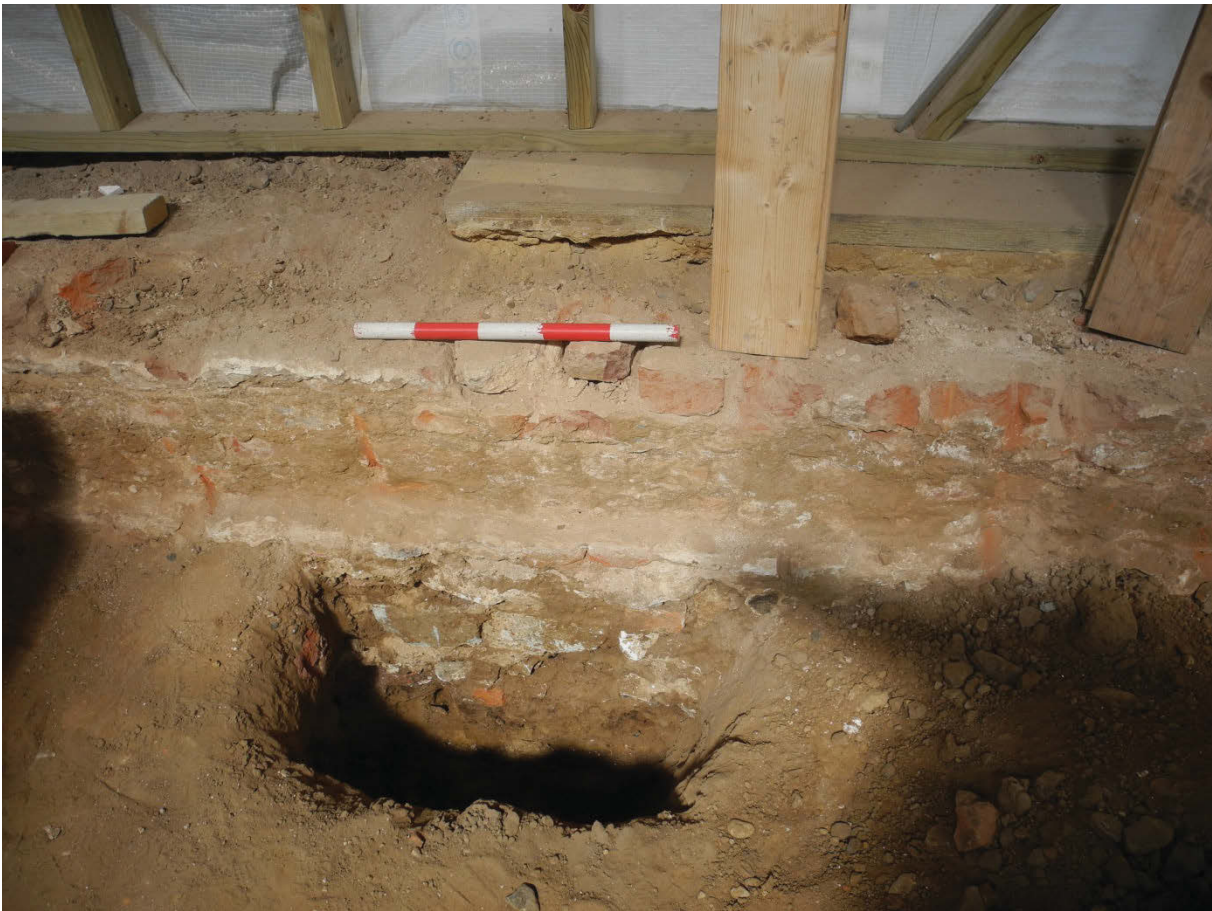
- 4.4.10 The south face of wall, [14], separating the nave and the northern aisle was exposed. This was brick built though a test pit near its east end showed that its southern face, at least, was founded on course stone rubble with occasional brick inclusions (Photo 12). It may be the original north wall of the early-16th century church.

Photo 12. Test pit exposing the southern phase of the footings to wall [14].

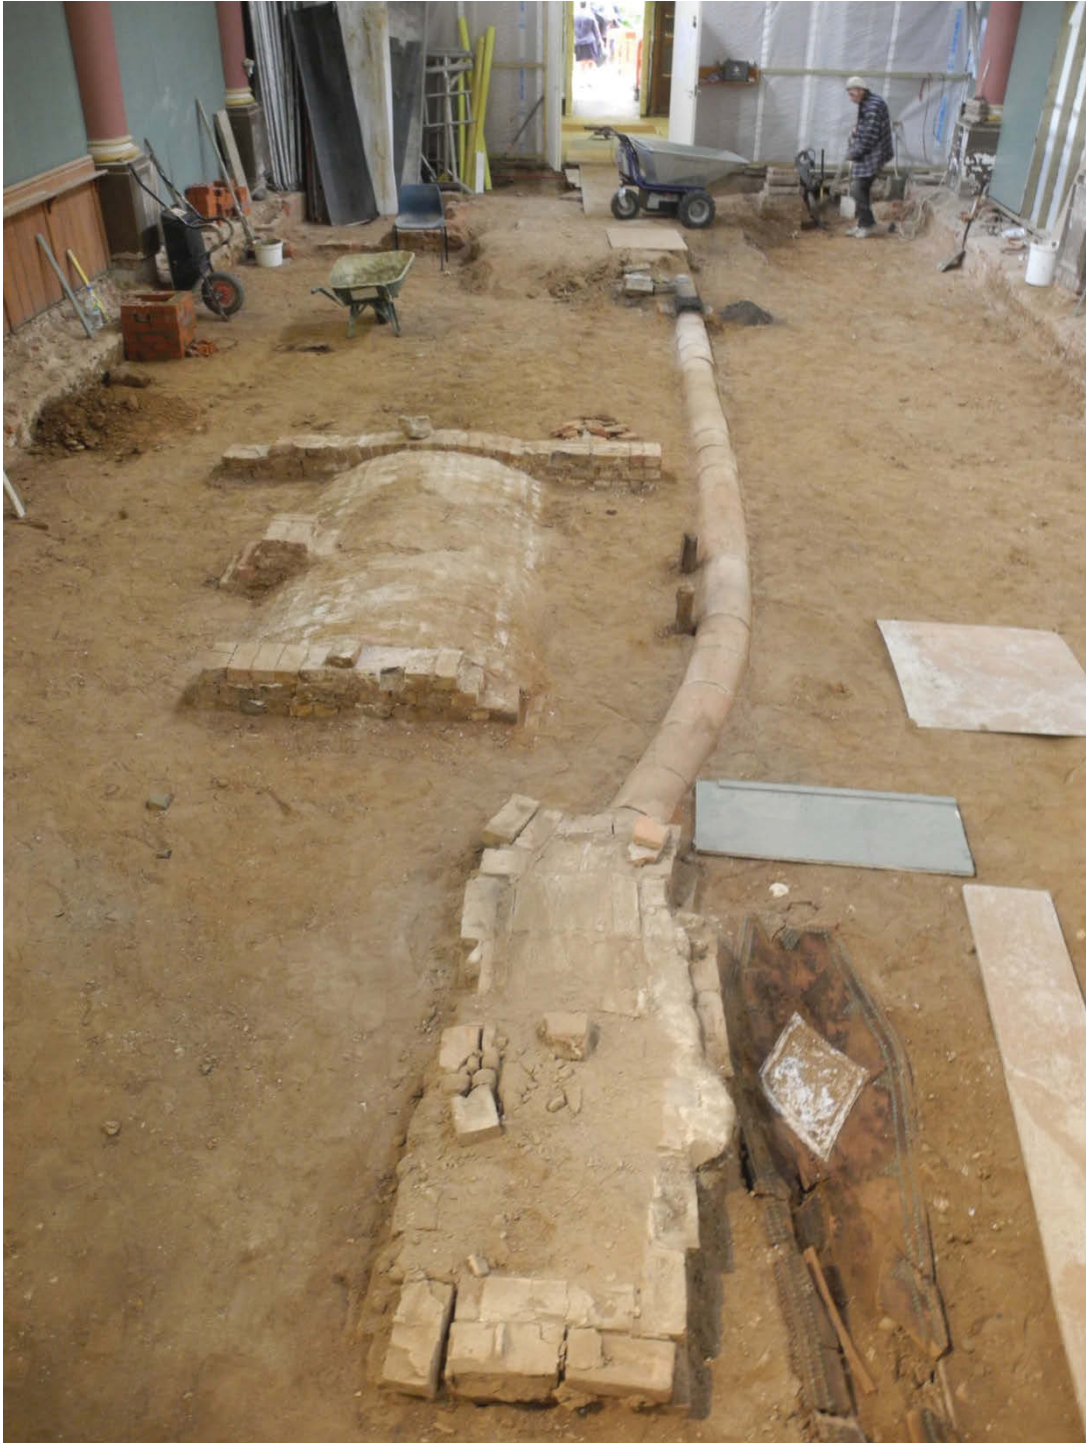
- 4.4.18 A circular flue pipe made of ridge tiles and a rectangular brick structure, [60], is part of a 19th century heating system (Photo 13). The flue included a small brick box with a metal hatch that allowed access to the flue. The larger brick structure at the east end the flue had a hole measuring 0.45m x 0.38m, presumably where fumes were sucked out from a stove positioned above it. The heating system probably connected with the flue found inserted in the west wall of the north aisle seen in TP3, and connected to the external chimney noted in a picture dated 1851 (Fig 9 MOLA 2015).

Photo 13 The nave with the flue of 19th century heating system [60], burial vault [61] and burial [58], looking west

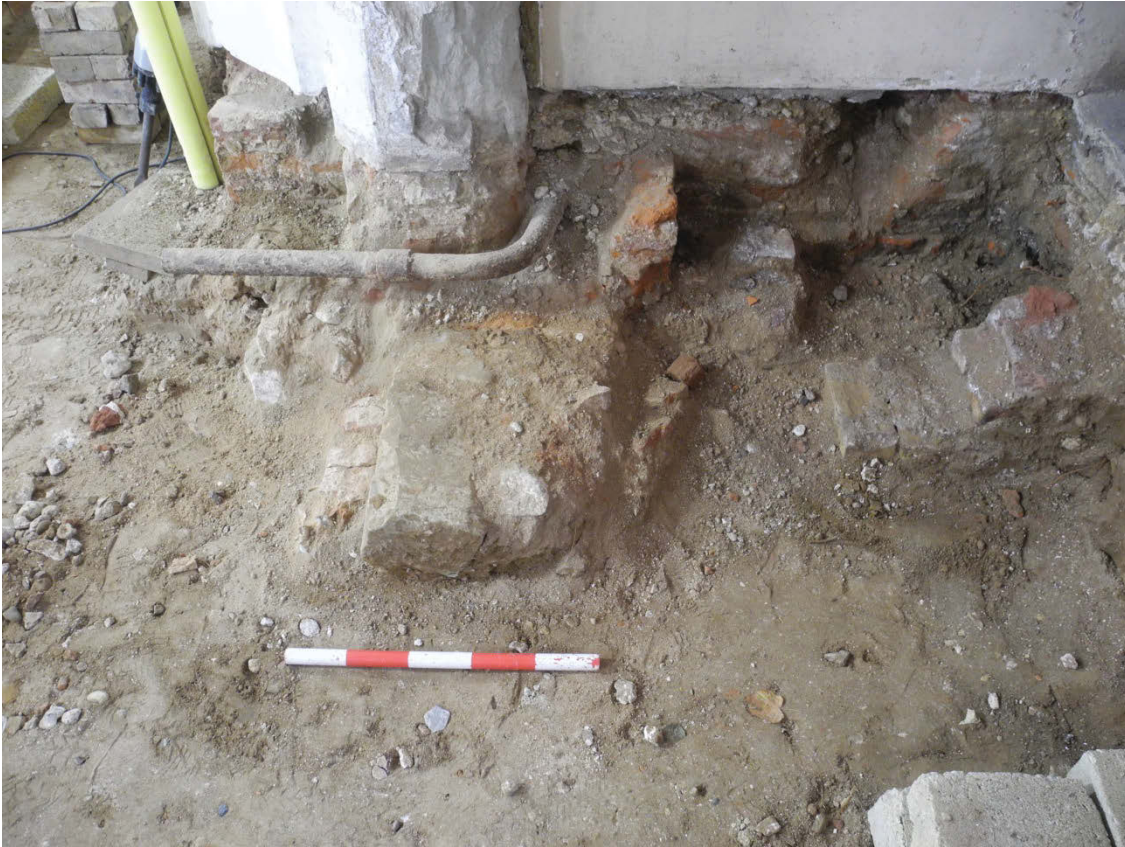
Photo 14 Walls [73 and [74] looking south

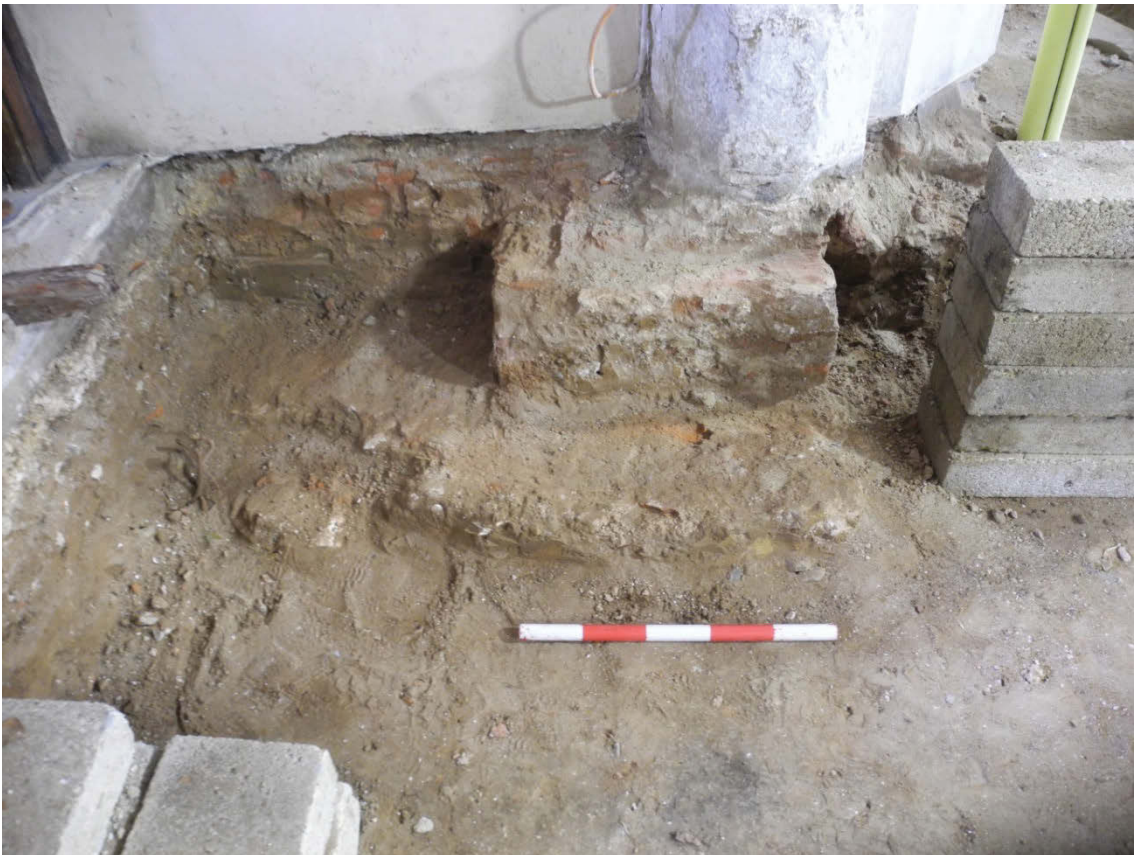
- 4.4.13 A brick plinth, [75], which the Tudor arch uses as a base, was built over an earlier brick and flint mortared surface, [76], which may be part of the entrance to the original, medieval, church (Photo 15).

Photo 15 Stone Tudor arch on brick plinth [75] and mortared foundation [76], looking north

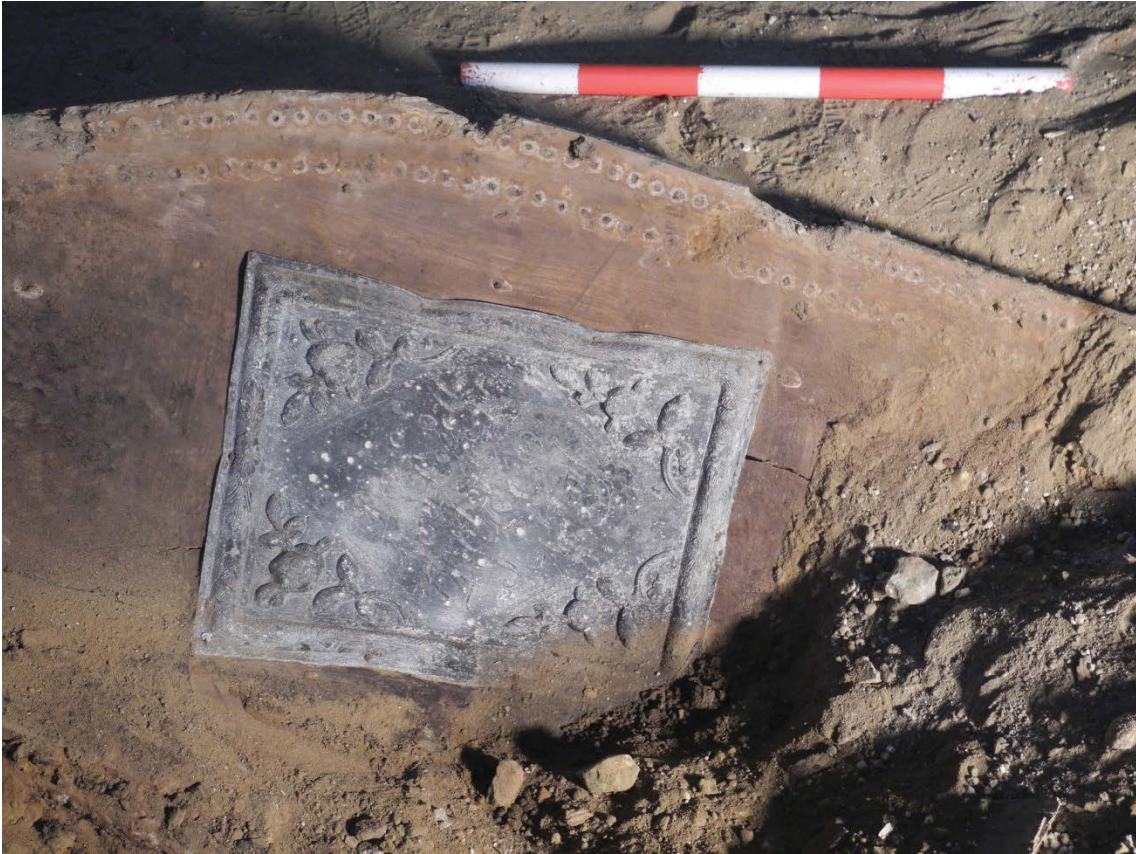
Photo 16 The Pechell name plate on coffin [63] looking north

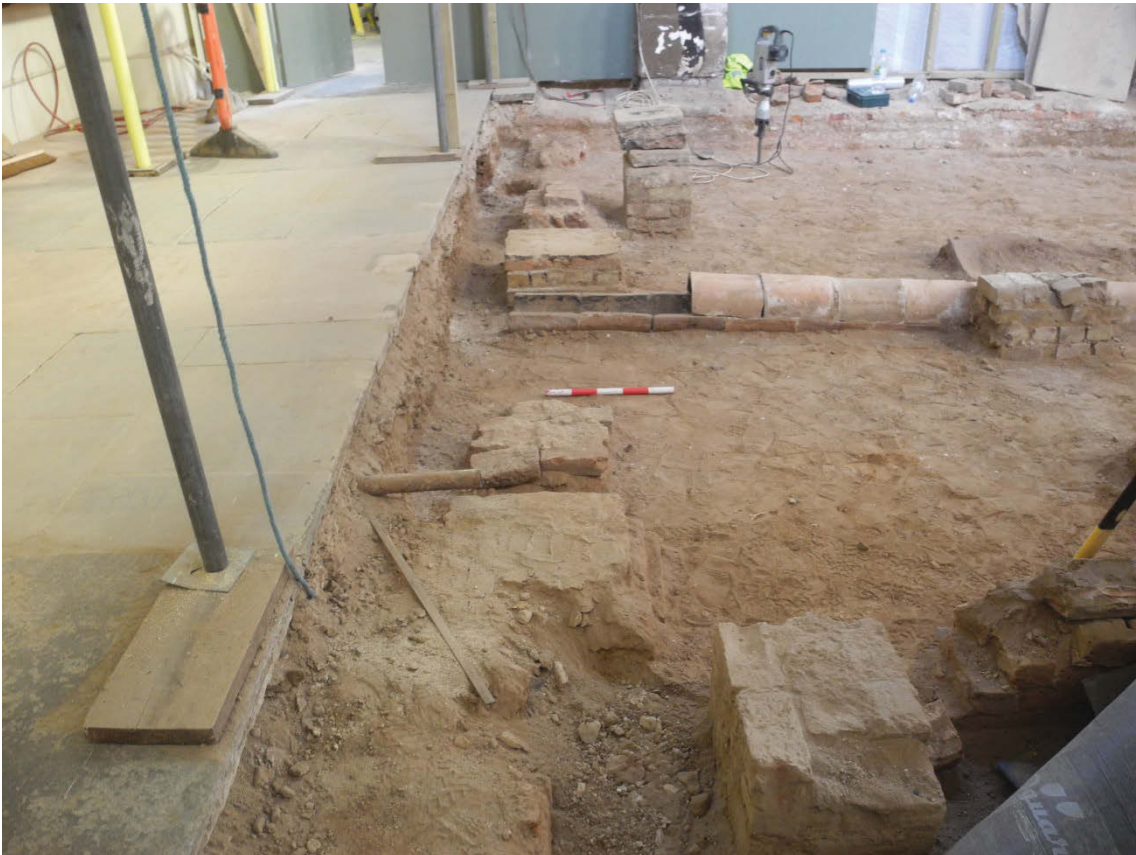
- 4.4.8 Two brick plinths, [64] and [65], were to support metal columns to hold up the western gallery built in 1750 (Photo 17). Plinth [64] was built into structure [62].
- 4.4.9 Two 19th century stepped brick plinths, [69] and [70], may also be supporting the western gallery, which was two tiered. Another stepped plinth, ([28]), found in the north aisle is also thought to be a support for this gallery.

Photo 17 Brick structures at the west end of the nave, looking north

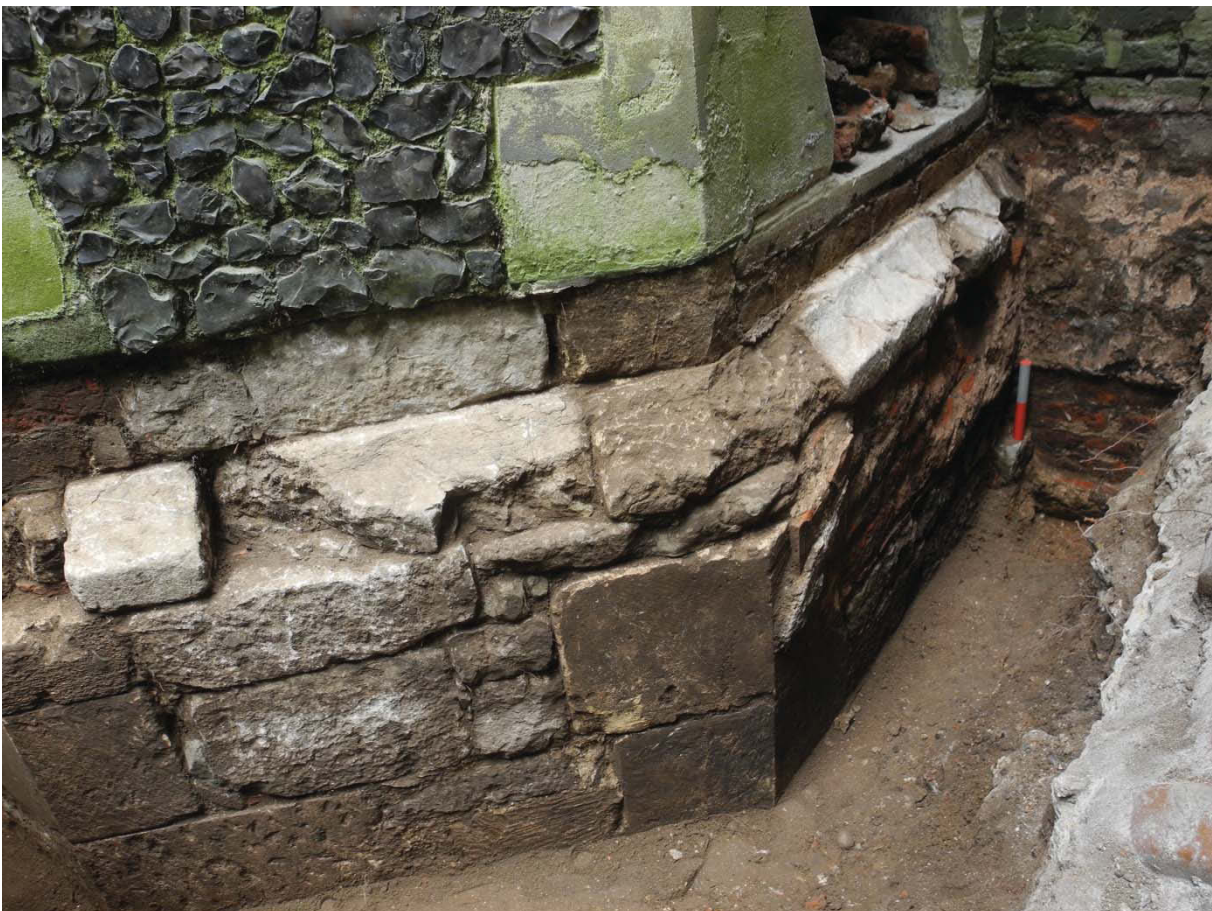
- 4.5.3 Below ground the original face of the Tudor was exposed, while above ground was the later knapped flint exterior of the church (Photo 18). The original face comprised mainly of faced ragstone blocks along with faced blocks of a fine grained yellow sandstone, possibly Reigate stone, used for the plinth and quoins.

- 4.5.4 A 17th century brick infill to a possible earlier doorway was noted in the south face of the turret. It was cut through by an external doorway that currently gives access to the stair turret. The original access was from inside the tower and is now blocked.

Photo 18 Face of original Tudor tower exposed with later knapped flint face, looking east

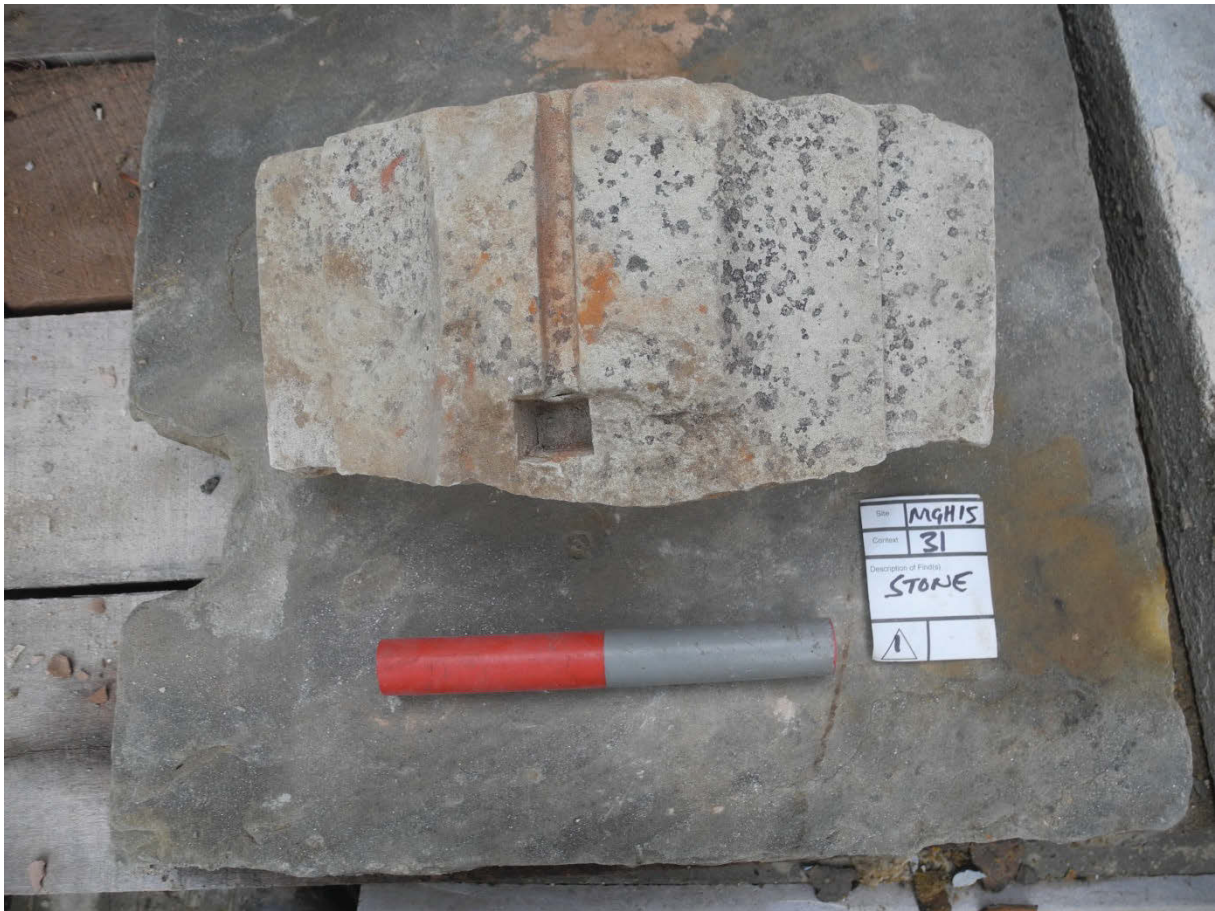
- 4.6.1 Although occasional fragments of pottery and coffin fittings were seen, no finds were retained. Several fragments of moulded stone were found; these were photographed and retained by the church.
- 4.6.2 Disarticulated human bone and coffin fittings/furniture were gathered up and later reburied in the respective areas they were found.

Photo 19 An example of moulded stone, possibly from window tracery of uncertain date
