GUILDHALL YARD AND SURROUNDING AREA: SECURITY London EC2V

Report on an archaeological watching brief

Site Code GUY17
NGR 532483 181395
OASIS reference molas1-342304

Report on a phase 2 archaeological watching brief

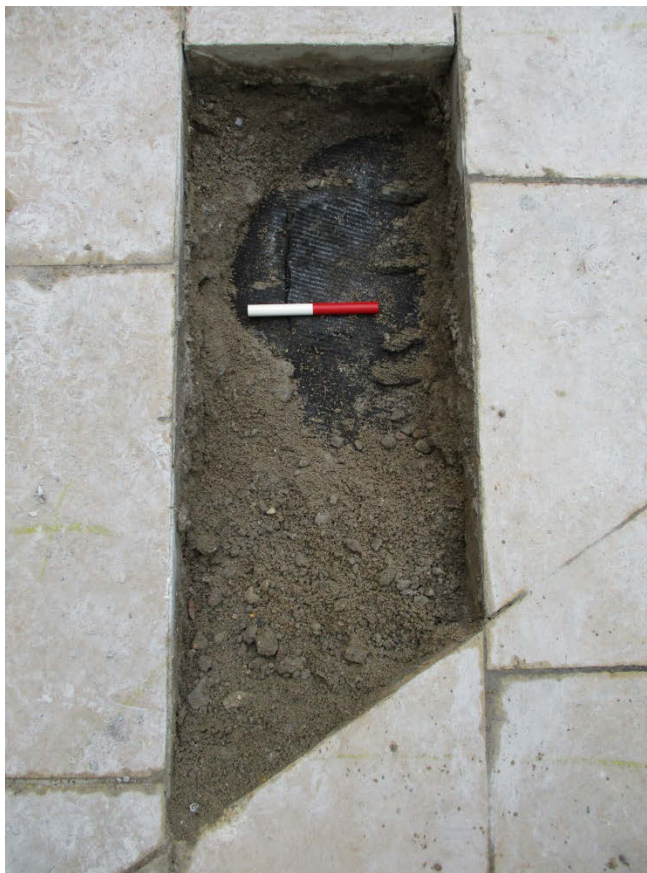
- 4.1.1 The paving slabs in the trench footprint were lifted to reveal a loosely compacted concrete bedding screed. This had been spread over a 25mm thick mesh and rubberised membrane laid across an underlying concrete raft. The paving slabs were 0.07m thick.

Test hole 1A looking north (0.2m scale)

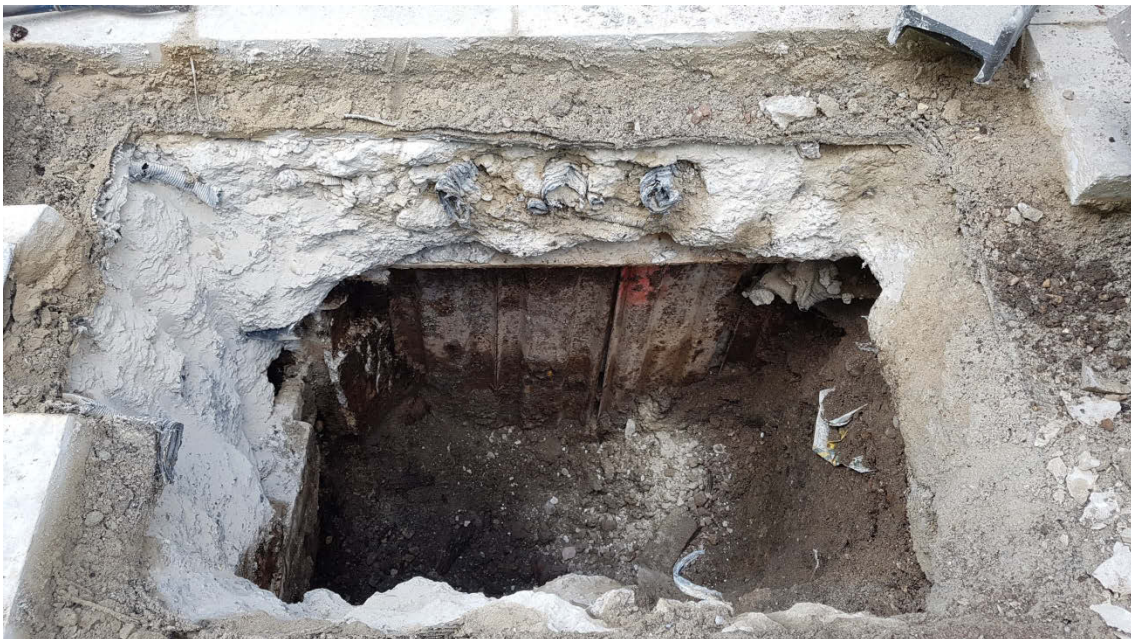
- 4.2.1 Trench 1B was located immediately outside of the north side of the original (GUD99) archaeological trench for the existing bollards. The rear face of the shoring for this trench (which looks to have been left in situ) was partially defined along the west and south side of the evaluation pit. This shoring consisted of sheet piles to the west, with vertical close boarding exposed at a lower level to the south.

- 4.2.2 All of the excavated material from the trench was composed of loosely compacted modern bulk backfill [6] which included what is likely to have been former archaeological deposits that had been disturbed and redeposited.

- 4.2.3 With reference to the sequence recorded in the earlier excavation, it is clear that this disturbed material constitutes the bulk backfilling of the construction cut for the deep level (N-S) 19th century sewer heading, that was recorded across the central portion of the GUD99 trench (*Fig 3*).

Trench 1B showing reverse of sheet piles at side of GUD99 excavation trench, with bulk backfill [6] in modern sewer construction trench in foreground (looking west)

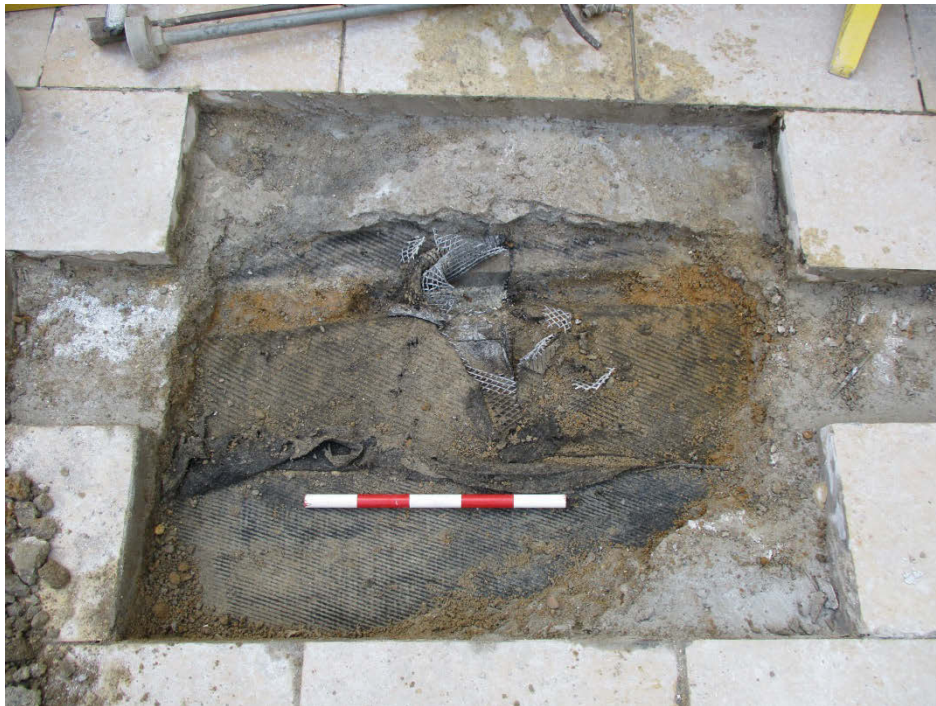
- 4.3.1 The paving slabs in the trench footprint were lifted to reveal a compacted concrete bedding screed. This had been spread over a 25mm thick mesh and rubberised membrane laid across an underlying concrete slab or raft. The pavement slabs were 0.07m thick.
- 4.3.2 In order to investigate the extent and depth of the concrete raft, the trench was extended to east and west and the concrete cored. The core showed the concrete to be 0.34m thick with Type 1 material defined below.
- 4.3.3 The paving slabs were 0.07m thick.

Test hole 1C prior to being extended looking east (0.5m scale)

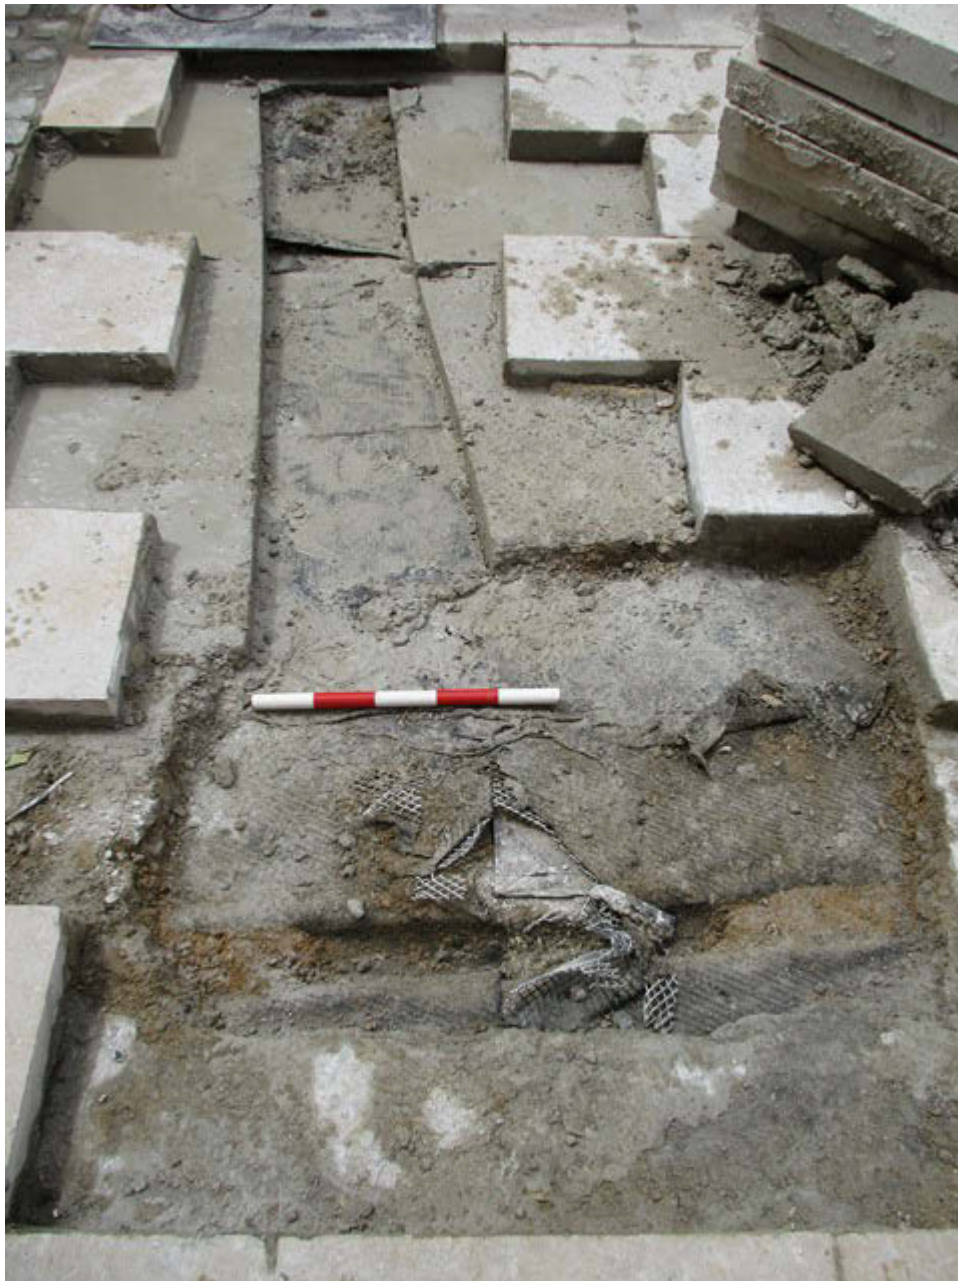
Test hole 1C after being extended looking west (0.5m scale)

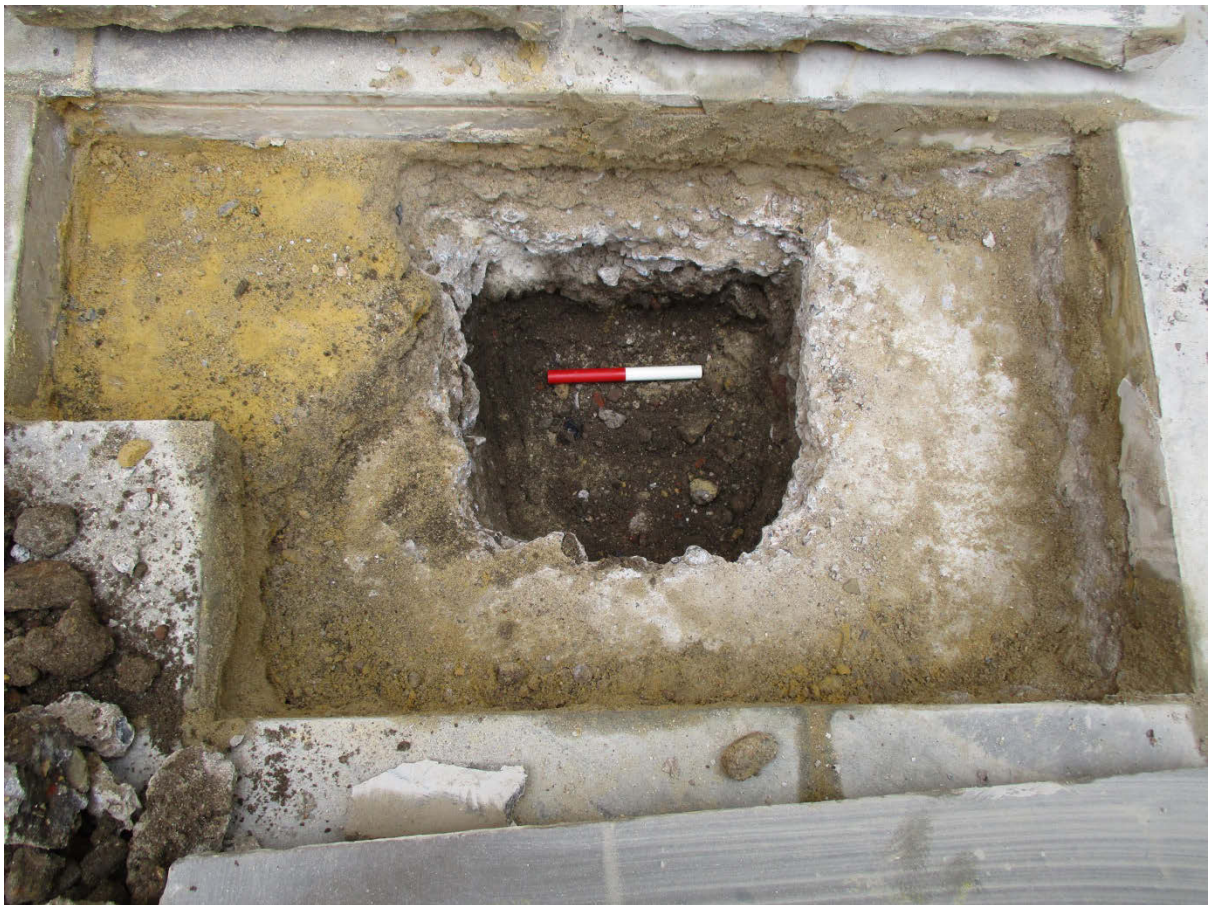
- 4.4.1 Pit 2A adjoining the south-west corner of St Lawrence Jewry church, was one of only two trial holes where soft deposits were exposed after a section of the overlying concrete slab had been broken out.
- 4.4.2 Seen at a depth of 0.28m–0.48m (14.99m OD –14.79m OD), the deposit was composed of loosely compacted light brown sandy silt with frequent gravel and small-medium fragments of red brick and tile [7]. Although it also contained small fragments of concrete, these may be derived from its disturbed surface, and the deposit could therefore be post medieval in date and constitute a fill or dumped make-up deposit.
- 4.4.3 Given the very limited view of this deposit, it could also represent archaeological deposits that have been previously disturbed and then redeposited.

Test hole 2A showing soft deposits [7] exposed beneath concrete slab looking east (0.2m scale)

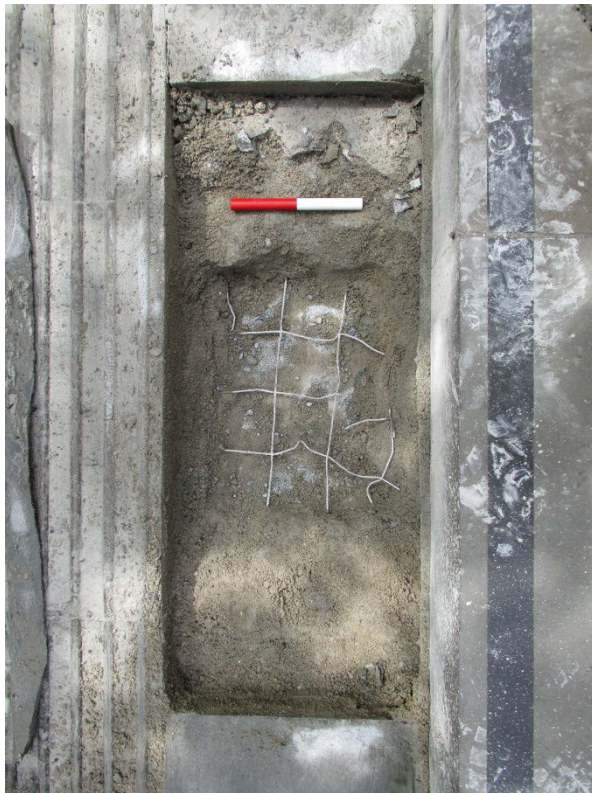
- 4.6.1 The paving slabs in the trench footprint were lifted to reveal a lightly reinforced (100mm thick) concrete bedding screed. The screed capped what appeared to be a more robust concrete slab or raft, which was exposed in a small hole in the base of the pit.
- 4.6.2 The paving slabs were 0.05m thick.

Test hole 6D looking south (0.2m scale)

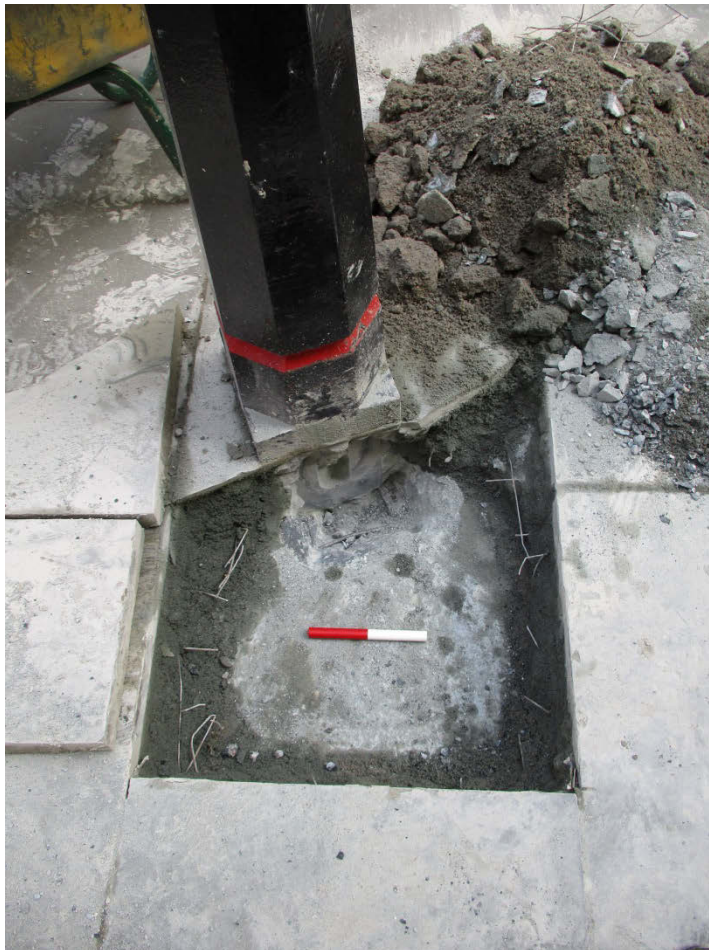
- 4.7.1 The paving slabs in the trench footprint were lifted to reveal a loosely compacted lightly reinforced (100mm thick) concrete bedding screed. The screed capped a much harder reinforced concrete slab, which was exposed in a small hole in the base of the pit adjoining an existing steel bollard.
- 4.7.2 The paving slabs were 0.06m thick.

Test hole 6E looking north (0.2m scale)

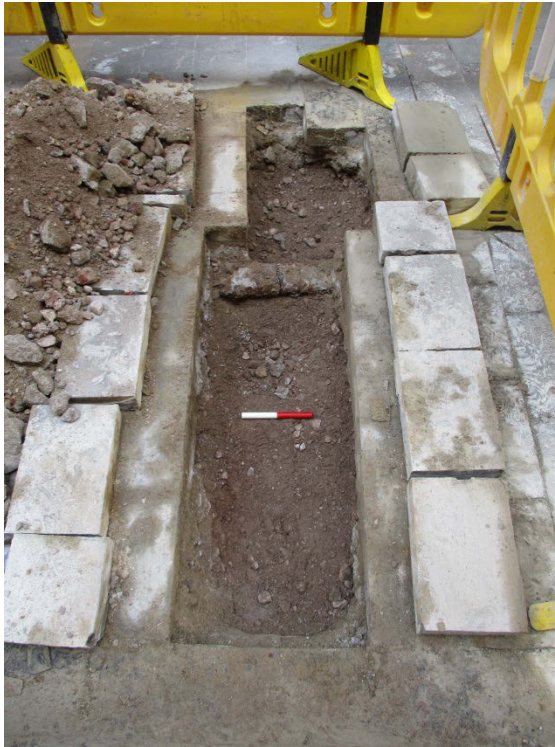
- 4.8.1 The paving slabs in the trench footprint were lifted to reveal a loosely compacted layer of fragmented brick and concrete rubble in a mixed silt matrix, which was clearly disturbed modern made ground over underlying utilities or service runs.
- 4.8.2 The paving slabs were 0.07m thick.

Test hole 8A looking west (0.2m scale)

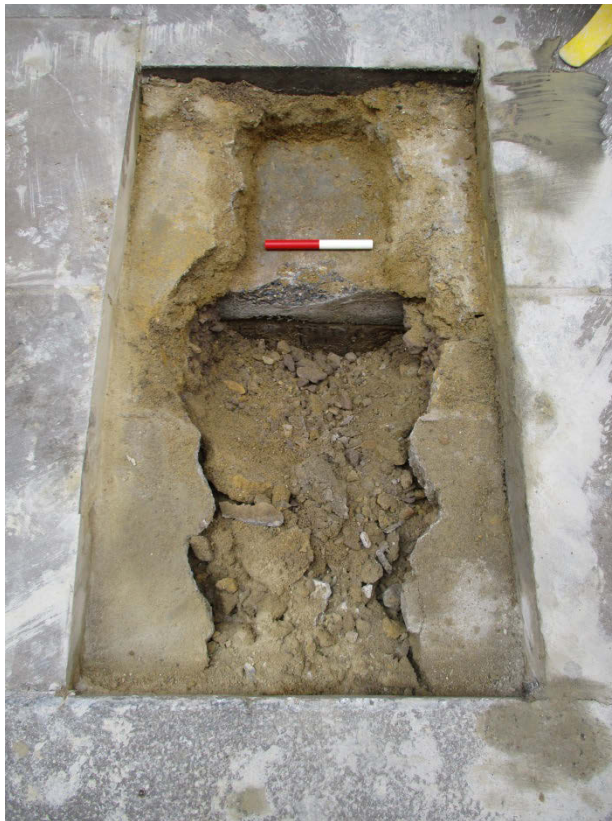
- 4.9.1 The paving slabs in the trench footprint were lifted and a section of the underlying concrete bedding screed removed, to reveal the surface and east face of the offset foundation of the adjoining 80 Basinghall Street basement. The external face of the footing had a waterproof tanking to its face.
- 4.9.2 Dumped against its external face, was a loosely compacted layer of fragmented brick and concrete rubble in a mixed sand and mortar matrix with frequent voids, representing the bulk backfill within the wider construction cut after the foundation had been constructed.
- 4.9.3 The paving slabs were 0.07m thick.

Test hole 9A looking west (0.2m scale)

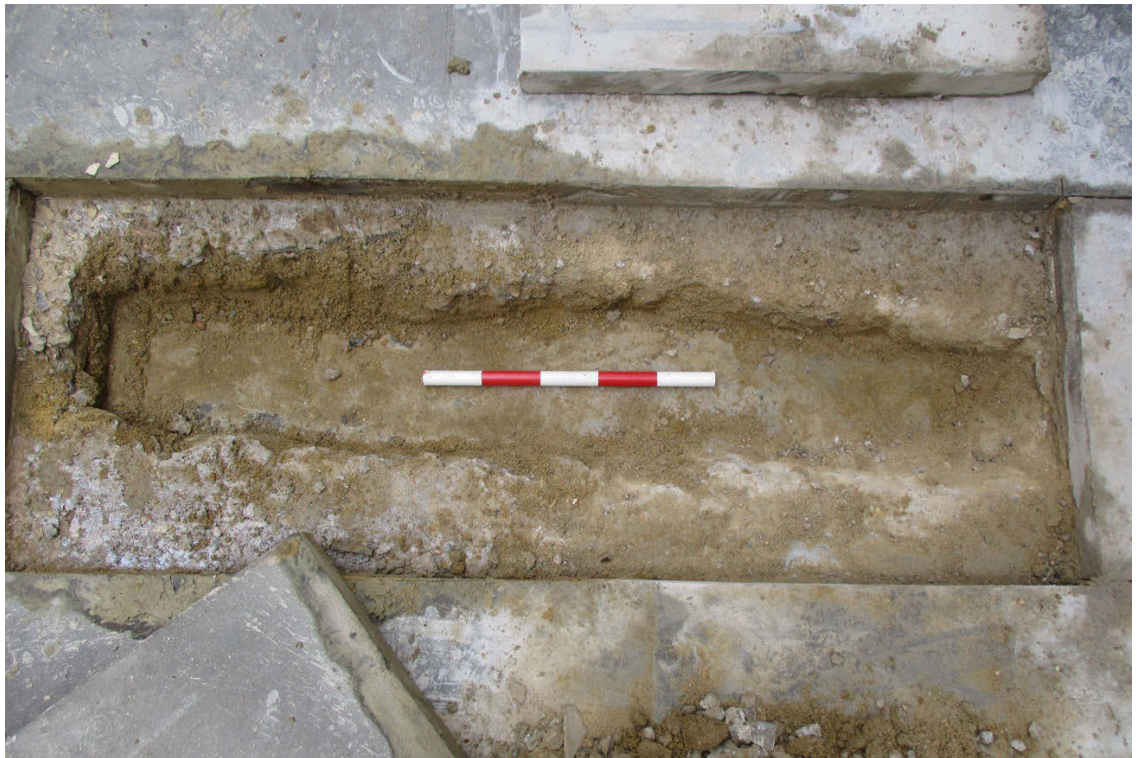
- 4.10.1 The paving slabs in the trench footprint were lifted to reveal a (100mm thick) concrete bedding screed. The screed capped a much harder concrete slab, whose surface was defined at a depth of 0.21m at c 13.90m OD.
- 4.10.2 The paving slabs were 0.07m thick.

Test hole 9B looking east (0.5m scale)

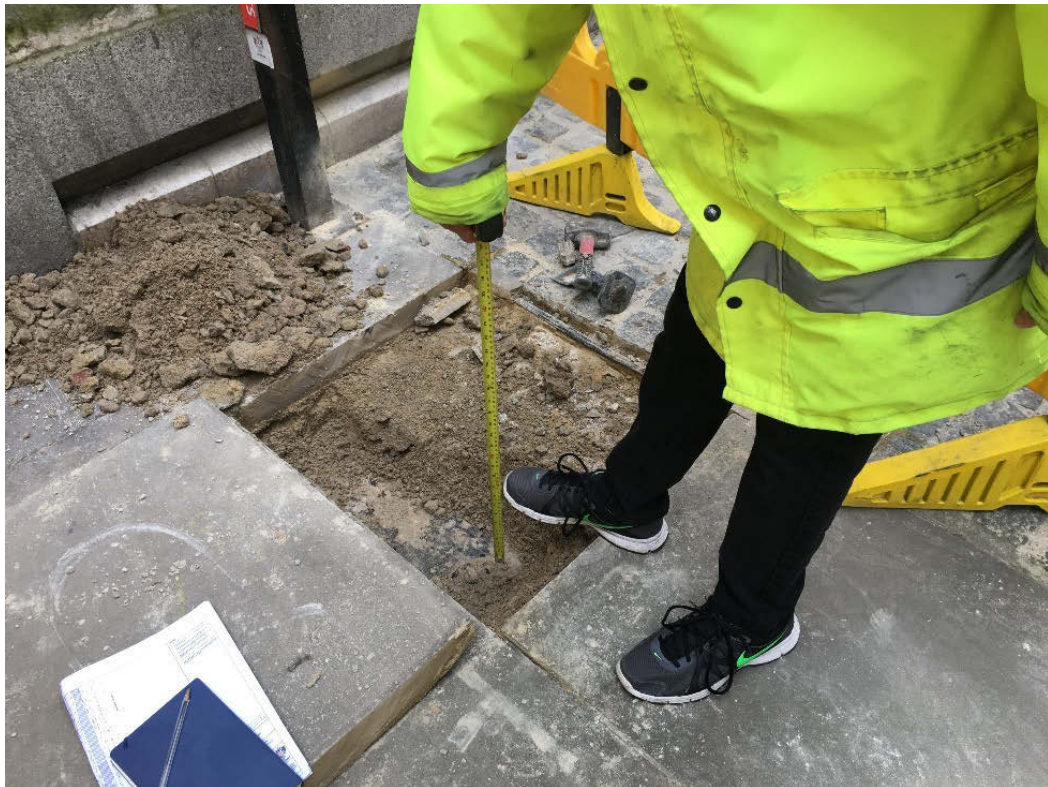
4.11.1 A single paving slab over the trench footprint was lifted to reveal a loosely compacted (50mm thick) concrete bedding screed. The screed capped a waterproofed concrete slab at a depth of 0.22m at c 13.73m OD. This slab represents the roof of the basement of the adjoining Mayor's and City of London Court.

4.11.2 The paving slabs were 0.05m thick.

Test hole 9D looking south-west

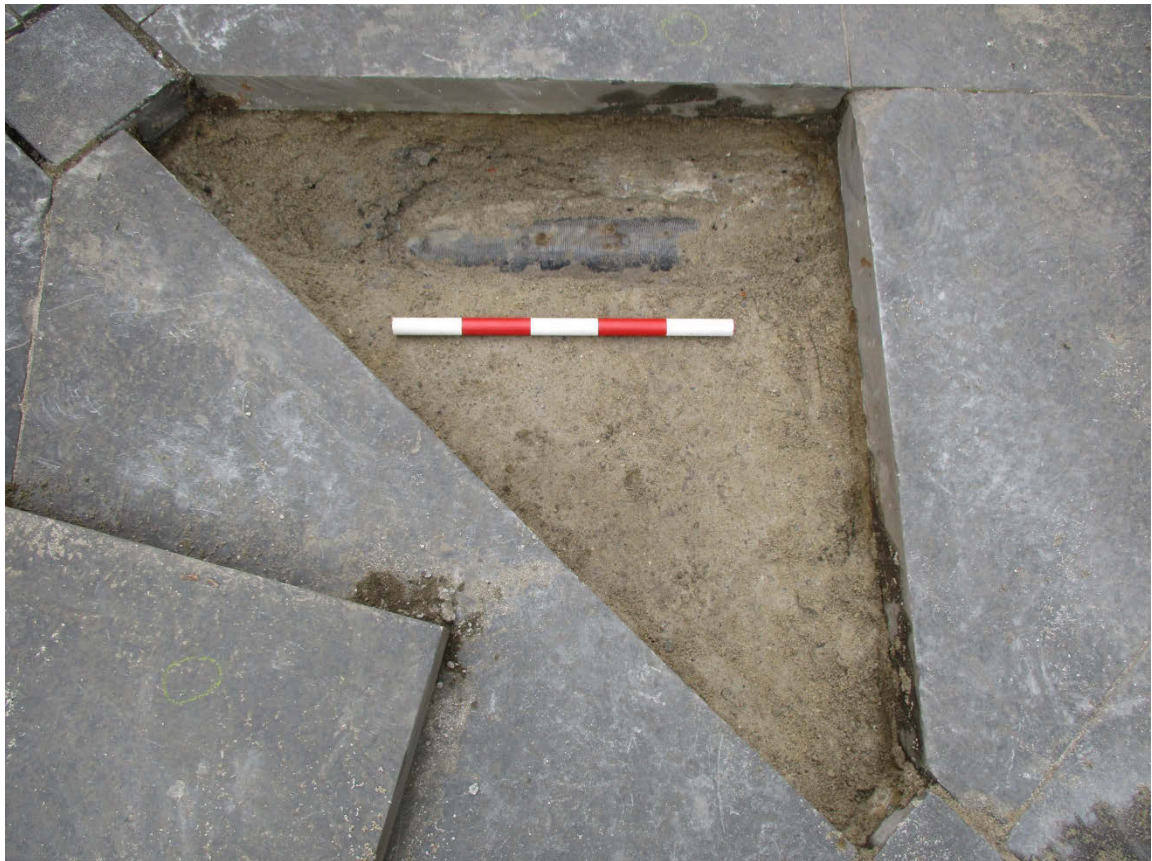
- 4.12.1 The paving slab in the trench footprint was lifted to reveal a loosely compacted (100mm thick) concrete bedding screed. The screed capped a concrete slab whose surface was defined at a depth of 0.19m at c 14.31m OD.
- 4.12.2 Cut into the concrete slab on the north side of the pit, was a plastic conduit for an east-west aligned service run, assumed to contain cabling.

Test hole 10A looking north (0.5m scale)
