ENTREPRISE HOUSE 21 Buckle Street London E1

Report on an archaeological evaluation

September 2019

Site Code UCK19
NGR 533995 181260
OASIS reference molas1-366396

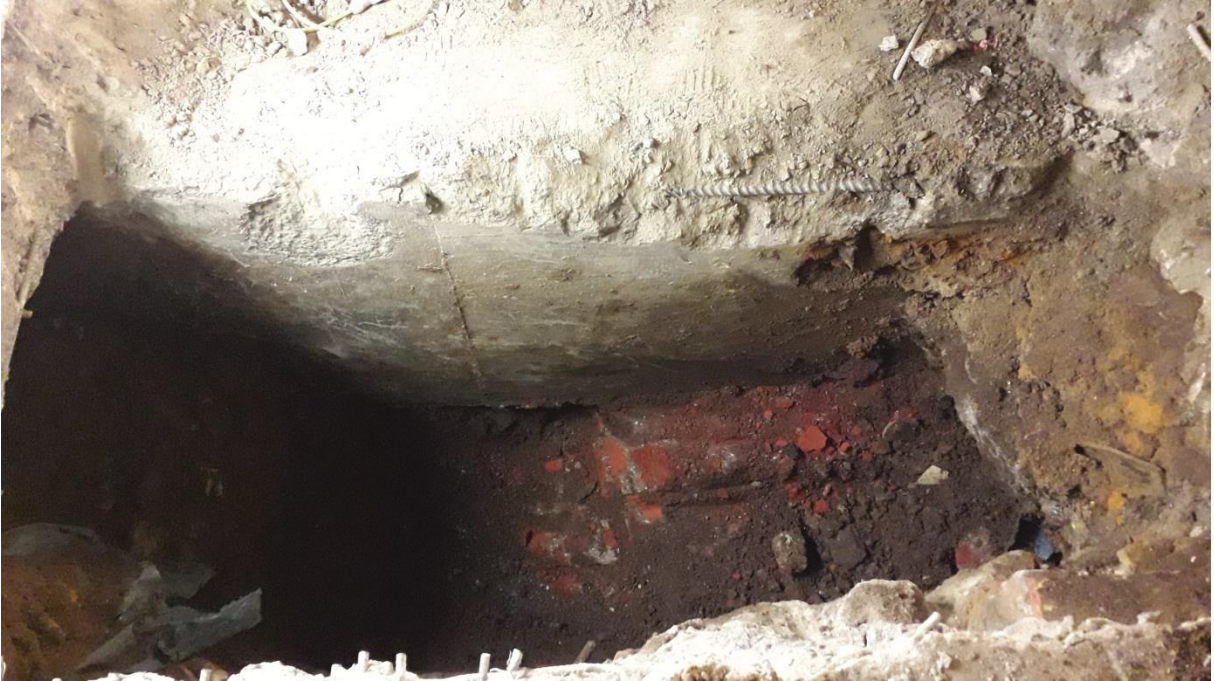
- 4.1.3 The only archaeological remains identified in this test pit was a red brick wall, [9], at 12.10m OD that ran NW-SE and filled the majority of the reduced size trench. This wall is considered to be c 18th / 19th century and looks to continue on the same alignment as the brick wall encountered in Test Pit 2 further to the north. The wall was not removed and could be seen to continue beneath the ground beam identified in the western portion of this trench (see Photo 1).

Photo 1 TP1 looking NE showing 18th century brick wall [9] partially under 1990s ground beam

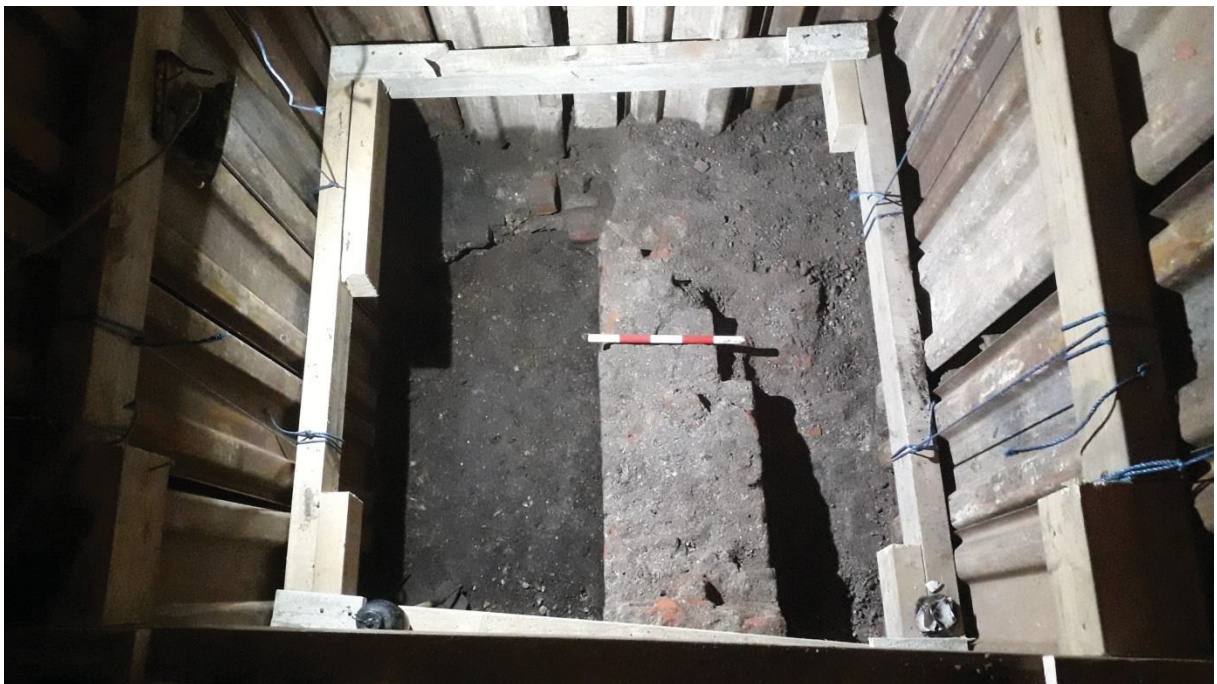
- 4.2.2 A number of post-medieval archaeological features were identified in this test pit, consisting of a red brick wall, [2], running NW to SE with a return at its NW end; a large York stone slab, [3], which may indicate a doorway or floor associated with this return; a mortar surface, [4], to the south east of the wall [2] which may be the bedding for a now removed floor; and a small brick feature, [5], may be a repair or buttress to the north east of wall [2] (see Photo 2).

Photo 2 TP2 looking NW showing 18th century brick wall [2]

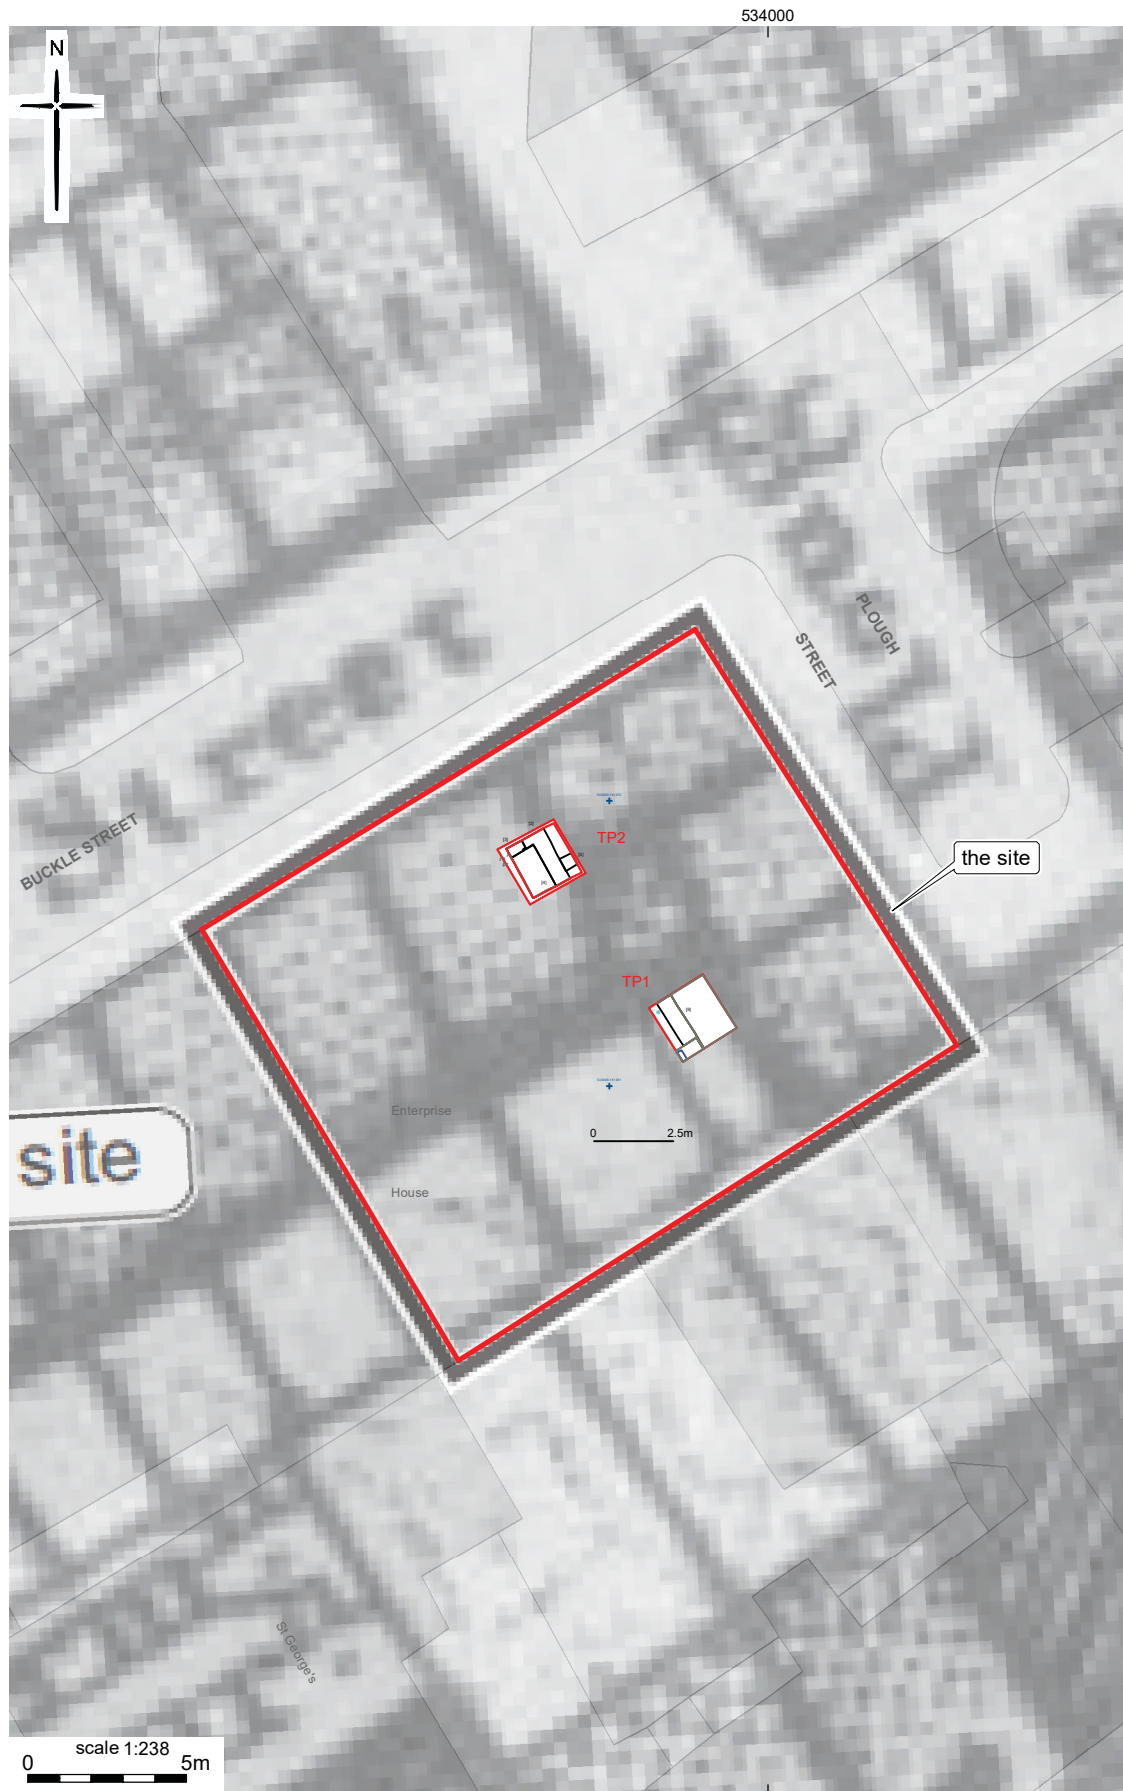
- 2.2.5 Historic map evidence indicates that the site was fully developed from at least the mid-18th century.
- 2.2.6 Faden's 1813 revision of Horwood's map of 1799 (Fig 4) is a detailed map that shows individual buildings for the first time. The site is occupied by two or three terraced houses fronting onto Buckle Street in the northern part of the site and three terraced houses fronting onto Plough Street in the eastern part of the site. The former have rear gardens or yards that occupy the rest of the site.

Fig 4 Locations of evaluation test pits and archaeological features in relation to Horwood 1799 plan

4.5.2 The base of the ground beams associated with the 1990s building lies at c 12.1m OD and it appears likely that the entire site was reduced to this level ahead of the 1990s construction activities. Below this 12.10m OD level archaeological remains survive. The only remains identified as being of archaeological interest were post-medieval in nature. These brick wall foundations are considered likely to be those depicted on maps dating from the late 18th century onwards (see Fig 4 to Fig 6).
