SPORTS PAVILION
East Marsh
London
E10

London Borough of Hackney

A standing building survey report

February 2008

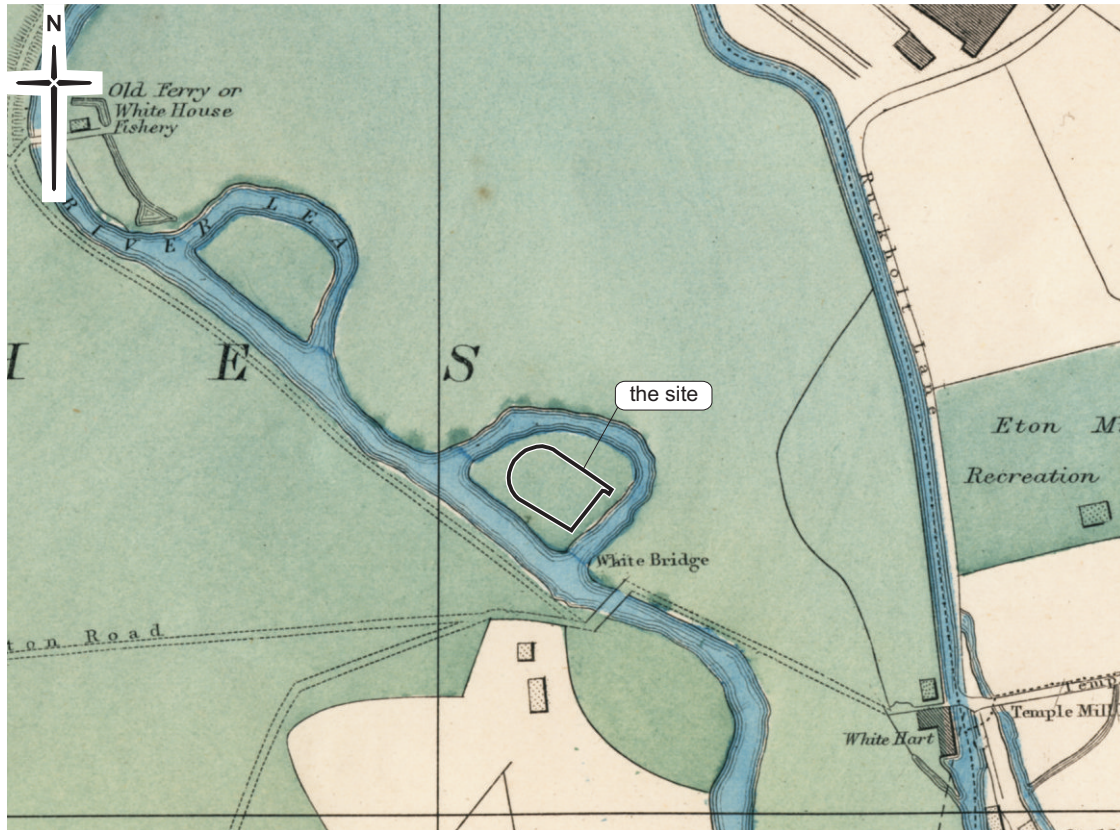
Fig 6 Bacon's map of London, 1900

As London grew, the land on the marshes became more valuable for building than grazing. The possibility that the owners of Lammas rights might unite to convert the marshes into building land led the district board to seek its purchase by the London County Council in 1889. The importance of the retention of the marshes for recreational use was highlighted when boys from the nearby Eton Mission, which was established by Eton College to assist the poor of Hackney, were ejected from the land for playing football. That year the owners of Lammas rights negotiated to sell their privileges to the London County Council for £75,000, of which the district board contributed £15,000 and private subscribers £10,000, and in 1893 the Marsh was opened to the public. Flood prevention works were carried out by the LCC; this included four cuts being made across the bends in the Lea, the old looping channels being retained to form islands; a bathing pool was created by the northernmost cut (Baker 1995, 108-115). The soil excavated from the new river cuts was used to level the ground, and former boundary posts dividing the Lammas pastures were removed (Sexby 1894, 7). Bacon's map of 1900 (Fig 6) shows how the Lea had been straightened and the

original bends in the river retained. The new river course had been excavated along the course of the footpath shown in Stanford's map of 1862 (Fig 5).

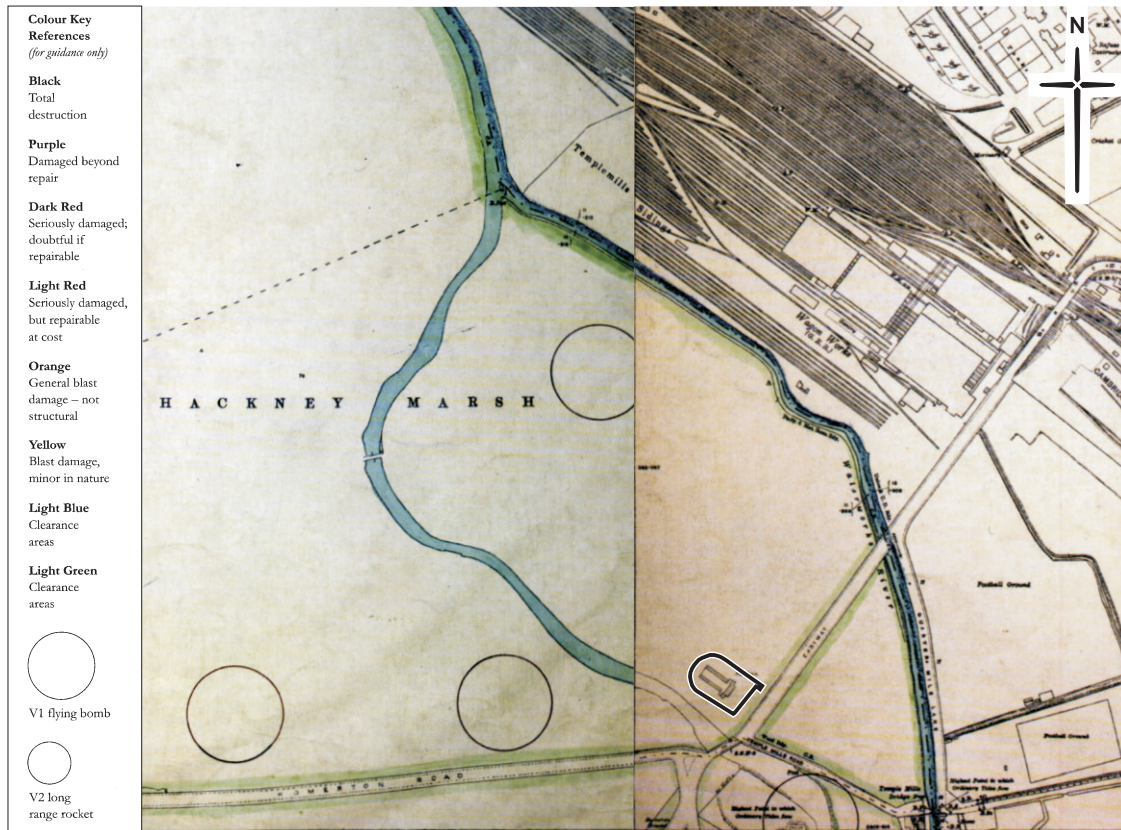
Fig 8 The London County Council Bomb Damage Map, 1945

The building is first shown on the London County Council bomb damage map from the Second World War, which was based on the Ordnance Survey 1:2,500 maps of 1916, continuously updated to 1940 (Fig 8). The building, marked 'pavilion' is depicted in a similar form to the present site; there is one main block, with small side wings on the west and east sides, and an enclosed yard with long ranges along the eastern and western sides. No third range at the northern end of the yard is shown, however, suggesting that there were fewer changing rooms than the 15 quoted in *The Times*, or that three of the changing rooms were situated inside the pavilion. The LCC bomb damage map also shows that a V1 flying rocket landed some distance to the south of the pavilion, landing in the River Lea to the south of the Eastway (later renamed Ruckholt Road), and although the map does not

indicate that the building was damaged, the brick pavilion and corrugated iron-clad dressing rooms were rendered unusable by bombing.

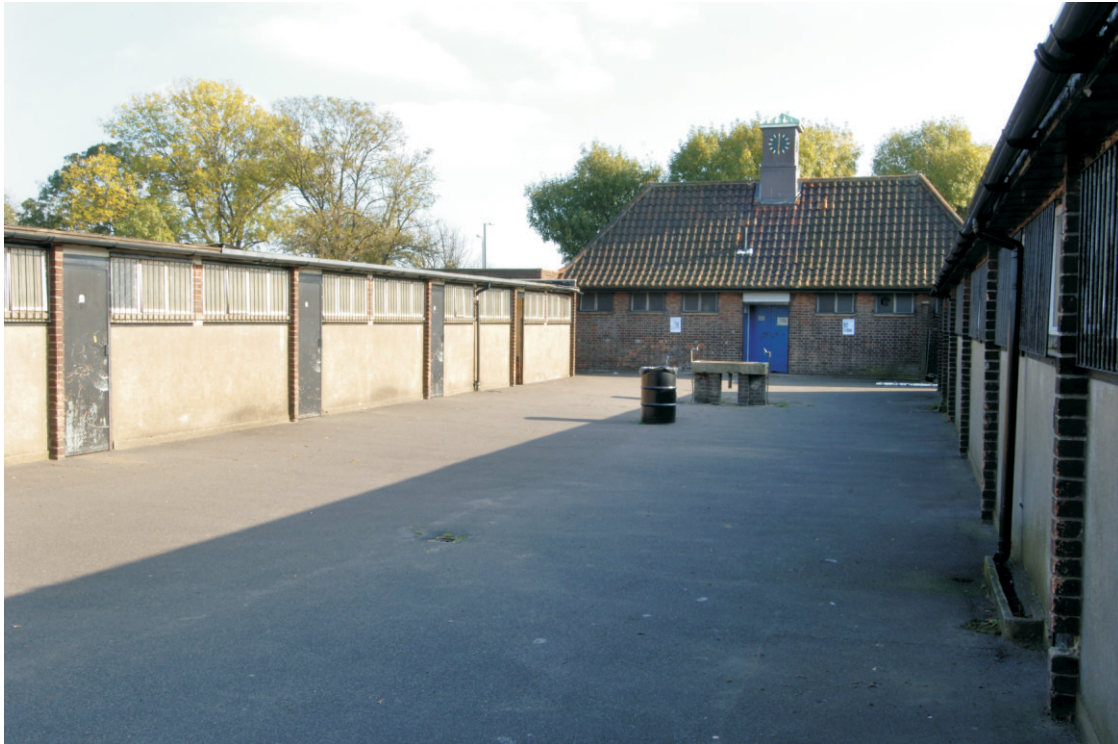
Fig 10 The internal yard, east and west changing room blocks and the main pavilion, looking south-east

Three long ranges, accommodating a total of fifteen changing rooms, are situated on the western, northern and eastern sides of the courtyard respectively. These are constructed of red brick in a stretcher bond, with walls one single brick thick, and flat concrete panel roofs supported by rolled steel joists, manufactured by Dorman Long & Co Ltd of Middlesbrough, on thin load bearing walls and covered with asphalt. The eastern and western ranges each contain six changing rooms, the northern range contains three. The partition walls between each changing room protrude from the front and rear external elevations by approximately the length of half a brick, *c* 110mm (Fig 17). The external faces of the front and rear walls of each changing room have been covered with a cement render. Each changing room has a steel plate door and is lit by four sealed and three top pivoting steel framed windows which look out onto the yard.

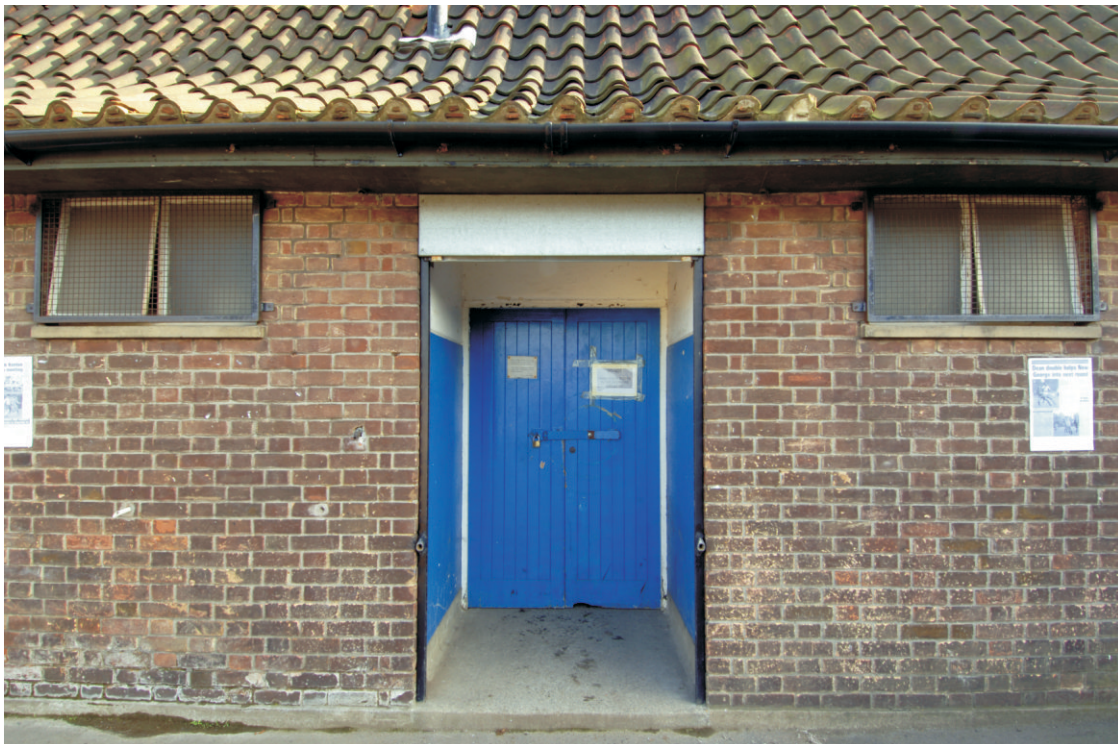
Fig 11 Entrance door to the main range, looking south-east

The main range was entered by a double leaf door situated in the centre of the north-facing façade (Fig 11). Six horizontally elongated frosted glass windows were situated in the north-facing façade, three on either side of the main door. These windows were covered with steel grilles to deter vandalism. Two stone plaques were set into the centre of the south-facing façade (Fig 12). The first plaque was set into a concrete frame with a projecting sill, measuring 1.095m wide x 0.83m tall. This frame is almost identical in style to the frames surrounding the six elongated windows in this façade. The inscription reads:

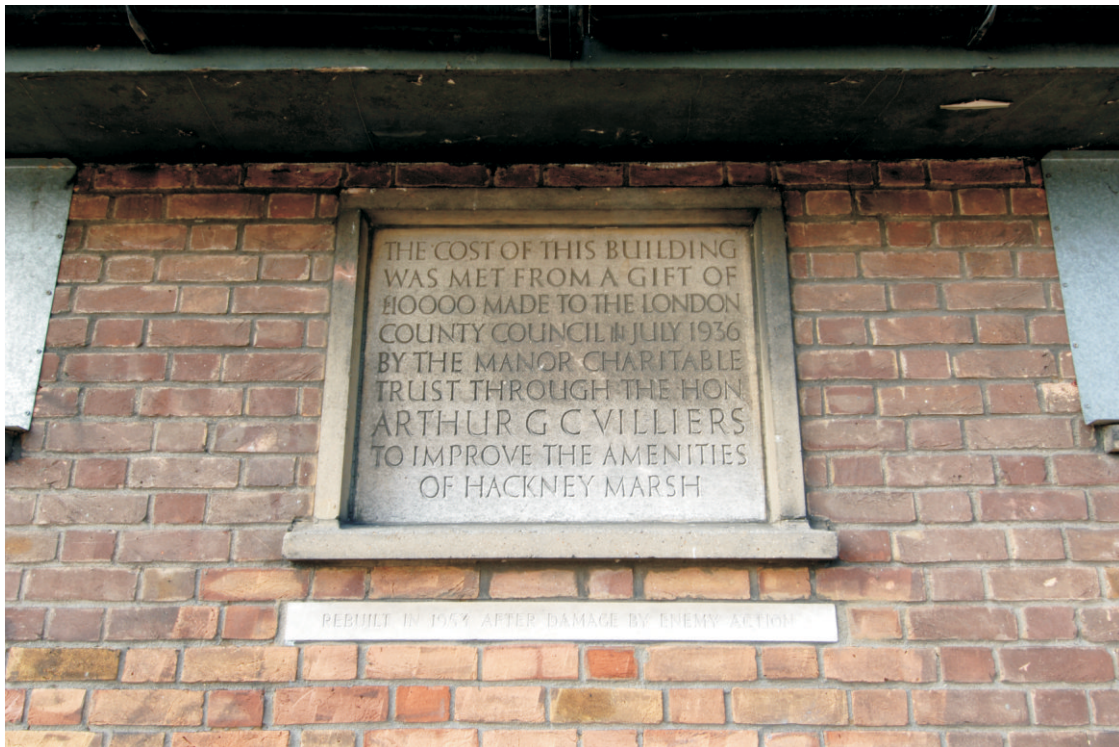
Fig 12 Commemorative plaques on the south wall of the main range, looking south-east

<p>THE COST OF THIS BUILDING WAS MET FROM A GIFT OF £10000 MADE TO THE LONDON COUNTY COUNCIL IN JULY 1936 BY THE MANOR CHARITABLE TRUST THROUGH THE HON ARTHUR G C VILLIERS TO IMPROVE THE AMENITIES OF HACKNEY MARSH</p>

Below this plaque was a longer, narrow plaque, measuring 1.09m long x 0.075m tall, which commemorates the rebuilding of the pavilion after damage was sustained during the Second World War. The inscription reads:

REBUILT IN 1953 AFTER DAMAGE BY ENEMY
ACTION

Given the local significance of the sports pavilion it is recommended that the plaques commemorating the £10,000 donation made to the LCC for the improvement of recreational facilities on Hackney Marsh in 1936, and reconstruction of the pavilion in 1953, be retained and relocated upon the redevelopment of the site. They could be incorporated into the structure of any new facility which might be constructed on the site.

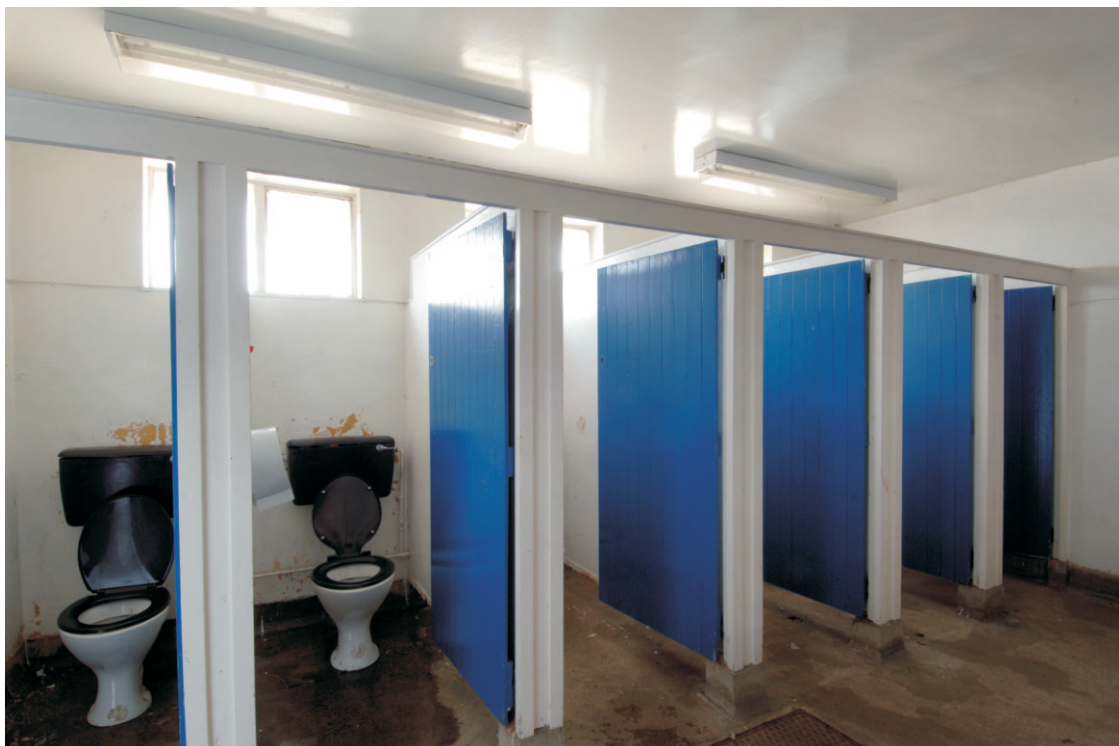
Fig 13 Lavatories in the main range, looking south-east

The centrally placed double leaf door in the north-facing external façade of the main pavilion gives entry to a small vestibule, G1. A cupboard, G2, houses the boiler which supplies the showers and lavatories with hot water; at the time of the measured survey, this cupboard was locked. Two door openings from G1 give access to the rooms on either side. G3, on the eastern side of the pavilion (Fig 13), contains the WCs and urinals, and G4, on the western side of the pavilion, contains a walk-through shower in the centre of the room, with wooden benches and garment hooks against the southern and northern walls (Fig 14). An opening in the west wall of G4 gives access to a second open shower, G5, which was probably converted from a former office or storeroom. G3 and G4 are lit by horizontally elongated, top pivoting frosted glass windows, situated high up in the wall. The windows in the south wall have been covered on the external side by steel sheets, preventing them from being broken but blocking the light; the windows in the north wall have been covered with steel grills, limiting the movement of the window panes and acting as a deterrent to intruders.

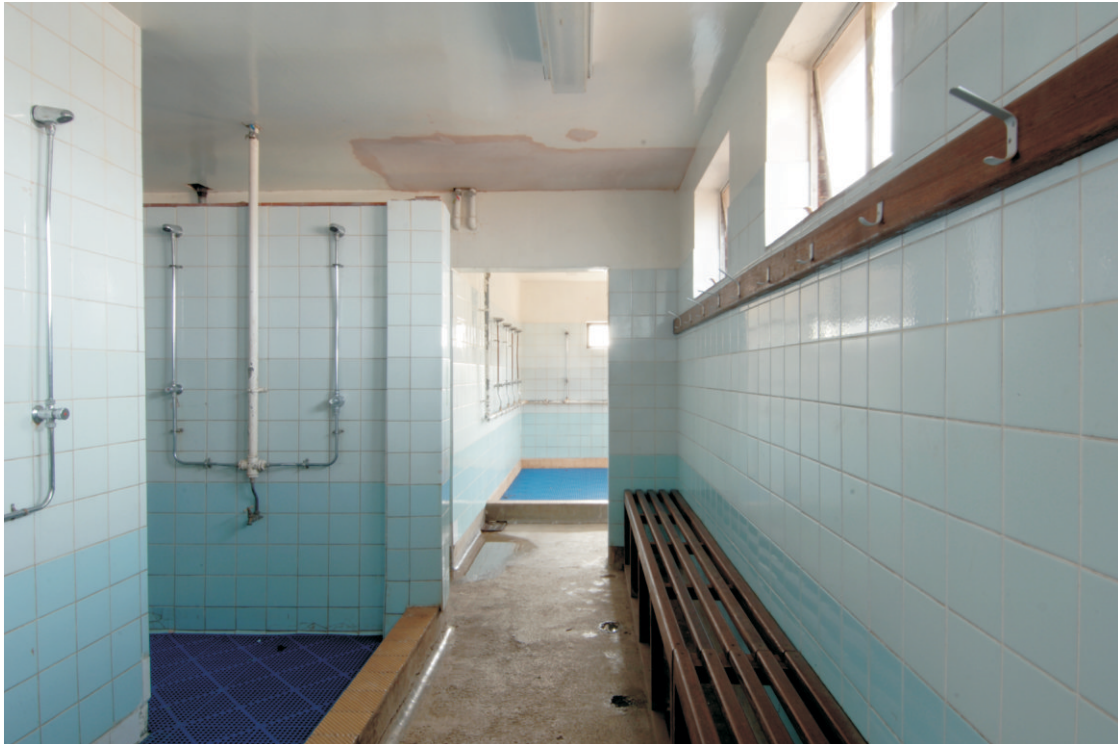
Fig 14 The showers in the main range, looking south-east

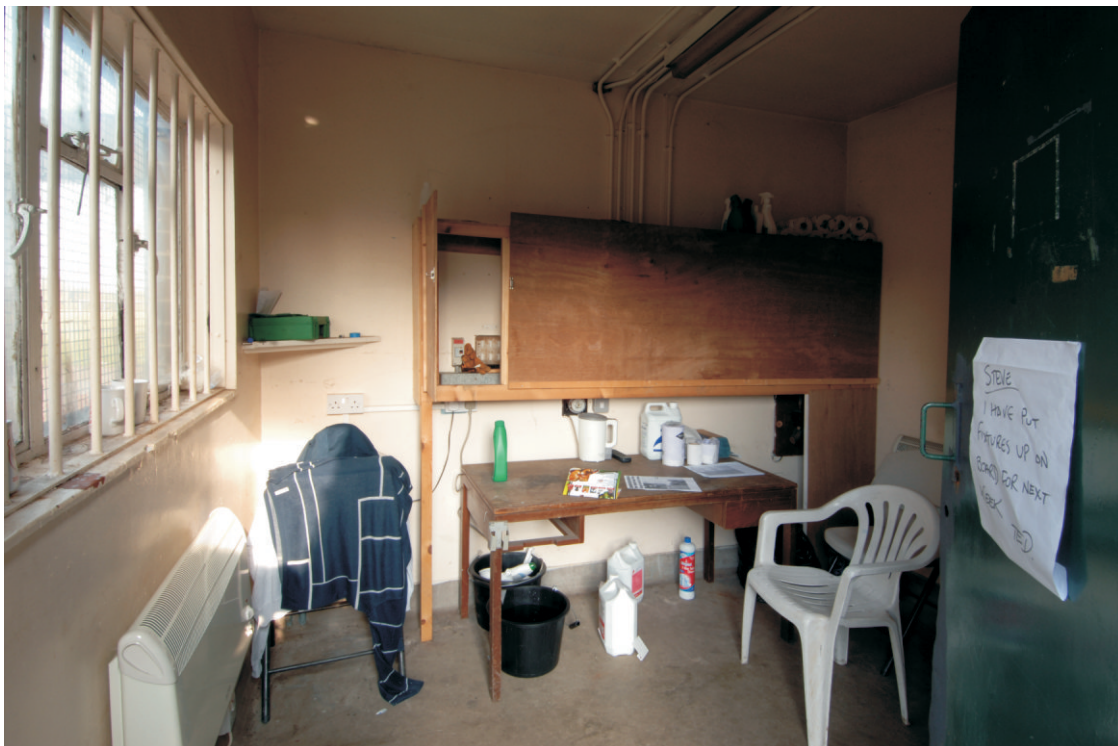
Fig 15 Interior of the Ranger's office in the east wing of the main range, looking north-east

The east wing of the main range contains two rooms; an office for the Ranger, G6 (Fig 15), which is decorated plainly and contains a desk, shelves, the cleaning equipment and the keys to the changing rooms (Fig 16) and a storage room for the goal nets and corner flags, G7.

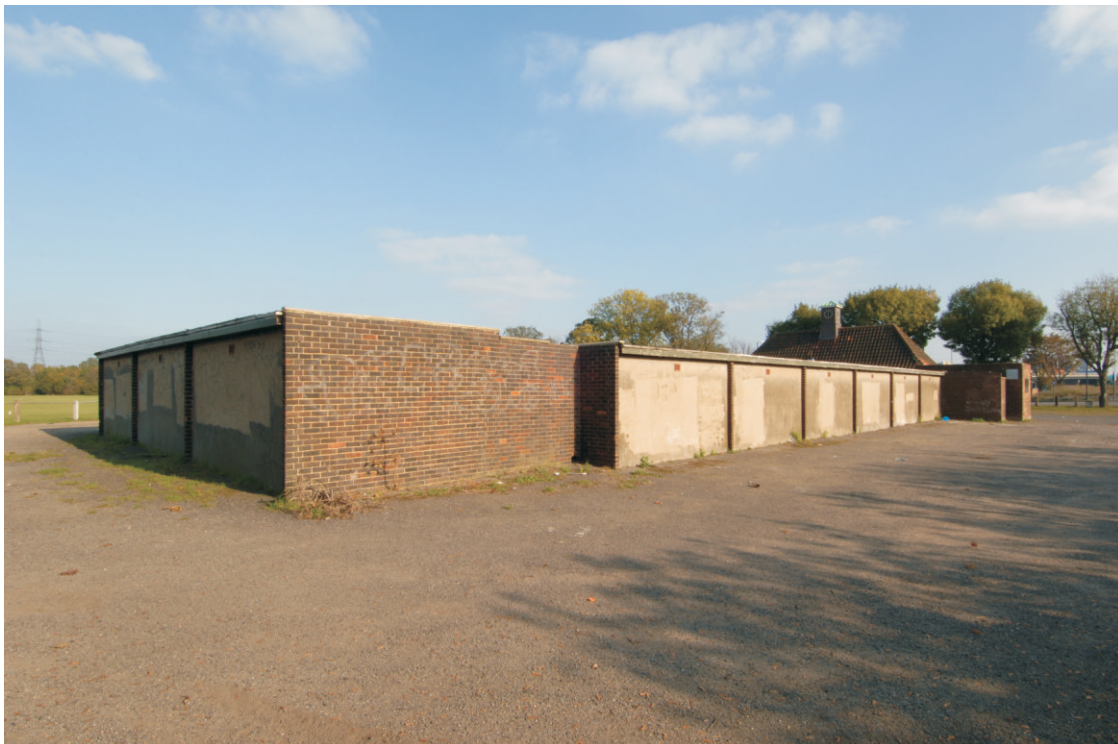
Fig 17 Exterior of the north and west changing room blocks, looking east

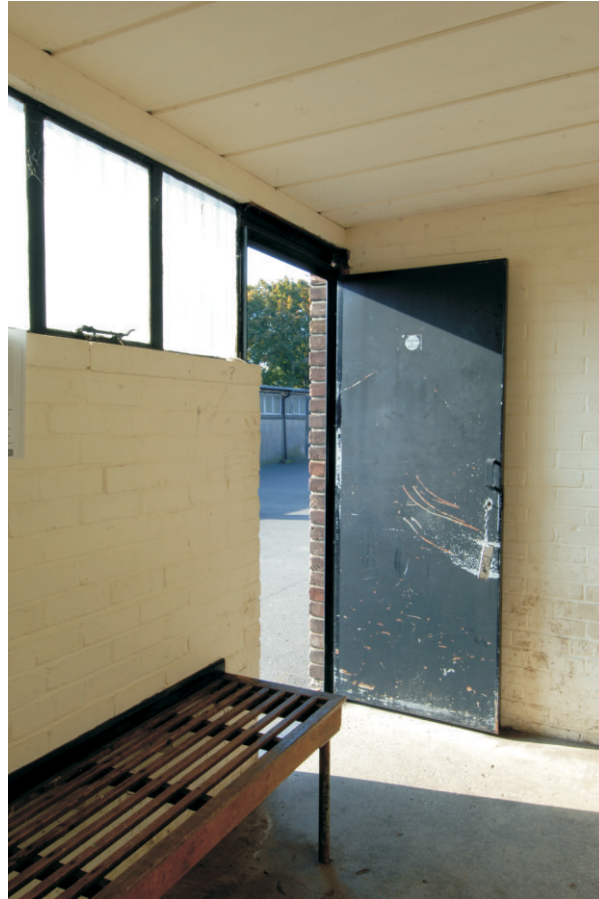
Fig 18 Entrance of changing room 15, looking north-east

Internally, the changing rooms are plain and undecorated (Fig 18). Each has a bare concrete floor, and timber benches with slatted seats are fixed to the walls on three sides of the room. Cast iron garment hooks mounted on wooden boards are fixed to two walls, above the benches. The interiors of the changing rooms appear to have been kept in good condition, and are free of graffiti. As the changing rooms are used by different teams each week, depending on the schedule of match fixtures, there are no facilities for storing kit between matches. The changing room closest to the entrance gate and Ranger's Office, C15, was used by the referees; this was the only room to be personalised in any way, with newspaper cuttings and photographs fixed to the walls and towels and other personal items left there (Fig 19).

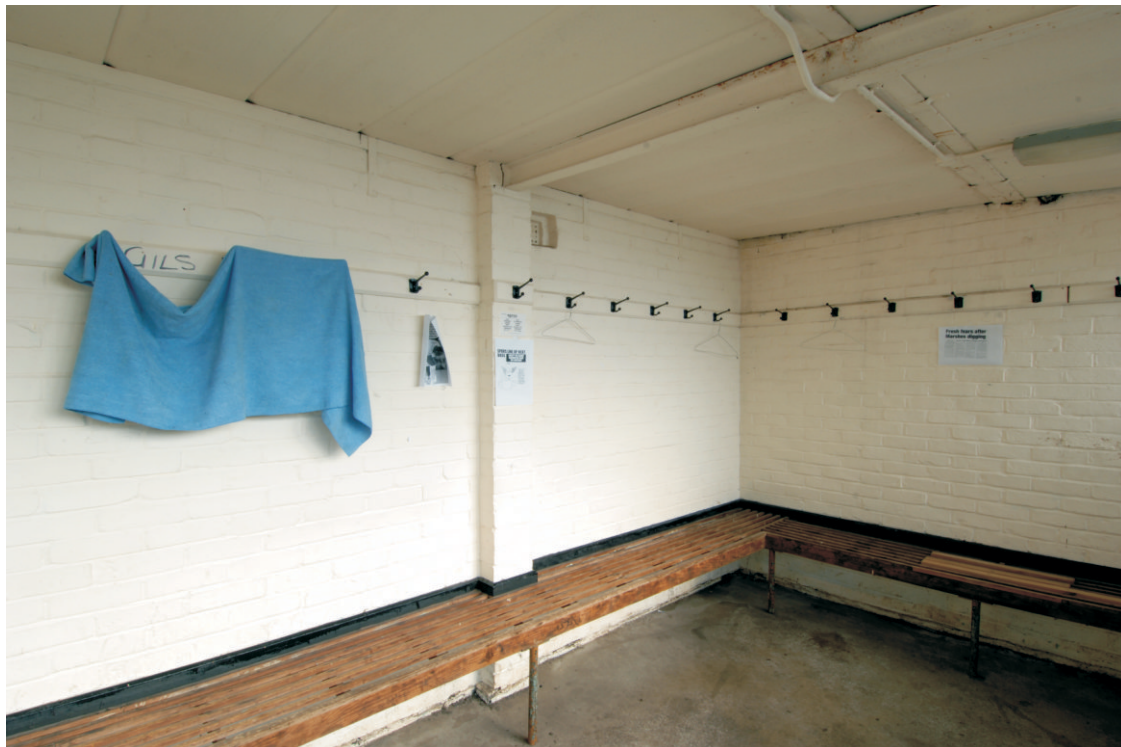
Fig 19 Interior of changing room 15, looking east
