7 PUDDING MILL LANE
Stratford
E15

London Borough of Newham

A Standing building survey report

February 2008

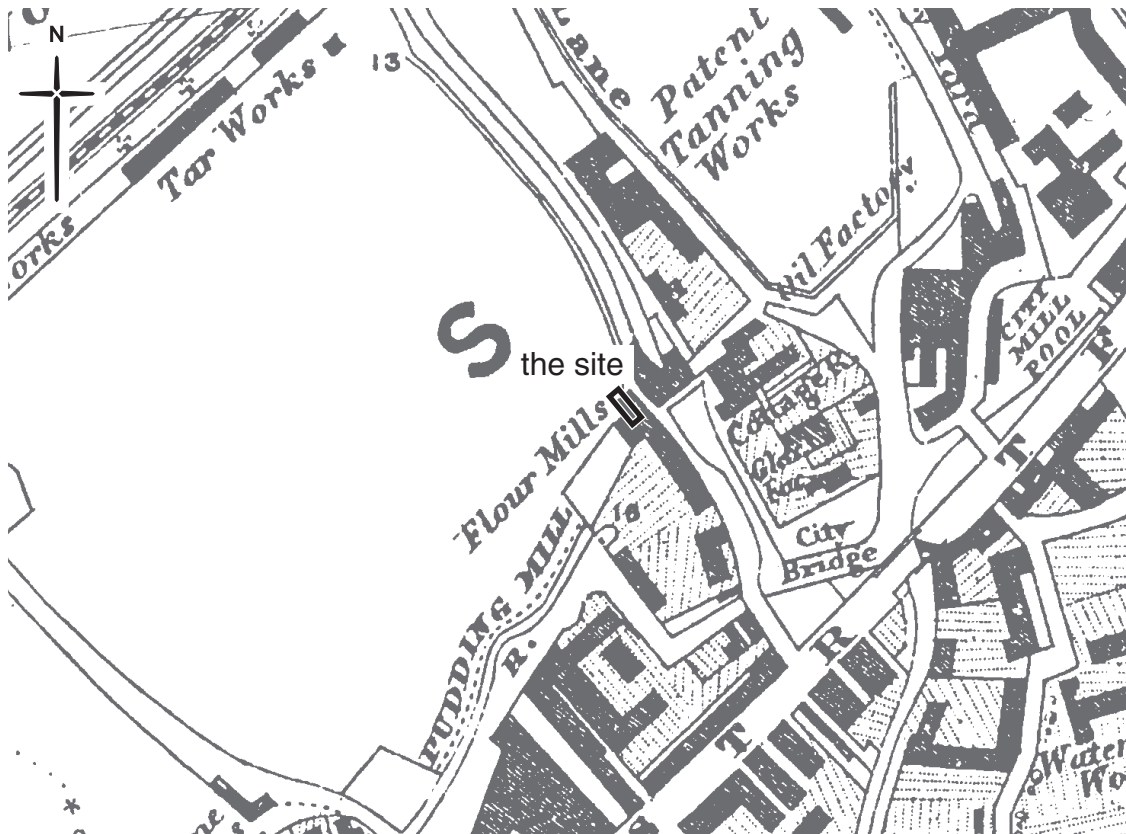
Fig 7 Stanford's library map of London and its suburbs, 1862

Stanford's map of 1862 shows that the site of the present building was occupied by flour mills, with an area of open ground separating it from tar works and the Eastern Counties Railway line to the north (Fig 7). At this time industrial development was largely confined to Stratford High Street and the watercourses immediately to the north and south. Pudding Mill Lane is shown as a path on the western side of the Pudding Mill River, which leads north from the bridge which carried Marshgate Lane over the river. The path terminated just short of the Eastern Counties Railway line to the north of the site; it may have been an access road for the tar works, which were probably owned by J P Murphy, who were based in Marshgate Lane from c 1818 to 1863 (Powell 1973, 76-89).

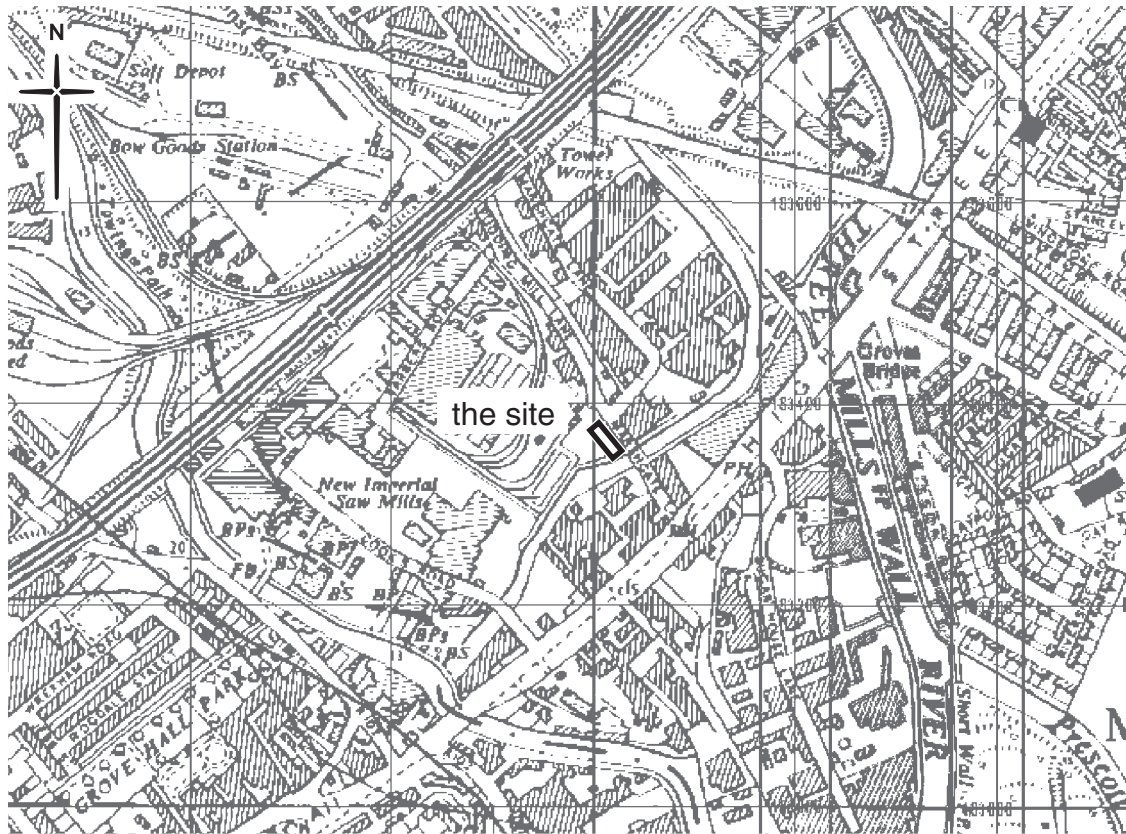
Fig 9 Ordnance Survey map, 1955

The company then moved to a nearby site at the former Crown Works (i.e. the site: 7 Pudding Mill Lane) on the northern bank of the Bow Back River, and the business is first noted at that address in the *Post Office Directory* of 1952. The Ordnance Survey map of 1955 had not been updated to show this new building, however, although it does show that the course of the Bow Back River to the south of the site had been straightened (see Fig 9).

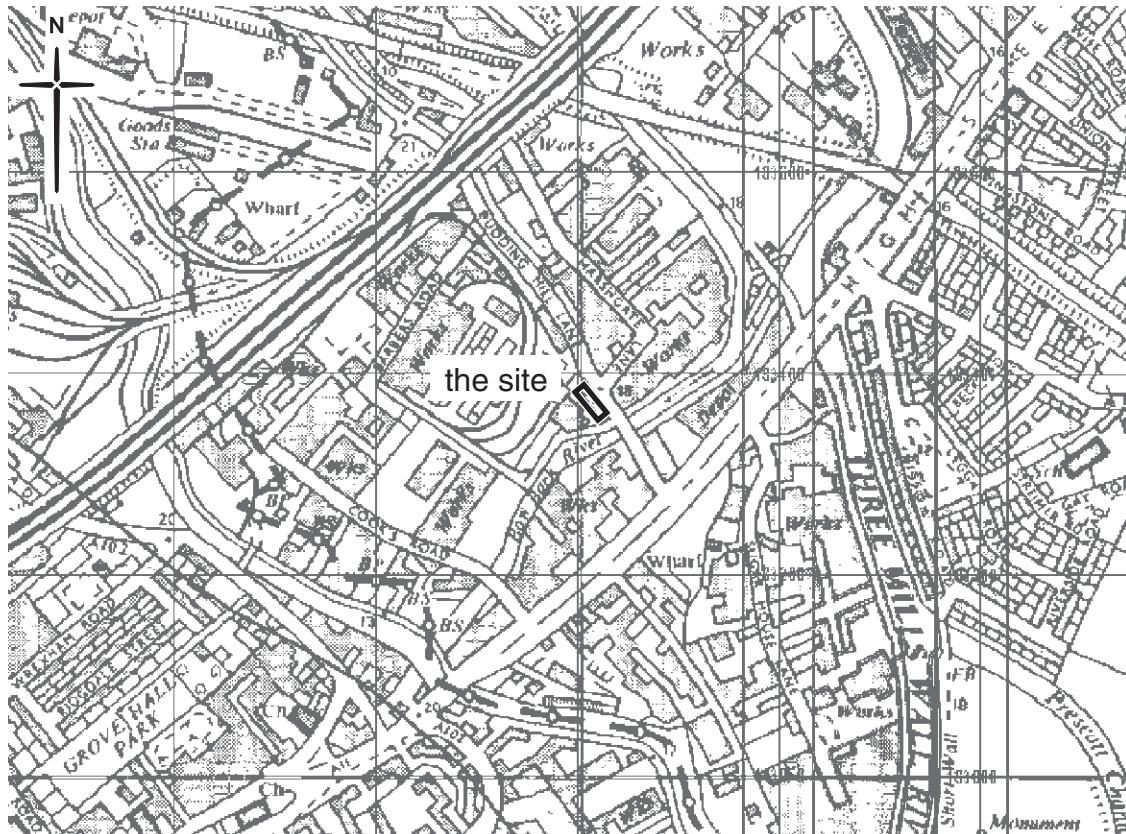
Fig 10 Ordnance Survey map, 1965

The present building is first depicted on the Ordnance Survey map of 1965, along with the steel frame and brick shed to the west of the site (Fig 10), which probably comprised part of the Robinson King & Co glassworks (Fig 11).

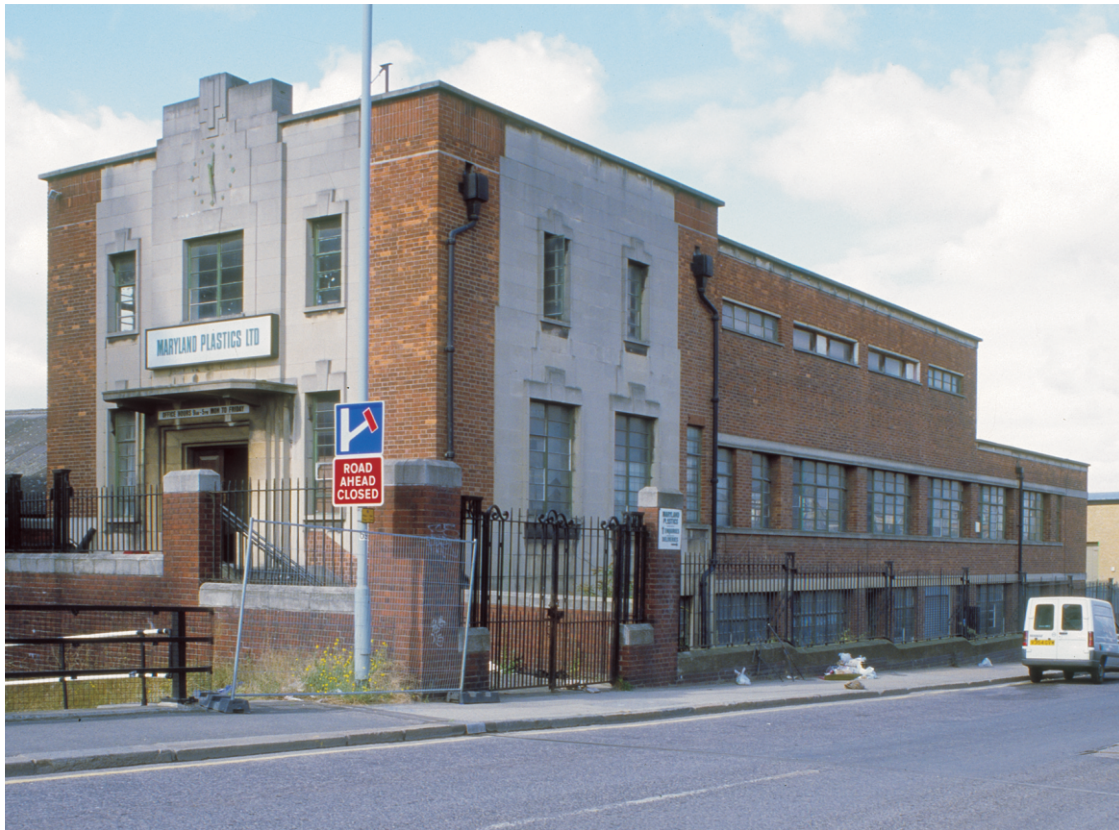
7 Pudding Mill Lane (Fig 12) is broadly aligned on a north-west–south-east axis, on the western side of Pudding Mill Lane, adjacent to its junction with Marshgate Lane, and on the northern bank of the Bow Back River, north of Stratford High Street. For ease of reporting, the main entrance of the building on the upper ground floor, in the south-west facing external elevation, will be reported as being situated at the southern end of the site.

The building was constructed with a reinforced concrete frame, using rectangular and square section columns and beams. The walls were largely infilled with red brick in Flemish bond with cement mortar. Artificial stone blocks of granolithic concrete composition were used to face the southern façade, the south end of the west-facing facade and to decorate the door and window frames, which featured projecting keystone embellishments at the southern end of the building.

The centre bay in the south-facing elevation projected slightly, and stood approximately 0.6m taller than the rest of this façade. The centre bay was simply decorated with an Art Deco-style geometric relief design, culminating in a clock above the central 1st floor

Fig 12 Exterior of 7 Pudding Mill Lane, looking north

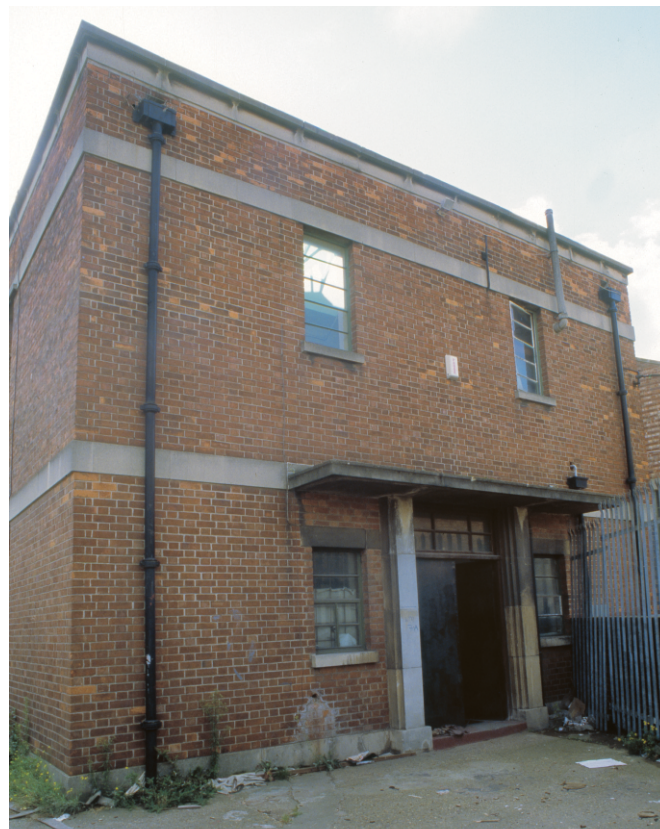
The north-facing external façade was more simply decorated than the south-facing (Fig 13). The main entrance door to the lower ground floor was placed centrally, with one small steel framed crittall window with a concrete lintel and sill placed on either side of the door opening. Simple concrete pilasters on either side of the doorway supported a concrete canopy, which projected over the door and windows.

Fig 13 Rear entrance in the north facing external façade, looking south-west

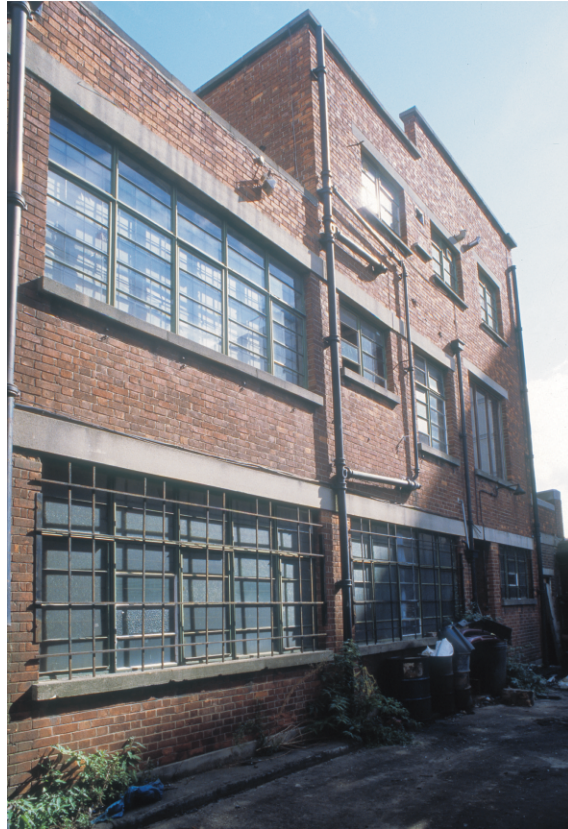
A band of concrete blocks was positioned above the steel frame crittall windows of the upper and lower ground floors. Each window in the east and west-facing facades on the lower ground floor had an individual concrete sill; a continuous sill ran under the upper ground floor windows of the west-facing façade (Fig 14) and in the centre and northern end of the east-facing façade. A moulded concrete cornice was situated at the top of the east and north-facing external elevations; the cornice terminated on the west-facing elevation, as this side of the building would not be seen by passing pedestrians or visitors.

Fig 14 The west facing external elevation, looking south-west

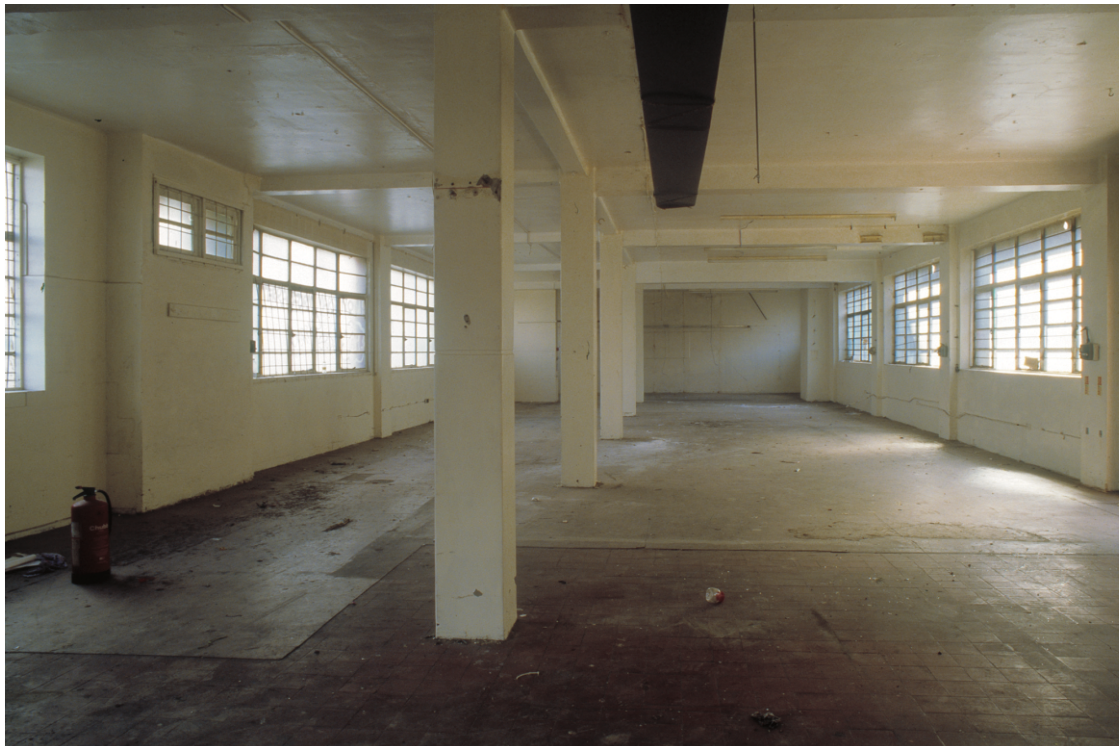
Much of the lower ground floor was occupied by a large room, LG1 (Fig 15), which was lit by windows in the east and west walls. The room was bisected by a line of square section columns, aligned towards the eastern side the building. Two blocked window openings were visible in the south wall of LG1; when originally open, these provided a little light to the southern end of the floor via the skylights in LG7.

Fig 15 Interior of LG1, looking south

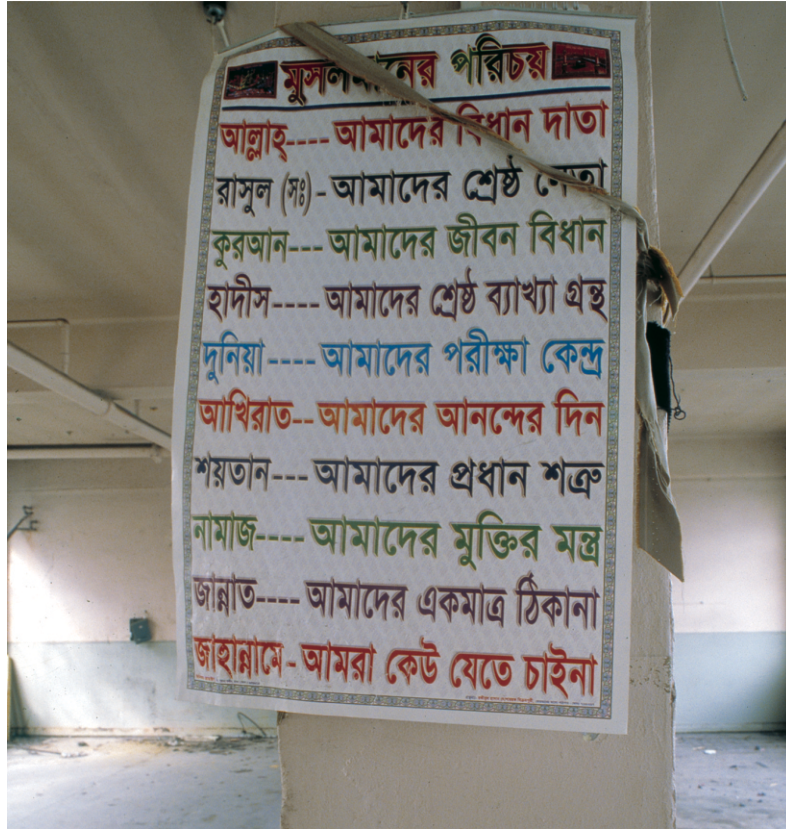
Fig 18 Poster in Bengali in UG8, looking north

On one of the columns in UG8 was a poster in Bengali (Fig 18). There has been a Bengali community in Britain since the 1870s, although the largest migration from Bangladesh, where approximately 85% of the population is Muslim, occurred in the 1960s and 1970s (www.bbc.co.uk/voices/multilingual/bengali.shtml). The rag trade has been associated with the Bengali community since their arrival, and in London was historically based in the area around Brick Lane, where commercial sewing was carried out by women in the home. Many clothing businesses which originated there have since moved away from inner city London in search of cheaper premises (www.indiacurrents.com/news/view_article.html). The poster, which explains the main tenets of Islam, is translated as follows:

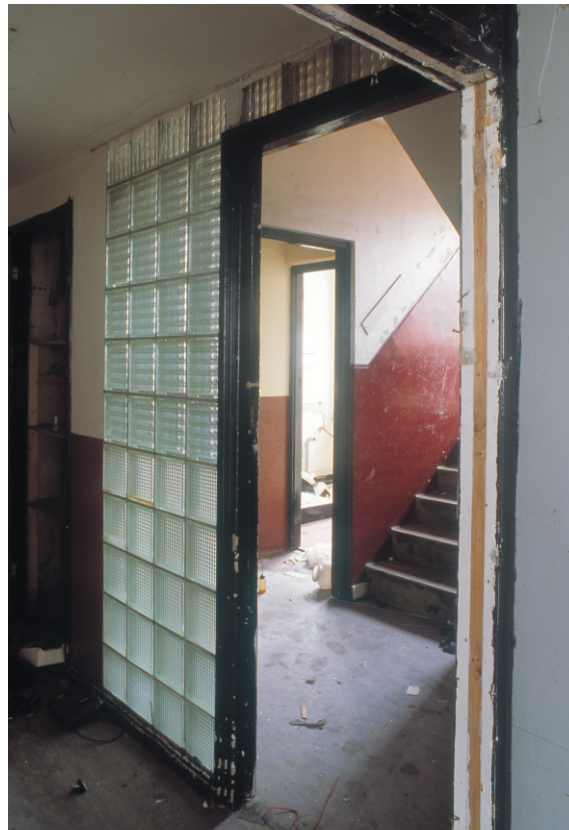
The 1st floor could only be reached via the staircase from UG7, on the upper ground floor (Fig 19). A large room, 1F1, took up the width of the building at its southern end. This room had three steel framed crissall windows in the south wall, looking out onto the main entrance forecourt and the Bow Back River. Two similar windows were placed in the east and west walls respectively. The room had two entrance doors from the corridor 1F3, suggesting that 1F1 originally comprised two rooms, separated by a partition wall. A blocked chimney breast was situated in the west end of the north wall of 1F1; this would

Fig 19 Corridor UG4 and stairs to the 1st floor, looking south-west

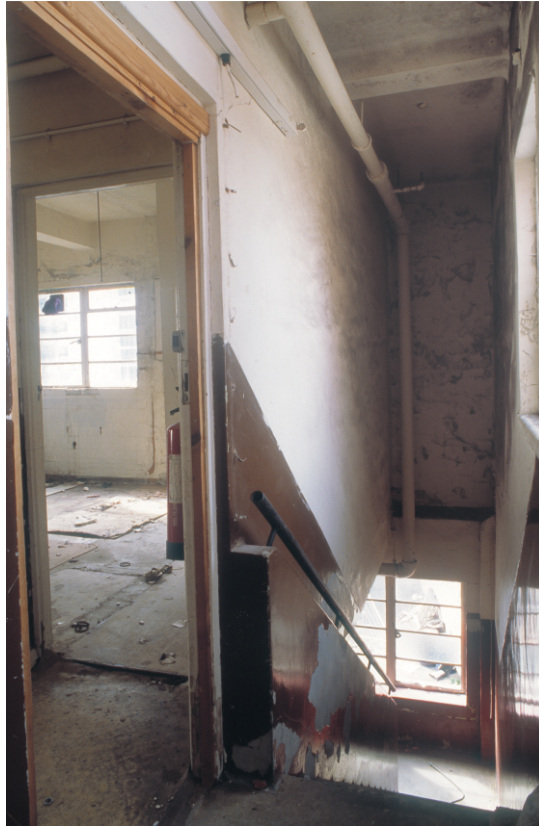
Fig 20 1F4, and the staircase from UG7, looking west

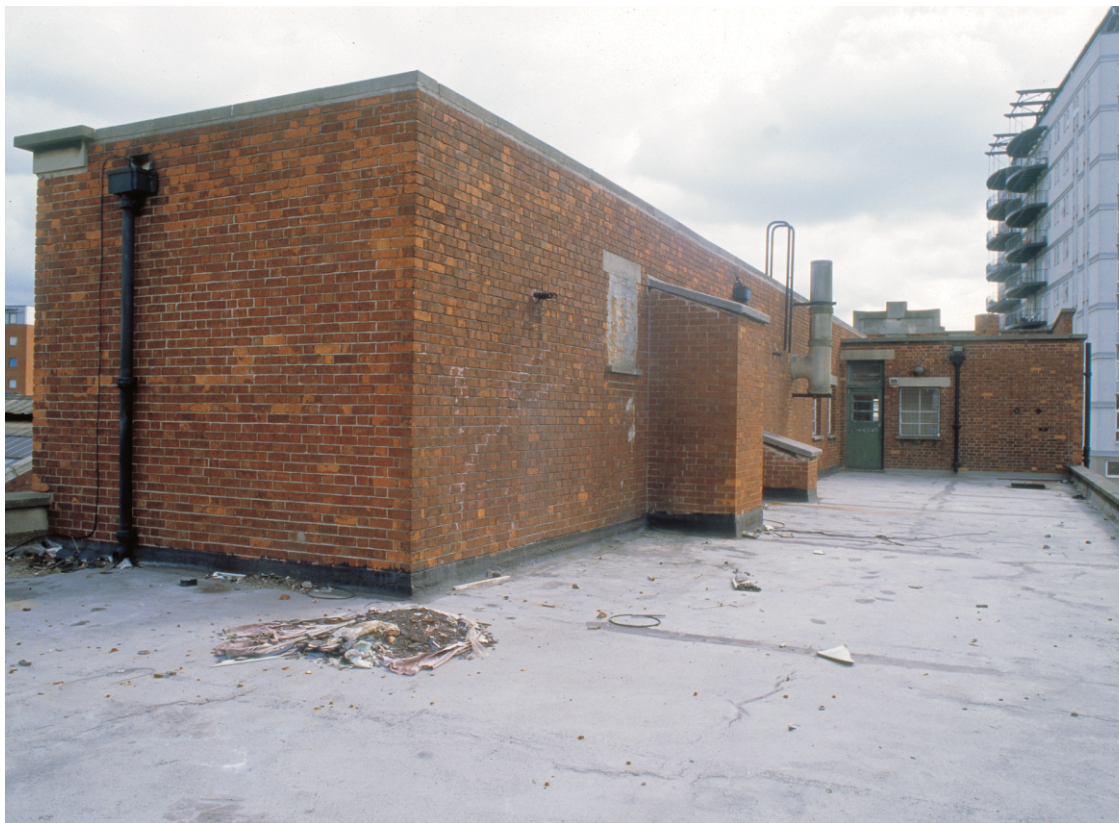
1F5 and 1F6 were two large rooms lit by windows in both the east and west walls. 1F7 contained the air conditioning plant and water tanks; the room was formerly divided in two by a cinder block wall, which had been partially demolished at the time of the survey. Double-leaf doors gave access to the roof from the western side of 1F6 (Fig 21).

Fig 21 The roof and the exterior of the 1st floor, looking south-east
