# BRICK WALL Angel Lane

Standing Structure survey report

March 2008

Site Code: OL-07707  
National Grid Reference: 538774 184765

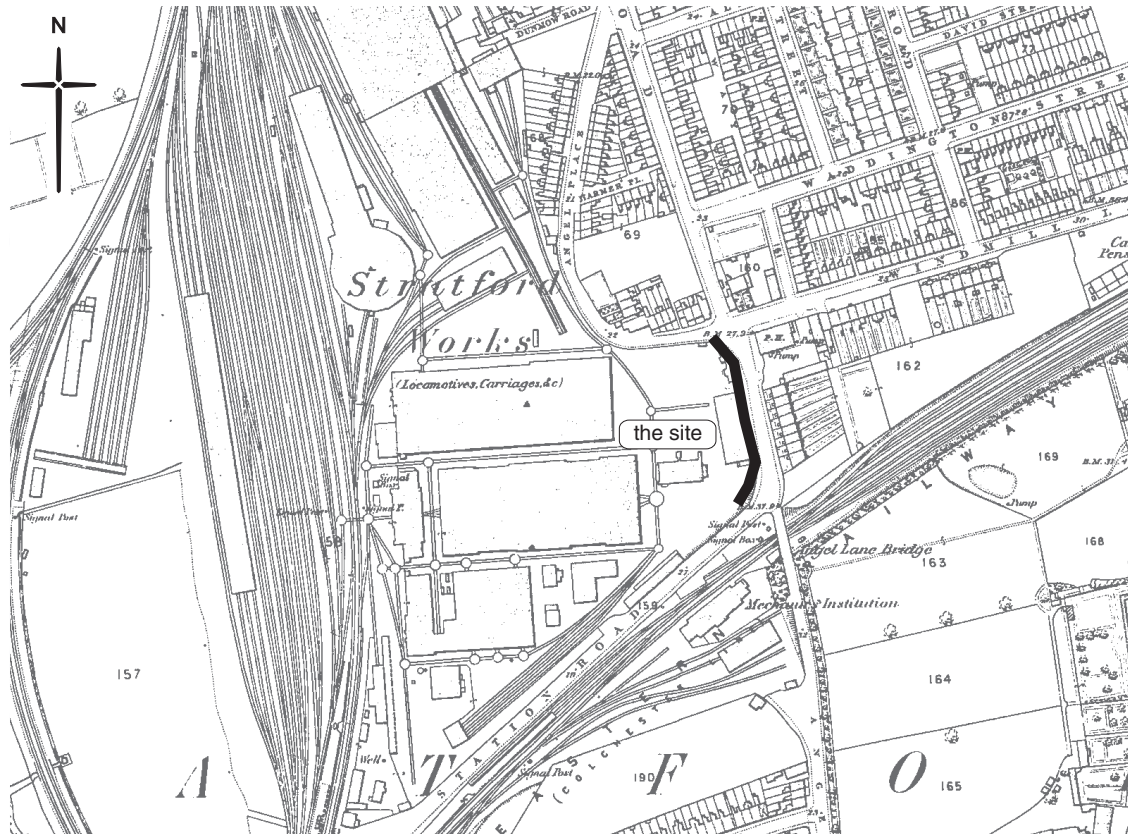
Fig 5 Ordnance Survey map, 1867

The 1st edition Ordnance Survey map of 1867 shows the intricate network of railway sidings associated with the locomotive works, and that the works themselves had expanded, with additional buildings adjacent to the Cambridge line and a rectangular building fronting Angel Lane, to the south of the building depicted on Stanford's map of 1862; this may have been the brass foundry, which was later enlarged. A single rail track leading off a turntable terminated just to the west of this building (Fig 5).

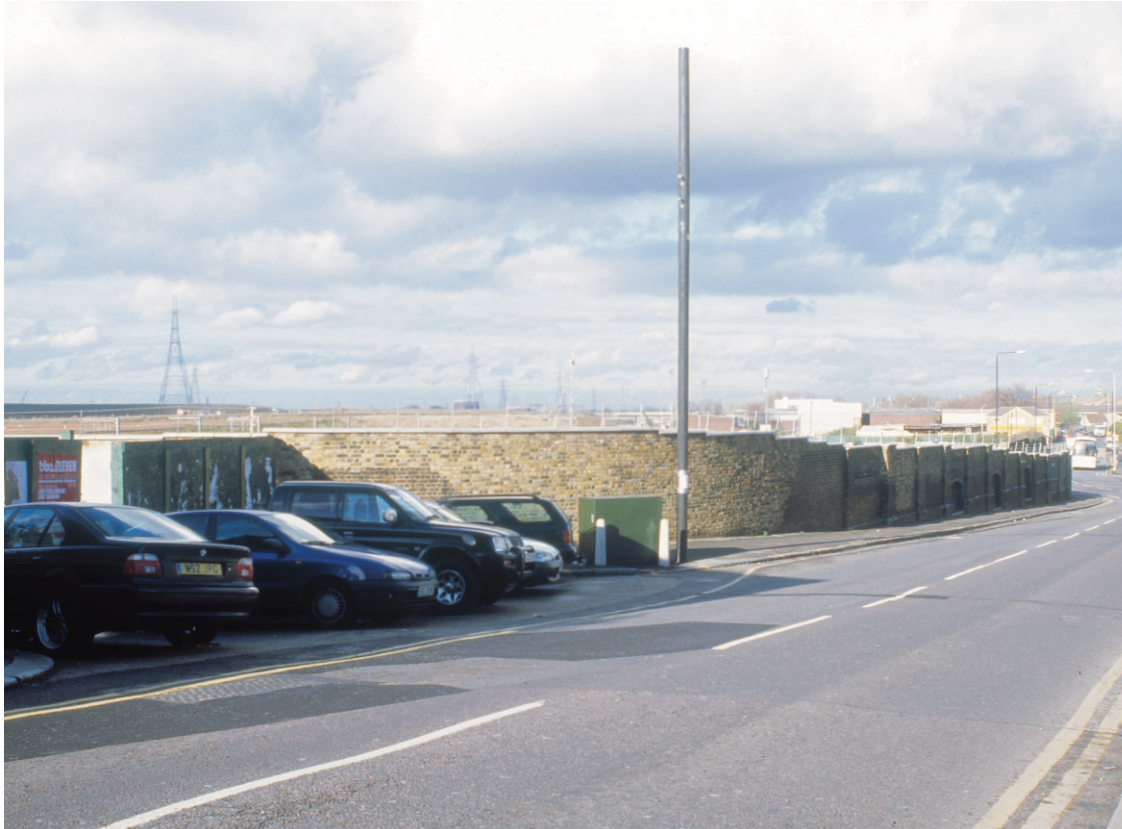
The site is situated on the western side of Angel Lane, on the northern side of a lay-by (Fig 9). The lay-by was formerly Station Road, the approach road to Stratford Railway Station and the access road for the main entrance gate to the locomotive works. The road went out of use and was removed after 1977, when it was shown on the Ordnance Survey map of that date (Fig 8).

Fig 9 Site of the former Hydraulic House and Station Road, looking north-west

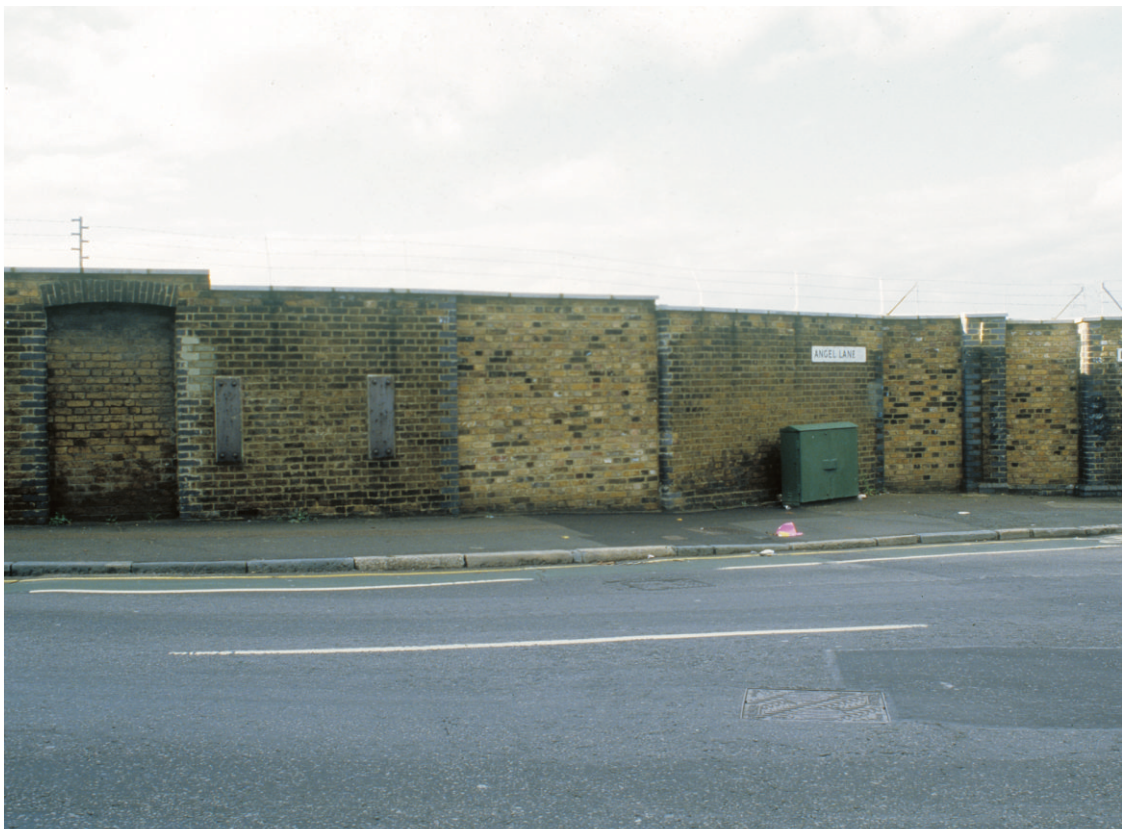
The northern end of the east-facing elevation of the wall in Angel Lane belonged to No. 2 Entrance Gate (Fig 10), one of four gates which allowed vehicles and employees to pass in and out of the locomotive works site. At the northern end of the wall, at the junction of Angel Lane and Leyton Road, were two door openings with blue brick dressings on the reveals. The openings had been blocked with re-used yellow London stock bricks, but when originally open, they would have allowed the regulated flow of staff in and out of the works, perhaps through turnstiles. To the south of the narrow blocked door openings was a wider opening, with blue brick reveals and also blocked with yellow London stock brick. The opening was 2.58 metres wide, sufficient width for a single vehicle to pass through.

Fig 10 Site of No. 2 Entrance Gate, looking west

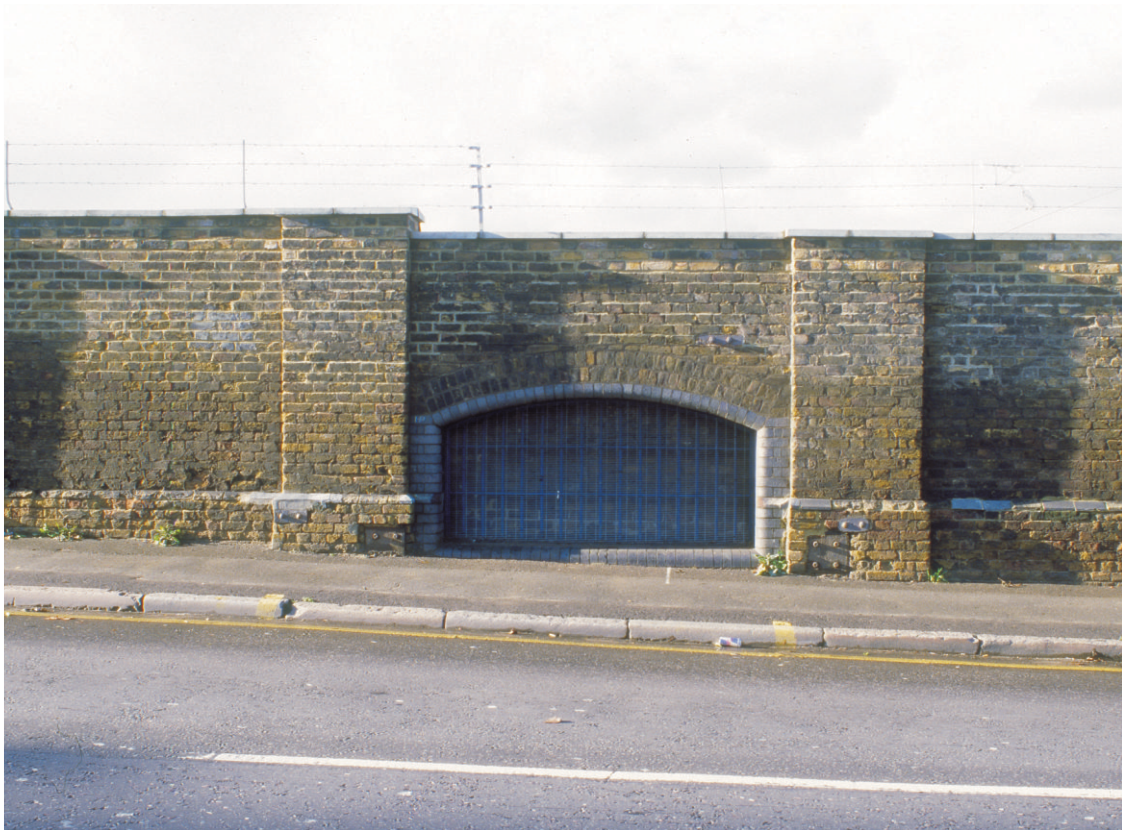
To the south of the rebuilt section, the wall changed character; a mixture of red and yellow stock bricks in Flemish bond were used in its construction. The wall is punctuated by a series of broad pilasters, with a continuous plinth running along the length of the wall. Window openings with blue brick dressings were interspersed along the length of the wall; these had wrought iron railings to prevent glass window panes from being broken; the windows were later removed and the windows blocked with yellow stock bricks. The level and height of the windows varied along the length of the wall; towards the northern end of the wall, where the ground level was lower, the window sill was 1.13 metres above pavement level (Fig 11). Further south, where the ground level was higher, the window sills were at pavement level with the remains of a concrete sill also visible at a higher level in the wall (Fig 12). This suggests that the foundry had at least two storeys; a ground floor, which would have had the appearance of a basement towards its southern end, and a 1st floor.

Fig 12 Blocked window opening lighting a room below street level in the former Brass Foundry, looking west

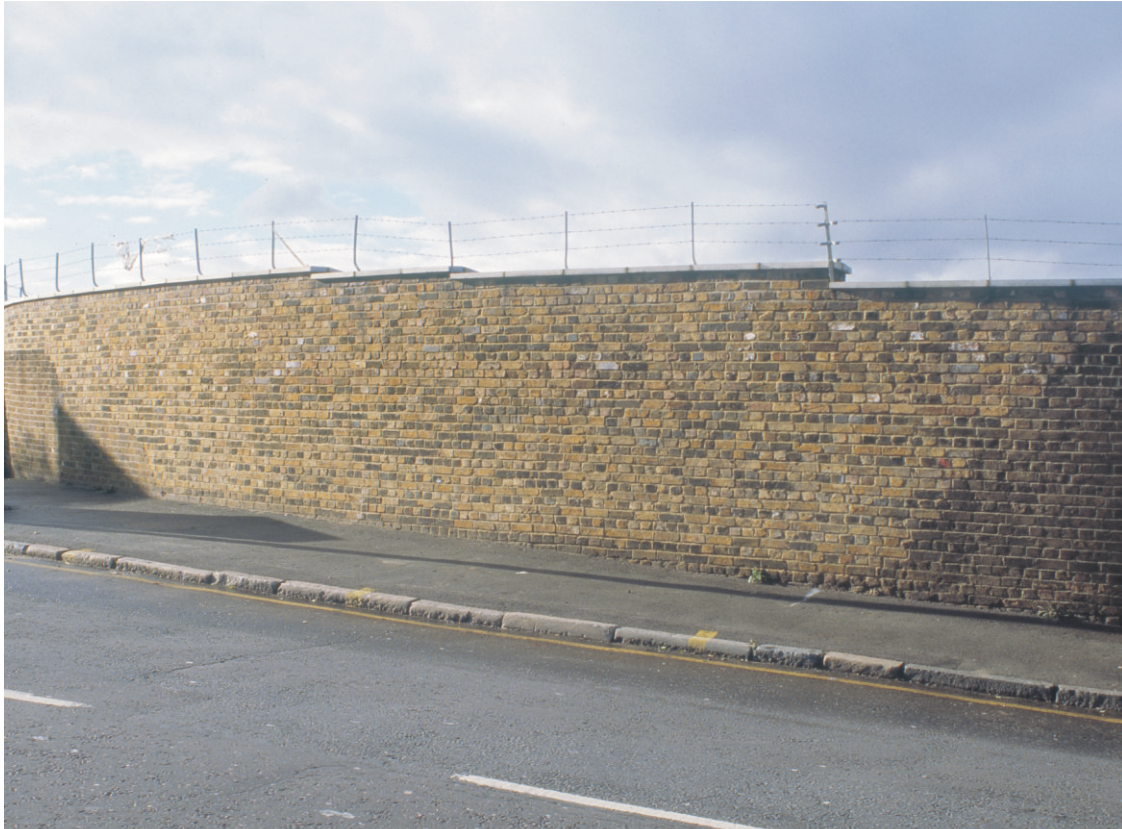
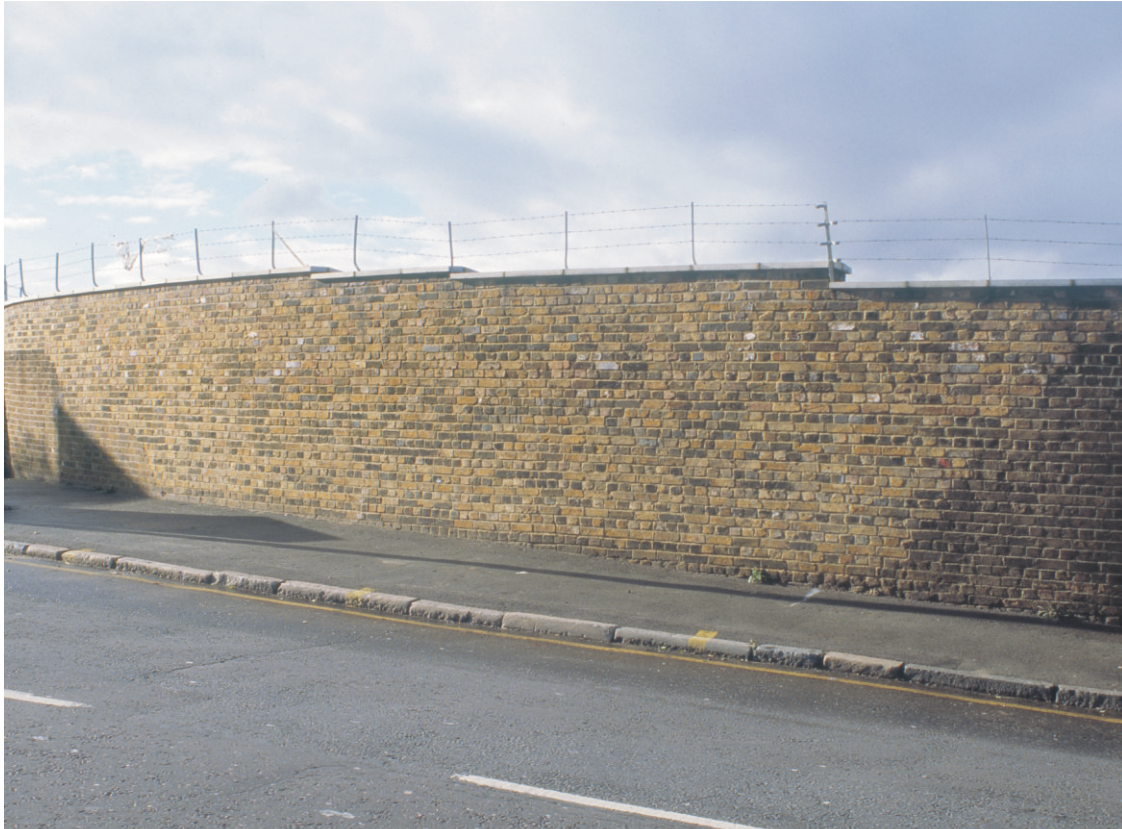
The southern end of the wall, which corresponded with the hydraulic house, was constructed of yellow stock brick in English bond, was rebuilt using re-used yellow stock bricks, probably within the last twenty years (Fig 13). Unfortunately, this has removed any trace of door or window openings which might have been associated with this structure.

Fig 13 Repaired section of the wall on the site of the former Hydraulic House, looking west

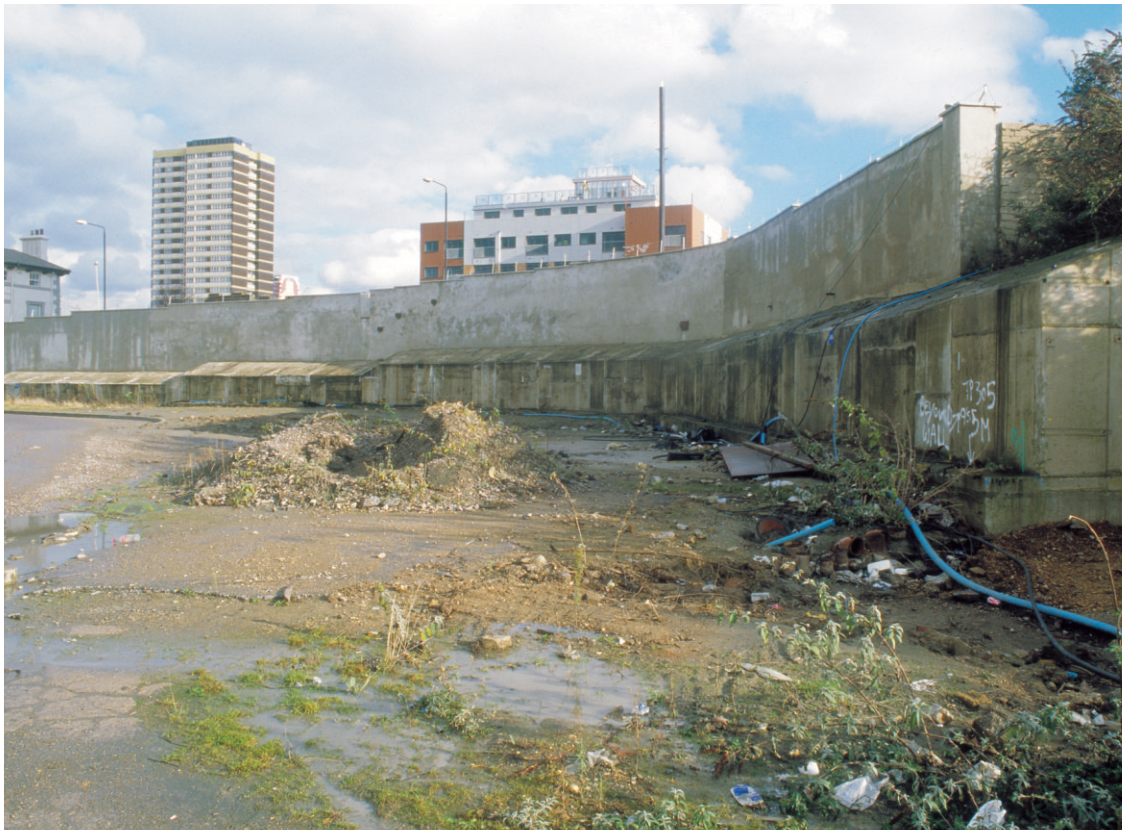
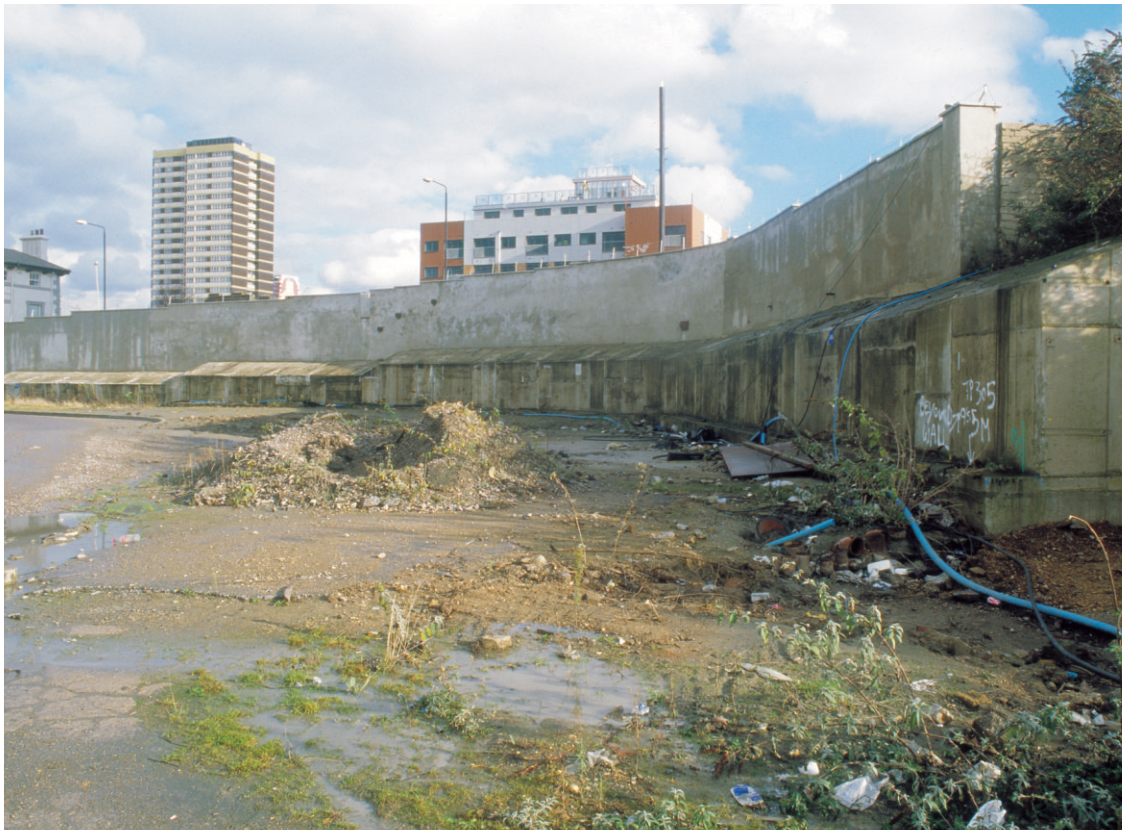
Fig 14 Site of the Hydraulic House, looking east

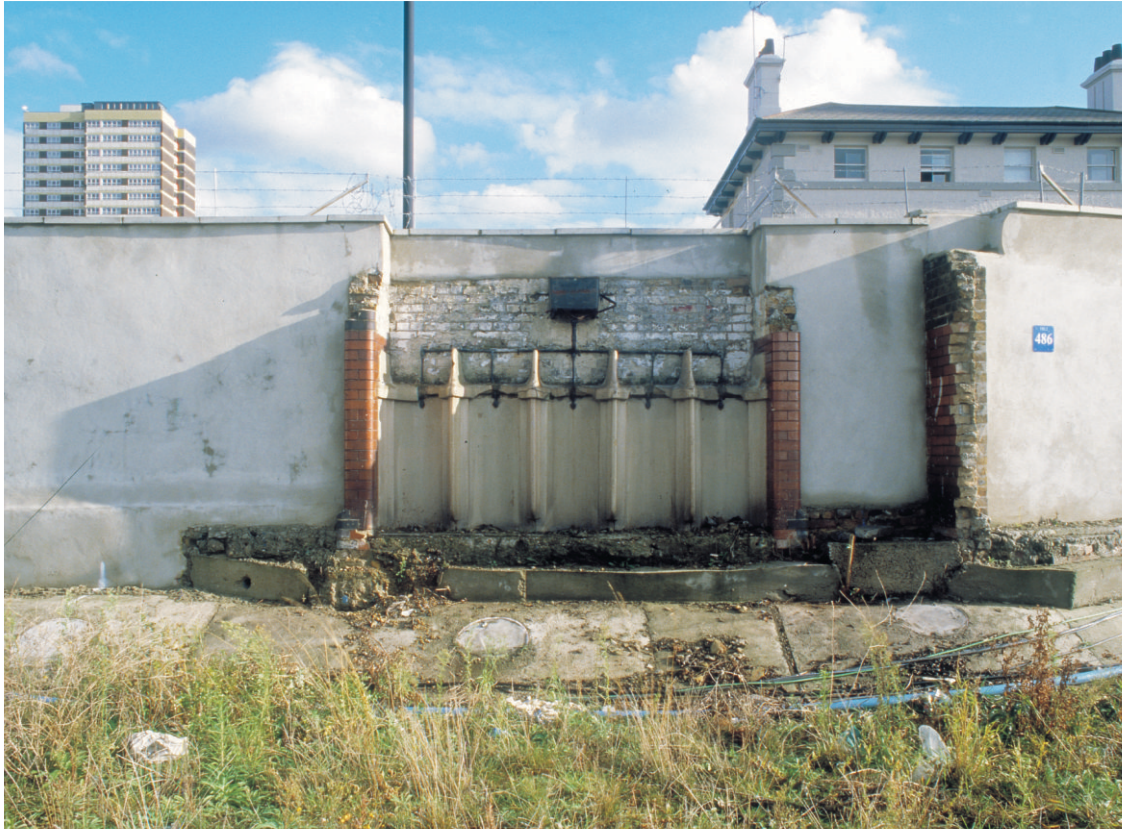
The west-facing side of the wall has been covered with a cement render, obscuring the blocked window and door openings that were visible on the east-facing elevation. A concrete buttress was constructed along the length of the wall to provide support (Fig 14). The wall was correspondingly featureless, aside from the remains of urinals on the northern side of No. 2 Entrance Gate. Glazed brick partition walls contained five ceramic urinals, with a central cistern flush (Fig 15).

Fig 15 Site of the Men's lavatories on the north side of No. 2 Entrance Gate, looking east
