UNITS 5-7
Vanguard Trading Centre
16 Marshgate Lane
E15

London Borough of Newham

Standing building survey report

April 2008

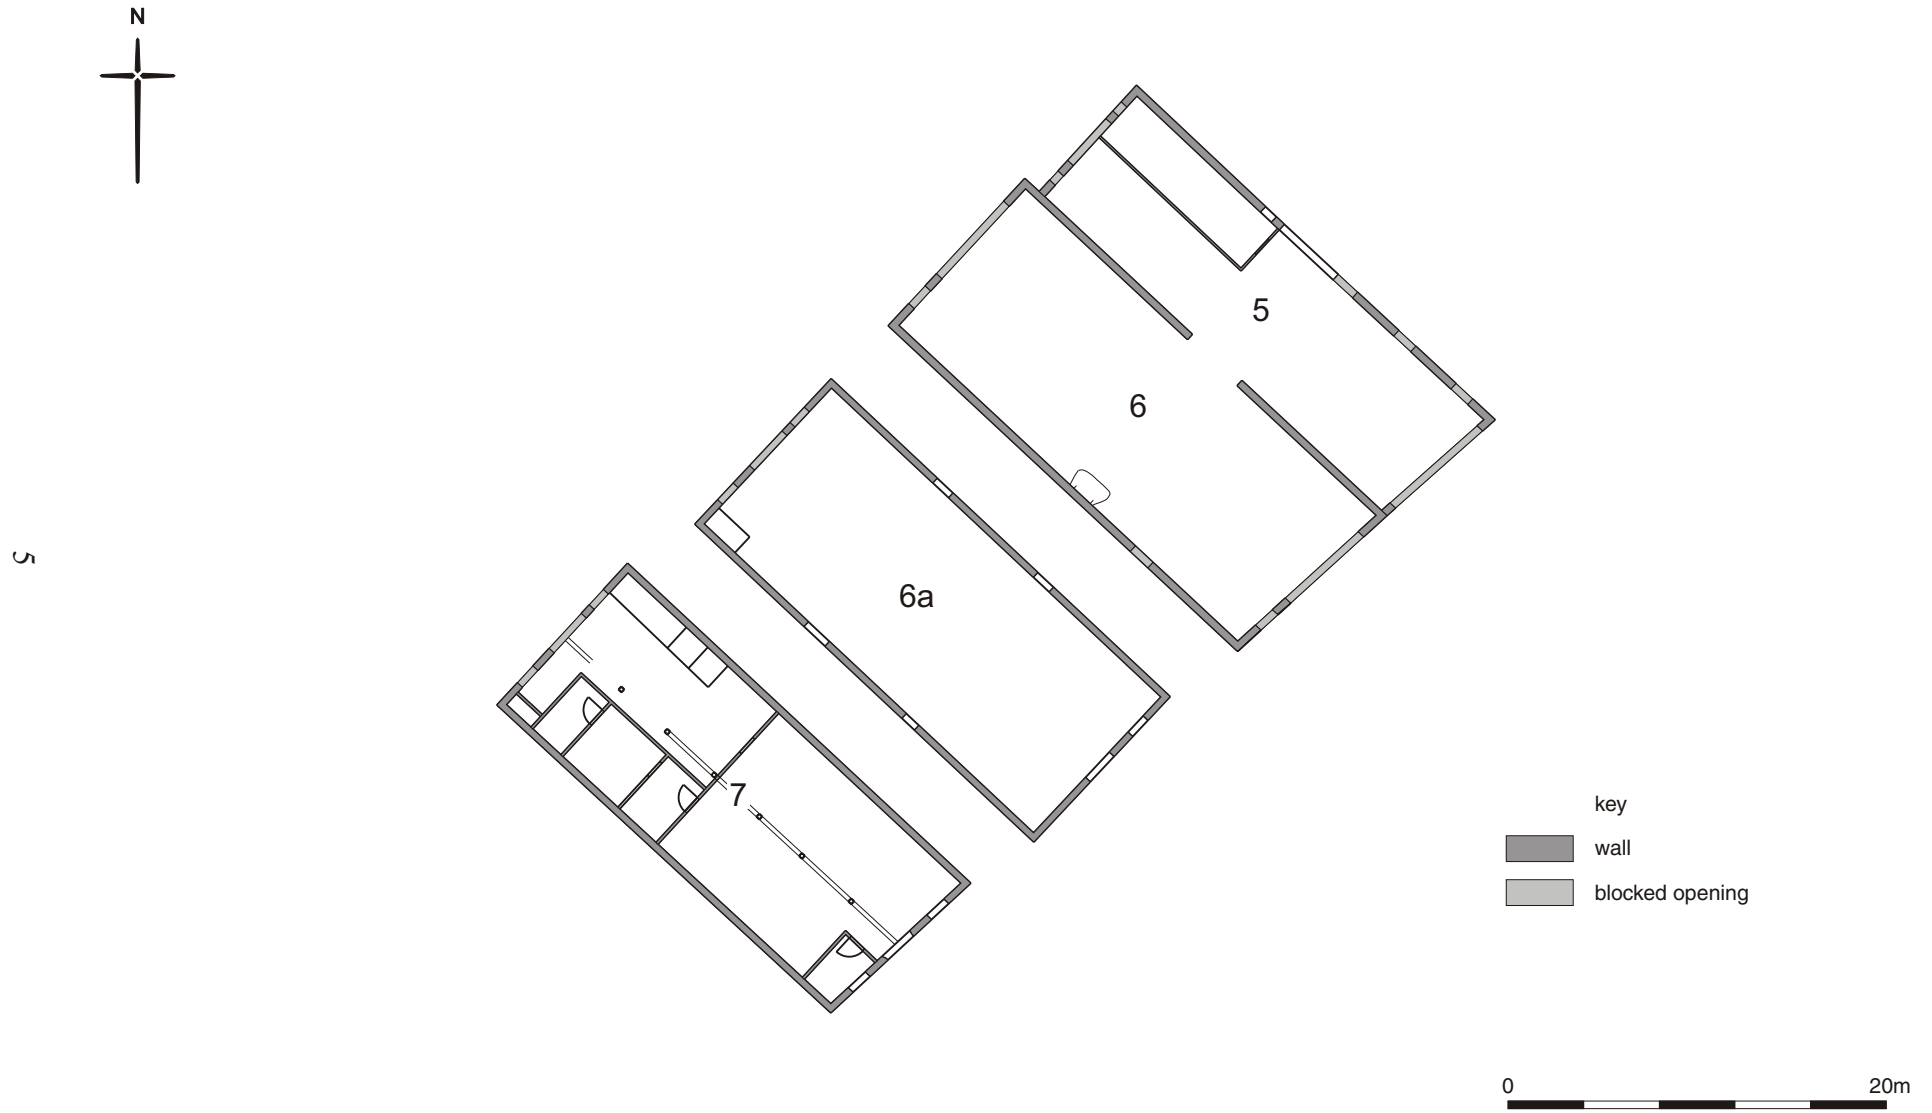
Fig 2 Plan of Units 5-7 at ground level

Plans of the ground floor of each structure and of the 1st floor of Unit 7, and the north-facing external elevation of Units 6, 6a and 7 (*Fig 2-Fig 4*) are reproduced in this report.

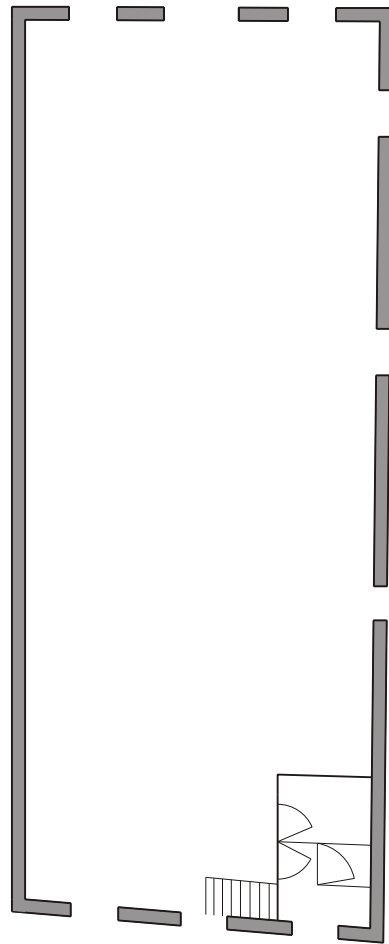
Fig 3 Plan of Unit 7 at 1st-floor level

The upper floor in Unit 7 was of timber, although the details of its construction were not visible above a plaster-board ceiling, and was supported by six cast-iron columns in a line positioned centrally on the ground floor. Small ground-floor partition walls of match-boarding were built forming cubicles or small offices and store-rooms. The upper floor was plain and devoid of fixtures and fittings.

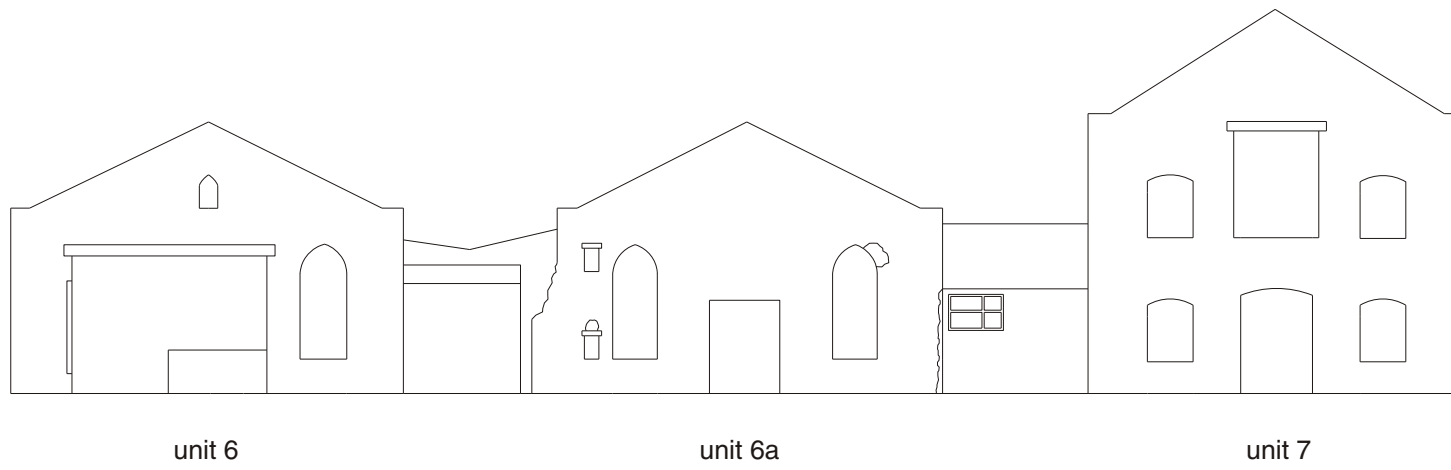
Fig 4 North-facing elevation of Units 6-7

The location and exterior of the standing buildings was determined in outline on the modern Ordnance Survey plan. Sketch plans of the ground floor and upper floor in Unit 7, and the north-facing elevations of Units 6, 6a and 7 were drawn, to which dimensions were added. These drawings have subsequently been redrawn accurately in AutoCAD, in which form they can be reproduced at any scale (*Fig 2-Fig 4*). Details of the construction, development and function of the internal and external elements of the building were noted.

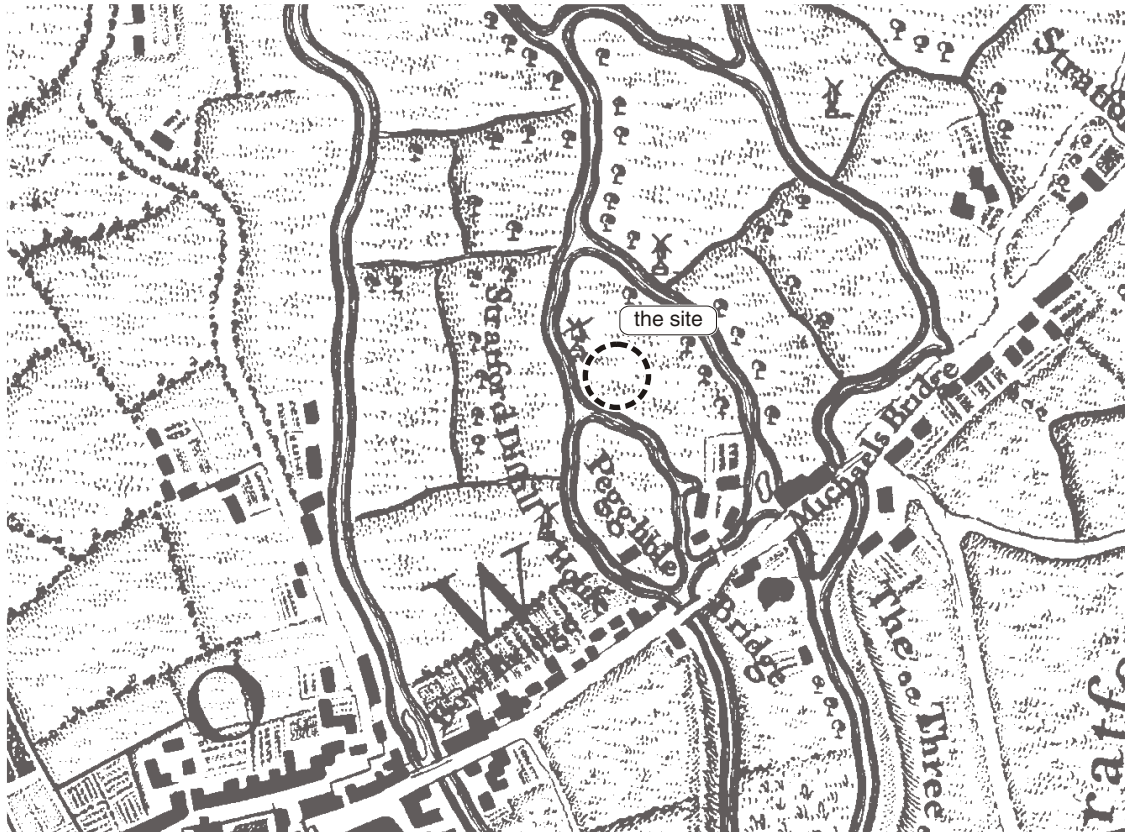
Fig 5 The site in 1746 (Rocque)

During the Middle Ages three water-mills can be identified from maps and documents on sites north of Stratford High Street. The mills on the River Lea and its branches were tidal, and for most of their history they depended solely on water power. The mills were employed mainly in grinding grain for flour, although in the 13th and 14th centuries there were references to fulling mills on two sites, and in the late 16th and early 17th centuries several mills were manufacturing gunpowder. The marshes by the River Lea provided ample room for industry; the river was navigable and furnished power for a group of tidal mills. The large number of water-mills on the Bow Back Rivers meant that there were fierce struggles for control of this valuable resource (Powell 1973, 89–93). A number of windmills were constructed to counter this problem, of which one was constructed adjacent to the present site (*Fig 5*).

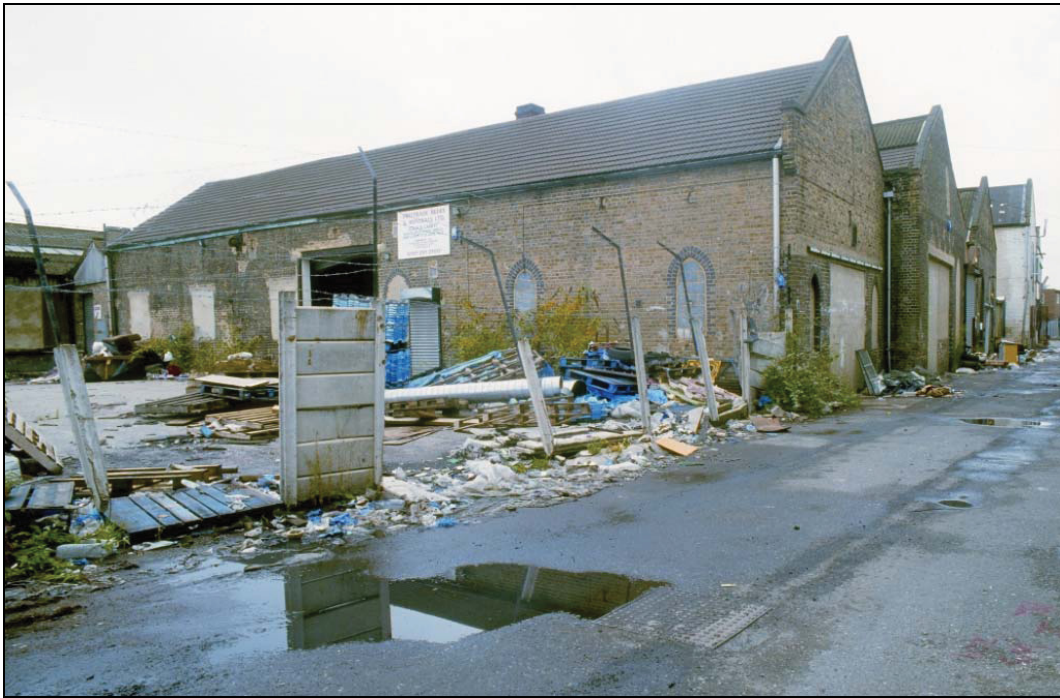
Plate 1 Exterior of Units 5-7, looking south-west (MoLAS 318/07/015)

The three eastern buildings, Units 5, 6 and 6A, were large, single-storey buildings constructed with load-bearing brick walls (*Plate 1*). Unit 7 was of similar construction, but within the same height of roof it had in addition an upper floor, which was supported on three centrally-positioned cast-iron columns (*Plate 2*). Every building had a simple pitched roof, its ridge running from north to south. The original roofs were probably slated, and Unit 6 had a roof which was slightly raised along its ridge with skylights, but subsequently the roofs had been replaced and at the time of survey were covered partly with slates, tiles and corrugated asbestos sheeting. The range of four buildings was situated at the centre of the Vanguard Trading Centre, with a later building, Unit 8, situated to the west and the City Mill River flowing beyond a substantial brick wall to the east.

The bricks in the walls were generally yellow and brown stocks, laid to English bond except in the gables of the single-storey buildings, where the bond was Flemish. The latter difference, seen in other buildings of this type, may indicate that the gables were expected to carry a lesser structural load; the gables in Unit 6 at least were thinner than the lower part of the end-walls. Unit 7 was two-storey, and its end walls were built in English bond all the way up. In Units 5, 6 and 6A, lancet window openings were dressed with dark blue engineering bricks, bull-nosed at projecting corners. Unit 7 had segmental-arched window

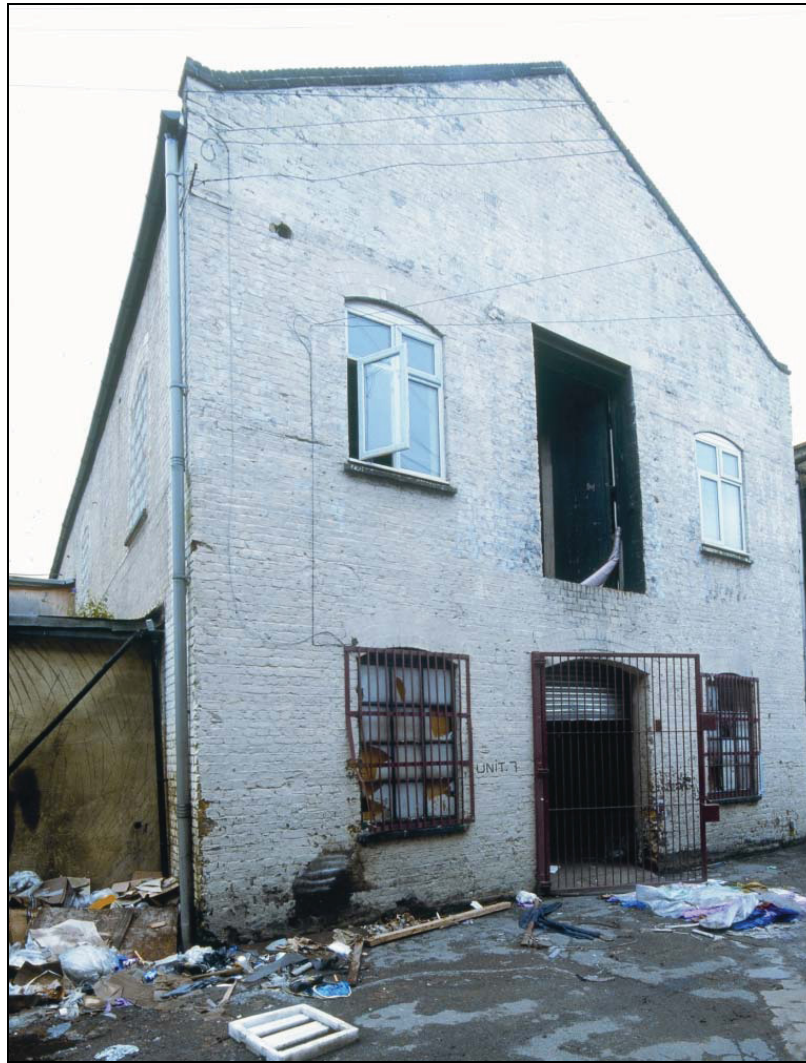
Plate 2 Exterior of Unit 7, looking south (MoLAS 318/07/016)

The window and door openings in Unit 7 were headed with segmental arches, rather than pointed arches as in the case of Units 5, 6 and 6A. Subsequently these openings had been blocked with PFA cement blocks in the east- and west-facing external elevations. The north-facing external elevation had a central door opening flanked by segmentally arched

windows at ground-floor level, and identical windows above at 1st-floor level. A squared opening with a concrete lintel was situated centrally above the main entrance, and the remains of an iron bracket on the eastern side of the lintel suggested that there had formerly been a crane fixed there to raise materials to and from the upper floor level. The opening may have been an enlargement of an earlier opening or window.

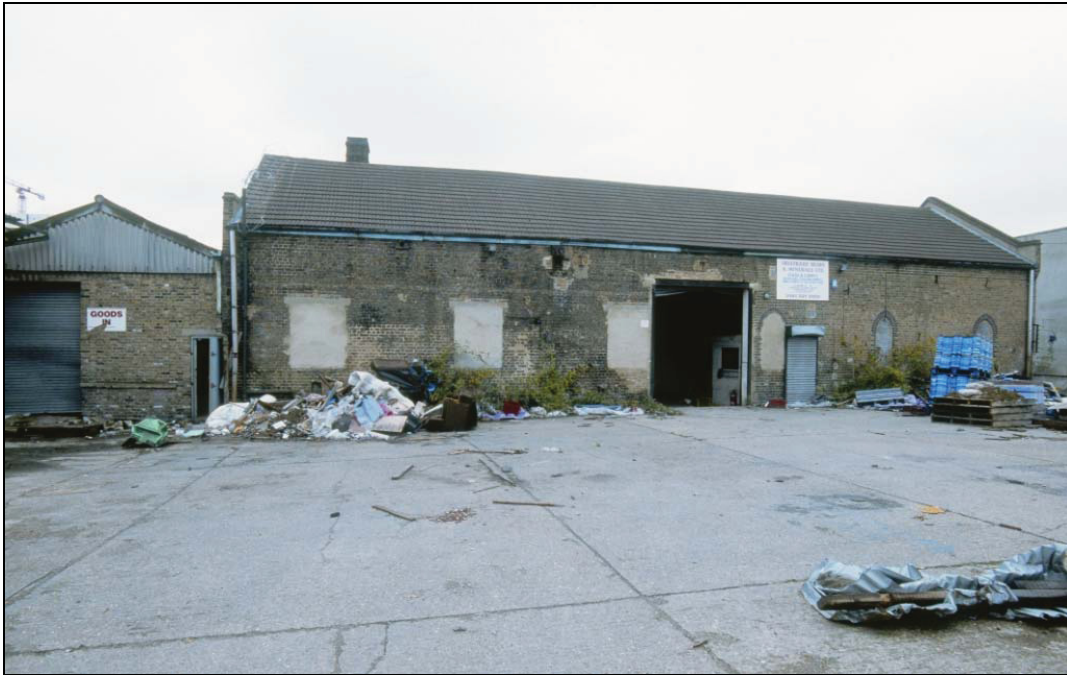
Plate 3 Exterior of Unit 5, looking west (MoLAS 318/07/001)

Unit 5 was situated at the eastern end of the site and contained blocked window openings in its east-facing external elevation, marking six bays (*Plate 3*). The three northernmost lancet window openings retained their dressings of engineering bricks, but the three southernmost windows had been enlarged, probably at an early date, with the addition of concrete lintels. All six window openings in this façade were subsequently blocked with PFA cement blocks, and the blockings in all but the two windows at the north end of the elevation had then been rendered with cement. Two door openings with RSJs for lintels were made in the east-facing elevation, partially truncating the earlier window openings, including one wide roughly central opening. Traces of a steel-framed canopy or porch, since removed, were observed to the east of Unit 5, which would have sheltered the entrance to the building and provided additional open-sided storage space.

The north-facing external elevation had a blocked opening at the centre, flanked on each side by a lancet window opening. The southern side of Units 5 and 6 was abutted by a later brick shed.

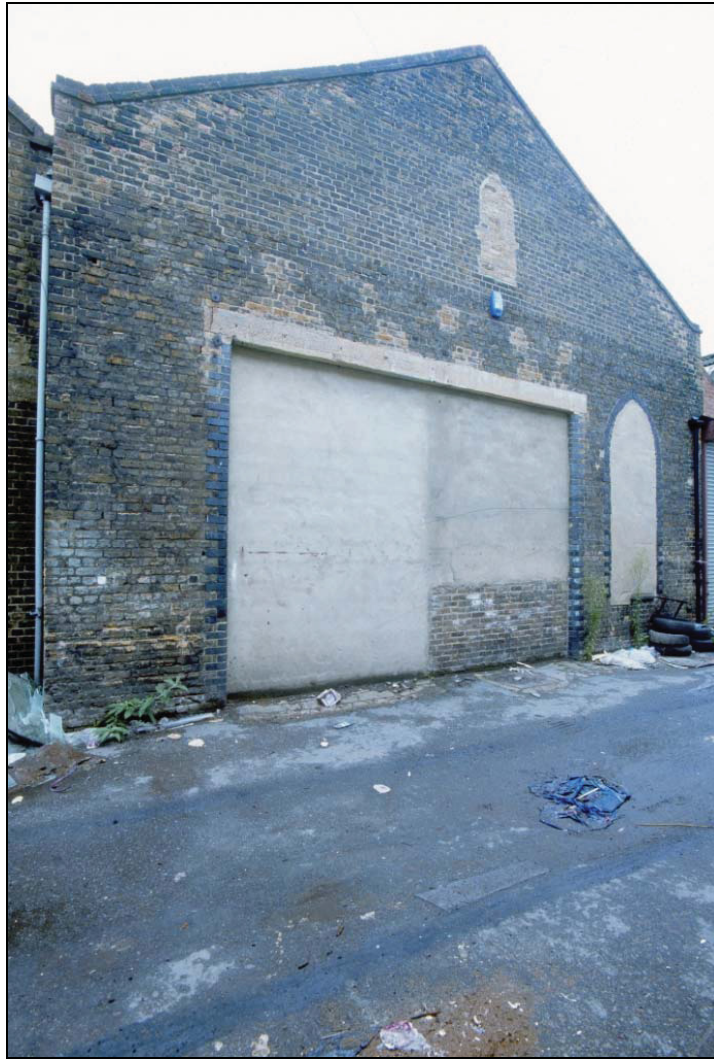
Plate 4 Exterior of Unit 6, looking south (MoLAS 318/07/007)

Unit 6 was situated immediately to the west of Unit 5, and they shared a common side wall, in which was a wide opening between the two buildings. Units 5 and 6 are therefore interpreted as contemporary with each other. The north-facing external elevation of Unit 6 would probably have originally had a central door flanked on each side by a lancet window. A large door opening with a concrete lintel and blue engineering brick dressings was inserted, probably in the mid to late 20th century, replacing the eastern window (*Plate 4*). The door, the remaining flanking window, and a much smaller lancet window in the gable above, lighting the roof, were all later blocked and the blocking rendered with cement.

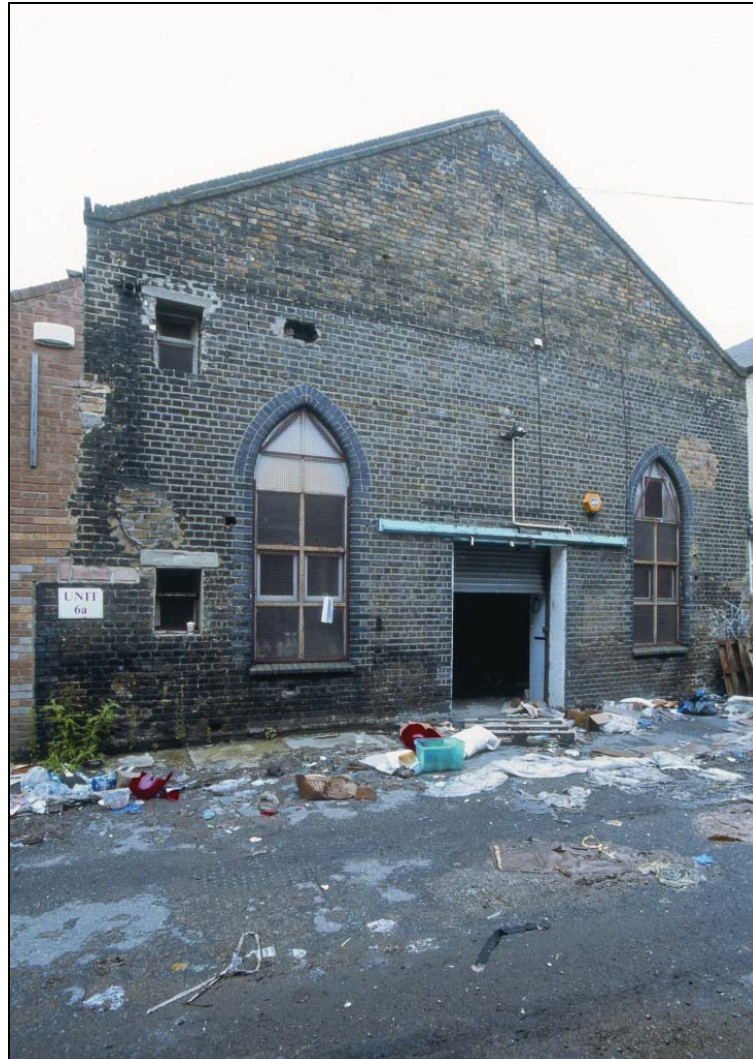
Plate 5 Exterior of Unit 6a, looking west (MoLAS 318/07/017)

Unit 6A was constructed separately from Units 5 and 6, possibly although not necessarily at a different time. The east wall of Unit 6A was physically separated from the western wall of Unit 6 by a gap varying in width between about 3m and 4m. This gap could originally have provided light and access to the sides of both buildings. Although this passage had been roofed with a metal and timber frame, probably in the late 20th century, there were traces of an earlier roof frame, entirely of timber, carried on brick corbels opposite each other in the walls of both Units 6 and 6A. To judge by the old and new profiles visible in the southern end wall, both roof frames took the form of simple lean-tos, with a central valley. The east wall of Unit 6A contained at least eight small square openings at ground level, at regular intervals, interrupted by doorways with segmentally-arched heads. All these openings had subsequently been blocked with brick.

The north-facing elevation of Unit 6A would have been largely identical to that of Unit 6, notably including lancet window openings. This elevation retained a small central door, though altered by the addition of a concrete lintel, flanked by lancet windows. A major internal modification, the addition of an upper floor over an office on the ground floor, was reflected externally by the insertion of two small windows at the eastern end of the north-facing external façade (*Plate 5*). The south-facing external elevation was largely identical to

the north-facing elevation, with the addition of a short square-section internal chimney stack in the south-eastern corner. This chimney would have served a furnace, presumably for some industrial purpose, but all evidence of openings or flues was absent from the base of the stack.

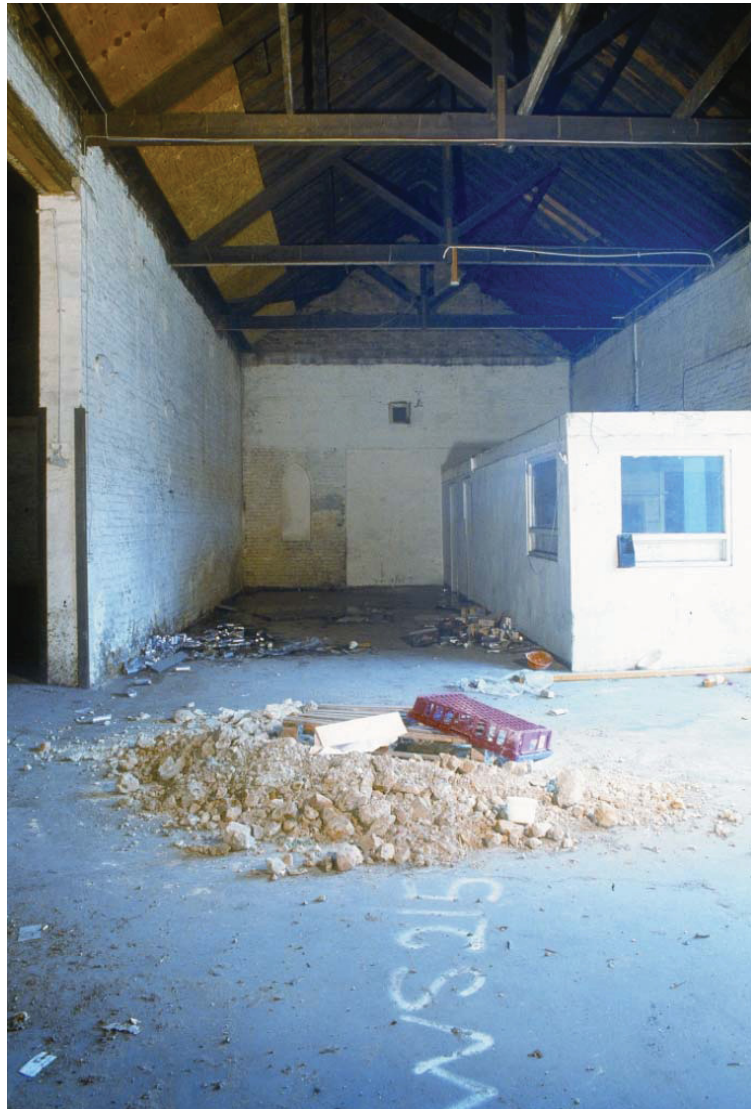
Plate 6 Interior of Unit 5, looking north (MoLAS 374/07/01)

Both these buildings were characterised by the presence of substantial timber roof frames, which were probably original. The roof frame of Unit 5 contained five king-post trusses, situated between each of the six window bays (*Plate 6*). The base of each king post was slightly jowled to support an angled side-strut on each side, running up to a blade (rather than a principal rafter), with a side-purlin being on the outer edge of the blade. The common rafters were fixed to the outer edge of the purlins, both side purlins and ridge purlin. The upper ends of the blades were strapped and bolted to the jowled top of the king posts, while the bottom of the king posts was bolted to the tie-beam with an iron stirrup. The roof was boarded under tiles and slates.

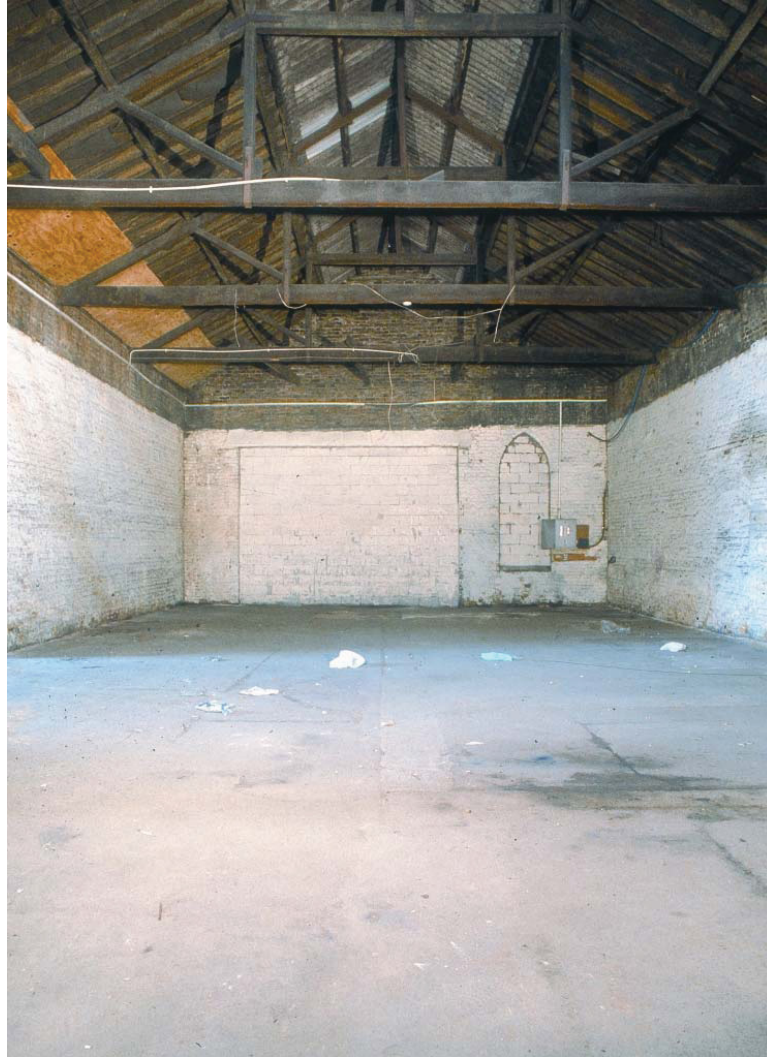
Plate 7 Interior of Unit 6, looking south (MoLAS 374/07/02)

The roof frame of Unit 6 was slightly more complicated, mainly to allow for inclusion of skylights to either side of the ridge (*Plate 7*). There were five trusses, spaced as in Unit 5, the tie-beam in each truss supporting two queen posts, one to either side of the central pair of skylights. From the base of the outer faces of the queen posts, which were not jowled, angled side-struts ran up to the blade, as in the roof of Unit 5. The queen posts were attached with iron stirrups to the tie-beams, fixed with cottered pins. The tops of the queen posts were connected by a straining beam, fixed with bolted iron straps, and longitudinal braces ran from each straining beam up to the ridge piece. A single such brace bore off the brick gable at the end of each roof frame, and simple, rather slight timber ties ran from the tie-beams in the end trusses to the brick end-walls. The roof pitches to either side were felted and probably boarded, while the former skylights had been replaced with corrugated asbestos sheeting.
