ALBYNS FARM Havering

Standing Building Survey

June 2008

Site Code: ALF08
National Grid Reference: 552944 183945

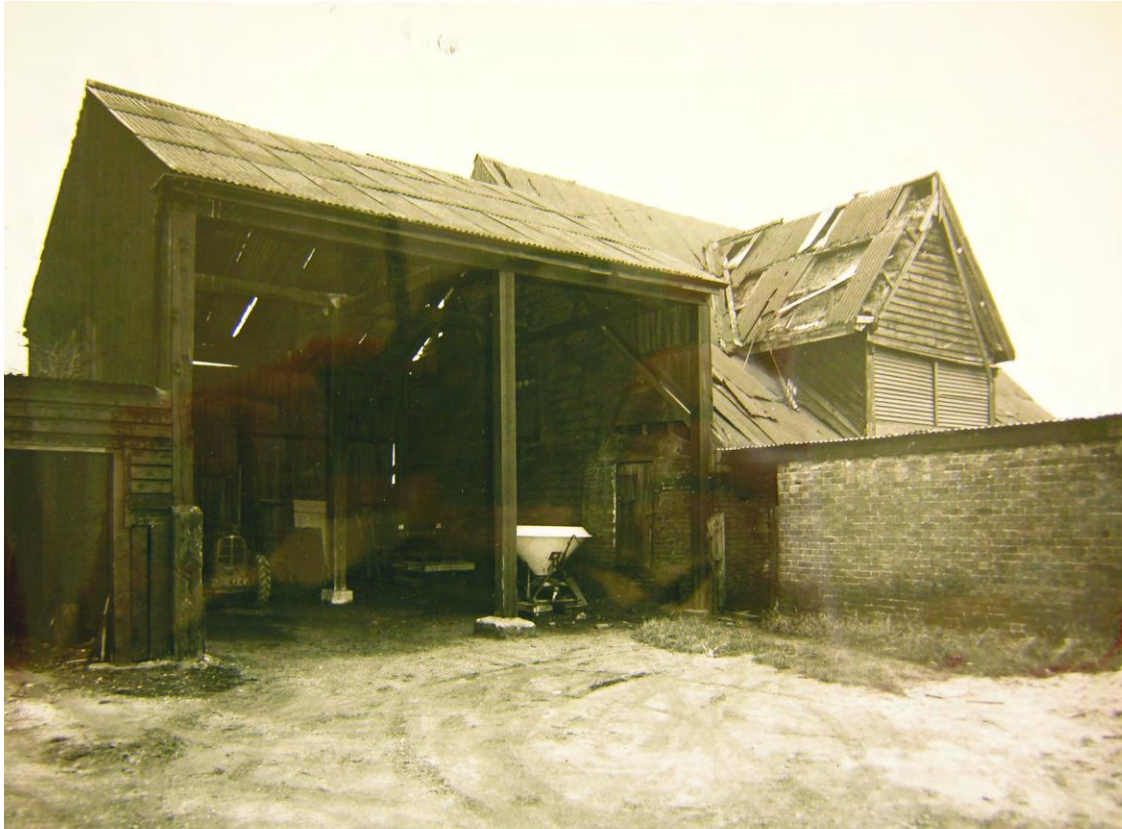
Fig 8 The barn at Albys Farm in the mid 20th century

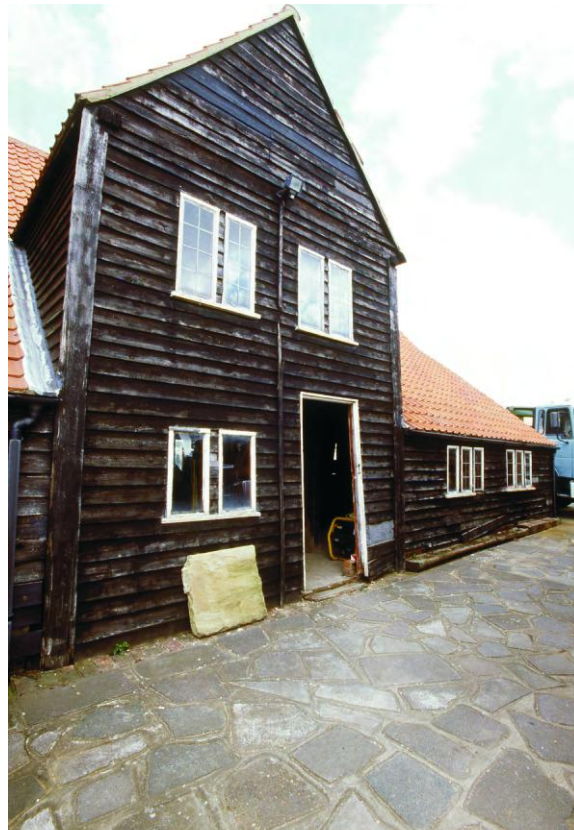
Fig 9 The wagon entrance and catslide roof in the south-facing facade of the barn

The earliest part of the structure is the four-bay barn, clad with black-stained weatherboarding and a pantiled roof (Fig 9 & Fig 10). The barn comprises trusses A-E and bays W-Z. A brick plinth wall, which carries the oak timber frame, is laid in Flemish bond, of which seven courses are visible at the western end of the building (Fig 11). Phase 1 of the barn is of box frame construction; a sill beam, laid on top of the brick plinth wall, supports ten posts, none of which are jowled, on which the wall plate is carried. The north and east external walls, and the former external walls on the south and west sides have mid rails between each post, with timber studs between the sill beam, mid rails and wall plate. Downward braces are positioned above the mid rails on all sides of the structure, and the northern and southern wall plates are each composed of two long lengths of oak, with a face halved and bladed scarf joint near the approximate centre of each wall plate.

This was an early addition to the structure, with the oak timber posts and studs at the western end of the structure appearing to date to the 18th century. The eastern side had been recently rebuilt, perhaps during the restoration works in the 1980s. The rafters and studs were second hand and ranged in date from the 18th to the early 20th centuries, some with merchants marks scribed on. After the construction of the eastern end of phase 2 the sill beam and timber studs at the southern end of Bays Y and Z were moved north by approximately 1.2 metres in order to incorporate an animal byre or stable. A photograph of the barn in the mid-20th century shows that the exterior of phase two was clad with brick (Fig 8). This was removed and replaced with machine cut softwood planks during the restoration work in the 1980s.

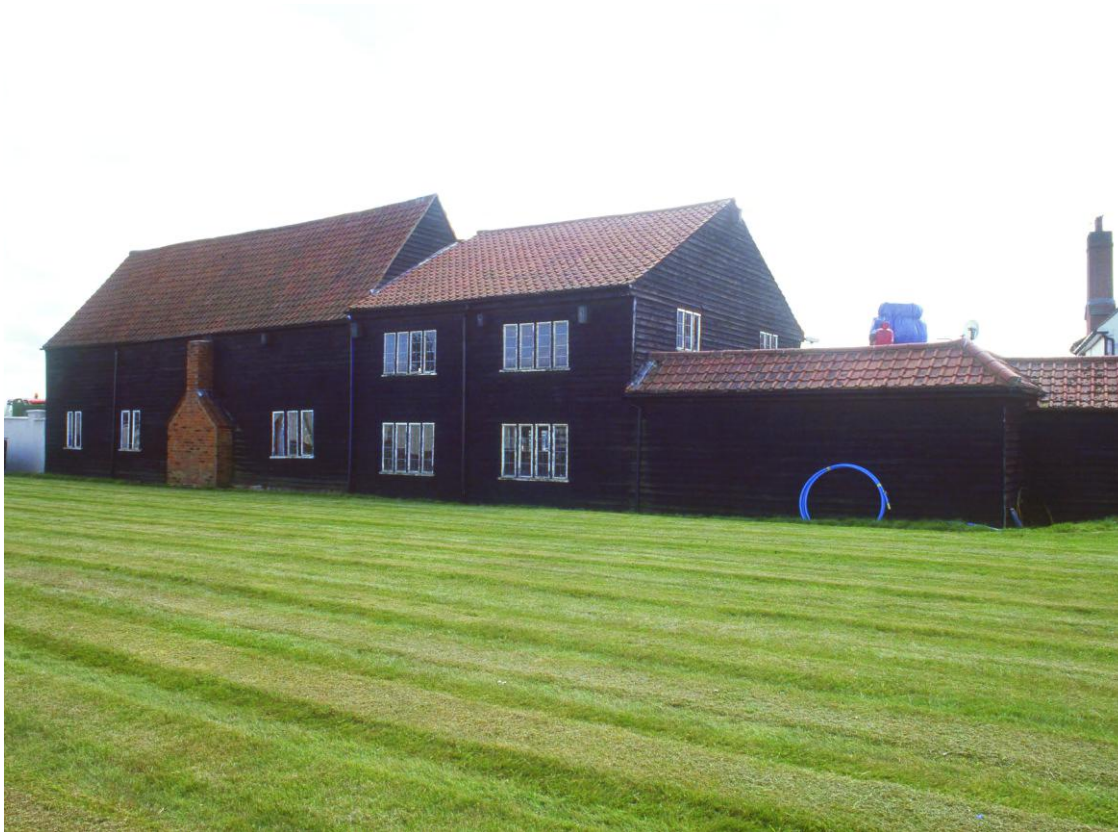
Fig 10 The north-facing external facade of the barn

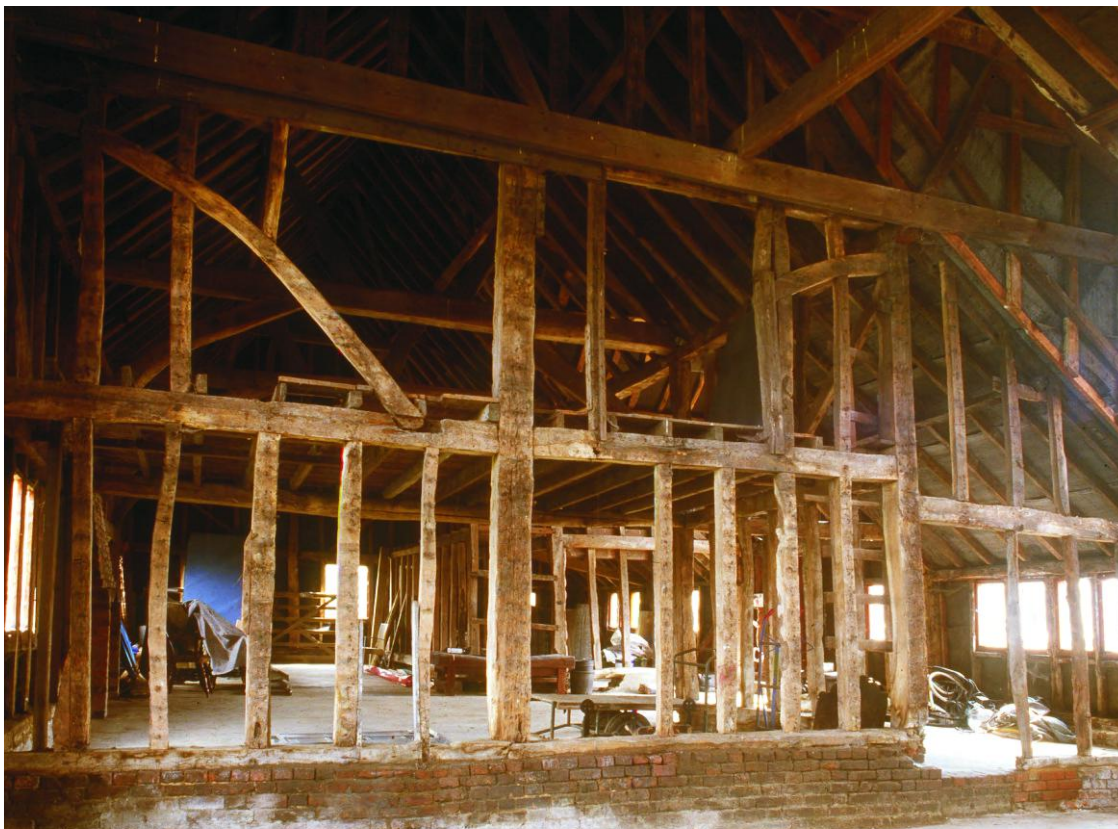
Fig 11 The west gable end of phases 1 and 2 of the barn

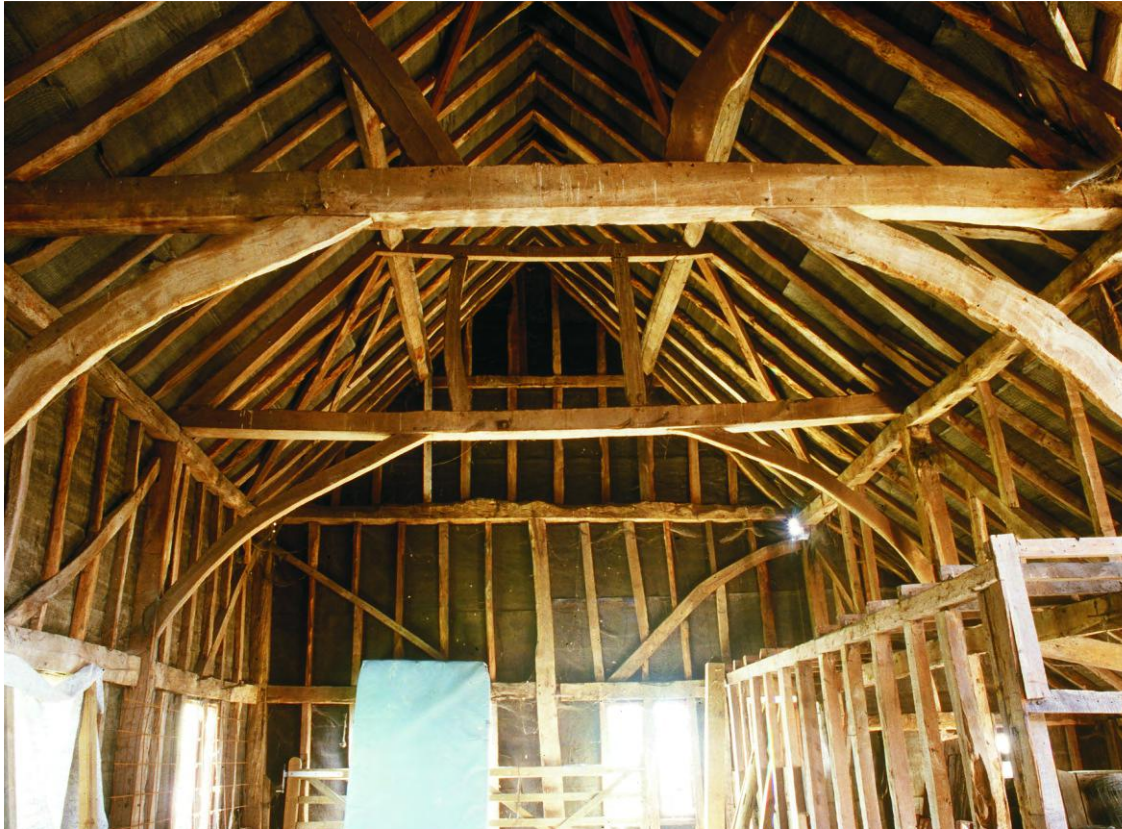
Fig 12 The roof trusses C and D, looking east

The roof trusses are carried on the wall plate above each post. The trusses are of two types; trusses B and C are tie beam roof trusses with raking queen posts and arch braces to the tie beams, whereas truss D is a modified version, with vertical queen posts and a queen post tie beam with clasped purlins over (Fig 12). The timbers used in the construction of truss D are more slender than those in trusses B and C, but are similar to those used in truss E, the eastern gable end of the barn.

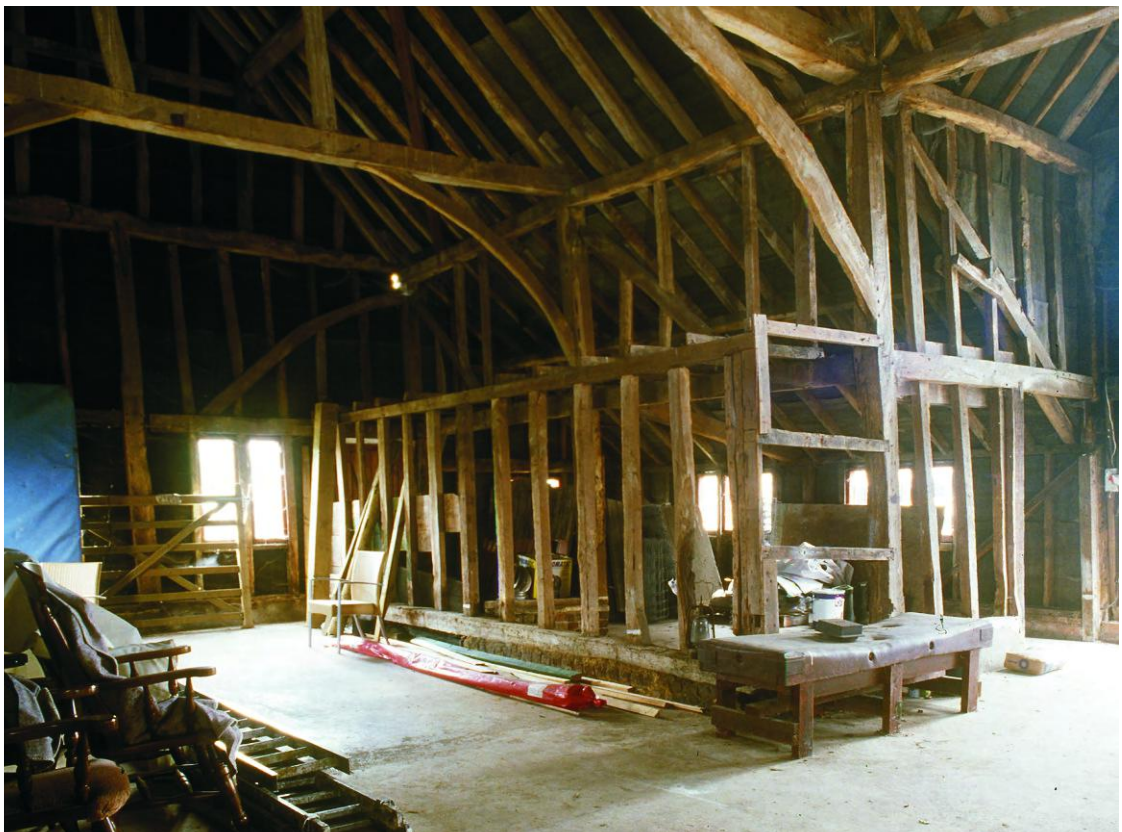
Fig 13 The animal byre or stable in the south-east corner of the barn

The southern ends of Bays Y and Z were altered by the construction of an animal byre or stable in the eastern side of phase 2 (Fig 13). The southern end of bay X is occupied by the formerly projecting gabled porch of the wagon entrance. The eastern and western sides of the porch were later abutted by the catslide roof lean-tos of Phase 2. A pair of bolted oak knees over the porch may be a later addition to strengthen the structure, or may be contemporary with the construction of the barn, and would date to the 18th century onwards. The northern end of bay X has been altered by the addition of a brick fireplace

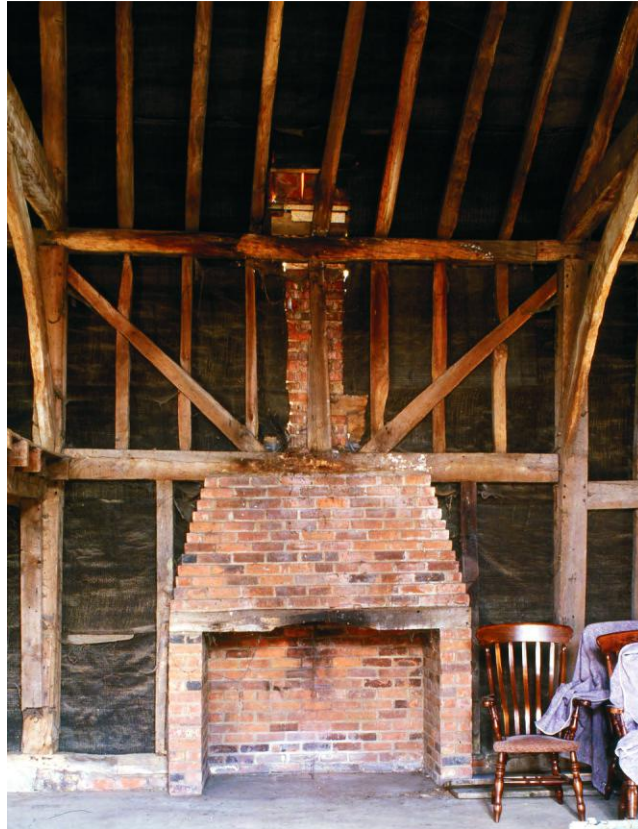
Fig 14 The fireplace inserted into the north wall of Phase 1 of the barn

and chimney stack (Fig 14). The fireplace was constructed on a rough concrete plinth, dating its construction to the early-mid 20th century. The construction of the fireplace necessitated the raising of the mid rail, the replacement of the lower studs and the shortening of the upper studs and braces (Fig 15). The barn was used as a blacksmith's workshop during the 20th century and the chimney stack was partially demolished in the 1980s (Rob Cox, pers com).

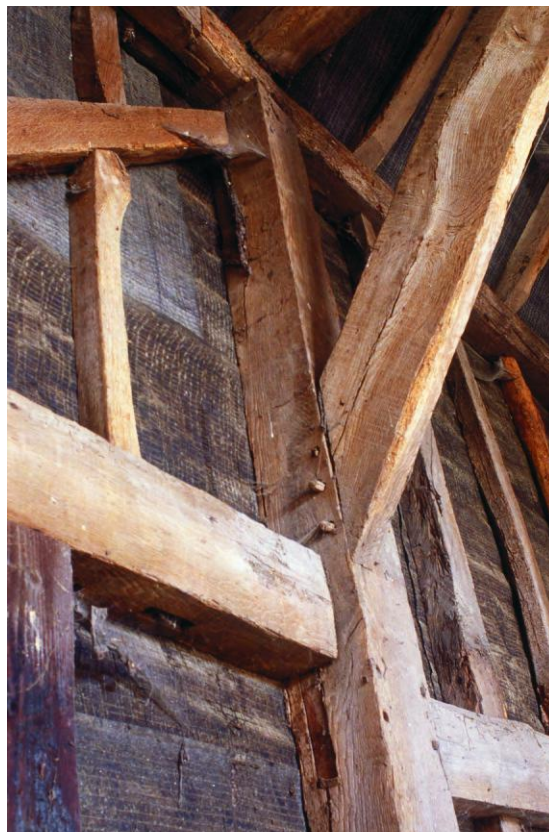
Fig 15 Detail of the raised midrail above the fireplace and the face-halved and bladed scarf joint in the wall plate

Various common forms of mortice and tenon jointing were used through out the phase 1 structure. Most of the minor stud tenons were not pegged, only the main wall posts. A well preserved 'face halved and bladed' scarf was found in both the wall plates. Hewett has found this joint in timber buildings from the late 16th century to Victorian periods (1980:269). The use of a pair of bolted on oak knees over the main barn porch is generally found in buildings on the 18th century in SE England (eg. Hewett 1980:256 in the House Mill at Bow on the R Lea/ Photo 144/01/007).

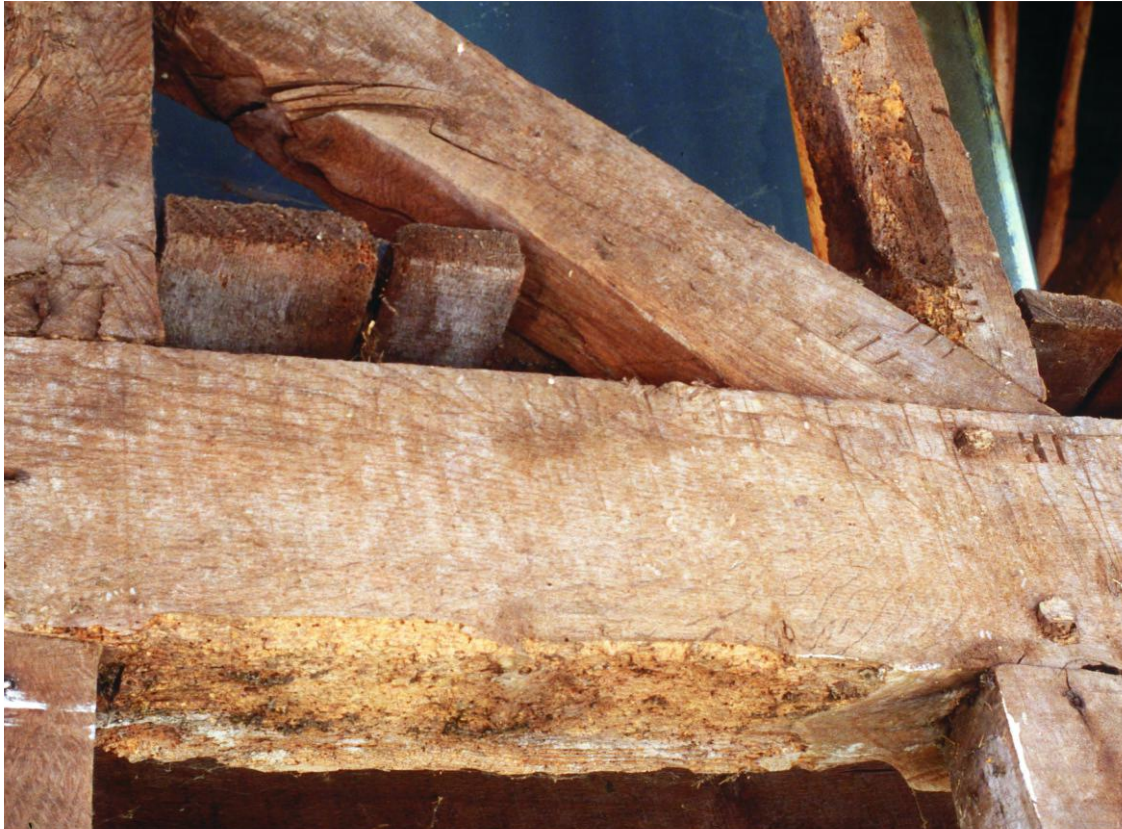
Fig 16 Carpenter's marks on a midrail and studs in the south wall of phase 1 of the barn
