## CHIMNEY EAST OF ROACH ROAD

London Borough of Hackney

A Standing building survey report

August 2008

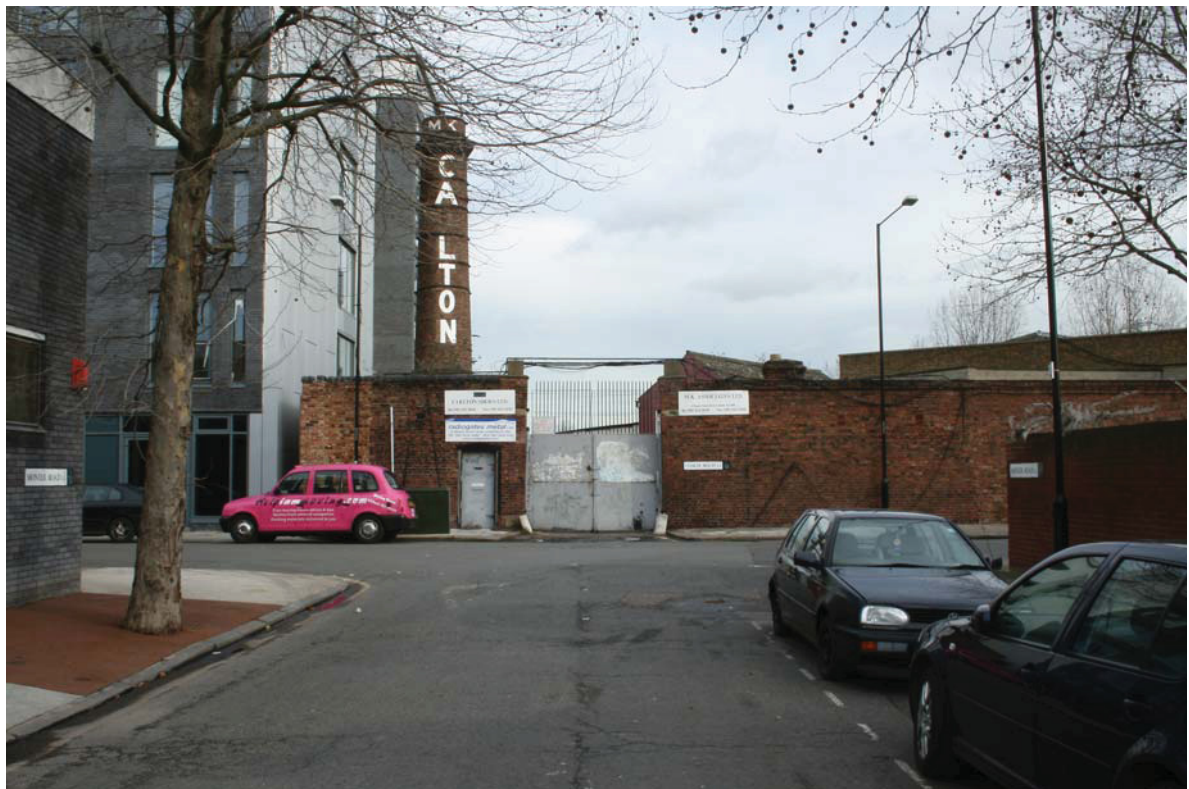
*Plate 1 View looking NE of the chimney and the boundary walls in context (32)*

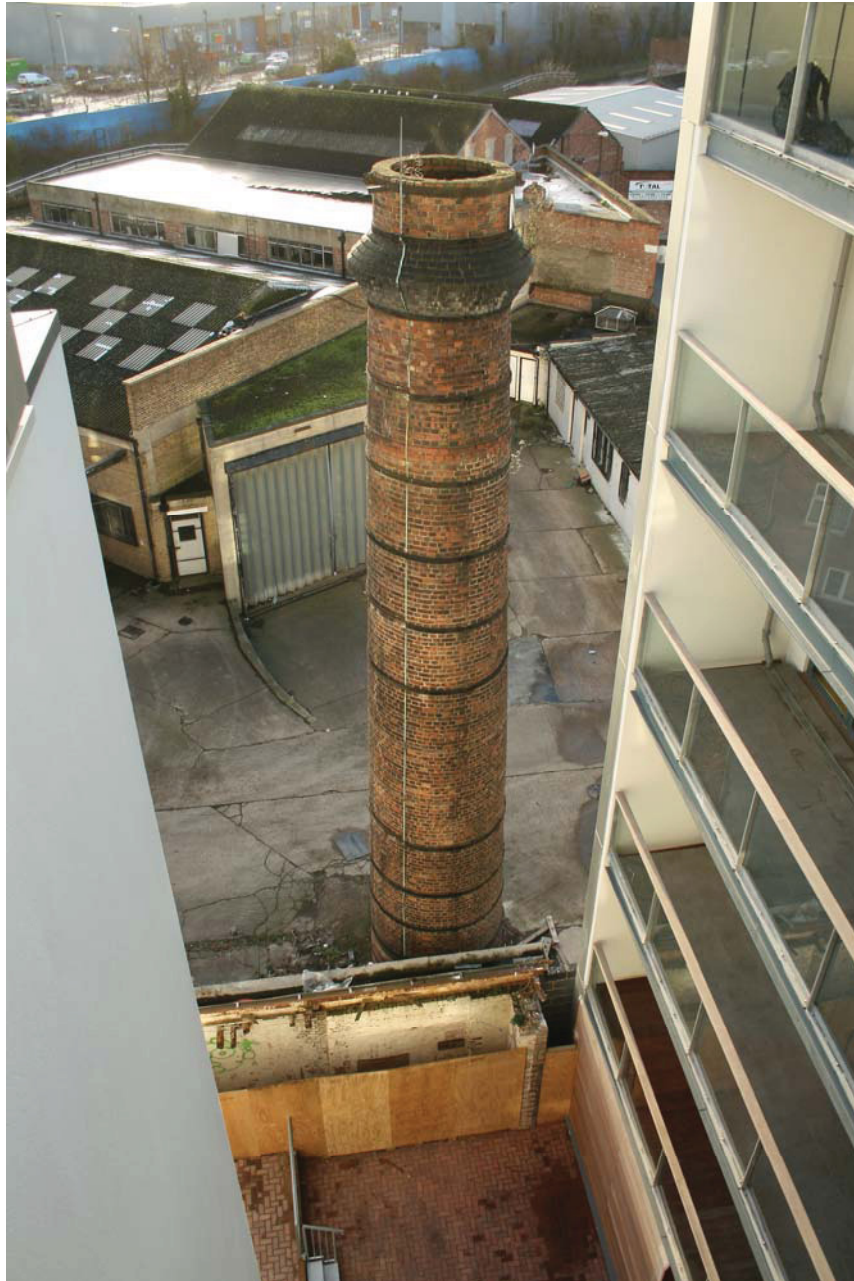
The chimney itself was constructed from red stock brick with yellow/grey mortar, laid in English bond, with 14 iron straps encircling it (Plate 2). The chimney's base measured 0.38m (four bricks) in thickness. Two of the straps are missing with one still present at the chimney's base. Each strap comprises two semi circular shaped sections bolted together on the north and south sides (respectively) of the chimney, giving support during thermal expansion and contraction.

*Plate 2 View looking SE of the chimney from the adjoining building (3)*

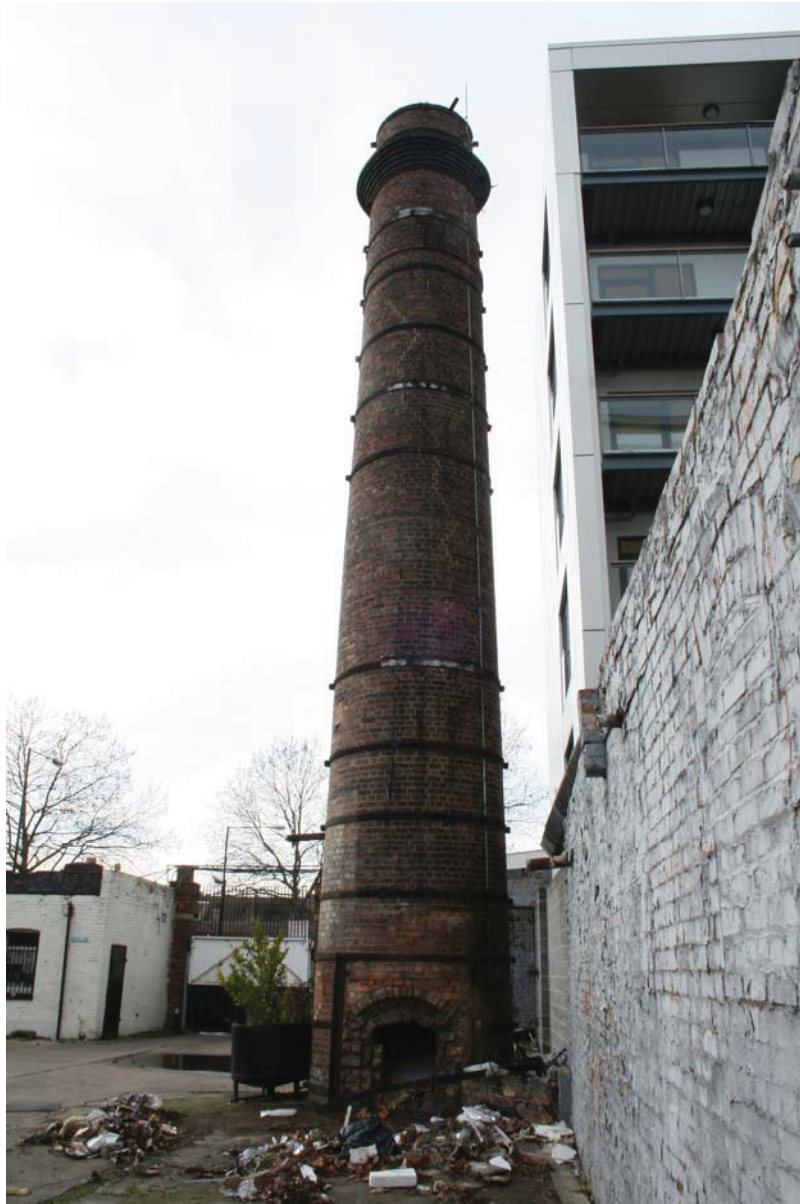
Near the top of the chimney there are six projecting string courses stepping out from the main chimney shaft and another five courses which step back in (Plate 3).

*Plate 3 View looking W of the chimney with lightning conductor (21)*

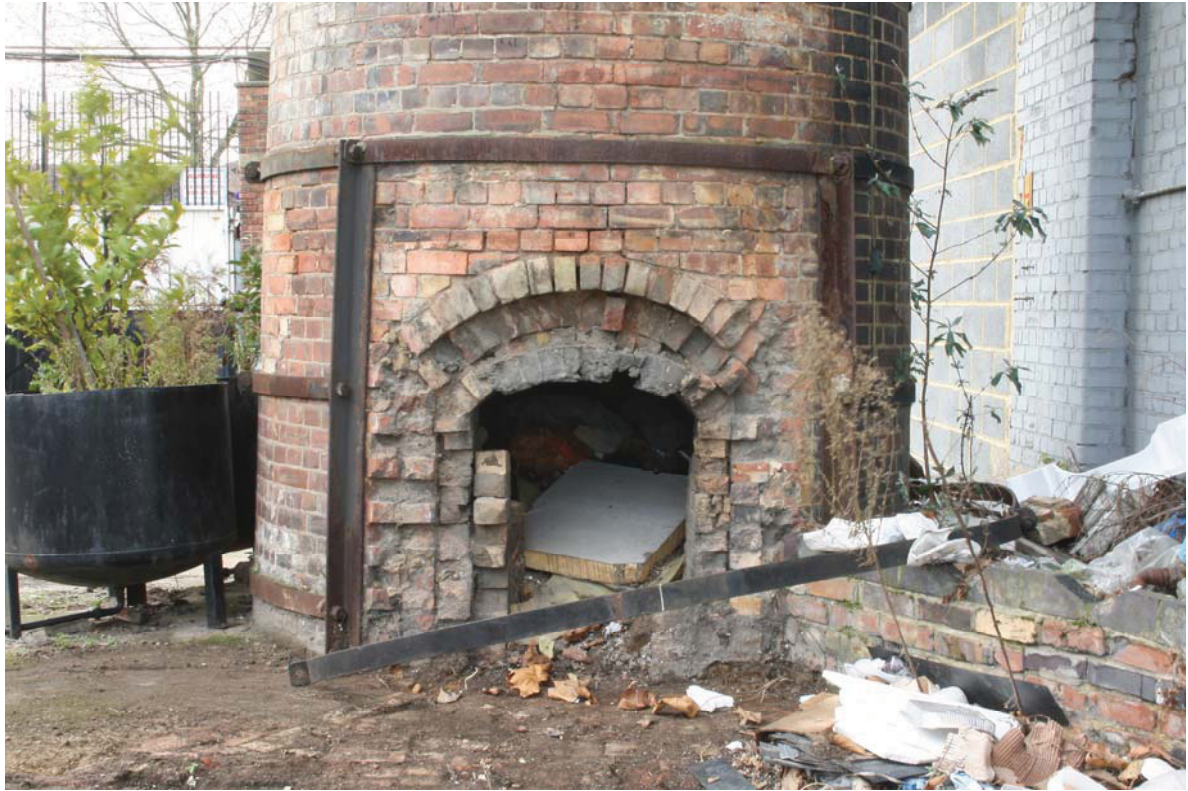
The chimney has an east facing opening at its base (Plate 4), which has a triple rowlock set arch, revealing a single course of firebrick lining, part of which has collapsed on the northern side.

*Plate 4 View looking W of the chimney opening (13)*

Either side of the opening has a vertical metal strap, both of which are attached to the first and second horizontal straps, which encircle the chimney. The rowlock arch has been heavily damaged by later demolition of a building, immediately east of the chimney, of which only the north wall is still *in situ*. The demolition has exposed the opening and has led to further damage through weathering.

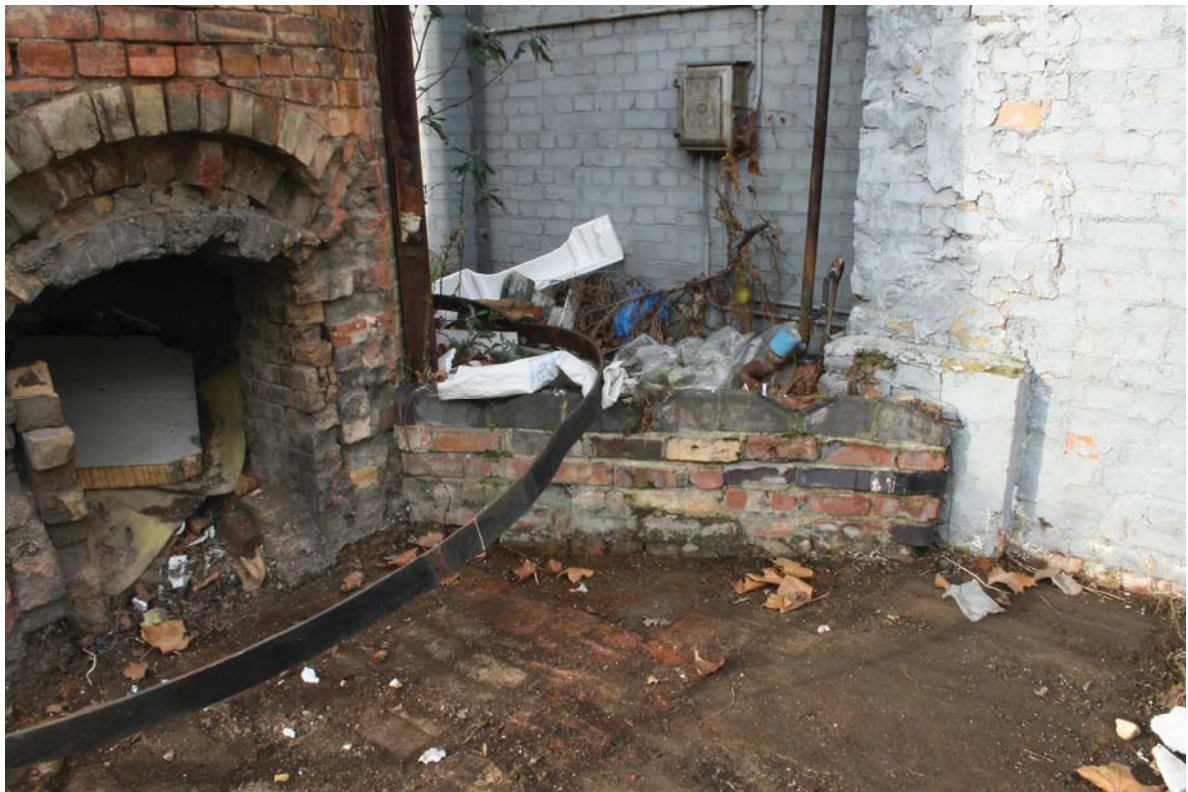
At the base of the chimney, to the right of the arch, is still visible one of the two wings (Plate 5) that were previously connecting it to the adjacent building; right in front of the arch part of the brick floor (Plate 6) laid out to help the materials handling between the inside and the outside of the chimney.

*Plate 5 View looking N of the brick floor in front of the opening (25)*

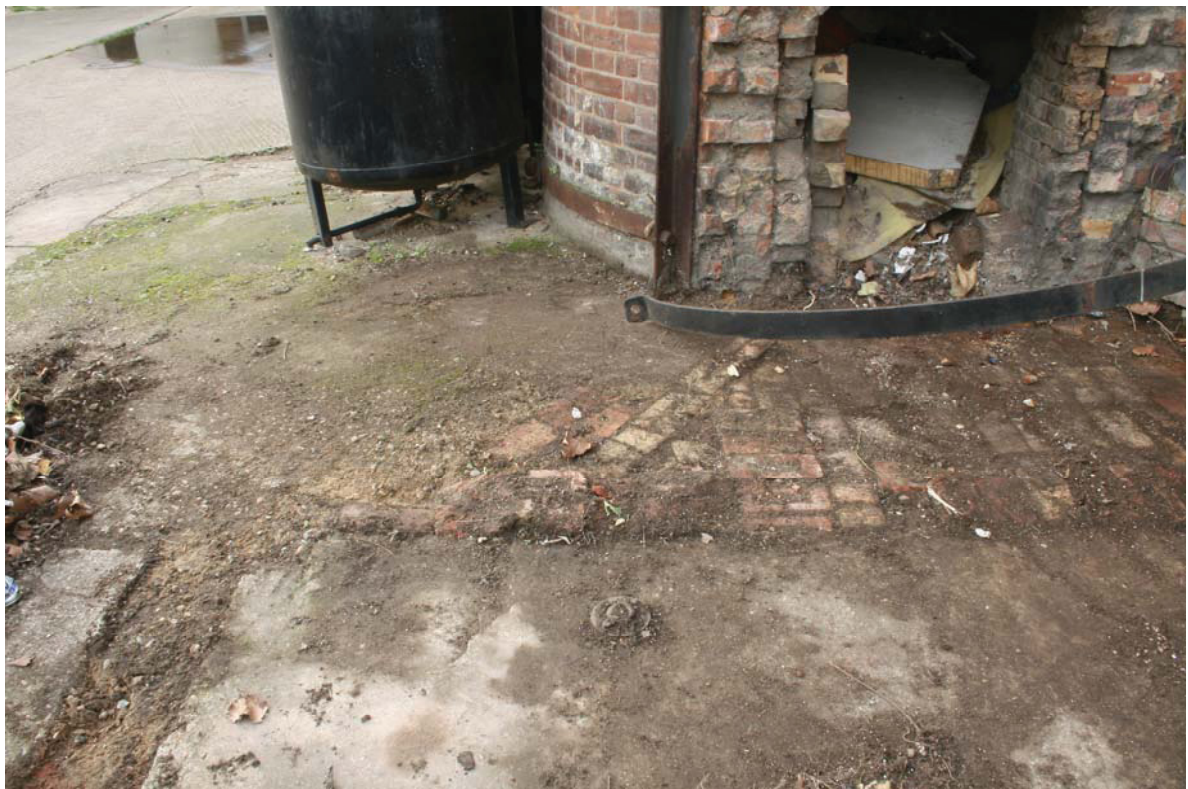
*Plate 6 View looking N of the brick in front of the opening (24)*

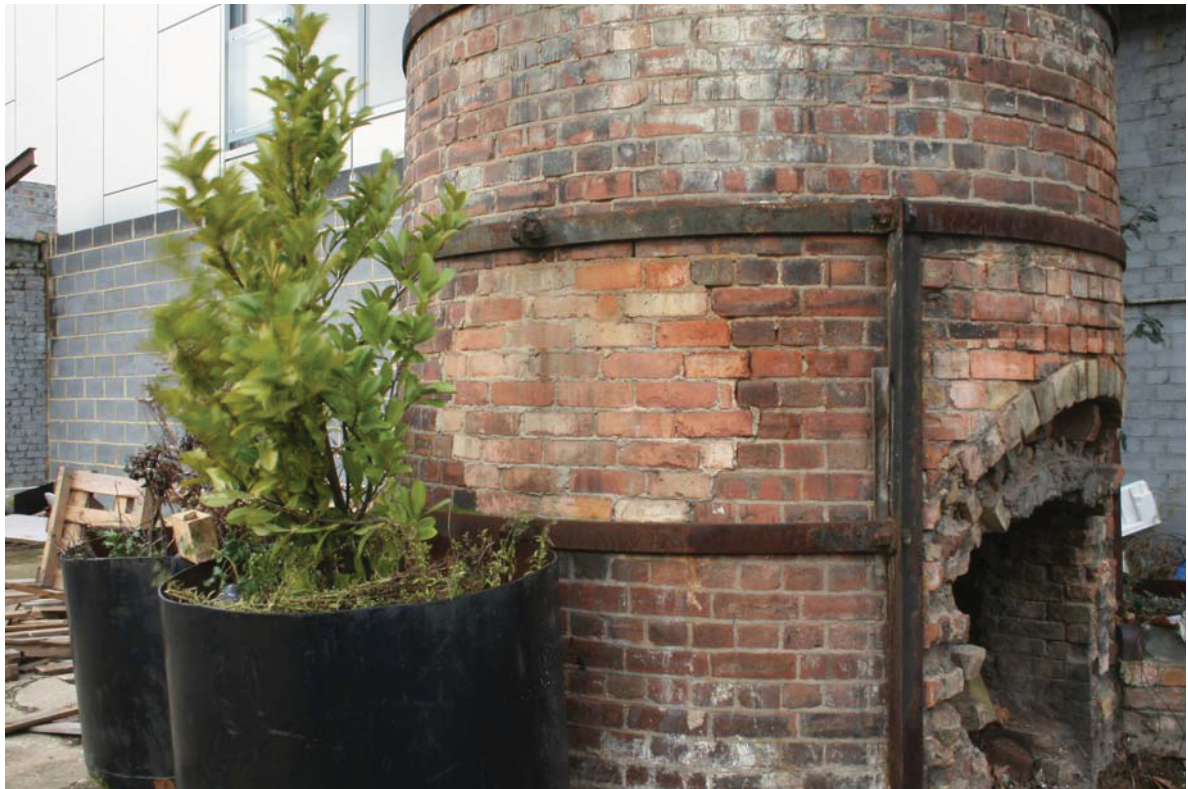
On the south-facing side of the chimney at approximately 1-1.76m from ground level there is a later repair using modern red bricks and yellow mortar (Plate 7), likely to be a blocked

Plate 7), likely to be a blocked inspection window. Another repair is visible between the sixth and seventh straps, again on the south facing side and using modern bricks and mortar

*Plate 7 View looking NW of blocked-off inspection window (16)*

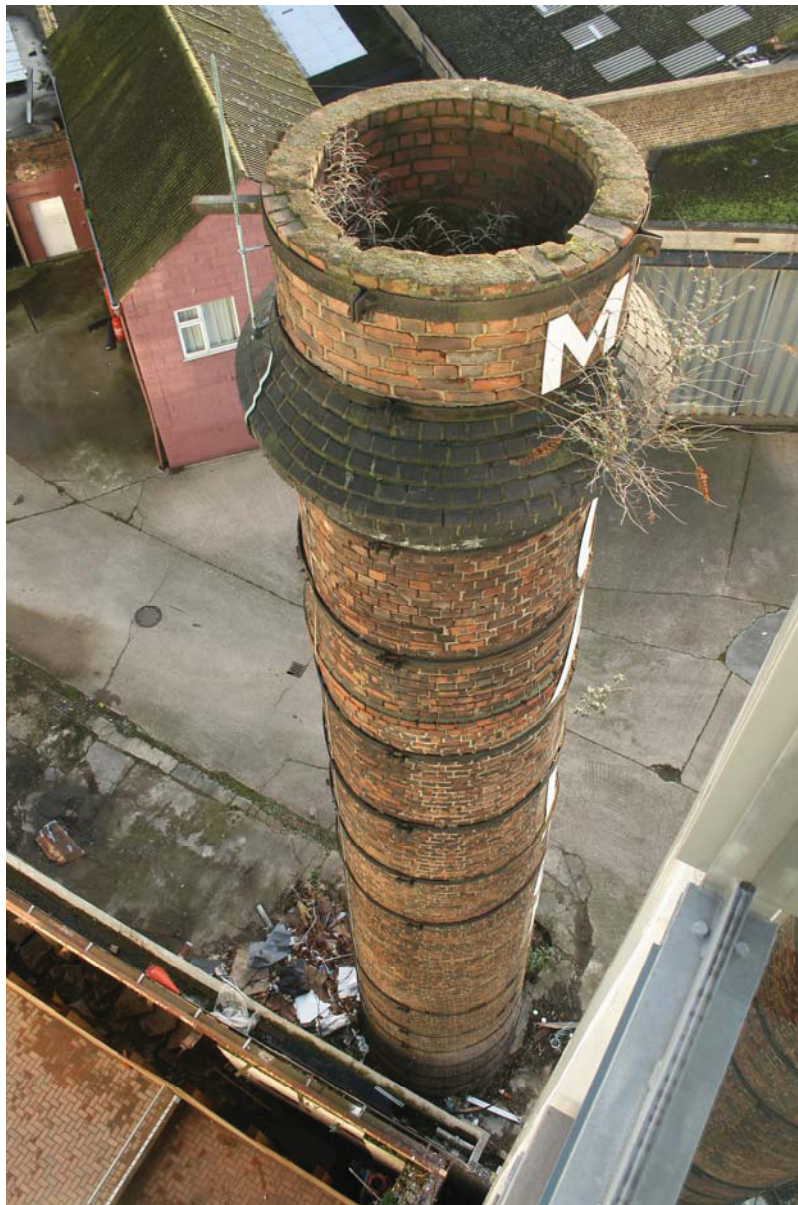
These were originally attached to the chimney with two angular wings, of which one is still visible on the floor to the east of the arched opening. The north wall of this building (Plate 8) is all that remained of the original structure and had undergone various alterations and additions since its original construction.

*Plate 8 View looking E of the chimney from the adjoining building (2)*

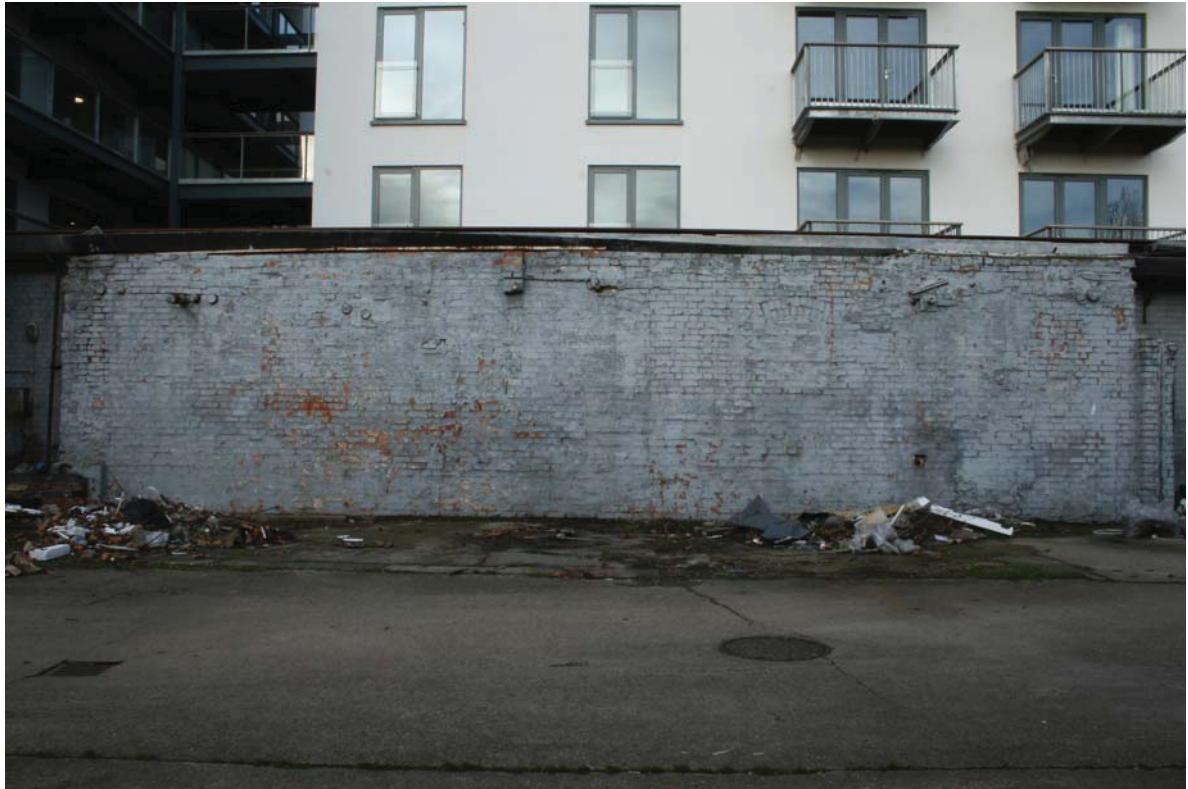
*Plate 10 View looking N of the perimeter wall to the east of the Chimney (7)*
